SUMMARY

1234 Main St. Summerside PE C1N 4J9

Robert Dunn
interNACHI Certified Home...
Dunn Right Inspections
902 432 4776
rob@dunnrightinspections.com

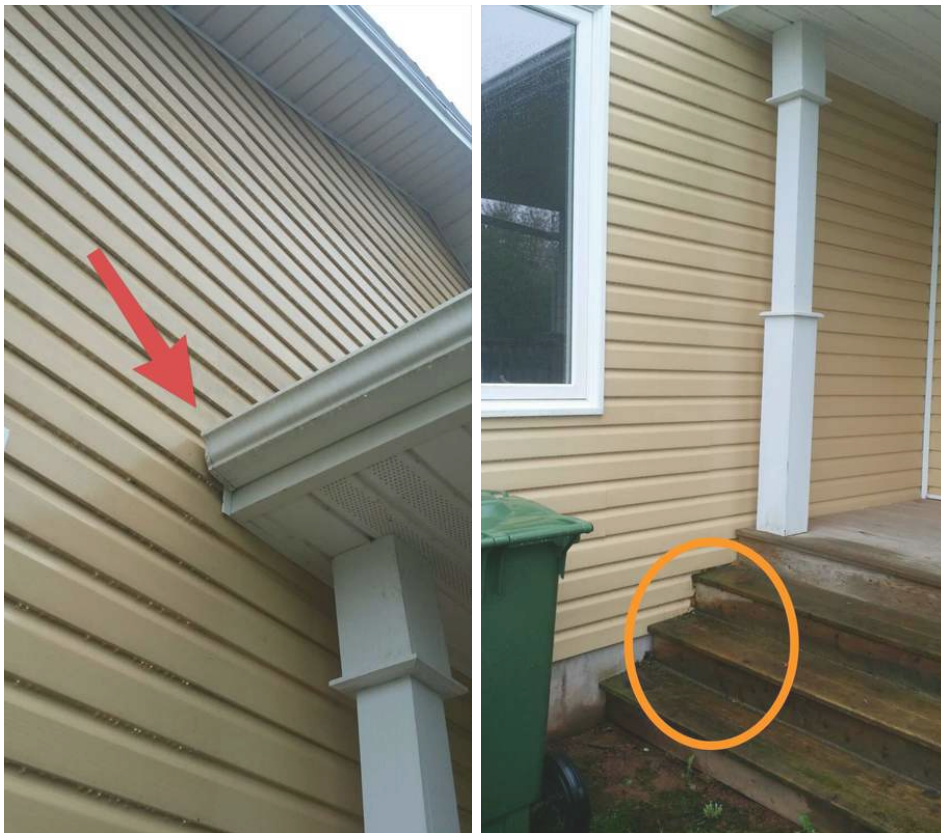
2.3.1 Flashings

MISSING

Kickout Flashings is missing at time of inspection. Flashings provide protection against moisture intrusion. Recommend a qualified roofing contractor evaluate and remedy.

Water over flowing gutter landing on porch steps due to missing Kickout Flashing

Contact a qualified roofing professional.

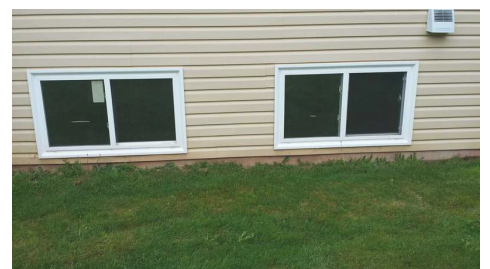
3.7.1 Windows

EGRESS WINDOW - EXIT

Recommend installing ladder or means to escape from the egress area.

Contact a qualified professional.

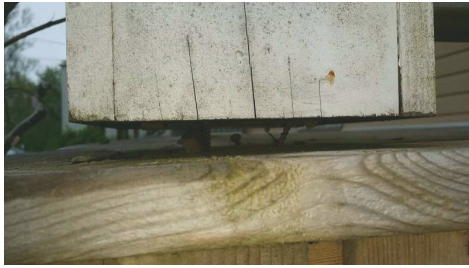
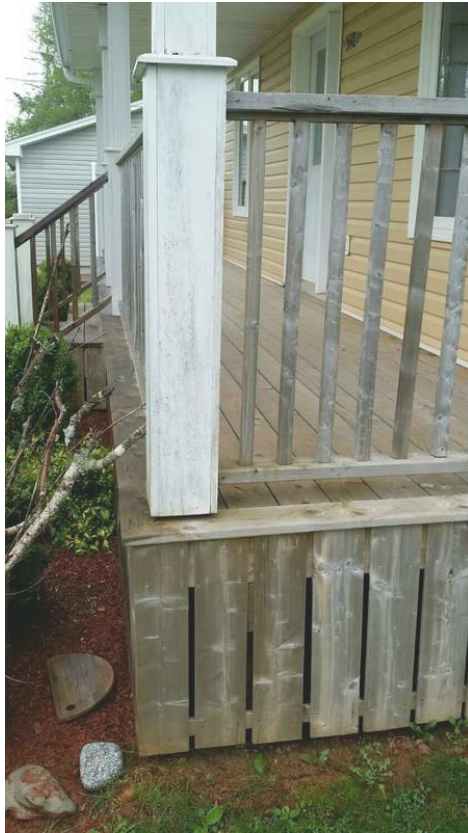
3.8.1 Decks, Balconies, Porches & Steps

COLUMN SUPPORT NOT ATTACHED TO PORCH

Recommend column be mechanically attached to porch floor as a means to better secure them.

Contact a qualified professional.

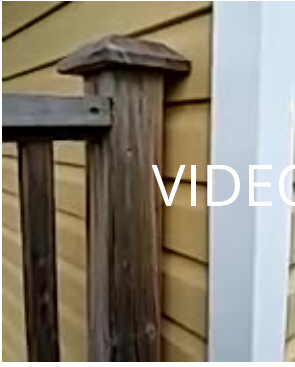
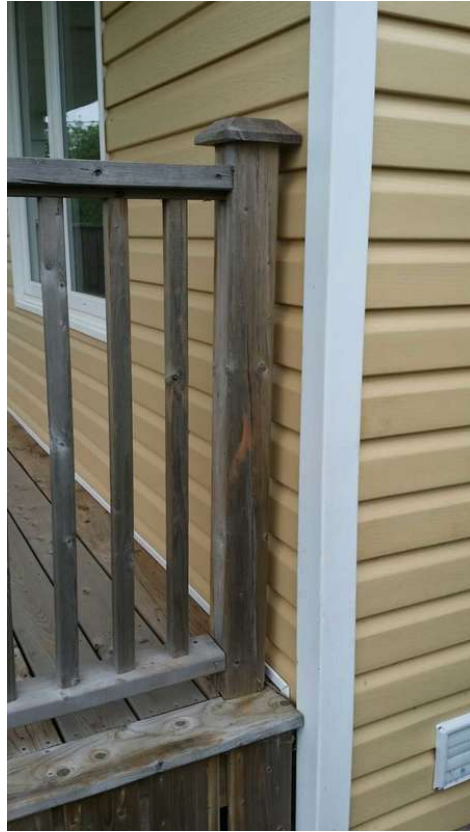
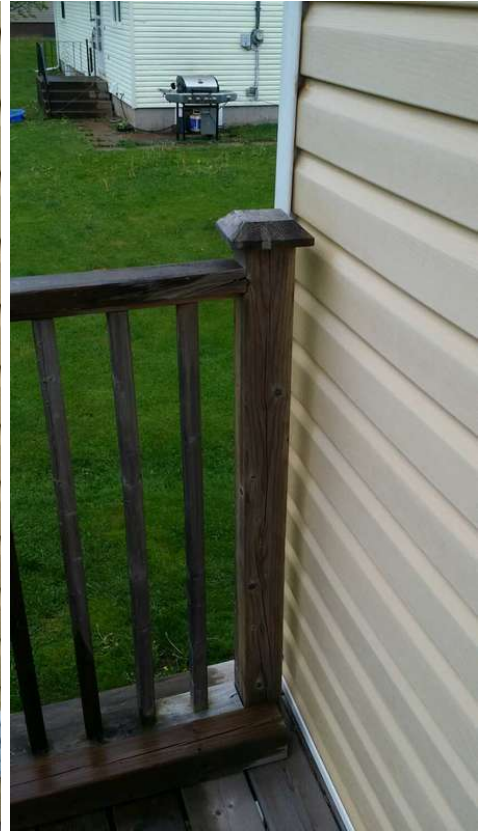
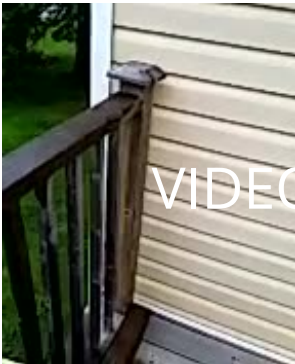
3.8.2 Decks, Balconies, Porches & Steps

LOOSE RAILING

PORCH AND BACK DECK

Loose Railing can create a possible fall hazard, recommend repair

Contact a qualified professional.

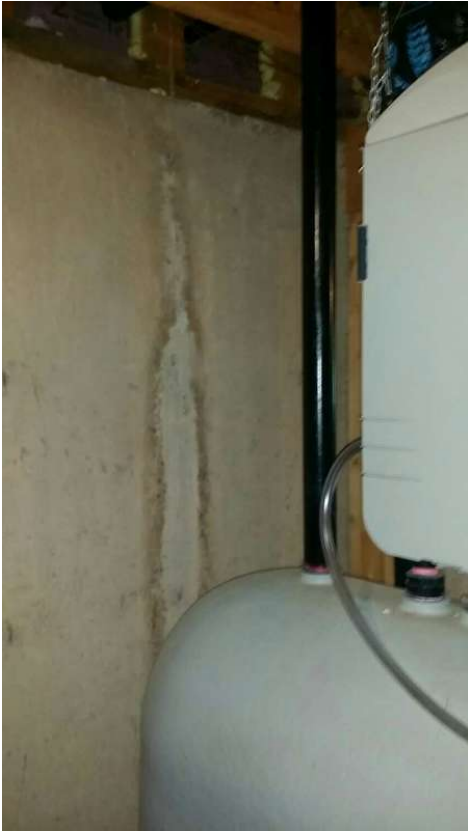
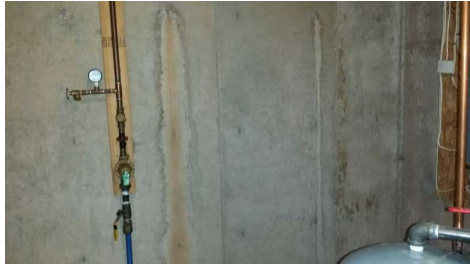
4.2.1 Foundation

EFFLORESCENCE OBSERVED

This is a mineral deposit left behind from exterior water infiltration.

Contact a qualified professional.

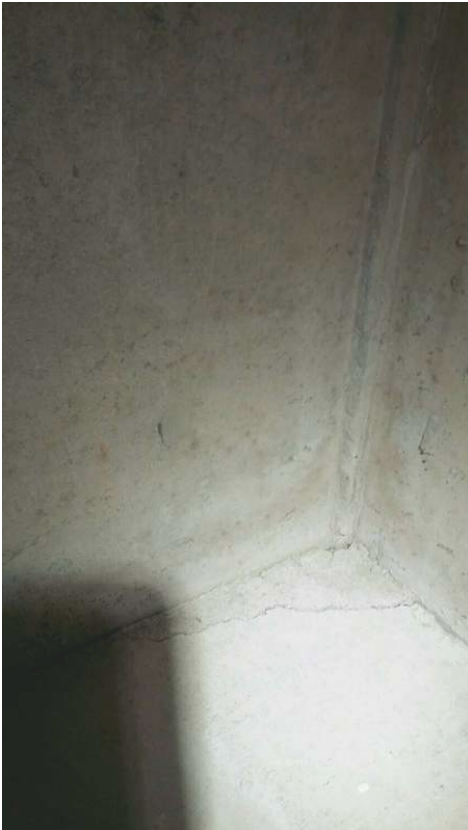
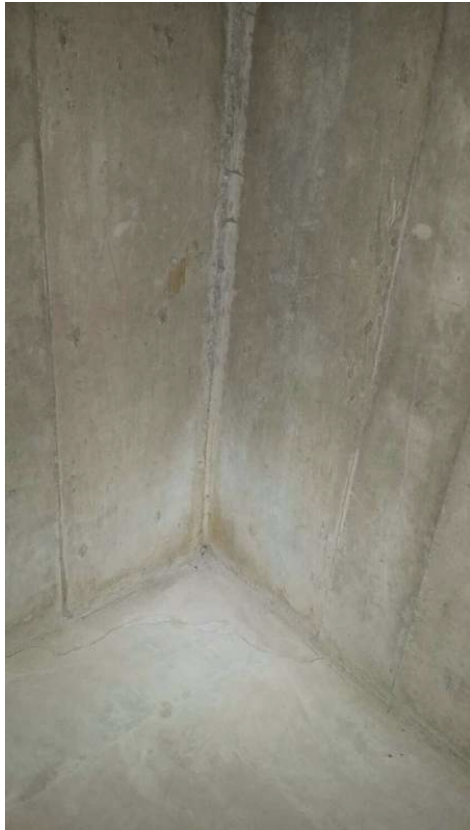
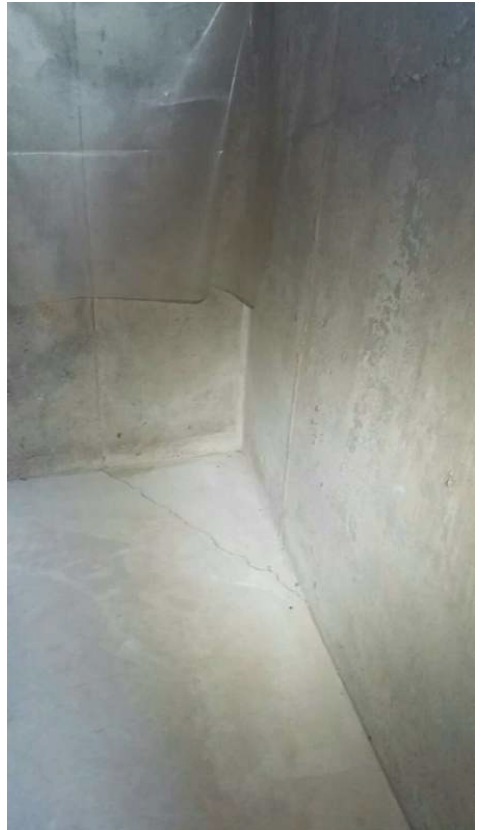
4.2.2 Foundation

HEAVING/SETTLING

The floor slab shows slight movement/settling due to soil movement.

Contact a qualified structural engineer.

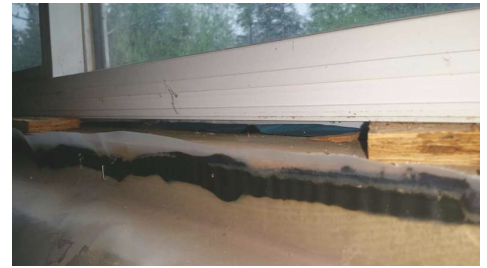
4.4.1 Vapor Retarders
(Crawlspace or Basement)

GAPS OBSERVED

BASEMENT

Contact a qualified professional.

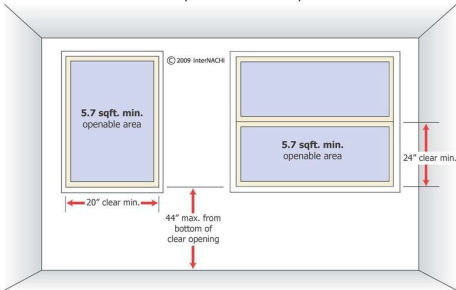
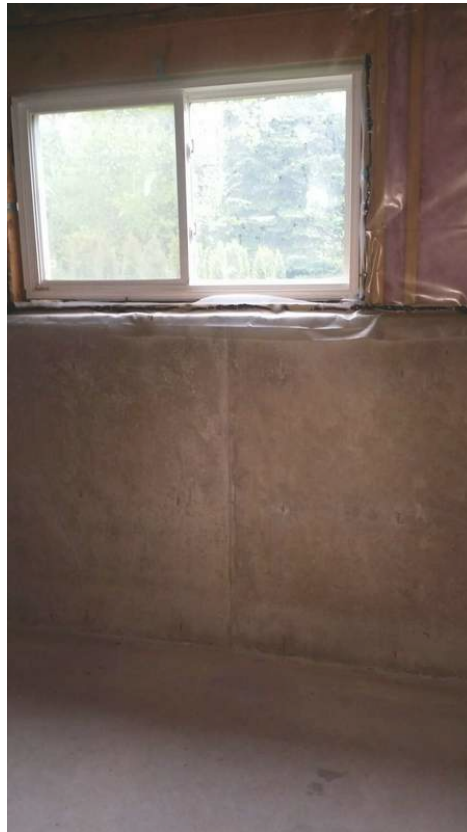
4.5.1 Emergency Basement Egress
EGRESS MAY NOT MEET CODE

Windows are 54 inches off the floor

Contact a qualified general contractor.

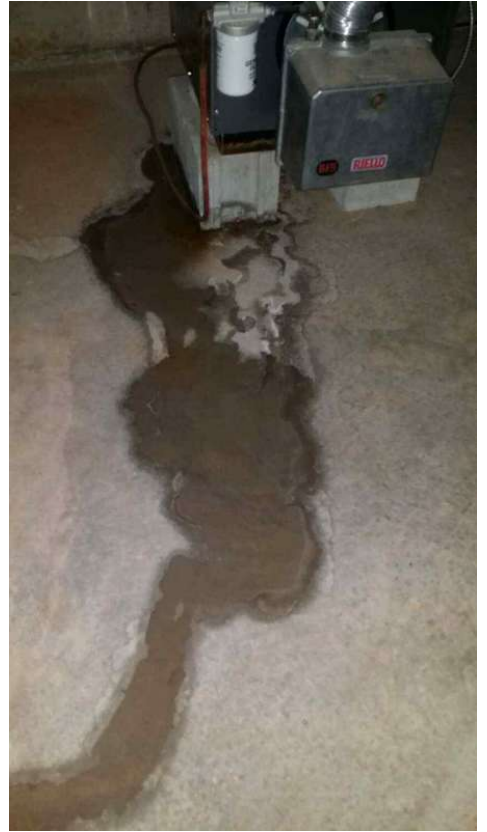
6.4.1 Hot Water Systems,
Controls, Flues & Vents

**WATER STAINS -
LEAKAGE**

BASEMENT

Water stains were observed beneath water heater, indicating a past or present leak. Leak was gone when I returned one week later.

Recommend further evaluation and repair by a qualified plumber.

Contact a qualified plumbing contractor.

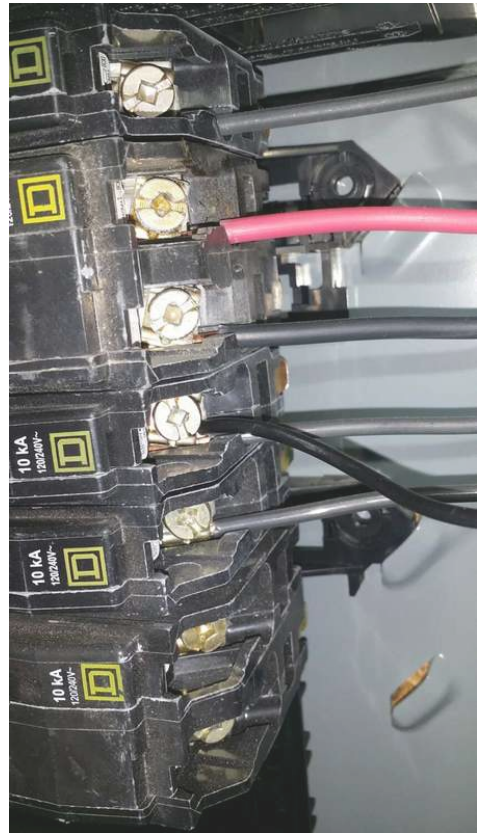
7.2.1 Branch Wiring Circuits,
Breakers & Fuses

DOUBLE TAPPED HOT CONDUCTORS

One or more electrical circuits were double tapped. This means that two or more wires are connected to a circuit breaker that is only designed to accept one wire. This looks like is a low Voltage wire for security system. Recommend that further inspection and repair by electrical contractor.

Recommendation
Contact a qualified electrical contractor.

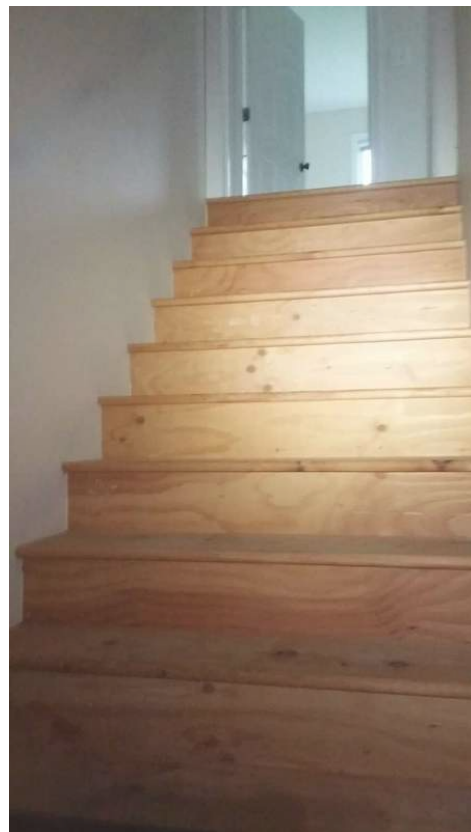
8.8.1 Steps, Stairways & Railings

Major Concern / Safety Hazard

NO HANDRAIL

BASEMENT

Staircase had no handrails. This is a safety hazard. Recommend a qualified handyman install a handrail.

Recommendation
Contact a qualified handyman.

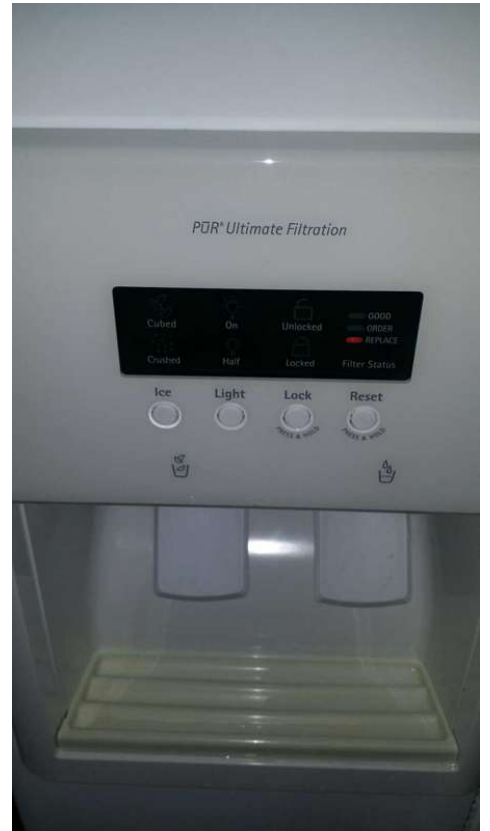
11.5.1 Refrigerator

ICE MAKER WATER DISPENSER

Ice maker was not operable and not tested. Recommend confirming operation of units prior to closing.

Recommendation
Contact a qualified professional.

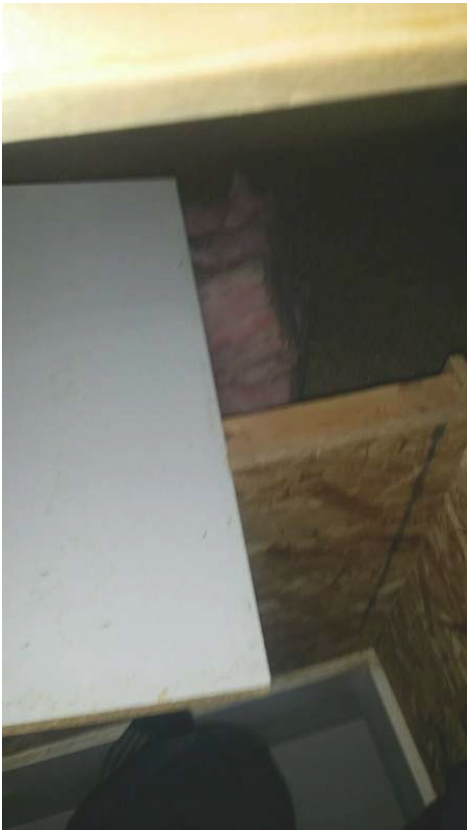
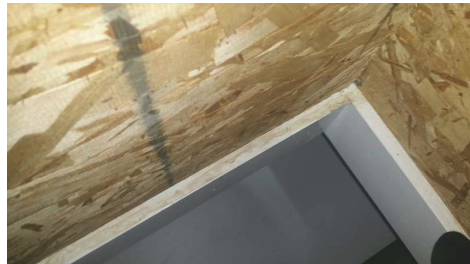
17.1.1 Attic Insulation

SEAL AROUND ATTIC ACCESS PANEL NEED TO BE REPLACED

Moist air escaping into the attic space can cause mold and wood decay.

Contact a qualified professional.
