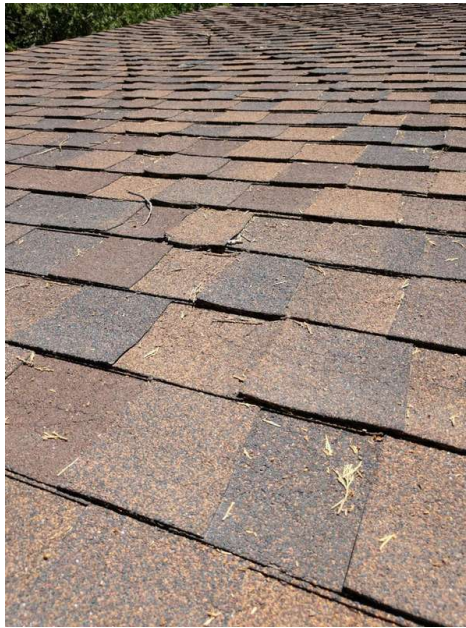
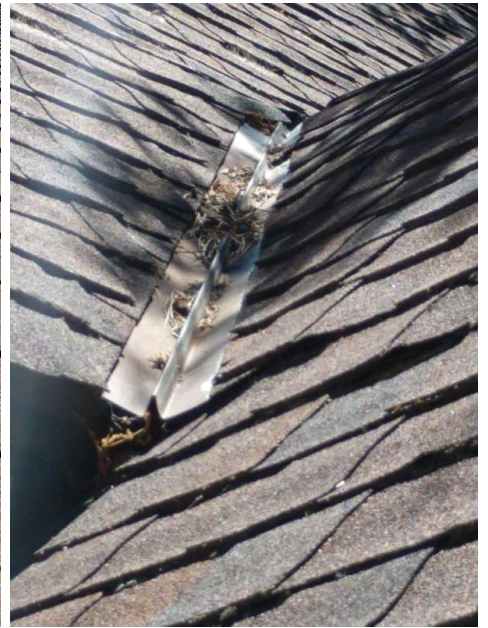
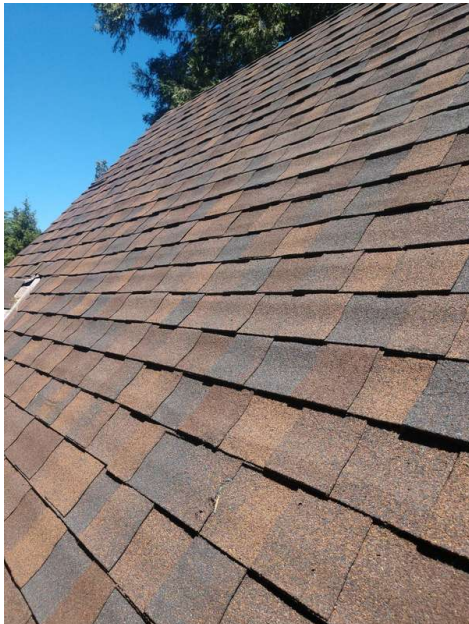
2.1.1 Coverings

**CURLING**

GARAGE, CARPORT, HOUSE

Observed the roof covering to be curling at the corners and edges. This is a sign of age and also the effects of moisture beneath.

Recommend further evaluation by a licensed roofing contractor.

Contact a qualified roofing professional.

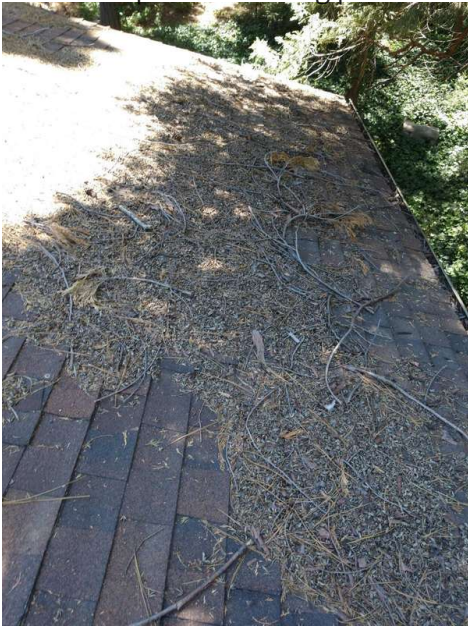
2.1.2 Coverings

**DEBRIS**

AREAS UNDER AND NEAR TREES.

Debris observed on roof surface. Recommend removal.

Contact a qualified roofing professional.

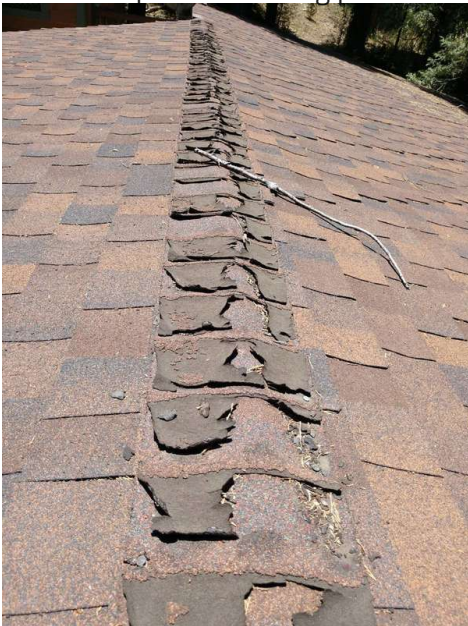
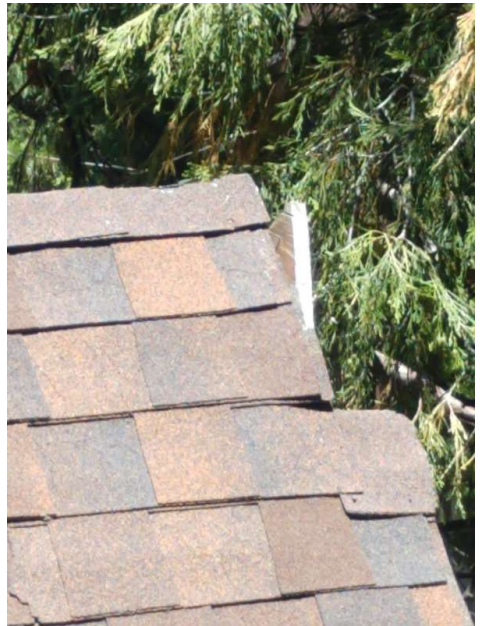
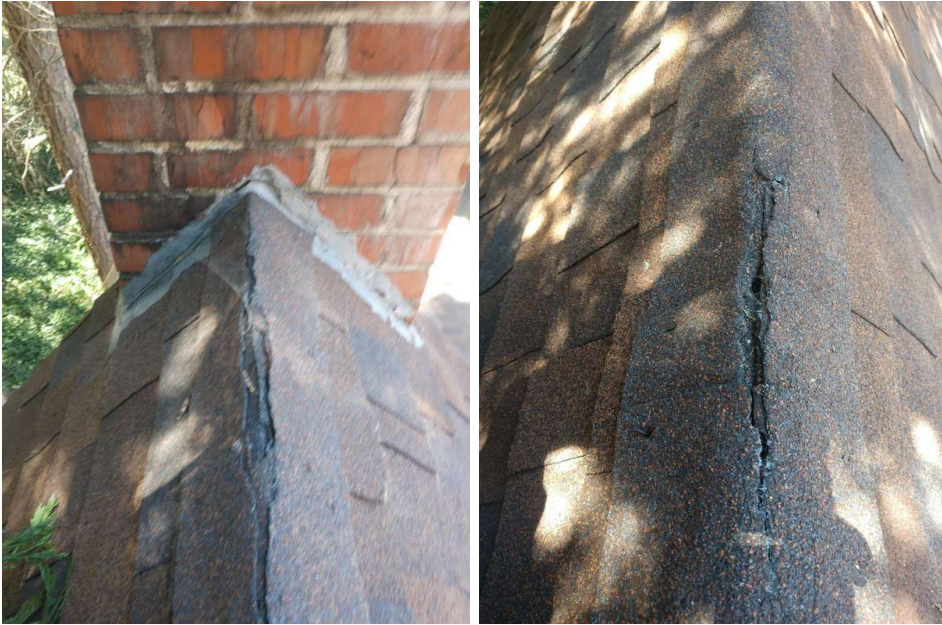
2.1.3 Coverings

**DAMAGED (GENERAL)**

RIDGES, LOWER PITCHED ROOFS.

Roof coverings showed moderate damage. Recommend a qualified roofing professional evaluate and repair.

Contact a qualified roofing professional.

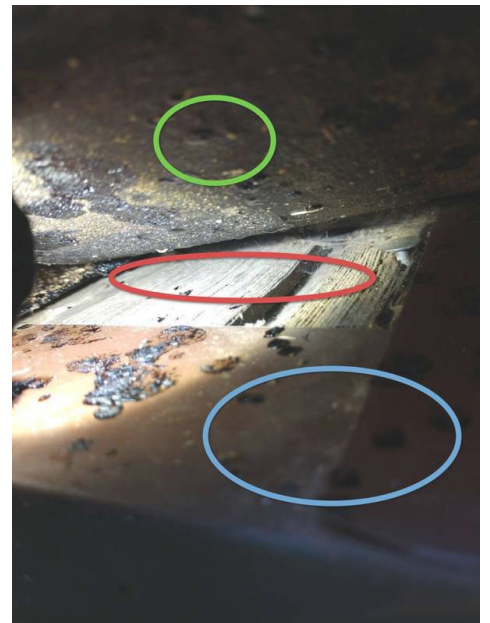
2.1.4 Coverings

**MULTIPLE LAYERS**

Observed at least 2 layers of roofing on the Garage and carport, and what appears to be a layer of roofing underneath the top layer covering the House. Roofing over an existing layer significantly reduces the lifespan of the material being installed.

Green circle - bottom of fiberglass shingle  
 Red circle - previous roofing material, wood shingle or shake  
 Blue circle - metal drip edge

Recommend monitoring and consulting a licensed roofing contractor for evaluation and repairs as needed.

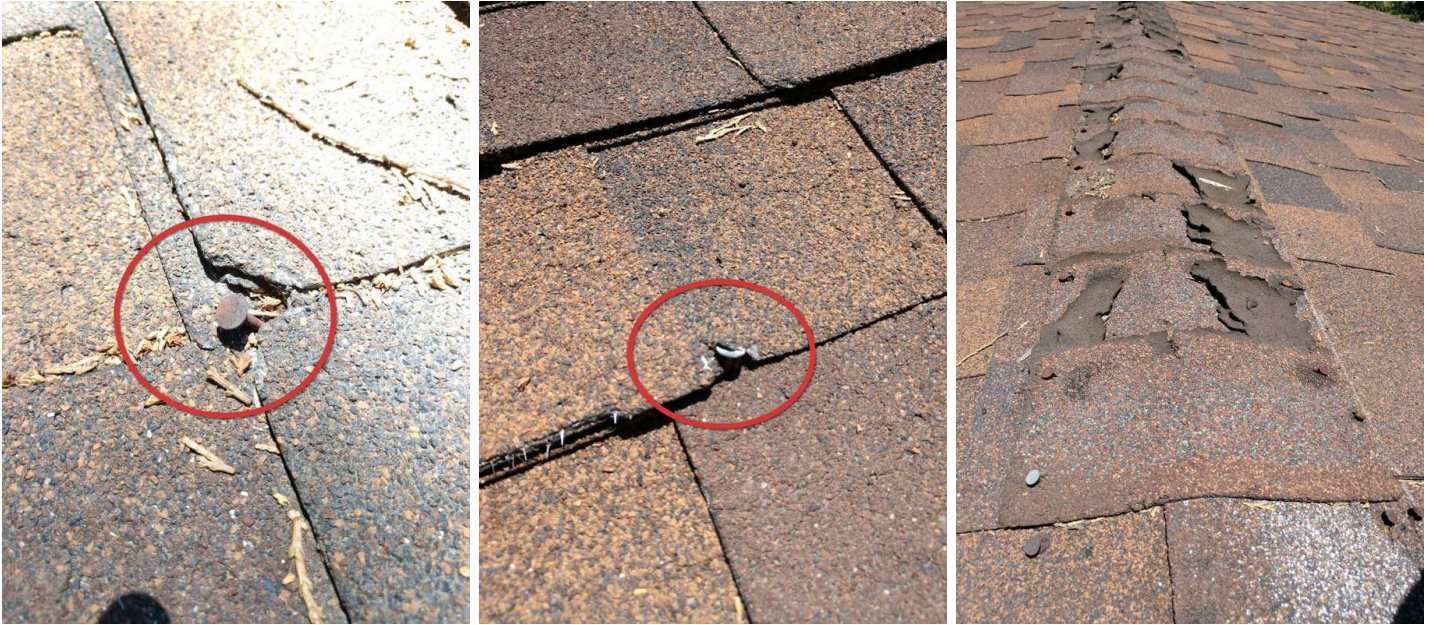
2.1.5 Coverings

**FASTENERS MISSING OR EXPOSED**

Observed missing or unsealed fasteners at ridge caps and roof to wall intersection. This could allow unwanted water entry below roof covering and underlayment, damage to these components, shortened life span of roof covering and sheathing, water intrusion into attic damaging insulation and interior ceilings.

Recommend licensed roofing contractor evaluate and correct.

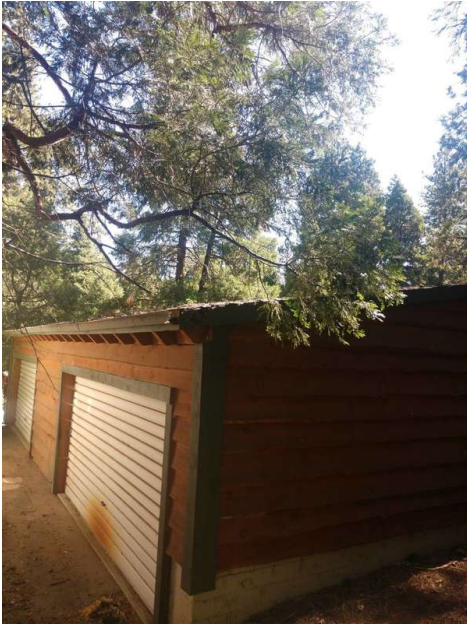
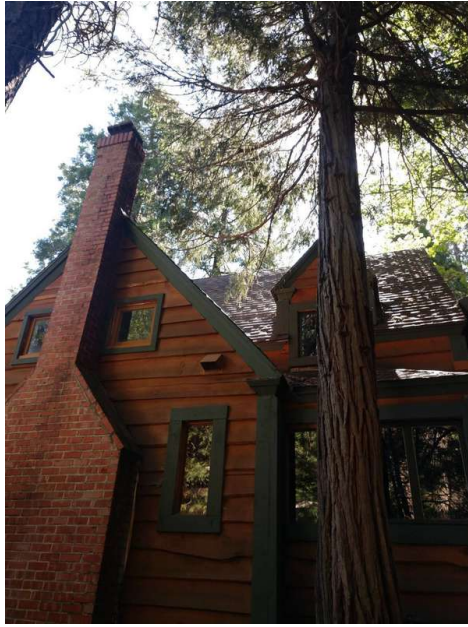
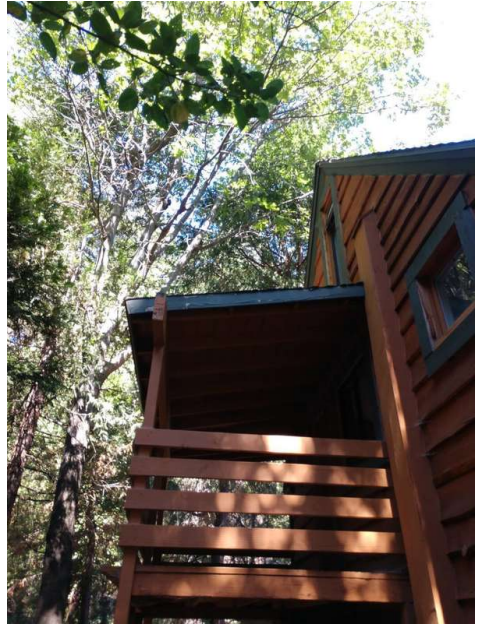
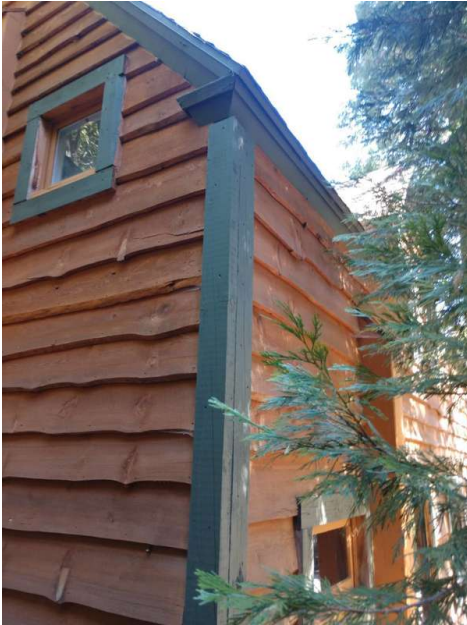
Tree branches are in contact with roof covering and structure. Tree limbs and branches can physically damage the wall coverings and roof coverings and can drop debris that can block valleys and gutters and hasten the deterioration of roof coverings. Tree limbs and entire trees can fall during high wind events.

Recommend evaluation and correction by licensed tree contractor.

Contact a qualified tree service company.

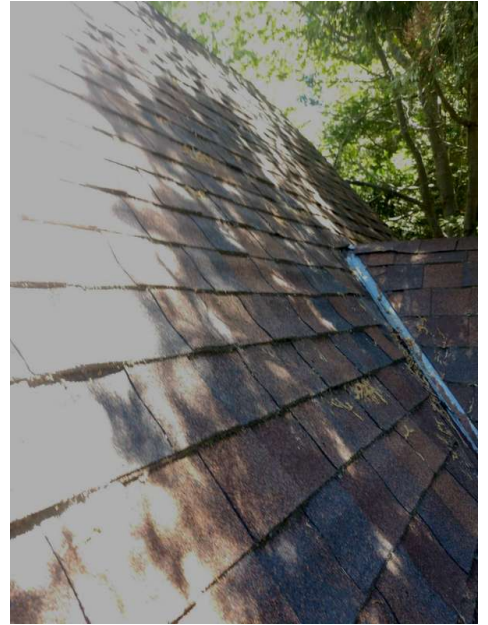
Observed bulges below the roof covering material. The ceiling covering inside is attached to the roof rafters, limiting access to view the inside of the roof sheathing.

Recommend evaluation by a licensed roofing contractor.

Contact a qualified roofing professional.

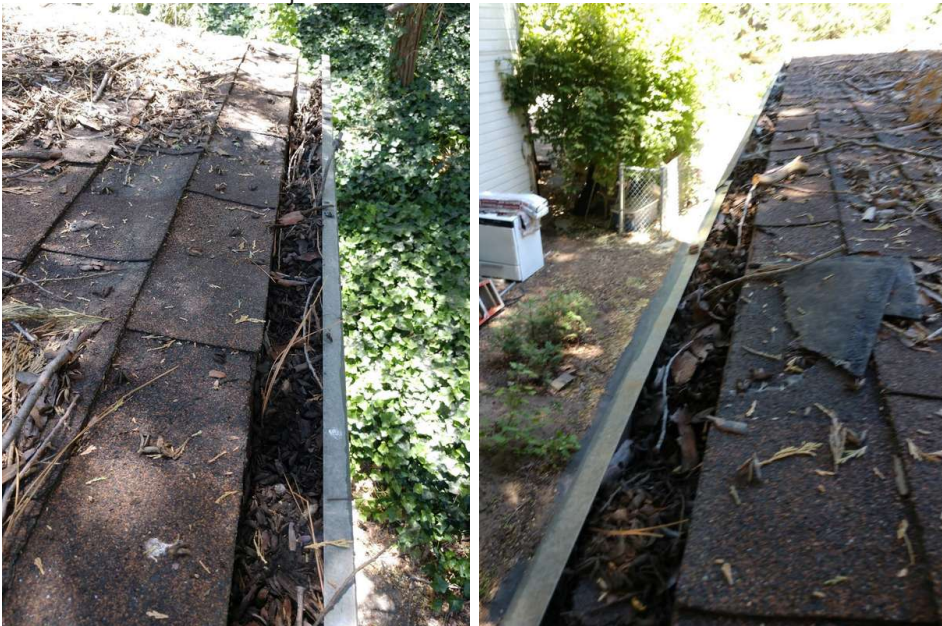
### 2.2.1 Roof Drainage Systems

#### **DEBRIS**

Debris has accumulated in the gutters. Recommend cleaning to facilitate water flow.

Recommended DIY Project

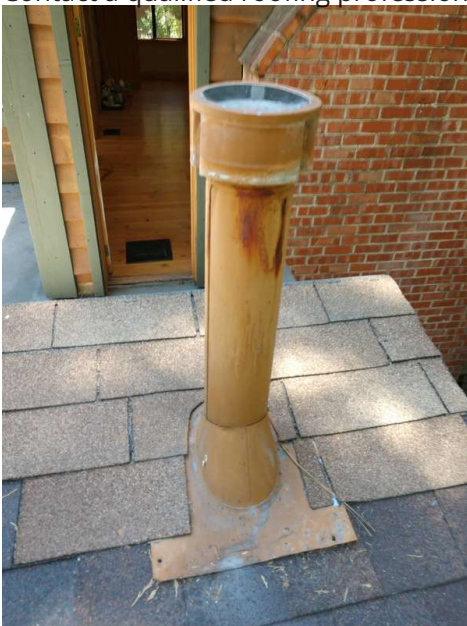
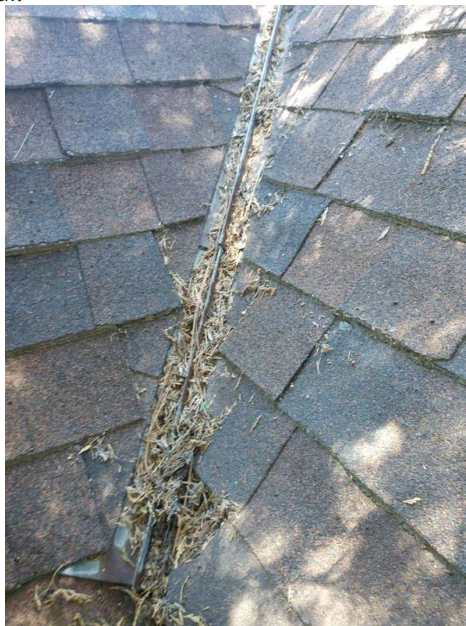
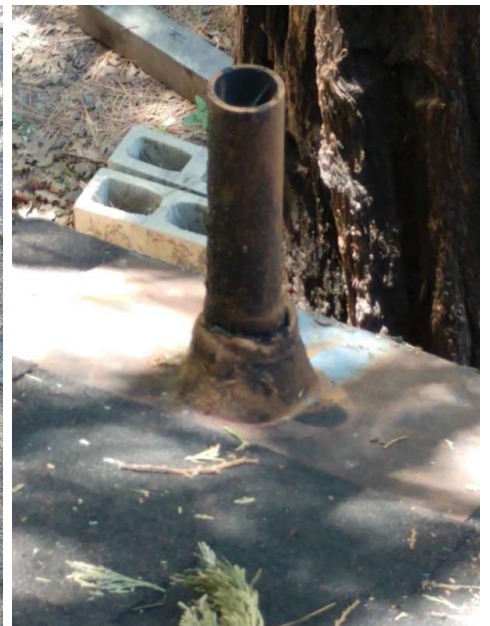
**CORRODED - MINOR**

Roof flashings showed signs of minor corrosion and are still in working condition. Flashings should be cleaned and painted to prevent severe corrosion leading to moisture intrusion.

Recommend annual maintenance to all roof penetration flashings by a licensed roofing contractor.

Recommendation  
Contact a qualified roofing professional.

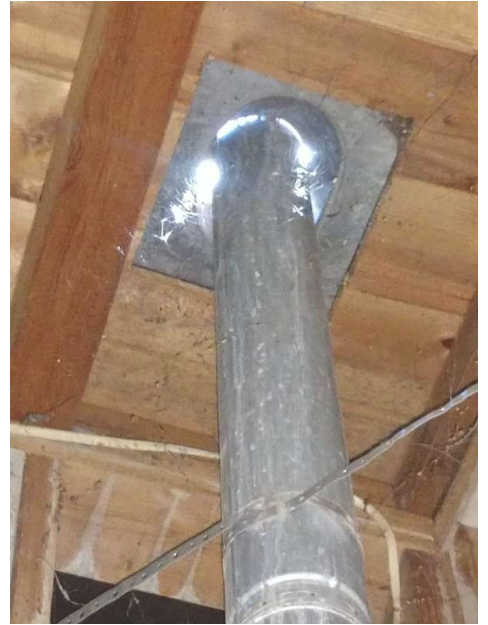
### 2.3.2 Flashings

#### **LOOSE/SEPARATED**

Flashings observed to be loose or separated from the penetrating pipes, which can lead to water intrusion and/or mold.

Recommend a qualified roofing contractor patch and seal.

Contact a qualified roofing professional.

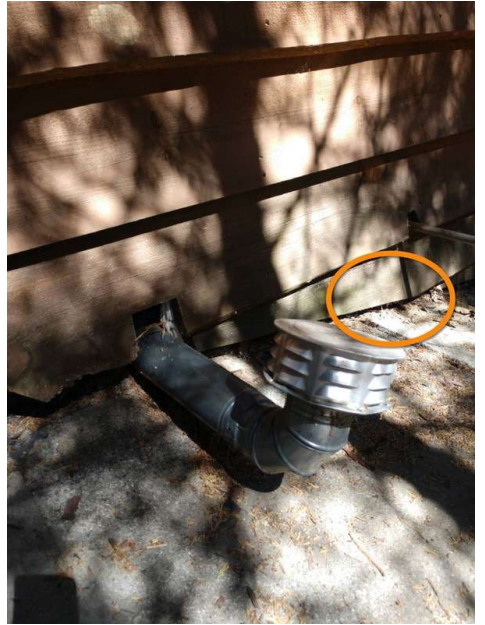
#### **INADEQUATE GROUND CLEARANCE**

Inadequate clearance between siding and ground. Recommend a minimum ground clearance between bottom of siding and ground of 2" to 4". Siding in contact with the ground or soil is a serious concern, the reasoning is that condition can provide direct access for wood destroying insects and excessive moisture absorption.

Recommend clearing soil and ground cover away from the siding where necessary, and trimming the siding as needed at concrete flat work. Consult a licensed siding contractor if this is not a DIY project.

Contact a qualified siding specialist.

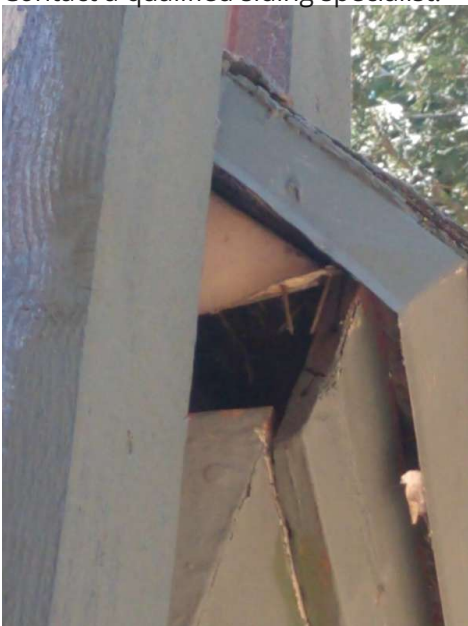
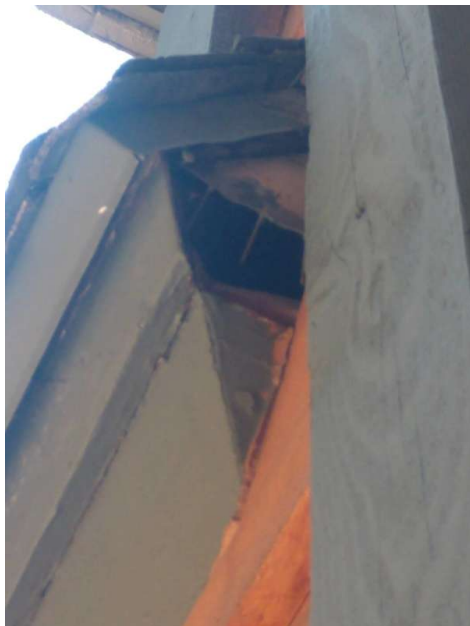
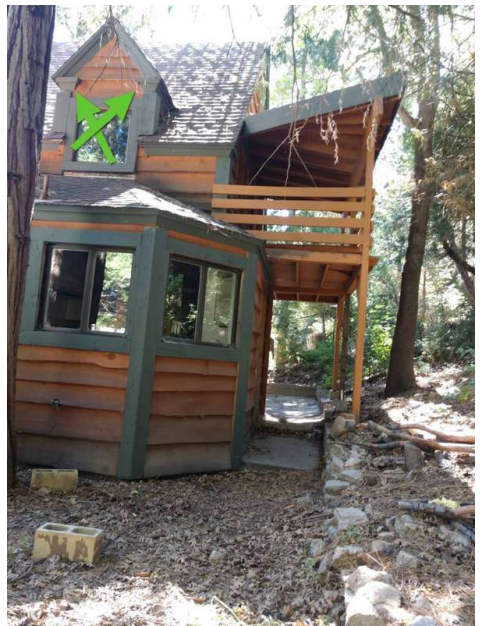
3.1.2 Siding, Flashing & Trim

**SIDING - VISIBLE GAP**

Observed a visible gap in the siding. This could allow excess moisture, as well as vermin into the structure. Recommend consulting a licensed siding contractor to evaluate and correct

Contact a qualified siding specialist.

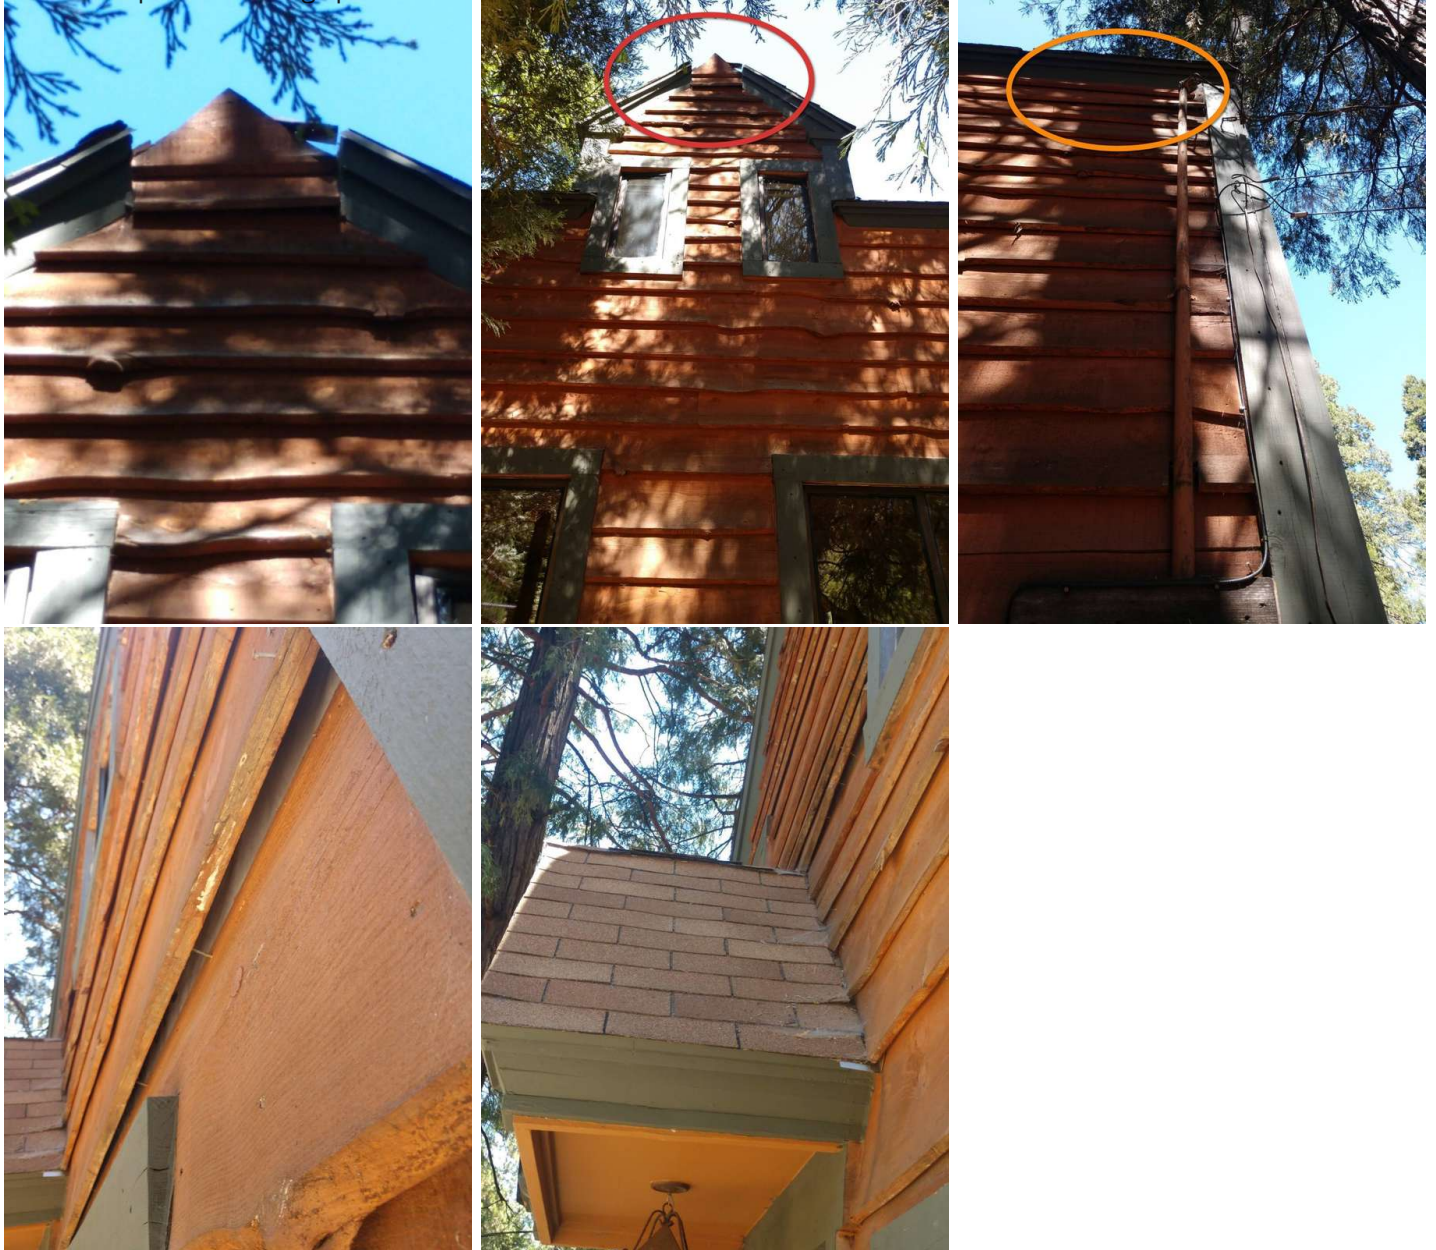
3.1.3 Siding, Flashing & Trim

**LOOSE BOARDS**

One or more siding boards were loose, which could result in moisture intrusion. Slab siding continues to cure long after it is installed, this is a common occurrence.

Recommend consulting a licensed siding contractor with experience in slab wood siding to secure and fasten.

Contact a qualified siding specialist.

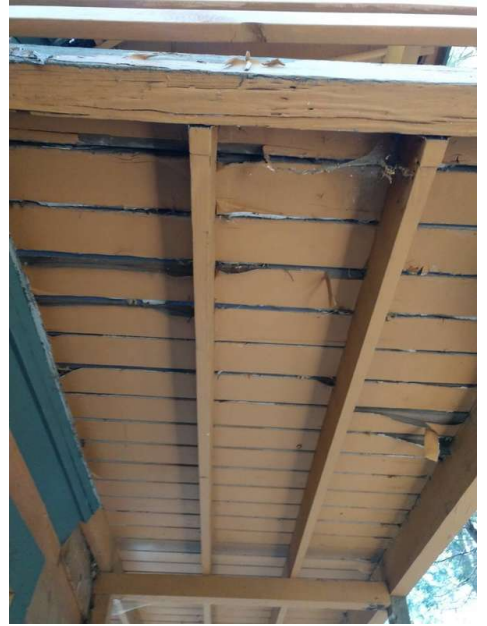
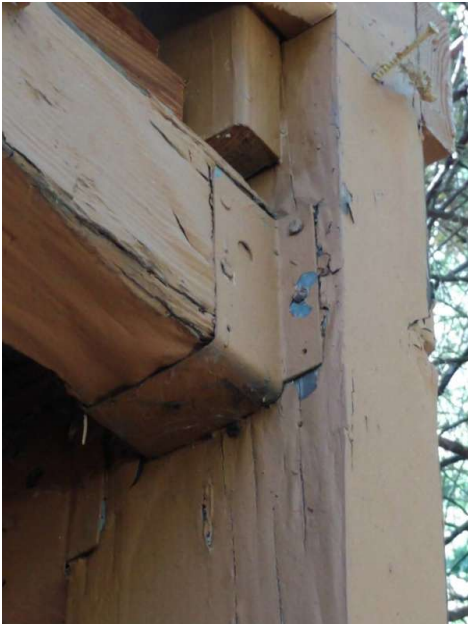
3.1.4 Siding, Flashing & Trim

**PAINT DAMAGE**

Observed damaged/aged paint on deck, siding and trim. A sound finish will extend the life of the materials.

Recommend evaluation and correction by a licensed painting contractor.

Recommendation  
Contact a qualified painter.

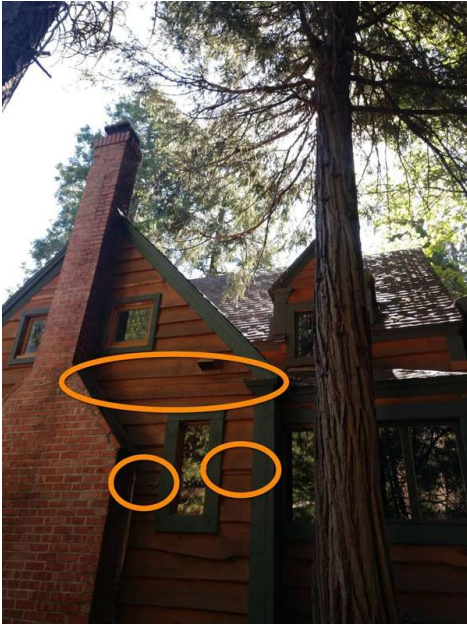
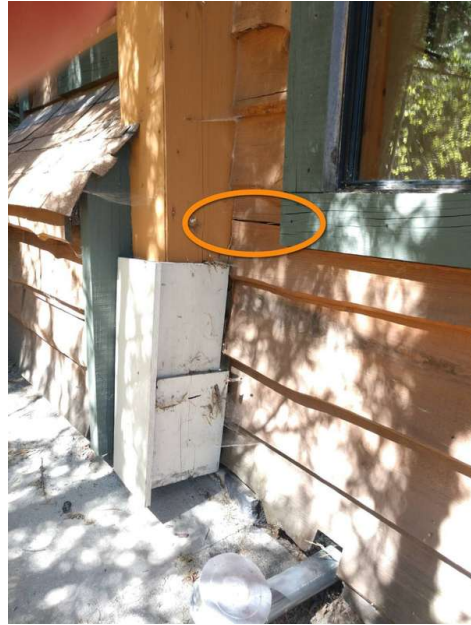
### 3.1.5 Siding, Flashing & Trim

#### **SPLITTING**

Siding was splitting in one or more areas, which can lead to moisture intrusion and/or mold. Recommend sealing. For excessive splitting, consult a licensed siding contractor to evaluate and correct

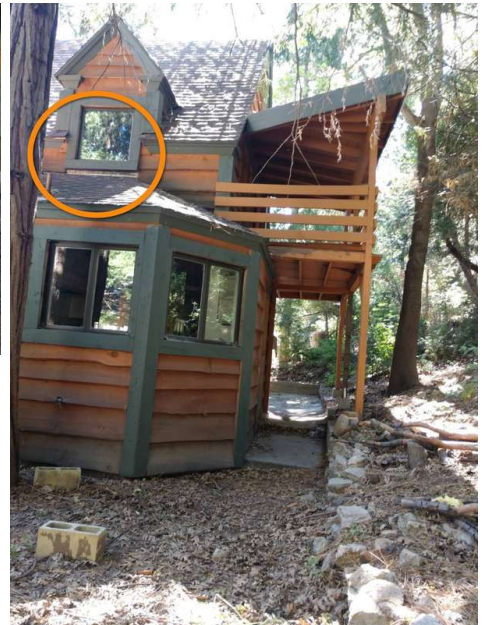
3.1.6 Siding, Flashing & Trim

**MISSING SIDING**

Observed missing siding boards. Exposure of exterior wall surface allows entry of water, which can become the cause of many unwanted issues. Recommend consulting a licensed siding contractor to evaluate and correct.

Contact a qualified siding specialist.

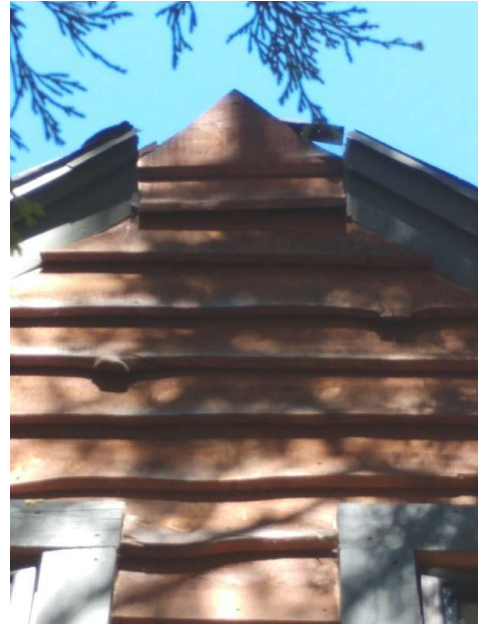
3.2.1 Eaves, Soffits & Fascia

**FASCIA - DAMAGED**

A section of the fascia and roof have been damaged and are now missing. This presents potential water infiltration issues.

Recommend qualified roofer evaluate & repair.

Recommendation  
Contact a qualified roofing professional.

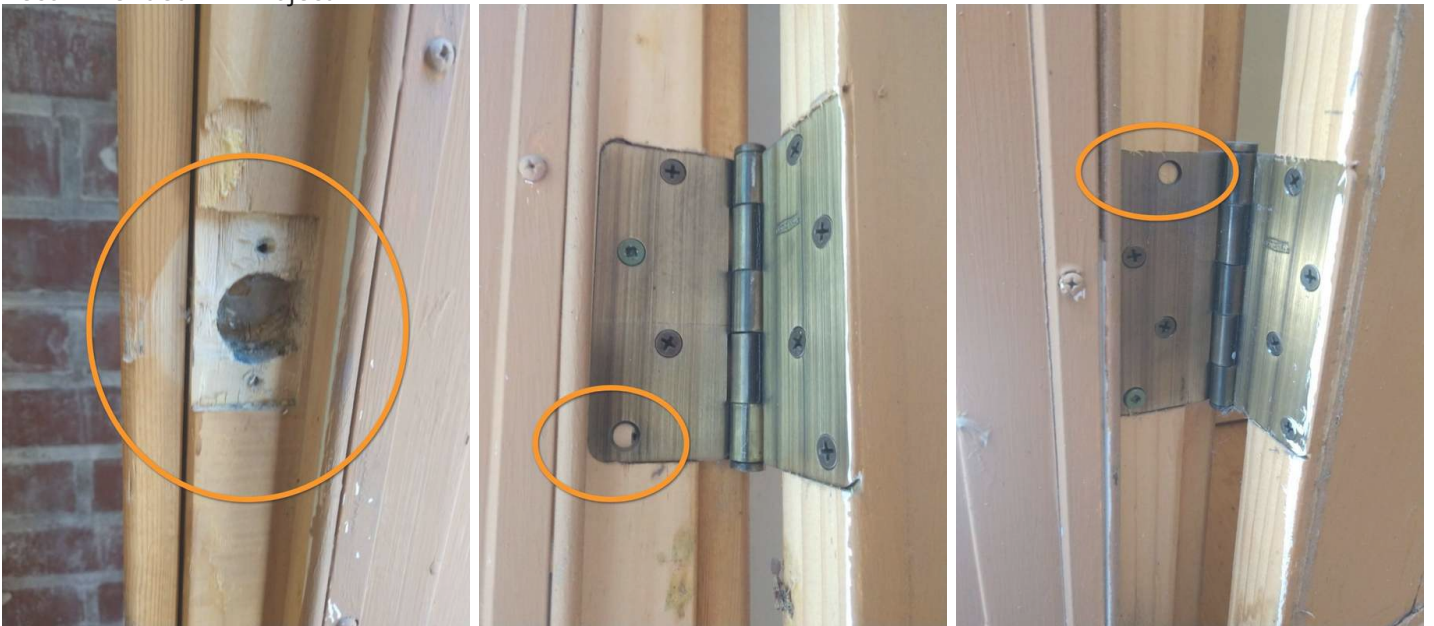
3.3.1 Exterior Doors

**HARDWARE MISSING**

Door is missing one or more pieces of hardware. Recommend replacing or upgrading.

Recommendation  
Recommended DIY Project

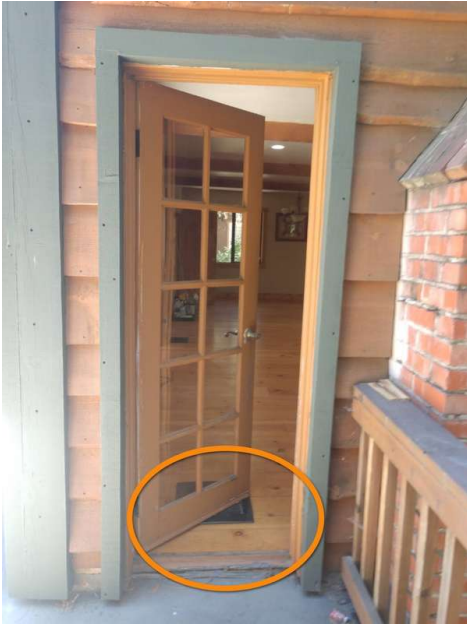
3.3.2 Exterior Doors

**DOOR DRAGS - MINOR**

Weatherstripping on bottom of door drags on the floor register. Recommend evaluation and correction by licensed contractor.

Recommendation  
Contact a qualified door repair/installation contractor.

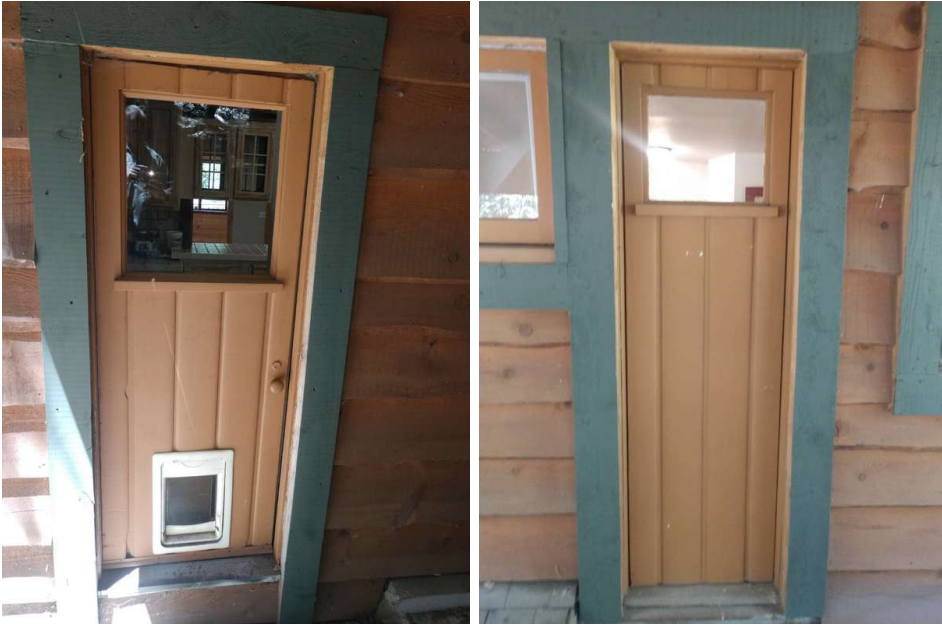
Door is missing any weatherstripping. This can result in significant energy loss and moisture intrusion. Recommend installation of standard weatherstripping as a DIY project or consult the services of a licensed contractor.

Contact a qualified door repair/installation contractor.

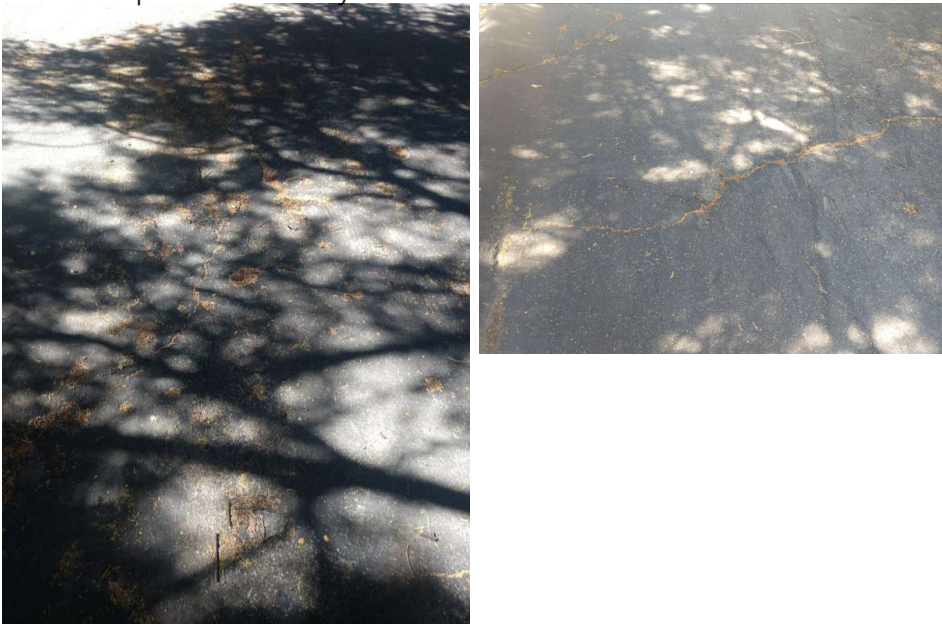
3.4.1 Walkways, Patios & Driveways

**DRIVEWAY CRACKING - MINOR**

Minor cosmetic cracks observed, which may indicate movement in the soil. Recommend monitor and/or have licensed driveway contractor patch/seal.

Contact a qualified driveway contractor.

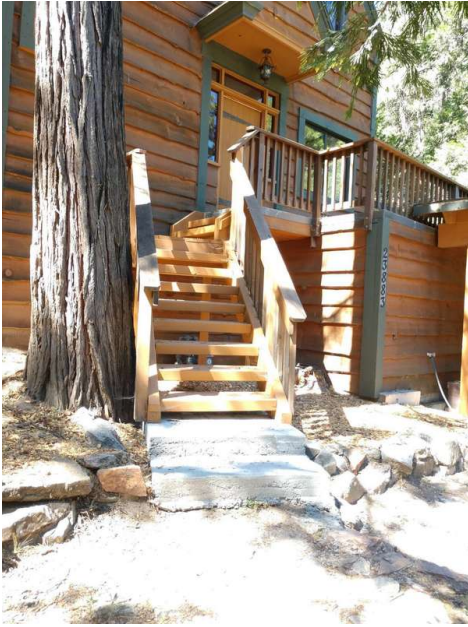
3.4.2 Walkways, Patios & Driveways

**EROSION**

Observed erosion around concrete. Recommend installing erosion control measures to prevent future damage.

Recommended DIY Project

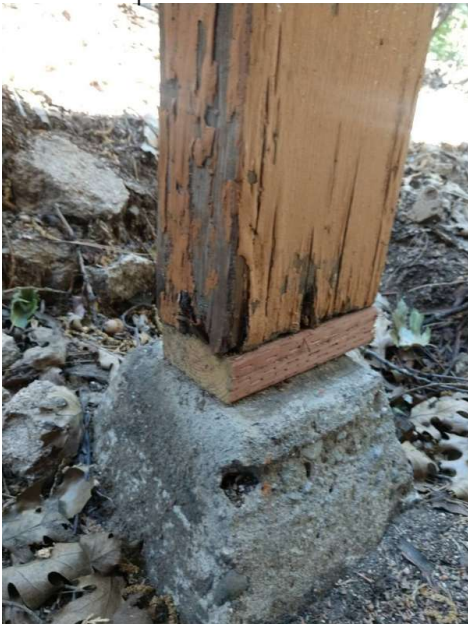
3.5.1 Decks, Balconies, Porches & Steps

**IMPROPER CONSTRUCTION PRACTICES**

Observed general substandard construction practices employed. Recommend licensed deck contractor evaluate and correct as necessary.

No mechanical fastener securing base to post.

Contact a qualified deck contractor.

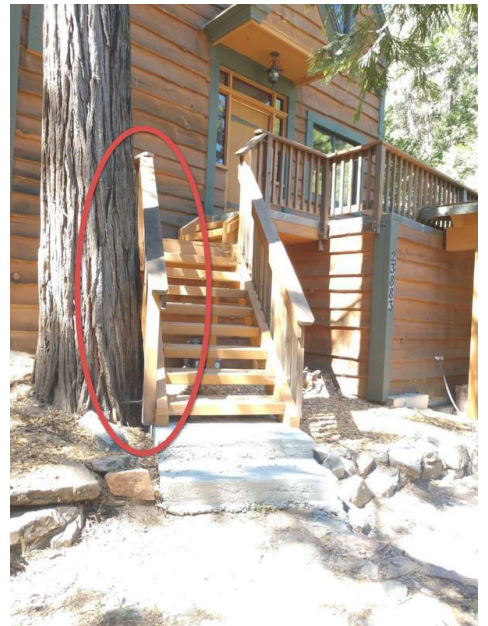
#### **RAILING LOOSE**

Observed stair railing to be loose. Recommend licensed contractor evaluate and correct.

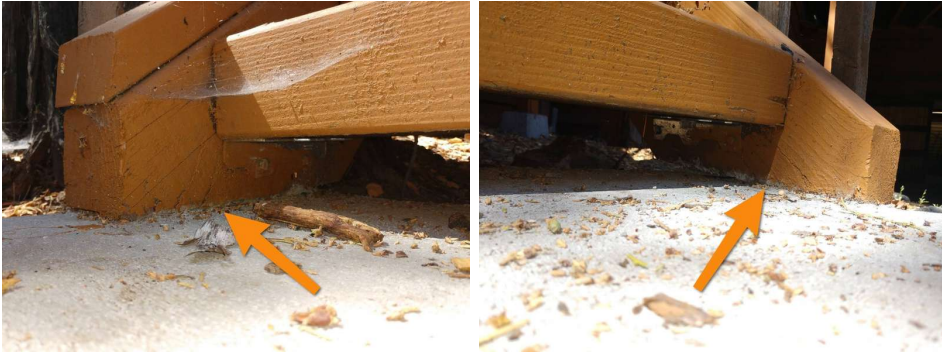
### 3.5.3 Decks, Balconies, Porches & Steps

#### **UNTREATED WOOD**

Recommend licensed contractor evaluate and correct.

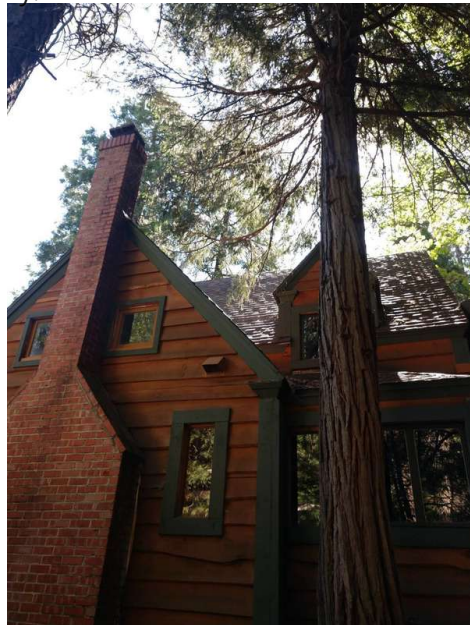
### 3.6.1 Vegetation, Grading, Drainage & Retaining Walls

#### **TREE OVERHANG**

Trees observed overhanging the roof. This can cause damage to the roof and prevent proper drainage. Recommend a licensed tree service trim to allow for proper drainage.

Contact a qualified tree service company.

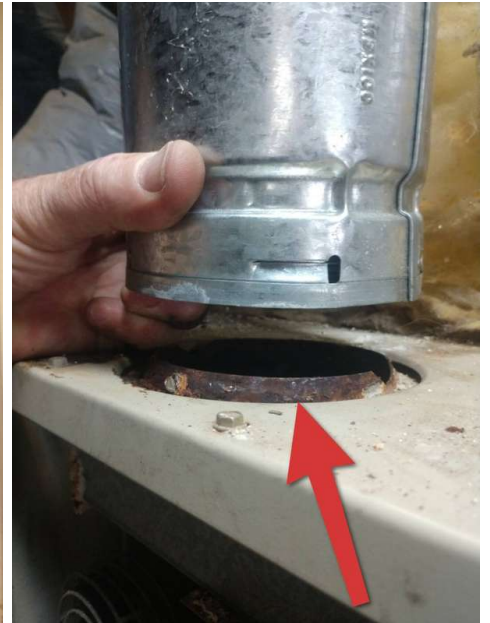
### 4.1.1 Equipment CORROSION

Furnace was corroded in one or more areas. This could be the result of improper venting, which the source would need to be identified. Recommend a HVAC contractor evaluate and repair.

Recommendation  
Contact a qualified HVAC professional.

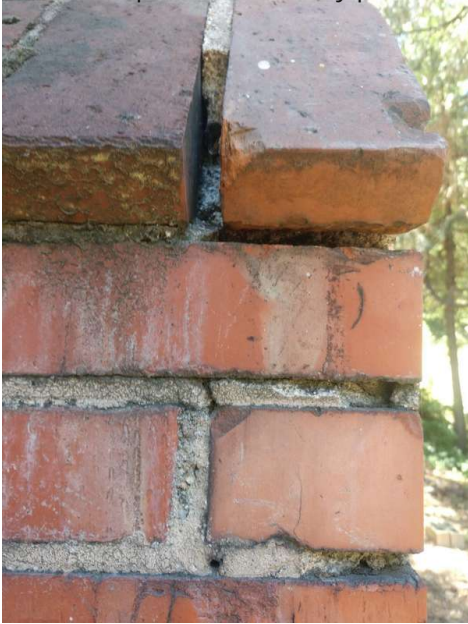
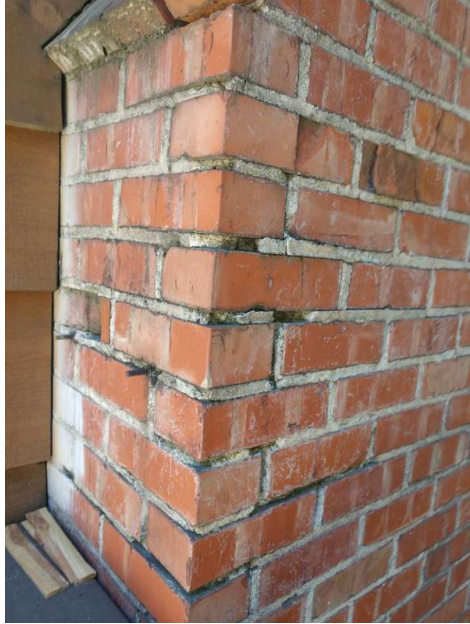
Joints in the masonry have deteriorated and should be repointed. (Repointing is the restoration of the mortar joints in the masonry).

Recommend consulting a licensed masonry contractor for evaluation and correction.

Contact a qualified masonry professional.

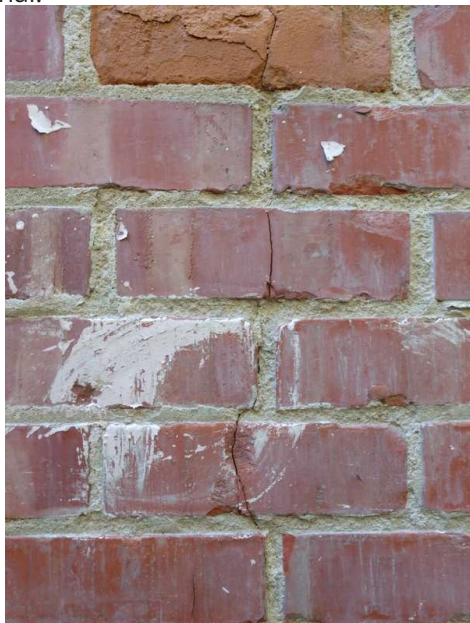
4.4.2 Vents, Flues & Chimneys

**CRACKING - MINOR**

Observed minor cracks in the exterior of the chimney. Recommend monitoring condition and consulting a licensed masonry contractor for evaluation and correction suggestions.

Contact a qualified masonry professional.

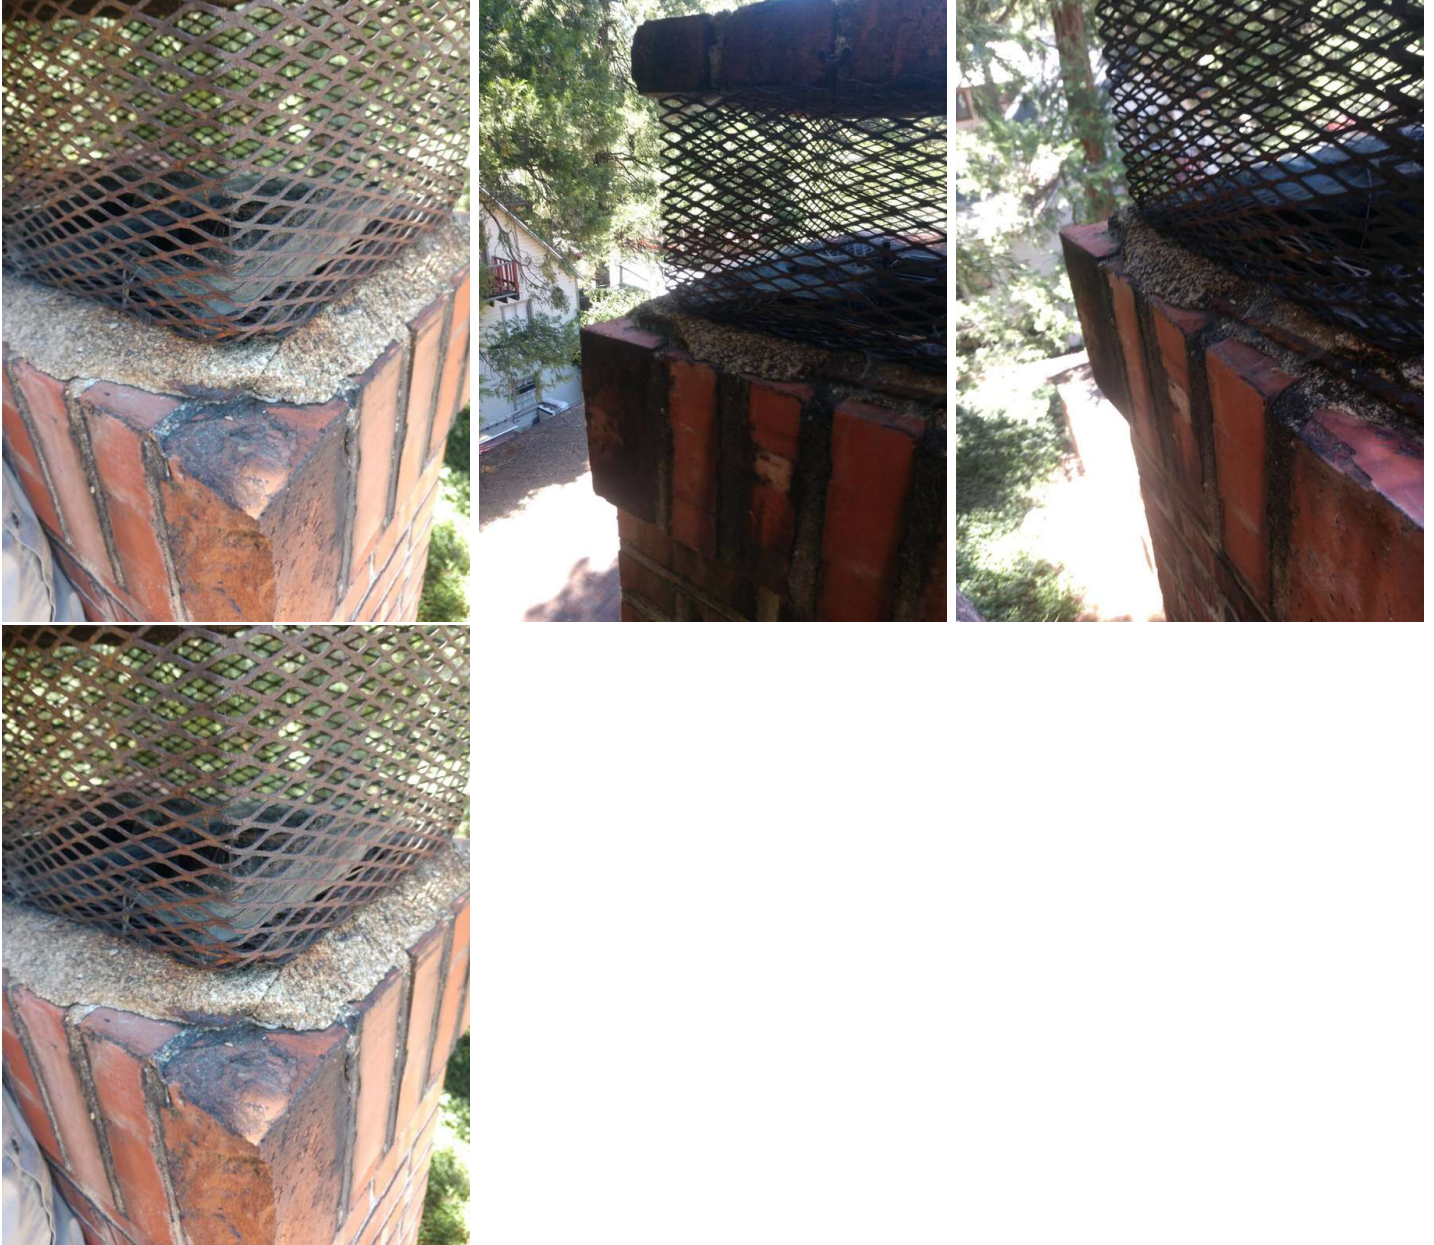
#### 4.4.3 Vents, Flues & Chimneys

### DAMAGED CROWN

Observed damaged and missing mortar of the chimney crown. This sheds water away from the flue and is subjected to continuous cycles of freeze/thaw which weakens the cementitious mix. As water intrusion continues, more deterioration occurs.

Recommend consulting a licensed masonry contractor for evaluation and correction.

Contact a qualified masonry professional.

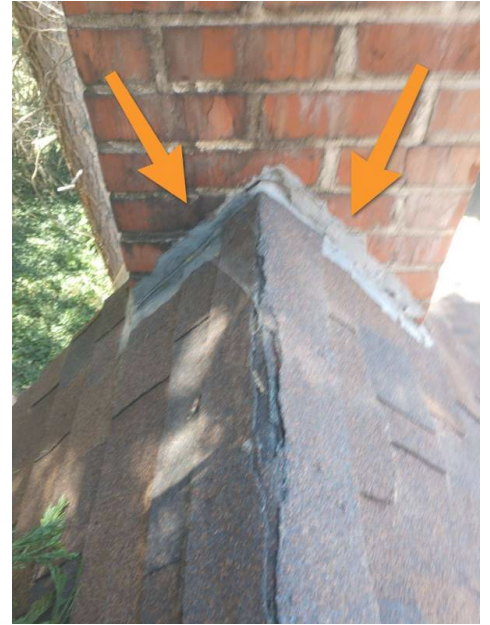
#### 4.4.4 Vents, Flues & Chimneys

### MISSING FLASHING

Observed the absence of any flashing at the roof to chimney intersection. Roof sealing compound has been applied in an effort to redirect water but is no substitute for proper flashing. The best time to install the step and counter flashings are when a roof is installed. Recommend proper flashings be installed by a licensed roofing contractor at time of roof replacement.

Recommendation  
Contact a qualified roofing professional.

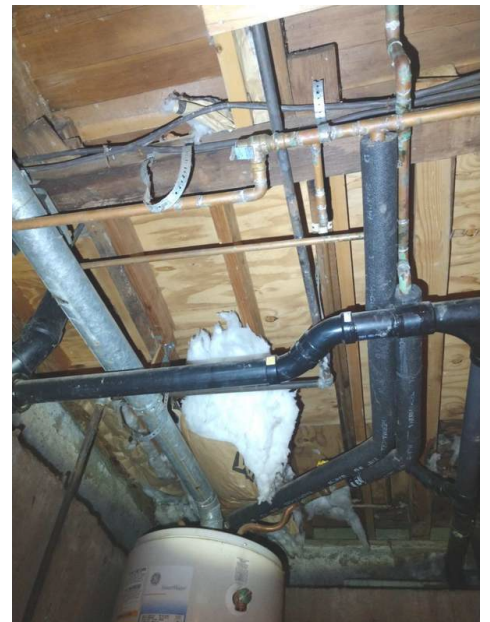
Observed drain lines in basement have over spaced supports. These drain lines carry water that weighs approximately 8 pounds per gallon. Over time the pipes will sag from the pull of gravity creating bellies in the overspanned sections. Supports should be placed every 4 feet horizontally at a minimum.

Recommend consulting a licensed plumbing contractor for evaluation and correction.

Recommendation  
Contact a qualified plumbing contractor.

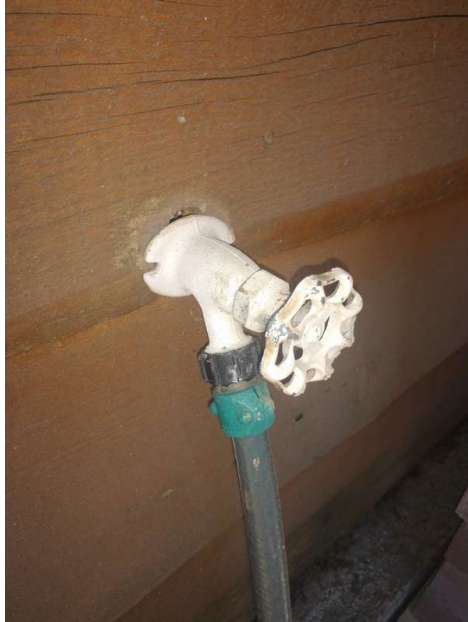
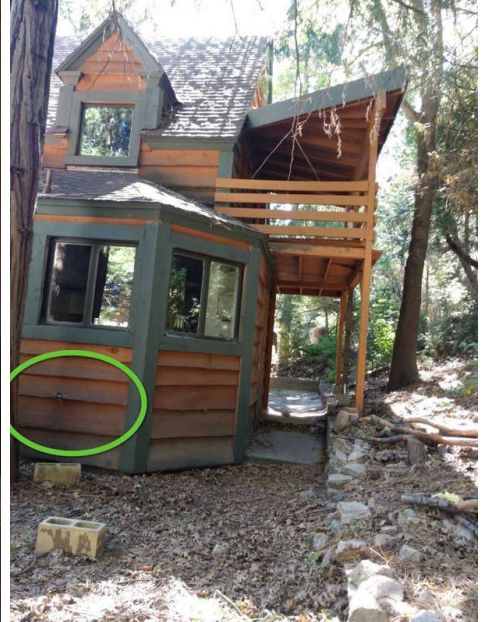
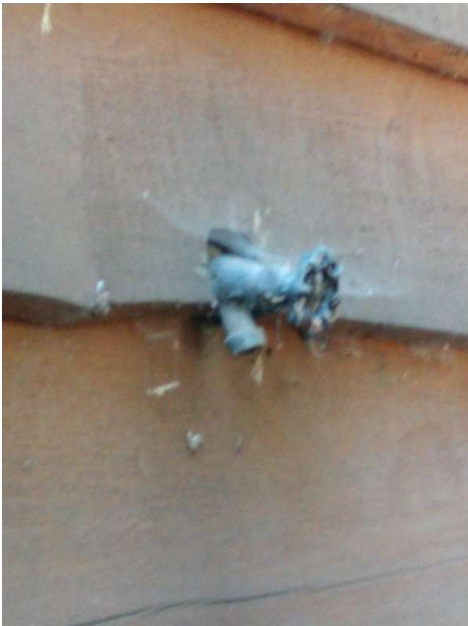
6.3.1 Water Supply, Distribution Systems & Fixtures  
**MISSING FROST-PROOF BIBB**

Missing frost-proof hose bibb at exterior locations. Here is a link to an explanation of its purpose and usefulness:

Recommend consulting a licensed plumbing contractor to evaluate and install.

Contact a qualified plumbing contractor.

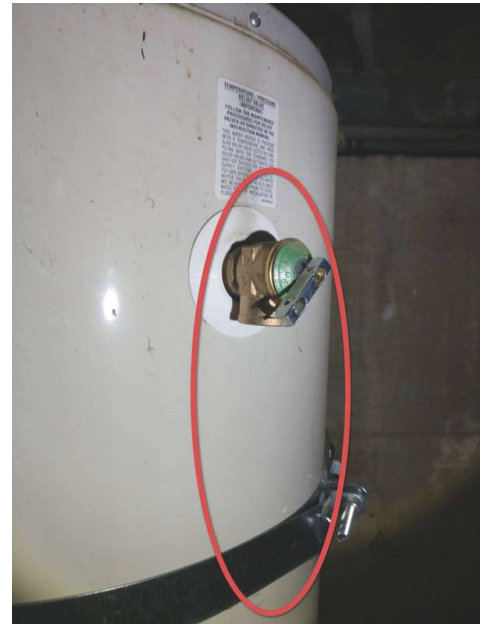
Safety Hazard

Missing discharge line from tpr valve. A discharge line terminating between 2 - 6 inches from the floor or receptor is required for safety reasons. In the event the valve discharges, very hot water with and steam are expelled and a person nearby could be injured.

Recommend installation by a licensed plumbing contractor.

Contact a qualified plumbing contractor.
