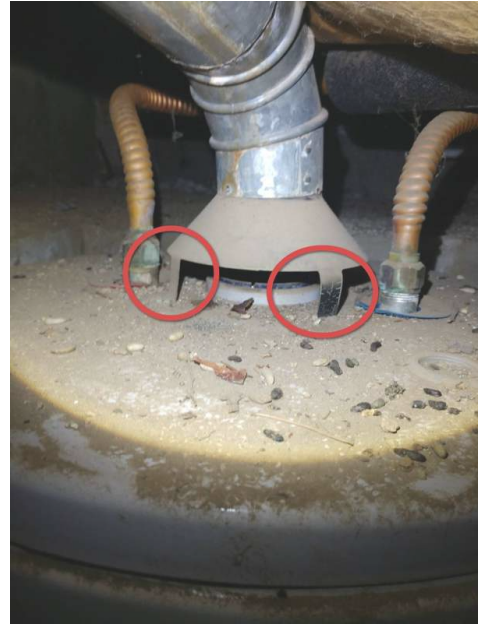
### VENT HOOD

Missing Fasteners at vent hood. Exhaust gasses need direction to the exterior of the building due to their unhealthy nature. A secure attachment is needed between the vent hood and the appliance in order to ensure positive alignment and the proper removal of gasses.

Recommend correction by a licensed plumbing contractor.

Contact a qualified plumbing contractor.

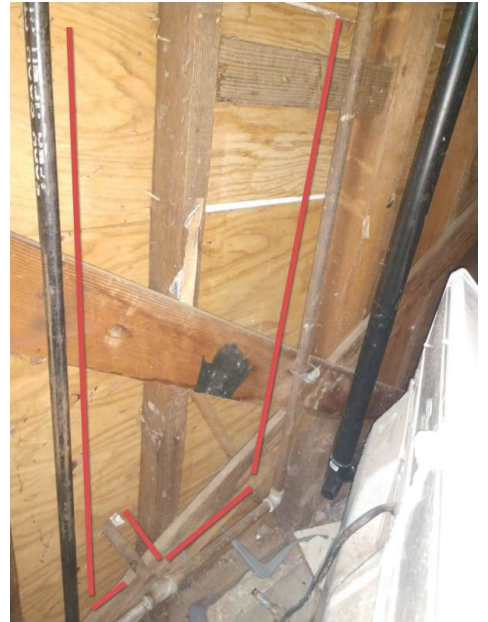
#### 6.5.1 Fuel Storage & Distribution Systems

### **BONDING ABSENT**

Electrical bonding was not observed at time of inspection. Here is a link to more information on the purpose of bonding from the American Gas Association:

Red lines indicate location of natural gas line entering the building from the meter, branching in two, then rising. No electrical bonding present.

Recommend evaluation and correction by licensed electrical contractor

Contact a qualified electrical contractor.

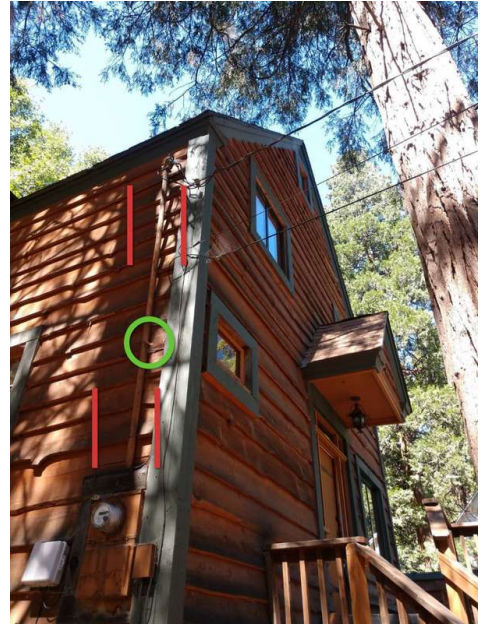
#### 7.1.1 Service Entrance Conductors

Observed missing or over spaced service mast support anchors. These are required within a foot of the meter base, at the top, and every 5 - 6 feet in between. The service mast is leaning away from the wall and needs to be re-secured.

Recommend consulting a licensed electrician to evaluate and correct.

Contact a qualified electrical contractor.

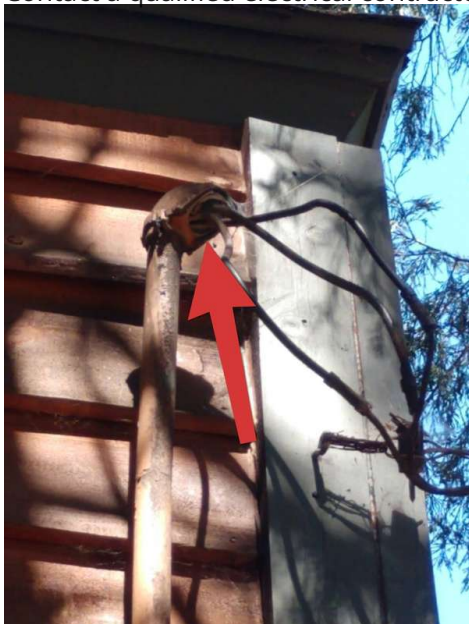
### 7.1.2 Service Entrance Conductors **WEATHER HEAD MISSING**

Observed missing weather head. This component serves to protect the conductors from rubbing and chafing against each other and the metal parts of the mast as well as helping to keep water out. Included is a graphic depiction of what the utility companies service and what is the homeowner responsibility.

Plastic protective insert is missing.

Recommend consulting a licensed electrical contractor for evaluation and correction.

Recommendation  
Contact a qualified electrical contractor.

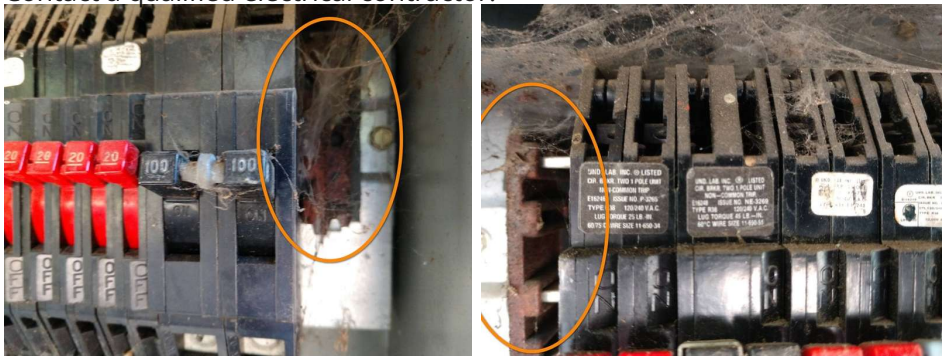
### CORROSION

Observed corrosion in panel box. This is evidence of moisture intrusion. Water or moisture and electricity do not mix well. A full evaluation by a licensed electrical contractor is recommended.

Contact a qualified electrical contractor.

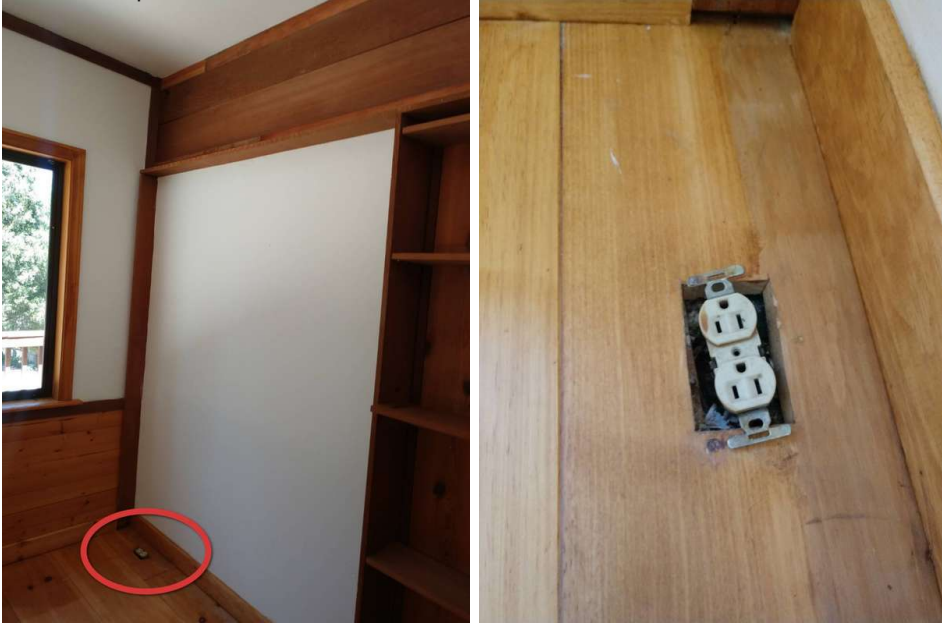
Observed loose receptacle with missing fasteners and cover plate. Recommend correction by licensed electrical contractor.

Recommendation  
Contact a qualified electrical contractor.

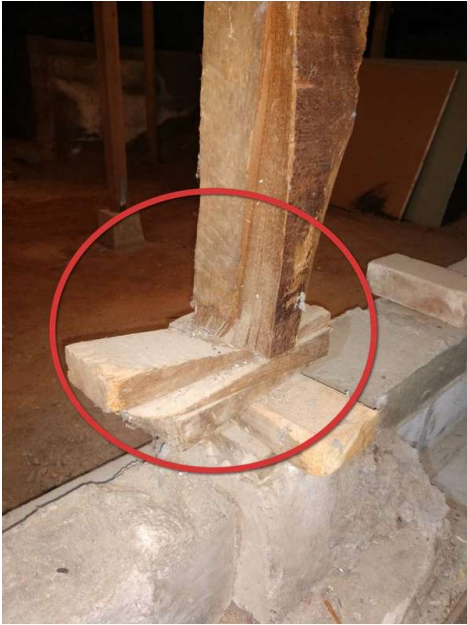
4x8 overspanned.

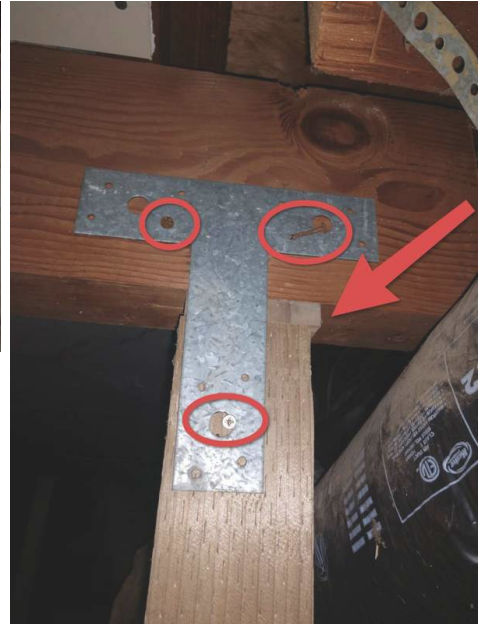
Inadequate number of and improper type of fasteners. Extension / shim inserted.

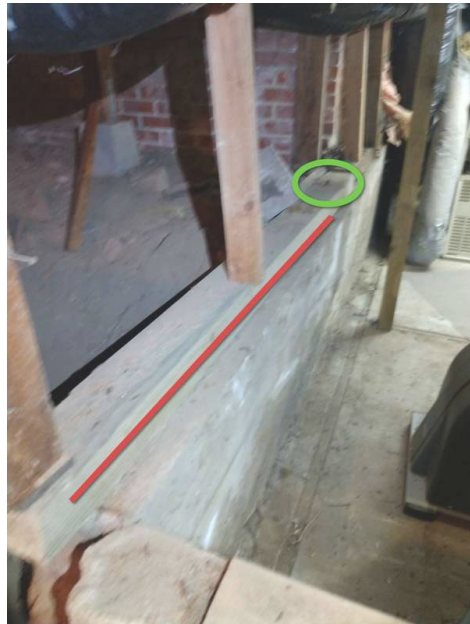
One bolt with no nut or fastener - green circle. No hold down bolts, posts not securely attached - red line

Undersized fasteners for this application.

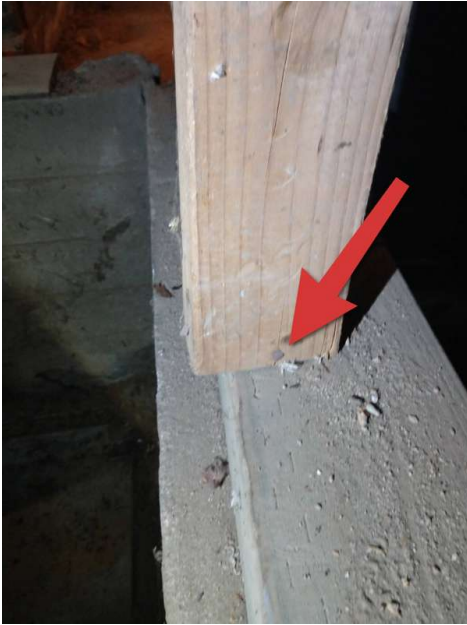
Improper support member, inadequate fastening, poor placement.

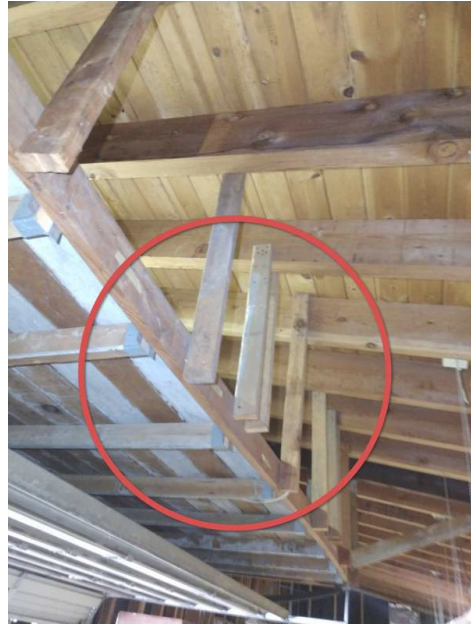
Substandard building practices above garage door.

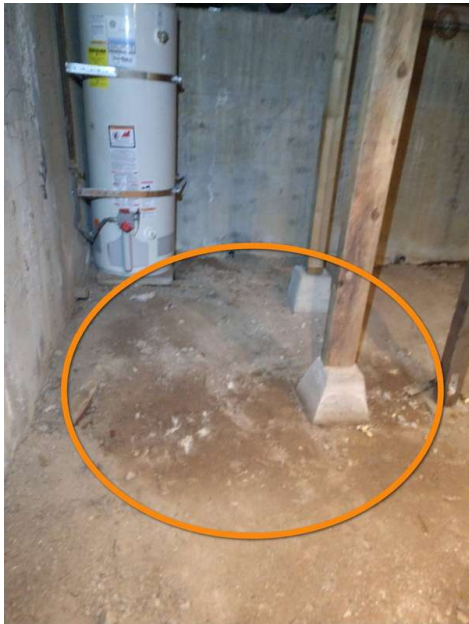
Moisture intrusion was evident on the surface of the floor slab or walls in the basement/crawlspace. This can compromise the soil's ability to stabilize the structure and could cause damage. Recommend a licensed contractor identify the source of moisture and remedy.

Recommendation  
Contact your builder

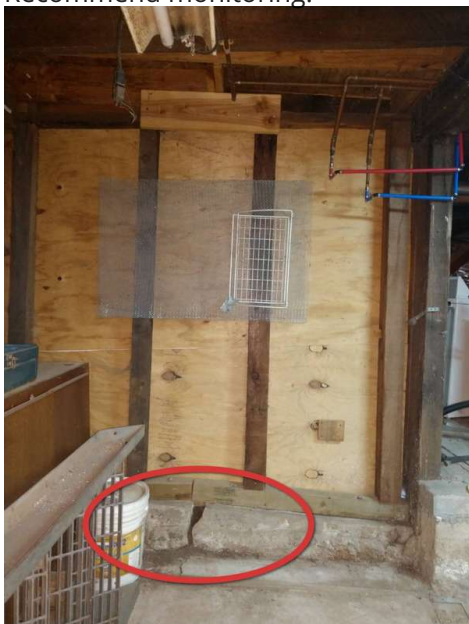
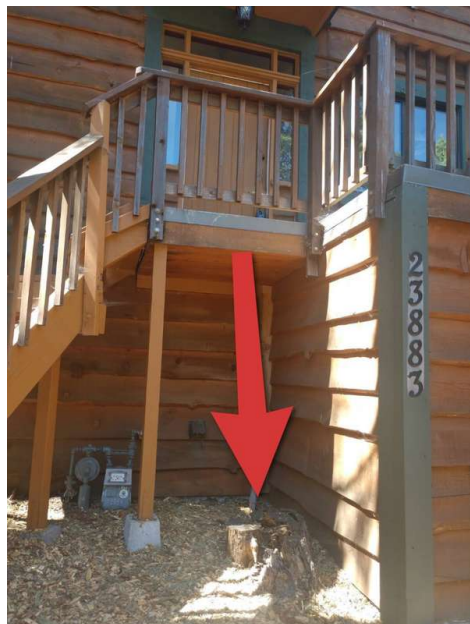
13.1.4 Foundation  
**FOUNDATION HEAVE**

BASEMENT

Observed a heaved foundation wall. The edges and face of the break are rounded and weathered, indicating age and time. The likely cause is a former tree at the location. As the tree has been removed long ago and the stump is considerably decomposed, further movement is unlikely. Recommend monitoring condition or consult a licensed structural engineer to evaluate and recommend proper corrective action if needed.

Recommendation  
Recommend monitoring.

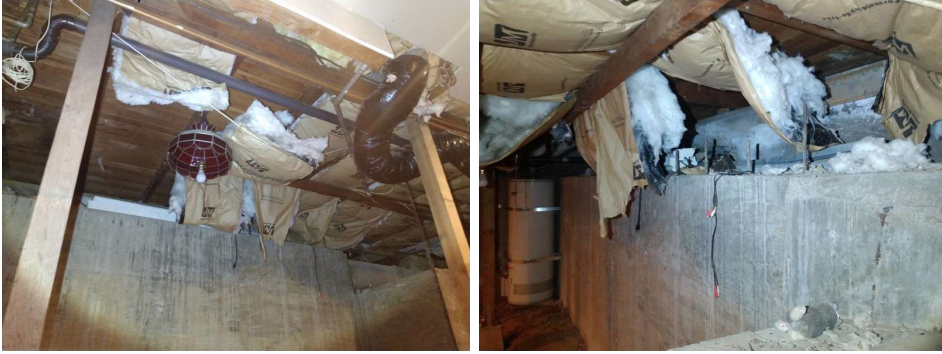
13.2.1 Basements & Crawlspace  
**INSULATION MISSING, DAMAGED OR FALLEN**

Observed missing, loose and fallen insulation. Recommend consulting a licensed insulation contractor to evaluate and correct.

Recommendation  
Contact a qualified insulation contractor.
