SUMMARY
1234 Main St. Truckee Ca 96161
Buyer Name
05/22/2018 9:00AM

Jason Rosenblatt
Internachi certified professional inspector
Compass Rose Home Inspections
(530) 448-4047
compassrosehi@gmail.com

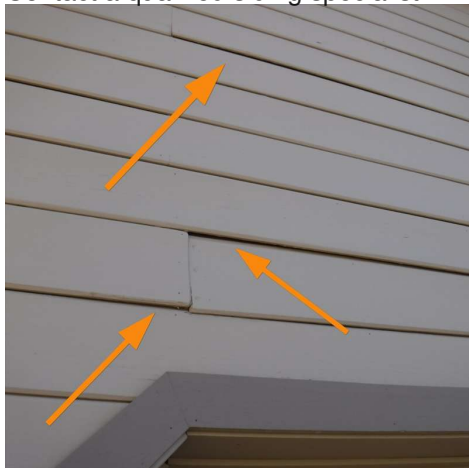
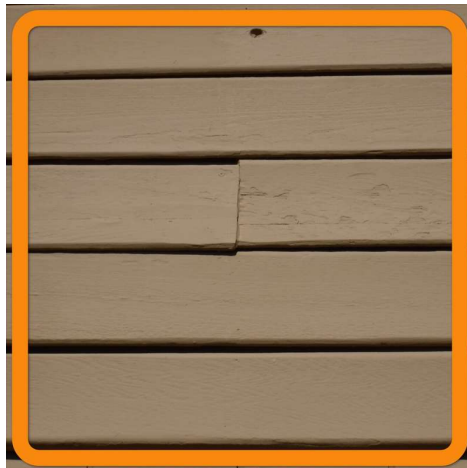
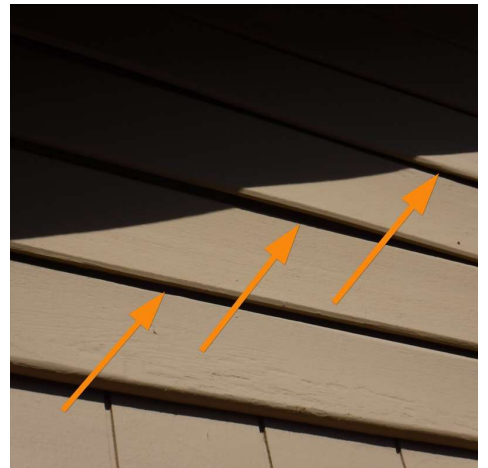
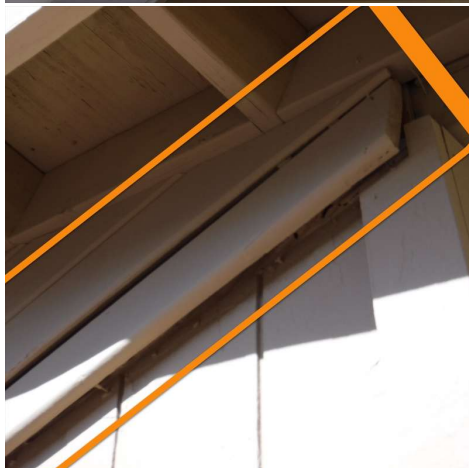
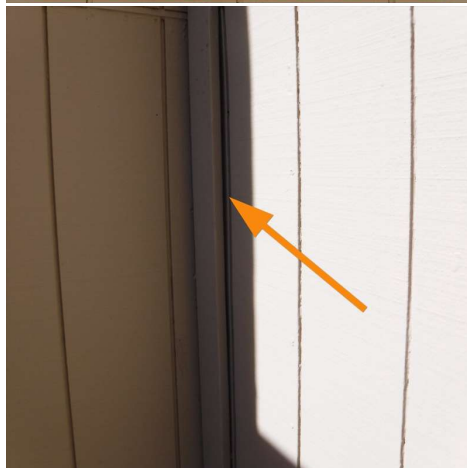
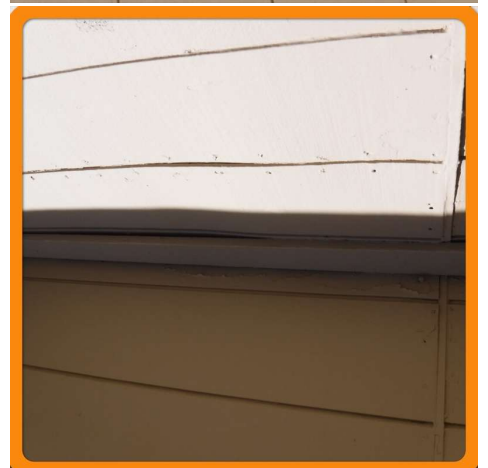
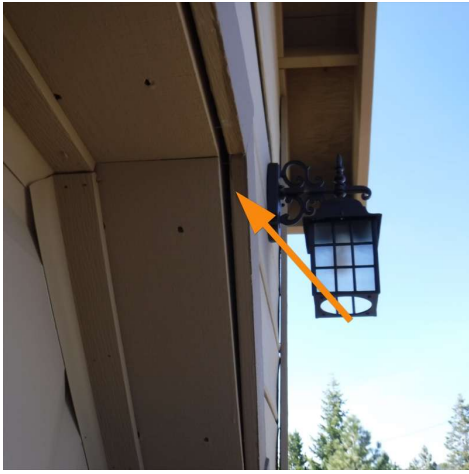
3.1.1 Siding, Flashing & Trim

LOOSE BOARDS

One or more siding boards / trim were loose, which could result in moisture intrusion. Recommend a qualified siding contractor secure and fasten.

Recommendation
Contact a qualified siding specialist.

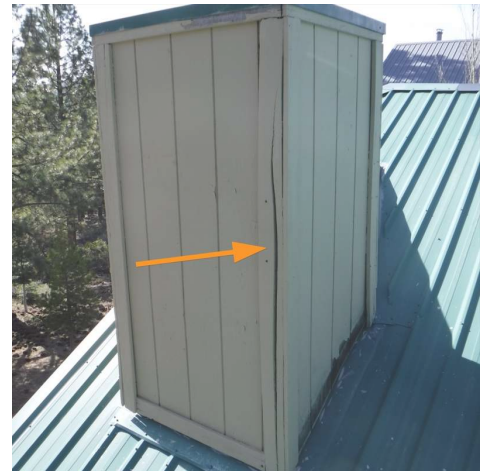
3.1.2 Siding, Flashing & Trim

SPLITTING

Trim was splitting in one or more areas, which can lead to moisture intrusion and/or mold. Recommend monitoring for excessive splitting, in which case a qualified siding contractor should evaluate and repair/replace.

Contact a handyman or DIY project

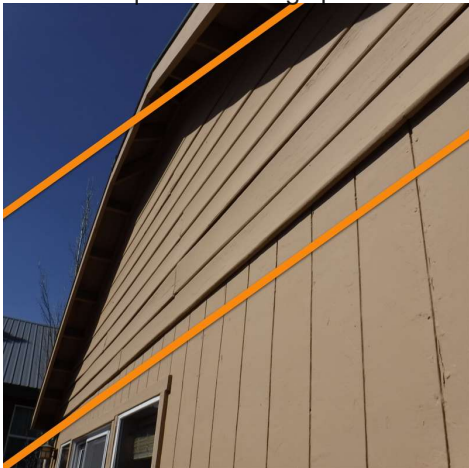
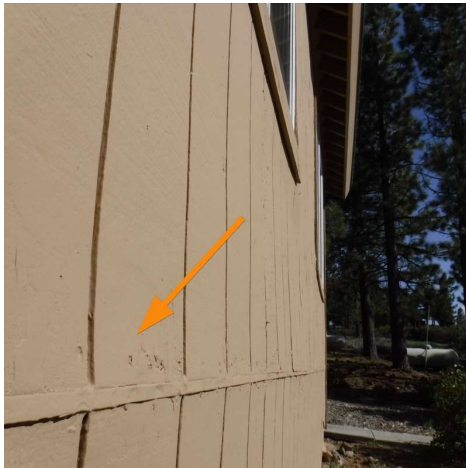
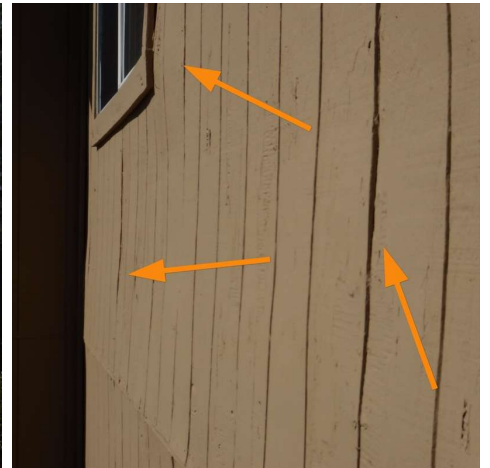
3.1.3 Siding, Flashing & Trim

WARPING/BUCKLING

Siding was warping or buckling in areas. This is often as a result of long periods of full sun exposure that will cause expansion/contraction and buckling of siding. Showed no signs of decay. Recommend a qualified siding contractor evaluate and repair.

Contact a qualified siding specialist.

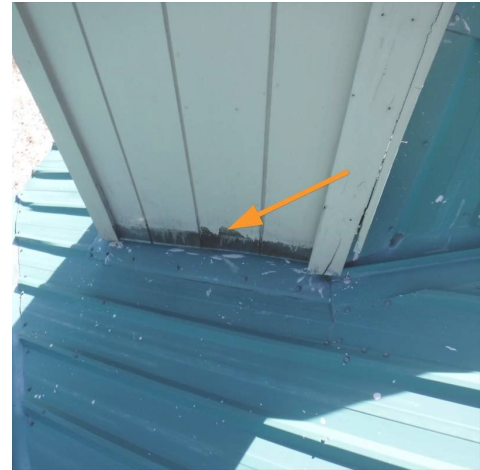
3.1.4 Siding, Flashing & Trim

TRIM MISSING

At time of inspection trim was missing at one or more locations on the home. Recommend replacement.

Contact a handyman or DIY project

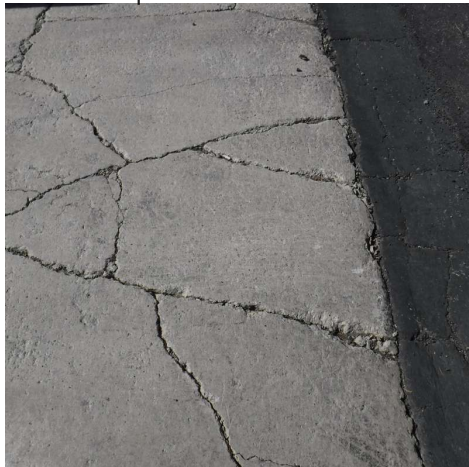
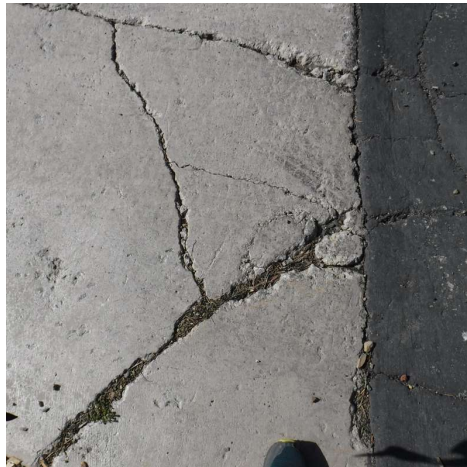
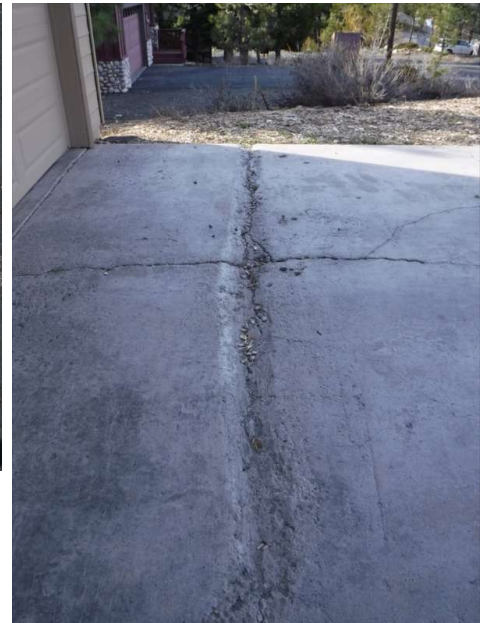
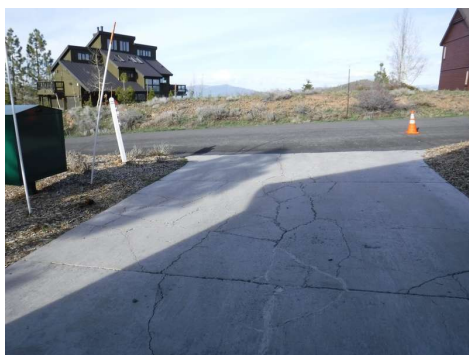
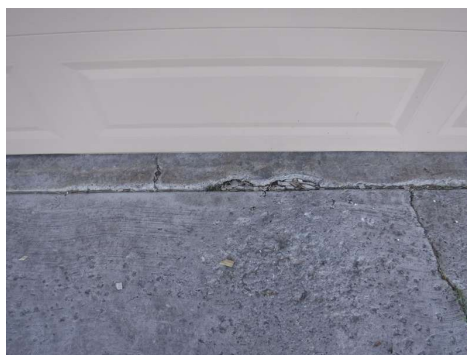
3.3.1 Walkways, Patios & Driveways

DRIVEWAY CRACKING - MAJOR

Major cracks observed. Recommend concrete contractor evaluate and replace.

Contact a qualified concrete contractor.

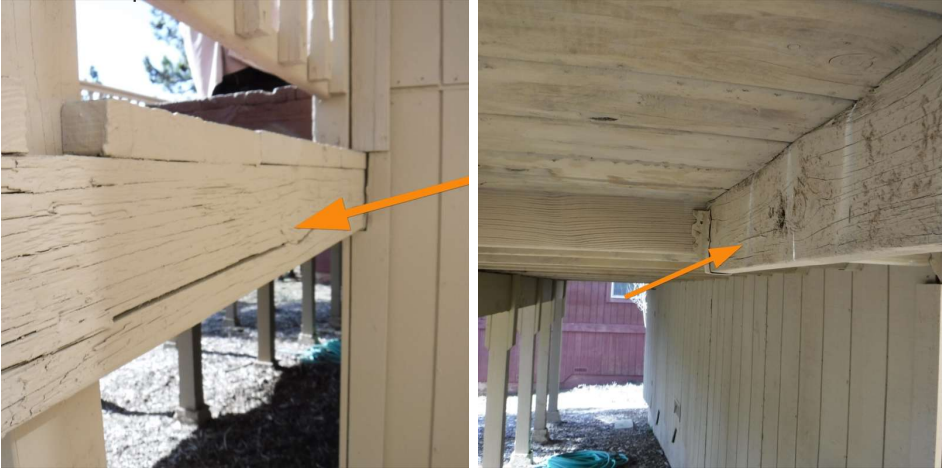
3.4.2 Decks, Balconies, Porches & Steps

DECK - ROTTED BOARDS

One or more deck boards are showing signs of rot. Recommend a qualified deck contractor replace.

Recommendation
Contact a qualified deck contractor.

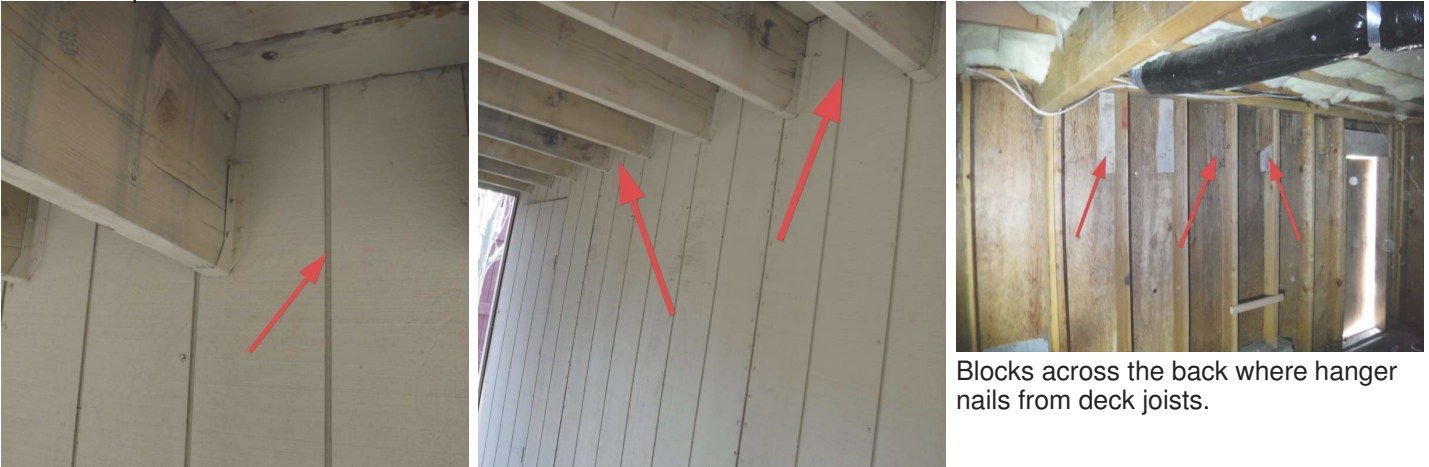
3.4.3 Decks, Balconies, Porches & Steps

IMPROPER DECK CONSTRUCTION PRACTICES

"Safety Issue" Poor construction practices were observed at deck inspection. No ledger at connection to house. Deck connections are the number one reasons that decks fail. Recommend qualified deck contractor evaluate and repair.

Blocks across the back where hanger nails from deck joists.

Recommendation
Contact a qualified deck contractor.

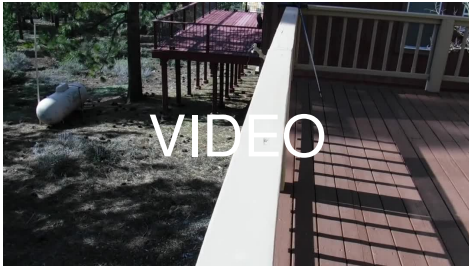
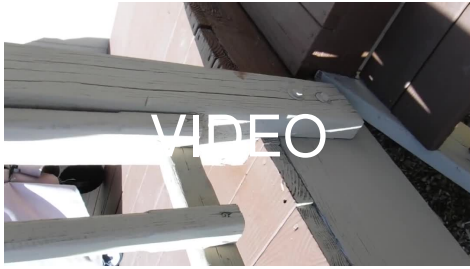
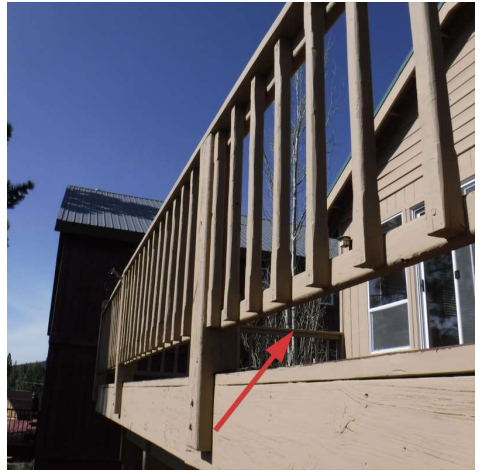
3.4.4 Decks, Balconies, Porches & Steps

RAILING UNSAFE

There is an unsafe opening in the railing. The spacing on the rail should not exceed 4". An opening greater than 4" is a serious safety hazard especially for children as their head or other body part can become trapped. Also Videos show loose deck railing connections creating an unsafe area. recommend re bolt of railing posts by qualified individual.

Recommendation
Contact a qualified deck contractor.

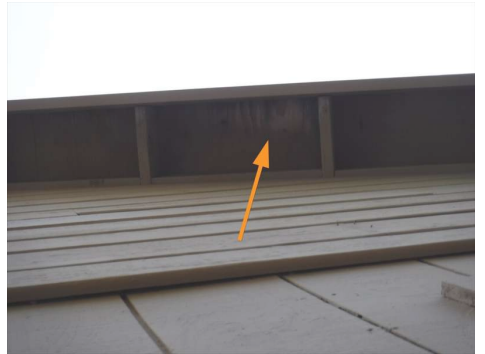
3.5.1 Eaves, Soffits & Fascia

EAVES - WATER STAINS

Water stains were observed under the roof eaves. This may indicate a previous leak. Recommend qualified roofer evaluate & repair.

Eave on left side of house

Contact a qualified roofing professional.

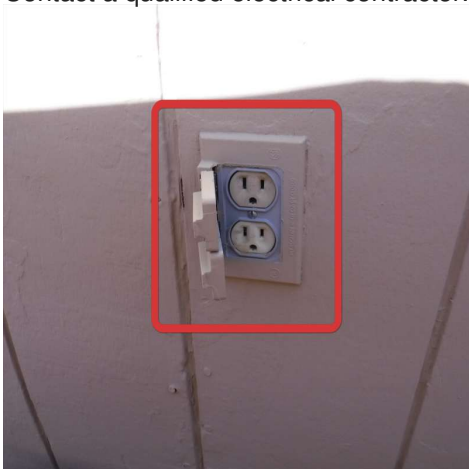
GFCI MISSING

Safety issue -- There as not sufficient GFCI outlets present on the exterior of the house. At least one GFCI receptacle should be present within 78" vertically of a walking surface in the front and rear of the home. A GFCI device protects from receiving electric shocks from electrical devices used in the home. I recommend licensed electrician upgrade by installing a GFCI in the exterior where it is missing.

No GFCI at exterior back of house on deck.

Contact a qualified electrical contractor.

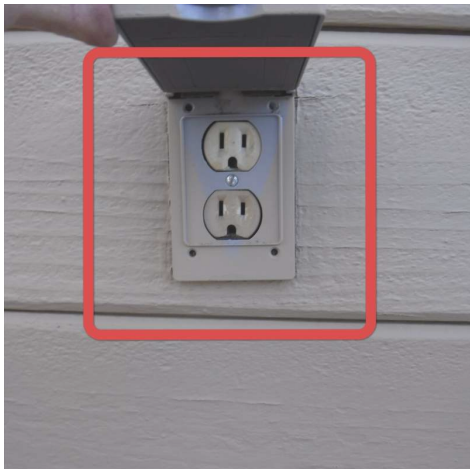
No GFCI at front exterior of house.

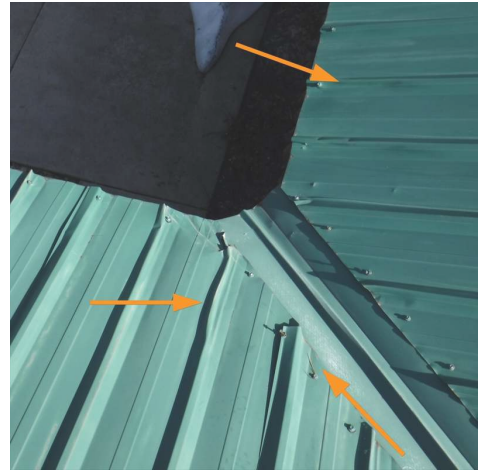
4.1.1 Coverings

DAMAGED (GENERAL)

Roof coverings showed moderate damage at convergence in valley at front of the house. Most likely caused by large amount of sliding snow. Some screws loose and metal bent. Recommend a qualified roofing professional evaluate and repair.

Damage at bottom of valley in front of house.

Contact a qualified roofing professional.

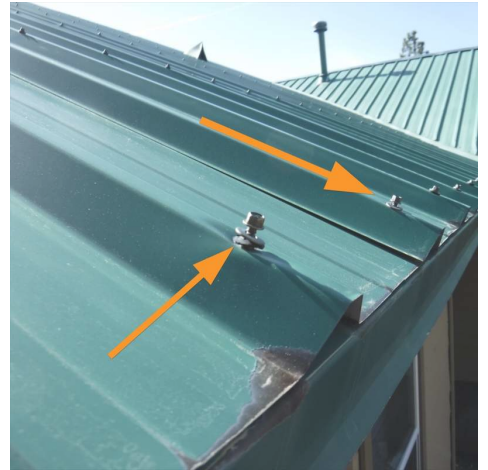
4.1.3 Coverings

SCREWS LOOSE

Screws loose on edge of roof. Temperatures in Tahoe and especially in Truckee can cause screws to come loose quicker than other areas. I recommend screws be tightened or replaced where needed once every few years. Keeping up on maintenance will increase the longevity of the roof.

Loose screws

Contact a qualified roofing professional.

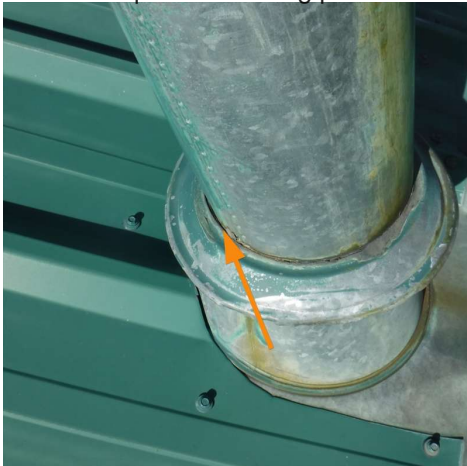
ROOF PENETRATIONS

Roof penetrations should be covered by a cricket if further than 18" from ridge or waterproofed with a boot when under 18" from ridge. Damage can occur due to sun and element exposure over time.

Gap in waterproofing

Contact a qualified roofing professional.

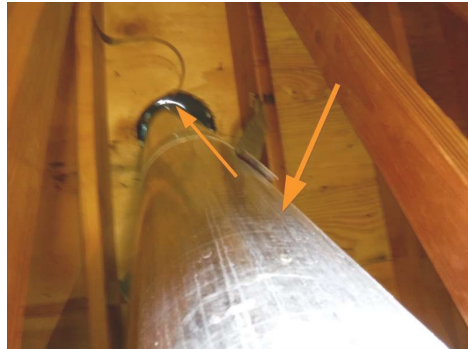
Pipe from inside attic. Water stains from gap in boot.

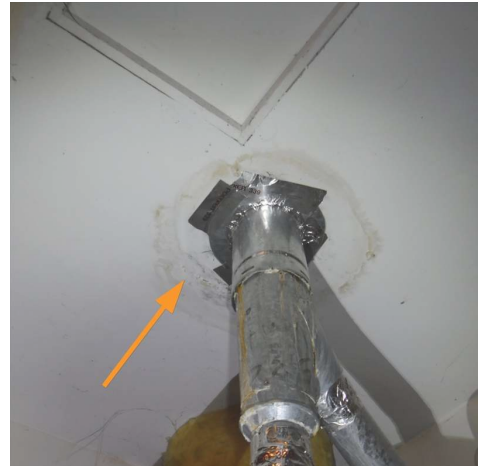
Same vent in garage with ring of water damage.

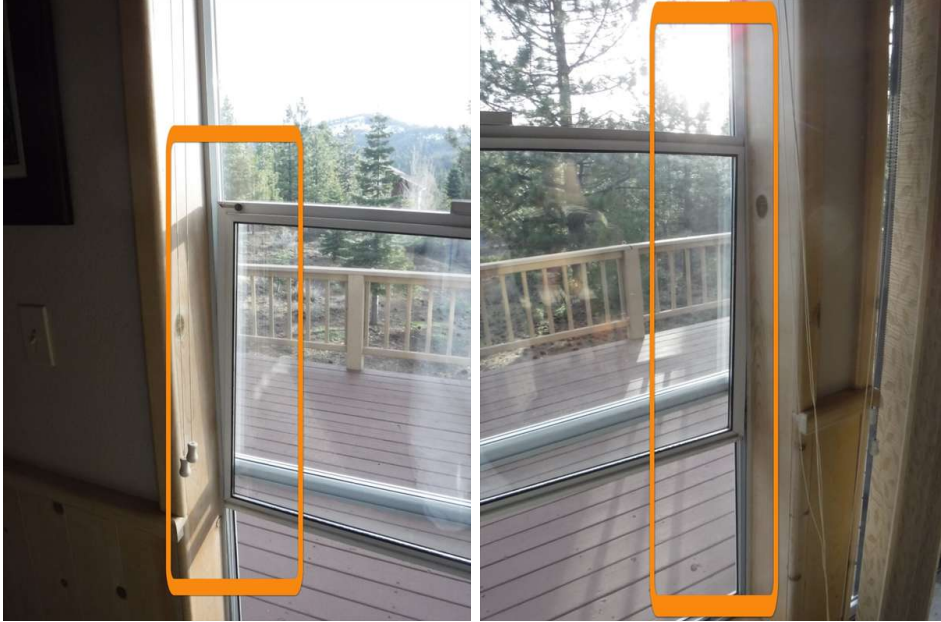
5.2.1 Windows

ROUGH OPERATION

At time of inspection double hung aluminum windows opened and closed with some uneven operation. Slider windows worked well. Did not see manufacture date. Recommend service by qualified professional.

Contact a qualified window repair/installation contractor.

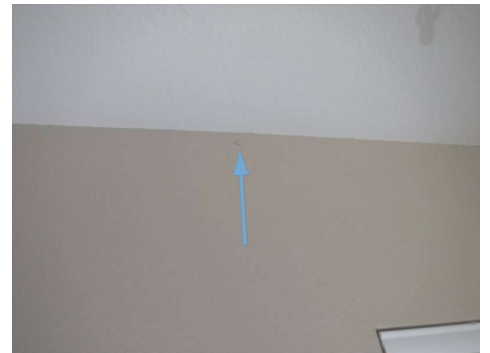
5.4.1 Walls

NAIL POPS

Protruding nail heads visible at the time of the inspection appeared to be the result of contact with moisture. After the source of moisture is located and corrected, protruding nails should be removed, drywall re-fastened and the drywall finished to match the existing wall surfaces. All work should be performed by a qualified drywall or painting contractor.

Recommended DIY Project

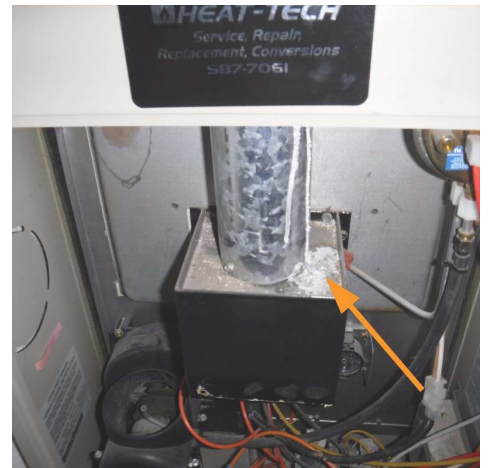
6.1.1 Equipment

CORROSION

Furnace showed minor water damage in one or more areas. This could be the result of improper venting, which the source would need to be identified. Recommend a HVAC contractor evaluate as well as recommended repair on through roof penetration

Water entering from gap in roof vent.

Contact a qualified roofing professional.

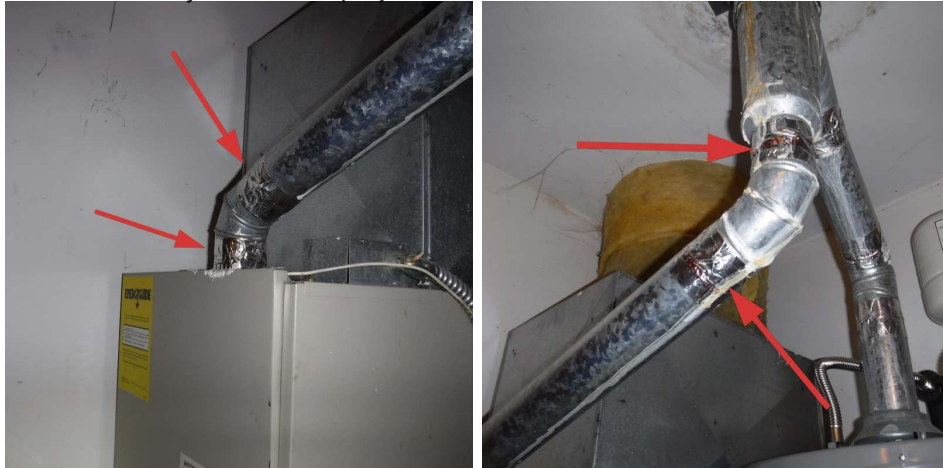
6.1.2 Equipment

FOIL TAPE ON PIPE CONNECTIONS

"Safety issue" At time of inspection foil tape was observed on the single wall vent pipe for the furnace. Tape is not recommended on single wall vent pipes due to possible fire danger. Recommend removal of tape and adding of 3 screws per connection.

Contact a handyman or DIY project

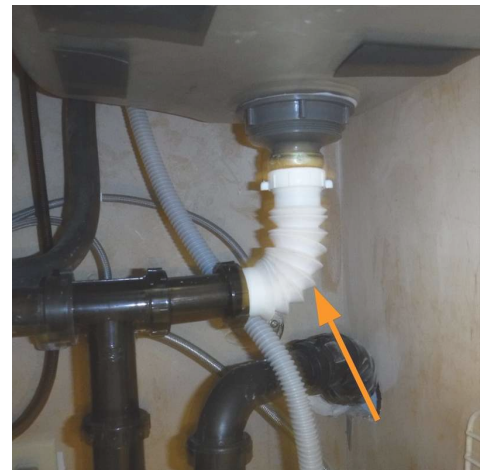
8.2.1 Drain, Waste, & Vent Systems

IMPROPER CONNECTION

An improper connection under kitchen sink was observed at a drain, waste or vent pipe. Recommend a qualified plumber evaluate and repair.

Flex line style drain.

Contact a handyman or DIY project

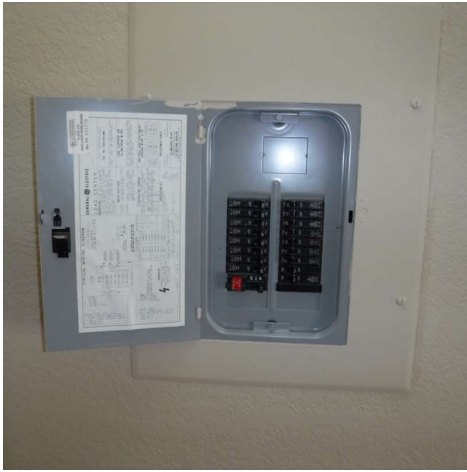
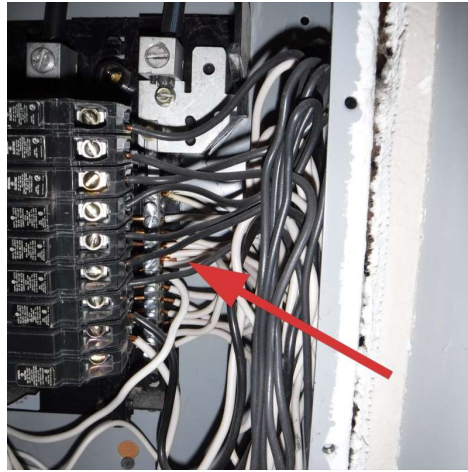
9.2.1 Main & Subpanels, Service & Grounding, Main Overcurrent Device

SUB PANEL

Double tap on neutral conductors is not permitted. One neutral per hole. Recommend licensed electrician to evaluate and correct.

Contact a qualified electrical contractor.

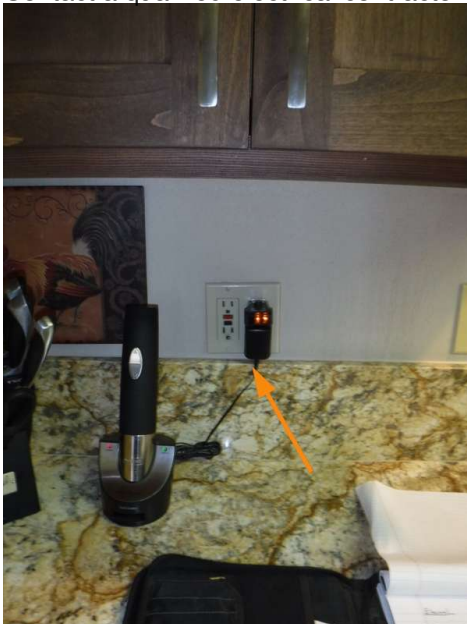
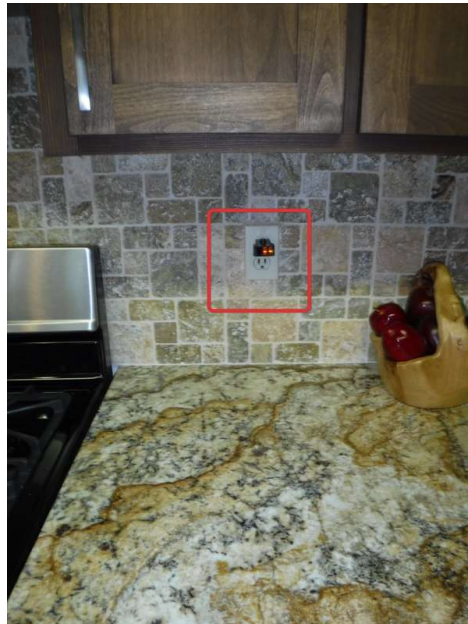
NO GFCI PROTECTION INSTALLED

No GFCI protection present in all locations. Recommend licensed electrician upgrade by installing ground fault receptacles in all locations. Kitchen outlets have one GFCI and outlet in the same plug. GFCI needs to connect through all outlets on each separate side of kitchen.

No GFCI

Contact a qualified electrical contractor.

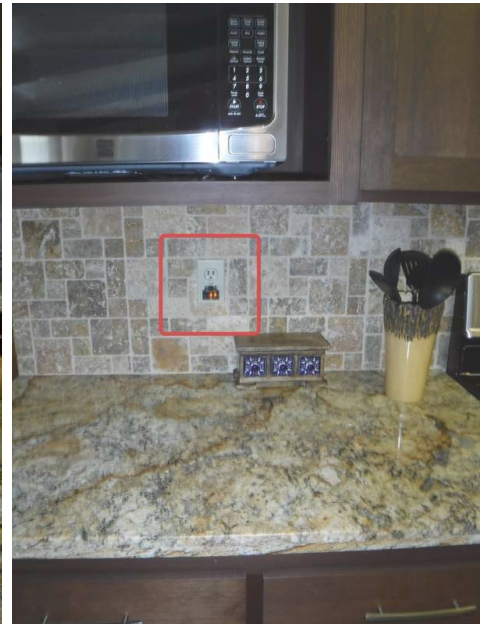
NO GFCI

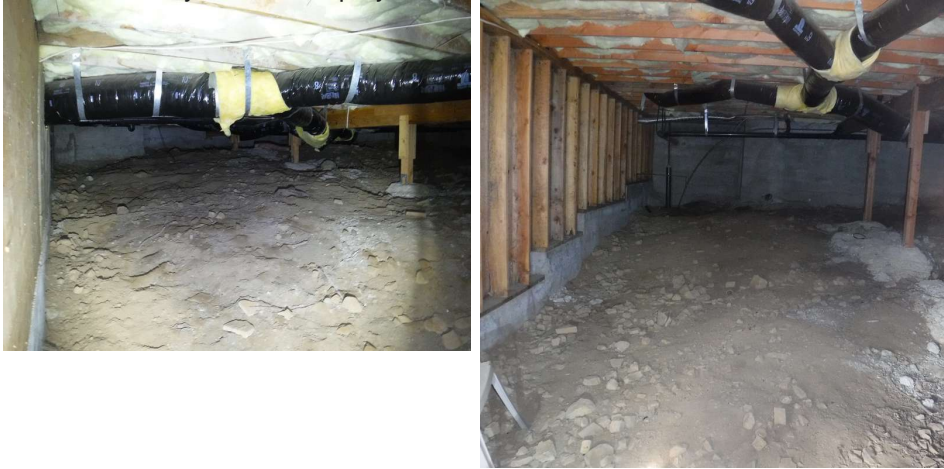
12.2.1 Vapor Retarders (Crawlspace or Basement)

NO VAPOR BARRIER

There is no vapor barrier on crawl floor. This can result in unwanted moisture in unconditioned space. Recommend installation of proper vapor barrier.

Contact a handyman or DIY project

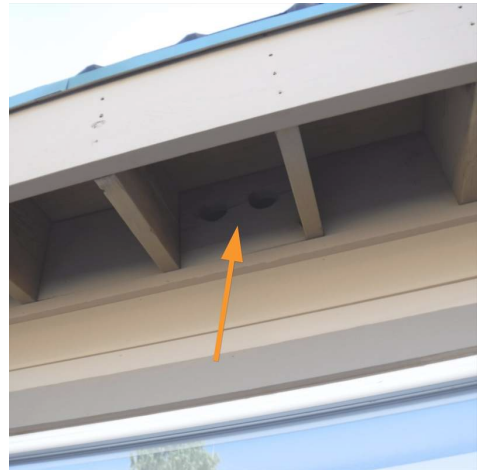
12.3.1 Ventilation

ATTIC VENTILATION INSUFFICIENT

Attic venting was insufficient at time of inspection. Modern standards recommend 1.5 square feet of venting area for every 300 square feet of attic floor space. Recommend an attic contractor evaluate and remedy. Soffit vents were only venting present at time of inspection. Gable vents will increase circulation of air in unconditioned space.

Contact a qualified general contractor.

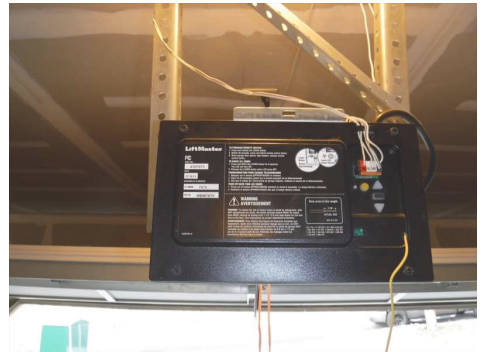
13.2.1 Garage door

GARAGE DOOR PRESSURE

At time of inspection the garage door closing pressure was set high. Higher settings can be dangerous for children and pets getting caught under door as it comes down. Recommend evaluation and adjustment by a qualified individual.

Adjust closing pressure.

Contact a handyman or DIY project

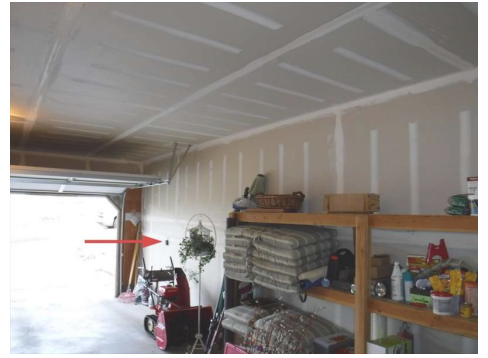
13.3.1 GFCI not present

NO GFCI

No GFCI at time of inspection. Recommend instal of GFCI in garage to protect against water penetration hazard.

Contact a qualified electrical contractor.
