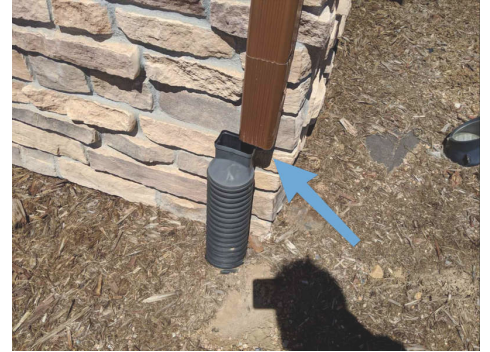
SE CORNER

GROUND DRAIN DOWNSPOUT DISCONNECT

The ground drain-line has settled and pulled loose from downspout, and needs re-connecting. The drainage may not fully push away from the home in this condition. This should be evaluated and corrected by qualified contractor.

Recommendation
Contact a handyman or DIY project

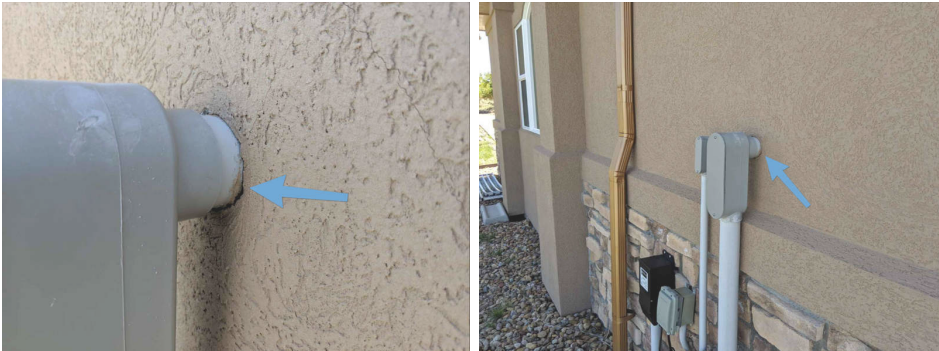
REAR OF DETACHED GARAGE

SEAL PENETRATION

Holes in the exterior wall should be sealed to prevent pest intrusion or water damage. Work should be performed by a qualified contractor.

Recommendation
Contact a handyman or DIY project

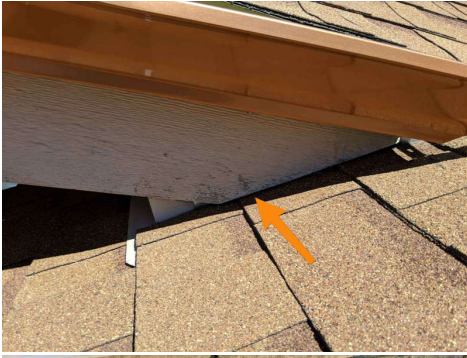
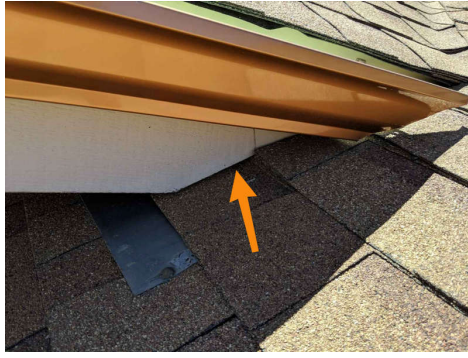
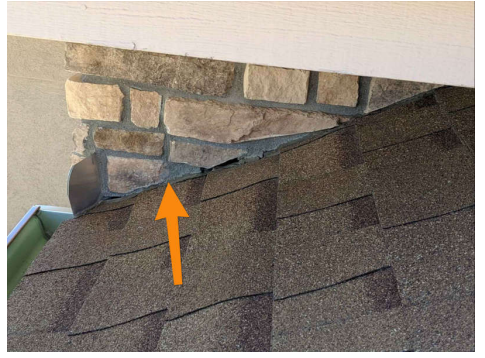
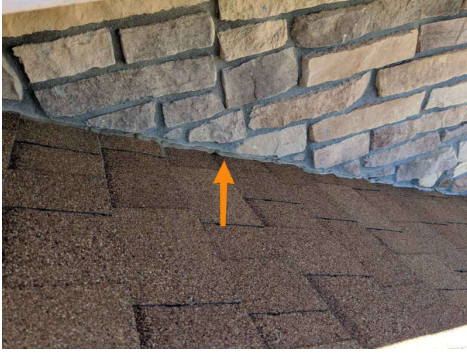
ABOVE DECK AND ABOVE FRONT PORCH

SIDING IN CONTACT WITH ROOF

The siding over the roof is showing deterioration to the bottom edge in areas. Normally, a 1" to 2" gap should be present between the siding and the shingles, to prevent damage to this bottom edge. It does appear that there is proper side wall flashing behind this siding. It is recommended that a siding professional repair or replace the damaged siding and ensure that a 1" gap is maintained over the roof areas, to prevent further deterioration.

Recommendation
Contact a qualified siding specialist.

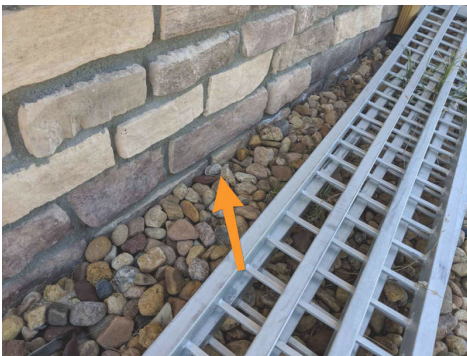
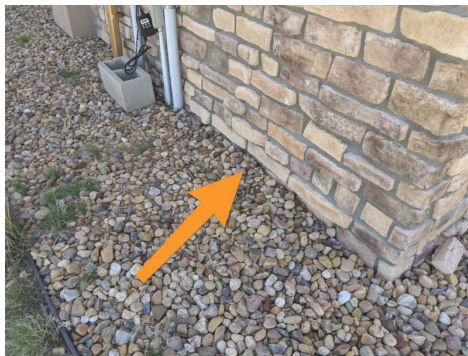
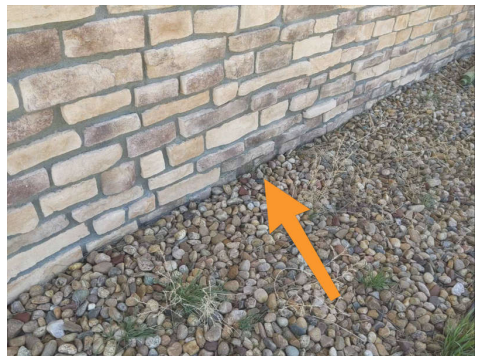
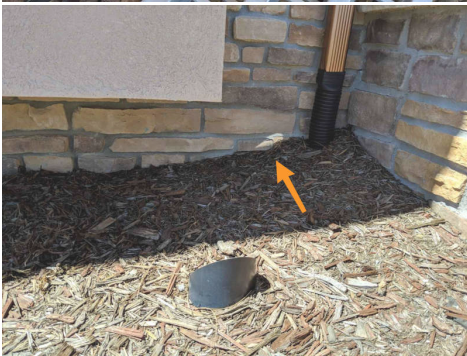
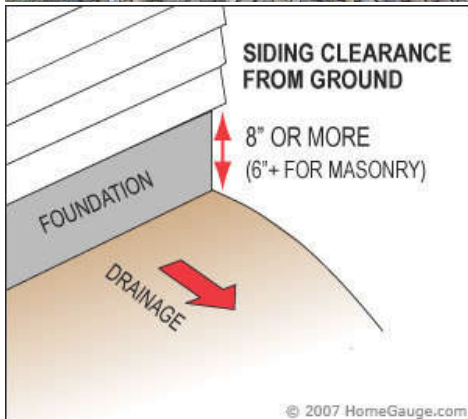
DETACHED GARAGE AND ALL SIDES OF HOME

SIDING IN CONTACT WITH SOIL

There is inadequate soil-to-siding clearance. Direct soil contact with siding material can cause damage to the siding and be an area for water intrusion, as well as wood destroying insect intrusion into the home. I recommend the grading be reviewed and corrected in this area, to ensure there is no soil-to-siding contact, and that the drainage slopes away from the home in this area.

Contact a qualified landscaping contractor

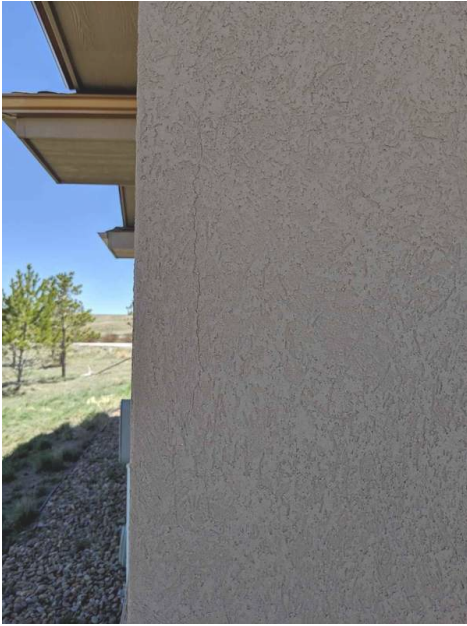
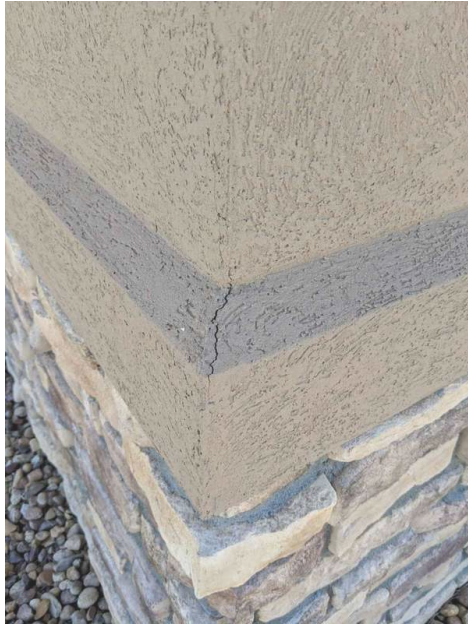
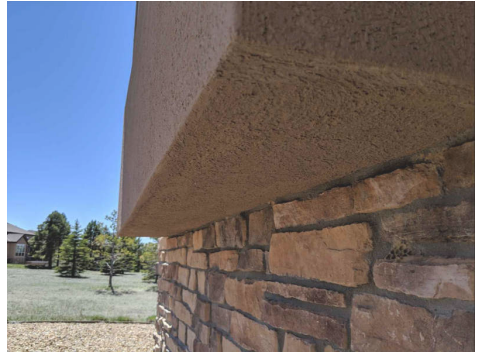
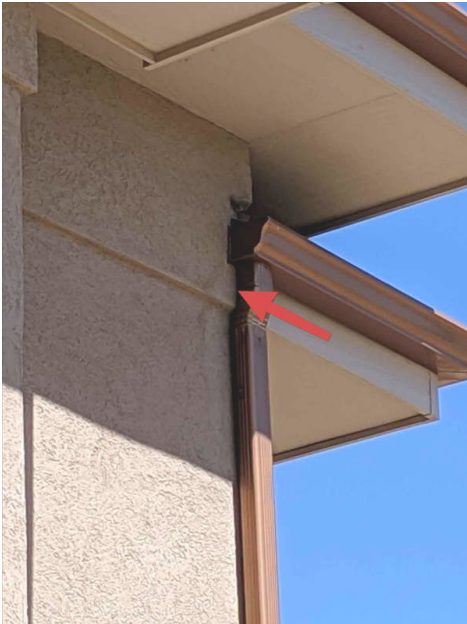
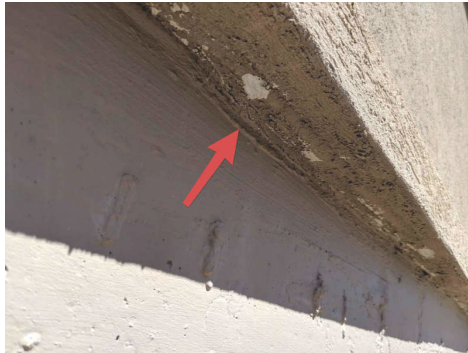
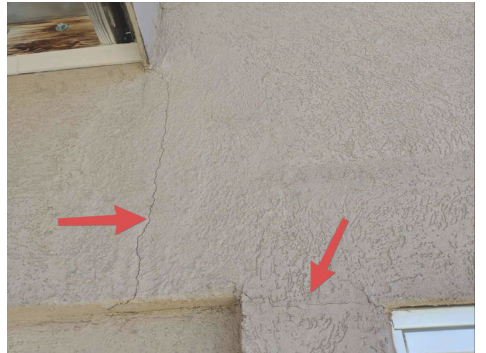
ALL SIDES

EIFS STUCCO, EVALUATION NEEDED

The house appears to be clad with a product known as Exterior Insulation Finish Systems (EIFS), also referred to as "Synthetic Stucco." Many EIFS clad houses have revealed moisture related problems such as deteriorated wood framing and mold issues. The house has some cracks present in areas around the home, representing potential moisture penetration issues. Testing of this cladding is beyond the scope of this inspection, and requires a specialist who can probe the siding and determine if moisture issues are present, and if repair is needed. I recommend a siding specialist familiar with EIFS inspect the home completely, and advise you on any repair needed.

No clear drainage plane

Contact a stucco repair contractor

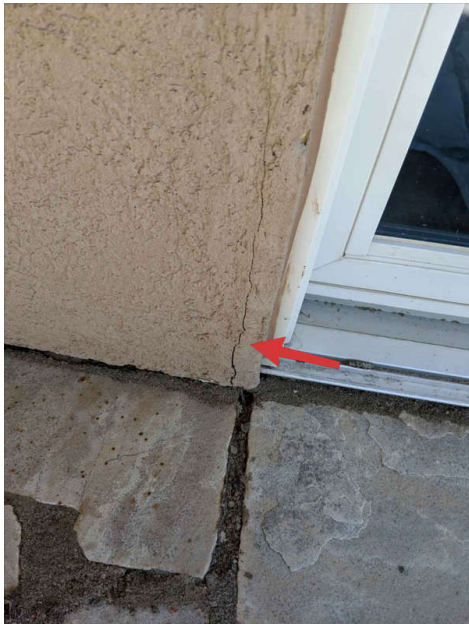
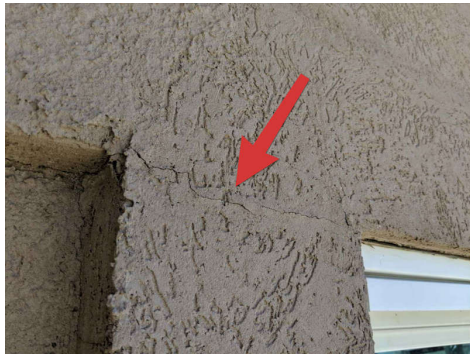
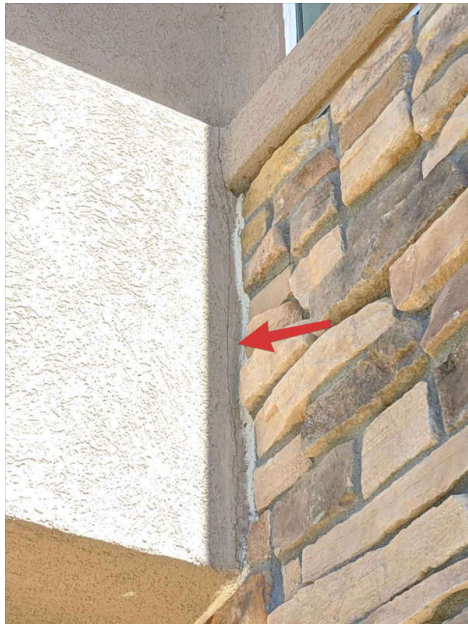
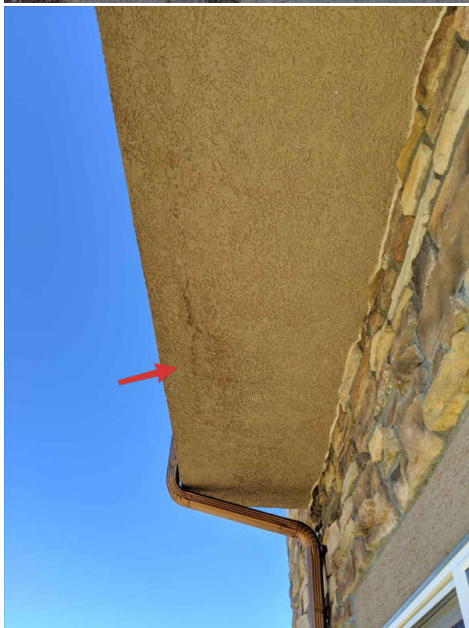
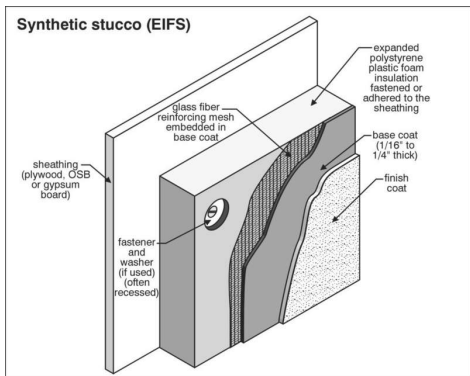
Moisture staining under west window

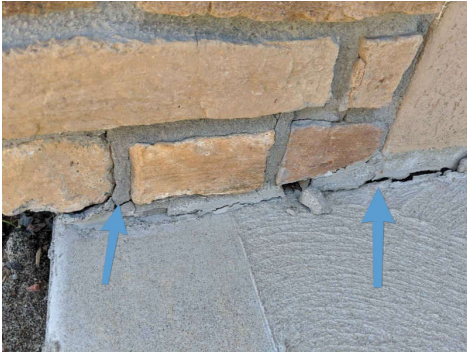
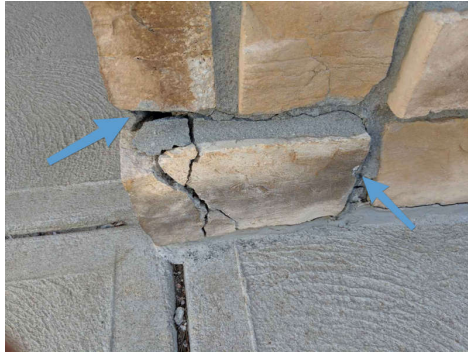
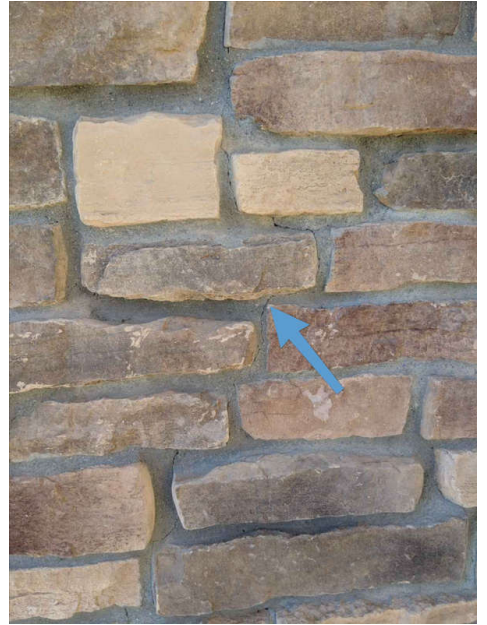
4.1.5 WALL COVERING
STONE VENEER MINOR CRACKING
 NEAR MAIN GARAGE DOORS

The stone veneer is cracked at some locations around the home. This appears to be minor and no moisture concerns are noted. A siding contractor should repair as needed.

Recommendation
 Contact a qualified siding specialist.

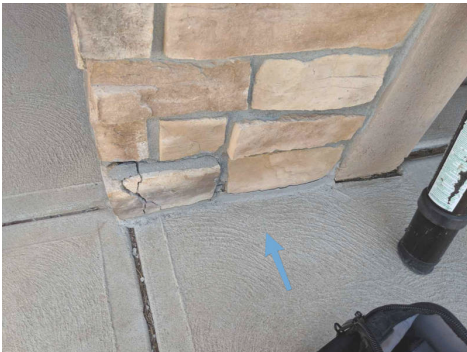
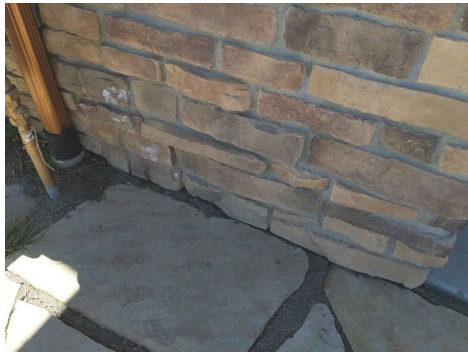
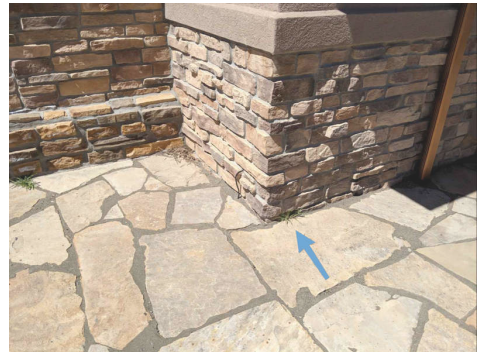
ALL SIDES

STONE VENEER IN CONTACT WITH HARDGRADE

The stone veneer is in contact with the concrete around the home in the above locations. No moisture concerns are noted at this time.

Contact a qualified professional.

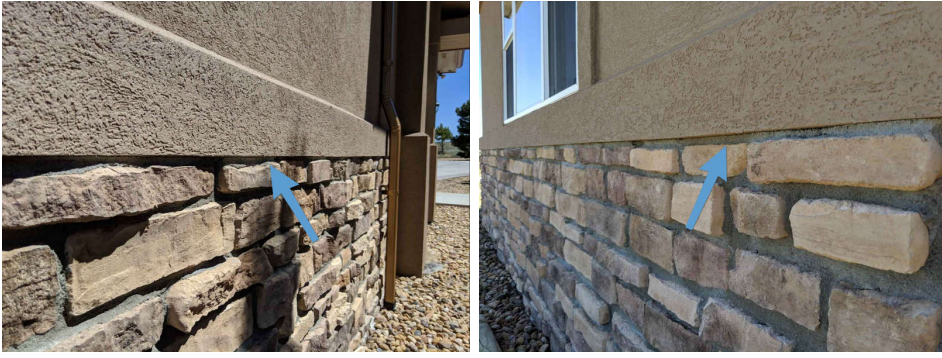
NO FLASHING BETWEEN MATERIALS

There's no flashing between the stucco and the stone veneer. It is unclear if this was required during the time of construction. No obvious moisture concerns present.

Contact a qualified professional.

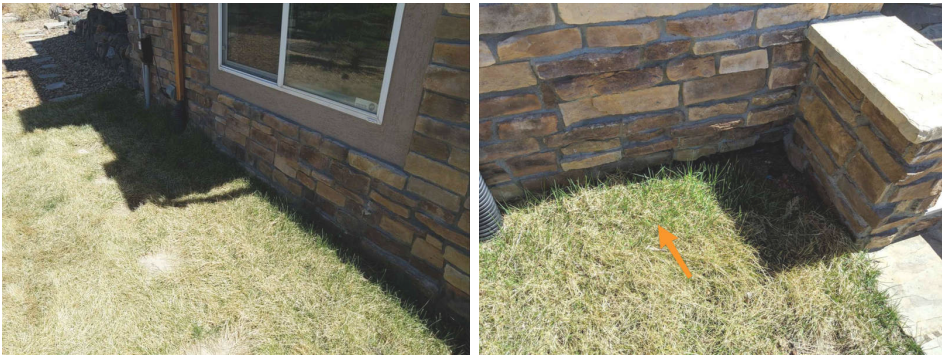
REAR YARD

GRASS AGAINST FOUNDATION WALL

There is grass against the west foundation wall. If this area is watered by a sprinkler, the siding and foundation will be exposed to excessive water.

Contact a qualified professional.

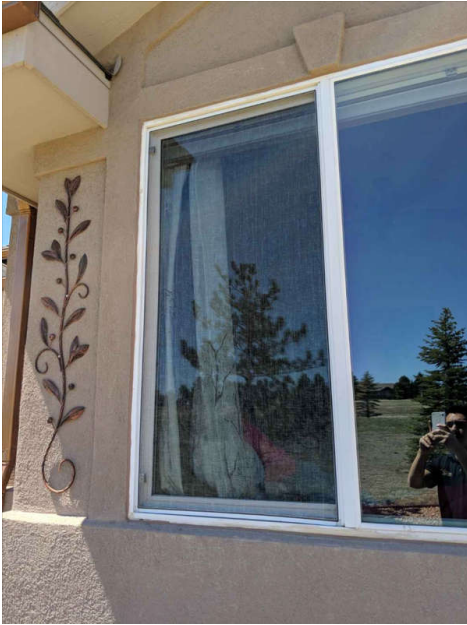
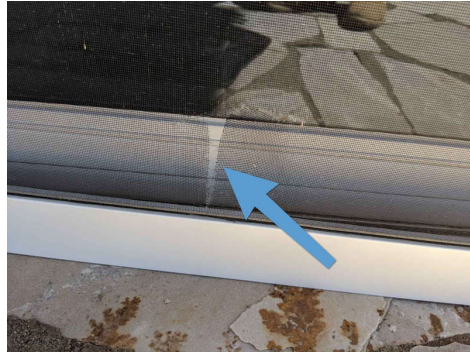
WORN SCREENS

The screens on several windows throughout are aging, and the screen material appears to be brittle. Consider rescreening in the near future, as a minor maintenance item.

Contact a handyman or DIY project

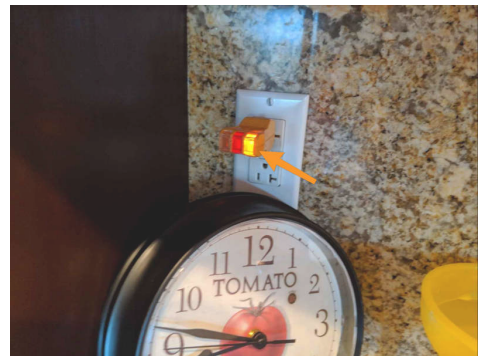
BASEMENT KITCHENETTE

10.6.1 RECEPTACLE OPERATION (POLARITY AND GROUNDING) **UNGROUNDING OUTLET(S)**

An ungrounded "three-prong" outlet(s) is present, even though 3 wire circuits with ground wires appear to be present elsewhere. This is a safety issue that needs to be corrected. An electrician should investigate and repair this item.

Recommendation
Contact a qualified electrical contractor.

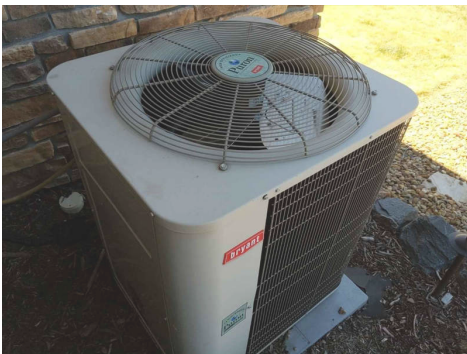
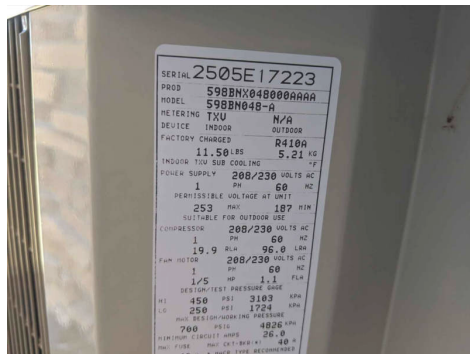
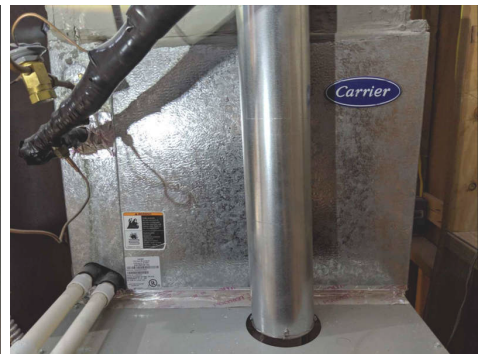
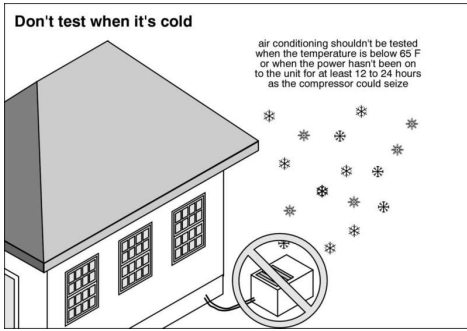
12.1.1 COOLING AND AIR HANDLER EQUIPMENT **AC TOO COLD TO TEST**

The A/C system(s) was not tested for proper operation because the outside air temperature is 65 degrees or less. Damage to the unit can occur if operated below this temperature. Liquid can be in the compressor unit, and can damage the compressor if run. A limited visual inspection of the system and electrical service was conducted with no concerns noted.

Recommendation
Contact a qualified professional.

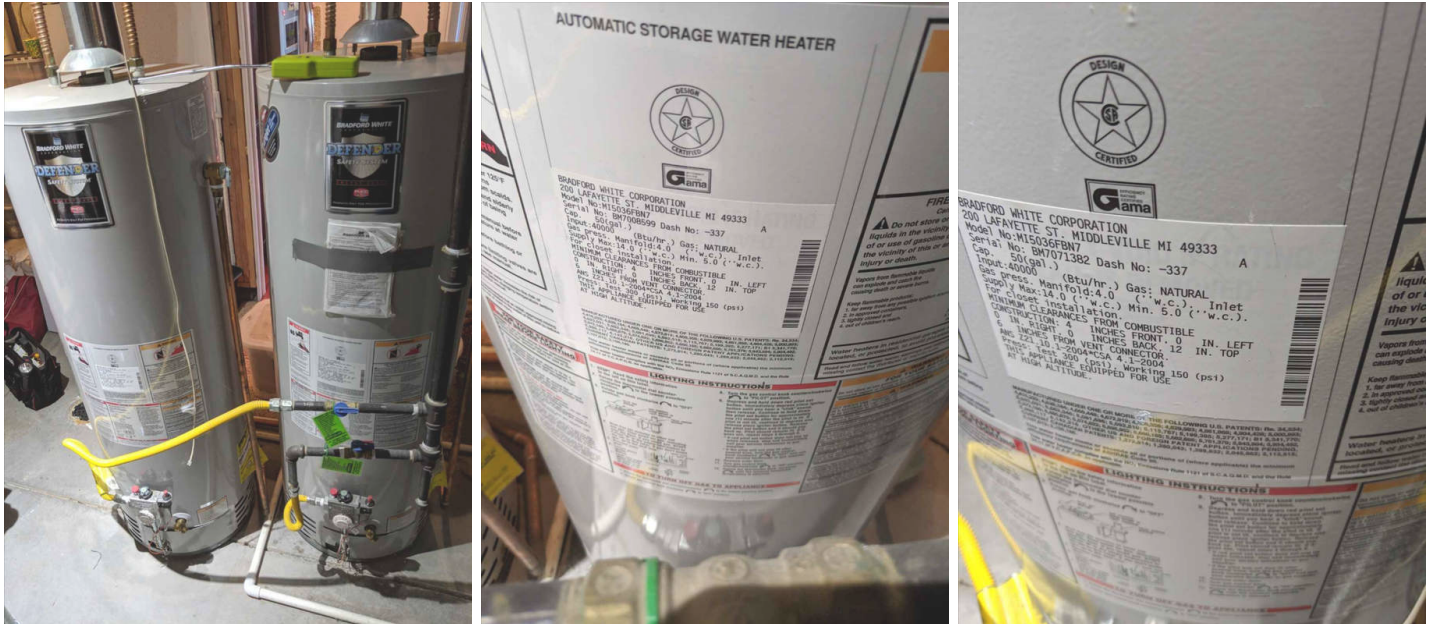
13.13.1 HOT WATER SYSTEMS, CONTROLS, CHIMNEYS, FLUES AND VENTS
OLDER UNITS - CONSIDER REPLACING

The water heater is older, and is over the age of average life expectancy (10-12 years). Based upon the age and condition of the unit, leaks could develop at any time, and replacement is recommended.

Recommendation
 Contact a qualified plumbing contractor.

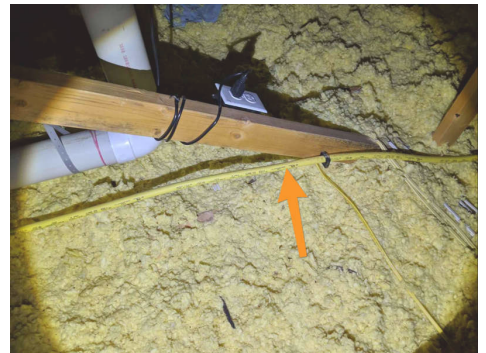
ATTIC

13.14.1 GAS DISTRIBUTION SYSTEMS
CSST NOT BONDED

There is a type of flexible gas piping called CSST installed in the home. This gas piping is not properly supported & does not appear to be properly bonded. This type of piping is required by the manufacturer to be bonded to the electrical grounding system of the home for safety. This requirement reduces the likelihood of damage to the piping from an electrical surge or lightning strike, which could result in gas leaks or a fire. A professional electrical contractor should evaluate and properly bond the CSST gas piping to the electrical grounding system as required. For more information, visit <https://scotthomeinspection.com/csst-direct-bonding-tech-bulletin/>

Recommendation
 Contact a qualified plumbing contractor.

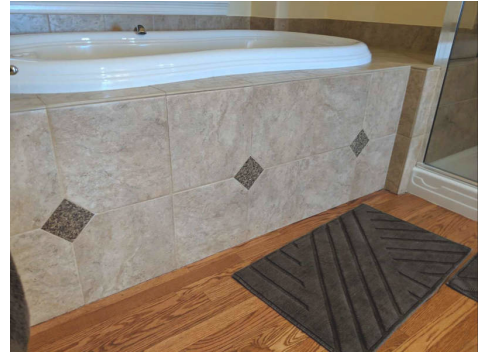
MASTER BATHROOM

NO ACCESS

There is no access panel installed or the panel was sealed at the time of inspection for the jetted tub and I was not able to inspect the motor and connections. I recommend that a removable panel be installed to give access to the jetted motor and piping that run under and around the tub. Contact a qualified contractor for advice and necessary corrections.

Contact a qualified professional.

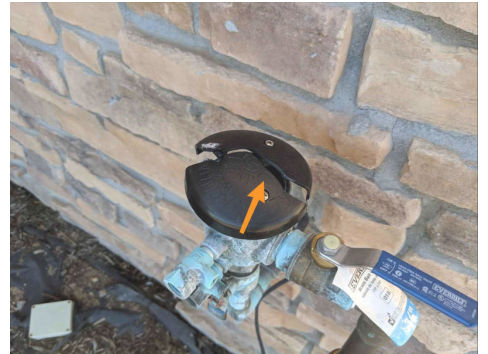
CAP DAMAGED

The backflow preventer cap at the lawn sprinkling supply outside is missing or damaged. This cap is needed, to protect interior components from damage and weathering. A qualified person should repair or replace as needed.

Contact a qualified landscaping contractor

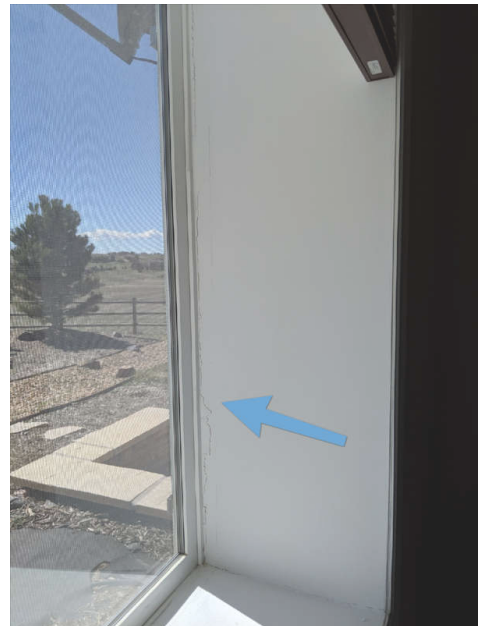
BASEMENT WINDOWS

MINOR CRACKING

Minor cracking was noted near the basement windows in the home. These cracks are typical of minor settling, and should be monitored for further movement, and patched and repaired as desired.

Recommend monitoring.

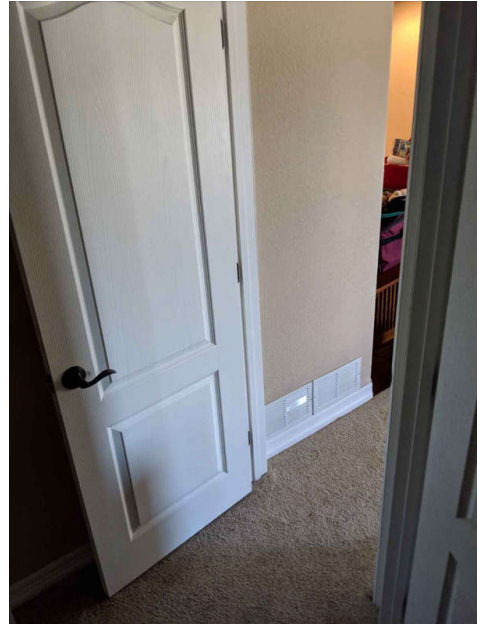
BASEMENT HALL

DOOR(S) NOT LATCHING

The door(s) will not latch properly when closed. This door needs to be adjusted or repaired, to properly close and latch. This should be evaluated and corrected by a qualified contractor.

Contact a qualified door repair/installation contractor.

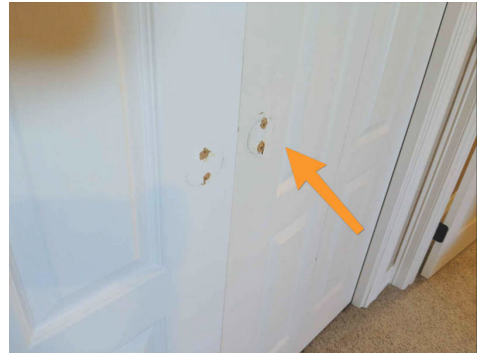
BOTH BASEMENT BEDROOMS

DOOR MISSING HANDLE

Basement bedroom closet doors missing handles. Replacement needed.

Contact a qualified professional.
