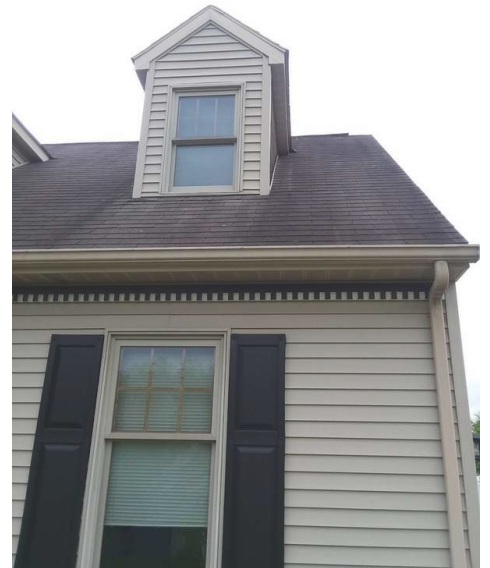
**DISCOLORATION**

Roof shingles are somewhat discolored, probably caused by algae and is aesthetic in nature.

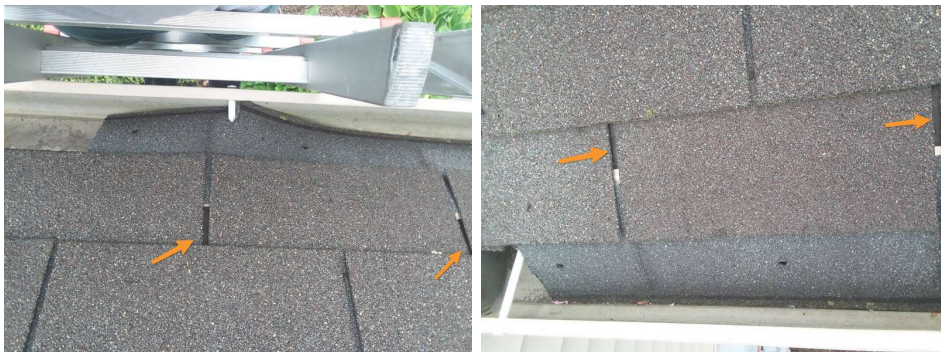
GARAGE, FRONT LEFT NEAR GUTTER

**SHINGLE DISPLACED**

Starter shingle pulled loose of nails and slid down into gutter. This shingle should be replaced to eliminate risk of leak into soffit area.

Underlayment exposed at water ways

Contact a qualified roofing professional.

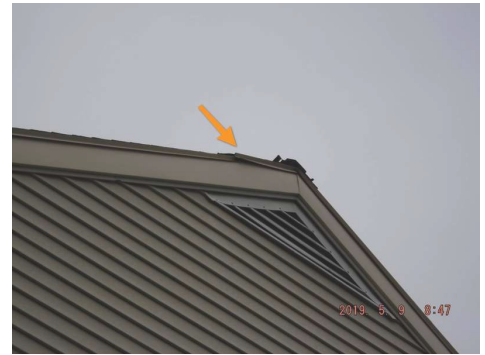
LEFT REAR OF HOUSE

**DRIP EDGE LOOSE**

A short piece of drip edge is loose or out of place near peak.  
Recommend refastening to avoid water entry behind shingles, underlayment, or fascia.

Contact a qualified roofing professional.

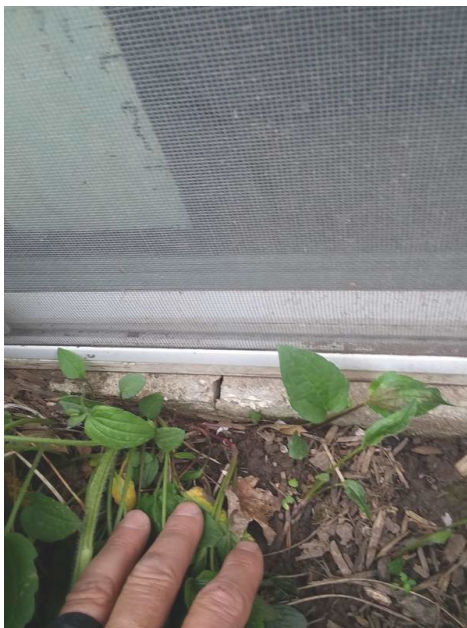
Left End of House

## SIDING GROUND CLEARANCE

Inadequate clearance between siding and ground. Recommend 6" minimum ground clearance to bottom of siding to deter direct access to wood destroying insects to wood components of house. At basement windows on left end of house, window wells should be installed. Recommend altering conditions to allow minimum clearance.

Contact a handyman or DIY project

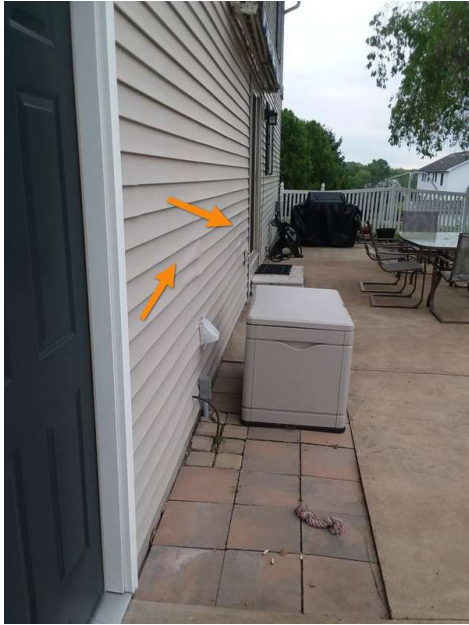
Two areas

## WARPING/BUCKLING

Vinyl siding was warping or buckling in areas. This is often as a result of nailing siding boards too tight to the home, but this doesn't seem to be the case here. This is mostly aesthetic, however insects could easily travel behind the siding at the gap. Recommend a qualified siding contractor evaluate and replace these pieces of siding.

Contact a qualified professional.

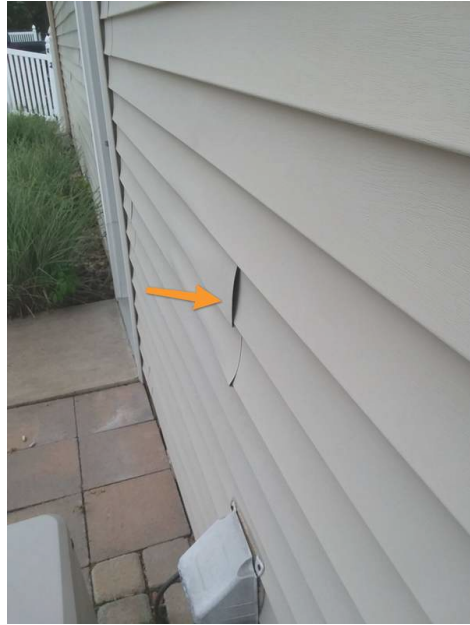
Gap could allow insect intrusion behind siding.

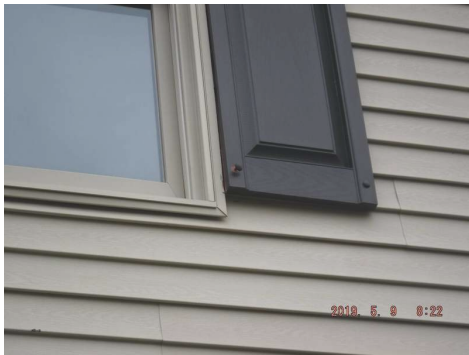
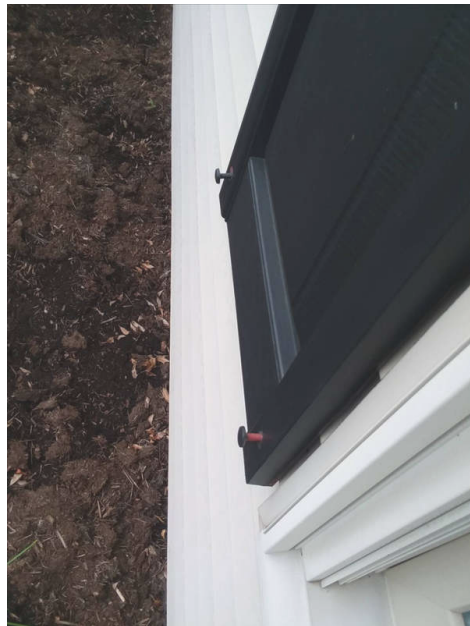
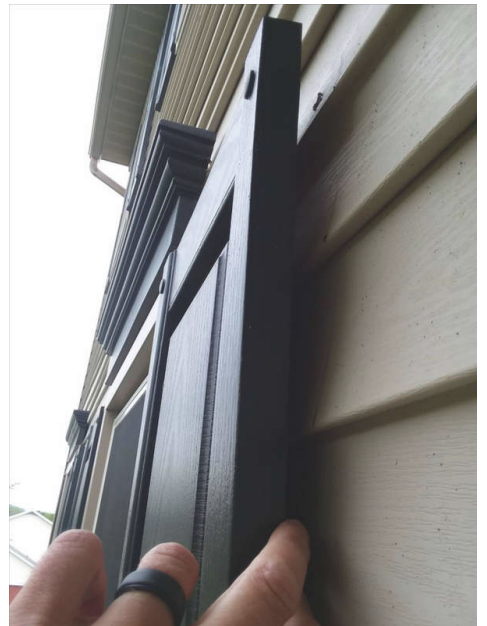
VARIOUS LOCATIONS

**SHUTTERS PINS**

A number of shutter pins, which fasten the shutters to the wall, are broken. Shutters are in danger of falling or being blown off. Recommend replacing broken pins.

Contact a handyman or DIY project

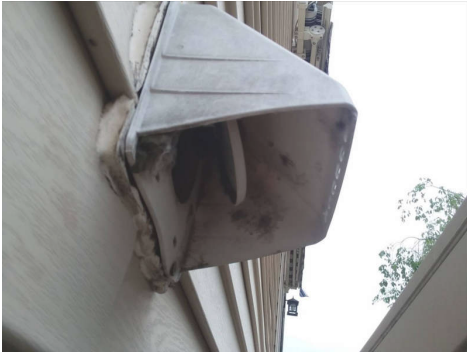
Dryer vent hood is cracked and flapper does not close tightly. Recommend replacing with a new dryer vent hood.

Flapper does not close

Recommendation  
Contact a handyman or DIY project

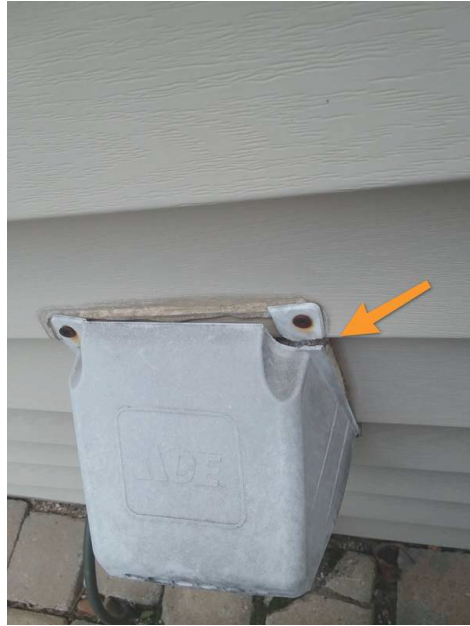
Cracked at top

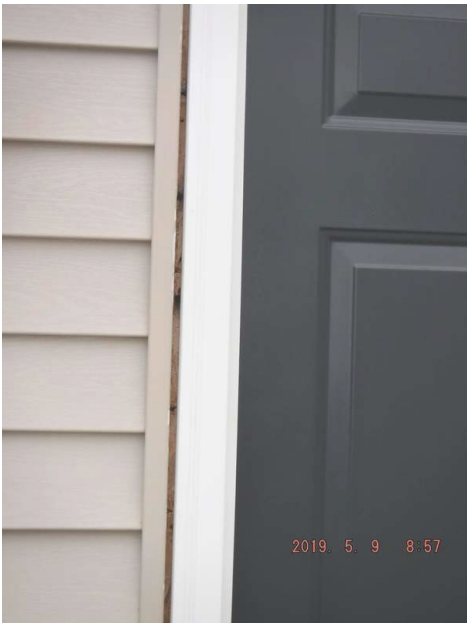
A gap exists between the siding j-channel and the door molding and also rear garage wall at top. This could allow water entry, leading to damage to the wall sheathing and/or molding. Recommend applying a high grade exterior caulking to seal the gap at door molding. The siding may be able to be slid back together and overlapped, assuming the siding panels slid apart over the years.

Sheathing visible

Recommendation  
Contact a handyman or DIY project

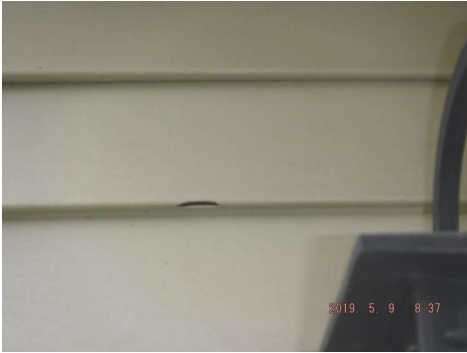
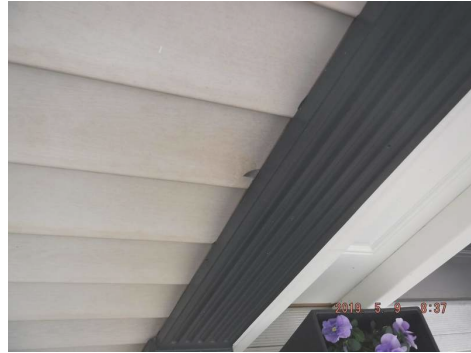
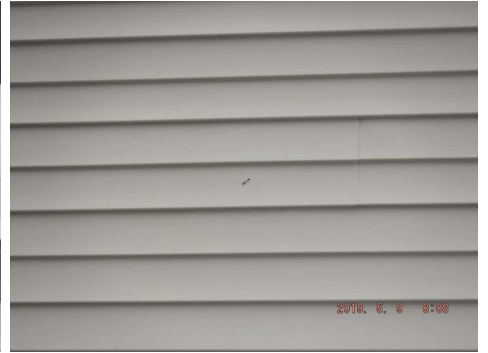
**SIDING MINOR DAMAGE**

A few areas of minor siding damage are present. Recommend sealing, by a qualified handyman, with a color-matched caulking to avoid water/insect intrusion.

Contact a handyman or DIY project

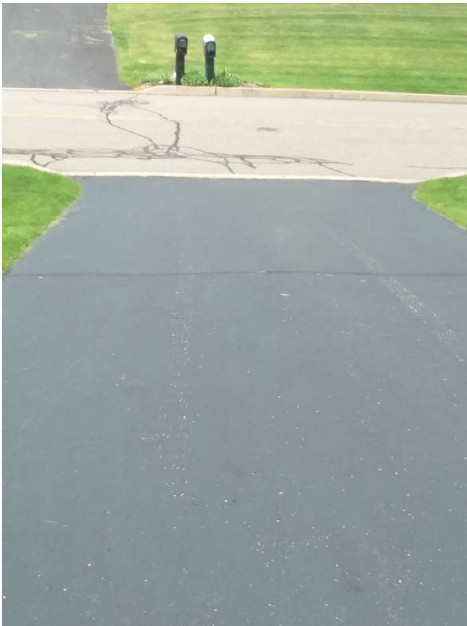
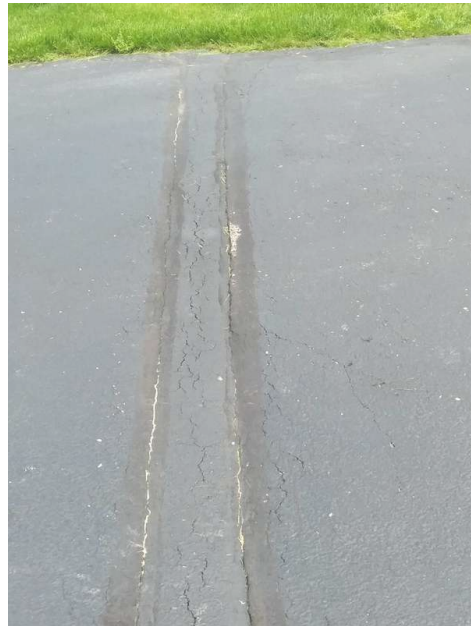
**DRIVEWAY CRACKING - MINOR**

Minor cosmetic cracks observed, which may indicate movement in the soil. Recommend monitor and/or have concrete contractor patch/seal.

Contact a handyman or DIY project

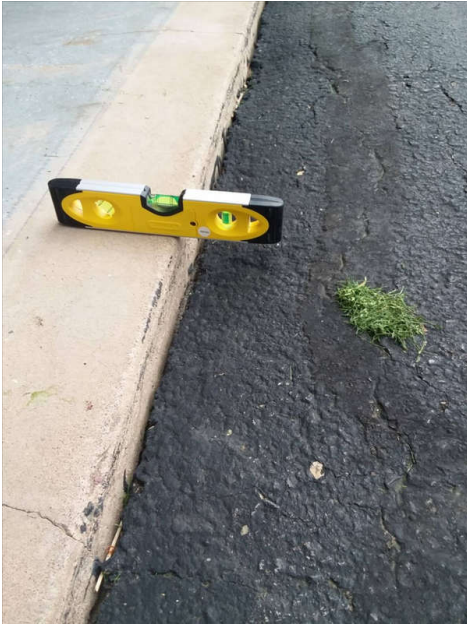
Driveway at garage

**ASPHALT SETTLING AT GARAGE**

Gap between driveway asphalt and garage concrete allows water to drain to ground, causing erosion and allowing asphalt to settle. The settling has resulted in a negative pitch of the asphalt towards the garage, and directing more water towards the gap. Recommend sealing the gap and monitoring the asphalt for further settling.

Contact a qualified professional.

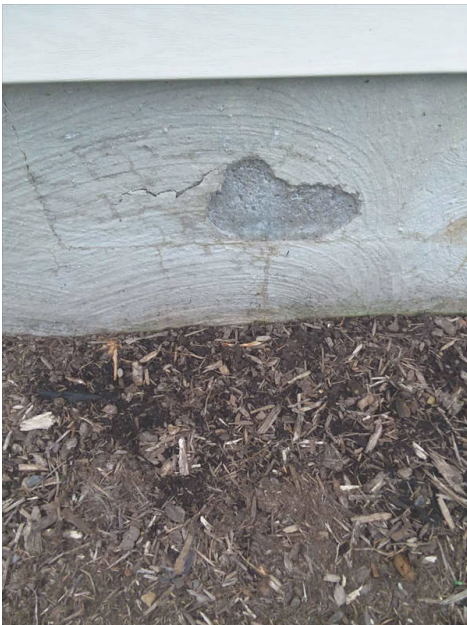
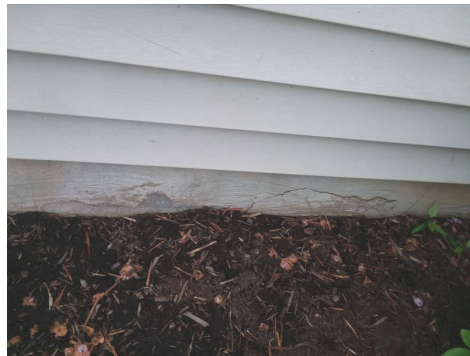
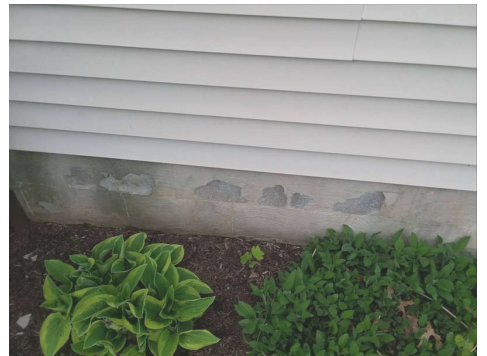
VARIOUS LOCATIONS

**MINOR PARGE FLAKING**

The parging at the foundation wall exhibits areas of flaking. Parging a CMU wall is mainly aesthetic but can offer a barrier to insect entry at minor cracks. Recommend monitoring the parging for further degradation and repair if desired.

Contact a qualified masonry professional.

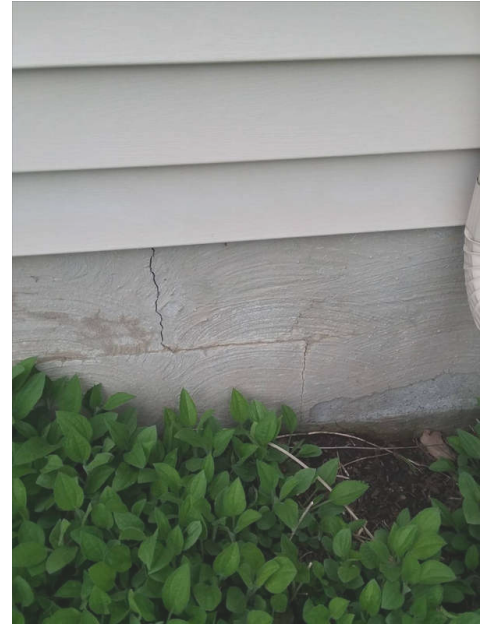
LEFT END OF HOUSE

**MINOR CRACKING**

Some minor cracking is evident at the basement wall. This is a common occurrence with CMU walls and does not pose a structural issue. Recommend monitoring for worsening of or additional major basement wall cracks.

Contact a qualified professional.

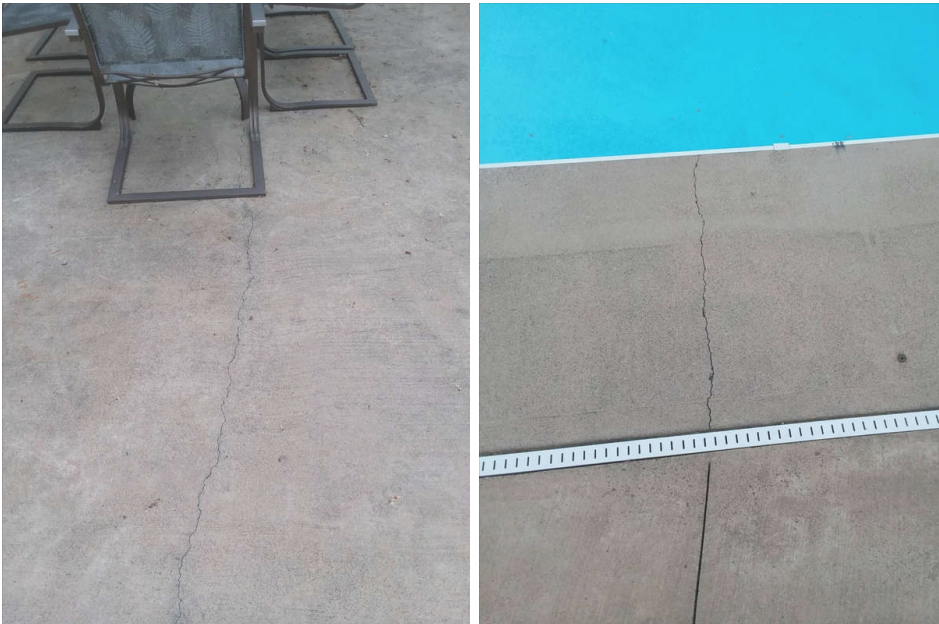
### POOL AREA SLABS

## **POOL PATIO MINOR CRACKING**

Minor cracking is evident at various locations around pool area. Recommend monitoring for future cracking, widening of cracks or crack settling to different heights.

Contact a qualified professional.

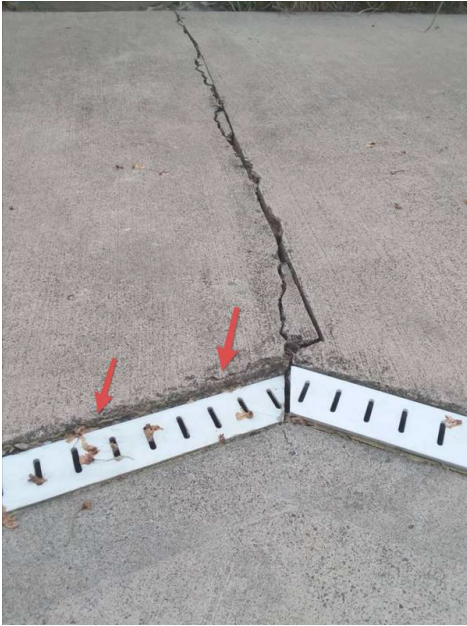
Settling has occurred at two areas at the concrete slab closest to swimming pool and has created a trip hazard. Recommend a qualified concrete contractor evaluate and repair/replace.

Approx. 3/4" height difference between slabs

Recommendation  
Contact a qualified concrete contractor.

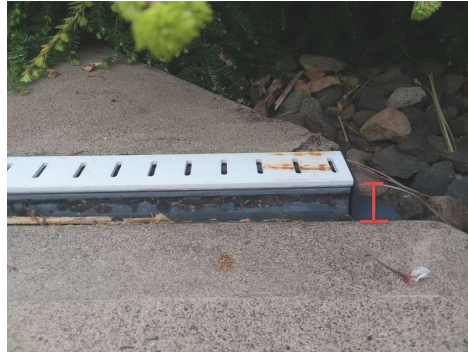
Approx. 1-1/4" difference in height between slabs.

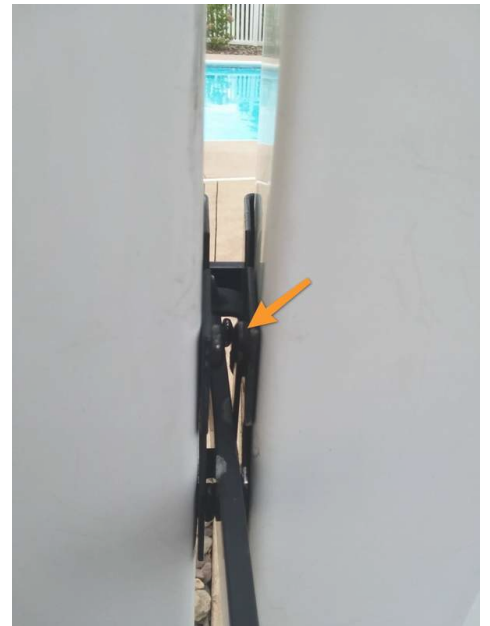
##### NEAR GARAGE

#### **POOL FENCE GATE**

The Pool fence gate near the garage is difficult to open. The post leans towards the gate and causes the latch screws to catch on the bracket. Recommend reinstalling the post next to the gate.

Re-set the post to widen the gap between the post and gate.

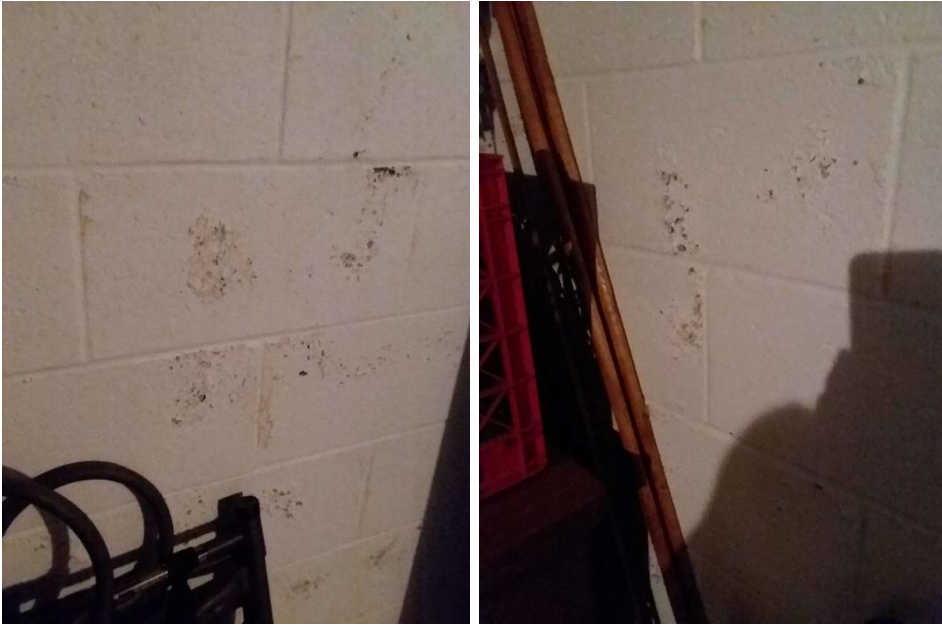
#### **EFFLORESCENCE**

Minor Efflorescence noted on the basement wall surface. This a white, powdery deposit that is consistent with moisture. Recommend maintaining low humidity in basement area.

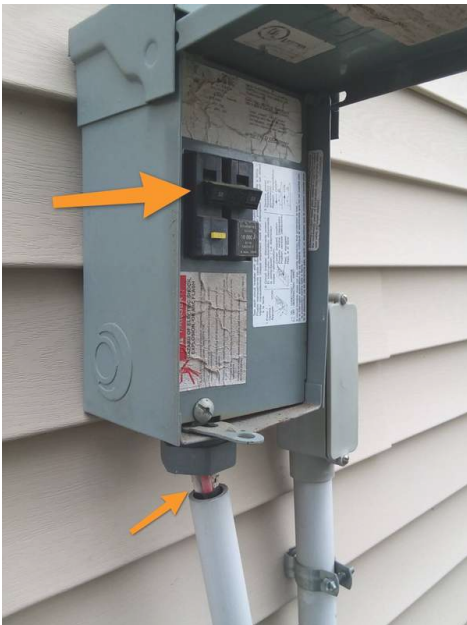
There is an unused electrical disconnect that may have powered a hot tub or other electrical equipment. The breaker is shut off at the main panel and the disconnect, the wire has been taped over, the conduit has been pulled partially out of the disconnect box and there is an opening into the box. Recommend a qualified electrician remove the wiring, conduit and disconnect box for safety purposes.

Breaker turned off, wiring exposed

Contact a qualified electrical contractor.

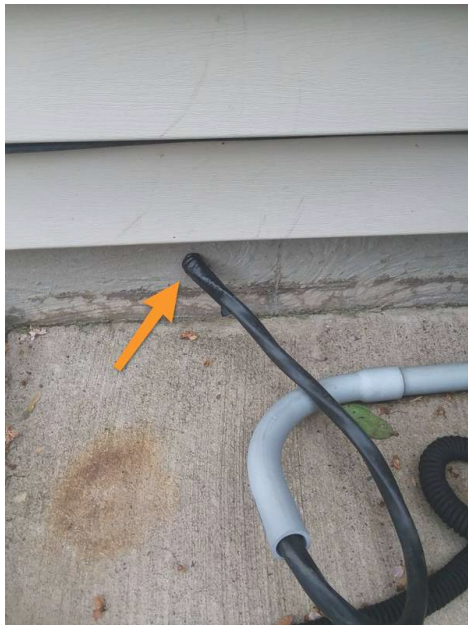
Wire taped but no adequate weather or human protection.

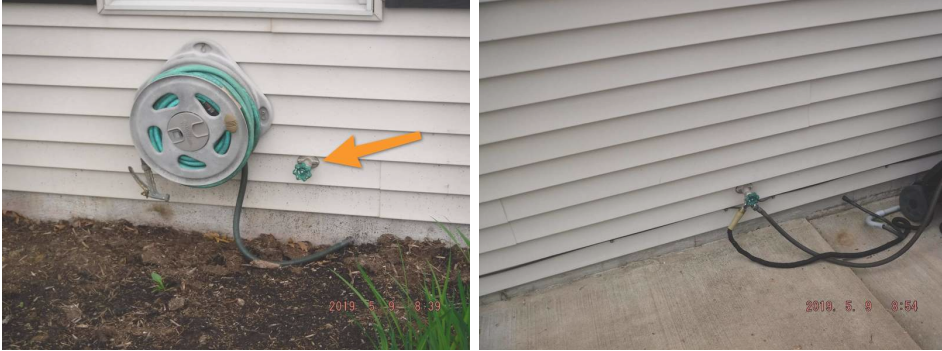
FRONT LEFT

**EXTERIOR FAUCET NOT ANTI-SIPHON**

The exterior faucets do not have an anti-siphon device to eliminate the possibility of siphoning contaminated water into the home's fresh water supply system. Recommend a qualified plumbing contractor replace existing exterior faucet with an anti-siphon exterior faucet or add a screw-on vacuum breaker.

Add anti-siphon device or change to hose bib with integral anti-siphon Rear

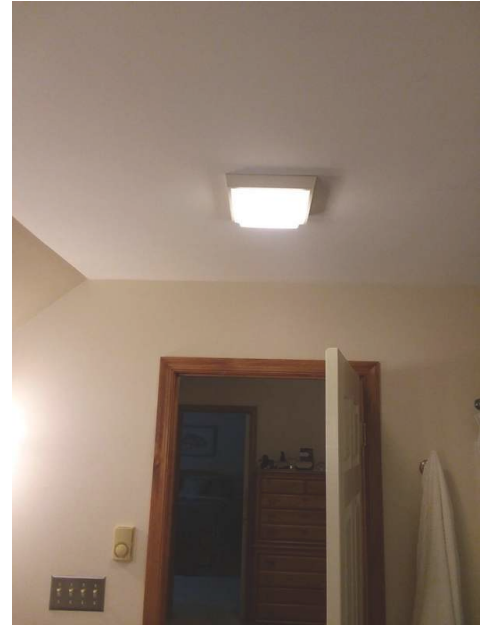
**BATH FAN**

Bath fan is noisy and may need a new fan motor. Recommend evaluation by handyman and parts replacement if necessary.

Contact a qualified professional.

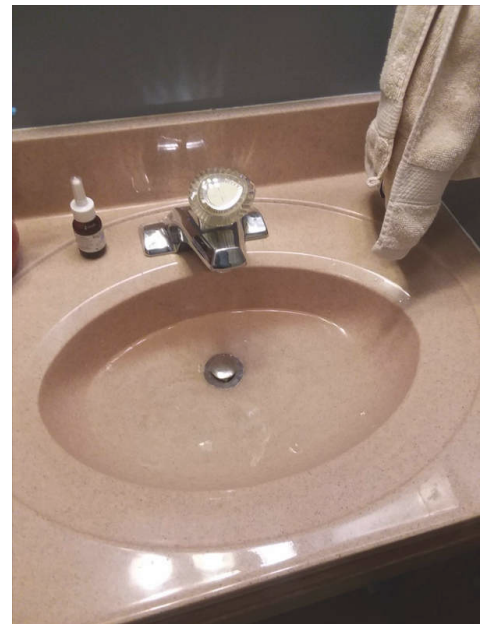
Vanity is draining very slowly. Recommend evaluating the clog and clearing the obstruction.

Slow Drain

Contact a handyman or DIY project

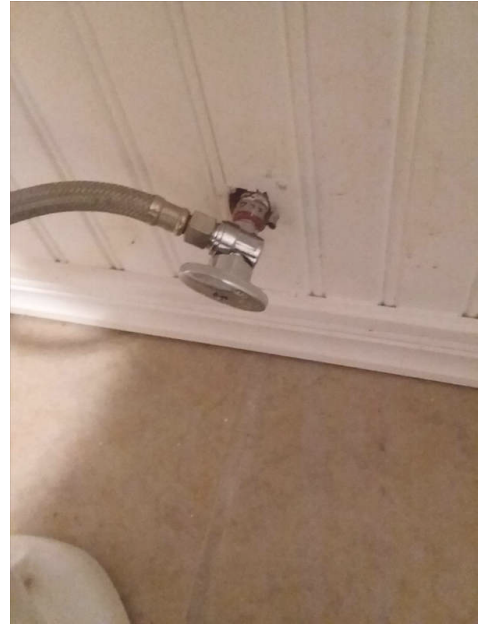
**TOILET FILL**

Toilet fills very slowly. Valve is on and hose is not kinked. Recommend qualified plumber evaluate and remedy.

Recommendation  
Contact a qualified professional.

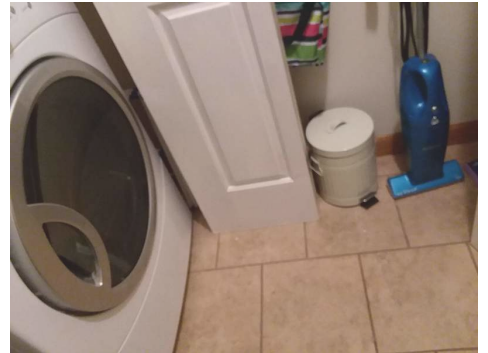
LAUNDRY AREA

### **BIFOLD DOOR INSTALLATION**

Bifold doors not properly installed. Recommend remove the doors, raise floor brackets up to top of floor surface, reinstall doors

Contact a handyman or DIY project

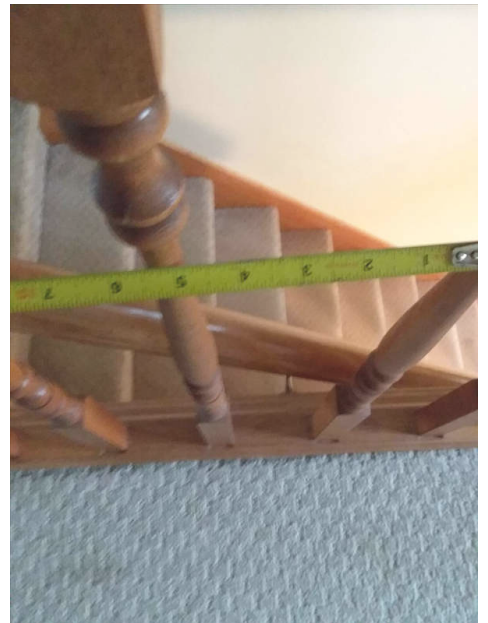
GUARD RAIL AROUND STAIR OPENING, 2ND FLOOR

### **BALUSTER SPACES TOO WIDE**

The baluster space is not up to modern building codes and safety standards. The space between balusters should not allow passage of a 4 inch sphere for child safety. Recommend a qualified handyman or original installer repair and bring up to code.

Contact a qualified handyman.

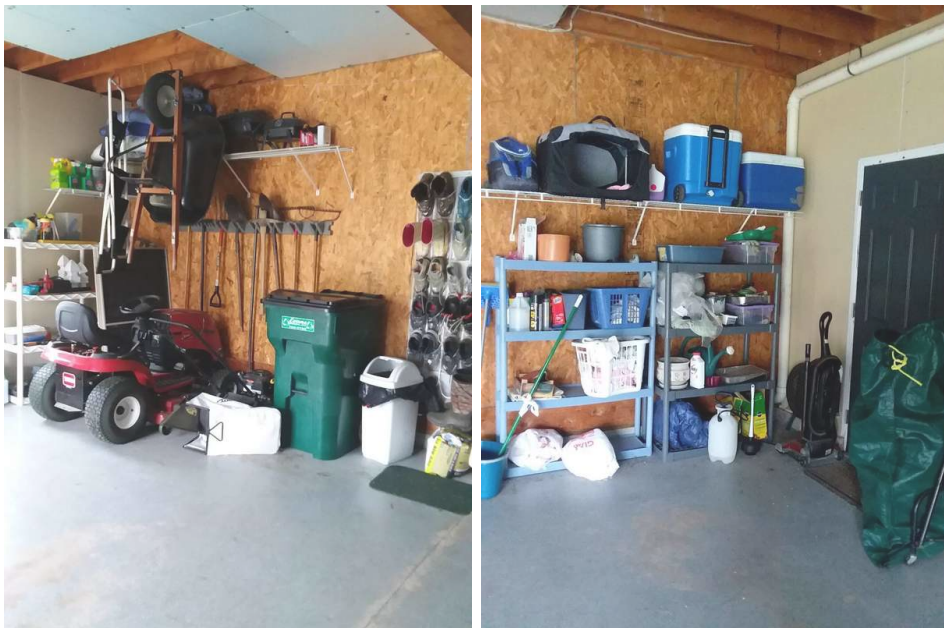
### GARAGE FIREWALL

## FIREWALL NOT UP TO CODE

Firewall separating the home and garage is not compliant with modern building codes and standards. Firewalls should be built with materials to delay fire spreading into the living space. This is mainly fire-code drywall and a fire-resistant door. The drywall is not present. The door is acceptable with the addition of self-closing hinges or closer. Recommend a qualified contractor evaluate and bring firewall up to standards.

Contact a qualified professional.
