SUMMARY

1234 Main St. Grove City OH 43123

Hyde Anderson
Cap City Property Inspections
(614) 373-6053
hyde@capcityinspect.com

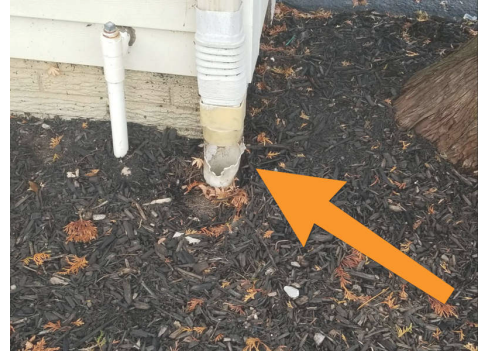
2.4.1 Gutters & Downspouts

DAMAGE/DISREPAIR OF DOWNSPOUT

One or more downspouts designed to discharge roof drainage was damaged or in disrepair to an extent that may limit its ability to function as designed.

Contact a qualified gutter contractor

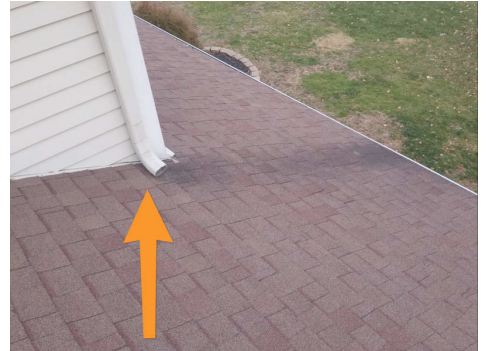
2.4.2 Gutters & Downspouts

DOWNSPOUT DISCHARGES ON THE ROOF

The downspout is improperly discharging onto the roof because of a missing transition extension.

Contact a qualified professional.

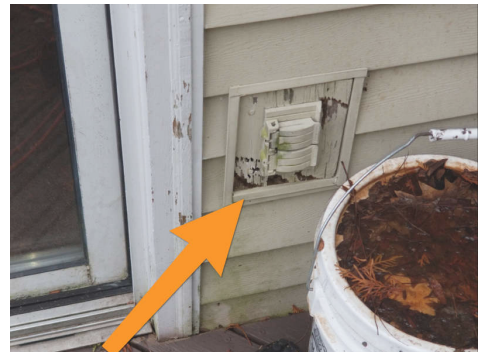
REAR OF THE HOME

DETERIORATION OF TRIM ON HOME

Trim at the home exhibited weathering and deterioration. It may need to be replaced. We could not determine the condition of underlying materials.

Contact a qualified professional.

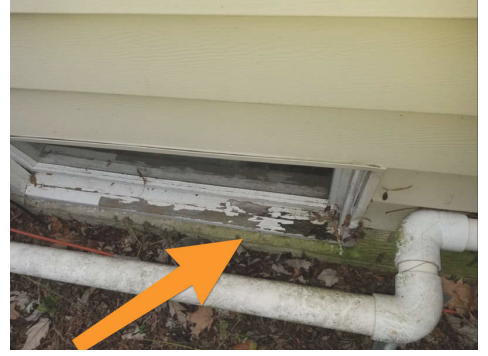
REAR BASEMENT WINDOW

DETERIORATION OF WINDOW FRAME

A window frame had general severe deterioration. Maintenance will be required to prevent leakage and replacement may be necessary.

Recommendation
Contact a qualified window repair/installation contractor.

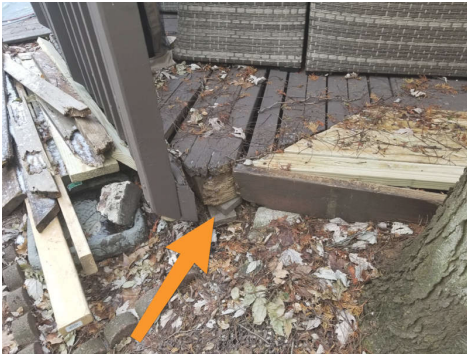
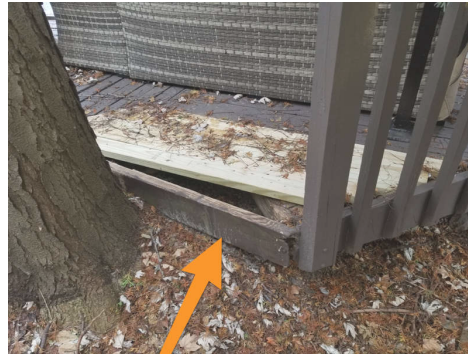
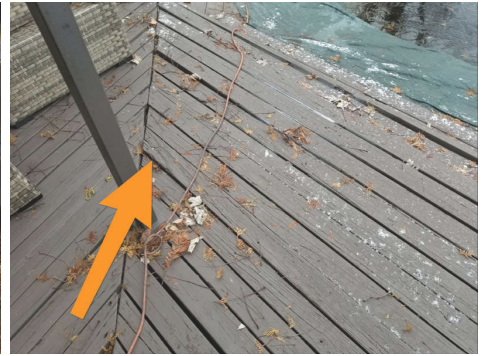
2.7.2 Deck, Porches and Patios **DECK OLD AND DETERIORATION**

This deck was old and exhibited deterioration commensurate with its age. Repairs may not be sufficient and some portions may need to be replaced.

Recommendation
Contact a qualified deck contractor.

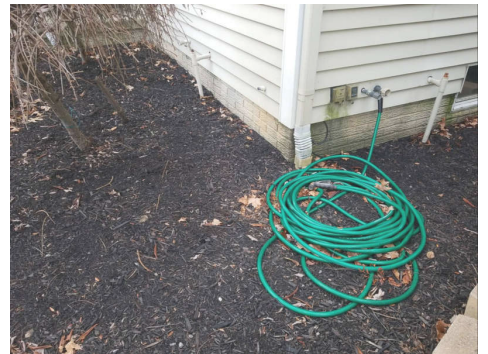
NEUTRAL OR NEGATIVE GRADING AROUND THE HOME.

The home had areas of neutral or negative drainage that will route runoff from precipitation toward the foundation. Excessively high moisture levels in soil supporting the foundation can effect its ability to support the weight of the structure above. The ground should slope away from the home a minimum of 1 inch per foot for a distance of at least six feet from the foundation. The Inspector recommends that these area be re-grading to improve drainage near the foundation.

Recommendation
Contact a qualified grading contractor.

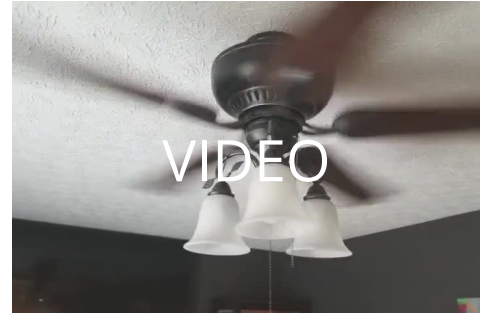
FAMILY ROOM

3.2.1 Ceilings, Walls & Floors **CEILING FAN WOBBLED DURING OPERATION.**

A ceiling fan wobbled during operation and appeared to be out of balance.

Recommendation
Contact a qualified professional.

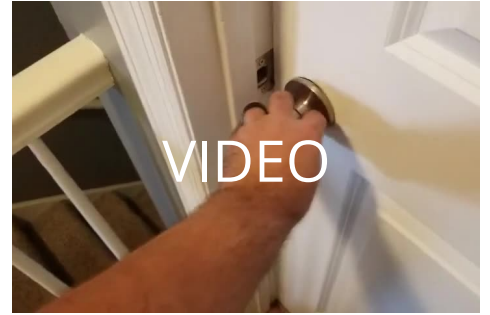
MASTER BEDROOM

DIFFICULT TO CLOSE DOOR, JAMB BINDING.

The door in the home was binding on the jamb and was difficult to close.

Recommendation
Contact a qualified professional.

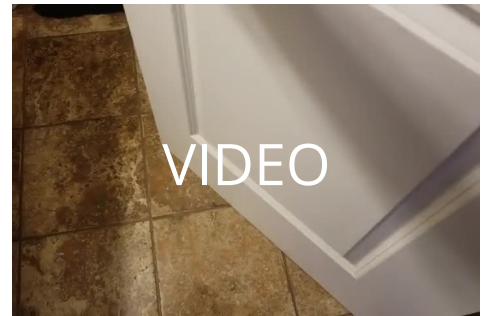
UPSTAIRS HALLWAY BATHROOM

DOOR WOULD NOT CLOSE, RUBS FLOOR

An interior door was rubbing on the floor and would not close.

Recommendation
Contact a qualified door repair/installation contractor.

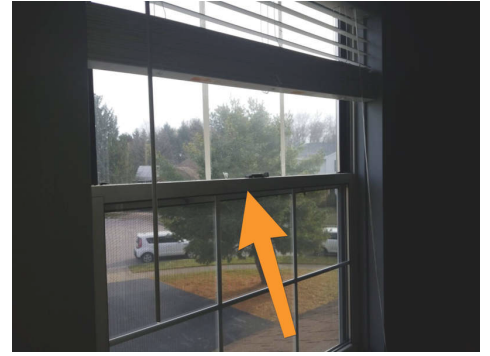
Master Bedroom

MULTIPLE WINDOWS HAD FAILED SEALS AND MOISTURE BETWEEN PANES

Condensation visible in the double-pane glazing of multiple windows indicated a loss of thermal integrity. Some windows may have lost their thermal integrity but may not be showing symptoms at the time of inspection. The Inspector recommends that you have each window in the home evaluated by a qualified contractor to determine the cost and exactly how many windows need to be repaired or replaced.

Contact a qualified window repair/installation contractor.

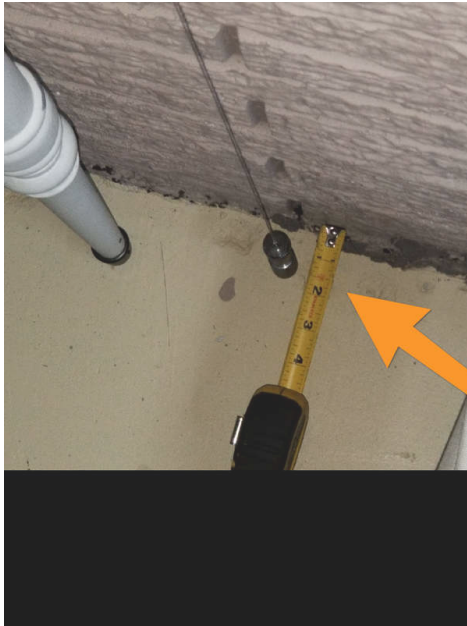
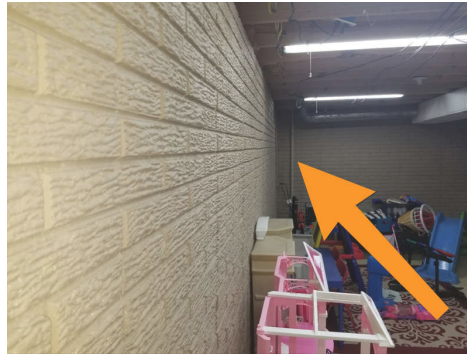
REAR BASEMENT WALL

FOUNDATION MOVEMENT

Larger than typical foundation movement was observed. This is usually the result of expansive soil or frost pressure, it may have been caused by installation of the swimming pool. Lot drainage and foundation improvements should be addressed to keep water away from the building. Repairs may be necessary. The rate of movement cannot be predicted during a one-time inspection. Cracks may need sealing on the exterior to prevent moisture penetration.

Contact a foundation contractor.

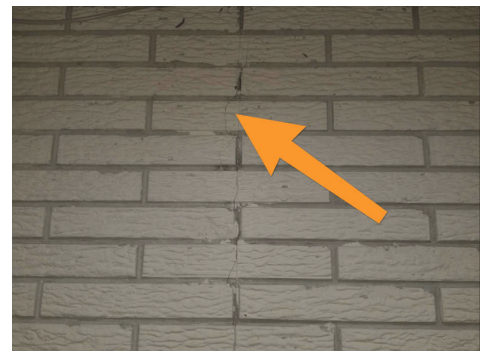
SETTLEMENT CRACKS SHOULD BE SEALED.

Cracking visible at the foundation wall appeared typical of settlement cracks. They should be sealed with concrete caulk to help prevent water penetration.

Contact a qualified professional.

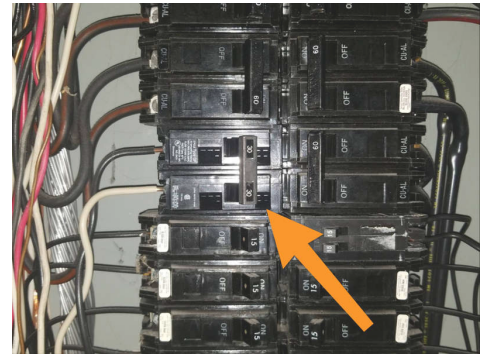
BREAKERS DIFFERENT BRAND THAN PANEL.

Circuit breakers in the service panel were of a brand different from the main panel brand. Because circuit breakers made by different manufacturers vary in design, panel manufacturers typically require that breakers manufactured by their company be used in their panels. Breakers from one manufacturer used in the panel of another manufacturer may result in poor connections which can create a potential fire or shock/electrocution hazard.

Contact a qualified electrical contractor.

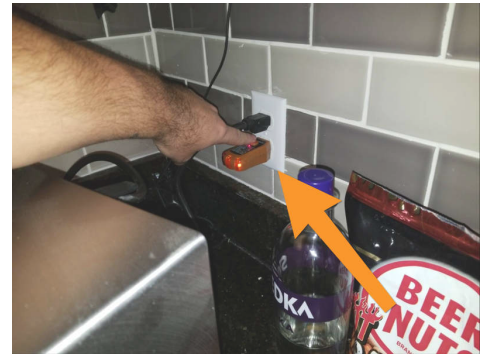
KITCHEN CORNER

OUTLETS NOT GFCI PROTECTED

No ground fault circuit interrupter (GFCI) protection of home electrical receptacles was provided at the time of inspection.

Contact a qualified electrical contractor.

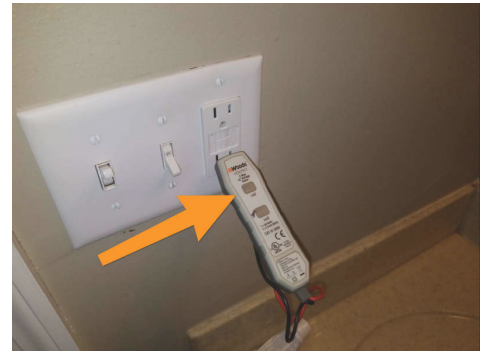
ALL BATHROOM OUTLETS

OUTLET IN HOME DID NOT OPERATE

An electrical receptacle in the home was inoperable at the time of inspection. The receptacle was tagged with a red dot marked "Non Op".

No power

Contact a qualified electrical contractor.

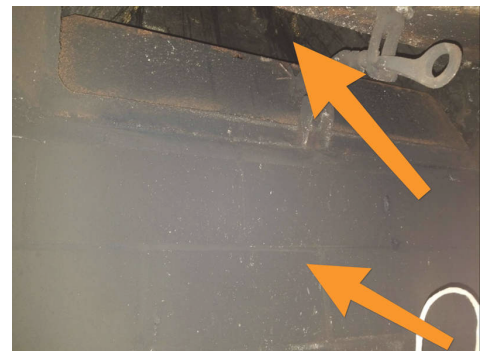
FAMILY ROOM

THE FIREPLACE WAS DIRTY.

The firebox of the wood-burning fireplace in the needed cleaning at the time of the inspection.

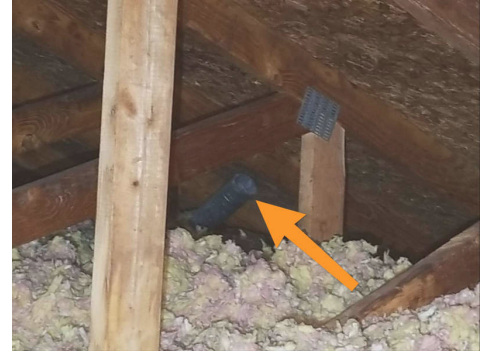
BOTH BATHROOMS

BATHROOM EXHAUST VENT DID NOT EXTEND TO THE EXTERIOR.

The exhaust vent for the bathroom terminated in the attic. To prevent excess moisture in this location, the exhaust vent should terminate at the home exterior.

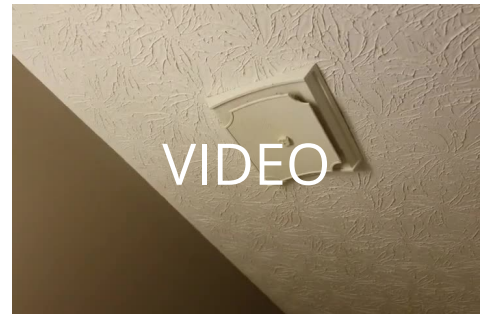
UPSTAIRS HALLWAY BATHROOM

NOISY EXHAUST FAN IN BATHROOM.

The exhaust fan was excessively noisy and may need to be replaced soon.

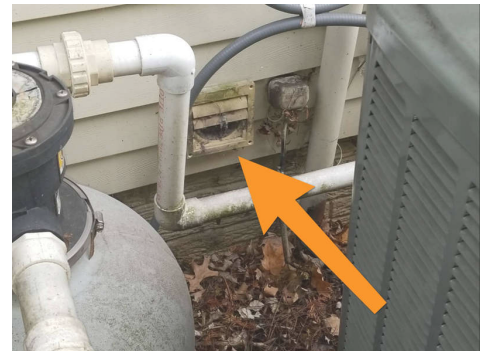
DAMAGED DAMPER ON DRYER VENT.

The dryer exhaust vent damper was damaged. This condition may allow pests to enter the vent, where they may create obstructions with nesting materials, creating a potential fire hazard. The Inspector recommends installation of a proper backdraft damper. All work should be performed by a qualified contractor.

Contact a qualified professional.

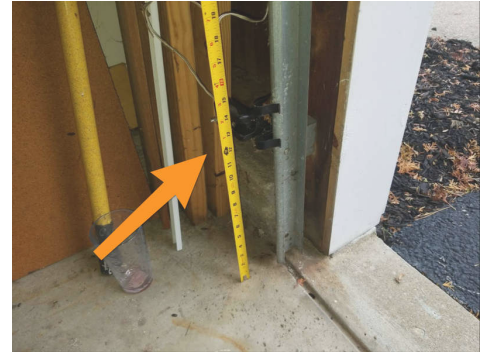
PHOTO SENSOR INSTALLED OVER 6 INCHES ABOVE FLOOR.

An overhead garage door photo sensor was installed at a height greater than 6 inches above the floor. Photoelectric sensors are devices installed to prevent injury by raising the vehicle door if the sensor detects a person in a position in which they may be injured by the descending door. Installation of photo sensors in new homes is required by generally-accepted safety standards and limit the maximum mounting height for garage door photo sensors to 6 inches.

Contact a qualified garage door contractor.
