SUMMARY

1234 Main St. North Augusta SC 29841

Jeff Young
SC License: RBI 49162 /...
Premier Home Inspections of the CSRA
706 836 4488
jeff@premiercsra.com

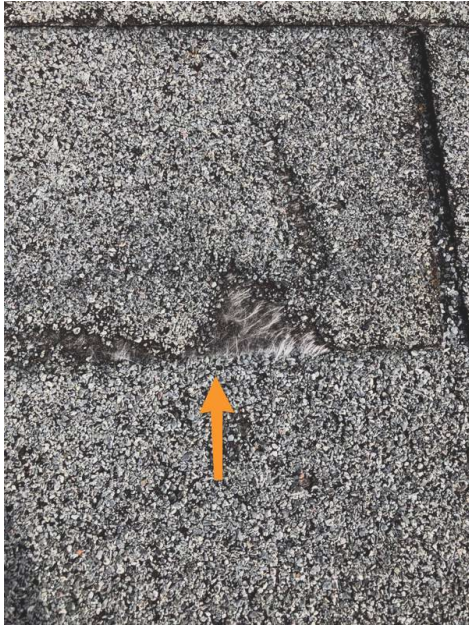
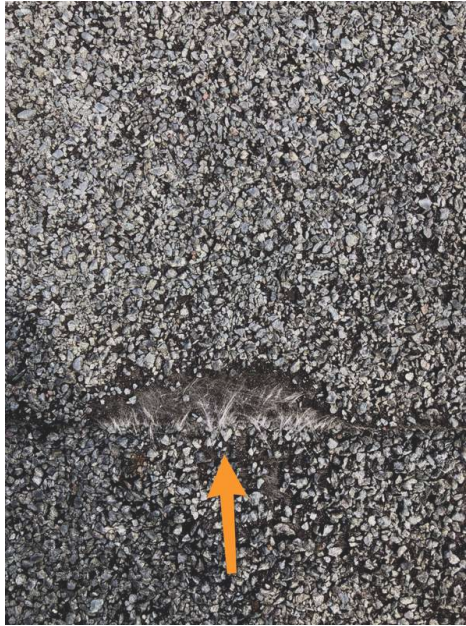
2.1.1 Coverings, Flashings, & Penetrations

SHINGLE DAMAGE (MINOR)

Minor damages to the shingles were observed in multiple locations. Given the damage was observed in various locations, this may be the result of storm damage.

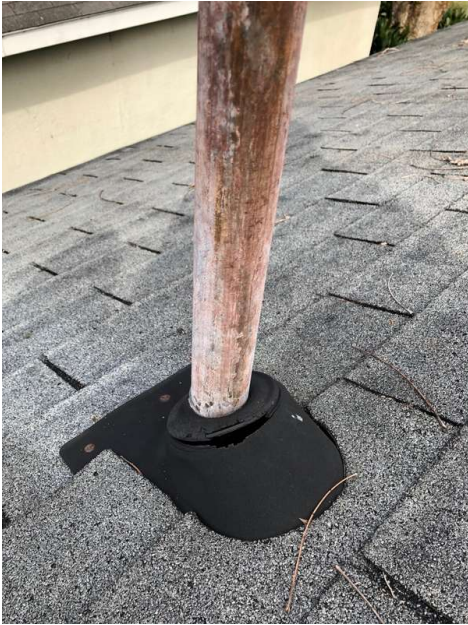
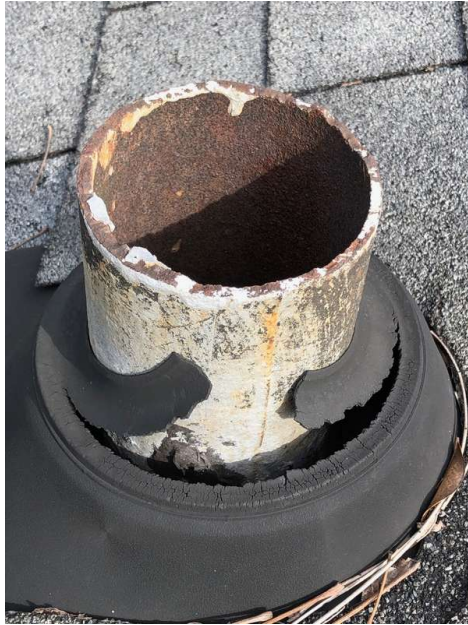
2.1.2 Coverings, Flashings, & Penetrations

FLASHING BOOT DAMAGED

MULTIPLE ON LEFT SIDE OF ROOF

The flashing boot was damaged at the time of the inspection. Due to the extent of damage, replacement is recommended.

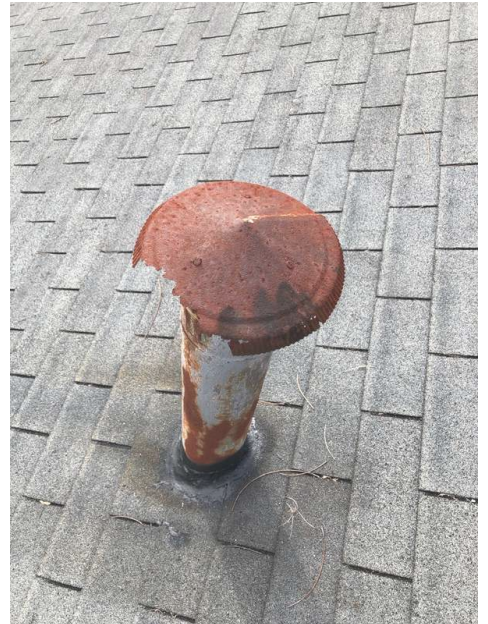
2.1.3 Coverings, Flashings, & Penetrations

FLUE CAP DAMAGED

The flue pipe located on the right side of the roof had a damaged flue cap. Replacement is recommended however there did not appear to be any subsequent damages as a result.

Contact a qualified professional.

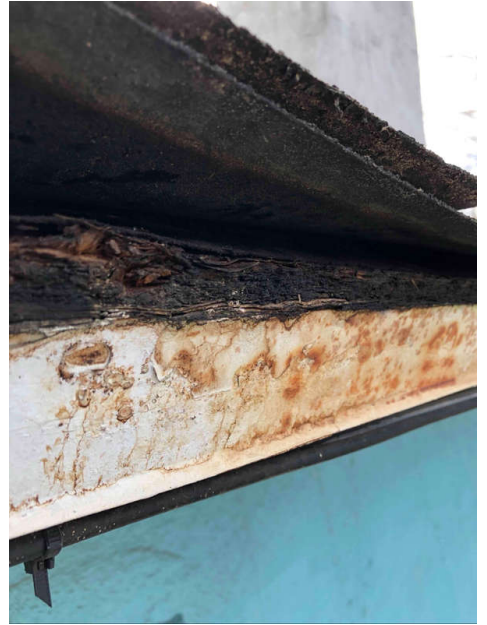
2.1.4 Coverings, Flashings, & Penetrations

ROOF DECKING WATER EXPOSURE

FRONT LEFT SIDE OF ROOF EDGE

The roof decking on the front left edge was wet. This could be the result of capillary reaction in which water running off the shingle edge wicks back up into the wood.

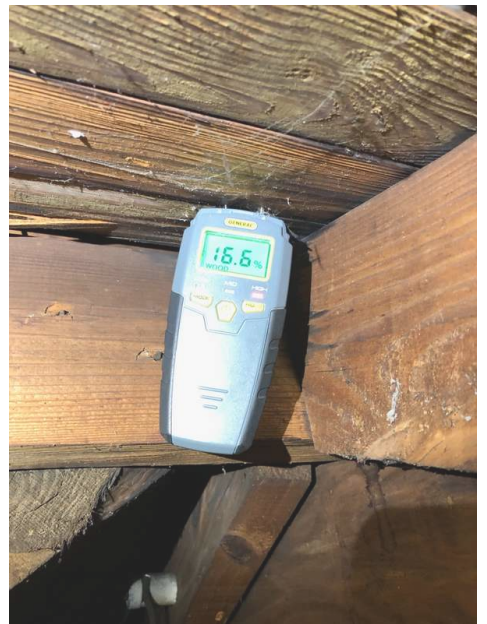
2.2.1 Roof Structure,Attic, & Ventilation

ACTIVE LEAK

There was an active leak on the roof decking. The moisture reading recorded higher than normal moisture levels. Evaluation and repairs are recommended.

* The observed leaks were observed at the roof ridge adjacent to the front gable.

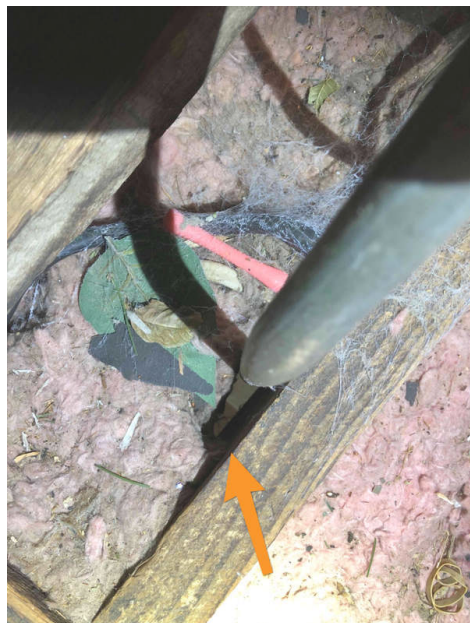
2.2.3 Roof Structure,Attic, & Ventilation

SEAL PENETRATIONS

FRONT GABLE VENT, REAR INTERIOR HALLWAY

Penetrations should be sealed to prevent water/moisture intrusion, potential rodent entry into attic space, and loss of conditioned air from the home.

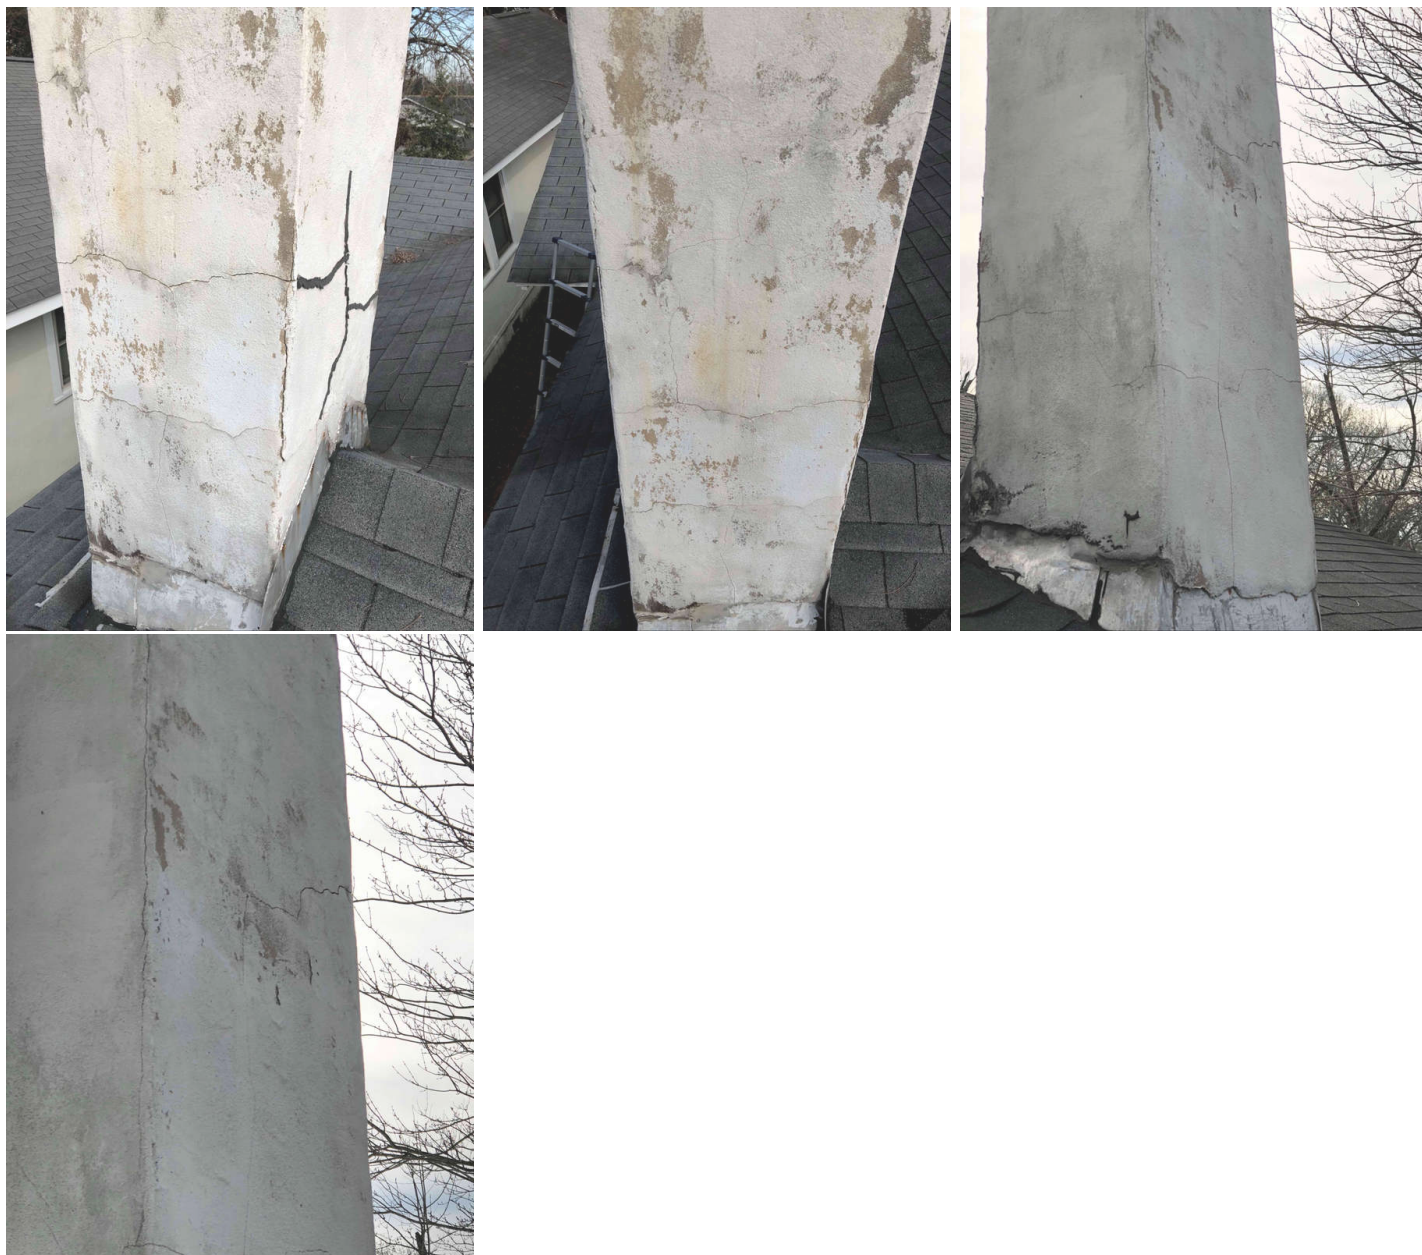
2.3.1 Skylights & Chimneys

EXTERIOR SURFACE CRACKING

The plaster on the exterior of the chimney was cracking in multiple locations.

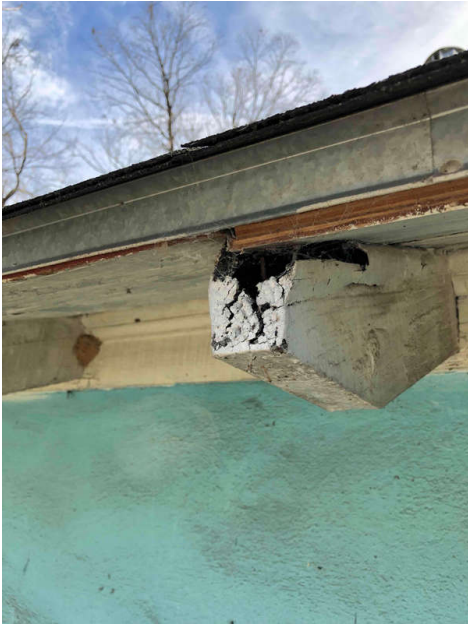
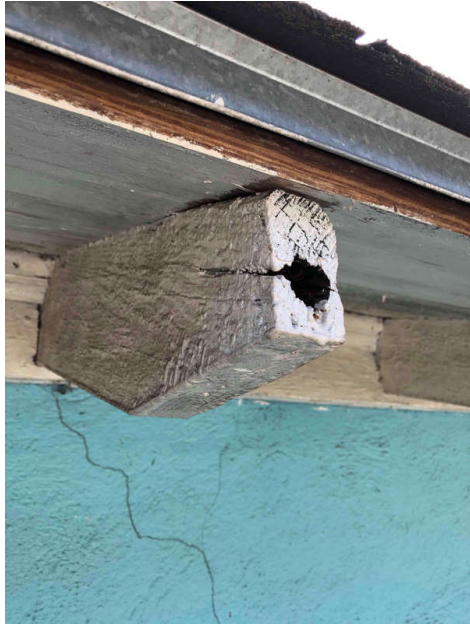
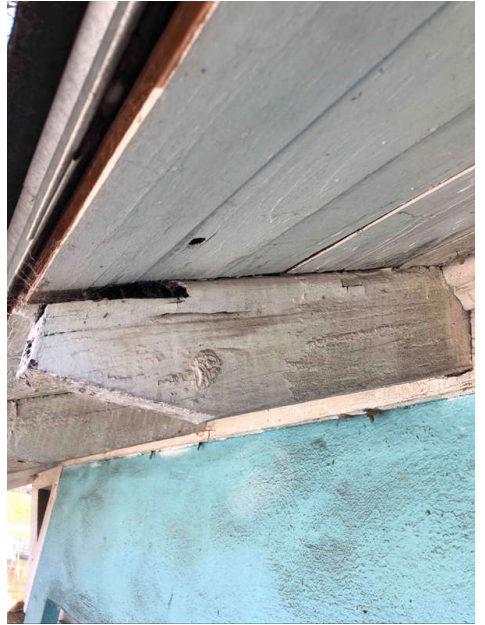
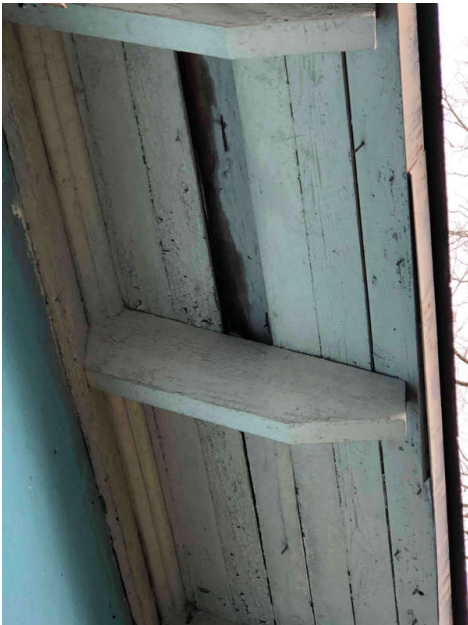
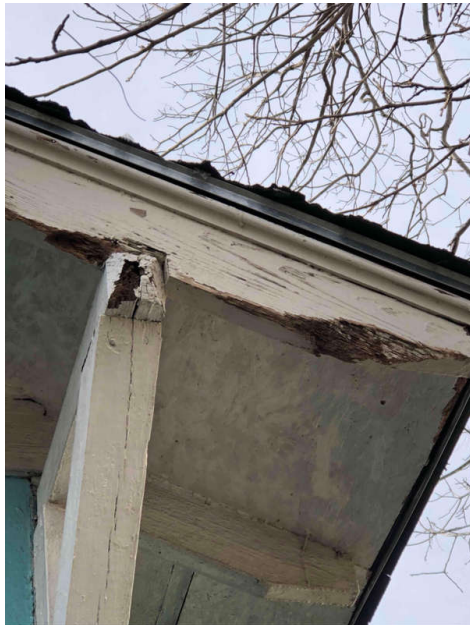
3.1.1 Siding, Flashing, Fascia, Soffits, & Trim

DAMAGED RAFTER TAILS

BACK LEFT SIDE OF ROOF EDGE

The rafter tails located on the back left side of the home were damaged.

Damaged Fascia board and Corbel were located on the back left corner.

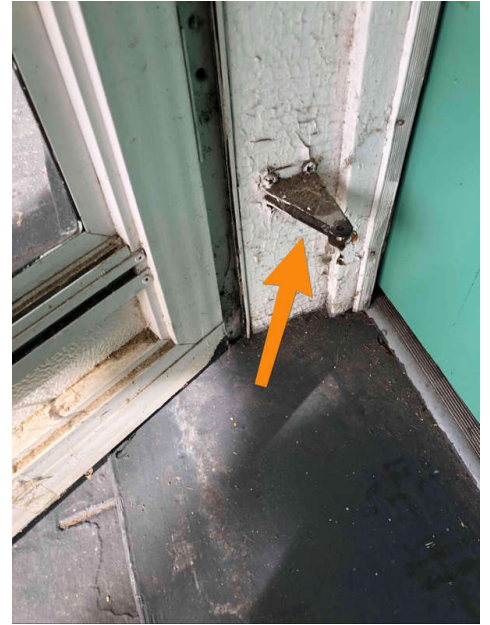
3.2.1 Exterior Doors & Windows

HARDWARE MISSING/DAMAGED

FRONT STORM DOOR

The front storm door hardware was missing.

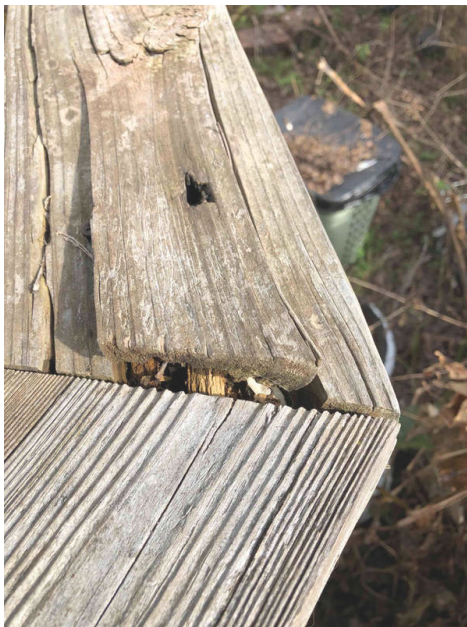
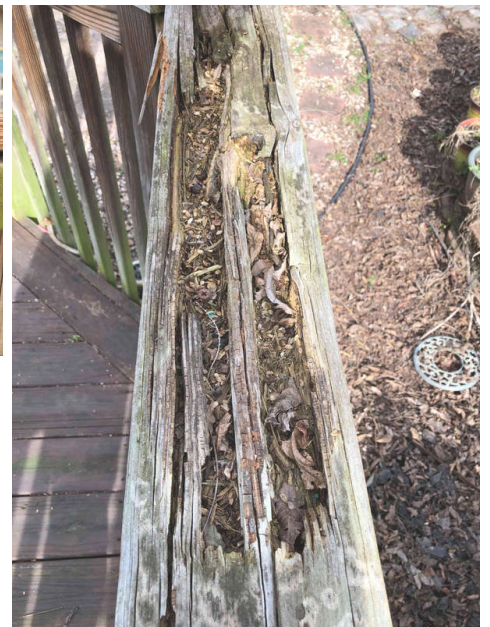
3.4.1 Decks, Balconies, Porches & Patios

GUARD RAIL DETERIORATION

The guard rail exhibited wood rot damages likely due to prolonged water/moisture exposure over time. The damaged areas should be replaced. As part of general maintenance, exterior decking components and the decking surface should be inspected, repainted, and sealed at least every 5 years to ensure the deck structure and all components are in good condition and to prolong the life of the deck.

*A portion of the railing system was pulling apart. The specific location is the back left side of the railing system.

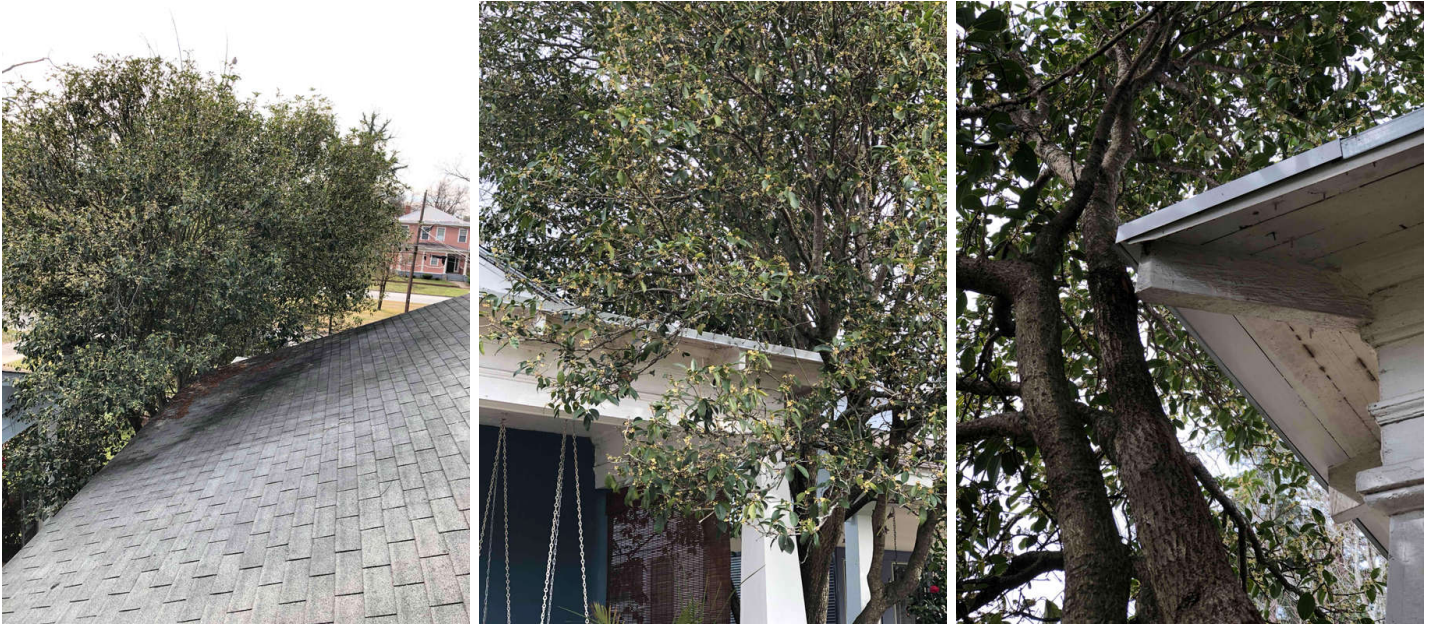
3.5.1 Vegetation, Grading, Drainage & Retaining Walls

TREE OVERHANG

RIGHT FRONT CORNER

Trees observed overhanging the roof. This can cause damage to the roof and prevent proper drainage.

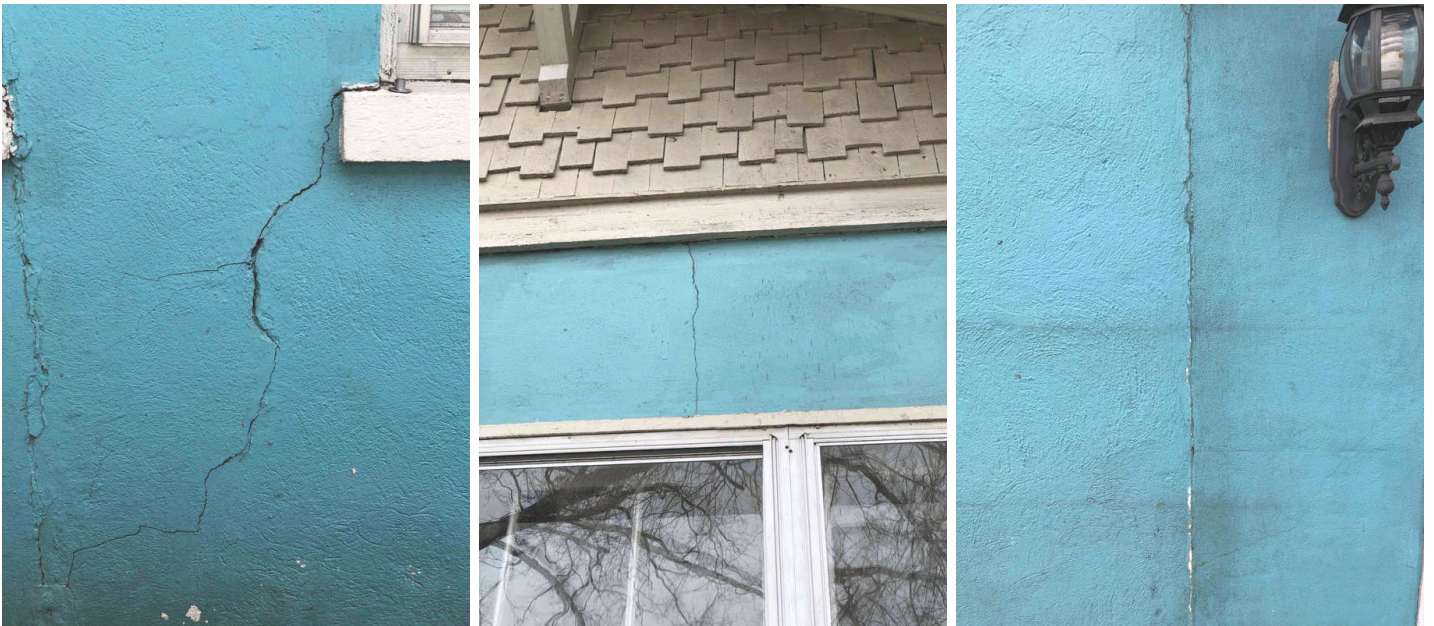
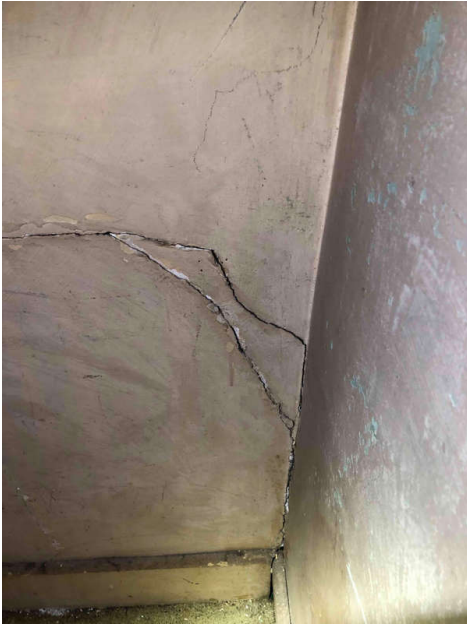
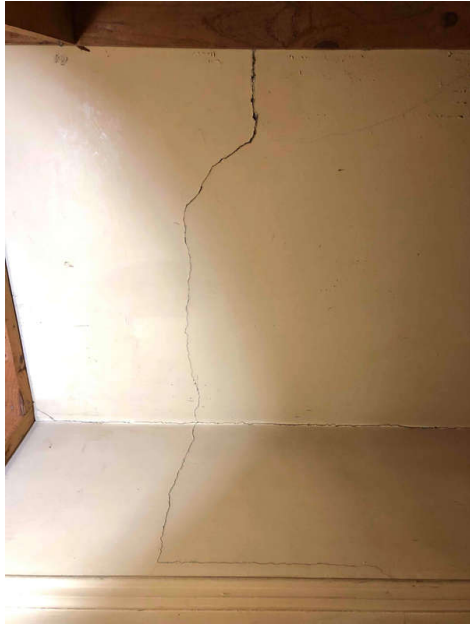
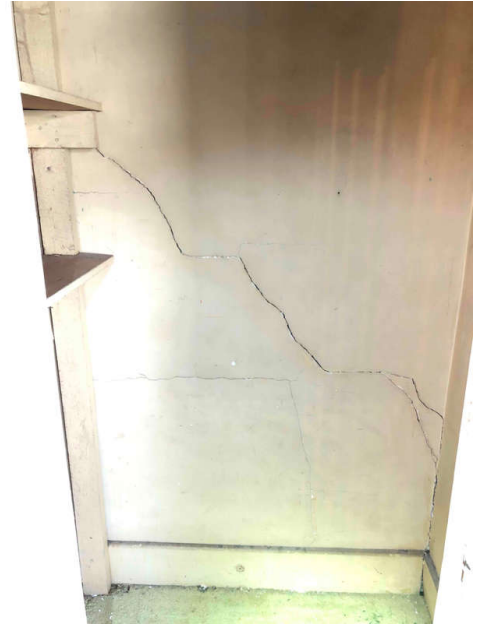
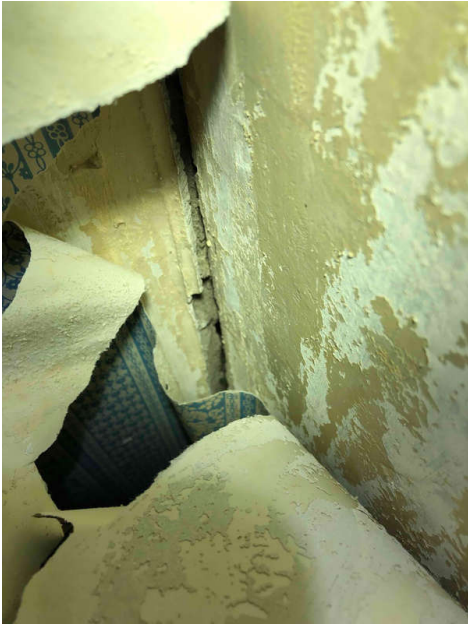
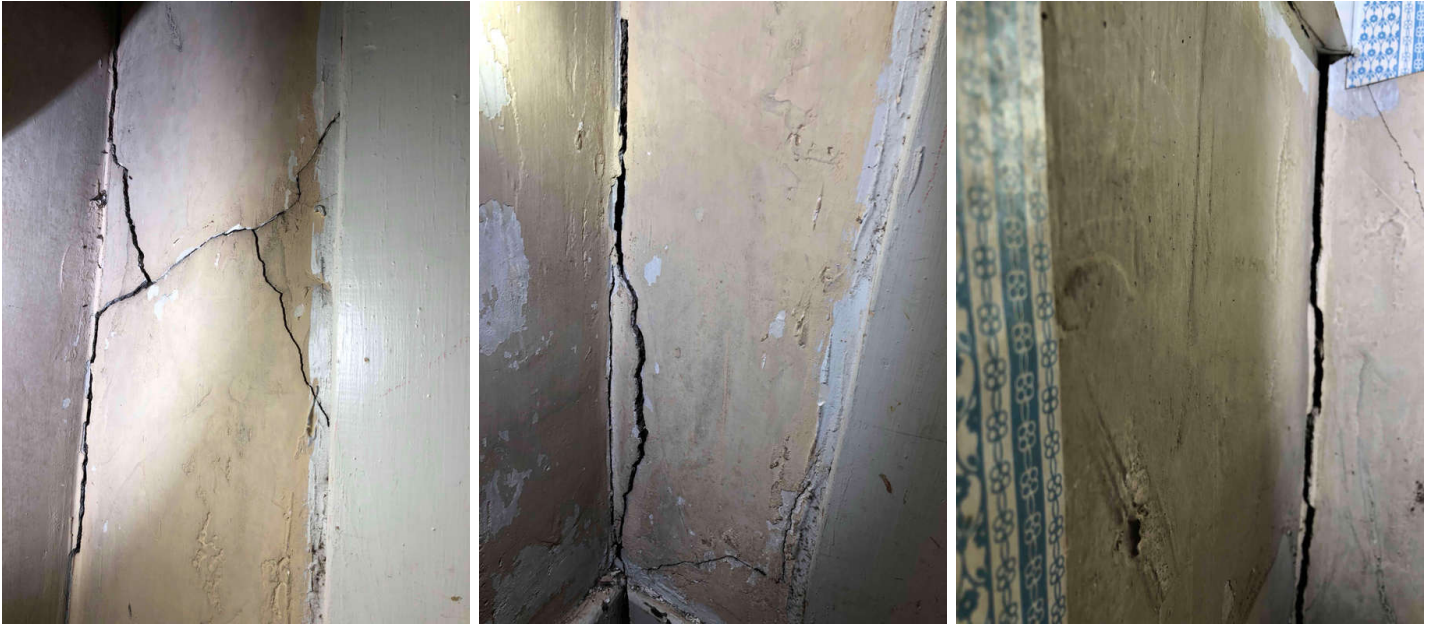
4.1.1 Foundation

DIFFERENTIAL SETTLEMENT CRACKING (SIGNIFICANT)

VARIOUS LOCATIONS

Settlement cracking was observed to have multiple planes of movement in multiple locations both interior and exterior. Generally speaking, the more planes of movement, the more problematic the settlement can be. Further evaluation by a licensed structural engineer is recommended.

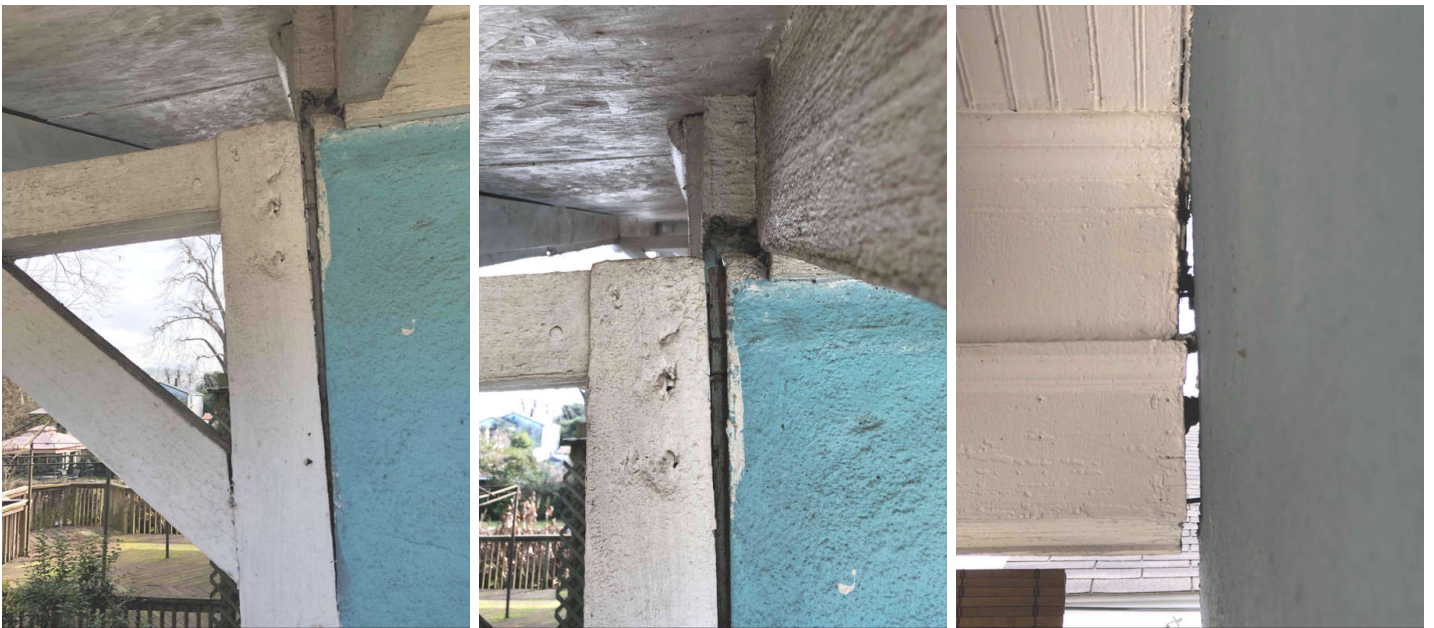
4.1.2 Foundation

SETTLEMENT RELATED MOVEMENT

The front porch as well as the back left Corbel exhibited signs of settlement related activity.

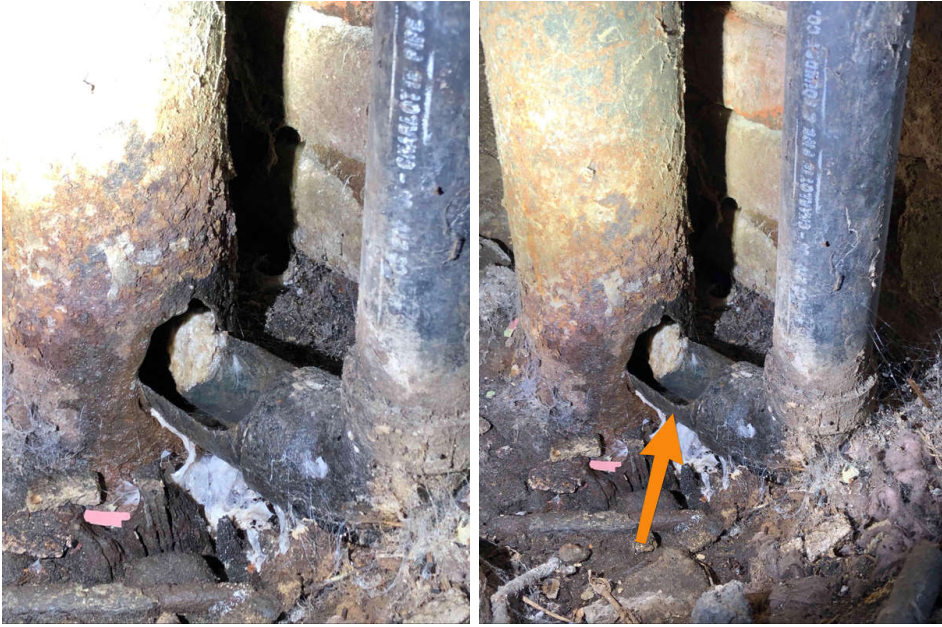
4.2.1 Crawlspace

ACTIVE LEAK IN DRAIN LINE

BELOW HALL BATHROOM

Active leaking was observed at the time of the inspection. The drain pipe was damaged. The damaged portion of pipe should be replaced.

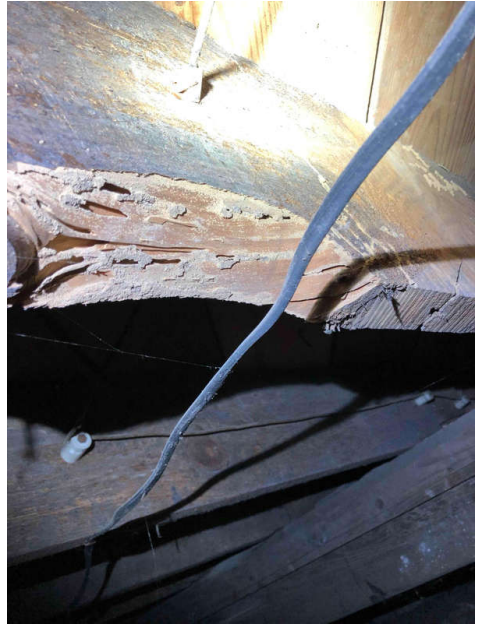
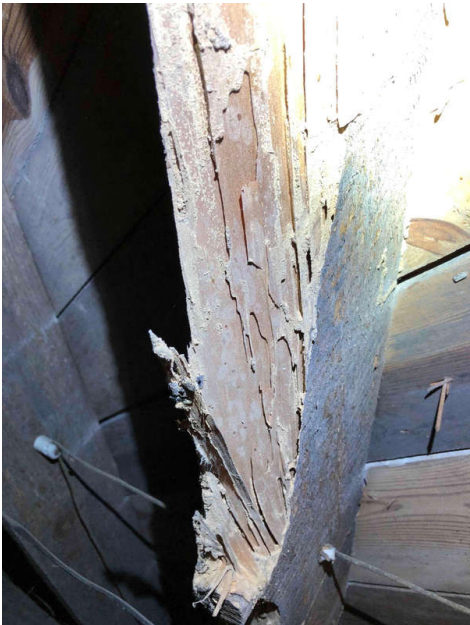
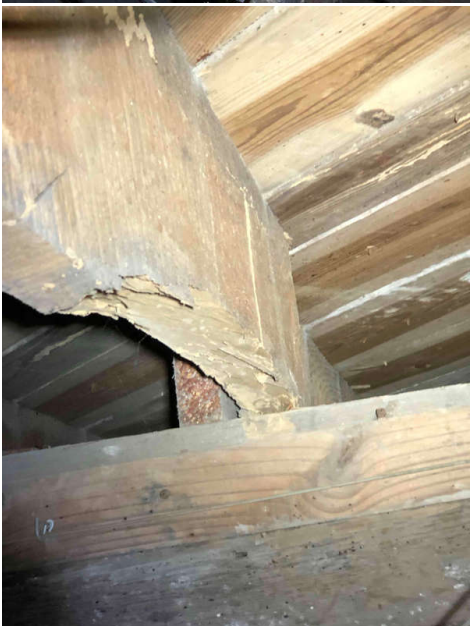
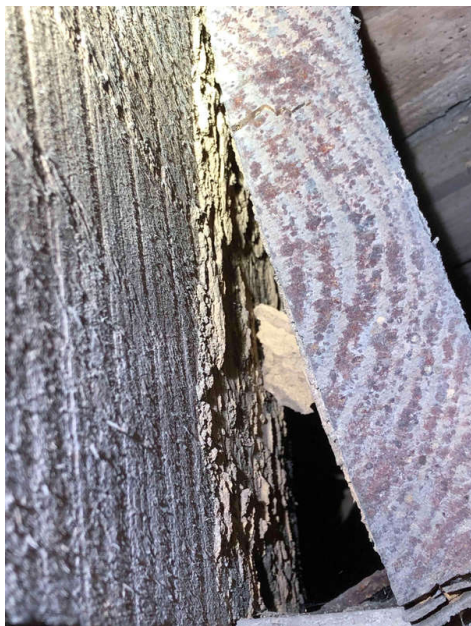
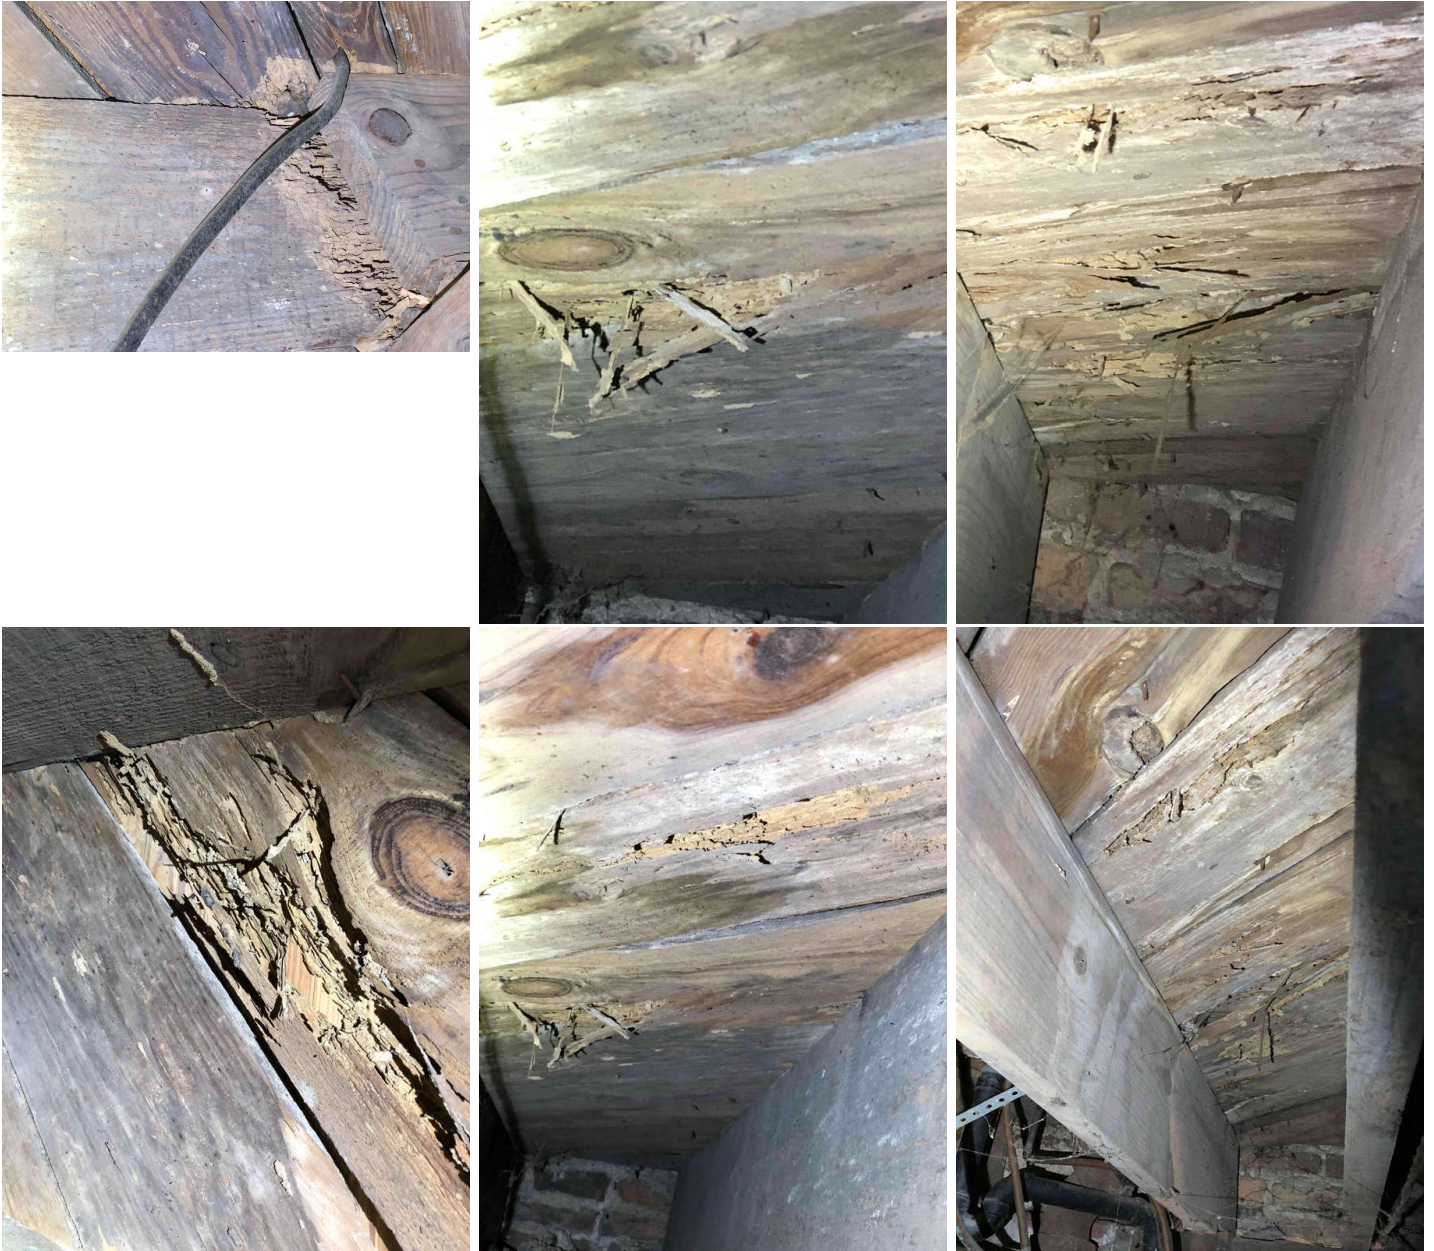
4.2.2 Crawlspace

PAST TERMITE DAMAGE

MULTIPLE LOCATIONS

Past termite damage observed in the crawlspace. At the time of the inspection there was no active termite activity observed. A termite letter/inspection is recommended prior to the end of your due diligence period.

* Termite damage was observed at various locations in the crawlspace. The floor joists and subfloor exhibited damages.

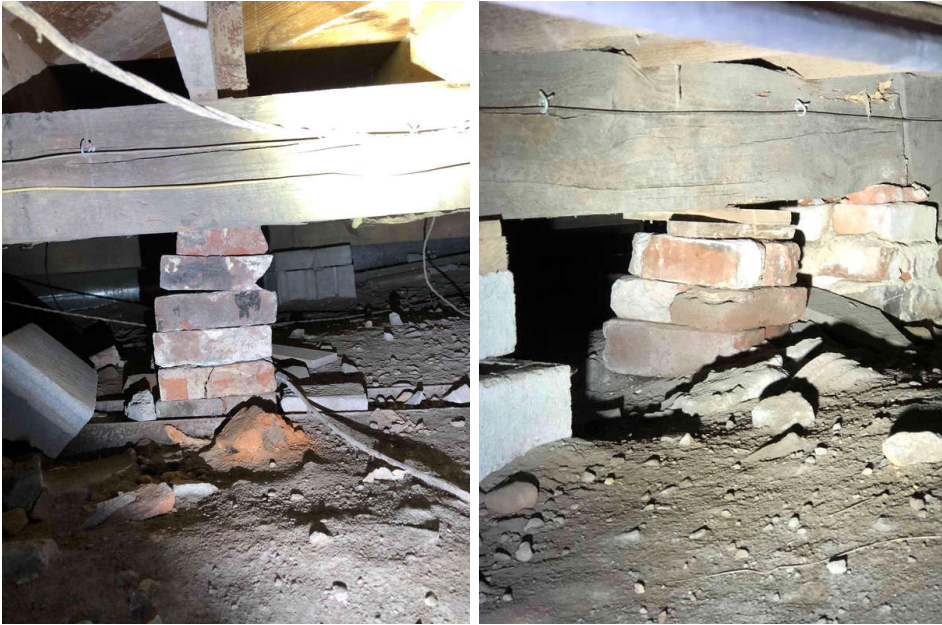
4.2.3 Crawlspace

IMPROPER BUILDING PRACTICE

The column was not in accordance with proper building practice. The column should be built up with the appropriate material. Consult with a General Contractor for further evaluation and repairs. No adverse damages were observed as a result of the improper practice.

* The observed practice was used in multiple locations throughout the crawlspace.

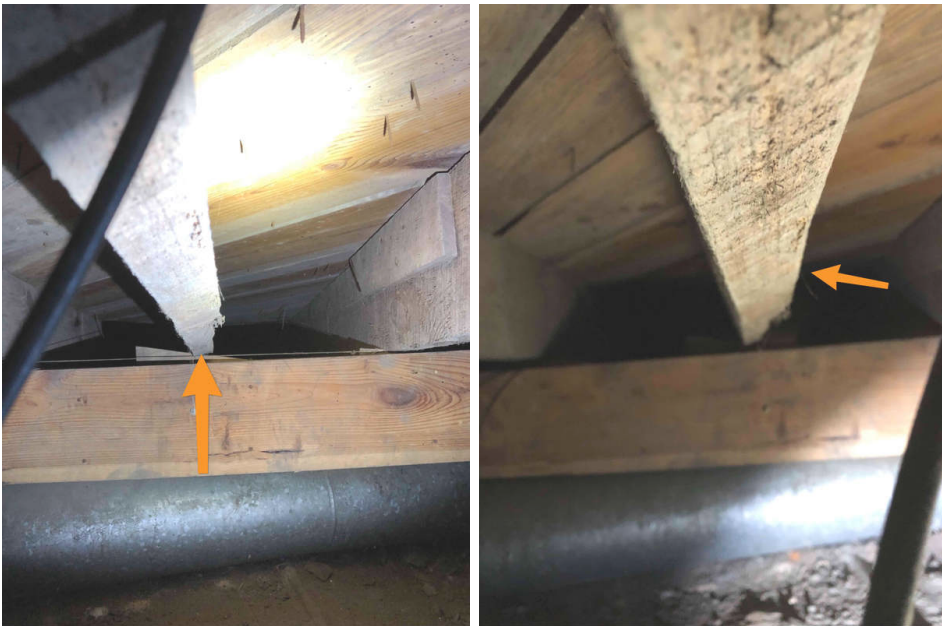
4.3.1 Floor, Wall, & Ceiling Structure

BEAM ROTATING OR TWISTING OBSERVED

CENTER OF CRAWLSPACE

The beam was found to be rotating or twisting. This can result in an unevenness of the floor.

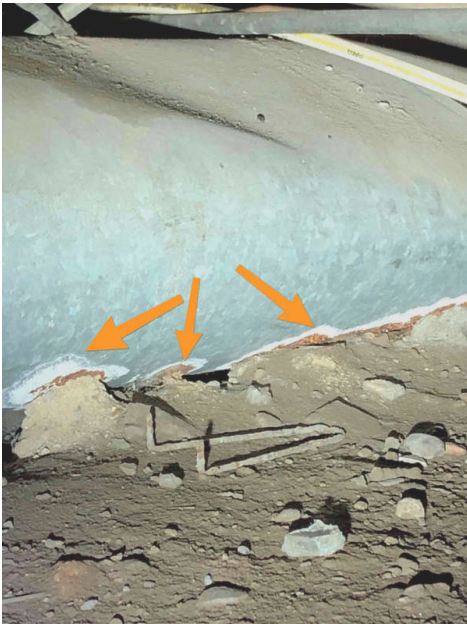
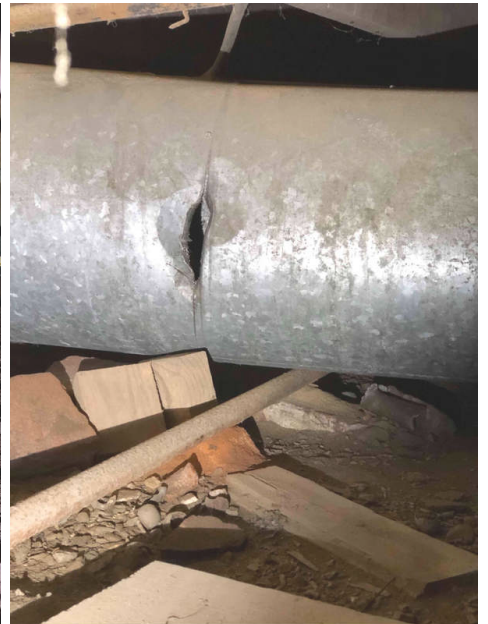
5.1.2 Heating & Cooling Equipment

DUCT DAMAGED

The ductwork in one or more areas was exhibited mechanical damages.

*The return duct showed signs of corrosion and rust in multiple areas.

*The return duct was punctured. The puncture was observed near the rear of the crawlspace.

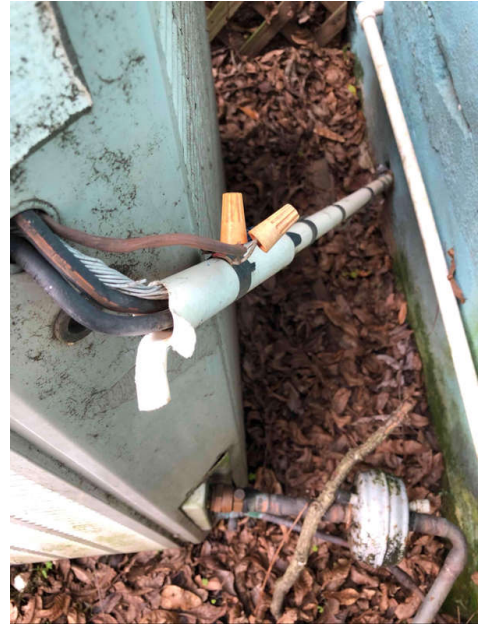
5.1.3 Heating & Cooling Equipment

EXPOSED ELECTRICAL WIRING

Exposed electrical wiring on the exterior of the home may result in damages over time as a result of exposure to the weather (elements). The wiring should be concealed with conduit.

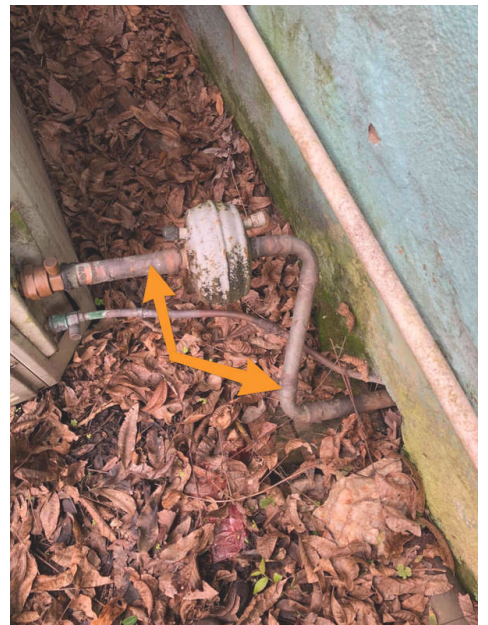
5.1.4 Heating & Cooling Equipment
PIPE INSULATION MISSING

The piping insulation on the refrigerant line was missing.

Contact a handyman or DIY project

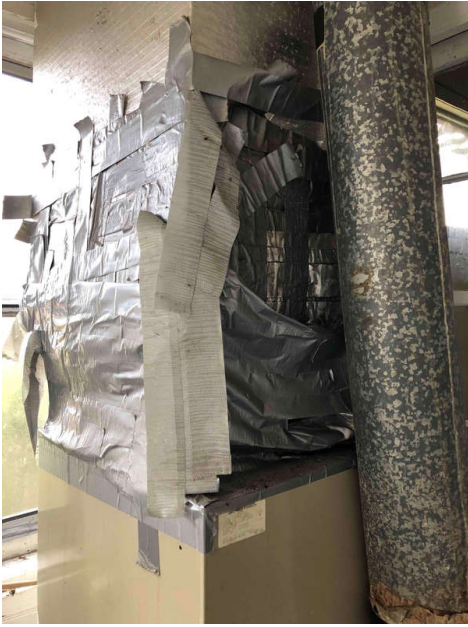
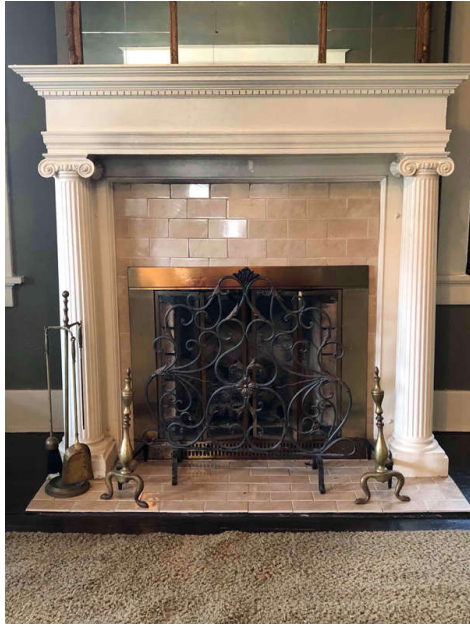
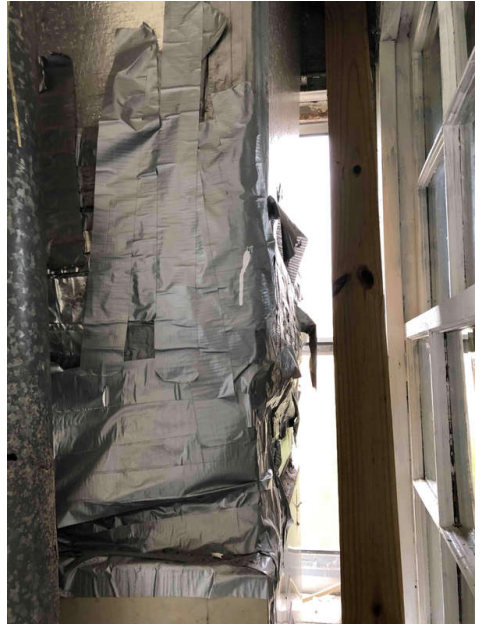
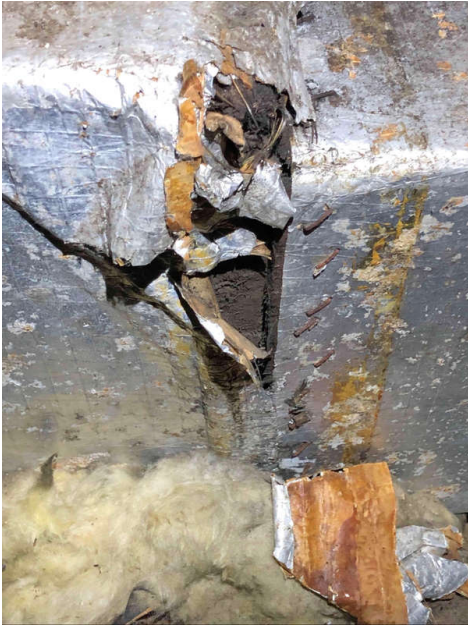
5.1.5 Heating & Cooling Equipment
DUCTWORK NOT SEALED PROPERLY

The ductwork was sealed with duck tape in multiple locations. Over time the duck tape will lose its adhesiveness and pull away resulting in ducts to become loose and potentially result in a loss of conditioned air. This was observed in some areas throughout the duct system.

Contact a qualified professional.

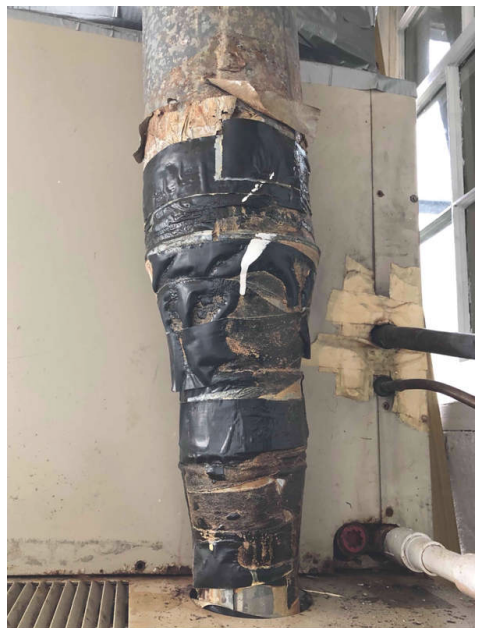
5.1.6 Heating & Cooling Equipment **FLUE IMPROPERLY SEALED**

The flue was sealed with duck tape. Duck tape should be used. Over time the duck tape will lose its adhesiveness and fail.

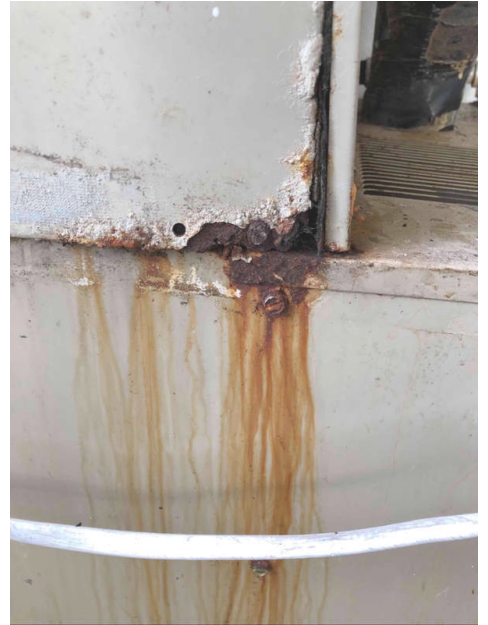
5.1.7 Heating & Cooling Equipment

RUST OBSERVED

Rust was observed at the base of the furnace. At the time of the inspection the furnace was functioning properly however further evaluation is recommended to determine the cause of the rust and ensure there is no on-going issue.

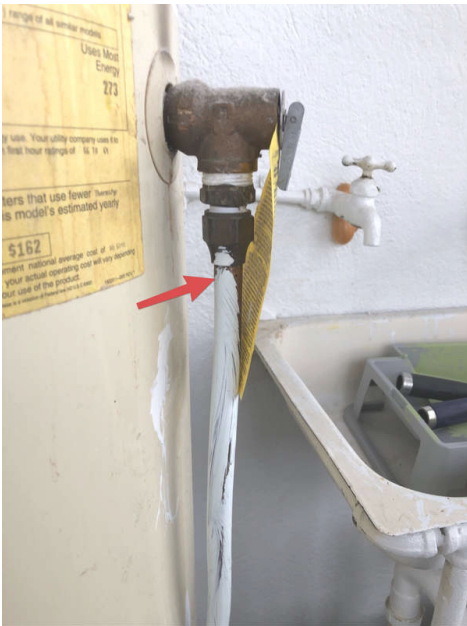
7.2.1 Hot Water Systems, Controls, Flues & Vents

TPR VALVE DISCHARGE PIPE INCORRECT SIZE

The TPR valve should have a discharge pipe installed that has a diameter equal to or not less than the diameter of the TPR valve outlet. This discharge pipe should extend to within 6 inches over the floor.

Recommendation
Contact a qualified plumbing contractor.

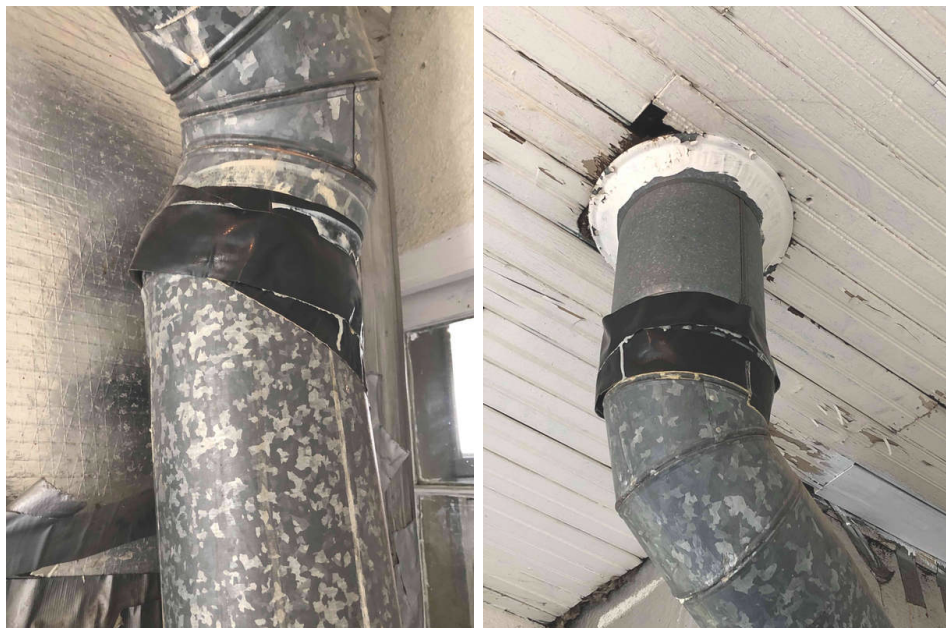
7.2.2 Hot Water Systems, Controls, Flues & Vents

FLUE IMPROPERLY SEALED

The flue pipe was not sealed properly.

See comment on furnace flue

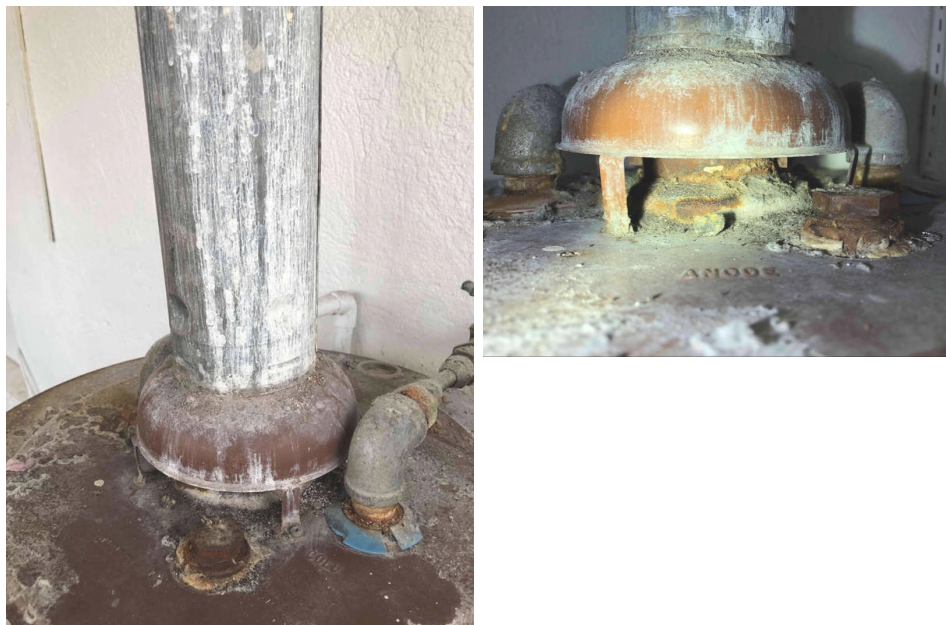
7.2.3 Hot Water Systems, Controls, Flues & Vents

RUST OBSERVED

Rust was observed below the exhaust flue, at the top of the water heater. Staining on the flue suggests water leaks. There was no active leaks present. Given the age of the unit, budget for future replacement.
