SUMMARY

1234 Main St. North Augusta SC 29841

Jeff Young
SC License: RBI 49162 /...
Premier Home Inspections of the CSRA
706 836 4488
jeff@premiercsra.com

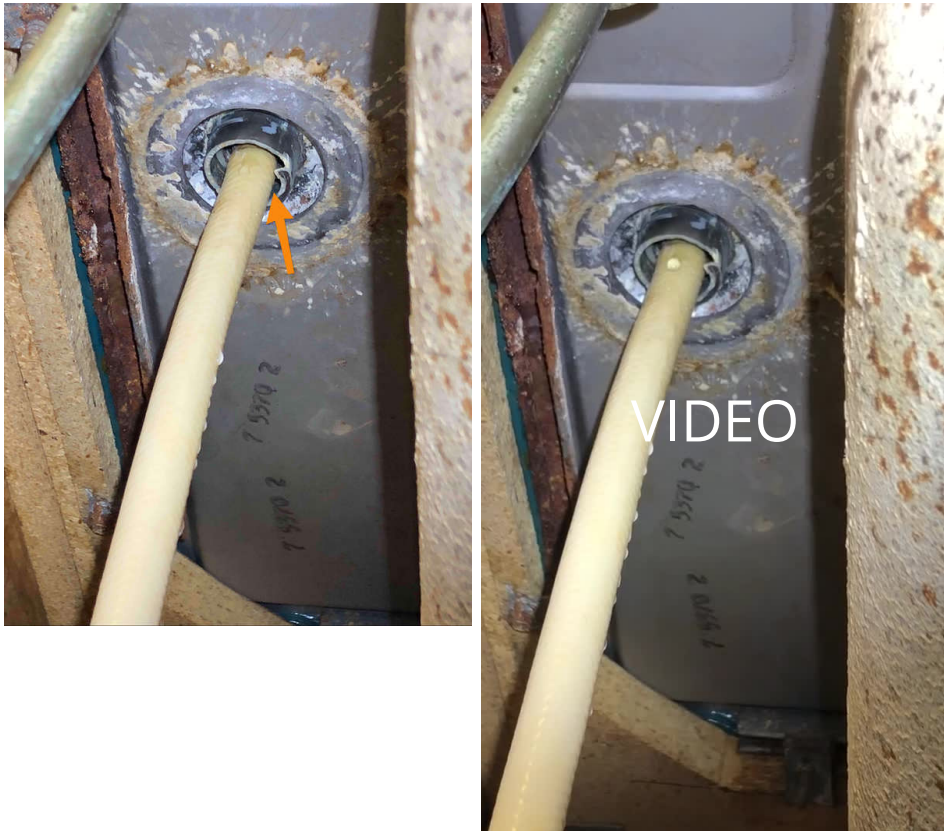
8.1.1 General

ACTIVE LEAK

There was an active leak below the kitchen sink. The leak was coming from the sink spray nozzle.

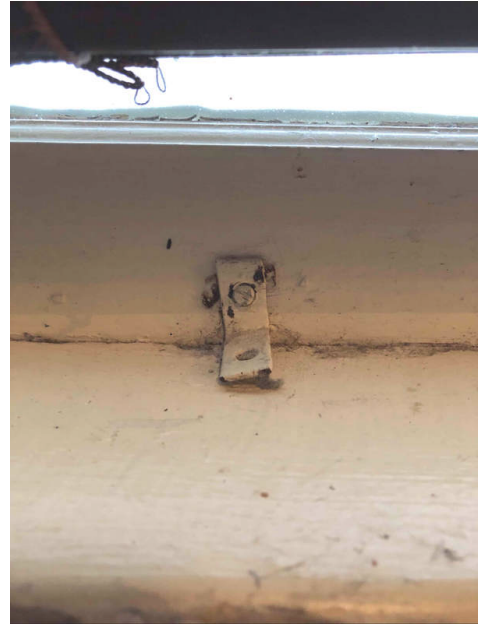
9.1.1 Living Spaces

SEALED/PAINTED SHUT

One or more windows are painted or sealed shut. At least 1 window per room should be accessible for safety egress in the event of a fire or emergency.

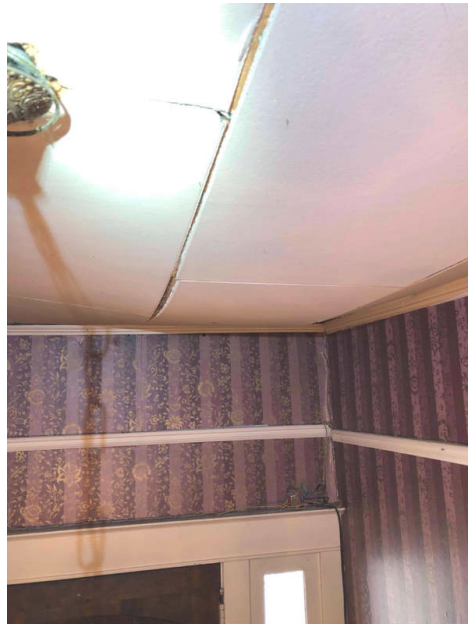
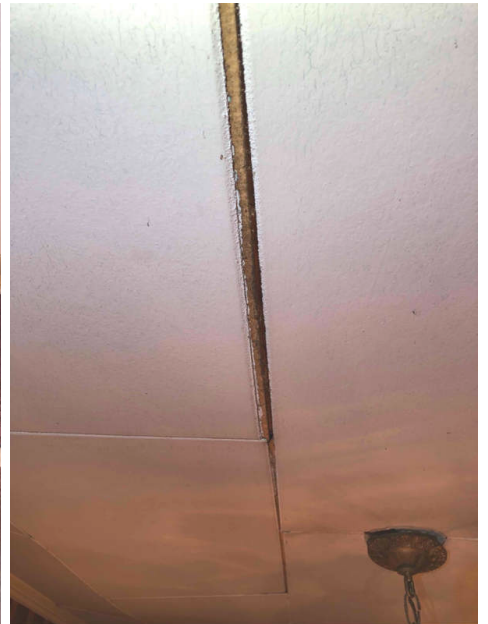
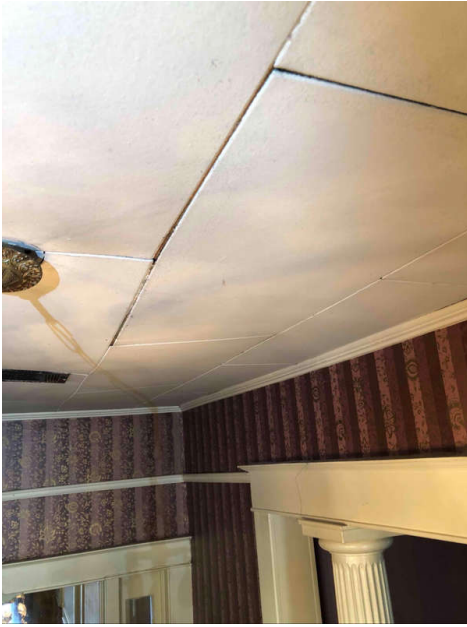
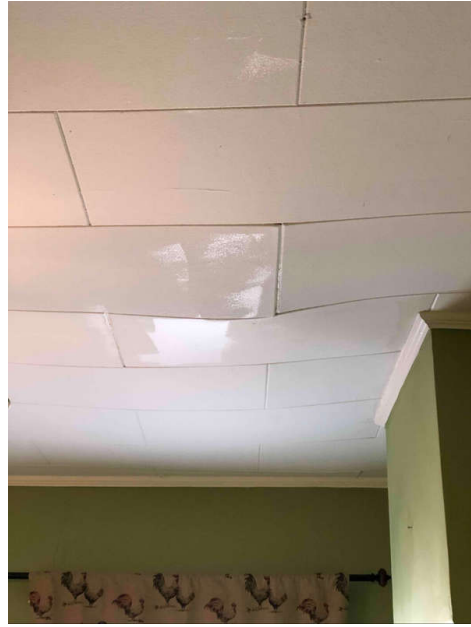
9.1.2 Living Spaces

CEILING TILES SAGGING

The ceiling tiles were sagging in various locations throughout the home. The most notable area of sagging was above the front door entrance.

The sagging did not appear to be the result of subsequent damage from leaks in the roof. Tiles appeared to have detached from the plaster ceiling. This may be the result of settlement, moisture, or quite possibly detachment overtime.

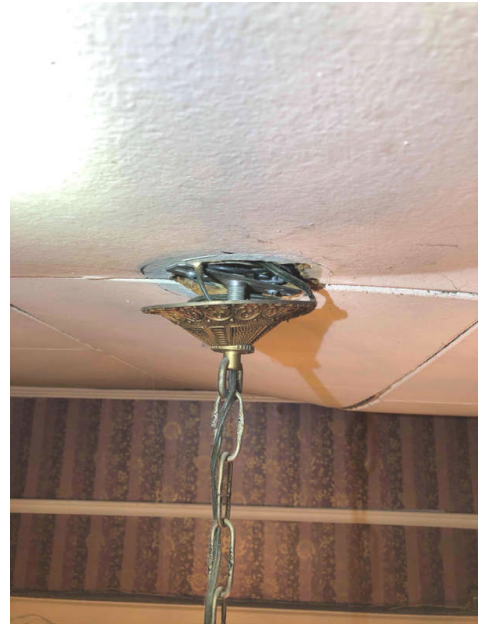
9.1.3 Living Spaces

LIGHT FIXTURE LOOSE

The light fixture located at the front door entrance was loose.

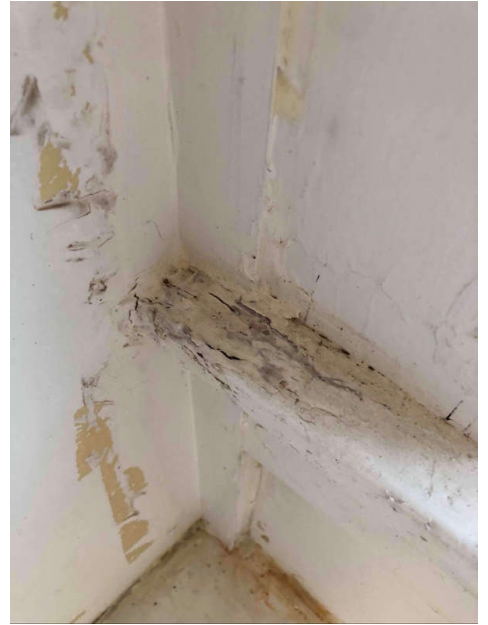
9.2.1 Bathrooms

WATER DAMAGE

The left side bathroom window sill exhibited water damage.

Although painted, the damaged portion was rotted as a result of excessive water exposure over time.

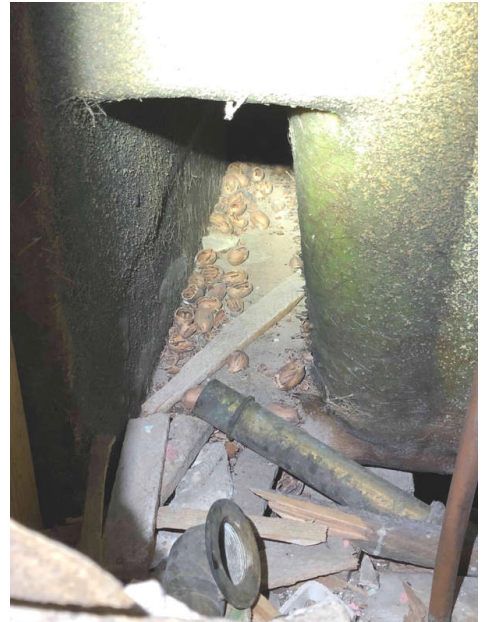
9.2.2 Bathrooms

EVIDENCE OF RODENT ACTIVITY

There was evidence of rodent activity below the bathtub in the right side hall bathroom. The evidence was only observed once the bathtub access panel was removed.

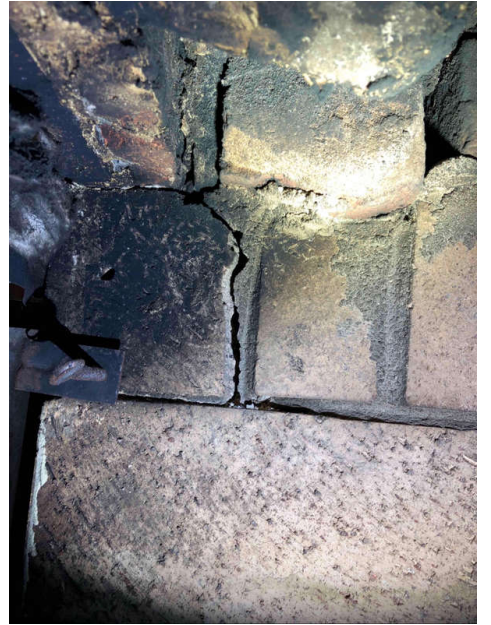
9.4.1 Fireplace

MORTAR JOINTS NEED MAINTENANCE

Cracking on the interior left side of the firebox needs repair. Repair the mortar with an approved fire rated compound.
