SUMMARY

1234 Main St. Port Orchard Washington
98367

Brandon Goff
Home Inspector Lic. 1014 SPI Lic. #88798
Mountains to Sound Home Inspection LLC
253.334.8631
brandon@mshomeinspection.com

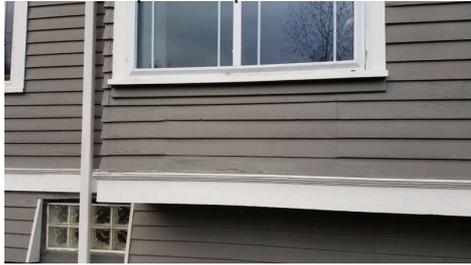
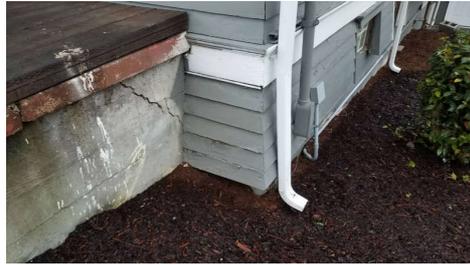
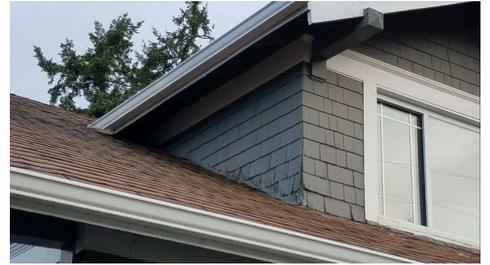
3.7.1 House Wall Finish **WEATHERED SIDING**

SEVERAL AREAS
Recommendation
Contact a qualified professional.

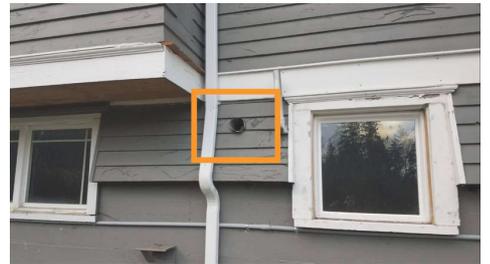
3.7.2 House Wall Finish **EXTERIOR VENTS NEED REPAIR**

The vent is missing or damaged and is in need of replacement.
Recommendation
Contact a qualified professional.

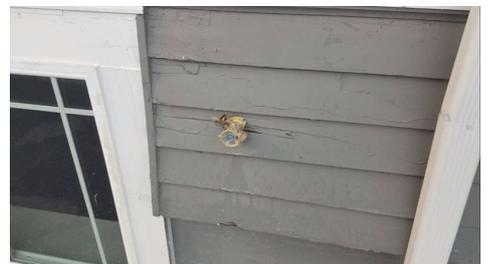
3.8.1 Exterior Plumbing **DRIPPING HOSE BIB**

A hose bib is dripping and needs service [CLICK HERE](#) to fix it yourself
Recommendation
Contact a qualified professional.

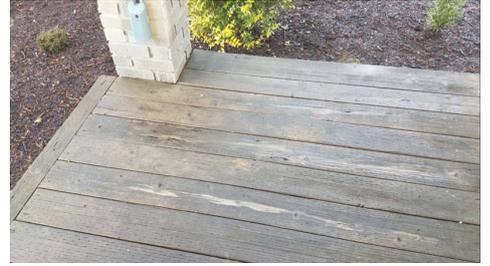
3.17.1 Deck **DRY ROT**

FRONT SIDE
Dry rot was observed in the structure of the deck which is usually caused by deferred maintenance and should be repaired.
Recommendation

Contact a qualified deck contractor.

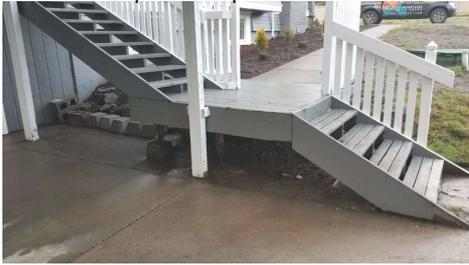
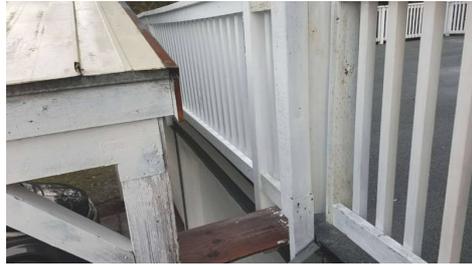
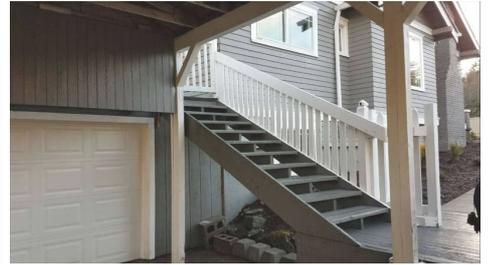
3.17.2 Deck

GUARDRAIL MISSING WHERE NEEDED

A guardrail is missing at a location where needed. We recommend installing to prevent a safety hazard.

Recommendation
Contact a qualified professional.

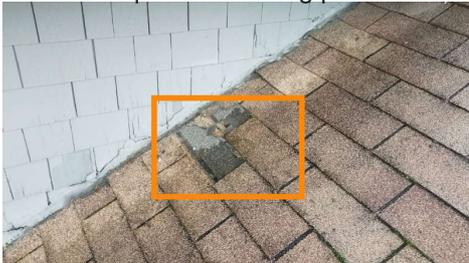
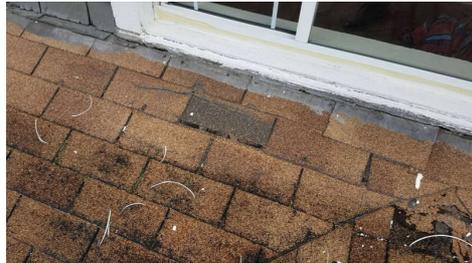
4.2.2 Composition Shingle Roof

ROOF HAS A FEW MISSING SHINGLES

The roof has a few missing shingles that should be replaced by a roofing contractor, before the close of escrow and preferably within the inspection period. This will help prevent the possibility of moisture getting past the roof covering, wearing the protective barrier beneath, and into the attic or residence. We recommend having a roofer inspect the rest of the roof as well.

Recommendation
Contact a qualified roofing professional.

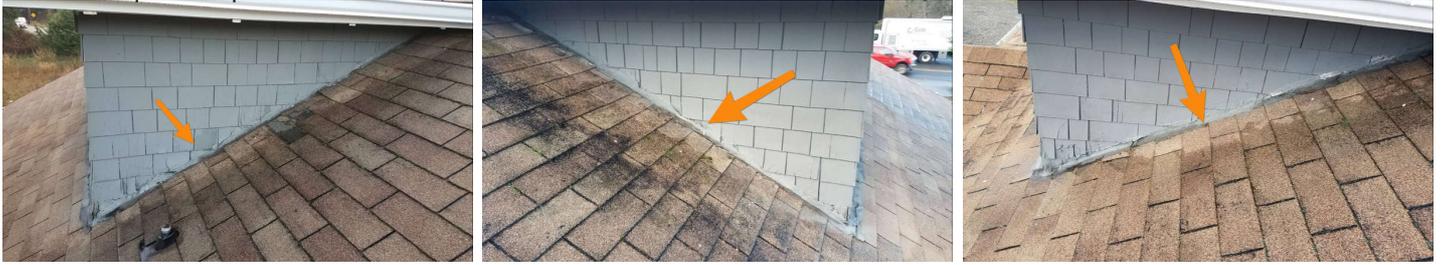
4.4.1 Vents & Flashings

SIDEWALL FLASHING MISSING

The sidewall flashing was missing. We recommend installing to prevent leaking.

Recommendation
Contact a qualified professional.

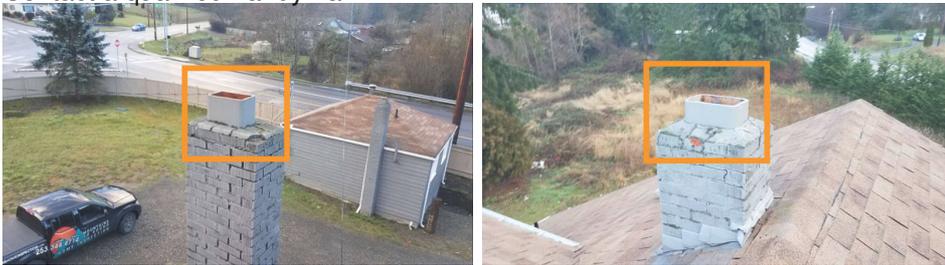
5.3.1 Weather Cap-Spark Arrestor

NO SPARK ARRESTOR OR WEATHER CAP

The chimney does not have a spark arrestor or weather cap which is mandated in most jurisdictions and should be installed. This will help prevent pests or debris from falling into the flue and causing an obstruction or damage.

Recommendation
Contact a qualified handyman.

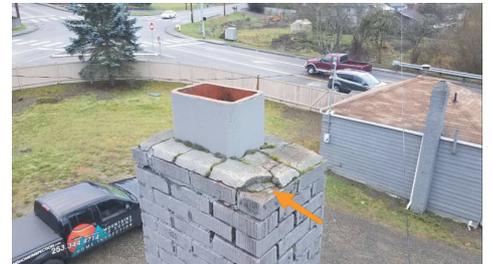
5.4.1 Crown or Termination Cap

THE IS WASHED OUT OR DETERIORATED AND SHOULD BE REPLACED

The crown, which is designed to seal the chimney wall and to shed rainwater, is washed out or deteriorated and should be repaired or replaced.

Recommendation
Contact a qualified masonry professional.

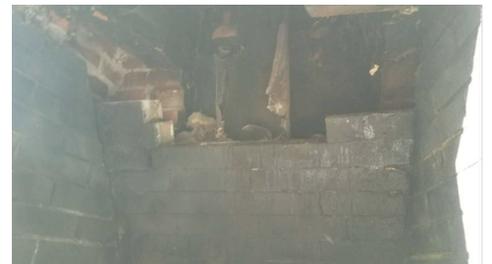
5.10.1 Common Observations

FIREPLACE NEEDS REPAIRS

The fireplace is in need of repairs prior to use.

Recommendation
Contact a qualified fireplace contractor.

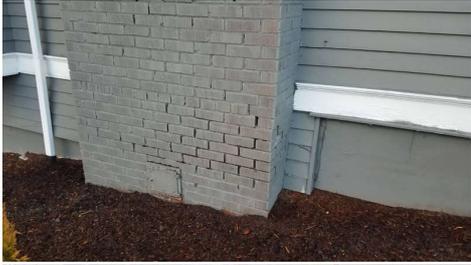
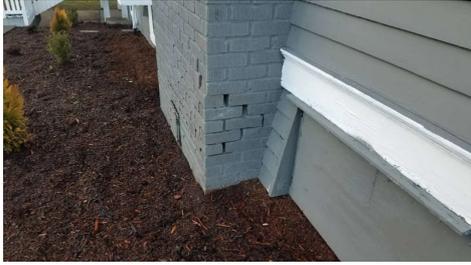
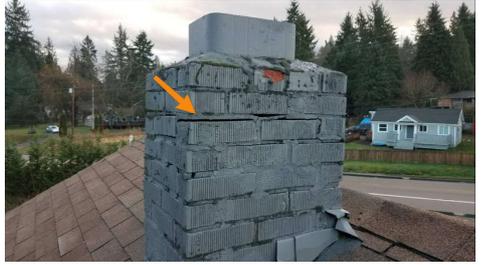
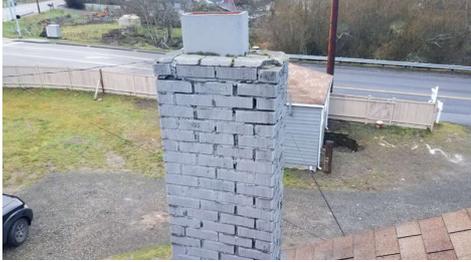
5.13.1 Chimney Condition

TUCK POINTING

The exposed sections of the exterior of the chimney needs re-pointing (tuck-pointing) due to having loose or

deteriorated mortar joints. Recommend Repair of old and or eroded mortar joints.

Recommendation
Contact a qualified professional.

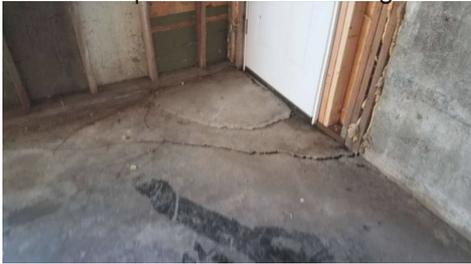
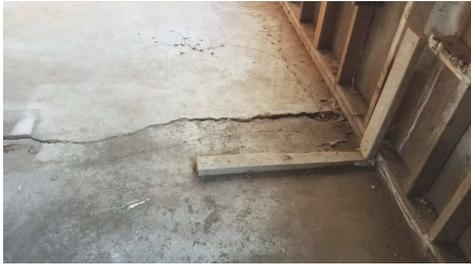
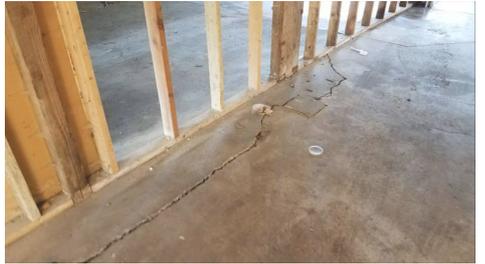
6.5.1 Slab Floor

CRACKED AND SETTLED

The garage slab floor is integral, and it has cracked, settled, and slightly deformed the structure. We can elaborate on this issue, but because it has structural implications you should consult an engineer.

Recommendation
Contact a qualified structural engineer.

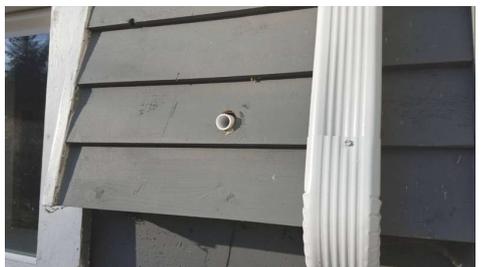
10.1.1 Water Heating System

END OF PRESSURE RELIEF VALVE DISCHARGE PIPE NEEDS AN ELBOW

The end of the pressure relief valve discharge pipe needs an elbow added for safety reasons. The elbow should point toward the ground, and discharge no more than approximately 6 inches above the ground, to prevent the possibility of spraying someone with hot water.

Recommendation
Contact a qualified handyman.

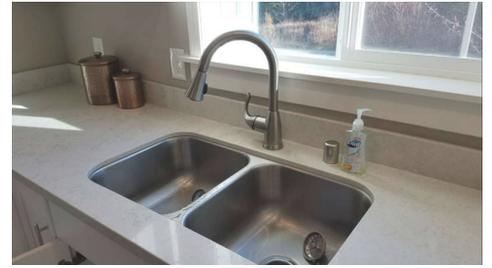
11.3.1 Sink and Faucet

HOT AND COLD REVERSED

The hot and cold water lines to the kitchen faucet are reversed and should be serviced as necessary. Hot water is on the right side and cold water is on the left side; this is opposite of the usual setup. I recommend correcting this issue to help prevent the possibility of a scalding type

injury.
Recommendation
Contact a qualified handyman.

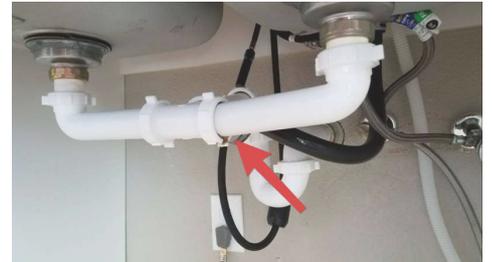
11.4.2 Trap and Drain

LEAK AT DRAIN LINE BELOW THE SINK

There is a leak at the drain line below the sink which should be repaired as necessary.

Recommendation
Contact a qualified professional.

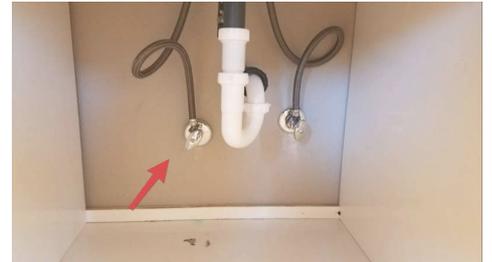
13.3.1 Valves and Connectors

LEAK ON THE HOT WATER SHUT-OFF

There is a leak on the hot water shut-off valve below the sink, which should be evaluated and repaired as necessary by a qualified plumber.

Recommendation
Contact a qualified plumbing contractor.

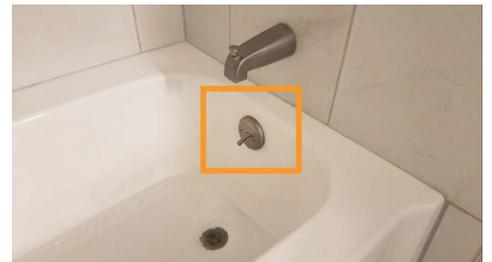
13.8.2 Tub-Shower

TUB STOPPER NEEDS WORK

The mechanical tub stopper does not engage, and should be serviced.

Recommendation
Contact a qualified handyman.

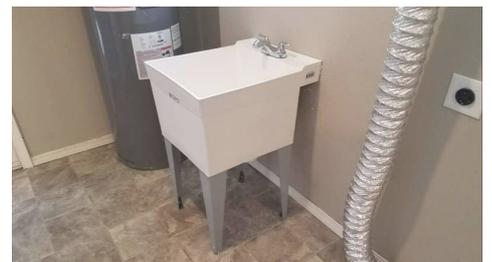
14.4.1 Sink

LAUNDRY SINK NOT SECURED

Laundry sink is not secure too. We recommend securing to prevent damage to Plumbing.

Recommendation
Contact a qualified professional.

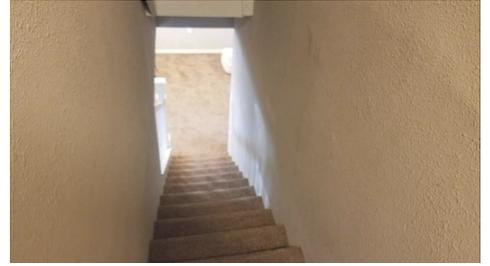
15.10.1 Handrails & Guardrails

NO HANDRAIL ON THE STAIRS

There is no handrail on the stairs, which is an essential safety feature that should be added as necessary by a qualified contractor.

Contact a qualified handyman.

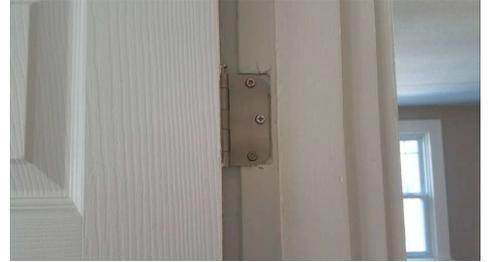
16.2.1 Doors

DOOR HARDWARE NEEDS ADJUSTMENT

The door hardware is Missing or in need of adjustment or repair.

Contact a qualified professional.

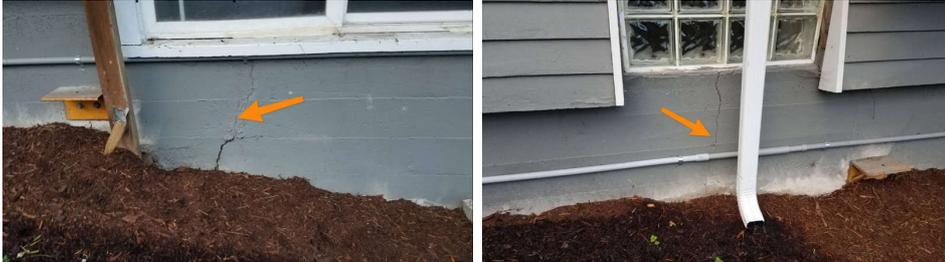
18.2.1 Foundation

CRACKS MODERATE

Moderate sized cracks were observed on the Exterior foundation. This suggests unstable or settling soils. Recommend a soil or structural engineer should be consulted for corrective repairs. This may include sealing the pieces back together with a concrete or similar patch. Sealing is to deny possible moisture entry. a structural engineer evaluate and provide a report on course of action and remedy.

Contact a qualified professional.

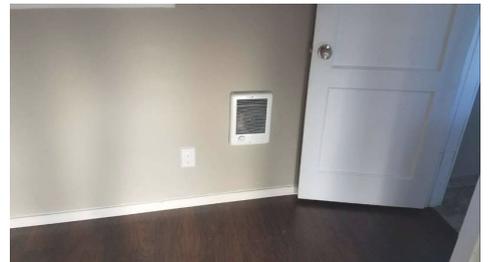
22.1.1 Living Area

HEAT FAILED

One of the heater failed to operate. Recommend repair.

Contact a qualified professional.

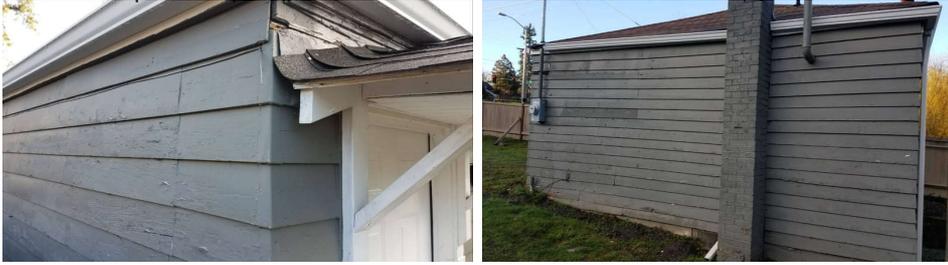
22.7.1 Exterior conditions

WEATHERED SIDING

The exterior siding was weathered. Maintenance and repairs are needed.

Recommendation
Contact a qualified professional.
