## SUMMARY

1234 Main St. Columbia MD 21044

Steven Madewell  
MD License #33112  
Madewell Inspection Services, LLC  
(301) 404-8437  
[steve@madewellhomeinspections.com](mailto:steve@madewellhomeinspections.com)

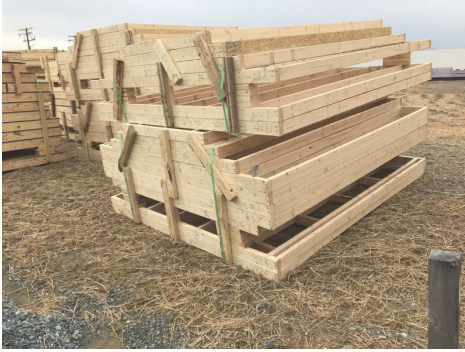
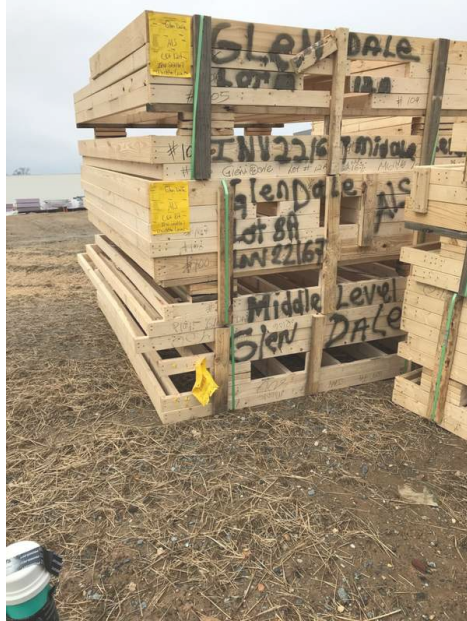
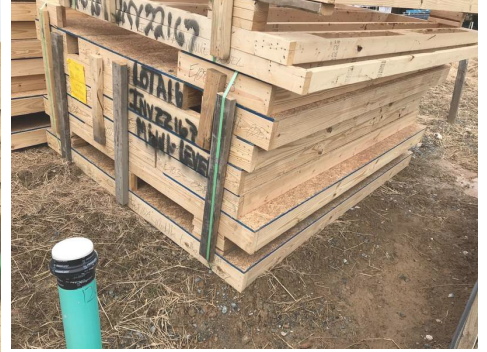
### 3.7.1 Improper Storage of Materials

Some building materials were not stored properly allowing ground contact that will damage the material overtime, and may allow mold growth. We recommend to properly store these items and discard any damaged materials.

Trusses Stored With Ground Contact / Uncovered

Contact your builder.

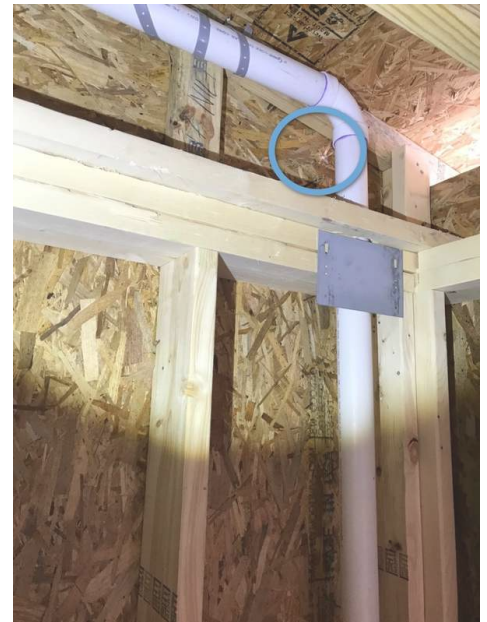
### 5.1.1 Wall Sheathing

The Wall Sheathing was damaged at the time of inspection. We recommend to inspect and repair.

Damaged OSB Sheathing On 4th Floor Exterior Wall

Contact your builder.

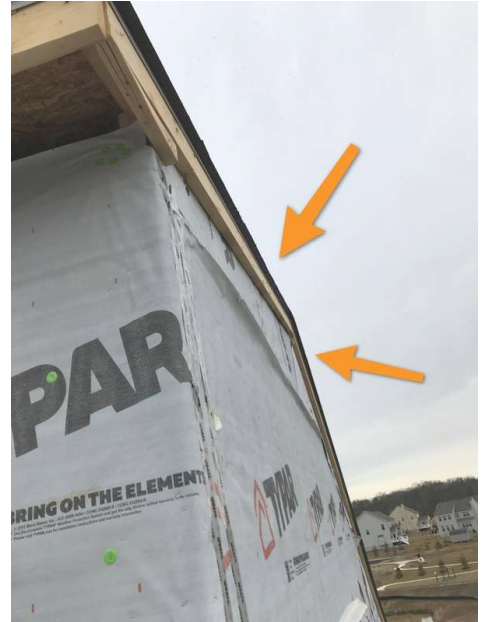
### 5.2.1 House Wrap & Metal Lath

The House Wrap Tape has not been applied around the exterior wall penetrations. Tape was also missing on the upper left exterior wall. We recommend to inspect and install according to manufacturers instructions.

Missing House Wrap Tape

Recommendation  
Contact your builder.

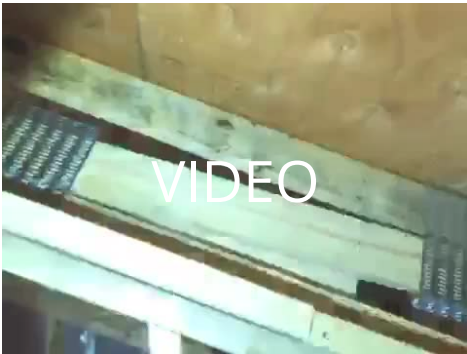
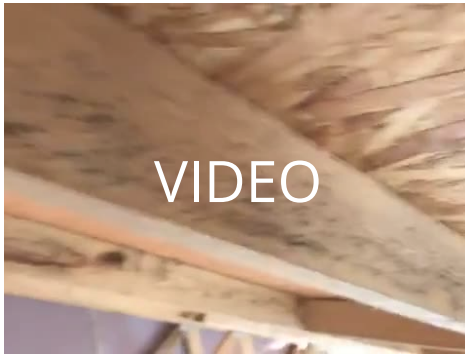
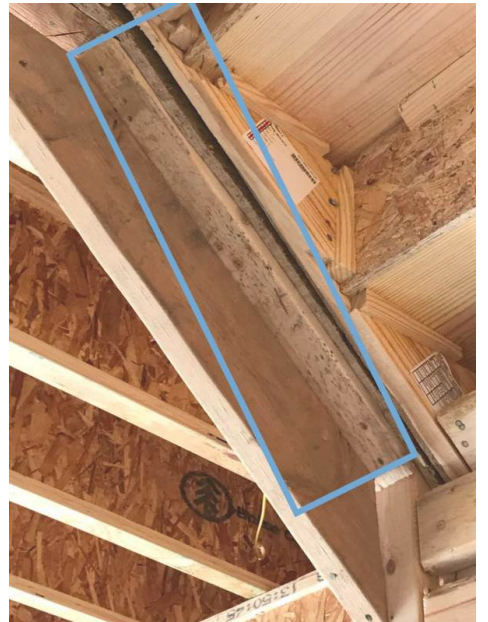
Areas of the floor and roof trusses had visible signs of microbial growth at the time of inspection. This is likely due to trusses being stored in damp areas. Affected trusses were observed on each level of the home, and in the attic space. Areas of concern on each level should be tested by a mold inspector. Fungal growth should be removed by a qualified contractor or mold remediation professional. If you have health concerns about mold you may want to consult with an environmental specialist.

Bio-Growth In Garage Adjacent To Stairs

Recommendation  
Contact a qualified mold inspection professional.

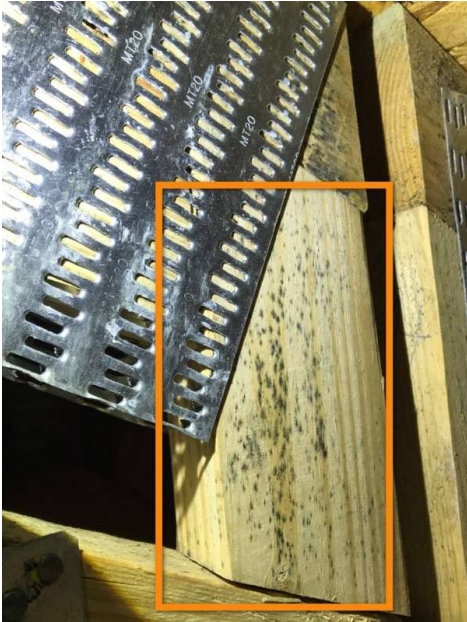
Suspected Mold On Roof Truss

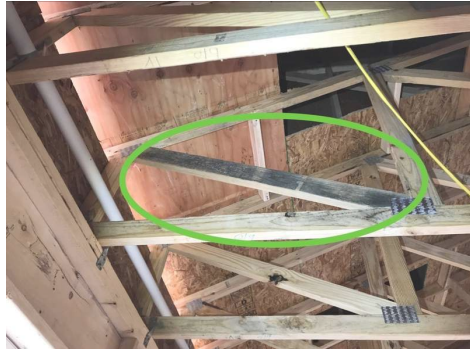
Suspected Mold Above 3rd Floor Bedroom (Front)

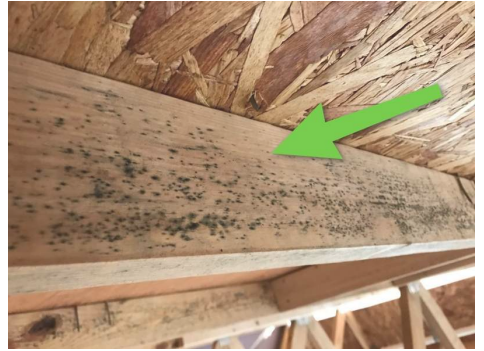
Suspected Mold On Roof Truss

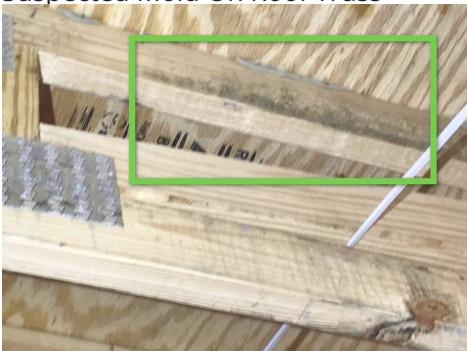
Suspected Mold On 3rd Floor Floor Truss

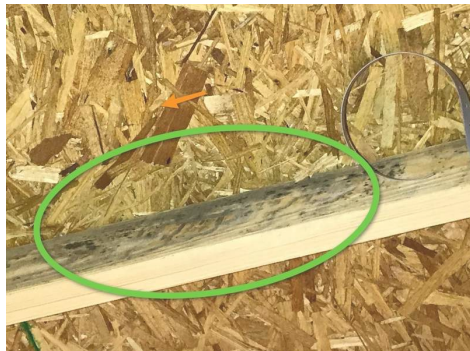
Suspected Mold On First Floor Truss

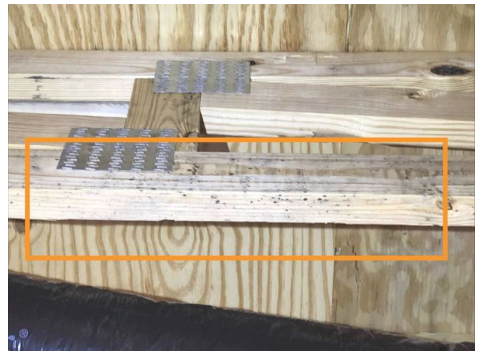
Suspected Mold Growth On Truss Above Master Bathroom

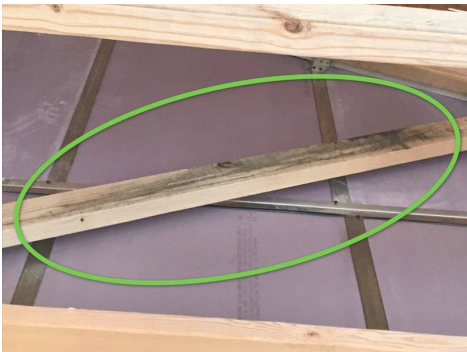
Suspected Mold Above 3rd Floor Bedroom (Front)

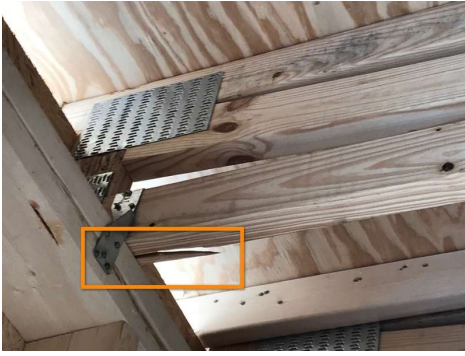
The Truss Chord was damaged/cut at the time of inspection. We recommend to have a Qualified Contractor to inspect and repair.

Damaged Chord Truss

Contact a qualified professional.

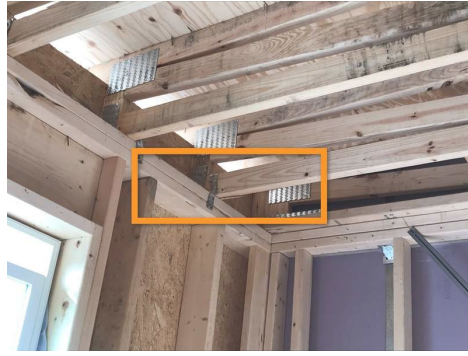
Damaged Chord Truss In Master Bedroom

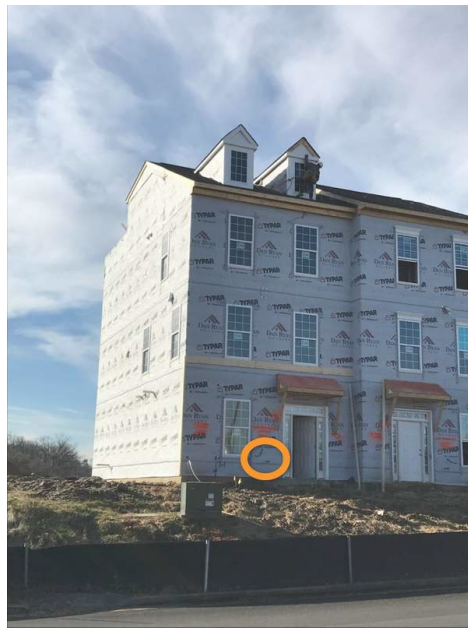
The front hose bib was loose at the time of the inspection. Recommend securing the front exterior hose bib.

Front Hose Bib Loose

Contact a qualified professional.

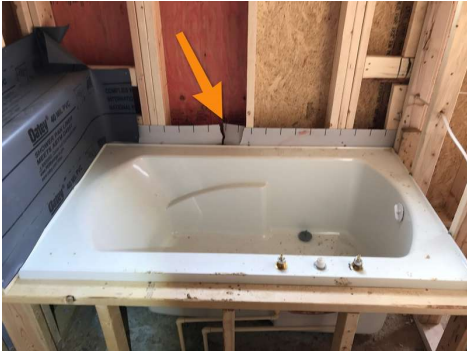
The draft Stop board behind the master bathroom tub was damaged at the time of inspection. Recommend repair or replacement by a qualified professional.

Damaged "Draft-Stop" Rigid Board

Contact a qualified professional.

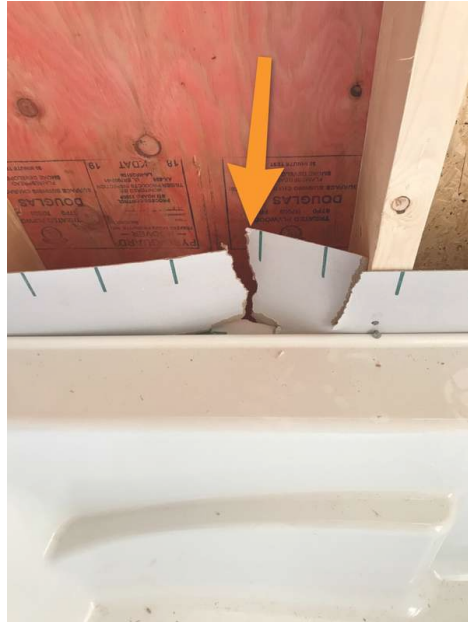
Damaged Draft Stop Board

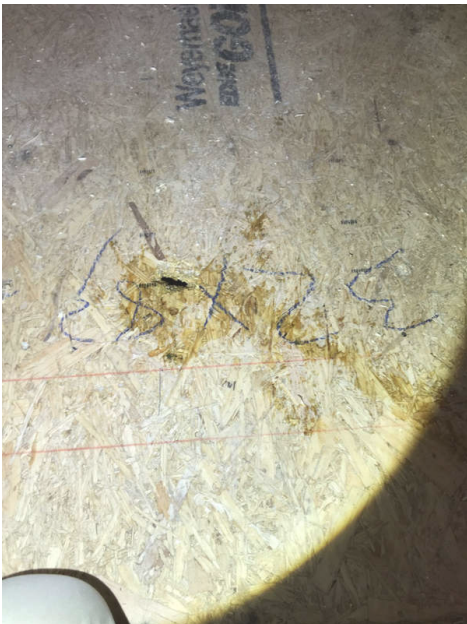
Fourth Floor

Two holes were observed in the OSB subflooring on the fourth floor. Recommend repair by a qualified professional.

Recommendation  
Contact a qualified professional.
