**SUMMARY**  
 1234 Main St. Colorado Springs CO  
 80920  
 Buyer Name  
 02/08/2018 9:00AM

Tom George  
 InterNACHI Certified Home Inspector  
 Cheyenne Home Inspections  
 (719)985-1975

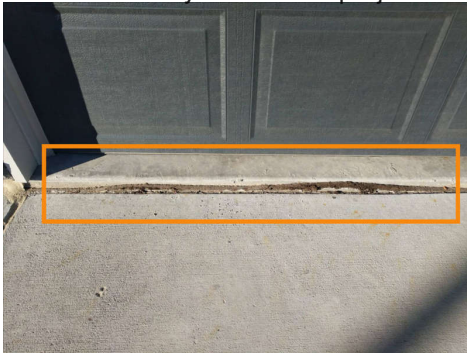
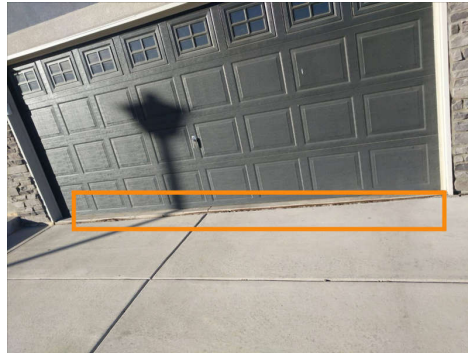
4.3.1 Walkways, Patios & Driveways

**EXPANSION JOINT - REPAIR / REPLACE FOAM**

DRIVEWAY

The expansion joint in between the home and the driveway has a foam material that appears to be damaged. This material allows for expansion and contraction but also keeps debris and water out of the joint. I recommend having the foam repaired or replaced.

Contact a handyman or DIY project

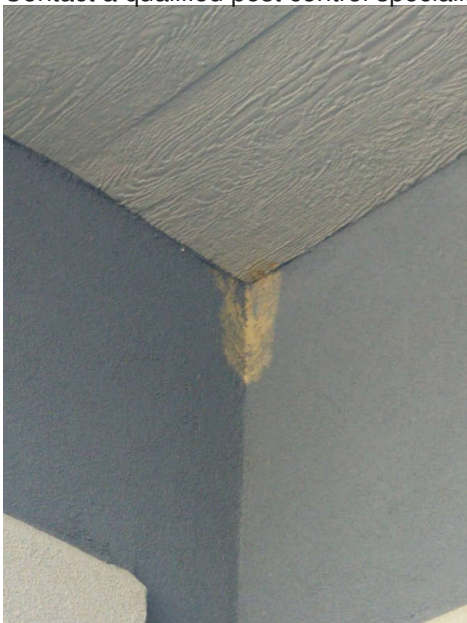
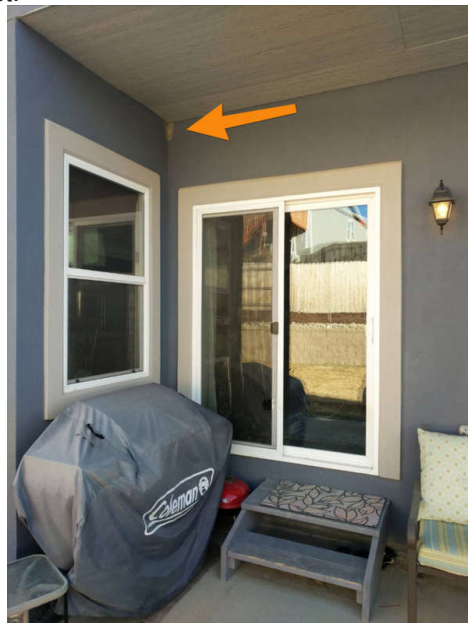
4.5.1 Soffits & Fascia

**WASP / BEE NEST**

While inspecting the soffit and fascia, it appeared that a wasp or bee nest was recently removed. I recommend contacting a Pest Control Professional if the pests return in the future.

Contact a qualified pest control specialist.

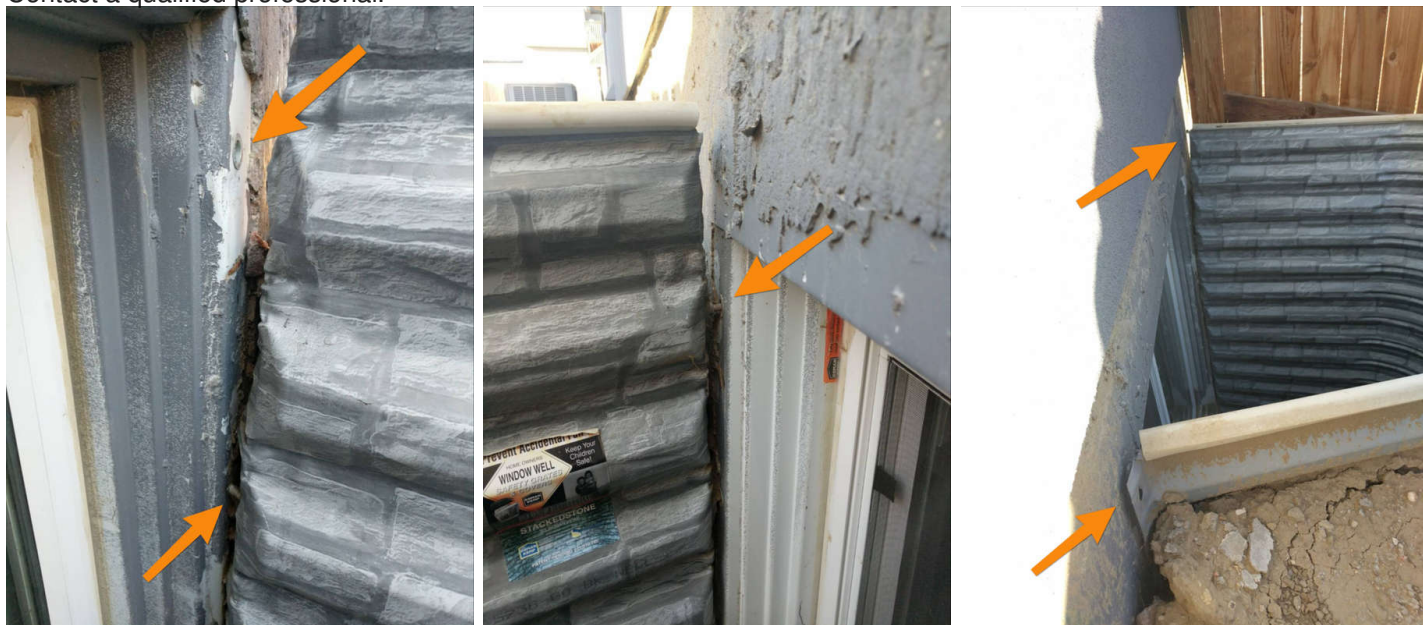
#### 4.8.1 Windows

### WINDOW WELL - FAILURE

SOUTHEAST CORNER

Window wells show signs of failure. The sides appear to be bowing in and the fasteners that secured the well to the home have failed. I recommend having evaluated by a professional for repair or replacement.

Contact a qualified professional.

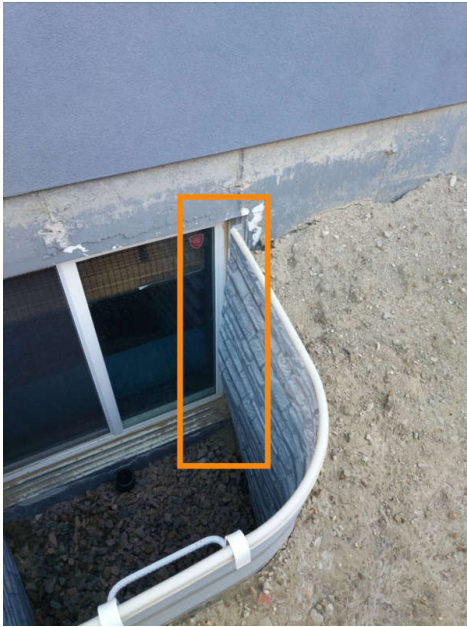
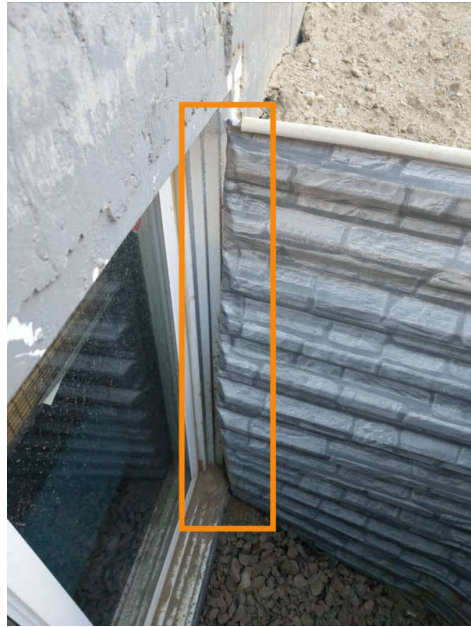
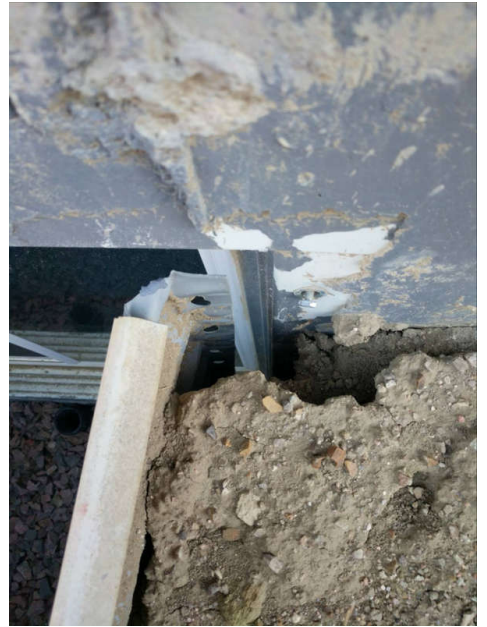
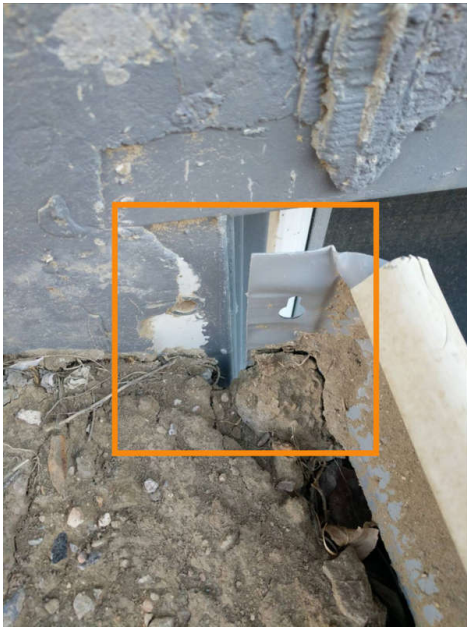
#### 4.8.2 Windows

### WINDOW WELL - FAILURE

SOUTHWEST CORNER

Window wells show signs of failure. The sides appear to be bowing in and the fasteners that secured the well to the home have failed. I recommend having evaluated by a professional for repair or replacement.

Contact a qualified professional.

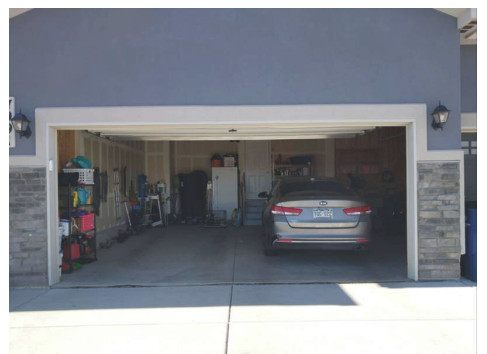
5.5.1 Garage Door Opener and Safety  
**RESISTANCE SETTINGS - NEED  
ADJUSTMENT**

The garage door does not automatically reverse when resistance is applied while it's coming down. This test is done to simulate if a child or pet were to be laying under the door so this is a safety hazard. I recommend having the resistance setting adjusted.

Recommendation  
Recommended DIY Project

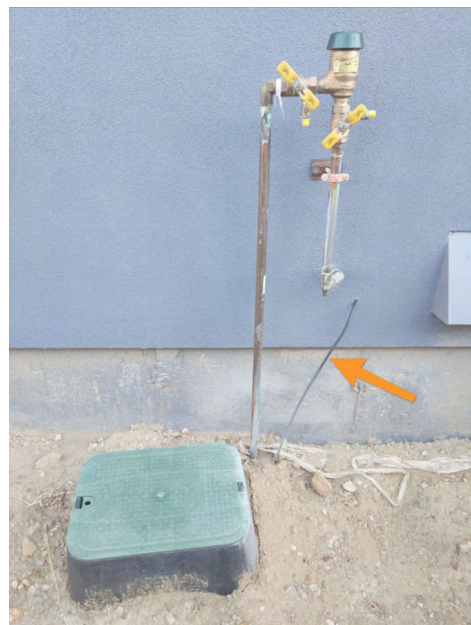
6.3.1 Branch Wiring Circuits, Breakers & Fuses  
**EXPOSED WIRES**  
SOUTH EXTERIOR

While inspecting the irrigation system, a wire that runs from the control module to the sprinkler zone valves appears to be exposed and is susceptible to damage. I recommend having the wire enclosed inside of conduit in order to protect the wire from any damage.

Contact a qualified electrical contractor.

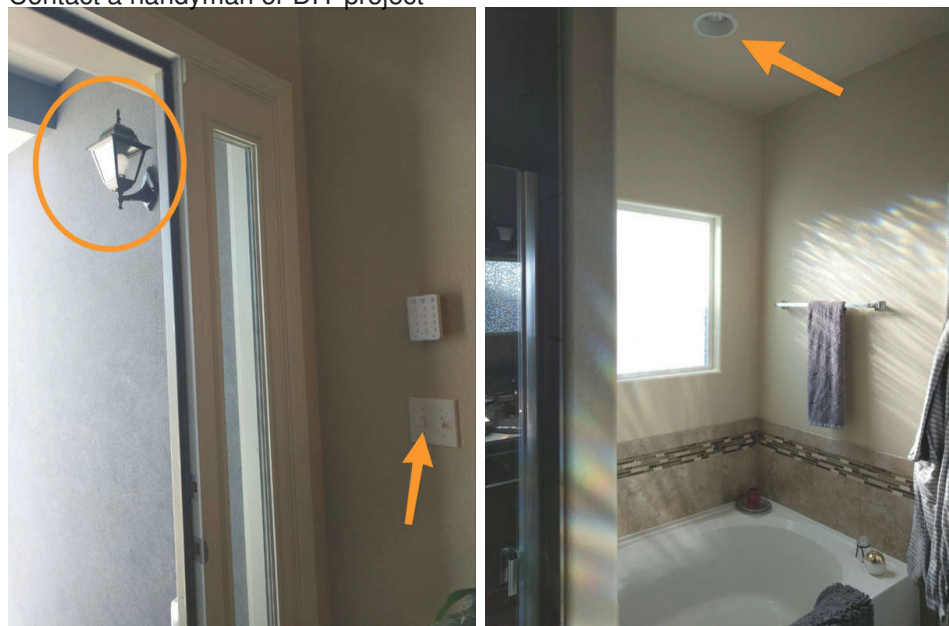
#### 6.5.1 Lighting Fixtures, Switches & Receptacles

### LIGHT FIXTURE - INOPERABLE

FRONT PORCH, MASTER BATHROOM

One or more lights were not operating during the inspection. It could be just a defective light bulb, however I recommend having the circuit evaluated to ensure that it does function,

Contact a handyman or DIY project

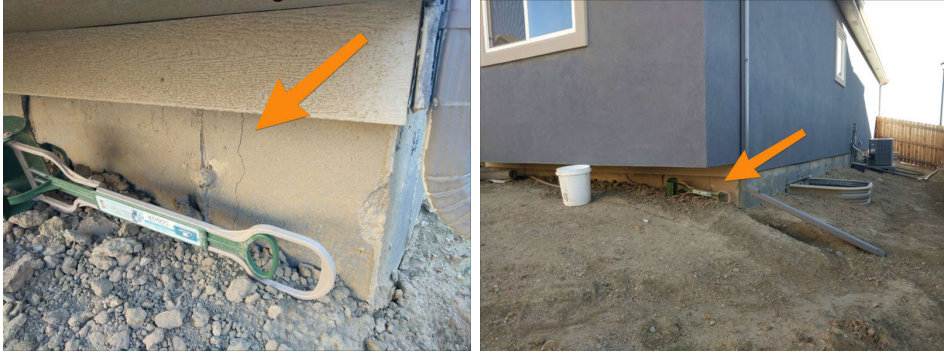
#### 7.1.1 Foundation

### CRACKING - MINOR

SOUTHWEST CORNER

While inspecting the foundation, I observed minor cracking in the foundation. As concrete ages, shrinkage and minor surface cracking is normal. I recommend monitoring the areas and having them further evaluated if cracking worsens.

Recommendation  
Recommend monitoring.

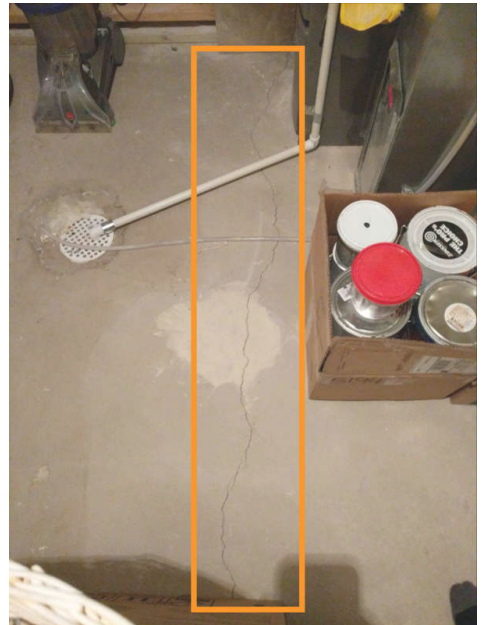
### 7.2.1 Floor Structure

#### **SLAB - MINOR CRACKING**

While inspecting the concrete slab in the home, I observed minor cracking. This is very typical in this area and is due to soil movement. I would consider these cracks purely cosmetic but I do recommend using a sealant to prevent water intrusion. Then monitor and maintain as necessary.

Recommendation  
Recommend monitoring.

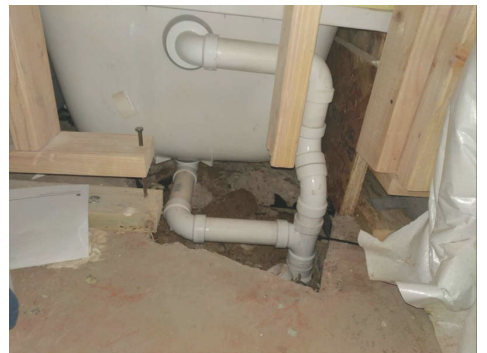
### 7.3.1 Wall Structure

#### **FRAMING - MODIFIED / IMPROPER**

##### BASEMENT UTILITY ROOM

An area of an interior wall appears to have been improperly modified in order to have a tub drain installed. I recommend having the framing evaluated to and repaired if deemed necessary by a professional.

Recommendation  
Contact a qualified professional.

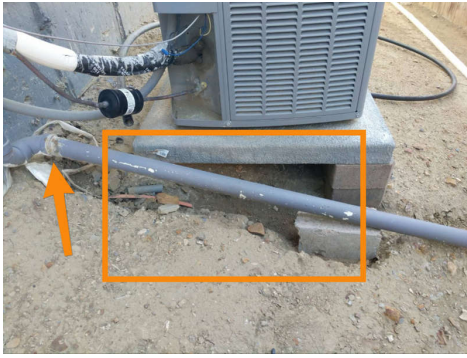
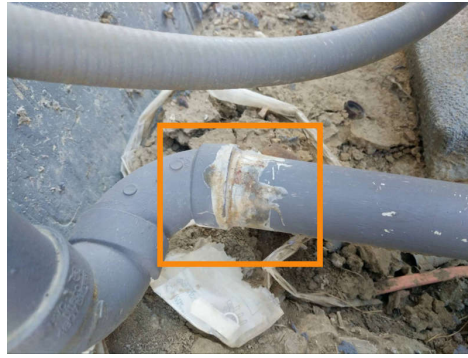
### 9.1.1 Cooling Equipment

#### **EROSION UNDER CONDENSOR PAD**

The concrete pad supporting the AC condenser appears to have major corrosion around it. I recommend monitoring the AC system for leaks that could be causing the erosion, then making any necessary repairs.

Recommendation  
Contact a handyman or DIY project

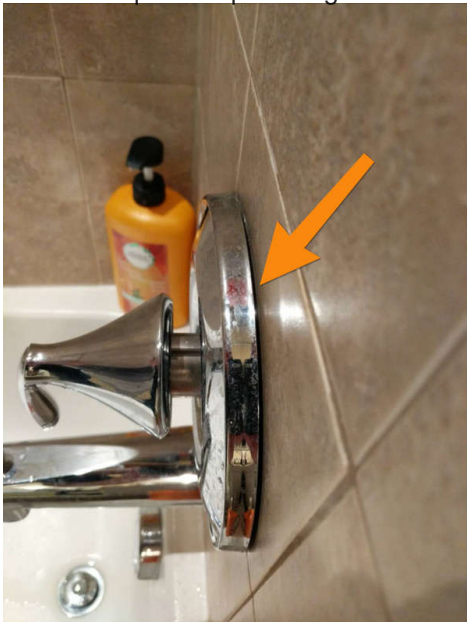
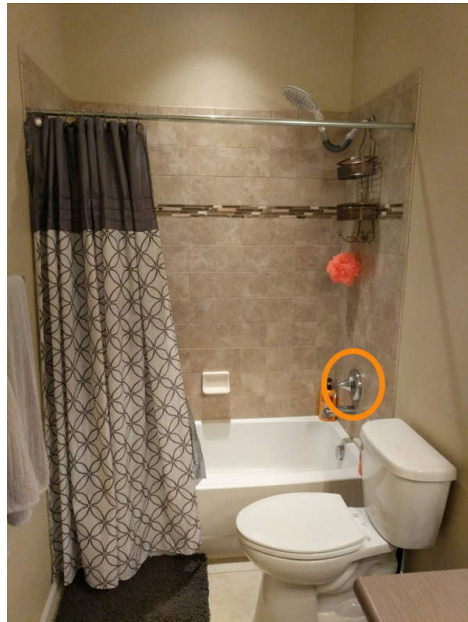
### 10.6.2 Fixtures

## TUB/SHOWER FAUCET - SEAL

GUEST BATHROOM - MAIN LEVEL

The tub/shower faucet appears to be loose, which can allow water to get inside the wall. When the faucet is properly installed, a tight seal is created which prevents any water from getting into the wall cavity. I recommend having the faucet evaluated and repaired if necessary in order to prevent moisture intrusion.

Contact a qualified plumbing contractor.

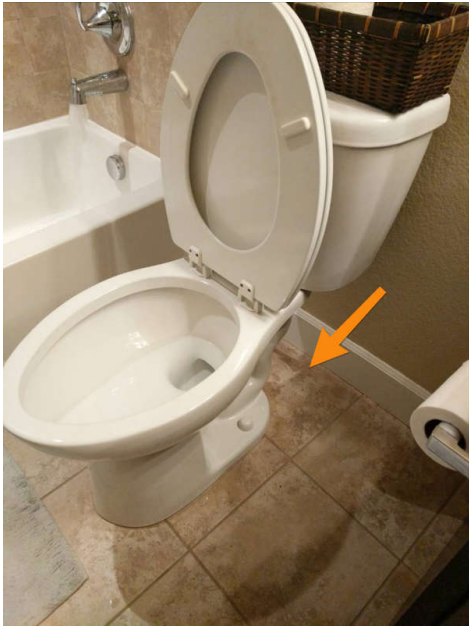
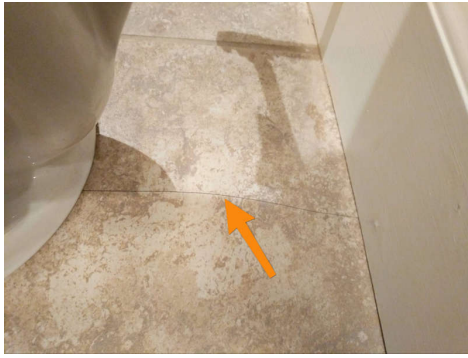
### 11.3.1 Floors

## TILE - DAMAGED TILE

When inspecting the home's flooring, I found that one or more tiles in the home were damaged. I recommend having the damaged tiles replaced. In the utility room, there was a stack of extra tiles that APPEARED to be the same tile.

Contact a qualified flooring contractor

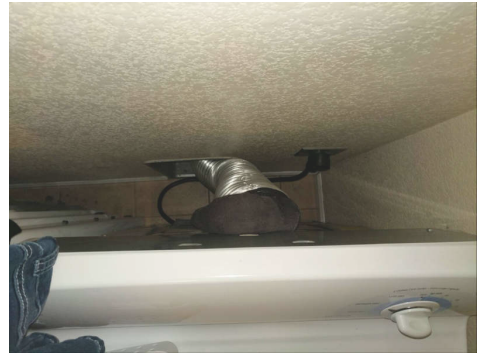
#### 14.7.1 Exhaust Systems

### **DRYER VENT NOT ATTACHED**

The dryer vent is connected to the back of the dryer but does not connect to the exhaust vent on the other side. It appears that the previous occupants are using the dryer to provide heat into the home. I recommend attaching to properly attaching the dryer vent to exhaust to the exterior in order to prevent moisture issues.

Recommendation  
Recommended DIY Project
