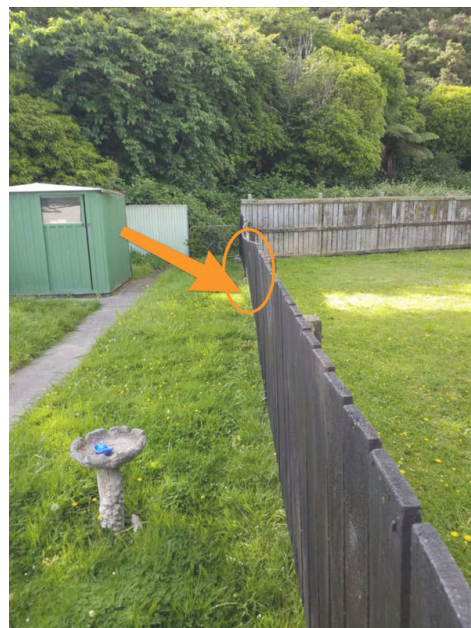
2.1.1 Fencing

**FENCING - BROKEN POST**

Contact a qualified handyman.

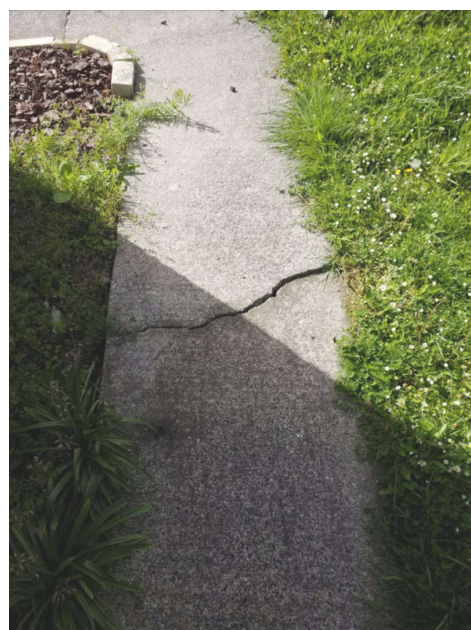
2.2.1 Paths

**PATH CRACKING - MINOR**

Normal settling & cracking observed. Recommend monitor and/or patch/seal.

Recommended DIY Project

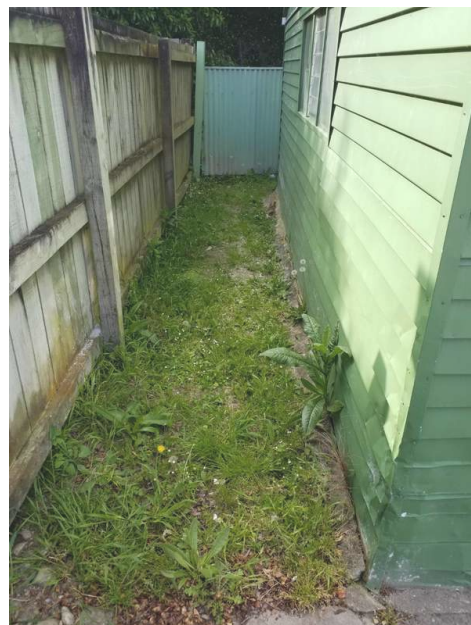
2.3.1 Contour grading

**PONDING WATER**

Standing water observed, which could indicate poor drainage and/or grading. Recommend

monitor and/or have landscaper correct.

Contact a qualified landscaper or gardener.

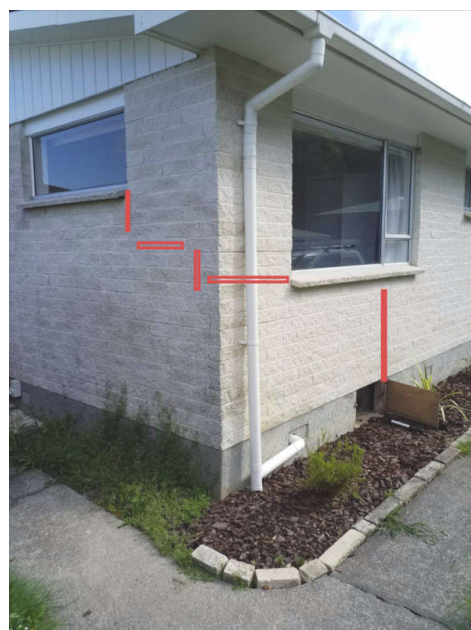
3.2.1 Structural Masonry

### STRUCTURAL MASONRY - MAJOR DEFECT

Safety Hazard

**Our inspector has found what we would consider major Issues, we recommend you seek advice from a professional specific to this type of construction or obtain a structural engineers report**

Contact a qualified structural engineer.

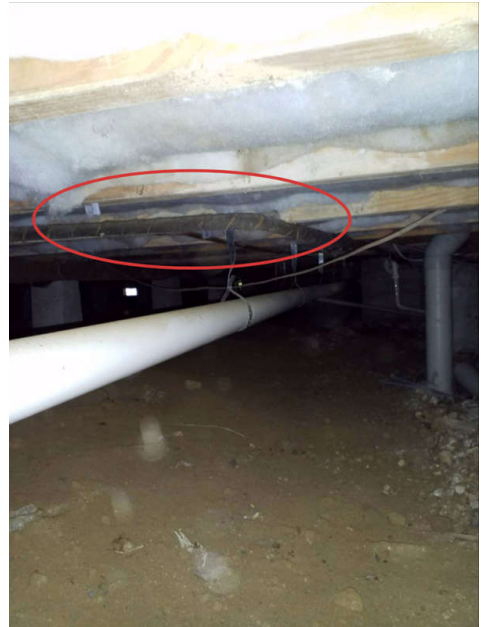
5.1.1 Subfloor Space

### ASBESTOS SUSPECTED.

Safety Hazard

Test sample is required for our lab to verify the presence of Asbestos.

Contact a qualified professional.

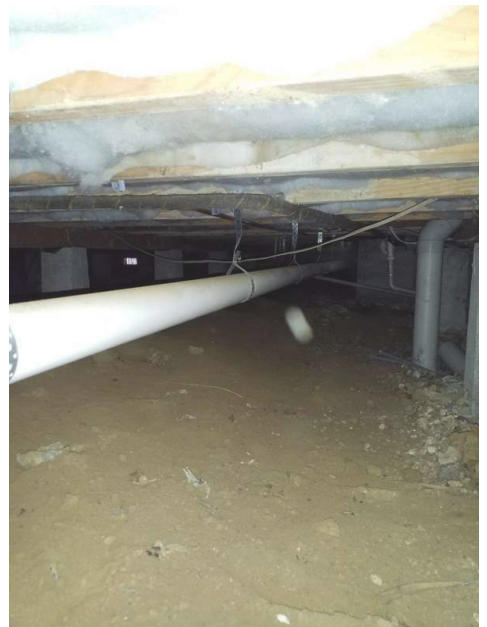
### 5.1.2 Subfloor Space

#### **ELECTRICAL - SUPPORT**

Loose or hanging cables can be a safety hazard especially if they come into contact with the ground.

We recommend these cables be properly secured and checked for fault or redundancy by a registered electrician.

Contact a qualified electrical contractor.

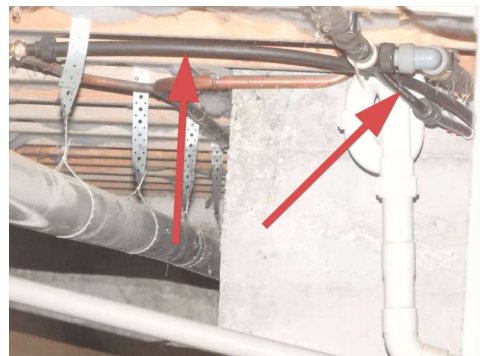
### 5.1.3 Subfloor Space

#### **PLUMBING - DUX QUEST**

Dux Quest pipes and connections identified.

Dux Quest was withdrawn from the market about 30 years ago. It pre-dates the current Building Code and the Building Act.

This product has been causing major problems for home owners throughout NZ.

Often insurance companies won't cover damage done by Dux Quest piping, especially if it has leaked before.

Contact a qualified plumbing contractor.

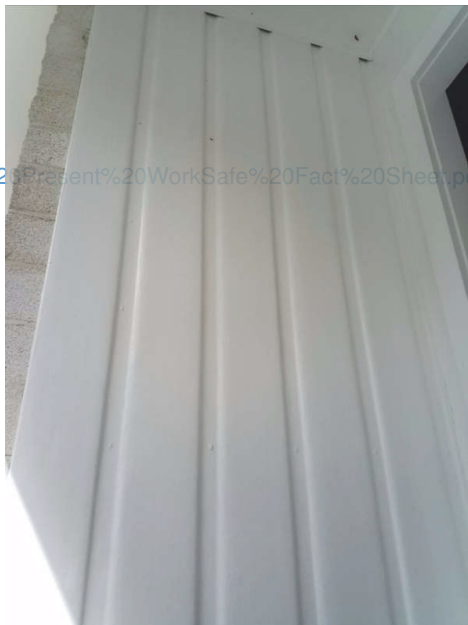
### 7.2.1 Fibre cement sheet product

#### **ASBESTOS PRODUCT SUSPECTED.**

Test sample is required for our lab to verify the presence of Asbestos.

Contact a qualified professional.

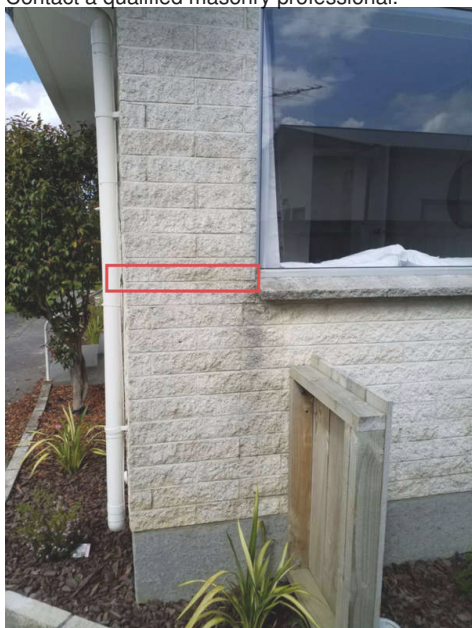
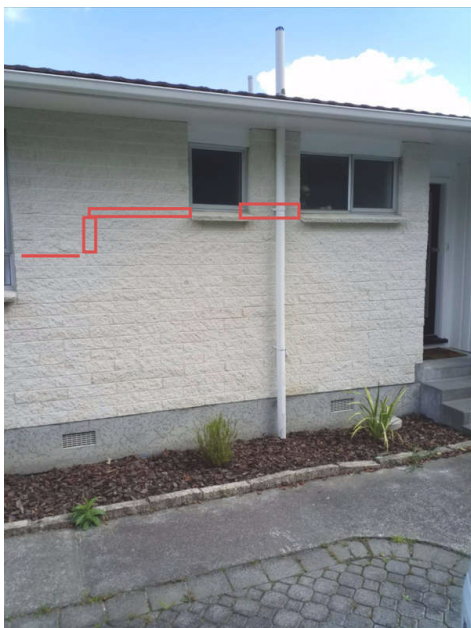
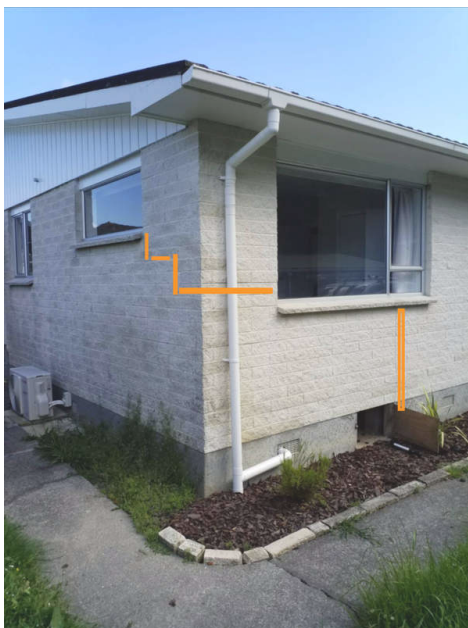
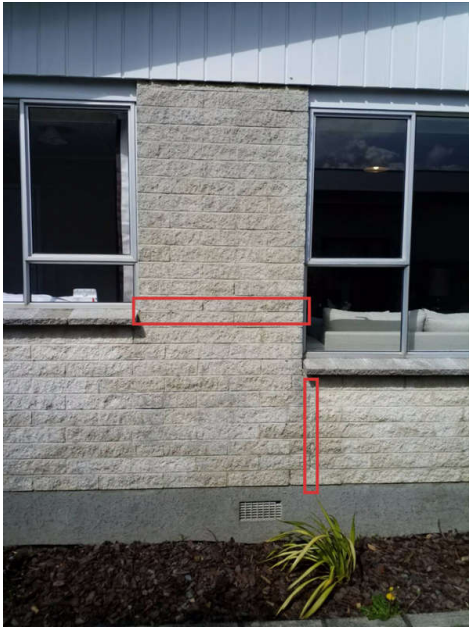
### 7.3.1 Brick veneer

#### **CRACKING**

Cracked, missing, loose Masonry

Performance of this deflection element has been compromised.

Maintenance or repair required in this area

Contact a qualified masonry professional.

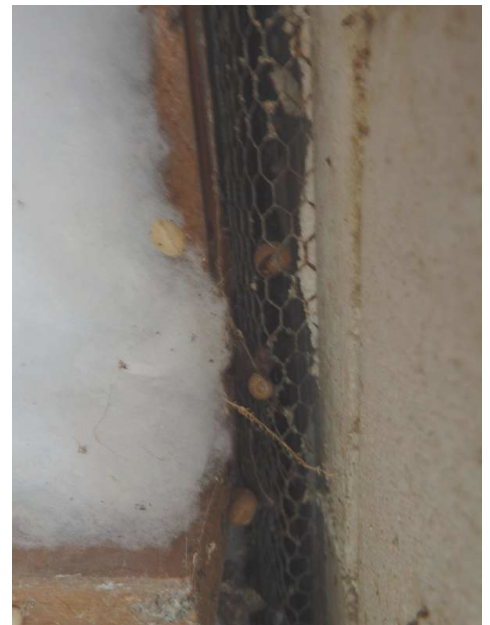
### 7.3.2 Brick veneer

#### **VENTILATION/WEEP HOLES**

This cladding system is not using weep holes to ventilate the cavity.

The cavity system here is relying on ventilation from the subfloor, this encourages warm moist air from the underfloor to circulate the internal wall cavity thus creating a good growing environment for mould. this is considered bad building practice and should be rectified should works be carried out in this area.

Contact a qualified general contractor.

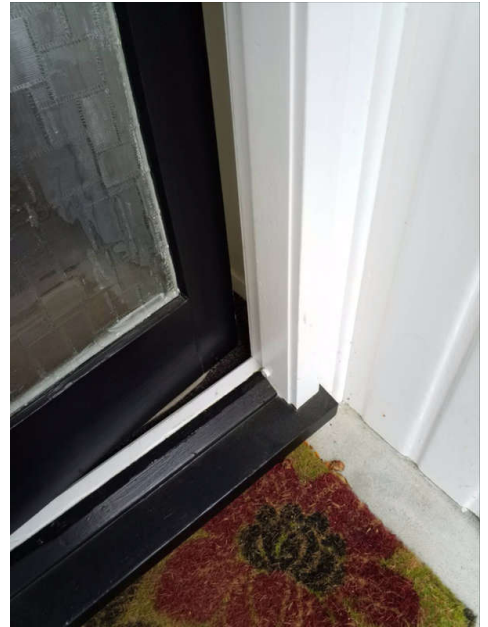
### 9.2.1 Door - Timber unit

#### **FLASHING**

This door is missing its flashing strip at the bottom, the back door has one. Maintenance or repair required in this area

Contact a qualified carpenter.

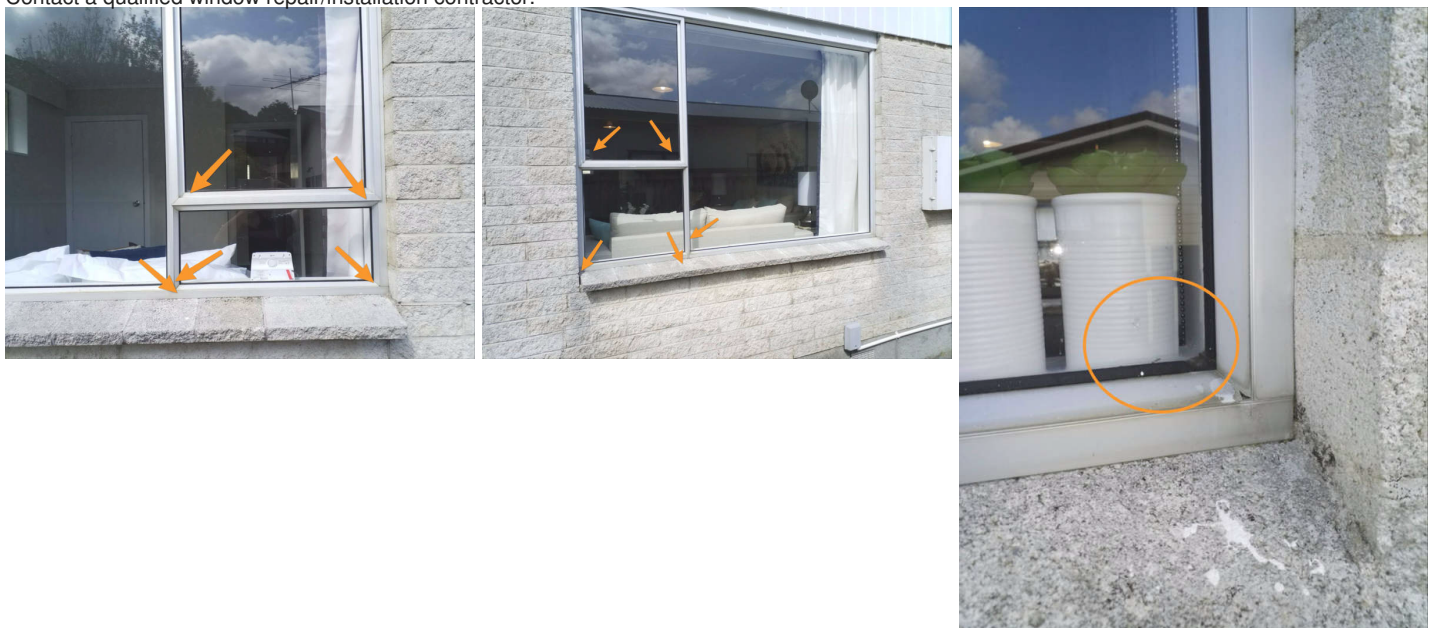
### 9.3.1 Window - Aluminium unit

#### **GLAZING SEAL**

KITCHEN

It's a common issue with older aluminium joinery, UV light causes shrinkage to the glazing seals exposing gaps typically in the corners of any glazed section.

We recommend replacement of the seals in this area.

Contact a qualified window repair/installation contractor.

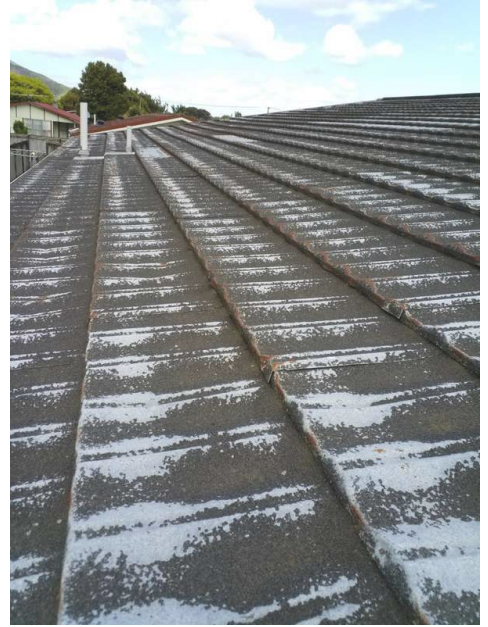
10.2.1 Material - Pressed metal tiles

### **CORROSION**

We have found rust in this area.

This is a potential weathertightness problem.

Maintenance or repair required in this area.

Profiled metal claddings are non-absorbent and are vulnerable to condensation on the inside of the cladding. They must be installed over an absorbent underlay.

Contact a qualified roofing professional.

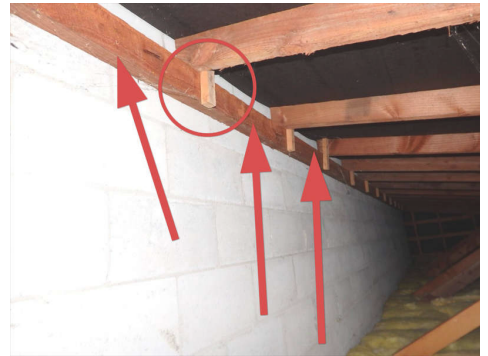
12.2.1 Roofing framing & connections

### **CONNECTION, INADEQUATE**

ROOFSpace

We strongly recommend this plate to be bolted and proper tie connections to be installed.

Contact a qualified carpenter.

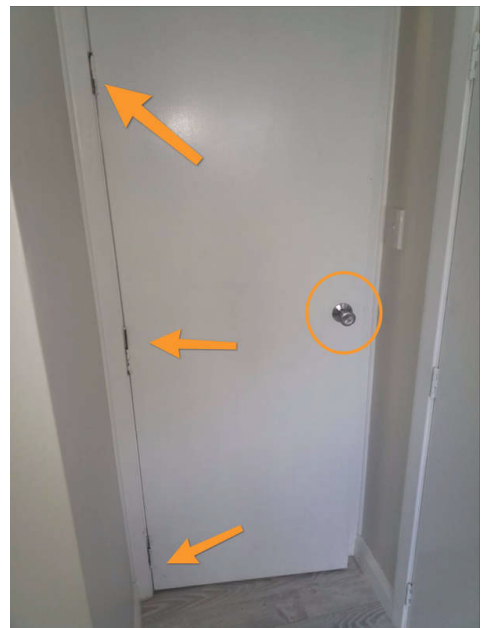
15.8.1 Doors and frames

### **DEFECTIVE HARDWARE**

Broken or defective hardware, (hinges, stays, latches, rollers, locks, handles etc.)

Maintenance or repair required in this area

Contact a qualified handyman.

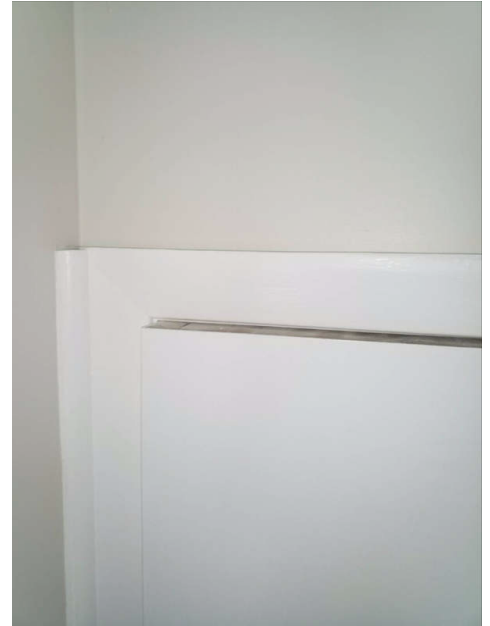
#### 20.3.1 Doors and frames

### **DOORS BINDING**

These doors are catching the frame, the door should have been trimmed to suit.

Recommendation  
Contact a qualified handyman.
