SUMMARY 1234 Main St.Colorado Springs CO 80920 Buyer Name 05/05/2019 9:00AM

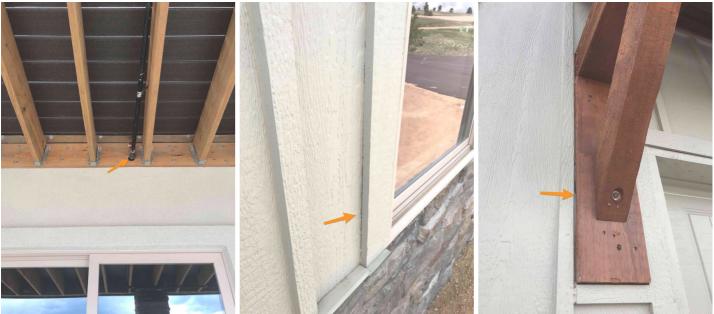
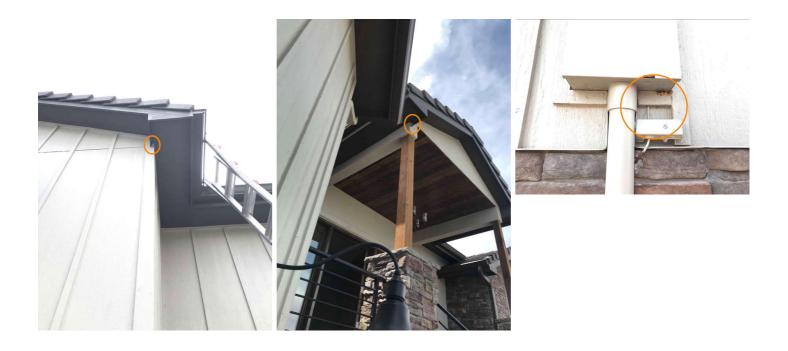
MULTIPLE LOCATIONS AROUND EXTERIOR

### 3.1.1 Siding, Flashing & Trim SIDING/TRIM - MAINTAIN PAINT/CAULKING

Areas of the exterior paint and caulking are in need of maintenance/repairs. In order to prevent moisture intrusion and to extend the life of the siding and trim, the gaps, pipes, conduit, etc. should be properly sealed. I recommend having the caulking and exterior paint evaluated and repaired as necessary by a qualified painting contractor prior to closing.

Recommendation Contact a qualified painting contractor.

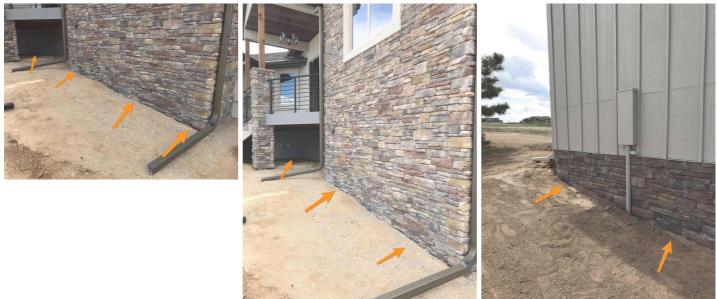
EAST SIDE OF EXTERIOR, SOUTH SIDE OF EXTERIOR

### 3.1.2 Siding, Flashing & Trim SIDING - GROUND CLEARANCE

Areas of the siding are in close contact with the ground. In order to prevent damage to the siding from rain/snow, as well as wood destroying organisms, I recommend having the siding and landscaping evaluated and addressed as necessary by a licensed contractor.

Contact a qualified siding specialist.

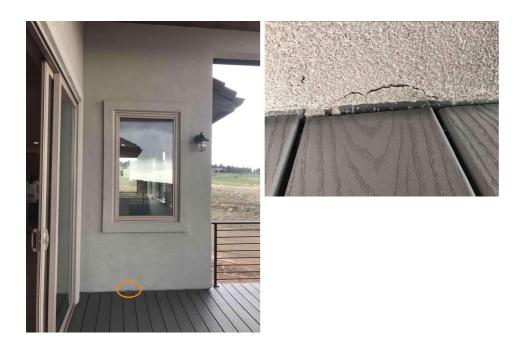
WEST SIDE OF EXTERIOR (UNDER DECK AND UPPER DECK AREAS)

### 3.1.3 Siding, Flashing & Trim STUCCO - REPAIRS NEEDED

Areas of the stucco appears to have cracking/damage. In order to prevent moisture intrusion, I recommend having the stucco evaluated and repaired as necessary by a qualified stucco contractor prior to closing.

Recommendation Contact a stucco repair contractor

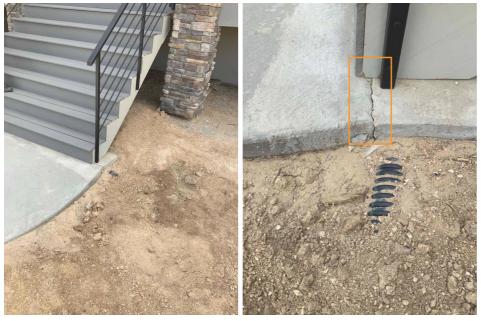
EAST SIDE OF EXTERIOR

# 3.3.1 Sidewalks, Patios, Porches, & Driveways CONCRETE - CRACKING

Cracking was observed in one or more areas of the concrete. I recommend having the cracks sealed in order to prevent moisture intrusion and further cracking.

Contact a qualified concrete contractor.

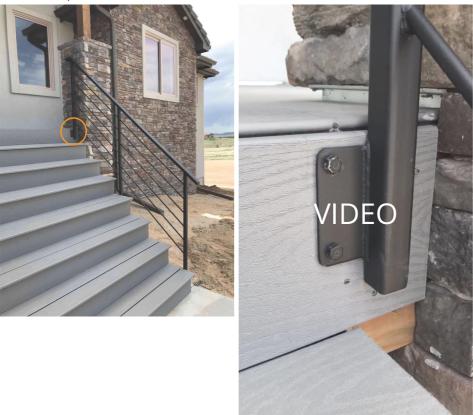
FRONT DECK

# 3.4.1 Deck RAILINGS/HANDRAILS - LOOSE

One or more areas of the railings/handrails appeared to be loose. I recommend having this evaluated and repaired/addressed as necessary by a licensed deck contractor prior to closing.

#### Recommendation Contact a qualified deck contractor.

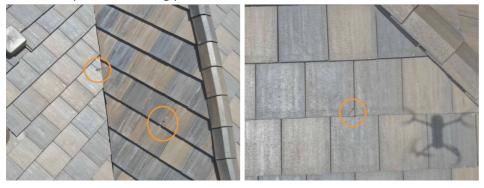
#### 4.2.1 Coverings ROOF - DAMAGED TILE

Damaged tiles were observed during the inspection. In order to prevent any moisture intrusion, I recommend having the roof evaluated and repaired/replaced as necessary.

Recommendation Contact a qualified roofing professional.

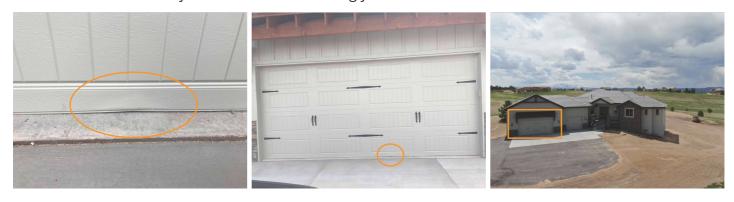
#### 5.5.1 Garage Door GARAGE DOOR - COSMETIC DAMAGE 2 CAR GARAGE DOOR

One or more areas of the garage door(s) appeared to have cosmetic damage but did not effect the function. This is not a major concern but something you should be aware of.

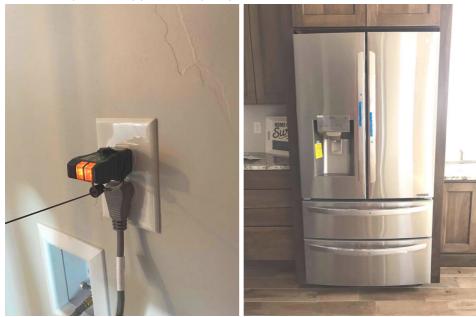
# 6.2.1 Refrigerator

Refrigerator was inoperable at time of inspection. It was plugged in and the receptacle did have power. I recommend having it evaluated and repaired/replaced as necessary by a qualified appliance repair technician prior to closing.

Contact a qualified appliance repair professional.

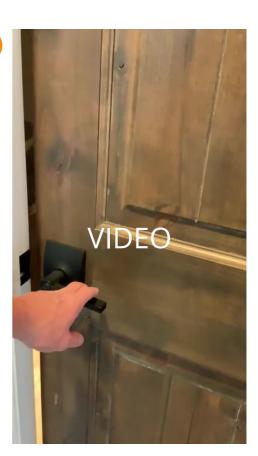
1ST FLOOR HALF BATH

### 7.1.1 Doors INTERIOR DOORS - DOESN'T LATCH / LOCK

One or more interior doors did not latch/lock properly. I recommend having the doors evaluated and repaired/replaced as necessary.

Recommendation Contact a qualified handyman.

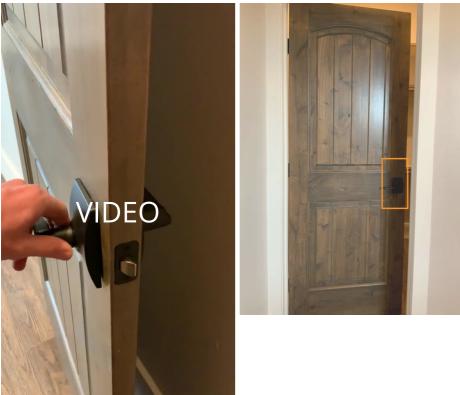
SOUTHWEST BASEMENT BEDROOM

### 7.1.2 Doors INTERIOR DOORS - LOOSE HARDWARE

One or more doors appeared to have loose hardware. I recommend having the loose hardware properly tightened.

Recommendation Contact a qualified handyman.

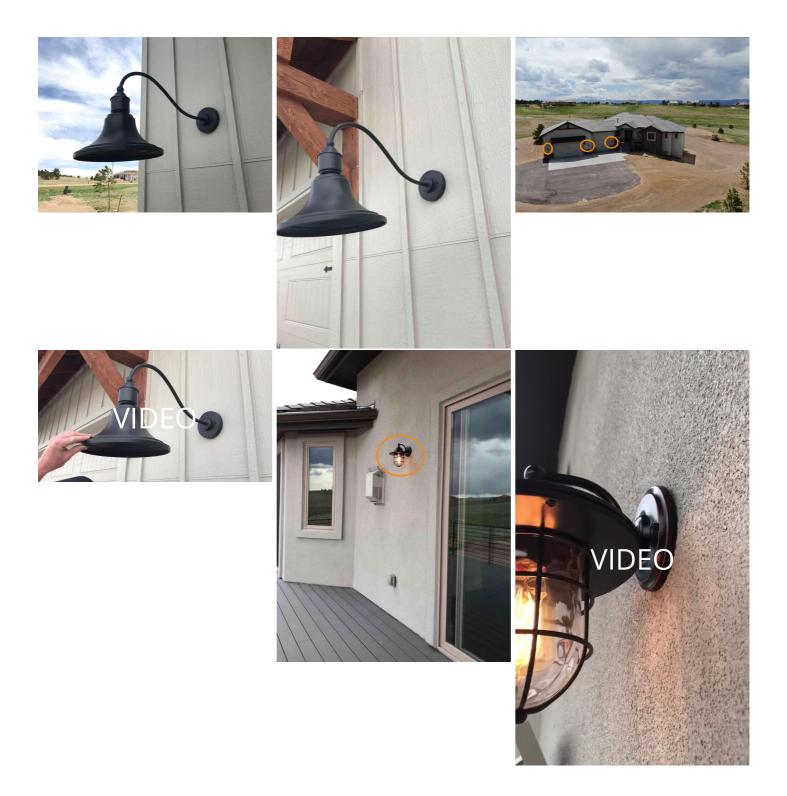
EAST SIDE OF EXTERIOR, BACK DECK

9.6.1 Fixtures, Fans, Switches & Receptacles ELECTRICAL - SEAL AND SECURE EXTERIOR LIGHT

Exterior light fixture(s) were not properly secured to the box. In order to prevent moisture intrusion, I recommend having the light properly sealed and secured by a licensed electrician.

Recommendation Contact a qualified electrical contractor.

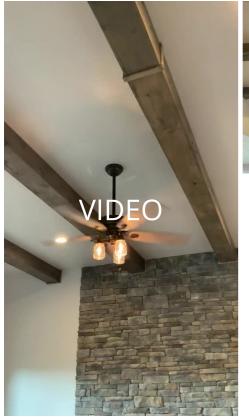
LIVING ROOM

### 9.6.2 Fixtures, Fans, Switches & Receptacles ELECTRICAL - CEILING FAN WOBBLE

One or more ceiling fans had an excessive amount of wobble. I recommend having the ceiling fan(s) evaluated and repaired as necessary by a licensed electrician prior to closing.

Contact a qualified electrical contractor.

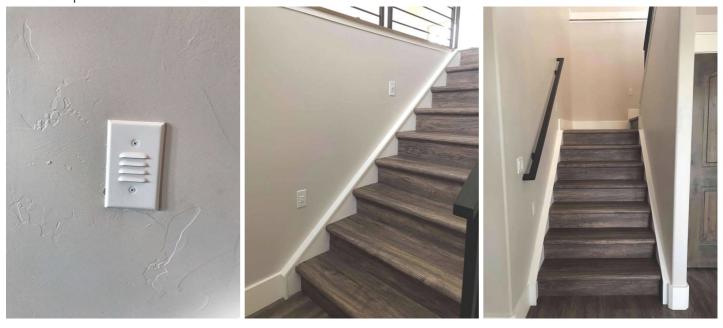
#### 9.6.3 Fixtures, Fans, Switches & Receptacles LIGHTING - RECOMMEND EVALUATION STAIRS FROM MAIN LEVEL TO BASEMENT

The lighting in the stairwell does not appear to be correctly wired and functioning properly. The chandelier does can not be controlled from the bottom of the stairs and the lighting to illuminate the steps do not function at all. There are switches at the top and bottom of the steps that don't appear to control anything. I recommend having this evaluated and repaired/replaced as necessary by a licensed and qualified electrician prior to closing.

Recommendation Contact a qualified electrical contractor.

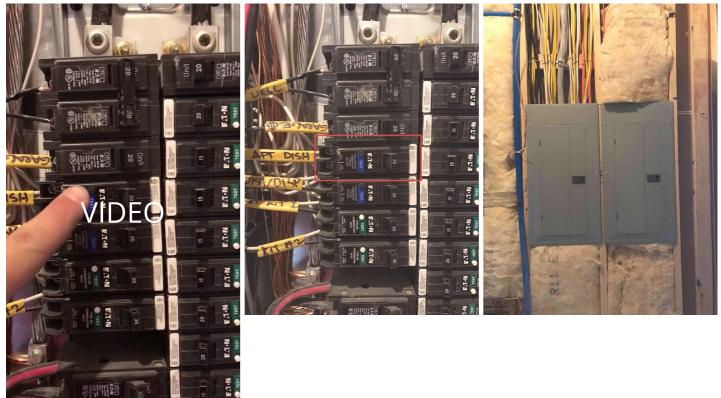
SUB PANEL A

## 9.7.1 GFCI & AFCI GFCI/AFCI COMBINATION BREAKER - FAILED TEST

One or more GFCI/AFCI combination breakers in the service panel did not function properly when tested. I recommend having the breaker evaluated and replaced as necessary by a licensed electrician prior to closing.

Contact a qualified electrical contractor.

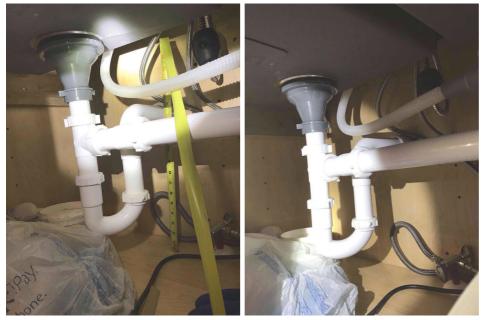
#### 10.1.1 Drain, Waste, & Vent Systems **DRAIN - RECOMMEND EVALUATION** KITCHEN

The drain rough-in for the kitchen sink is approximately 19" off the floor, which is higher than industry standard. In order to ensure the sinks and disposal all drain properly, I recommend having this evaluated and repaired/replaced as necessary by a licensed and qualified plumber prior to closing.

Contact a qualified plumbing contractor.

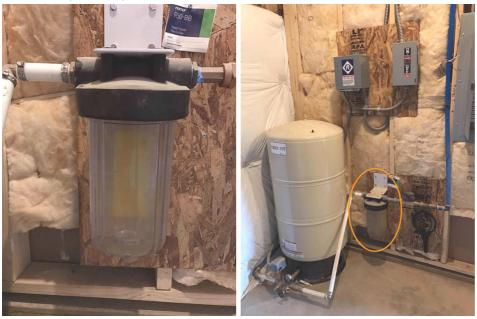
#### 10.2.1 Water Supply WHOLE HOUSE FILTER - MISSING FILTER BASEMENT UTILITY ROOM

The whole house filter housing was missing the actual filter. I recommend having one installed. Recommendation

Contact a qualified professional.

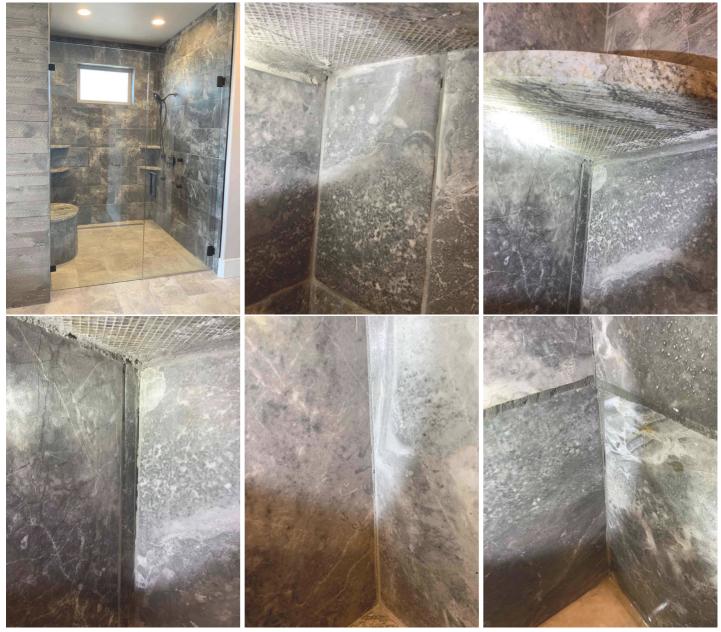
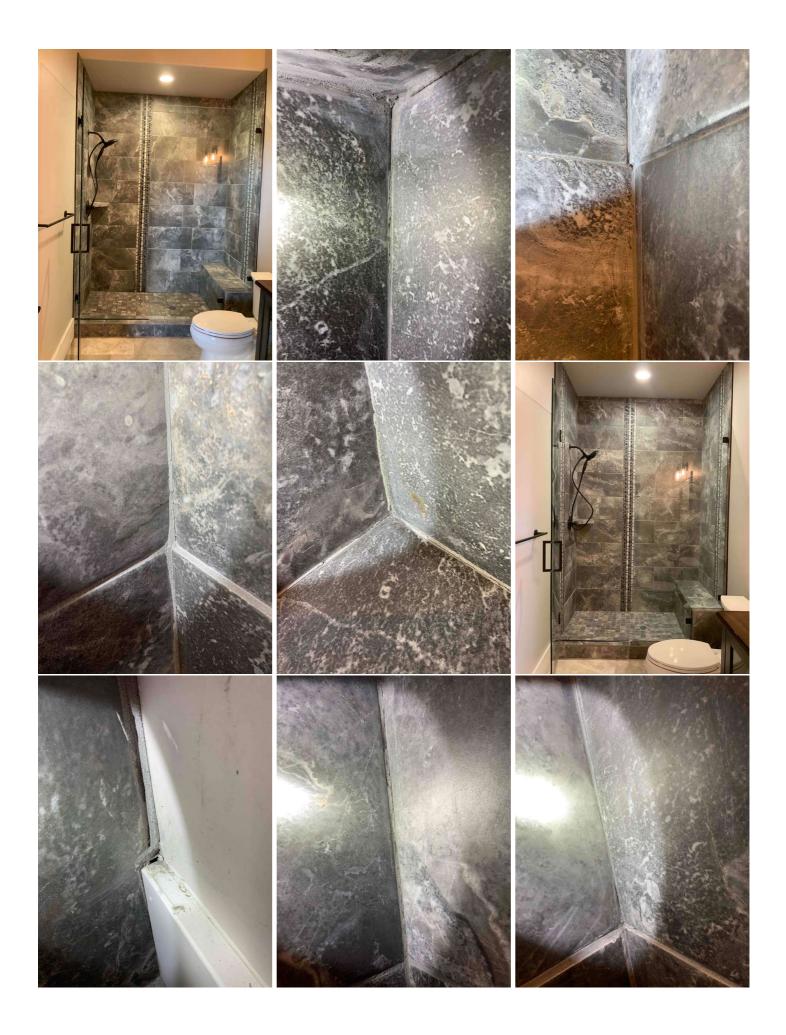
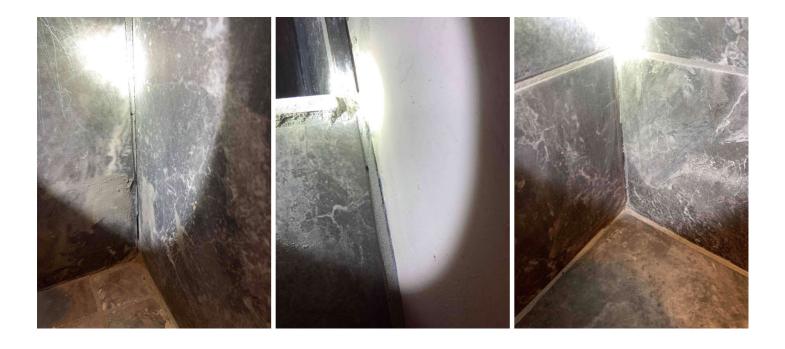
MASTER BATHROOM, BOTH BASEMENT BATHROOM

# 10.5.1 Fixtures TUB/SHOWER HAS FAILING CAULKING/GROUT

Areas of the caulking/grout in the tub/shower appeared to be failing and is in need of repair. In order to prevent water intrusion, I recommend having this evaluated and repaired as necessary by a qualified contractor prior to closing.

#### Recommendation Contact a qualified professional.

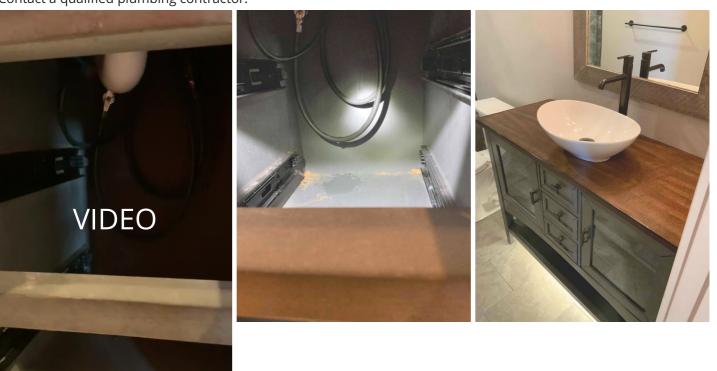
NORTHEAST BASEMENT BATHROOM

# 10.5.2 Fixtures SINK - ACTIVE LEAK

Active leaks were observed under one or more sinks. I recommend having the leak evaluated and repaired as necessary by a qualified plumbing contractor prior to closing.

#### Recommendation Contact a qualified plumbing contractor.

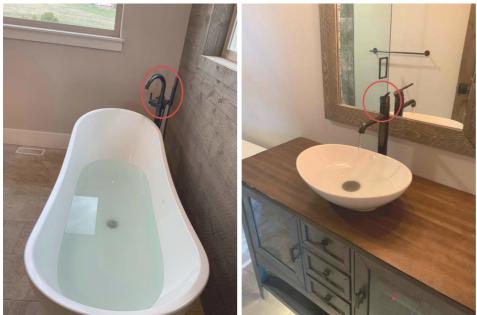
MASTER BATHROOM TUB, SOUTHWEST BASEMENT BATHROOM

#### 10.5.3 Fixtures FAUCET - HOT & COLD ARE BACKWARDS

One or more faucets appeared to have the hot and cold water supply installed backwards. In order to prevent any injuries from accidental scalding, I recommend having the faucet evaluated and corrected as necessary by a qualified plumbing contractor prior to closing.

Contact a qualified plumbing contractor.

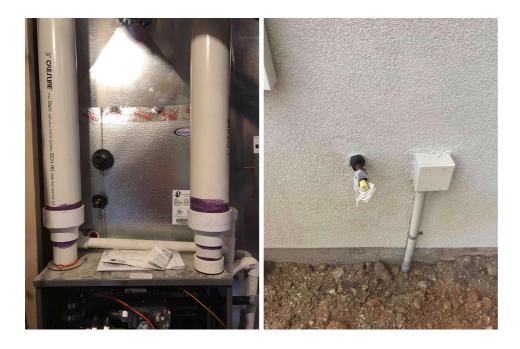
#### 11.1.2 Air Conditioning AIR CONDITIONING - INSTALLATION NOT YET COMPLETE

The installation of the AC was not yet complete, therefore it was not inspected/tested during the inspection.

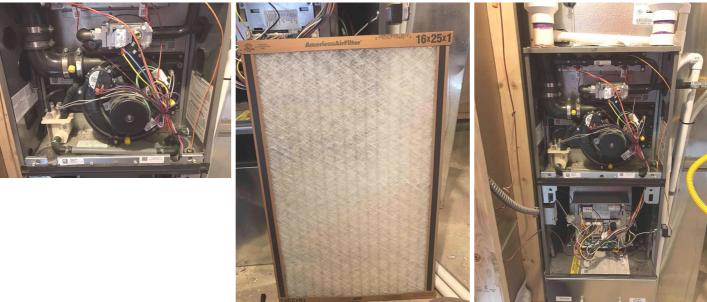
### 12.1.1 Forced Air Furnace **FURNACE - CLEAN AND SERVICE**

The furnace appeared to be in good overall condition, however I recommend having it cleaned and serviced prior to closing by a licensed HVAC contractor, followed by annually.

Recommendation Contact a qualified HVAC professional.

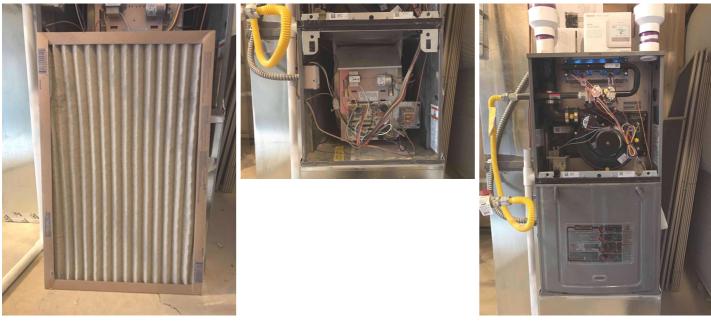
# 12.2.1 Forced Air Furnace on Right FURNACE - CLEAN AND SERVICE

The furnace appeared to be in good overall condition, however I recommend having it cleaned and serviced prior to closing by a licensed HVAC contractor, followed by annually.

Recommendation Contact a qualified HVAC professional.

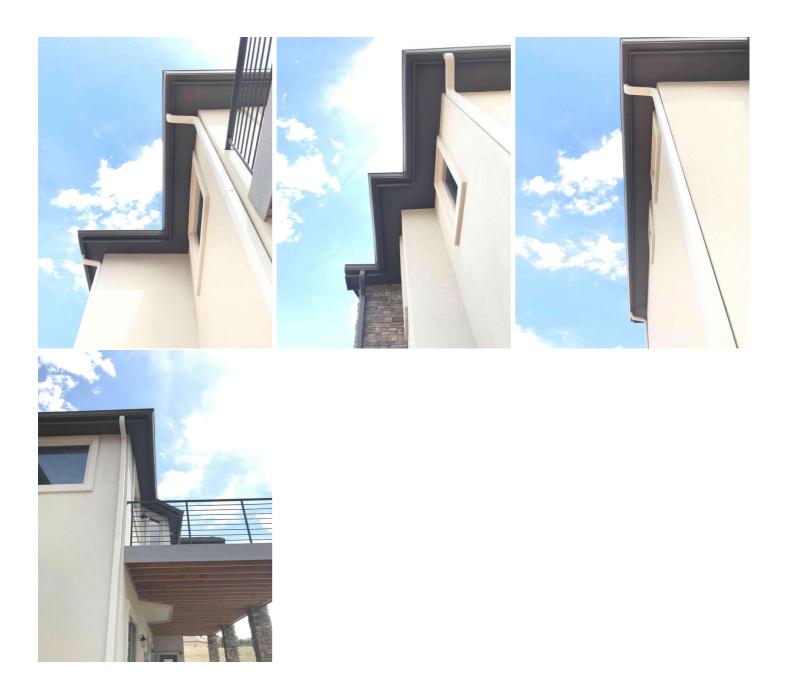
## **ATTIC - INSUFFICIENT VENTILATION**

Attic venting appeared to be insufficient at time of inspection. There are no soffit vents installed, which would allow cross ventilation. I recommend having the ventilation evaluated and added as necessary by a licensed contractor.

Recommendation Contact a qualified professional.
