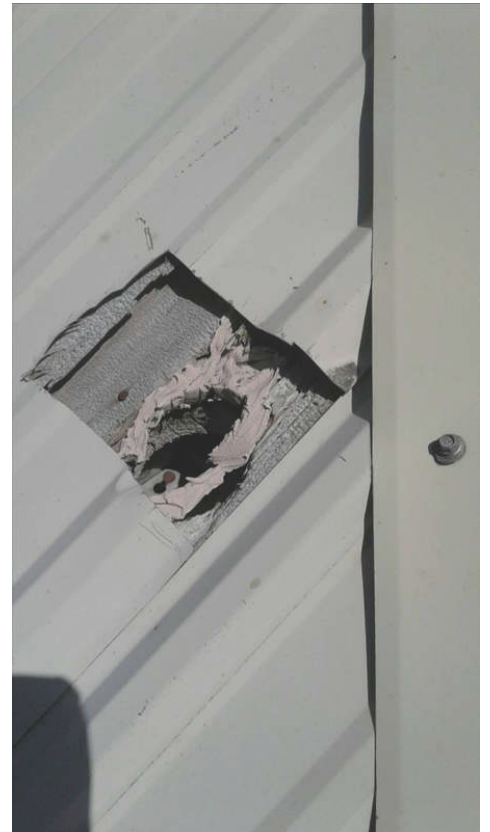
DAMAGED AREA

The roof had an area where a penetration had been removed. This uncovered area will allow moisture penetration into the roof structure. I recommend a qualified roofing professional evaluate and repair.

Recommendation
Contact a qualified roofing professional.

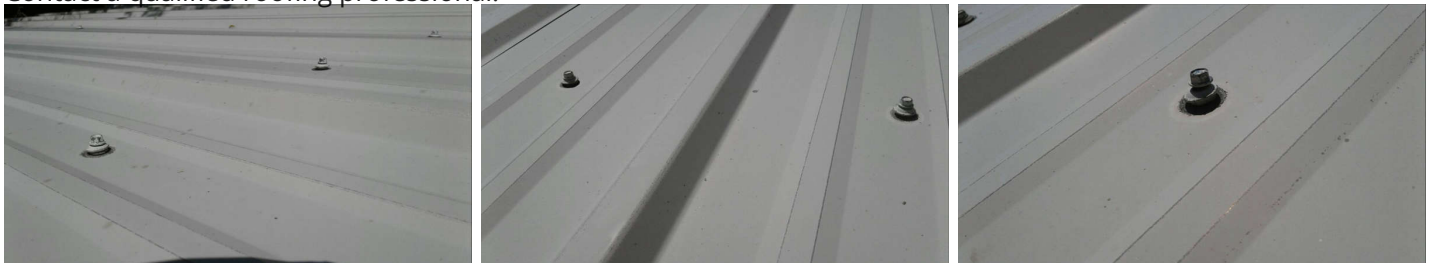
LOOSE FASTENERS

Some of the roof fasteners were loose, which could allow moisture intrusion. I recommend that a competent person tighten or replace the fasteners.

Recommendation
Contact a qualified roofing professional.

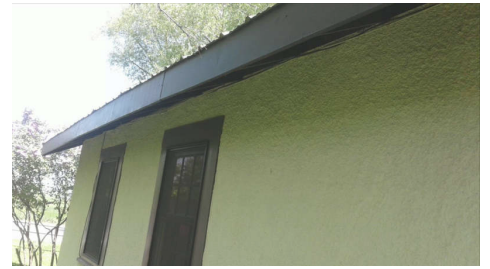
GUTTERS MISSING

There are no gutters present on the structure. Gutters are recommended because they collect rain water from the roof and direct it away from the building. I recommend that a competent person install rain gutters.

Recommendation
Contact a qualified handyman.

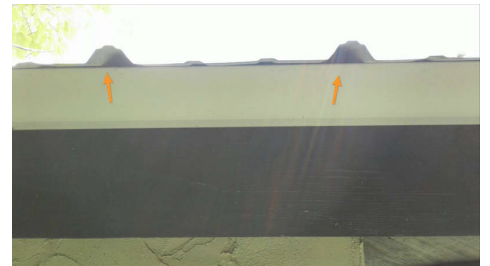
MISSING CLOSURE STRIP

Steel roof sheeting was missing its closure strip. All roof sheeting should have closure to prevent intrusion by moisture and insects. I recommend that a competent person evaluate and remedy.

Recommendation
Contact a qualified professional.

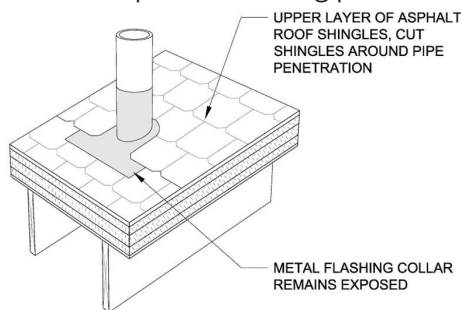
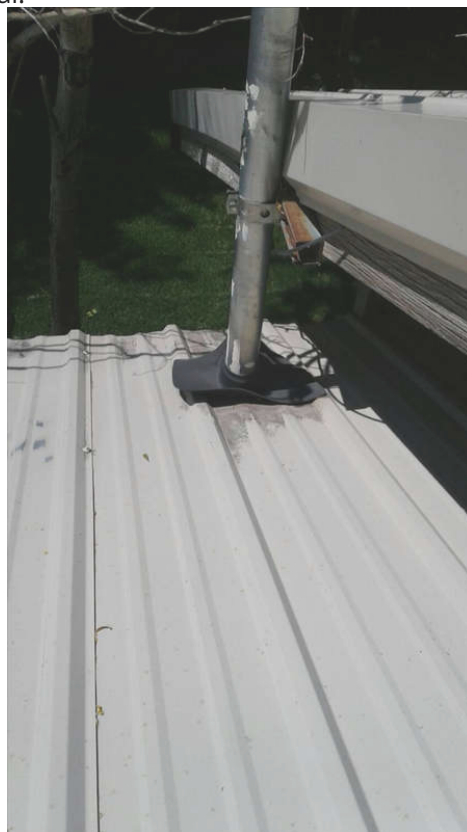
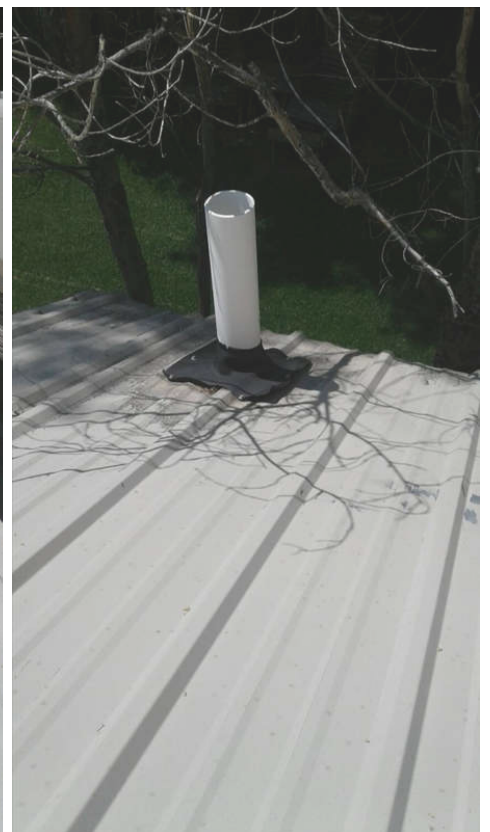
MISSING/POORLY-INSTALLED RUBBER BOOT

One or more roof penetrations were missing a rubber boot. Caulking sealants are considered to be a temporary fix and are not sufficient to seal around roof penetrations. I recommend that a competent roofing professional evaluate and repair.

Recommendation
Contact a qualified roofing professional.

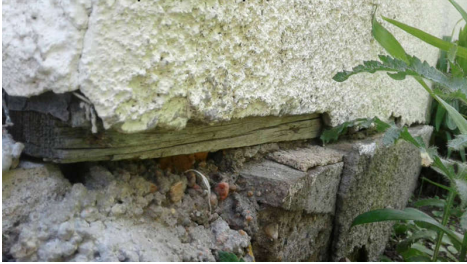
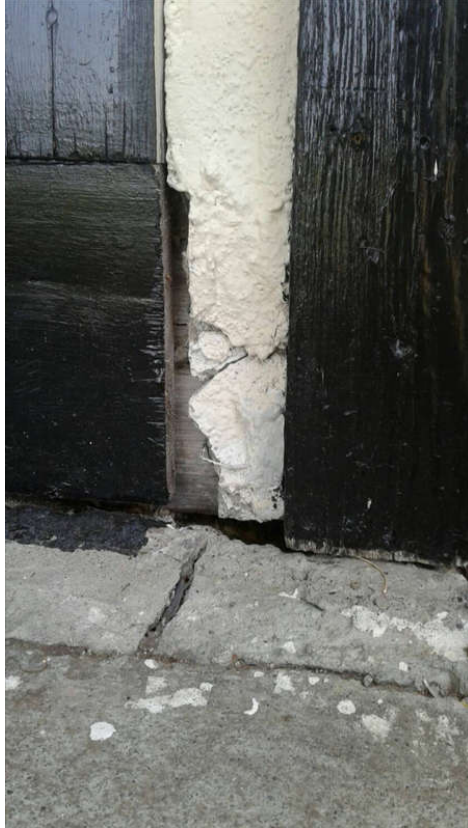
NORTH, NORTHWEST

OPEN PENETRATION

There were one or more open penetrations through the siding. This could allow moisture intrusion. I recommend that a competent person seal these openings.

Contact a qualified professional.

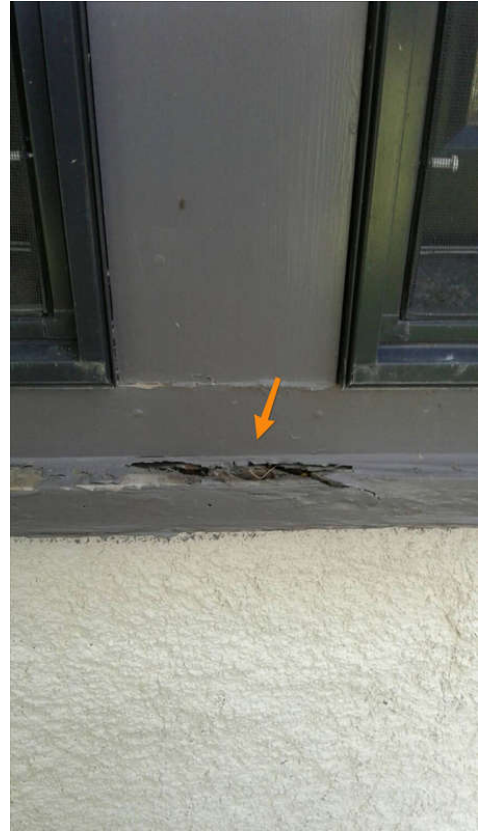
NORTH

ROTTING

Some areas of the siding showed signs of rotting. This can damage the siding and allow moisture to penetrate the structure. I recommend that a competent person evaluate and repair.

Contact a qualified professional.

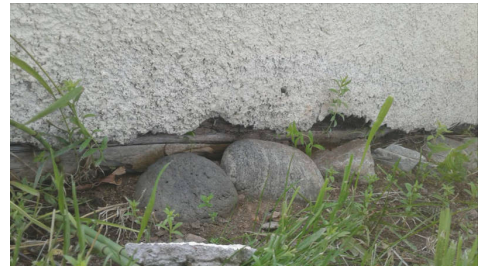
FRAME IN CONTACT WITH GROUND

The frame of the deck was in contact with the ground. This can lead to premature deterioration.

Contact a qualified professional.

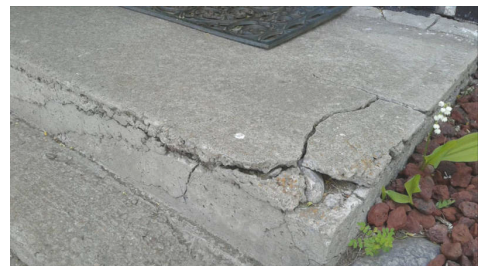
STAIRS - DETERIORATED

One or more sections of the exterior stairs are deteriorated. Recommend qualified concrete contractor evaluate & repair.

Contact a qualified concrete contractor.

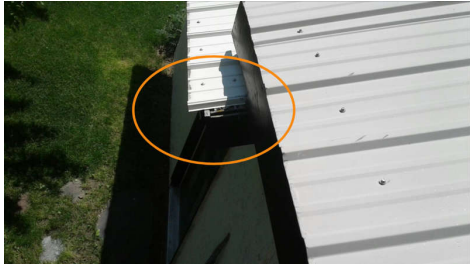
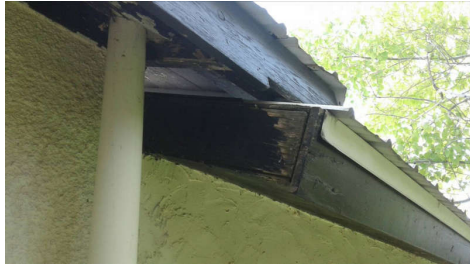
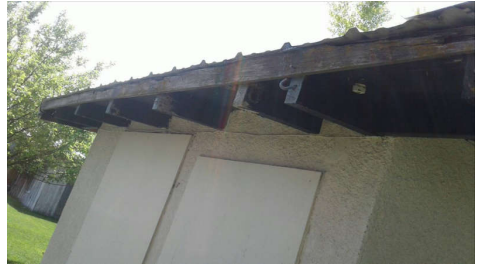
FASCIA - ROTTED

One or more sections of the fascia are rotted. Recommend qualified roofer evaluate & repair.

Contact a qualified roofing professional.

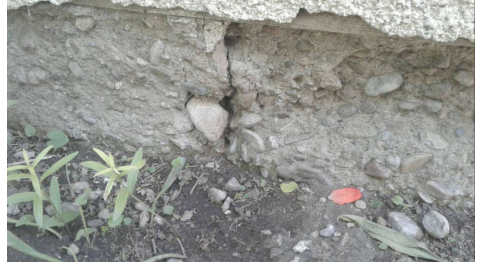
FOUNDATION SPALLING

The foundation walls were observed to have spalling. Spalling is a result of water entering brick, concrete or natural stone and forcing the surface to peel, pop out or flake off. In concrete, spalling happens because there is moisture in the concrete. In basements, especially, moisture and often salt, too, pushes outward from the inside. I recommend further evaluation by a competent foundation contractor.

Contact a qualified professional.

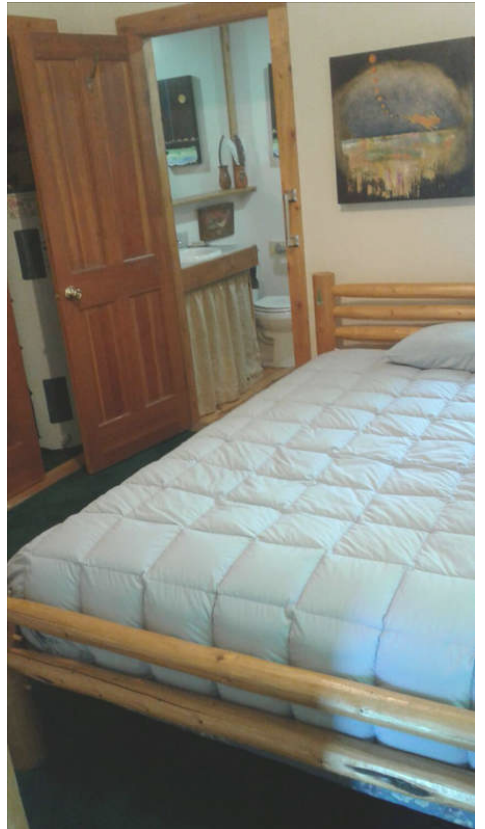
MASTER BEDROOM, MASTER BATHROOM

ROOMS WITHOUT HEAT SOURCE

One or more rooms did not have a permanently installed heat source.

Contact a qualified professional.

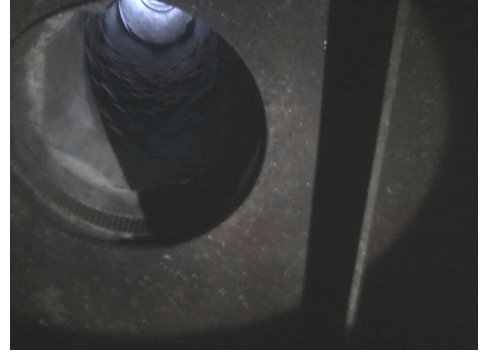
DAMPER MISSING/INOPERABLE

Damper was inoperable, which could allow toxic fumes into the home. Recommend a qualified fireplace contractor evaluate and repair.

Contact a qualified fireplace contractor.

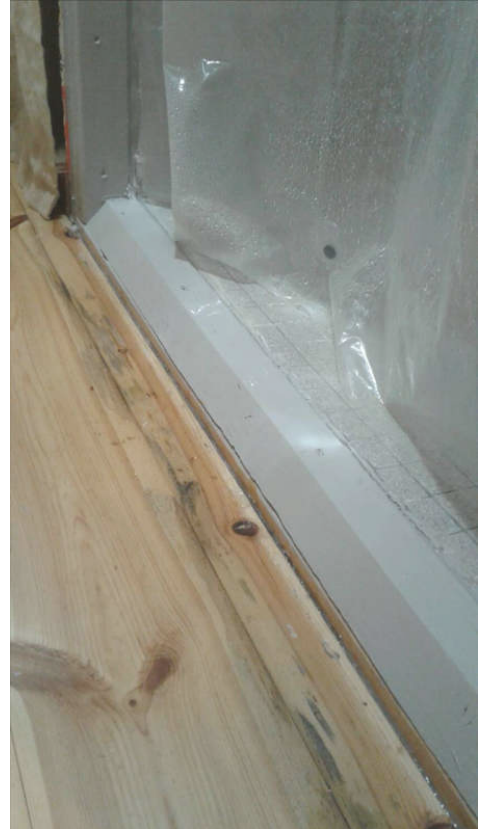
SHOWER STALL- POOR THRESHOLD

The shower was observed to lack a threshold, which may make it difficult to prevent water leakage while the shower is in use.

Contact a qualified professional.

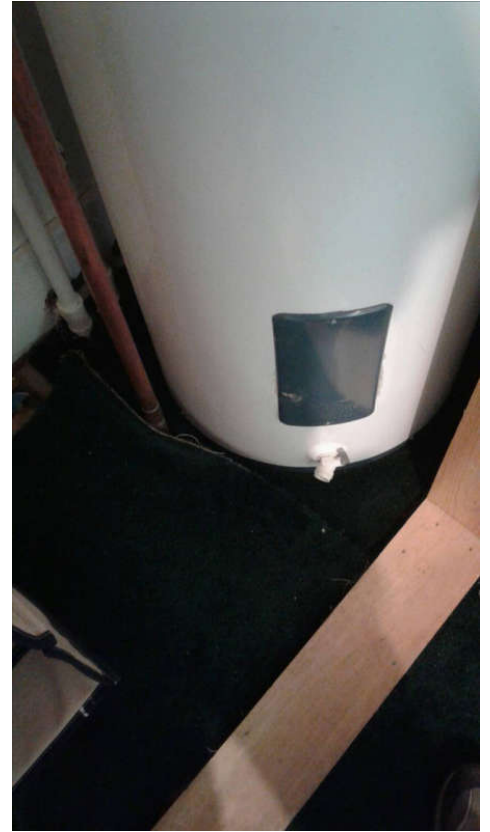
NO DRIP PAN

No drip pan was present. Recommend installation by a qualified plumber.

Contact a qualified plumbing contractor.

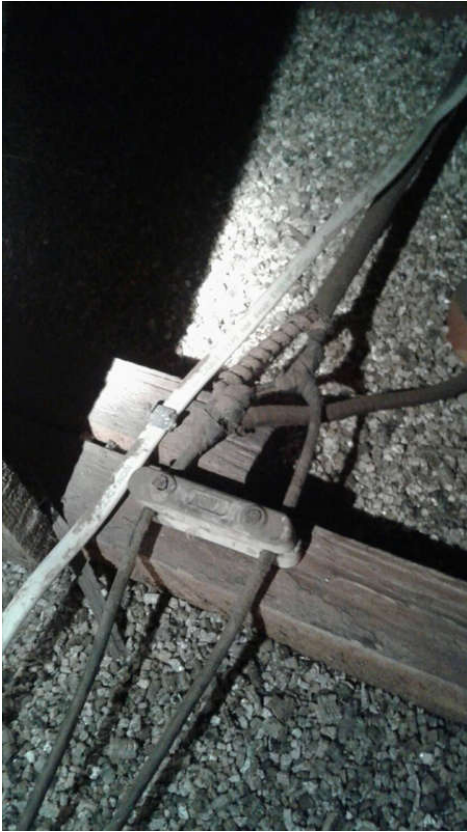
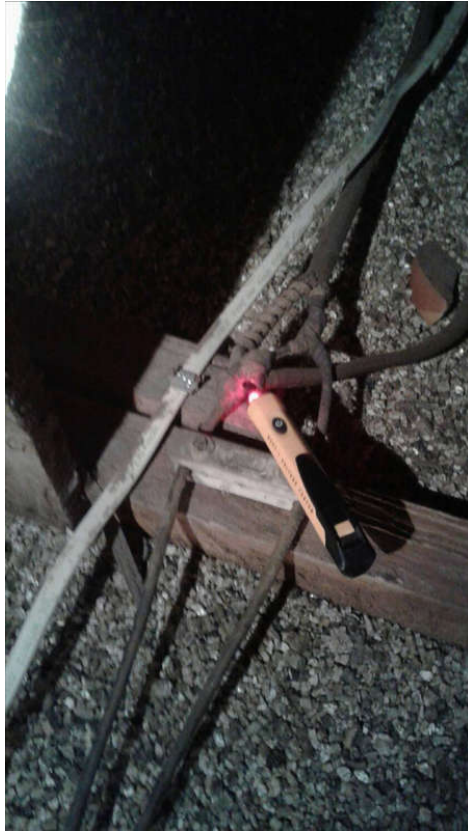
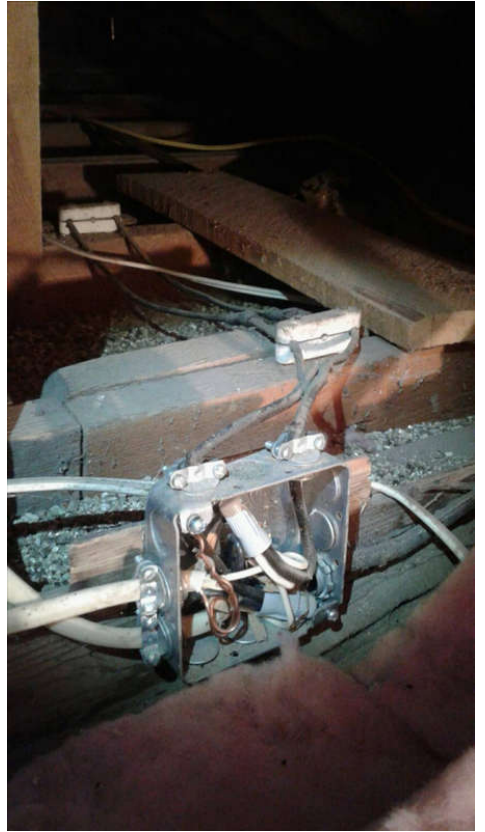
KNOB & TUBE WIRING

Knob-and-tube (K&T) wiring was an early standardized method of electrical wiring in buildings, in common use in North America from about 1880 to the 1940s. The system is considered obsolete and can be a safety hazard, although some of the fear associated with it is undeserved.

- Have the system evaluated by a qualified electrician. Only an expert can confirm that the system was installed and modified correctly.
- Do not run an excessive amount of appliances in the home, as this can cause a fire.

Contact a qualified professional.

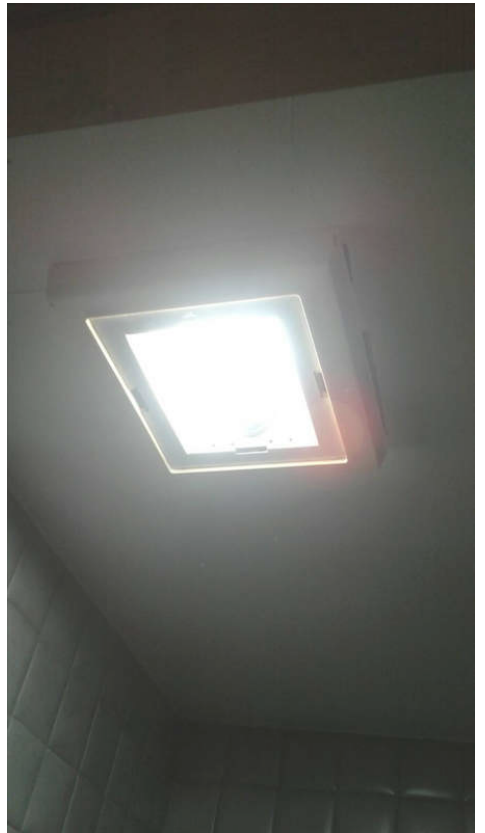
EXHAUST FAN INOPERABLE

The exhaust fan was inoperable. I recommend further evaluation by a professional electrical contractor.

Contact a qualified electrical contractor.

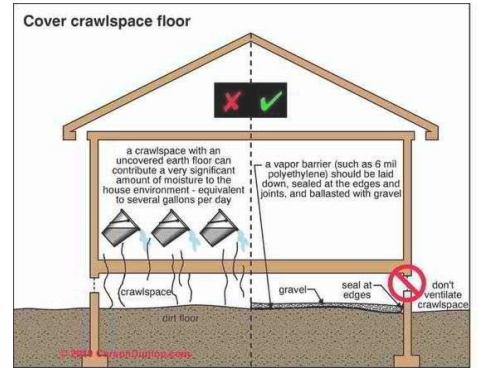
NO VAPOR BARRIER

There were no vapor barriers installed in the attic or crawlspace. Vapor barriers can limit the amount of moisture that enters the house through the ground into the crawlspace or condenses in the attic. I recommend further evaluation by a competent insulation contractor.

Recommendation
Contact a qualified insulation contractor.

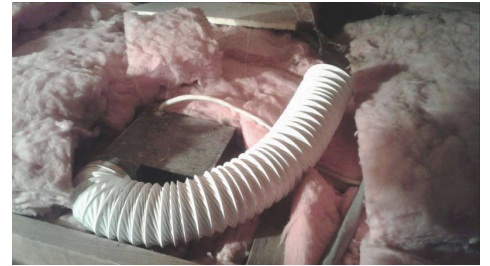
BATHROOM VENTS INTO ATTIC

Bathroom fan vents into the attic, which can cause moisture and mold. Recommend a qualified attic contractor properly install exhaust fan to terminate to the exterior.

Recommendation
Contact a qualified HVAC professional.

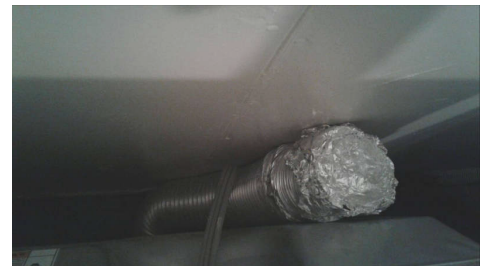
FLEXIBLE VENT

Flexible dryer vent pipe was observed. Modern building standards call for exhaust ducts to be constructed of minimum 0.016-inch-thick (0.4 mm) rigid metal ducts, having smooth interior surfaces, with joints running in the direction of air flow. Flexible duct can allow lint buildup, which is a fire hazard. I recommend that a competent person replace the duct.

Recommendation
Contact a qualified professional.

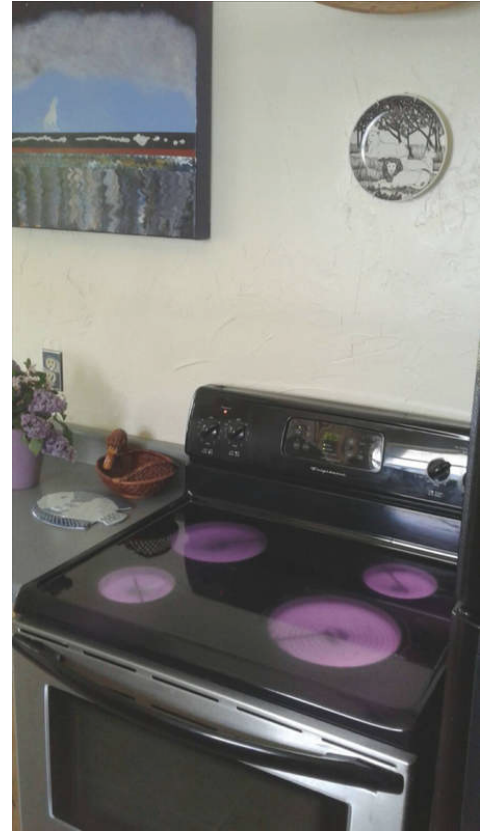
EXHAUST SYSTEM MISSING

No exhaust system present to prevent moisture and grease in kitchen area. Recommend qualified contractor install range hood or exhaust system.

Recommendation
Contact a qualified professional.

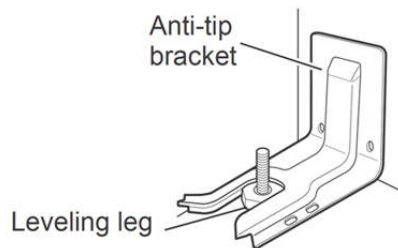
10.2.2 Range/Oven/Cooktop
RANGE NOT FASTENED

Range was not fastened to the floor. This poses a safety hazard to children. Recommend a qualified contractor secure range so it can't tip.

Recommendation
Contact a qualified professional.
