SUMMARY

1234 Main St. Windham NH 03087

Buyer Name
01/18/2019 9:00AM

Jenna Roberts-Weeks, CPI
AHIT & InterNACHI Certified (CPI)
Summit Home Inspection, LLC
6039529101
contact@summit-homeinspection.com

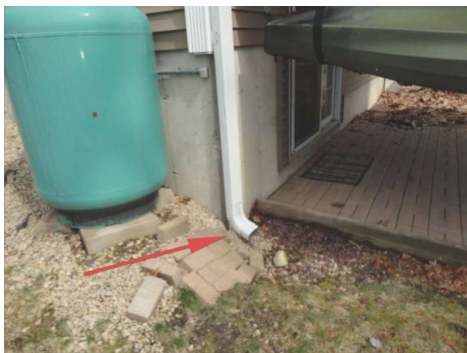
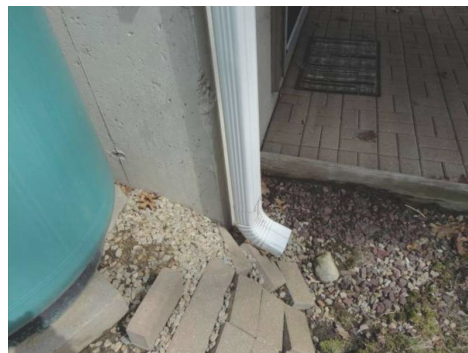
2.2.1 Roof Drainage Systems

DOWNSPOUTS MISSING

SOUTHWEST

Home was missing downspouts in one or more areas. This can result in excessive moisture in the soil at the foundation, which can lead to foundation/structural movement. Recommend a qualified contractor install downspout extensions that drain at least 6 feet from the foundation.

Gutter extension should discharge a minimum of 6' away from foundation to prevent water intrusion. Southwest corner of residence is missing downspout extension. Noticeable erosion under gas tank and patio pavers.

Contact a qualified gutter contractor

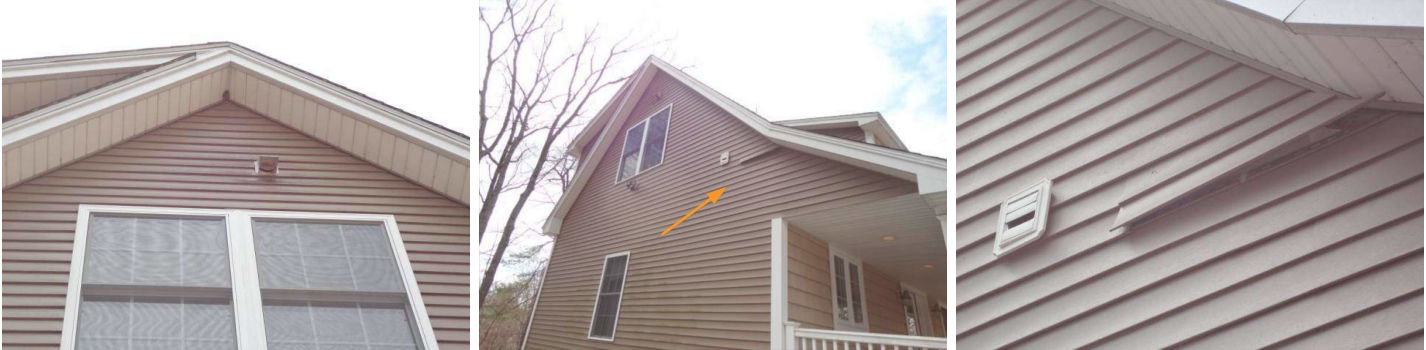
3.1.1 Siding, Flashing & Trim

LOOSE BOARDS

NORTH

One or more siding boards were loose, which could result in moisture intrusion. Recommend a qualified siding contractor secure and fasten.

Contact a qualified siding specialist.

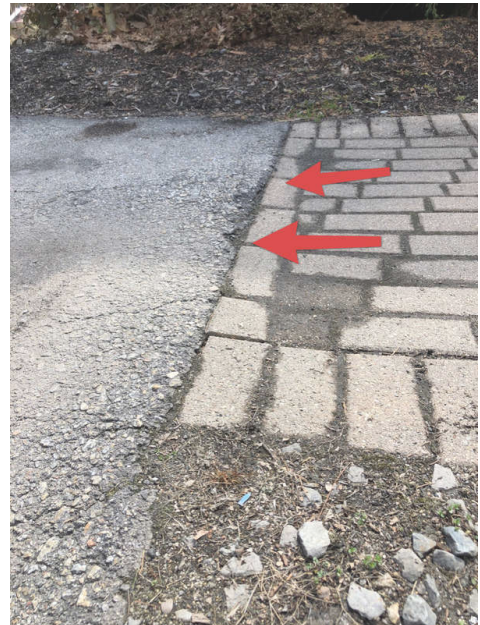
3.3.1 Walkways, Patios & Driveways

DRIVEWAY TRIP HAZARD

Trip hazards observed on front walkway and driveway. Patch or repair recommended.

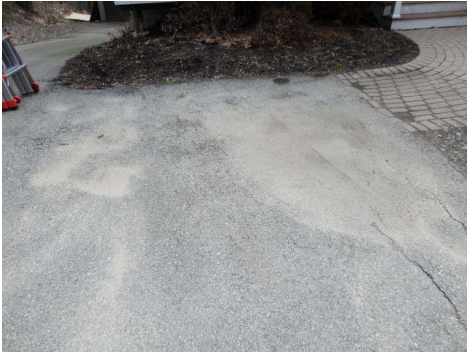
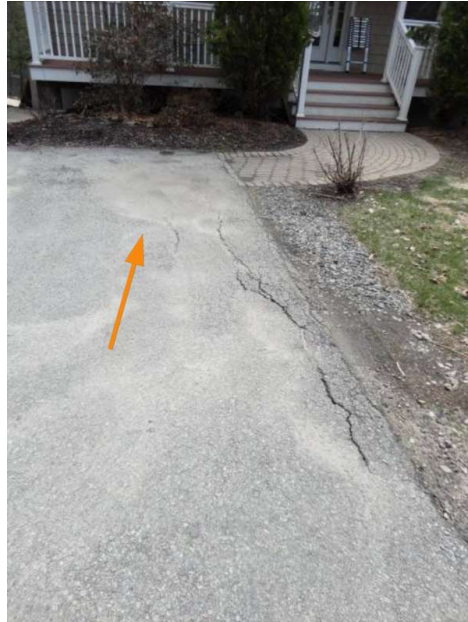
3.3.2 Walkways, Patios & Driveways

DRIVEWAY - UNEVEN (ICE HAZARD)

NORTHWEST

One or more uneven portions observed in the driveway and walkway. This may hold water and freeze during the winter months resulting in slip/fall hazards. Recommend repairing or replacing to create an even surface.

Uneven pavement may cause a safety issue during winter months (ice hazard).

Contact a qualified driveway contractor.

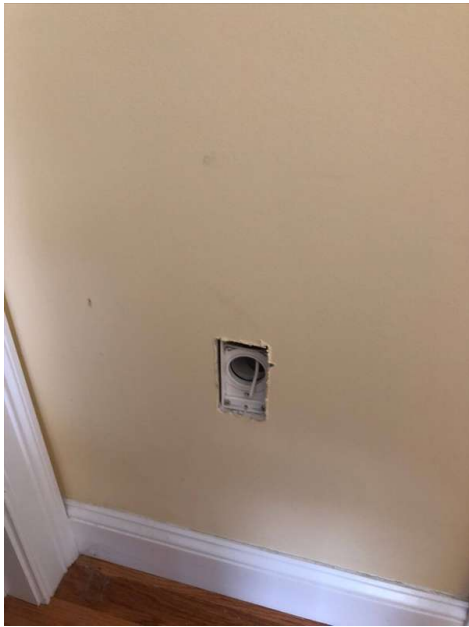
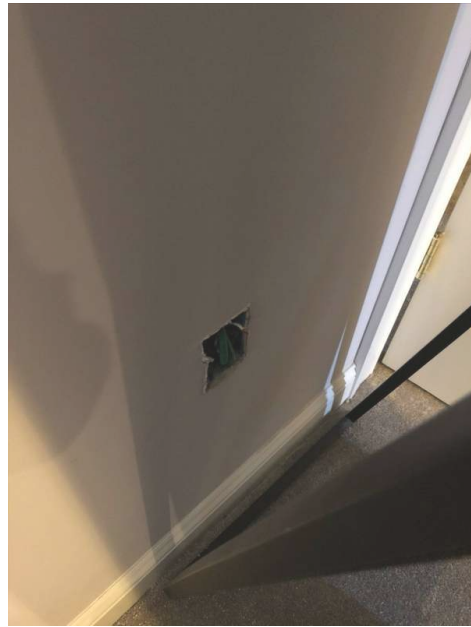
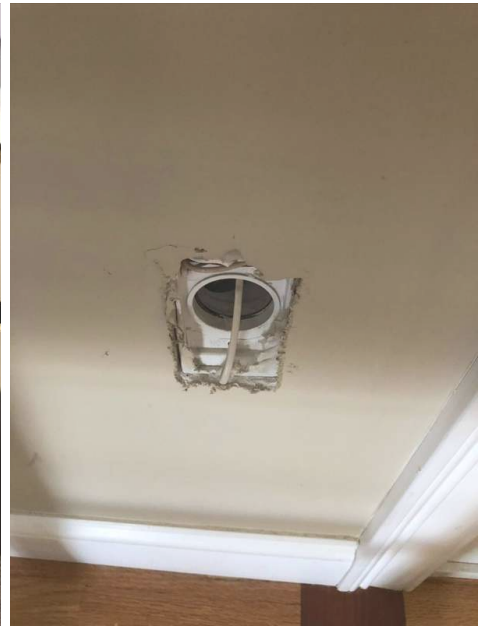
7.4.1 Lighting Fixtures, Switches & Receptacles

COVER PLATES MISSING

1ST FLOOR LIVING ROOM 1ST FLOOR DINING ROOM 2ND FLOOR BEDROOM

One or more receptacles are missing a cover plate. This causes short and shock risk. Recommend installation of plates.

2nd Floor hallway missing cover plate. 2nd Floor bedroom. Missing cover plate.

Main floor entry way. Missing cover plate.

Contact a qualified electrical contractor.

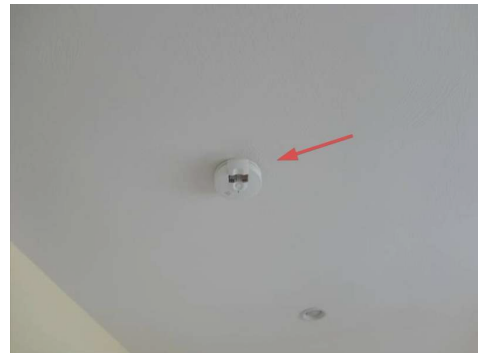
7.6.1 Smoke Alarms

NO BATTERY (HARDWIRED)

Smoke alarm was missing battery for back-up system. Recommend replacing battery in all units upon taking ownership of the residence.

Smoke alarm in 2nd floor north bedroom missing battery.

Contact a handyman or DIY project

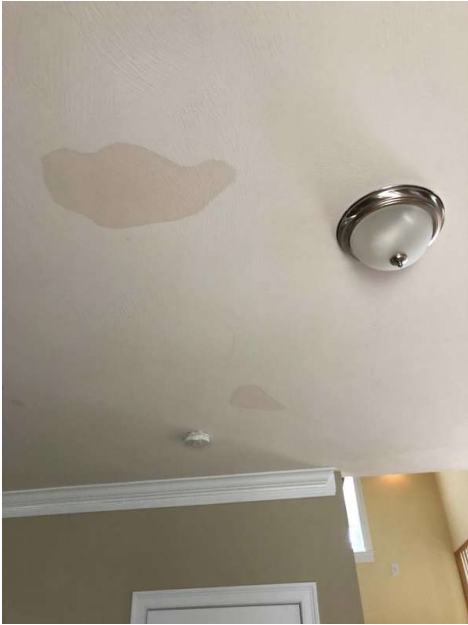
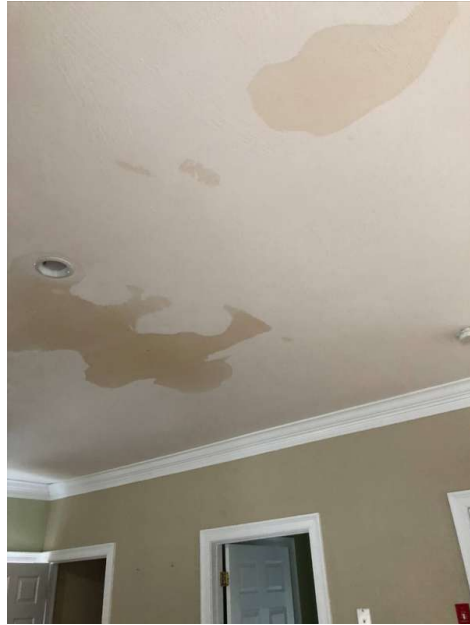
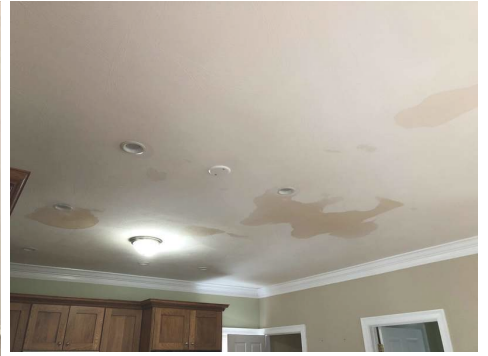
12.5.1 Ceilings

STAIN(S) ON CEILING

There is a stain on ceiling/wall that requires repair and paint. Source of staining should be determined.

Moisture stains in kitchen ceiling tested negative for moisture at time of inspection.

Contact a qualified drywall contractor.

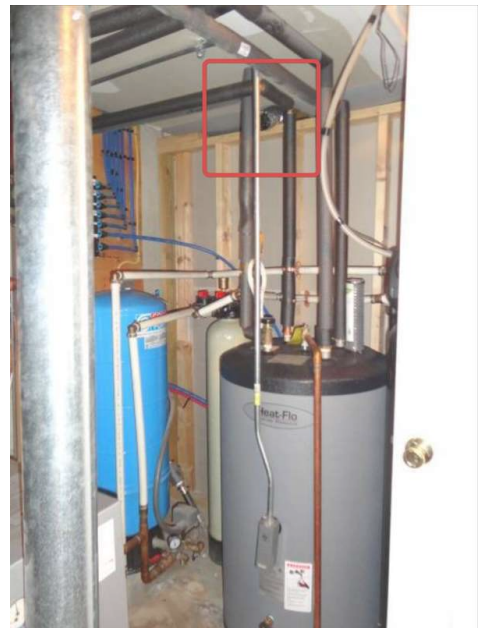
13.2.1 Exhaust Systems

BATHROOM DOES NOT VENT OUTSIDE

BASEMENT BATHROOM

Bathroom exhaust fan does not vent to outside. Vents in to basement utility room with major house components. Recommend license contractor evaluate and repair/replace as needed.

Basement bathroom exhaust vent

Contact a qualified HVAC professional.
