SAVIOR
INSPECTION SERVICES

SUMMARY
1234 Main St. Melissa TX 75454
Buyer Name
04/19/2019 9:00AM

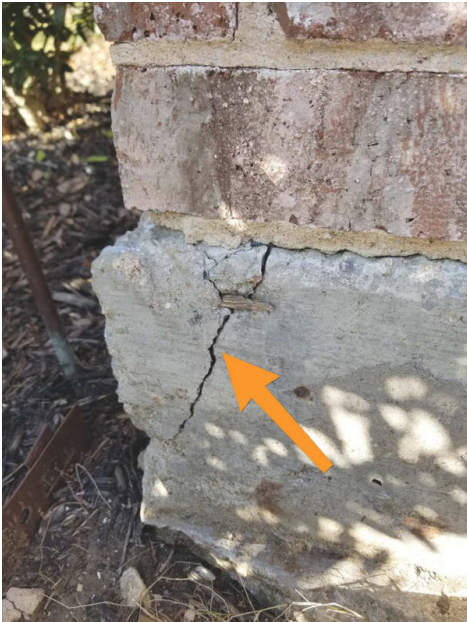
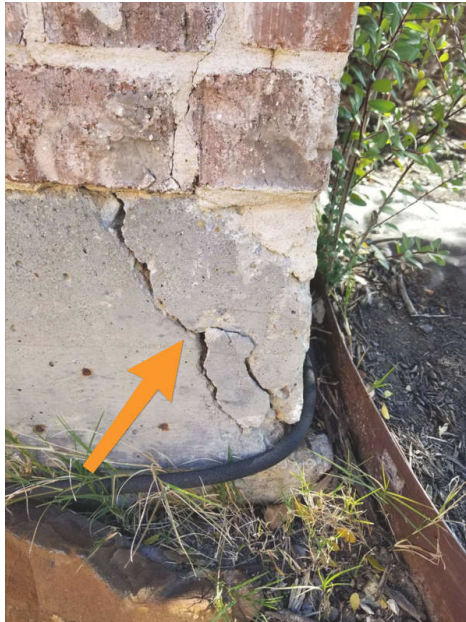
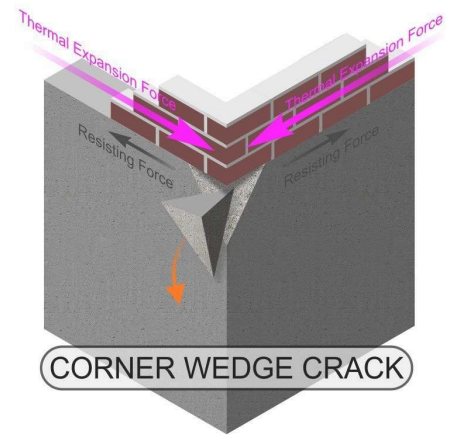
CORNER WEDGE CRACK

One or more corners of the foundation had cracking and/or damage. This is cosmetic in nature, common and does not effect the overall integrity of the foundation. However, the Inspector recommends having corner wedge cracks repaired to prevent damage to the brick siding that rests directly above the corner of the foundation.

Recommendation
Contact a qualified masonry professional.

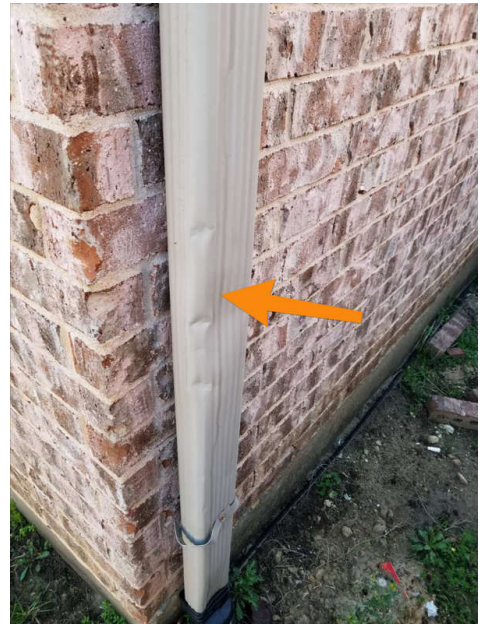
Southwest

DAMAGED GUTTER/DRAIN

General gutter/drain damage noted in one or more locations.
Recommend repair to ensure proper water drainage.

Recommendation
Contact a qualified gutter contractor

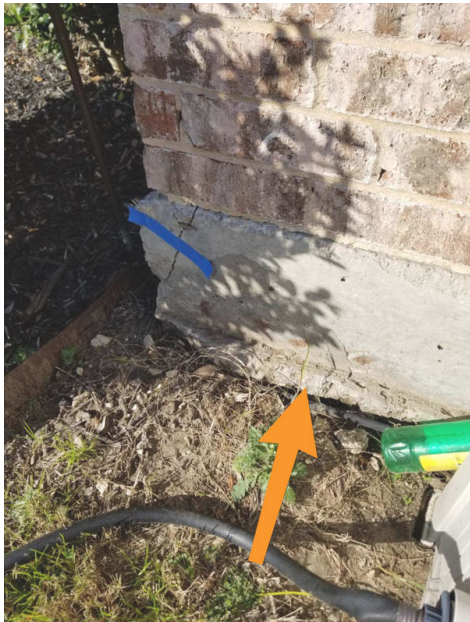
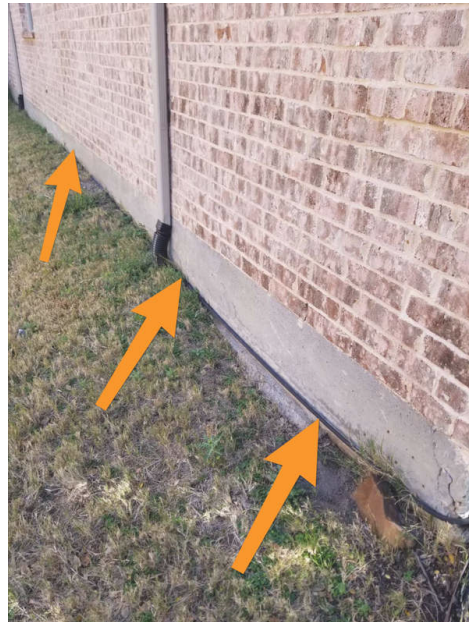
IMPROPER SOIL LEVEL

At the time of inspection, there was an improper amount of soil around one or more areas of the foundation. The Inspector recommends allowing 4-6 inches of foundation to be visible above the grading. Too much soil may allow water intrusion into the structure. Too little soil can result in erosion under the foundation and lead to foundation issues.

Contact a qualified landscaping contractor

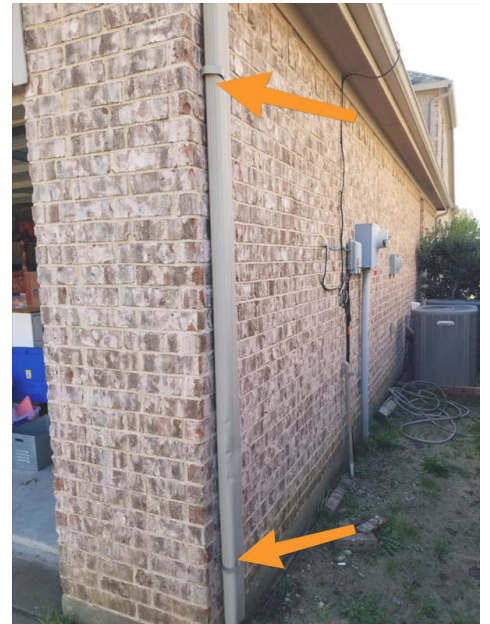
Southwest

LOOSE GUTTERS

The gutters were loose/not properly secured in on or more locations.

Contact a qualified gutter contractor

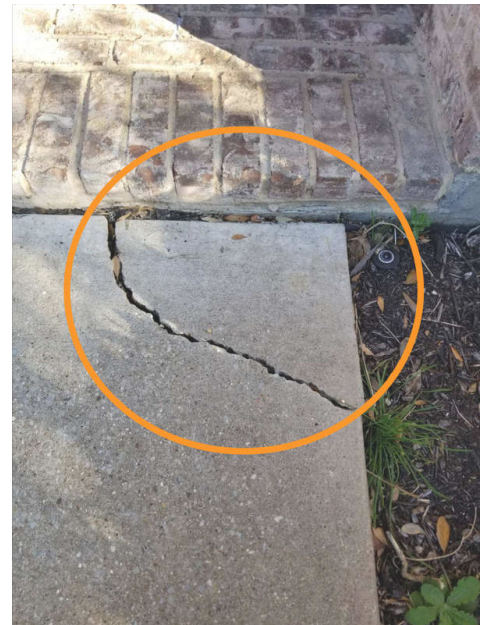
Front Porch

SIDEWALK SETTLING

Sidewalk settling noted near the front porch. This is a trip hazard and should be repaired. It's likely caused by the absence of rebar in this location from when the sidewalk was originally poured.

Contact a qualified professional.

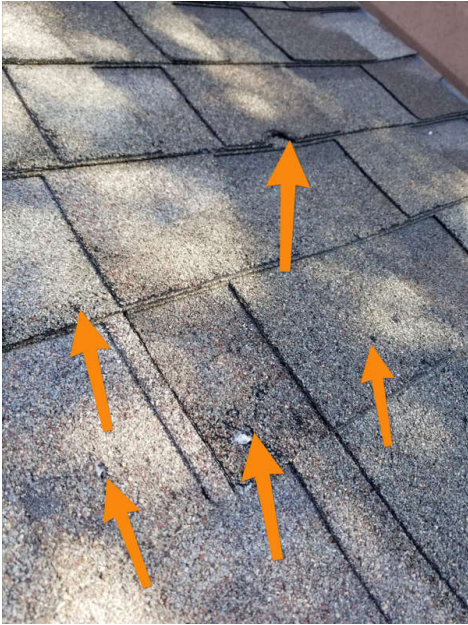
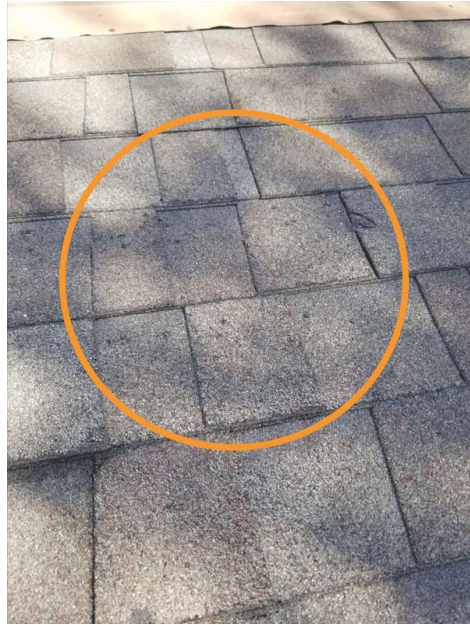
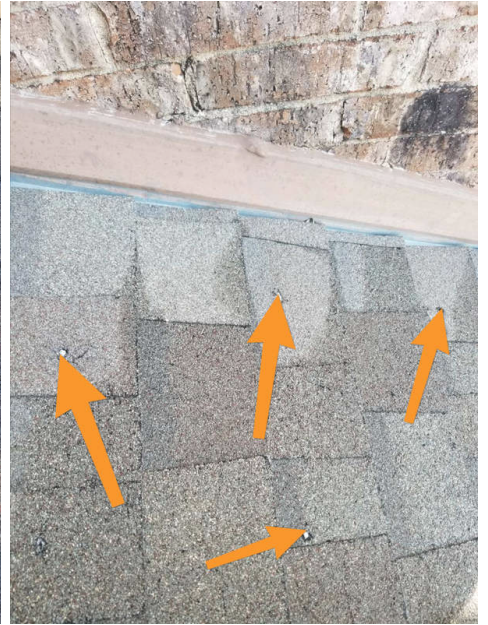
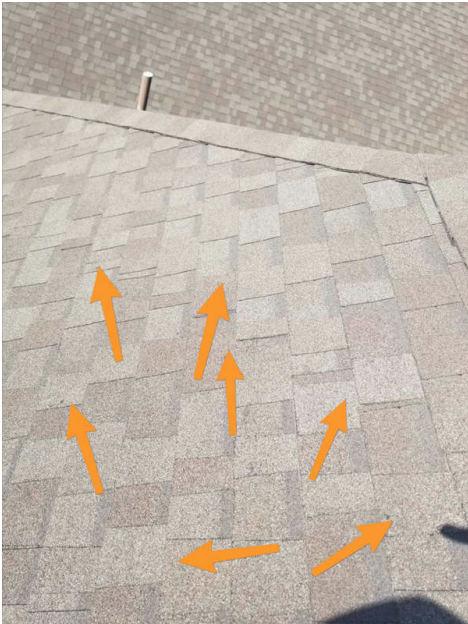
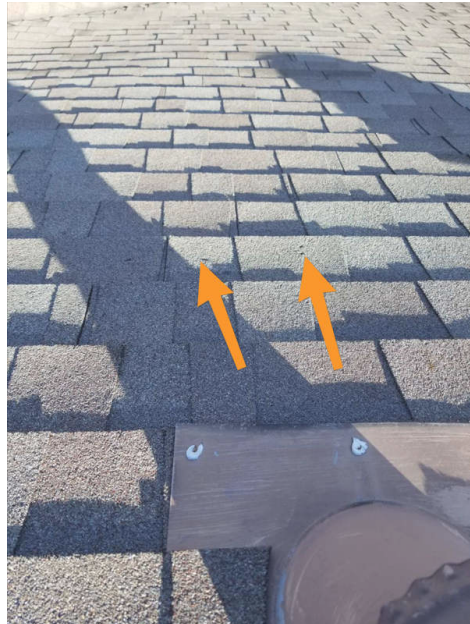
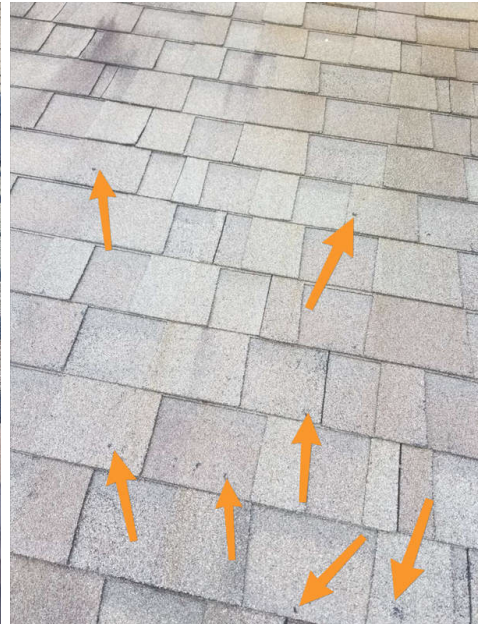
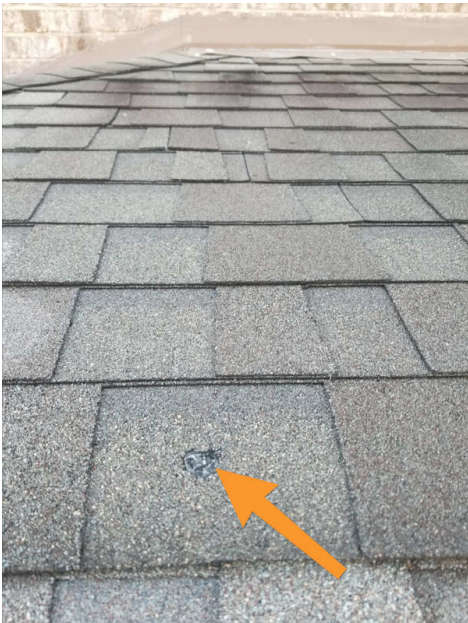
DAMAGED COVERINGS

Roof coverings exhibited general damage that could affect performance. This damage is likely hail damage. Multiple homes in this area were affected by hail within the past year.

Contact a qualified roofing professional.

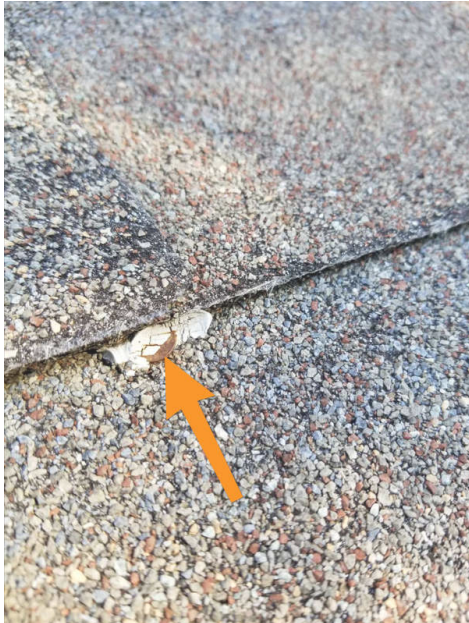
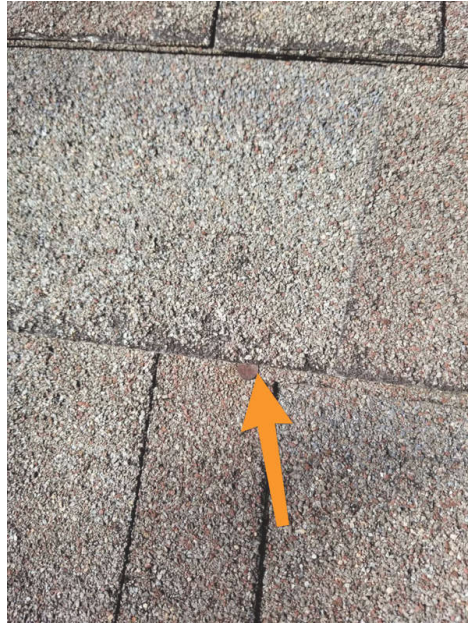
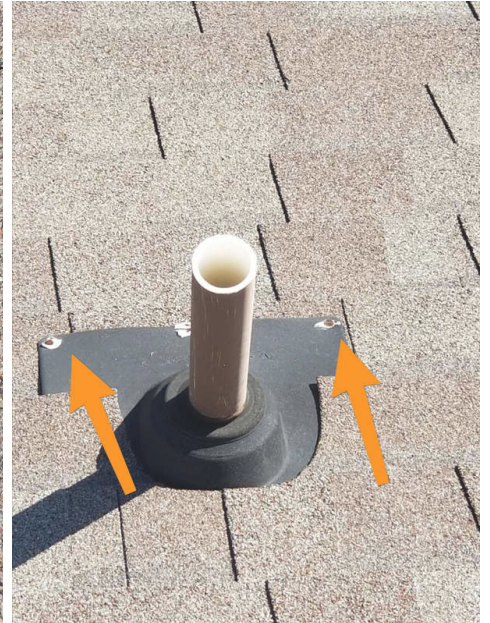
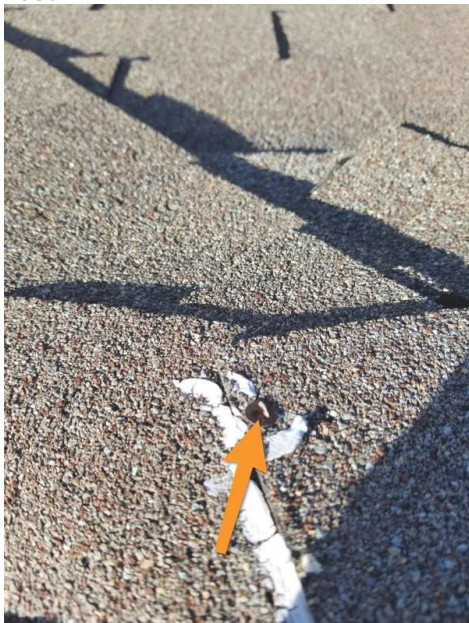
EXPOSED NAILS

Under-driven or exposed nails/screws were found in one or more roof coverings, which may result in water intrusion in these areas.

Contact a qualified roofing professional.

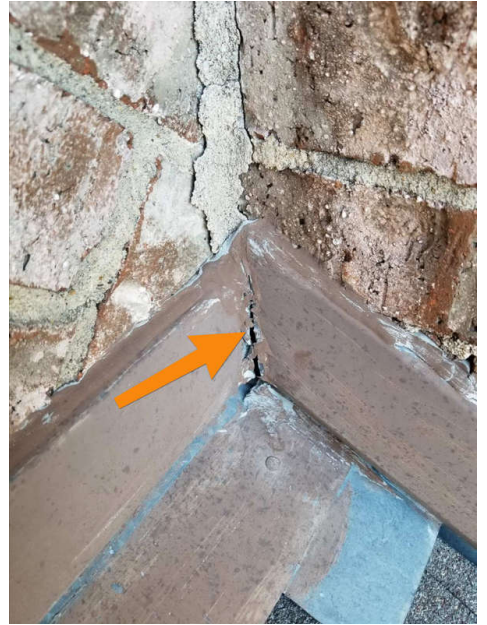
East Roof

FLASHING SEALANT

In several locations, caulking/sealant on flashing is in need of replacement. One example is shown above.

Contact a qualified roofing professional.

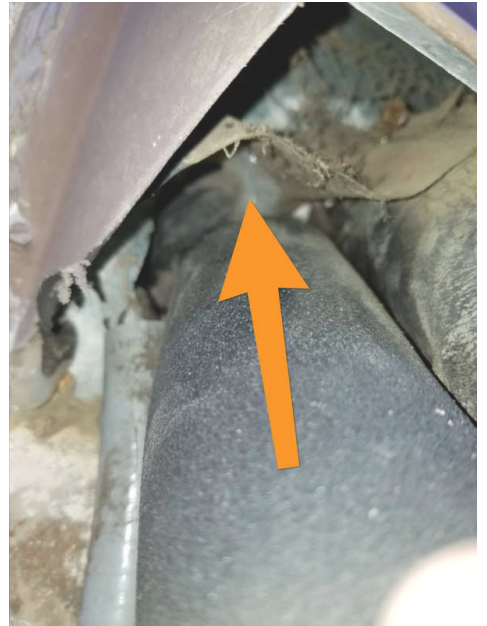
AC Lines South Exterior

EXTERIOR GAPS/HOLES- SEALANT NEEDED

Exterior wall had gaps/holes that should to be sealed with an appropriate sealant to prevent moisture/pest entry.

Contact a qualified handyman.

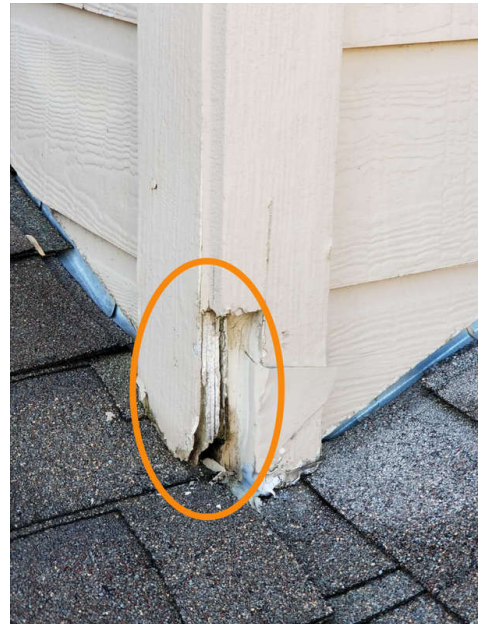
West Roof

ROT IN TRIM BOARDS

In one or more locations, a trim board showed evidence of rot and is in need of repair/replacement. If not repaired, rotting trim/siding boards can spread rot to the structural wood framing behind it.

Contact a qualified carpenter.

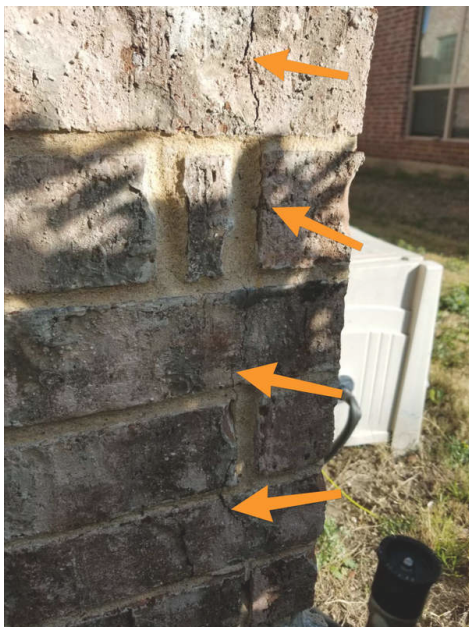
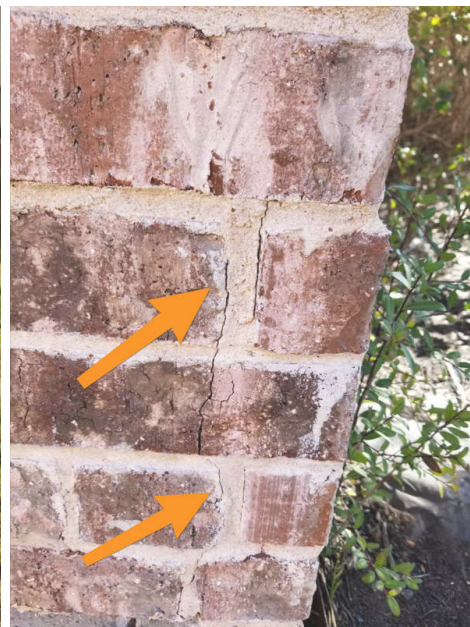
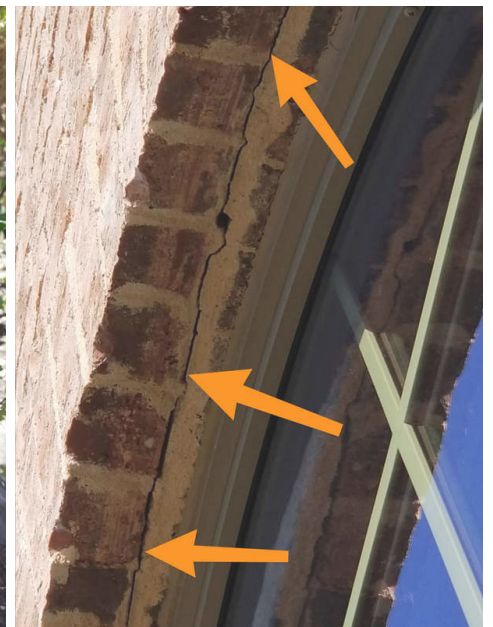
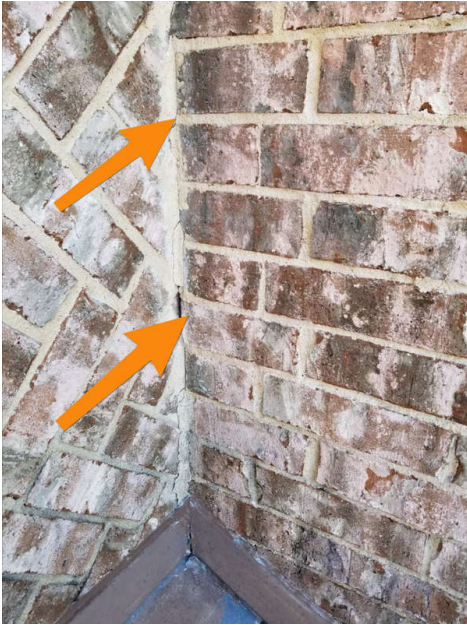
CRACKS IN BRICK/MORTAR-MINOR

At time of inspection, there were one or more minor cracks in the brick and mortar siding. These appear to be mostly cosmetic in nature, however, should be repaired to prevent moisture intrusion and further damage.

Contact a qualified masonry professional.

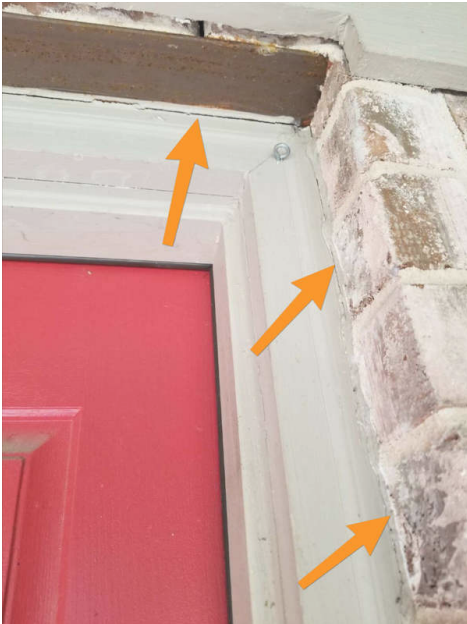
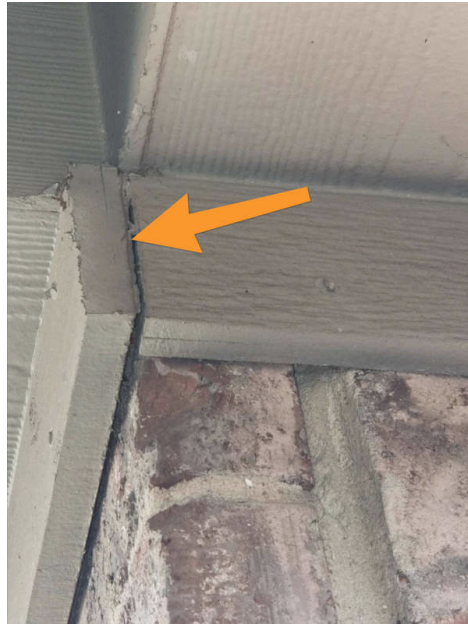
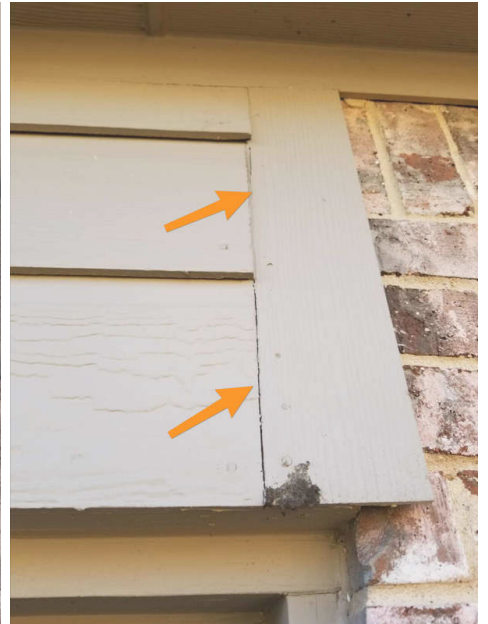
TRIM/MOLDING CAULKING

One or more locations need caulking replaced around trim/molding to prevent moisture intrusion and rot to the trim/molding and/or underlying framing. Some examples are shown above.

Contact a handyman or DIY project

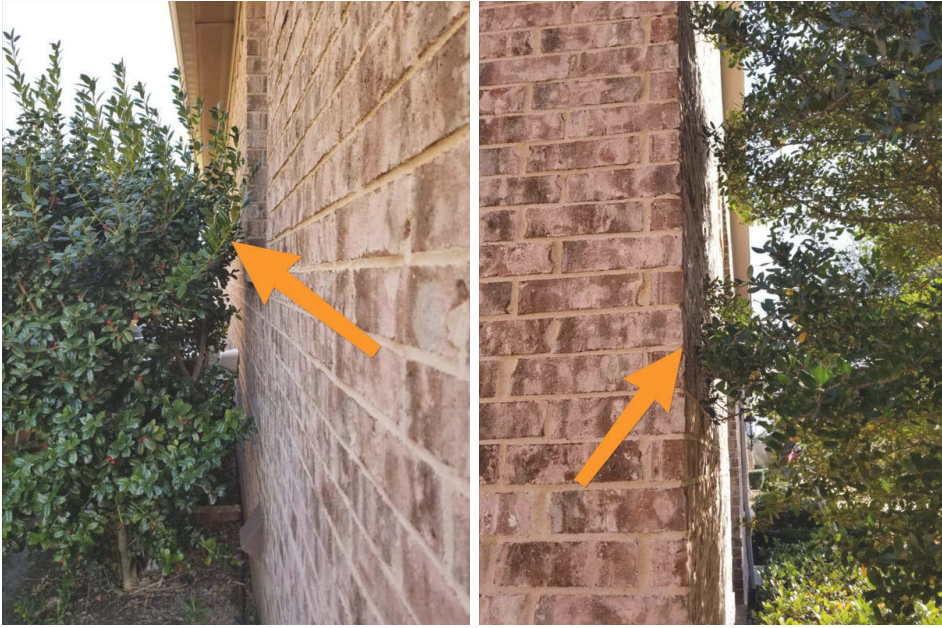
VEGETATION/STRUCTURE CONTACT

Trees/shrubs in contact with exterior structure. Recommend trimming shrubs/trees away from structure to help prevent mechanical, moisture and pest damage to the structure.

Recommendation
Contact a qualified lawn care professional.

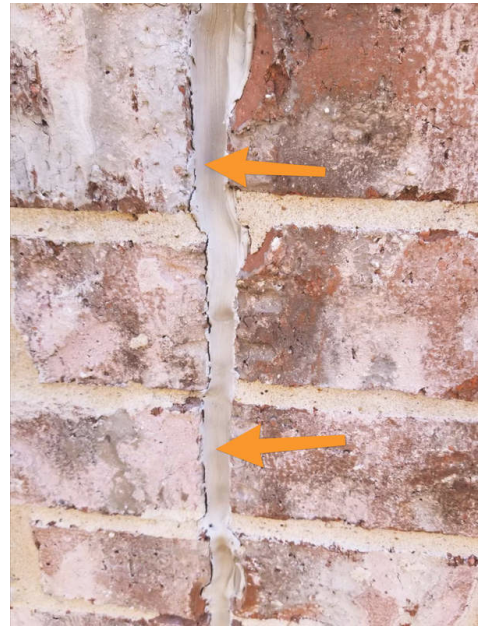
South

2.5.6 E. Walls (Interior and Exterior)
EXPANSION JOINT CAULKING

In all locations, the brick siding expansion joint caulking is deficient and in need of repair/replacement.

Recommendation
Contact a qualified handyman.

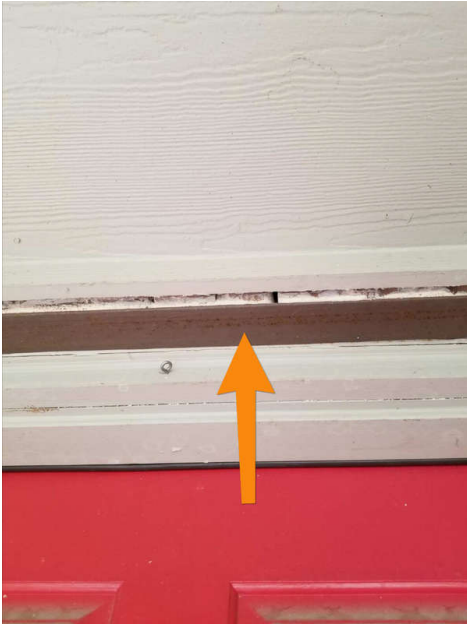
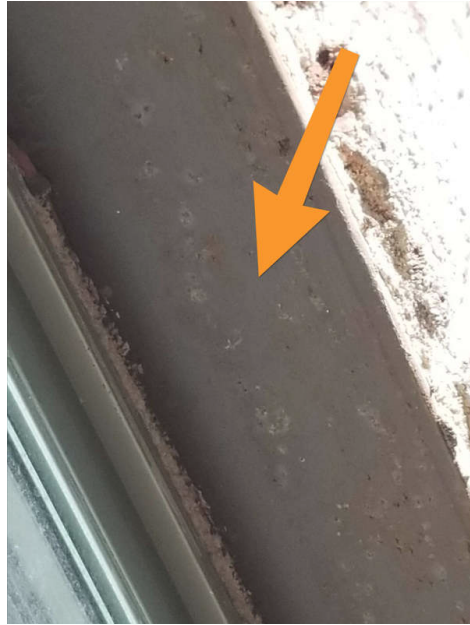
RUSTED LINTEL

One or more lintels are rusting and need to have the rust removed and then painted to prevent future damage. Rusting lintels can cause damage to the surrounding brick/stone. Once corrosion begins, rust is produced, which occupies up to six times the original volume of the steel. The expansion of volume leads to cracking of masonry. A couple of examples are shown above.

Recommendation
Contact a qualified painting contractor.

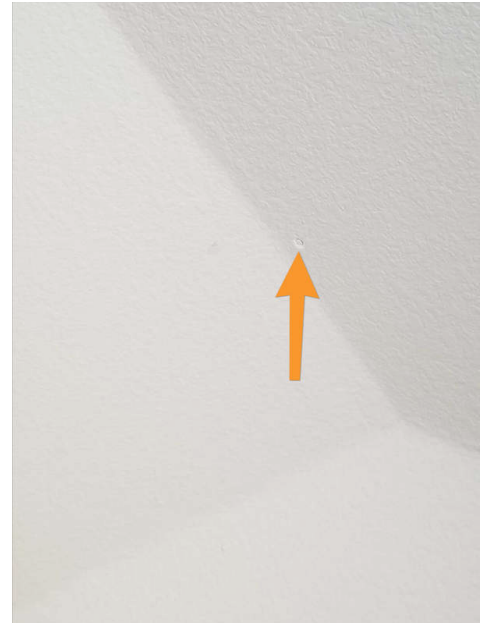
2nd Floor Southwest Bedroom

NAIL POP

One or more nail pops observed throughout the home. Nail pops are common and usually cosmetic in nature. One example is shown above. Here's a helpful DIY article on how to repair them: [Nail Pop Repair](#).

Contact a handyman or DIY project

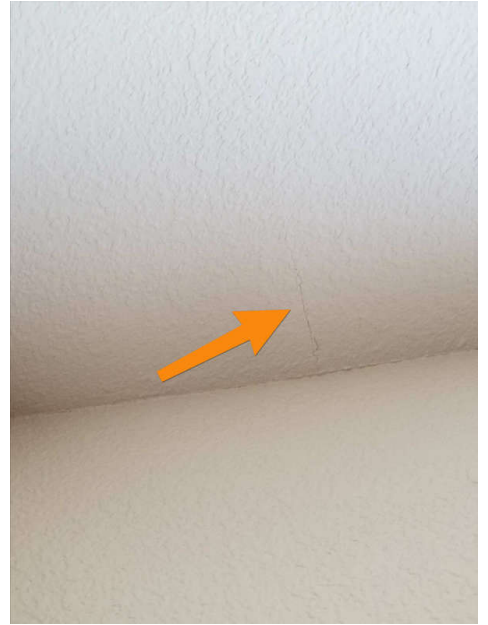
Dining Room

INTERIOR CRACKS - MINOR

Minor cracking was observed in the drywall throughout the home. They're usually caused by normal contracting and expanding wood framing and/or minor settlement. They're cosmetic in nature. An example or two is shown above.

Contact a handyman or DIY project

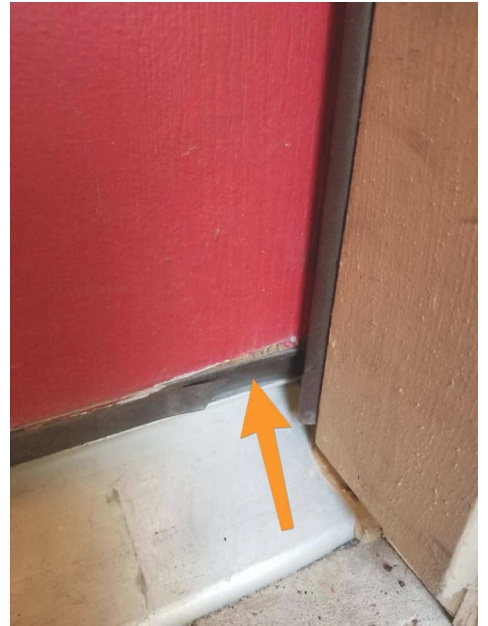
Front Door

WEATHERSTRIPPING/DOOR SWEEP INSUFFICIENT

One or more doors had deficient weatherstripping and/or door sweeps. This can result in energy loss and/or moisture/pest intrusion.

Contact a handyman or DIY project

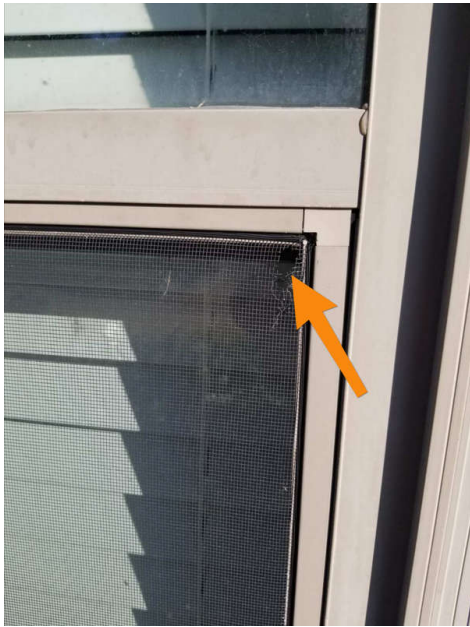
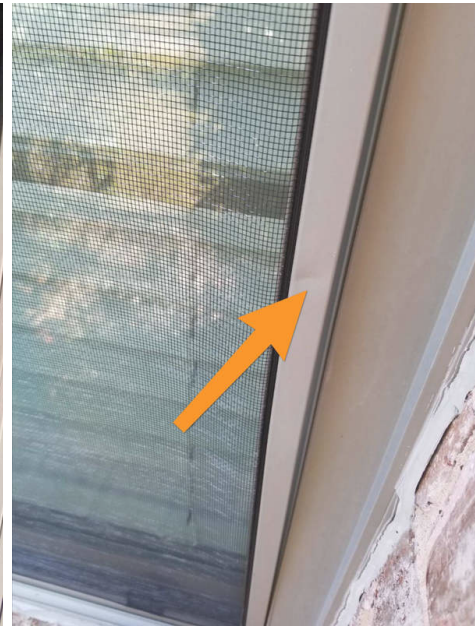
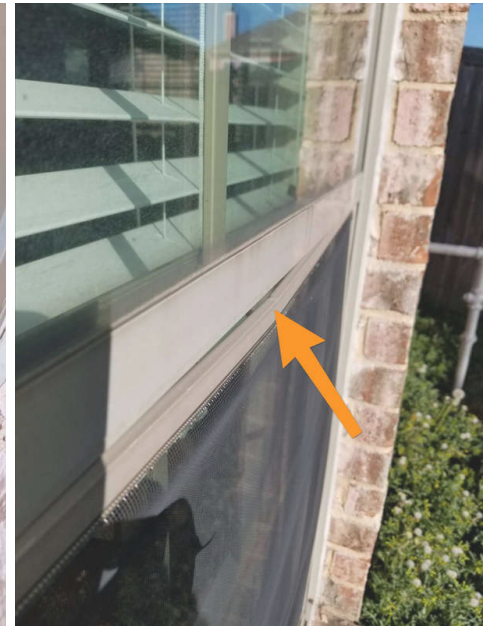
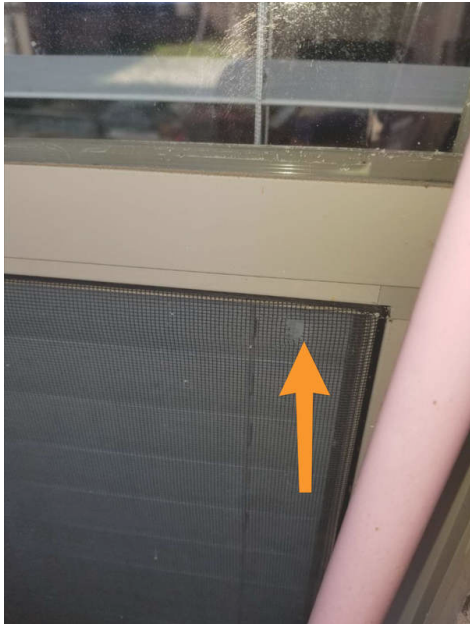
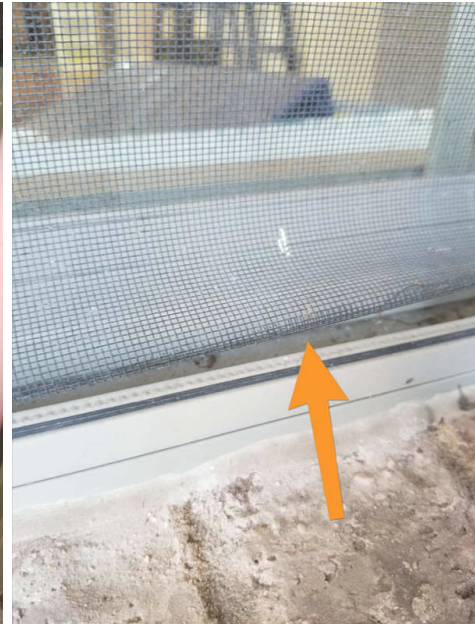
DAMAGED WINDOW SCREEN

One or more window screens were damaged at the time of inspection.

Contact a qualified window repair/installation contractor.

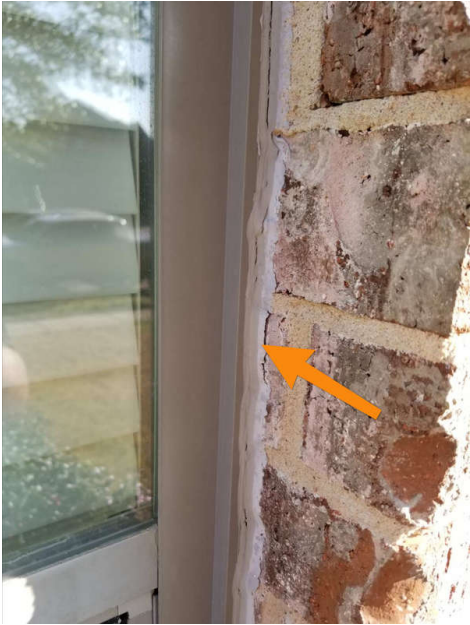
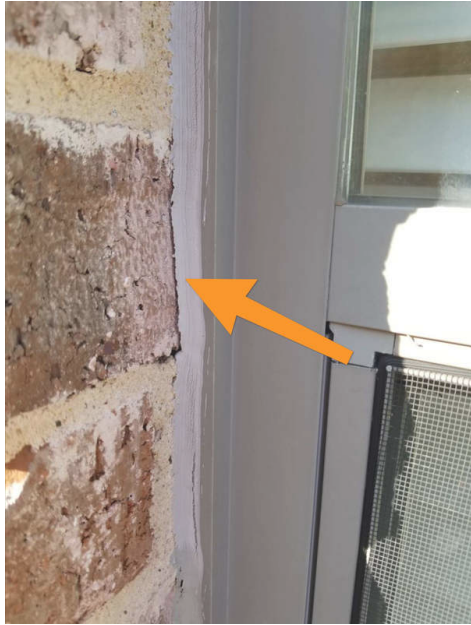
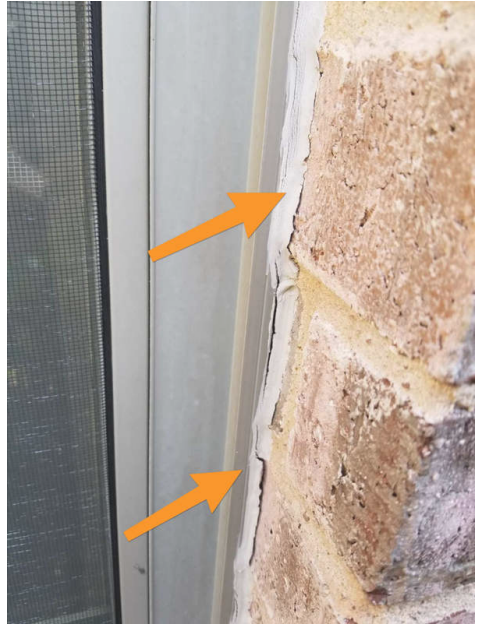
CAULKING

One or more windows need caulking to prevent moisture intrusion. This applies to both the interior and exterior. A couple of examples are shown above. The Inspector recommends checking all windows and caulking them where needed.

Contact a qualified handyman.

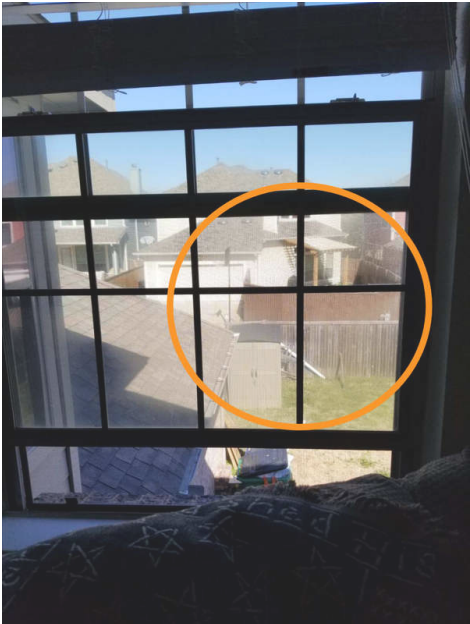
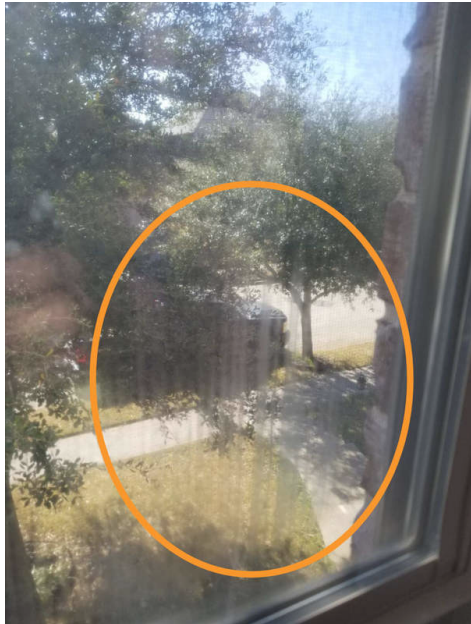
FAILED SEAL

Observed condensation and/or discoloration between the window panes, which indicates a failed seal. Recommend qualified window contractor evaluate & replace.

Contact a qualified window repair/installation contractor.

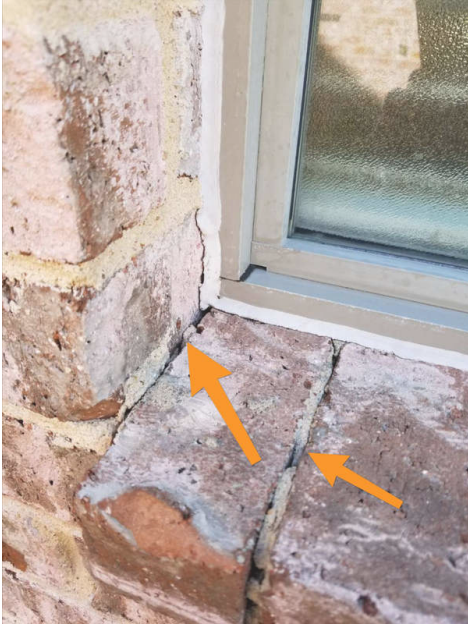
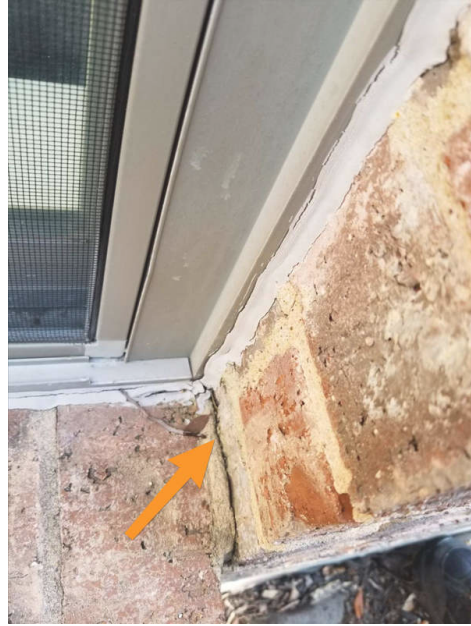
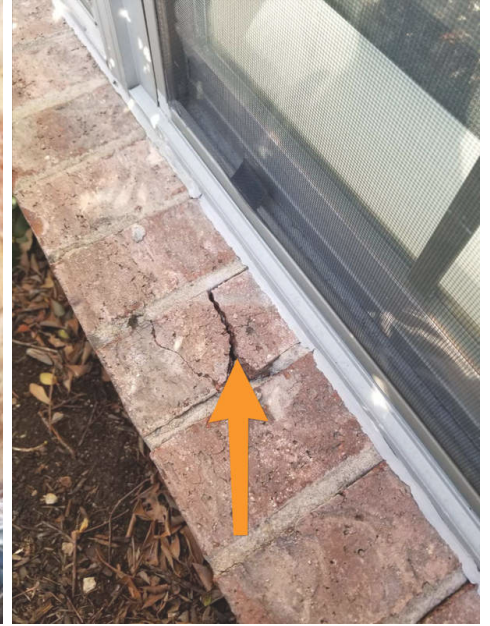
WINDOW SILL MORTAR

One or more brick window sills have cracked bricks and/or mortar. Cracks in brick window sills are very common. If they are not repaired they may result in moisture intrusion which can lead to structural damage.

Recommendation
Contact a qualified masonry professional.

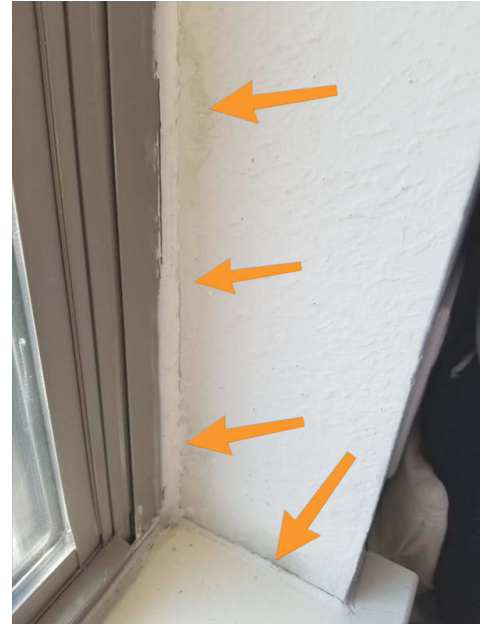
2nd Floor Northeast Bedroom

MOISTURE INTRUSION

At the time of inspection, there was evidence of moisture intrusion around one or more windows. If not corrected, moisture intrusion can lead to mold growth and extensive repairs in sheet rock and window frames.

Recommendation
Contact a qualified window repair/installation contractor.

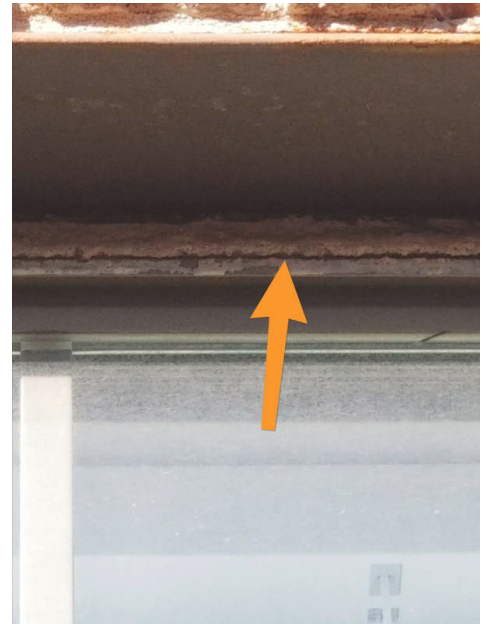
North

CRACKED MORTAR

Mortar is cracked on top of multiple windows. This is very common in homes this age. These cracks should be repaired to prevent moisture intrusion and further damage. One example is shown above.

Recommendation
Contact a qualified professional.

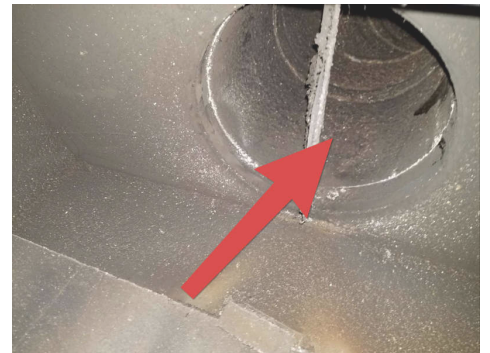
Fireplace

CREOSOTE BUILDUP

The chimney had a layer of creosote, so underlying structure couldn't be inspected for cracks. A buildup of creosote is a fire hazard. The chimney should be cleaned prior to using the fireplace.

Recommendation
Contact a qualified chimney sweep.

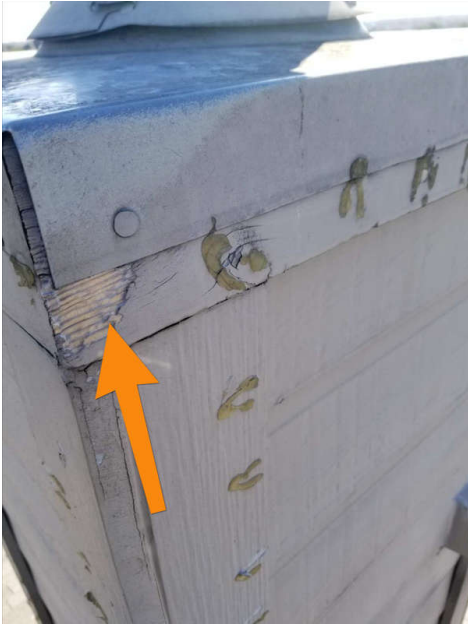
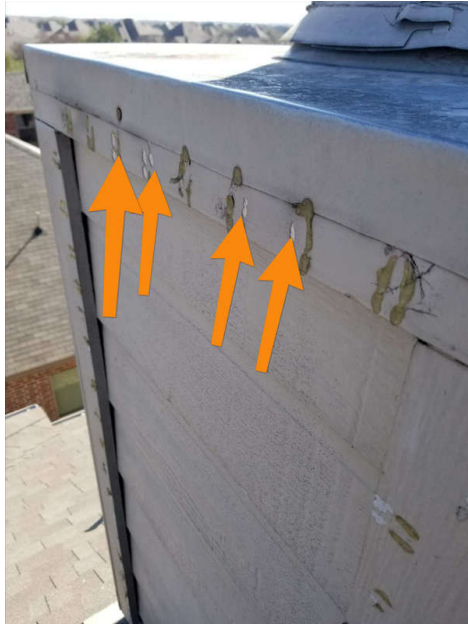
CHIMNEY DAMAGE

General deterioration noted on chimney in several locations. Some of this may be from hail and some from normal wear. Noted further in the report, there were indications of leaks in the attic coming from around the chimney.

Recommendation
Contact a qualified chimney contractor.

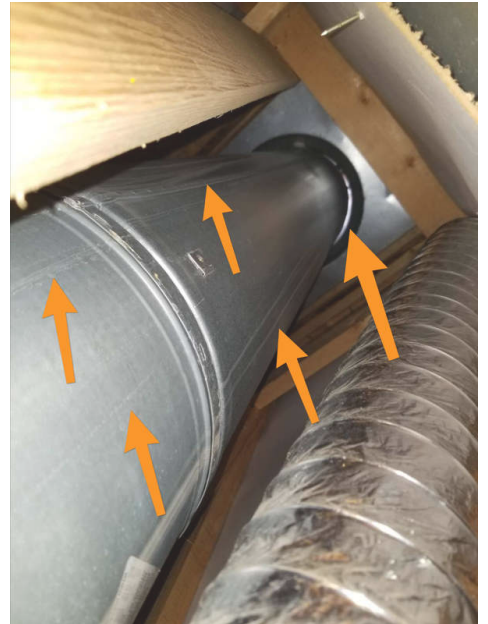
Attic

LEAK AT CHIMNEY

There was evidence of water intrusion coming from the top of the chimney pipe in the attic where the pipe penetrates the roof. It appeared as though the water had run down the pipe and into the fireplace area. Once all rooftop repairs are made to the chimney, flashing around the chimney and the shingles, the problem will likely be resolved but should be monitored for any more leakage.

Contact a qualified professional.

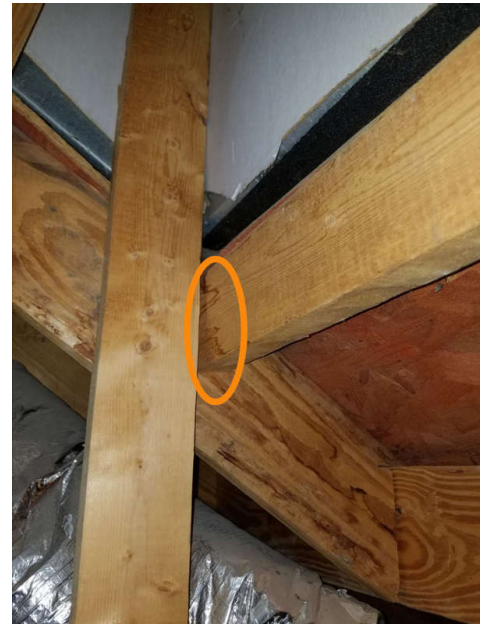
Attic

FLASHING LEAK

Water intrusion was also noted in the attic around the chimney flashing area. This leak is likely coming from defective rooftop flashing around the base of the chimney.

Contact a qualified roofing professional.

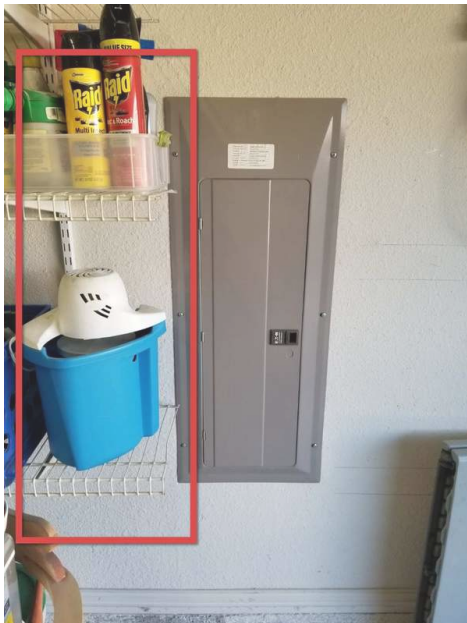
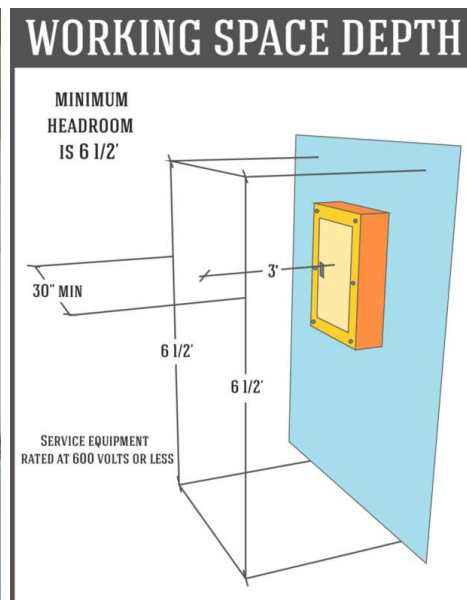
ELECTRICAL PANEL- INADEQUATE CLEARANCE

The service panel did not have proper clearances to provide quick access for an emergency disconnect. The clear working space required in front of a panel is 30" wide by 36" deep with a minimum headroom clearance of 6 feet-6 inches.

Contact a handyman or DIY project

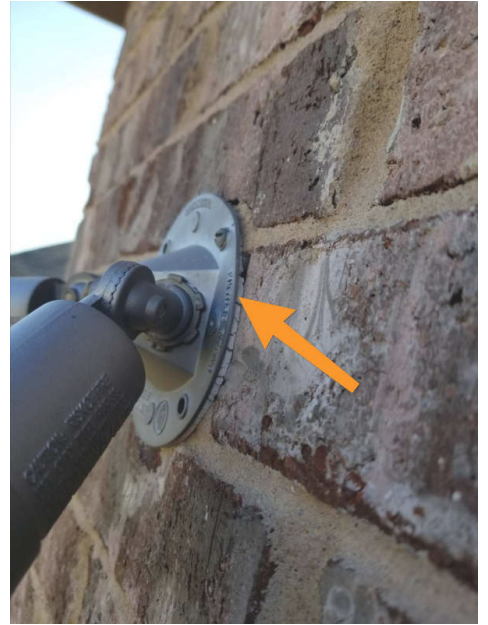
Beside Garage

EXTERIOR LIGHT NOT SEALED

One or more exterior lights need to be sealed with caulk to prevent moisture intrusion.

Contact a handyman or DIY project

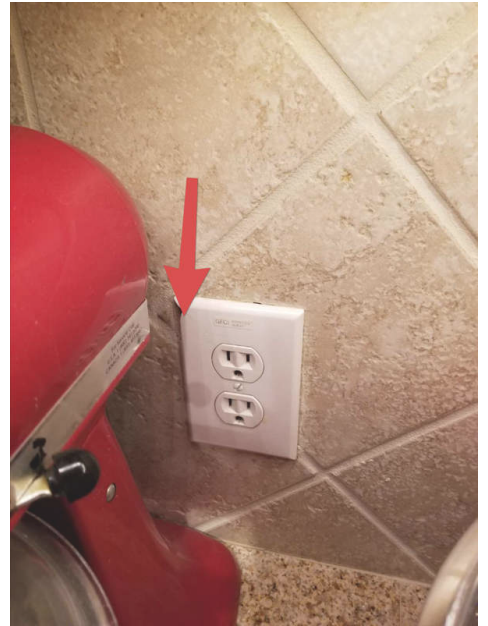
Kitchen

COVER PLATES DAMAGED

One or more electrical receptacle/switch cover plates were damaged and in need of replacement. This is a potential shock/electrocution hazard.

Contact a qualified electrical contractor.

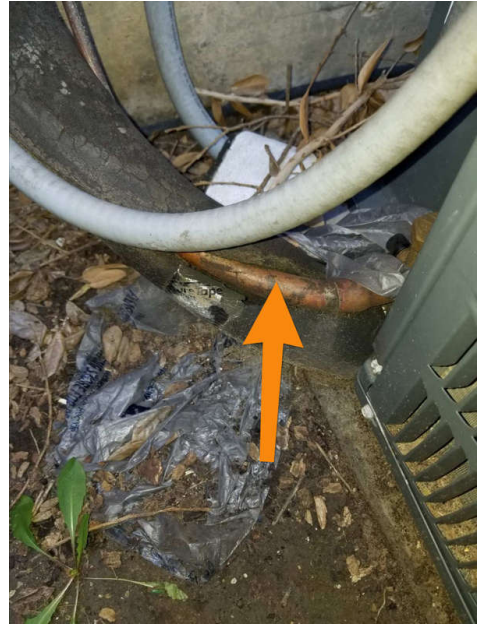
South

REFRIGERANT LINE INSULATION

Missing or damaged insulation on refrigerant line can cause energy loss and condensation. Recommend installing/replacing insulation.

Contact a handyman or DIY project

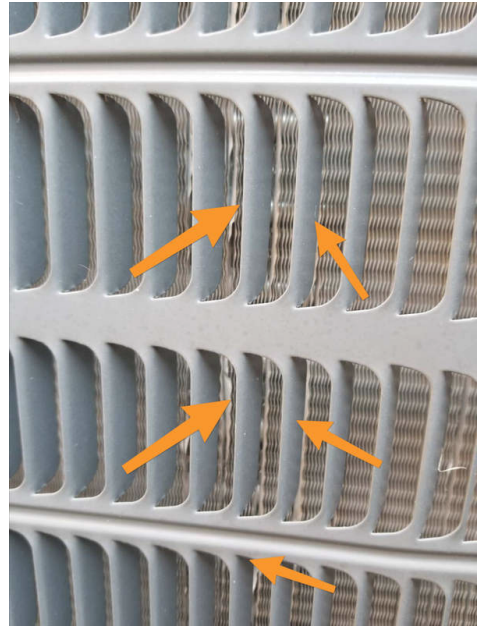
South

CONDENSER FIN DAMAGE

At time of inspection, there was minor damage to some of the condenser fins.

Contact a qualified heating and cooling contractor

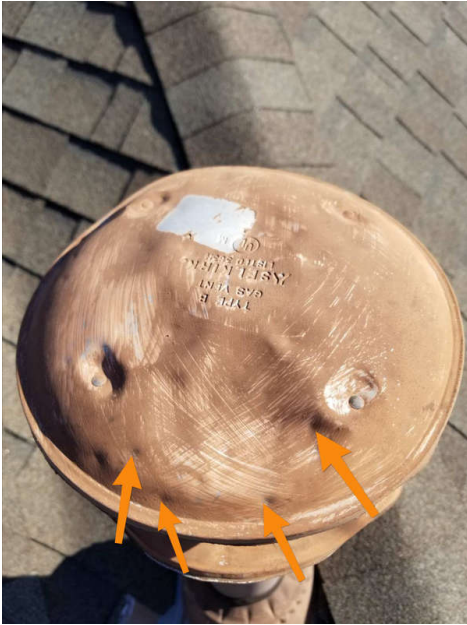
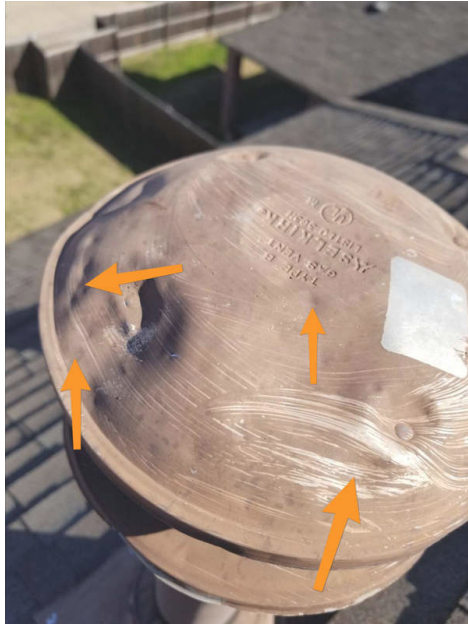
HAIL DAMAGE

Several vents on the roof had evidence of minor hail damage.

Contact a qualified roofing professional.

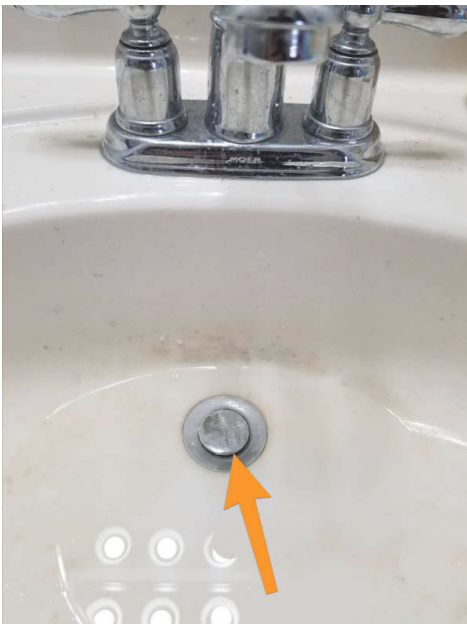
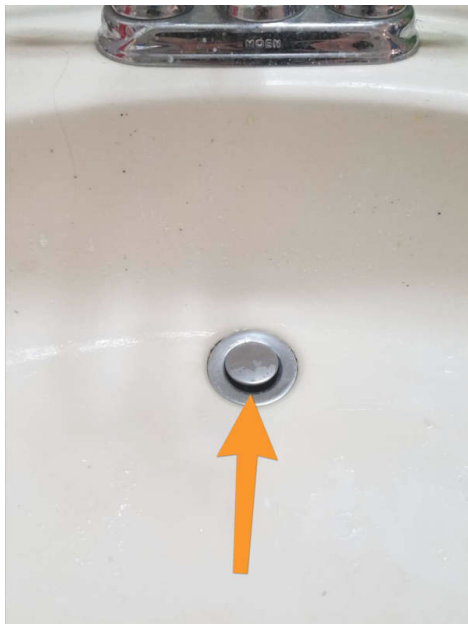
SINK STOPPER LEAKED

One or more sink stoppers leaked, not allowing the sink to hold water.

Contact a handyman or DIY project

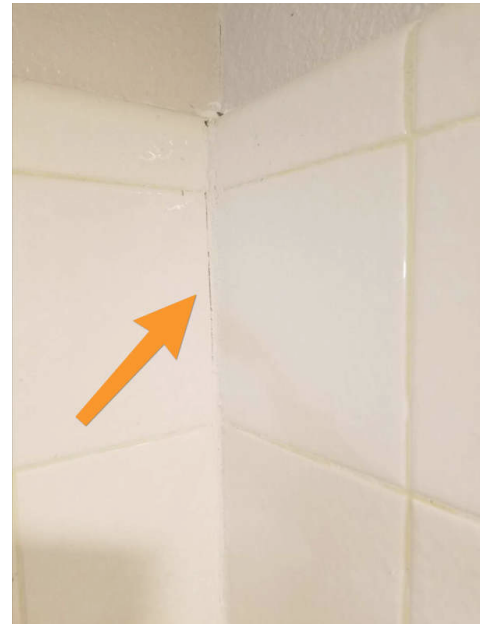
2nd Floor North Bathroom

SHOWER GROUT- CRACKED/MISSING

In one or more locations a shower had cracked and/or missing tile grout. Recommend repairing grout to prevent moisture intrusion behind the tiles.

Recommendation
Contact a handyman or DIY project

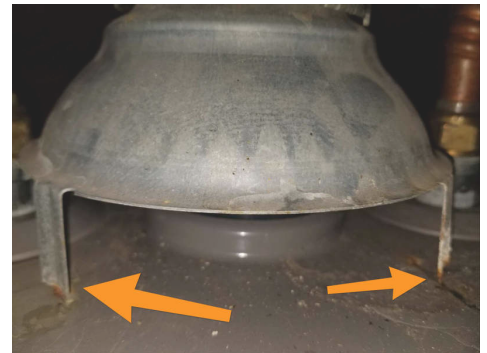
Attic

5.3.1 C. Water Heating Equipment
VENT LOOSE

South hot water heater vent is disconnected from top of hot water heater and was rattling due to the wind.

Recommendation
Contact a qualified plumbing contractor.
