SAVIOR
INSPECTION SERVICES

SUMMARY
1234 Main St. Melissa TX 75454
Buyer Name
04/19/2019 9:00AM

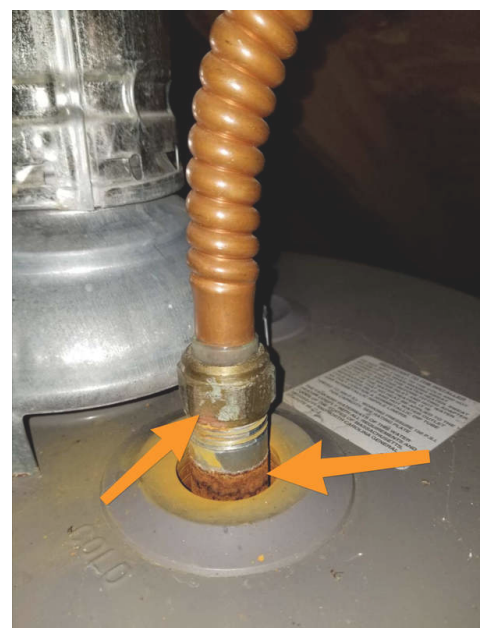
Attic

5.3.2 C. Water Heating Equipment
CORRODED CONNECTION

One or more water heater connections were corroded and need further evaluation to determine cause and remedy.

Recommendation
Contact a qualified plumbing contractor.

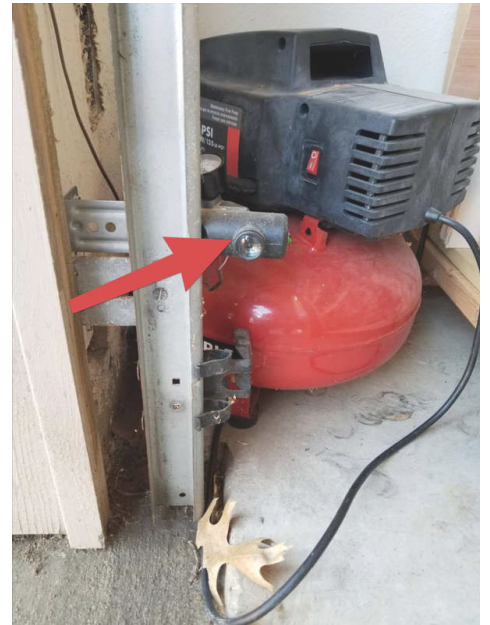
SENSORS TOO HIGH

Garage door sensors were too high. Should be 6 inches from the garage floor to prevent children from being able to get under the sensors. Recommend moving sensors down to 6 inches above the garage floor.

Contact a handyman or DIY project
