SUMMARY
1234 Main St. Leominster Ma 01453
Buyer Name
10/02/2018 9:00AM

Mark Fratoni
License # 821
Wachusett Home Inspection, LLC
(978) 990-3200
mark@wachusettinspection.com

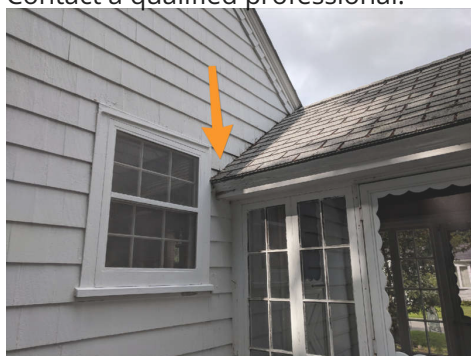
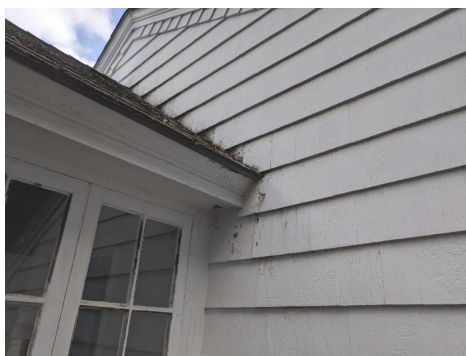
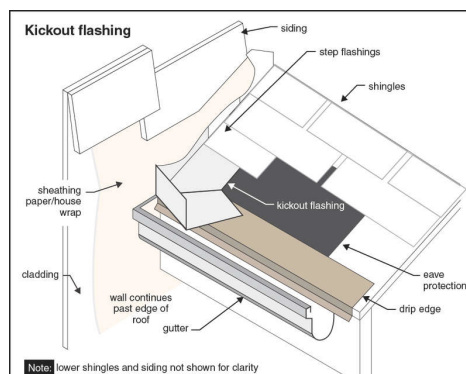
2.1.1 Siding, Flashing & Trim

FLASHING - NO KICK-OUT FLASHING VISIBLE

BREEZEWAY

Kick-out flashings divert water from entering behind the siding where roofs terminate at sidewalls (see attached infographic for a visual description/example). A lack of flashing where a roof terminates into a sidewall can lead to moisture intrusion and damage to the wall cavity, which often goes unnoticed for quite some time.

Contact a qualified professional.

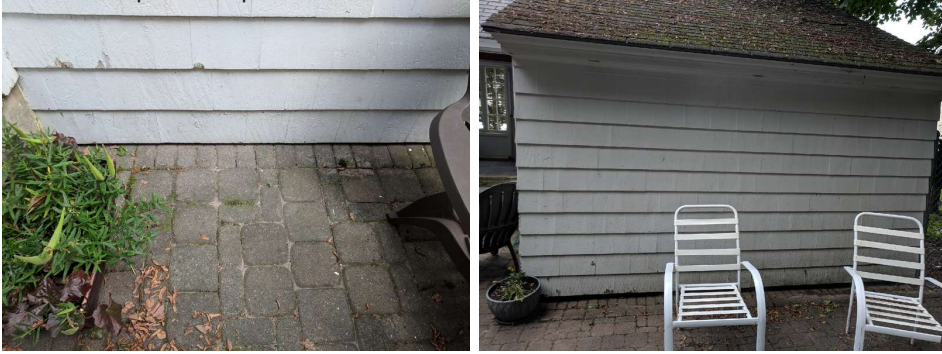
2.1.2 Siding, Flashing & Trim

SIDING - IMPROPER GROUND CLEARANCE

GARAGE

Siding installed near (or in contact) with the ground can lead to moisture intrusion behind the siding material, and subsequent damage to the wall/structure. In many cases the siding material is more rot resistant than the material it is protecting, so damage may go unnoticed. This is particularly true with vinyl siding, which does not rot (but the material behind it can).

This configuration is also conducive to hidden attacks from wood destroying insects, such as carpenter ants and termites.

Recommend consulting with a qualified professional to determine the most sensible approach to correcting this configuration, or reducing the potential for damage to the structure.

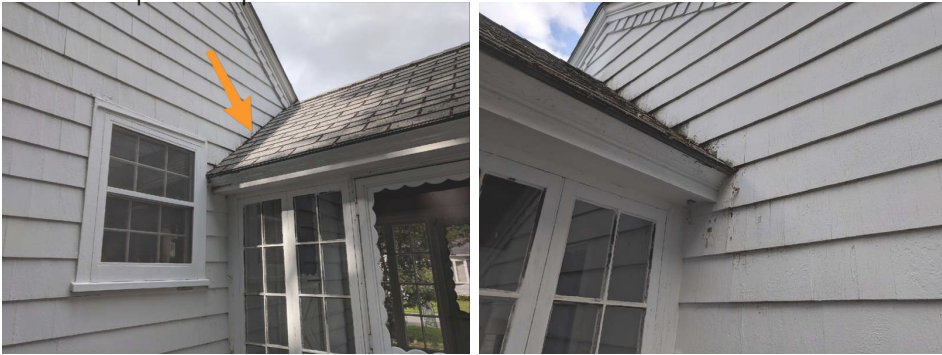
2.1.3 Siding, Flashing & Trim

SIDING - ROOF - LACK OF CLEARANCE

BREEZEWAY

The observed configuration (siding in contact with roof material, or very close to it) can lead to premature siding failure in these areas, and should be corrected.

Recommendation
Contact a qualified professional.

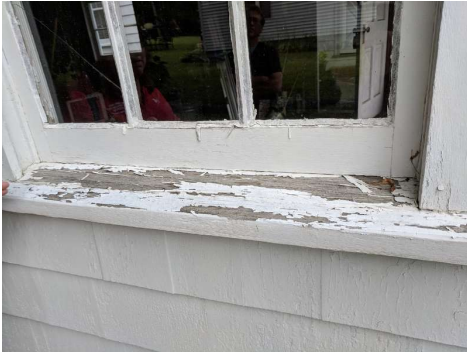
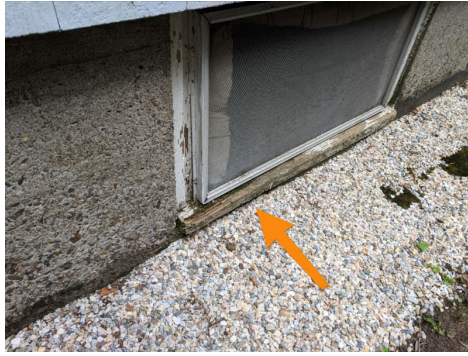
2.1.5 Siding, Flashing & Trim

WINDOW SILLS

Overall the windows sills were in good condition at the time of inspection, with the exception of one sill on the left side of the garage, and basement window sills in contact with the ground.

Recommendation
Contact a qualified professional.

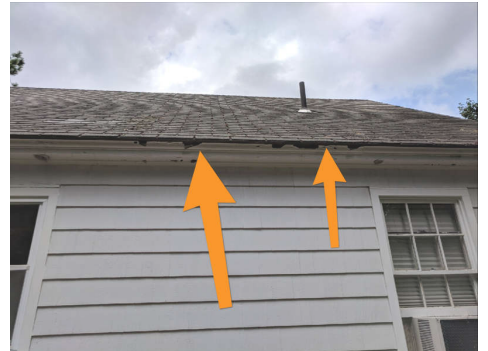
2.1.6 Siding, Flashing & Trim

TRIM

The rear fascia board had peeling paint, and appeared to have some wood rot. Repair as needed.

Contact a qualified professional.

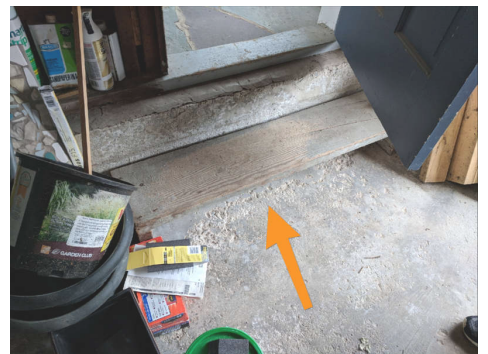
2.3.1 Decks, Balconies, Porches & Steps

WOOD STEP

The wood step leading from the garage into the breezeway was not properly secured and is a trip hazard, and should be repaired.

Contact a qualified professional.

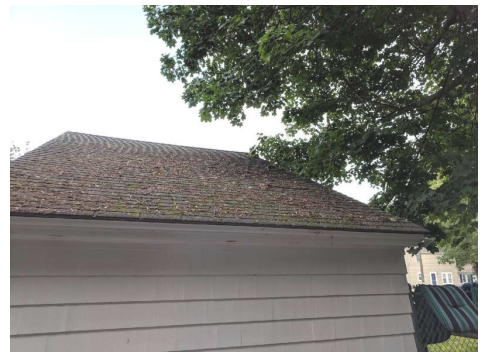
2.4.1 Vegetation, Grading, Drainage & Retaining Walls

TREE OVERHANG

Trees observed overhanging the roof. This can cause damage to the roof and should be corrected.

Contact a qualified professional.

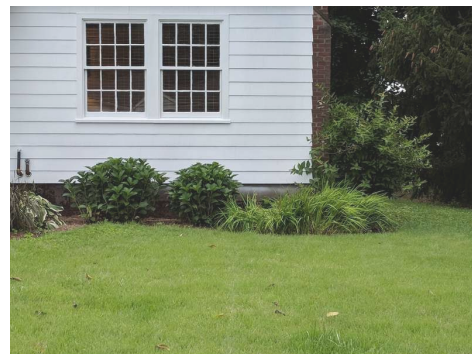
2.4.2 Vegetation, Grading, Drainage & Retaining Walls

VEGETATION TOUCHING HOME

Trees and vegetation should not be in contact with the home, and ideally not in close enough proximity to hold moisture against the building materials.

Contact a qualified professional.

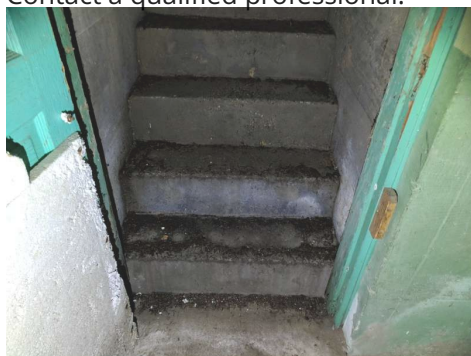
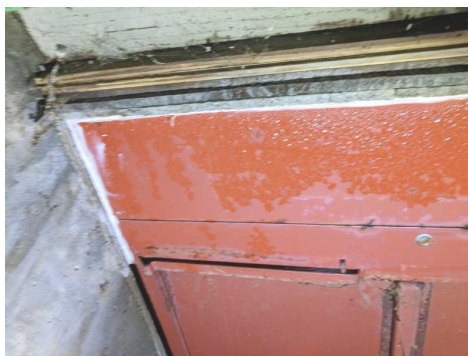
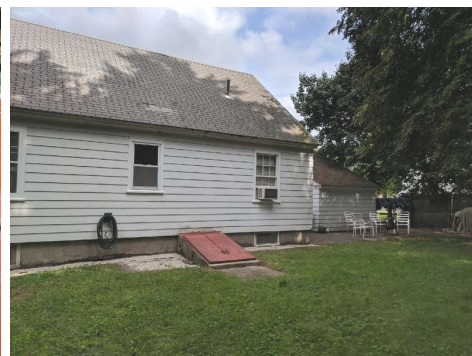
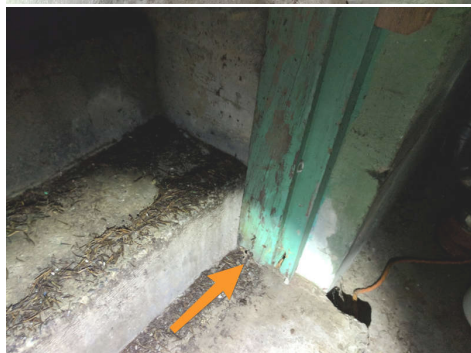
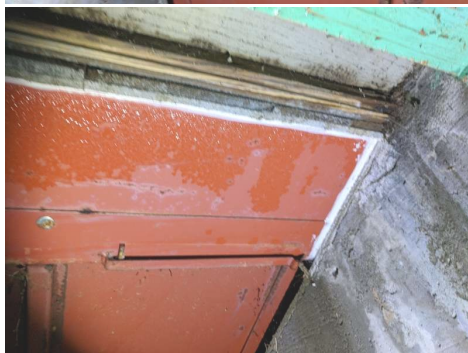
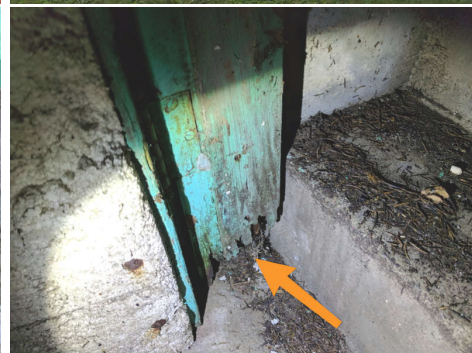
2.6.1 Window Wells and Areaways

BULKHEAD

The bulkhead was not properly flashed to shed water from the siding material down and away. Active moisture intrusion was observed at the inside of the bulkhead in this area.

Wood rot and active moisture was also noted at the base of the wood entry door frame.

Wood rot

Contact a qualified professional.

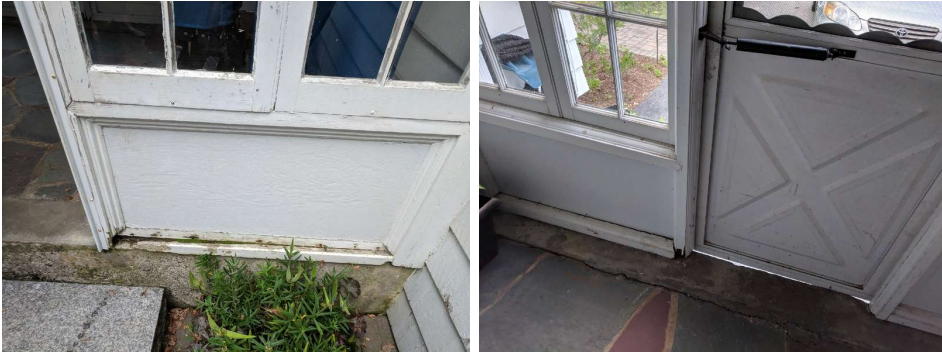
2.7.1 Breezeway

WALLS

Significant wood rot was noted at the base of the walls in the breezeway, front and back. A qualified Carpenter should determine the scope of repair required.

Contact a qualified professional.

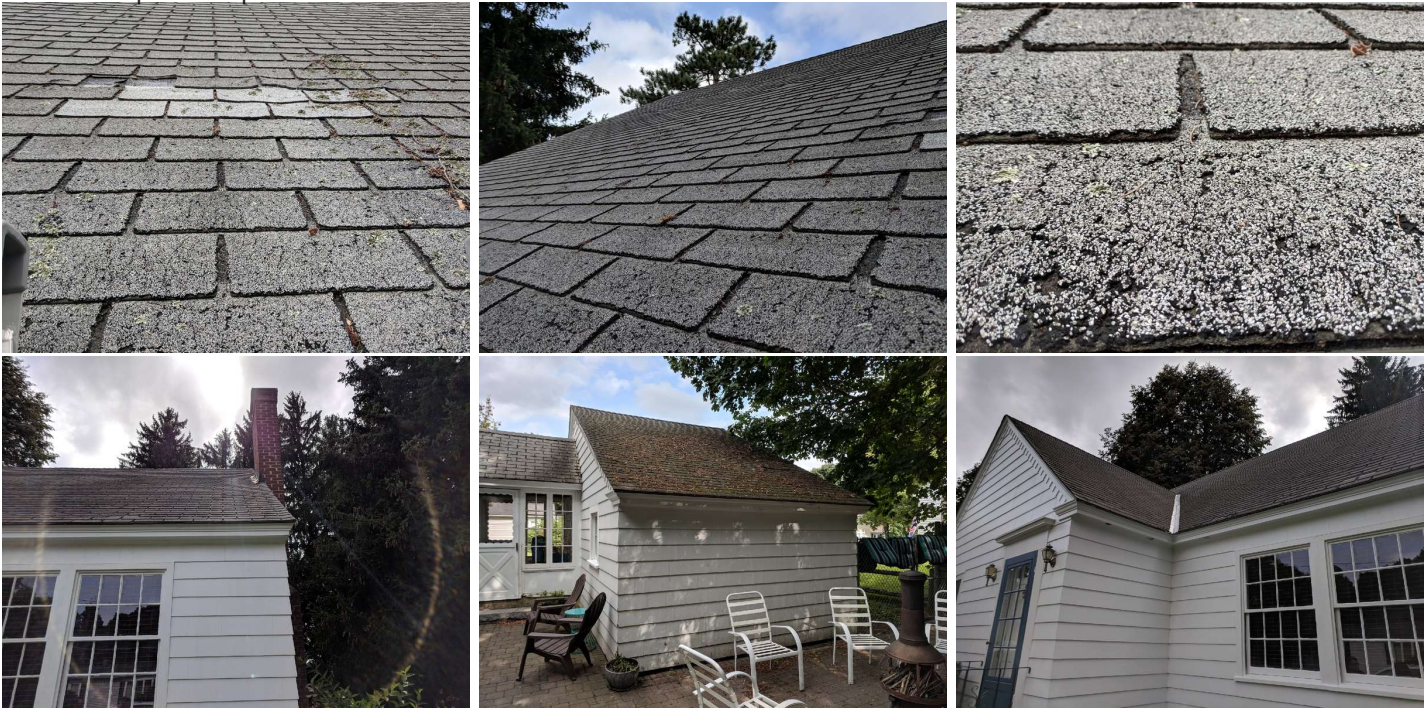
3.1.1 Coverings

END OF LIFE

The roof covering material has reached the end of its useful life, and will need to be replaced. When obtaining bids be sure the bid includes completely stripping the roof material and replacing all flashing materials.

Recommendation
Contact a qualified professional.

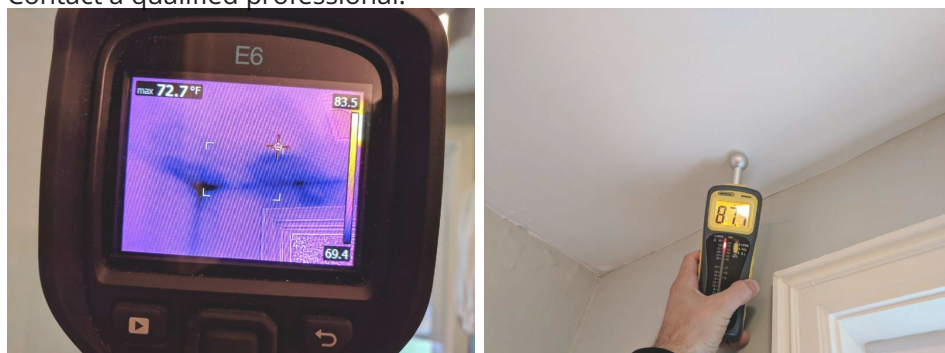
3.5.1 Active Leaks

ACTIVE LEAK

What appeared to be active moisture, likely due to a roof leak, was observed at the rear side of the house in the bathroom. Further investigation is recommended to determine the source of the leak and make necessary corrections. Understand that if this is a long-term leak concealed damage may exist.

Contact a qualified professional.

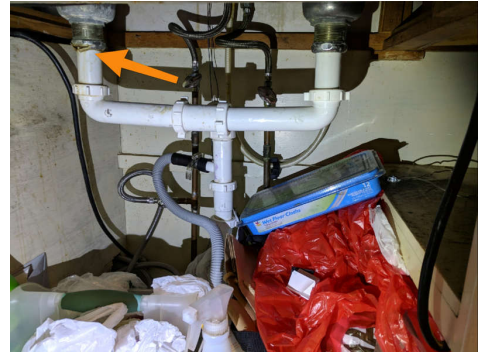
5.1.1 Fixtures / Faucets

KITCHEN SINK

Minor repairs needed on the drain side to prevent leakage.

Contact a qualified professional.

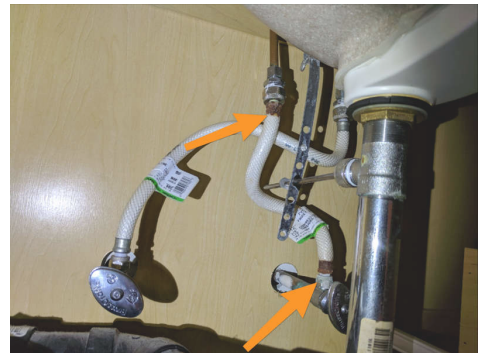
5.1.3 Fixtures / Faucets

CORROSION

Corrosion noted at Water Supply hoses beneath bathroom sink. Recommend replacing the hoses before they become a problem.

Contact a qualified professional.

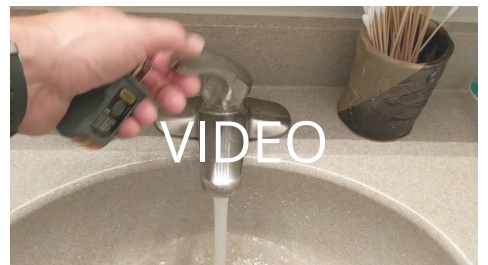
5.1.4 Fixtures / Faucets

BATHROOM SINK FIXTURE

Although the bathroom sink fixture was functional, mechanically it was not correct.

Contact a qualified professional.

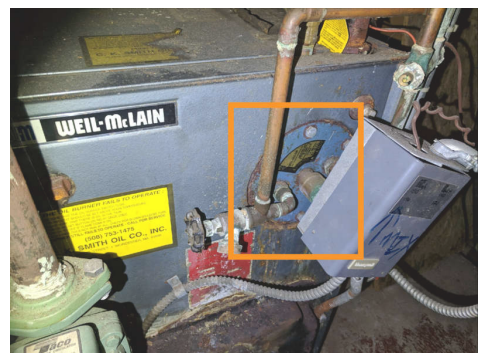
5.4.1 Water Heater

CORROSION AND WATER STAINING

Evidence of leakage observed at the tankless water heater.

Contact a qualified professional.

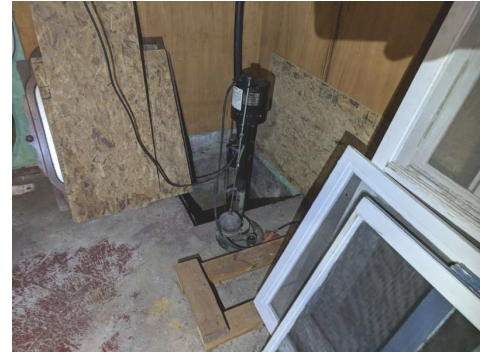
5.6.1 Sump Pumps / Sewage Ejectors
HAPHAZARD INSTALLATION

Recommendation
Contact a qualified professional.

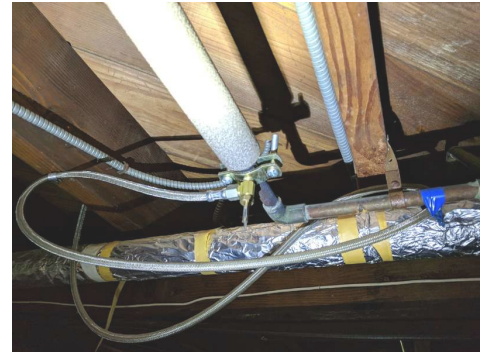
5.8.1 Miscellaneous
SADDLE VALVE

The use of a saddle valve was noted. These are typically installed as a quick solution when a water line is needed at an appliance, such as a refrigerator. Saddle valves are not recommended as they are common leak points.

Recommendation
Contact a qualified professional.

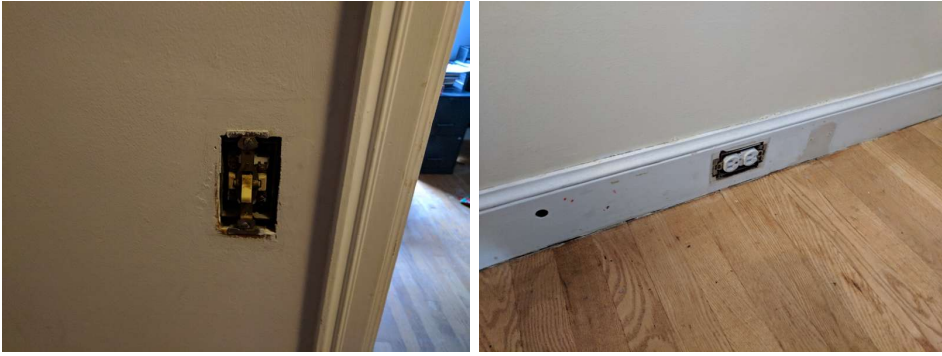
6.7.1 Miscellaneous
COVERS

All receptacles and switches should have proper covers installed for safety.

Recommendation
Contact a qualified professional.

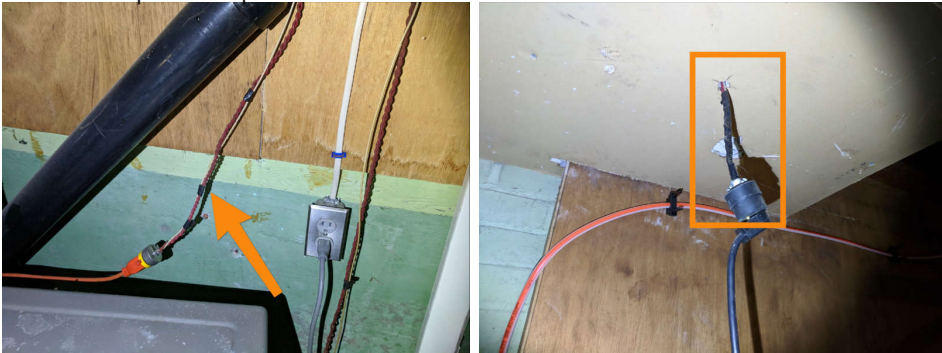
6.7.2 Miscellaneous

UNPROFESSIONAL ELECTRICAL WORK

Inspector noted unprofessional electrical work in two areas of the basement. At the rear near the laundry sink, and at the connection to the sump pump. A licensed electrician should clean up these, and any other unsafe configurations noted.

Contact a qualified professional.

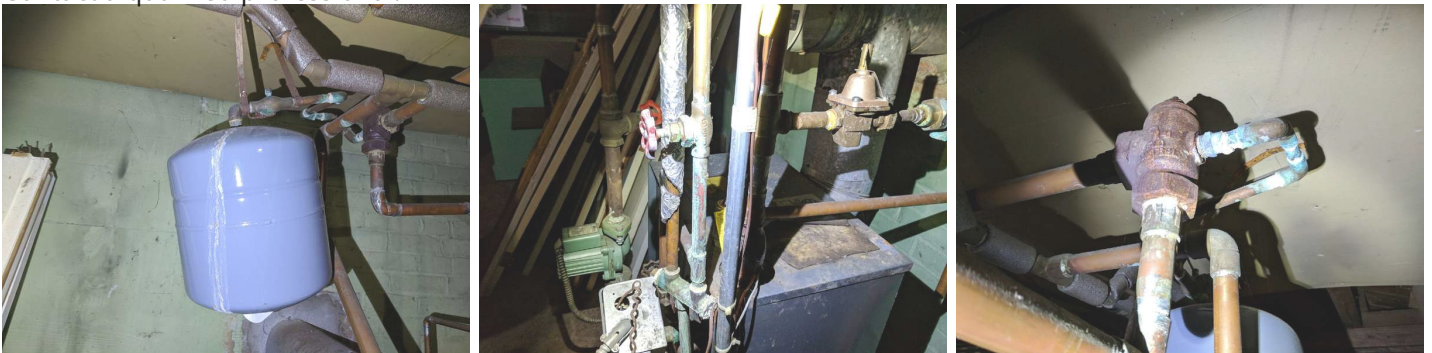
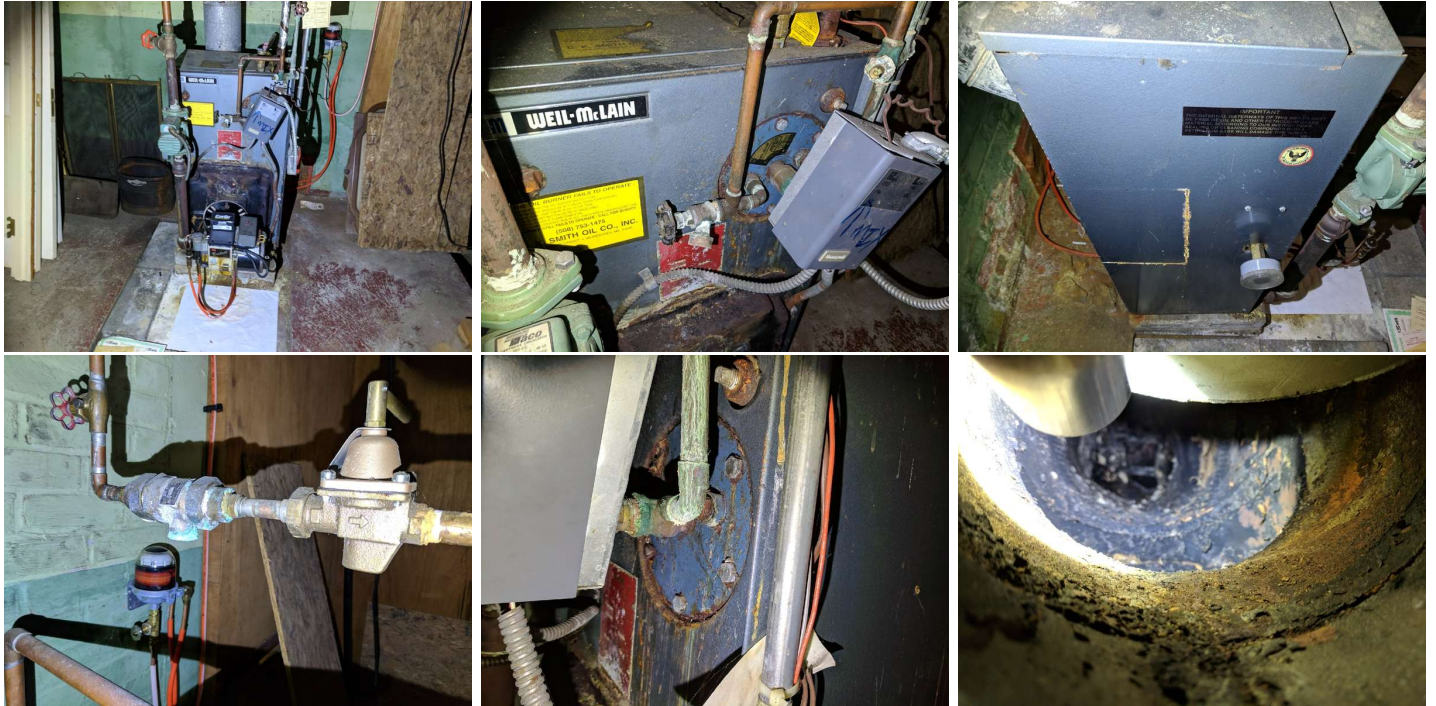
7.1.1 Heating Equipment

BOILER - FULLY DEPRECIATED

The boiler appeared to be quite old, and has likely exceeded its expected service life. Corrosion and leakage was noted at several fittings. Many leaks appeared to be long-term in nature (suggesting a general lack of maintenance) and have caused damage to adjacent materials. Further investigation by a qualified professional is recommended to determine if repair is appropriate, or if replacement is the most efficient route.

Contact a qualified professional.

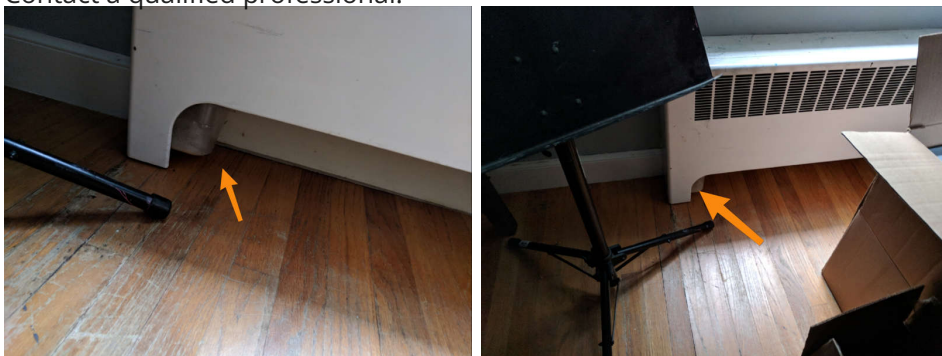
7.2.1 Distribution Systems

LEAK

One of the tenants living in the house disclosed the presence of a leak at a second floor Radiator on the left side of home. Evidence of historic leakage was apparent, and a small vessel meant to catch water was observed in this location. Repair as needed.

Contact a qualified professional.

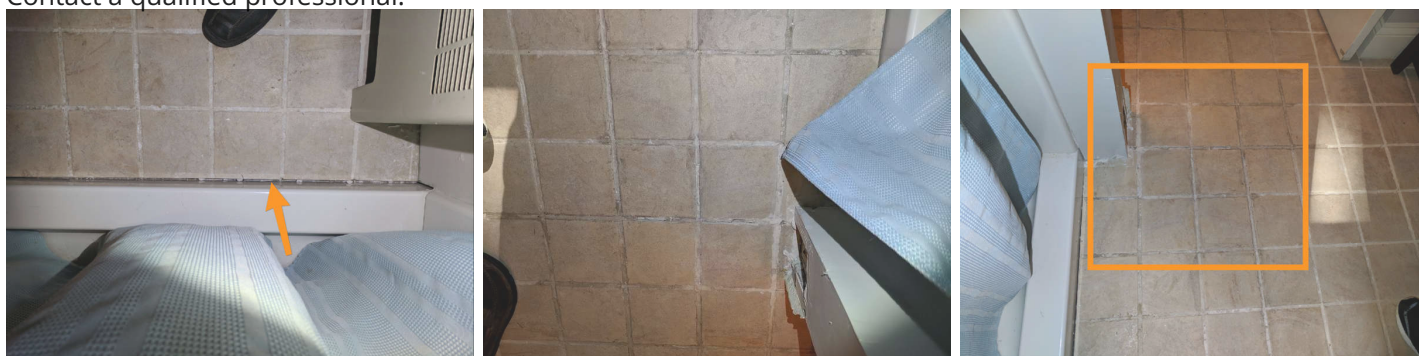
8.3.2 Floors

BATHROOM

The tile floor in the bathroom had apparent water damage adjacent to the shower, and cracked grout adjacent to the toilet. Understand that concealed damage may exist beneath this area.

A large gap was noted between the flooring and the shower stall, which should be properly caulked to seal out water.

Recommendation
Contact a qualified professional.

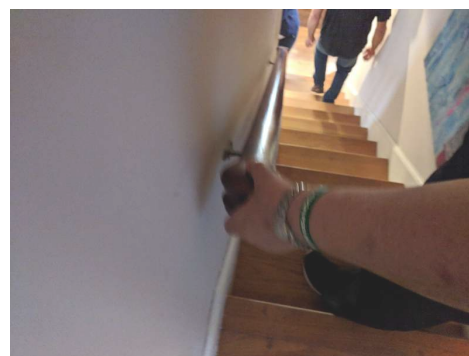
8.4.1 Steps, Stairways & Railings

LOOSE HANDRAIL

FIRST TO SECOND FLOOR

Recommendation
Contact a qualified professional.

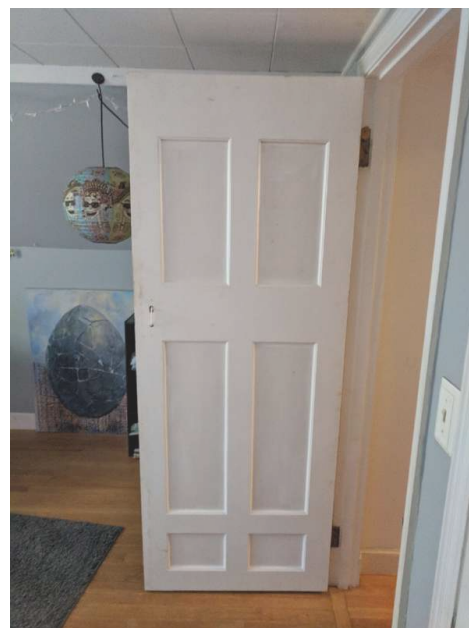
8.5.2 Doors

IMPROPER INSTALLATION

The second floor right bedroom door was installed upside down, and had no latching Hardware.

Contact a qualified professional.

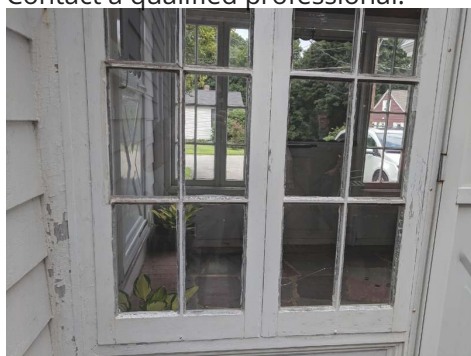
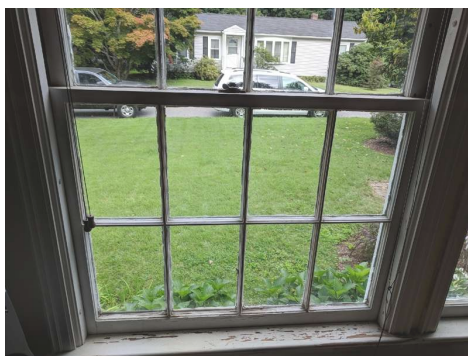
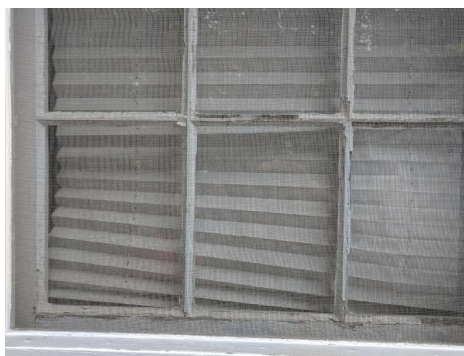
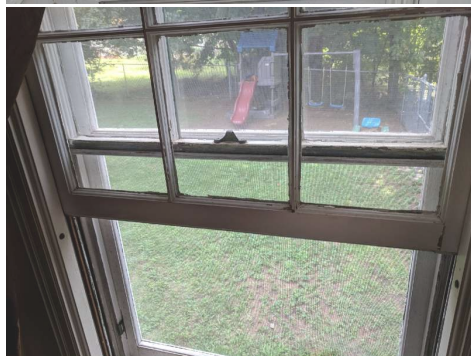
8.6.1 Windows

WOOD WINDOWS

The original wood windows remaining in the home were in overall poor condition and in need of restoration work including glazing, scraping and painting, and replacing cracked panes. The majority of the windows in the home appeared to be original.

Contact a qualified professional.

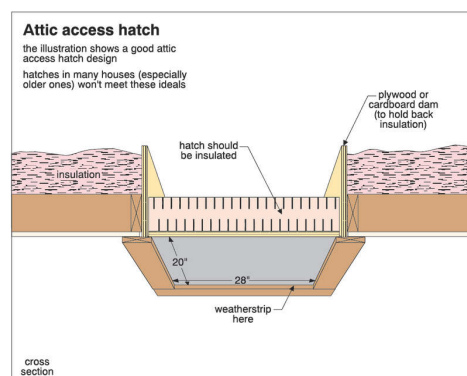
10.1.3 Attic Insulation

ATTIC ENTRANCE - INSUFFICIENT AIR SEALING

SEVERAL

The attic hatch and/or door should be insulated and air sealed.

Recommendation
Contact a qualified professional.

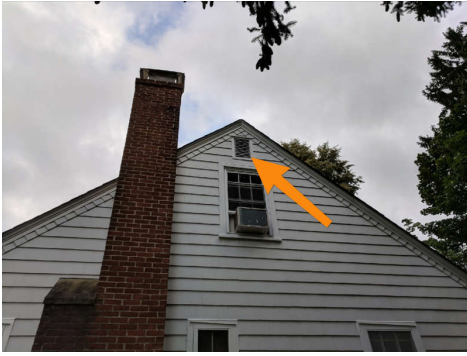
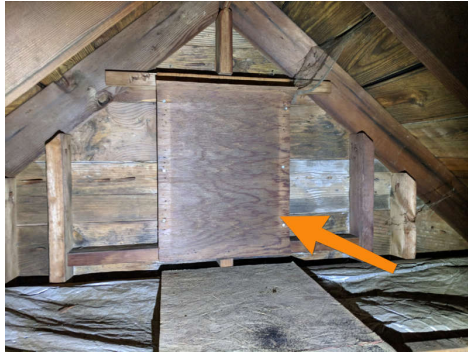
10.2.1 Ventilation

BLOCKED VENT

The gable end vent on the right side of the home was blocked off with plywood. Inspector did not observe an apparent reason for this, nor was an adverse effect noted, however in order for Gable end vents to work properly (cross ventilation) both need to be open.

Recommendation
Contact a qualified professional.

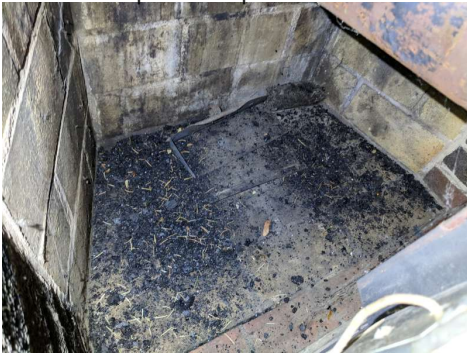
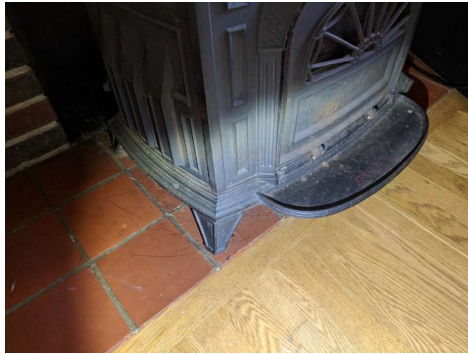
11.1.1 Fireplaces, Stoves & Inserts

WOOD STOVE

The wood stove should not be used until further evaluation and repairs are completed. The inspector noted significant creosote buildup inside the wood stove. The flue pipe was not properly connected to the back of the wood stove. And the Hearth did not appear to be sufficient to provide proper clearance to combustibles.

Contact a qualified professional.

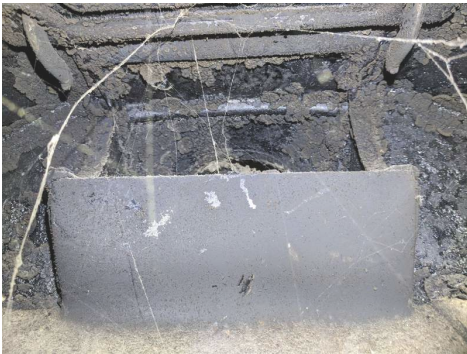
Open Gap at flue

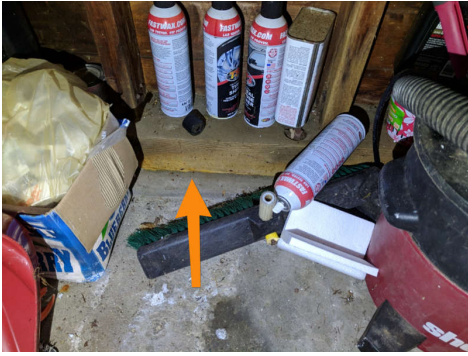
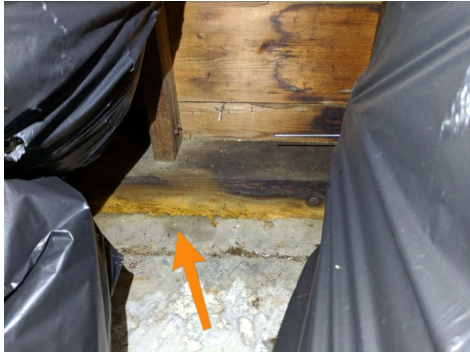
12.3.1 Visible Framing

APPARENT MOISTURE DAMAGE

What appeared to be minor damage was noted at the sill plates.

Contact a qualified professional.

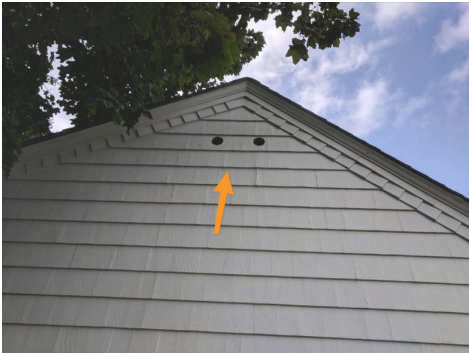
12.6.1 Miscellaneous

VENTS

What appeared to be holes cut for ventilation were noted at the left side. These holes should be covered in some sort of screening material to prevent pest entry.

Similar events were cut into the soffit material on the main house, and most were covered properly with the exception of one.

Recommendation
Contact a qualified professional.
