SUMMARY
1234 Main St. Aztec NM 87410
Buyer Name
04/15/2019 9:00AM

Kyle Sage
InterNACHI- Certified...
Sage Inspectors
970-799-4726
kyle@sageinspectors.com

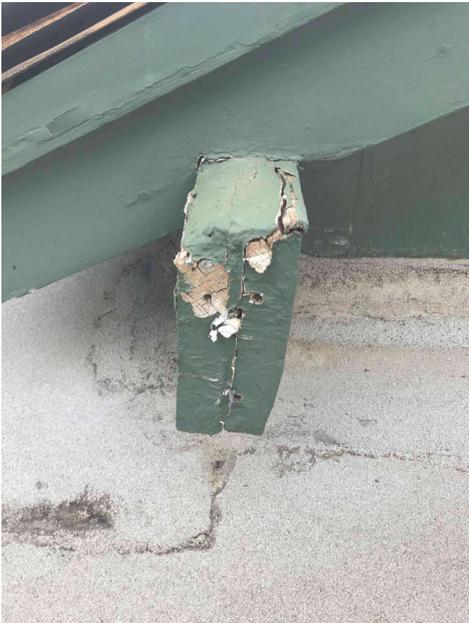
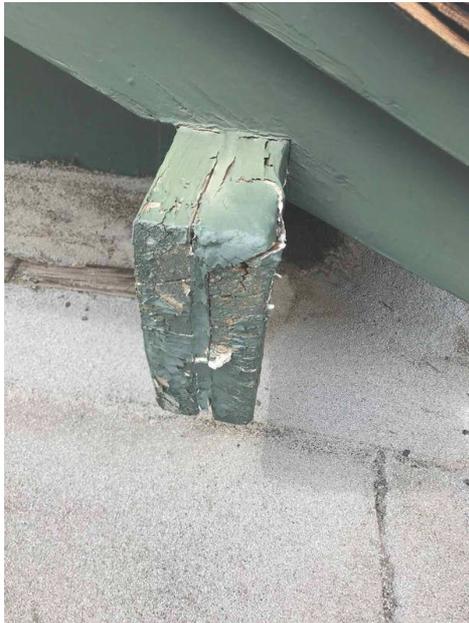
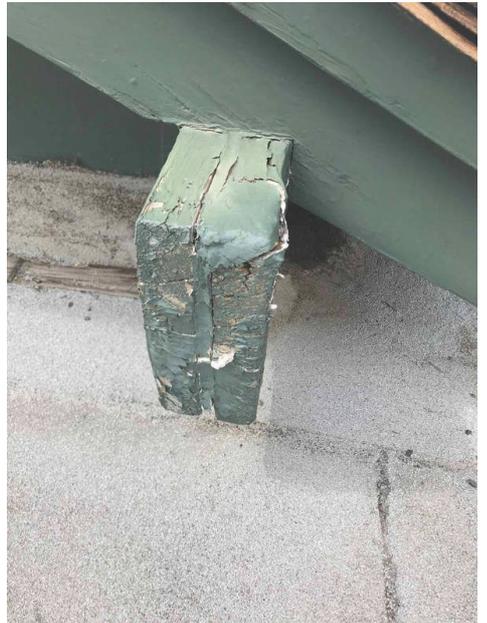
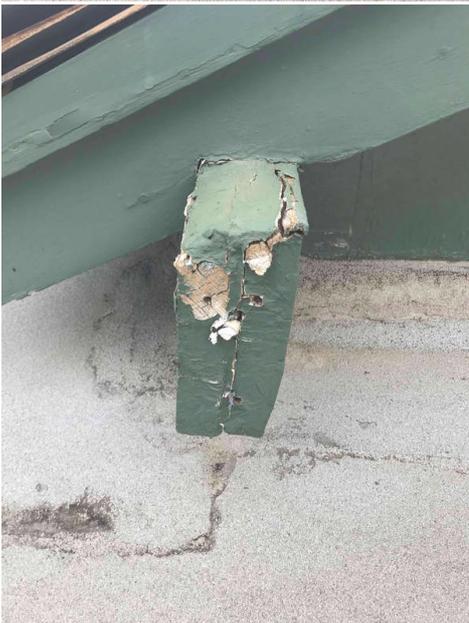
2.1.1 Roof Structure Exterior

ROOF OVERHANG BEAM

Minor Deficiency

Roof overhang beam is rotting due to paint coming off. Recommend having a qualified roofer or contractor look at to repair.

Recommendation
Contact a qualified professional.

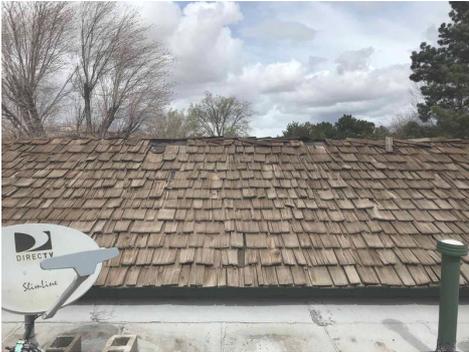
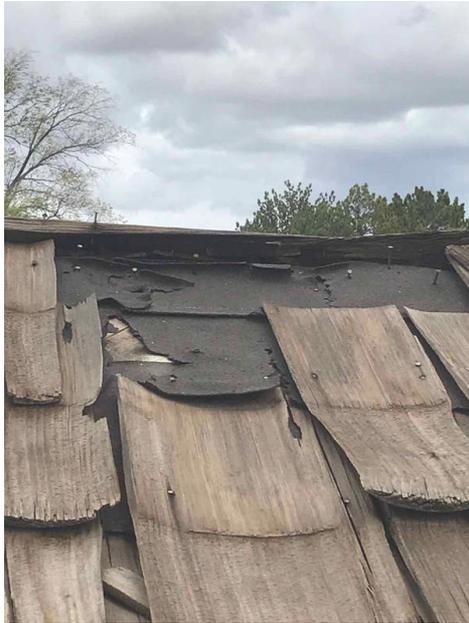
2.8.1 Asphalt Composition Shingle

EXPOSED ROOF SHEATHING- QC

Minor Deficiency

Wind damage had exposed roof sheathing to weather. This damage should be repaired as soon as possible to help prevent damage from moisture intrusion to the home materials, the roof structure and to prevent development of microbial growth such as mold. All work should be performed by a qualified contractor

Recommendation

Contact a qualified professional.

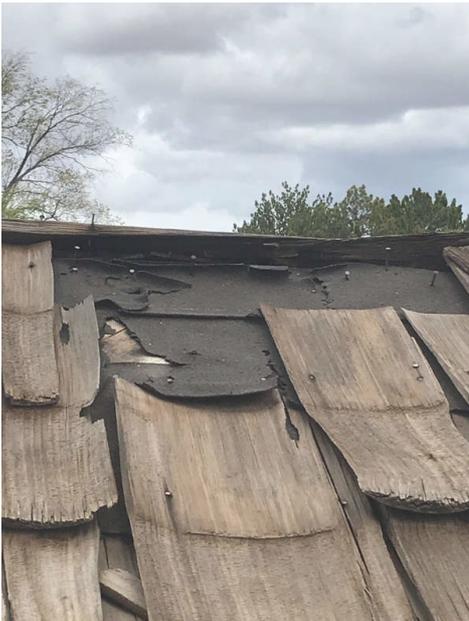
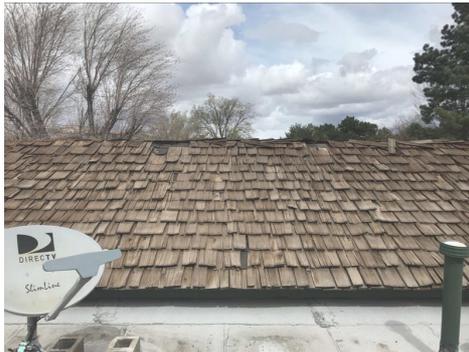
2.8.2 Asphalt Composition Shingle

LOOSE/MISSING SHINGLES- QC

Minor Deficiency

The roof had loose and/or missing shingles. The Inspector recommends replacement of any loose or missing shingles by a qualified roofing contractor to avoid damage from moisture intrusion.

Recommendation

Contact a qualified professional.

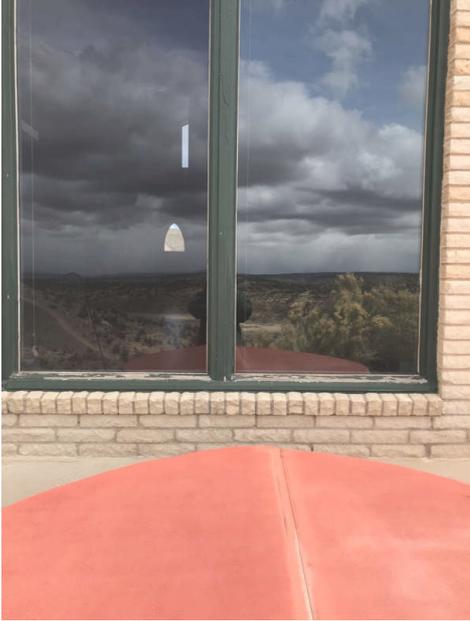
Southwest

PEELING PAINT, WOOD

Maintenance or Recommendation

The wood windows had peeling paint and needed maintenance at the time of the inspection. Windows appeared to have suffered some damage from sun and moisture. Wood windows eventually operate poorly if wood is left exposed to sun and moisture. Repair of long-term neglect can be expensive. The Inspector recommends maintenance be performed by a qualified contractor.

Recommendation

Contact a qualified window repair/installation contractor.

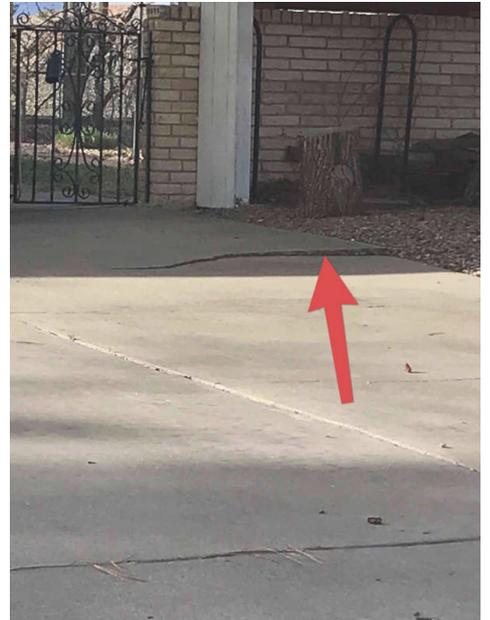
4.1.1 Driveway

MODERATE HEAVING- QC

Minor Deficiency

Moderate heaving visible in the driveway at the time of the inspection has created trip hazards that should be corrected by a qualified contractor.

The large tree is causing this.

Recommendation

Contact a qualified professional.

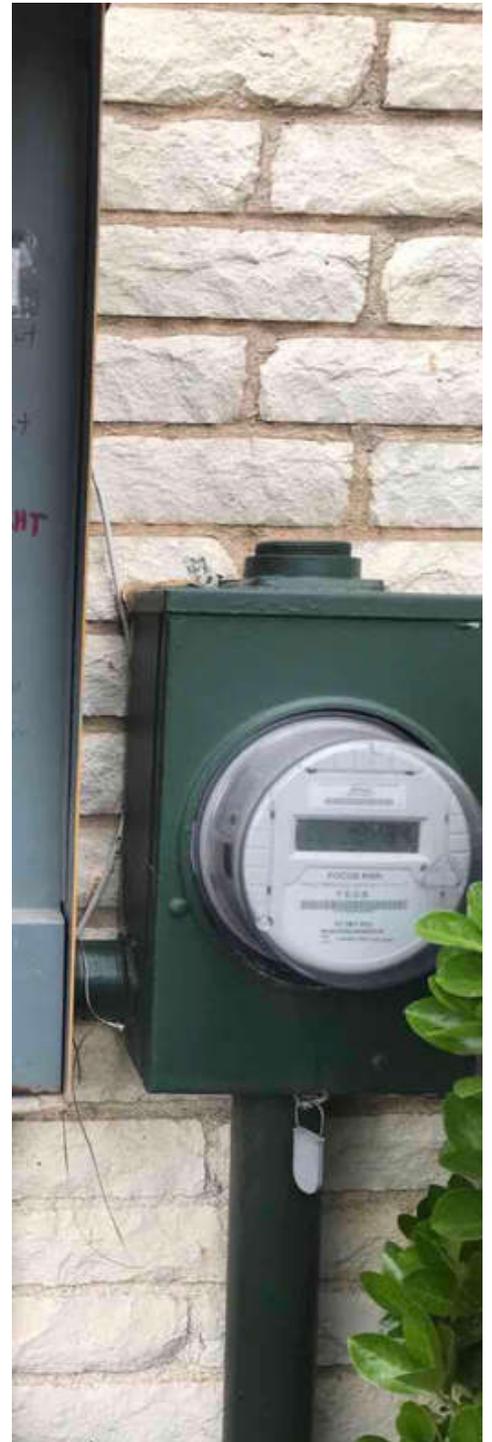
5.3.1 Electric Meter

METER OK

At the time of the inspection, the Inspector observed no deficiencies in the condition of the electric meter. Electric meters are installed by utility companies to measure home electrical consumption.

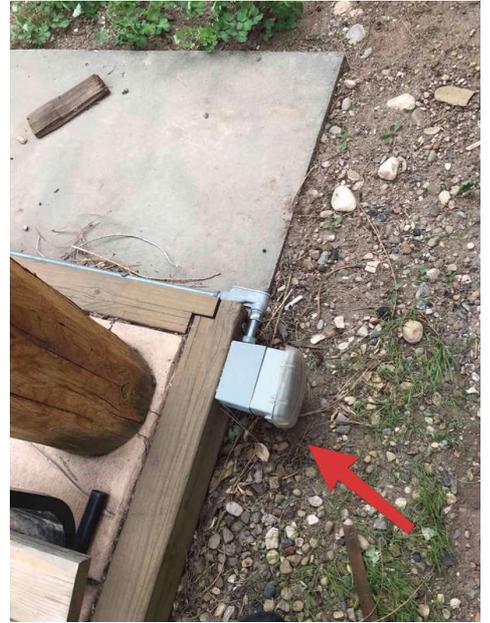
5.14.1 Exterior Electrical Receptacles

DID NOT RESPOND

Minor Deficiency

An exterior Ground Fault Circuit Interrupter (GFCI) electrical receptacle did not respond to the test button. The Inspector recommends replacement with a new GFCI receptacle by a qualified electrical contractor.

Recommendation
Contact a qualified electrical contractor.

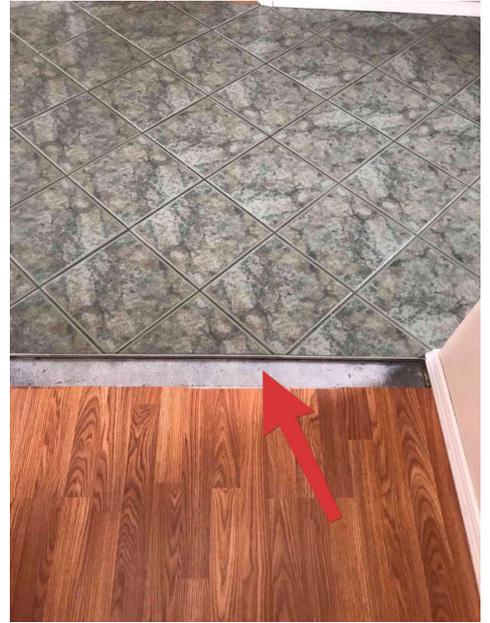
7.1.1 Floors

POOR INSTALLATION

Minor Deficiency

NEAR ENTRY WAY

Wood floor transition is missing. Poor coverings in the entry way exhibited evidence of poor installation practices at the time of the inspection.

Recommendation

Contact a qualified professional.

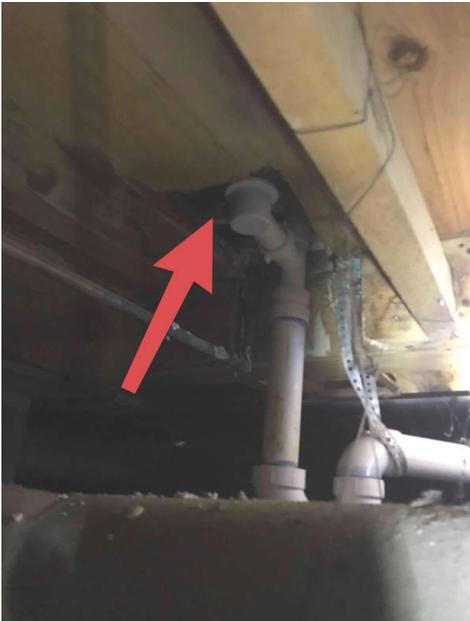
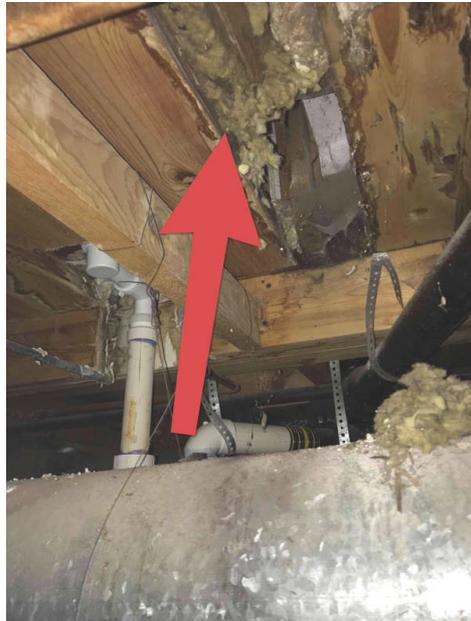
12.2.1 Floor Structure

LOCALIZED DECAY- LEAKS FIXED

Minor Deficiency

The floor joists had areas of localized advanced decay that appeared to be connected with plumbing fixture leakage. At the time of the inspection, no moisture showed in the framing at these areas, indicating that leaking plumbing fixtures have been repaired.

Recommendation
Contact a qualified professional.

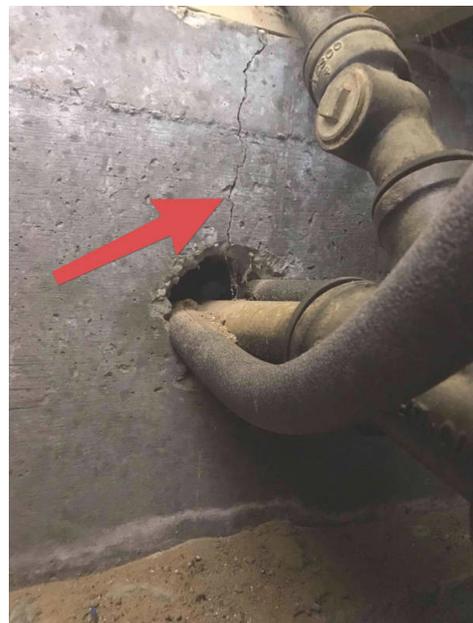
12.3.1 Foundation

MODERATE, NOT THRU-WALL- SE/QC

Minor Deficiency

Moderate cracking was visible in the poured concrete foundation wall. Cracking did not appear to be continuous through the wall. Determining the cause of cracking lies beyond the scope of the General Home Inspection. The Inspector recommends that you have this condition evaluated by a qualified foundation repair contractor or structural engineer to determine the cause of cracking and the likelihood of continued damage and to discuss options and costs for stabilization.

Recommendation

Contact a qualified professional.

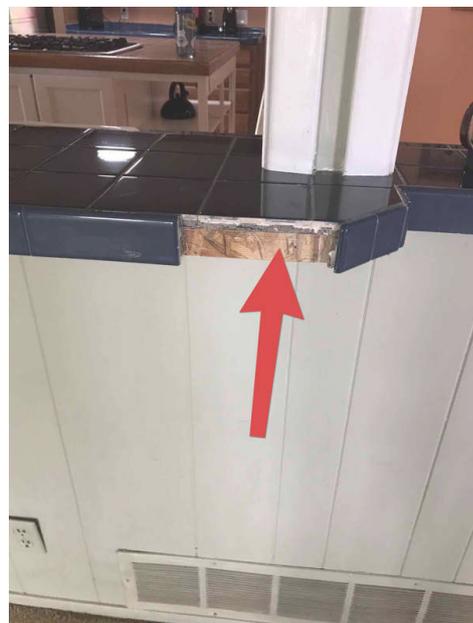
13.9.1 Cabinets

DAMAGED TILES- QC

The kitchen countertops had damaged tiles. The Inspector recommends repair by a qualified contractor. If matching tiles are no longer available the countertop may need to be re-tiled, which will be expensive.

Minor Deficiency

Recommendation

Contact a qualified professional.

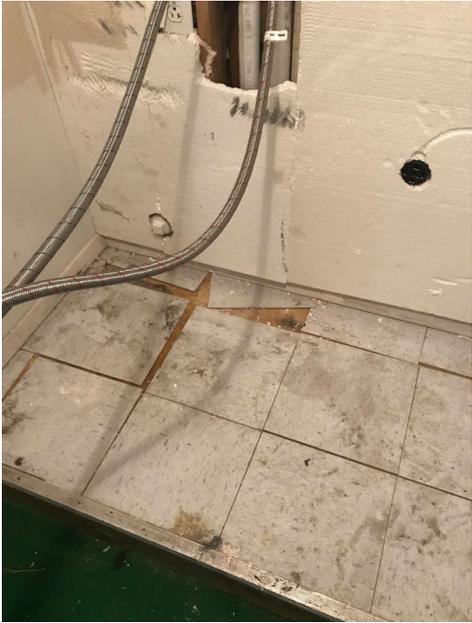
14.1.1 Floors

POORLY INSTALLED

Floor tiles in the laundry room were poorly installed.

Minor Deficiency

Recommendation

Contact a qualified professional.
