SUMMARY

1234 Main St. Porter TX 773654687

Ralph Swan Jr.
INTERNACHI Certified Home...
Swan Home Inspections PLLC
(832) 517-6625
ralph@swanhomeinspections.com

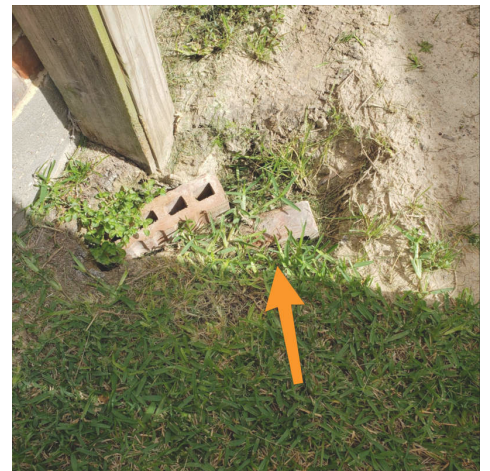
2.2.1 B. Grading and Drainage

GRADING IMPROVEMENT RECOMMENDED

SOUTH EXTERIOR

The soil grade and drainage patterns around areas of the structure appeared to be inadequate. It is recommended these areas be improved to direct water away from the structure.

Contact a qualified landscaping contractor

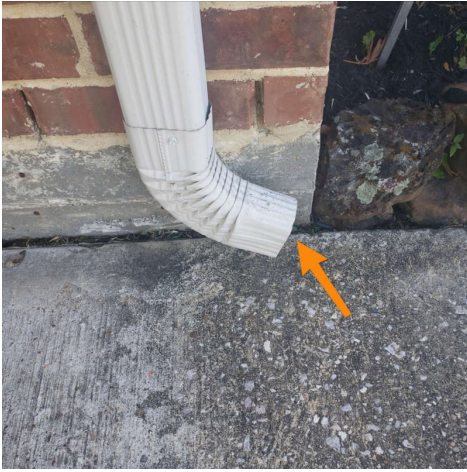
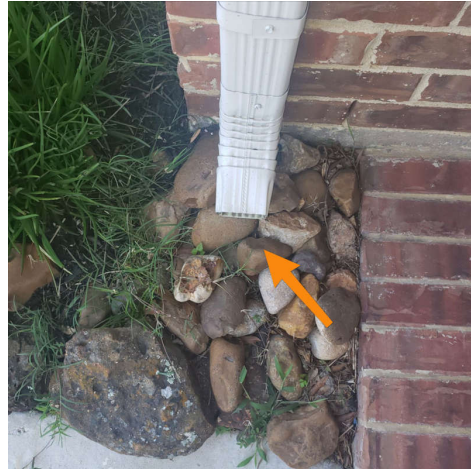
2.2.2 B. Grading and Drainage

DOWNSPOUTS DISCHARGING NEAR FOUNDATION

VARIOUS LOCATIONS

Downspout's were observed to be discharge near the foundation. We recommend adding extensions so that the downspouts discharge at least 6' away from the structure.

Contact a qualified gutter contractor

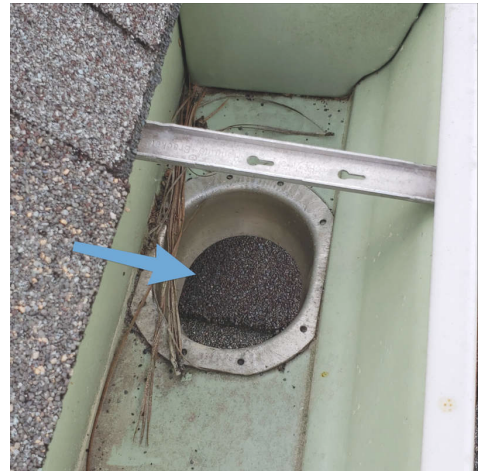
2.2.3 B. Grading and Drainage

GUTTER DISCHARGES TO ROOF

VARIOUS LOCATIONS ON ROOF

One or more gutters around the home was found to be discharging directly to the roof surface. This condition should ideally be corrected to help prevent premature deterioration of the shingles in this area due to high water volumes. This is a common issue for new homes.

Contact a qualified gutter contractor

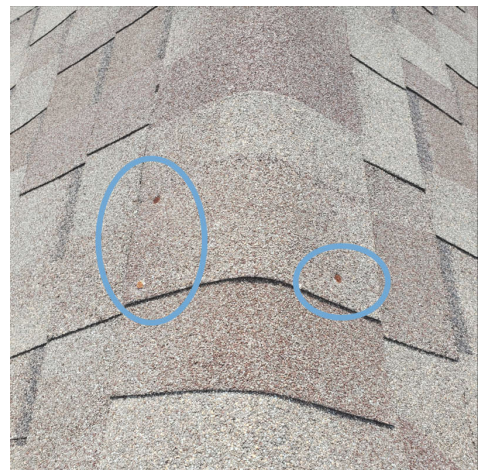
2.3.1 C. Roof Covering Materials

FASTENERS-EXPOSED

ROOF COVERING

Some areas of the roof had fasteners visible. Fasteners have been installed to secure shingles or flashings from being blown loose by wind. Exposed fasteners should be sealed periodically to prevent moisture intrusion into the roof structure.

Contact a qualified professional.

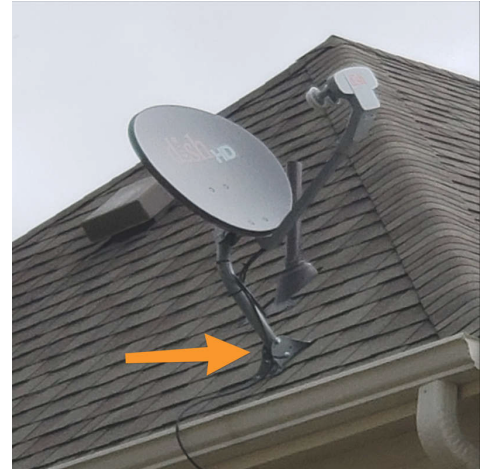
2.3.2 C. Roof Covering Materials

SATELLITE BOLTED THROUGH ROOF

ROOF COVERING

Satellite dishes bolted through the roof surfaces is not a recommended configuration. The penetrations should be properly sealed.

Recommendation
Contact a qualified professional.

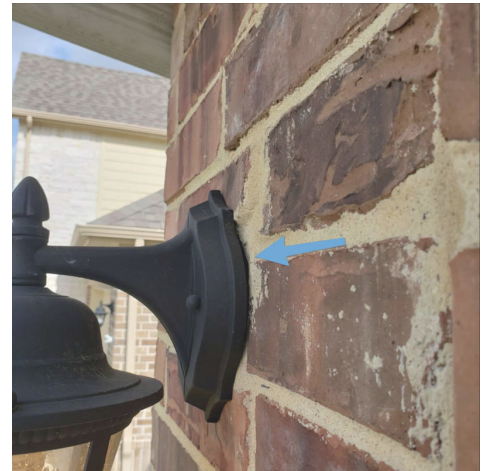
2.5.1 E. Walls (Interior and Exterior)

SEAL PENETRATIONS

EXTERIOR WALLS VARIOUS LOCATIONS

Exterior wall penetrations had gaps that should be sealed with an appropriate sealant to prevent moisture and insect entry.

Recommendation
Contact a qualified professional.

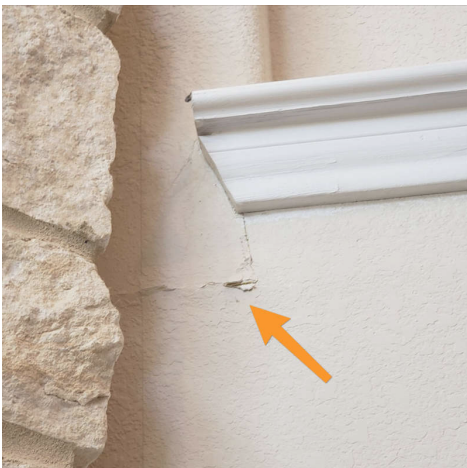
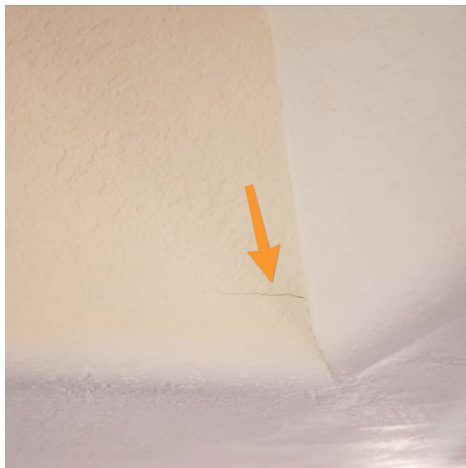
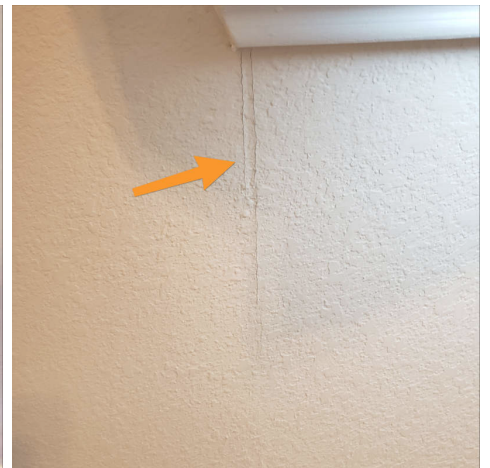
2.5.2 E. Walls (Interior and Exterior)

TYPICAL INTERIOR WALL CRACKS

LIVING AREA NEAR FIREPLACE, UPSTAIRS LOFT, UPSTAIRS BEDROOM #3

Interior wall cracks were observed on the interior walls of the structure. In my opinion, the wall cracks appeared to be typical for a home of this age. This can imply some structural movement of the structure has occurred, as is typical of most houses. We recommend the cracks be monitored.

Recommendation
Recommend monitoring.

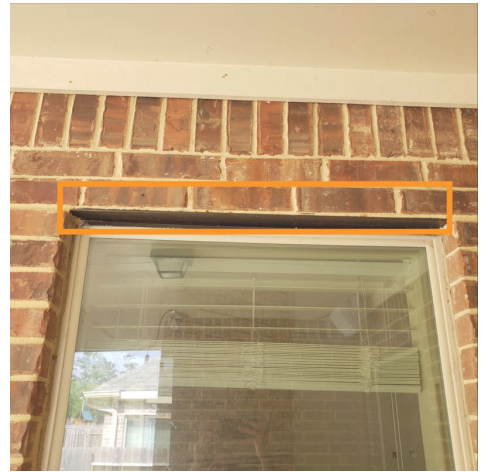
2.5.3 E. Walls (Interior and Exterior)

WEEP HOLES NOT PRESENT

BACK PORCH

Weep holes were not present above all of the exterior steel lintels. Older homes not equipped with weep holes above these steel lintels are not required to install them.

Contact a qualified masonry professional.

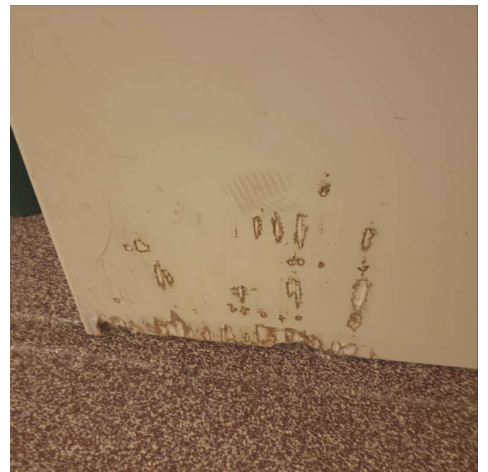
2.5.4 E. Walls (Interior and Exterior)

DRYWALL FLAWS

GARAGE

Damage/flaws to the interior drywall was observed. These areas appeared to be cosmetic and may required for our well repair.

Contact a qualified professional.

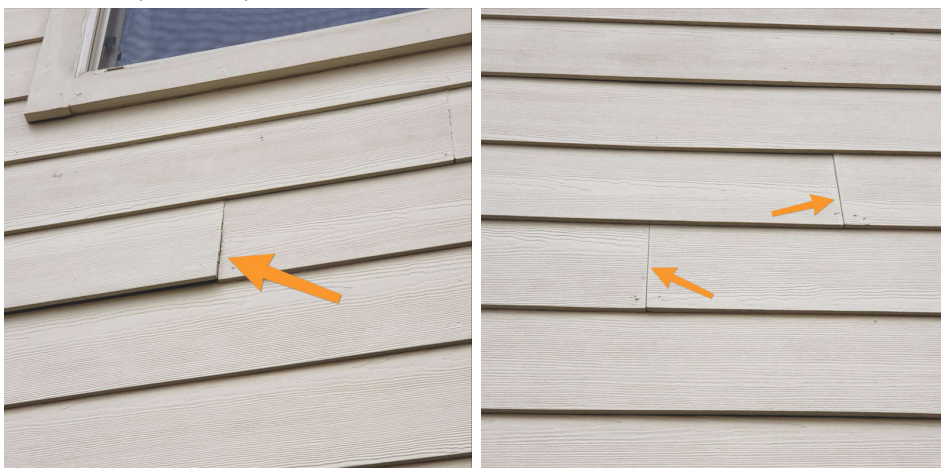
2.5.5 E. Walls (Interior and Exterior)

SIDING CAULKING

VARIOUS EXTERIOR LOCATIONS

Cracking, deteriorated, and/or missing sealant was observed around exterior wall connection joints. It is recommended all joints be properly sealed to prevent moisture intrusion.

Contact a qualified professional.

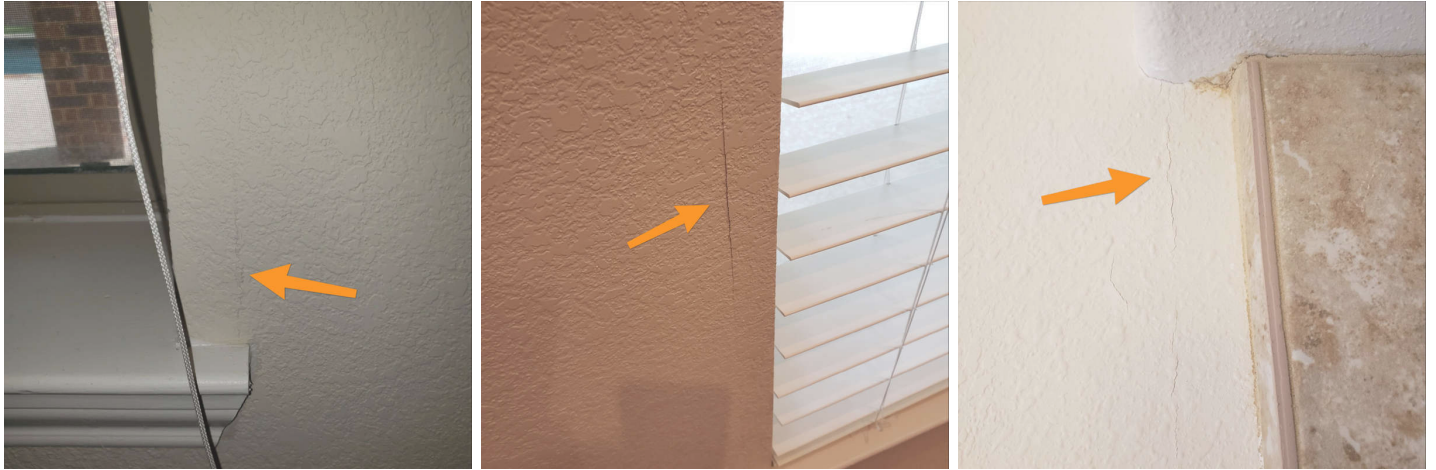
2.5.6 E. Walls (Interior and Exterior)

DRYWALL JOINT SEPERATION CRACKS

LIVING ROOM, MASTER BATHROOM

Dry wall joint separation cracks were observed. These cracks are mainly cosmetic. Cosmetic improvements may be necessary.

Recommendation
Contact a qualified professional.

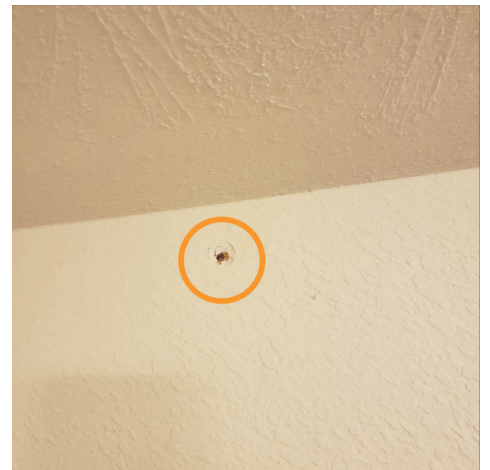
2.5.7 E. Walls (Interior and Exterior)

NAIL POPS

UPSTAIRS HALL

Nail pops were observed on the interior ceilings. Cosmetic improvements are recommended.

Recommendation
Contact a qualified professional.

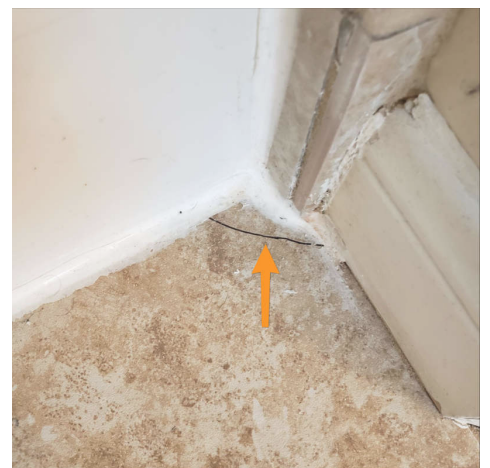
2.6.1 F. Ceilings and Floors

CRACKED FLOOR TILE

MASTER BATHROOM

Cracked floor tiles visible at the time of the inspection will need to be replaced.

Recommendation
Contact a qualified flooring contractor

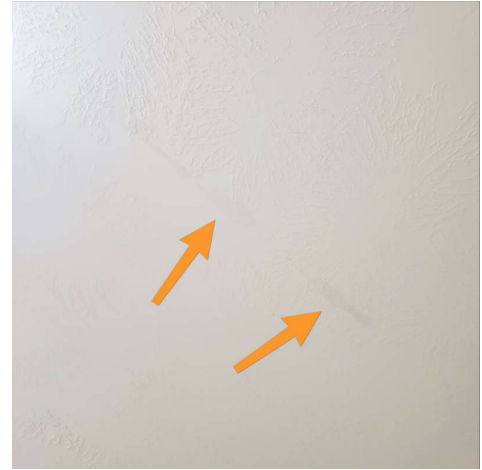
2.6.2 F. Ceilings and Floors

STAINS - PREVIOUS MOISTURE

MASTER CLOSET

Stains visible on the ceiling at the time of inspection appear to be from previous leakage or the source of moisture may be inactive. The moisture meter and/or thermal imaging did not indicate elevated levels of moisture, which may suggest the leak has been repaired.

Recommendation
Recommend monitoring.

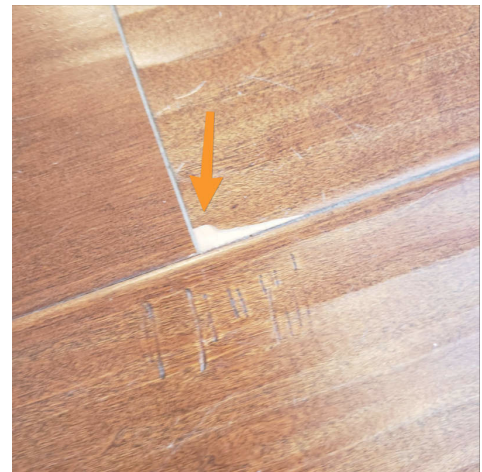
2.6.3 F. Ceilings and Floors

WOOD FLOOR DAMAGE

LIVING ROOM

Wood floors were damaged or deteriorated in areas of the home and may need to be repaired or replaced.

Recommendation
Contact a qualified flooring contractor

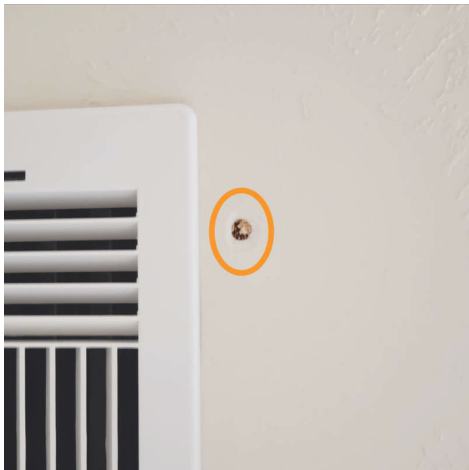
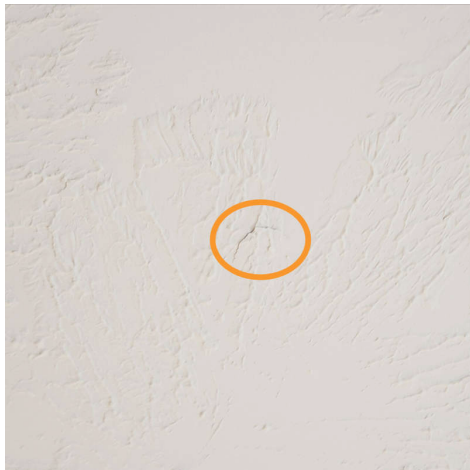
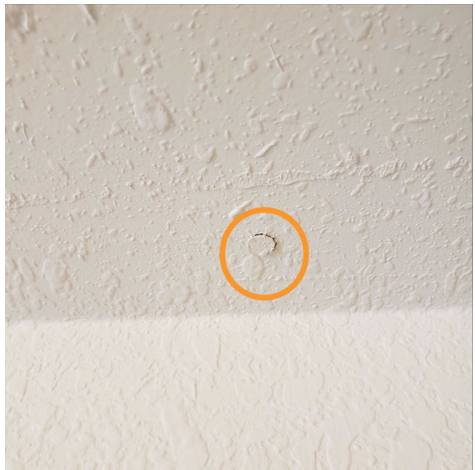
2.6.4 F. Ceilings and Floors

NAIL POP

MASTER CLOSET, MASTER BATHROOM, UPSTAIRS BEDROOM #1

Nail pops were observed on the interior ceilings. Cosmetic improvements are recommended.

Recommendation
Contact a qualified professional.

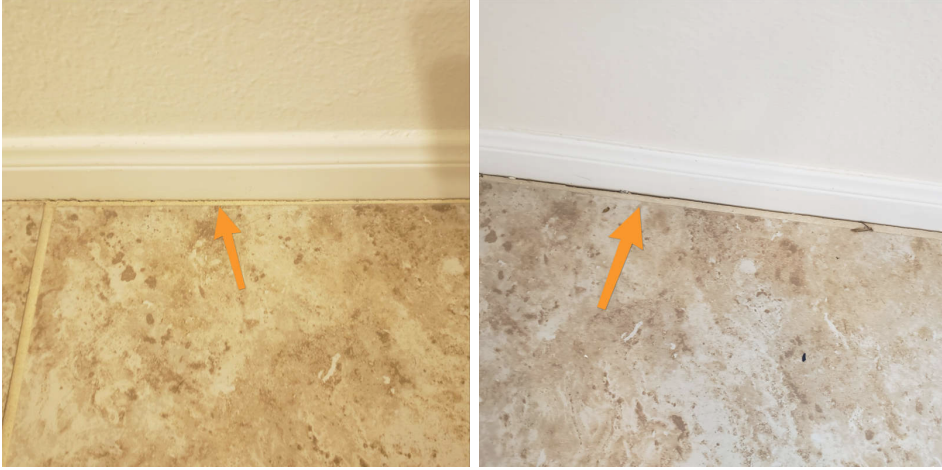
2.6.5 F. Ceilings and Floors

FLOOR/TRIM CAULK

BATHROOM #1, ROOM DOWNSTAIRS BY BACK DOOR

Where the interior flooring meets the trim, sealant was observed to be missing. Recommend repair/correction by a qualified professional.

Contact a qualified professional.

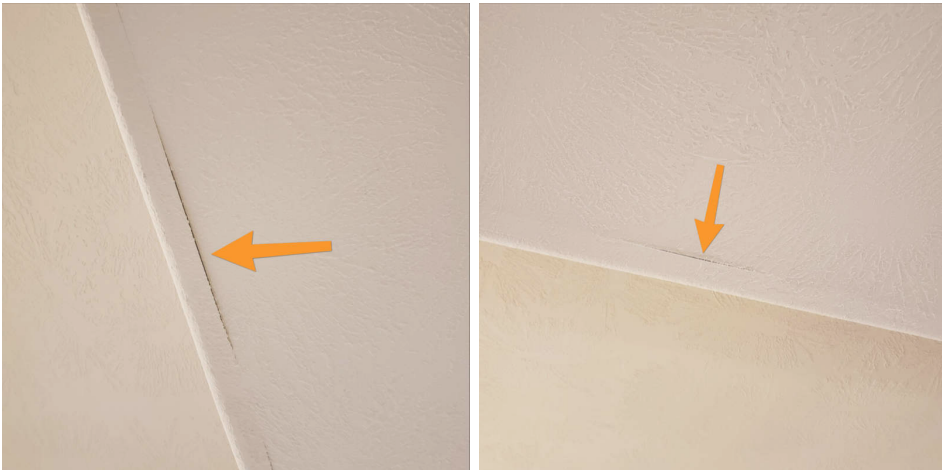
2.6.6 F. Ceilings and Floors

DRYWALL JOINT SEPERATION CRACKS

UPSTAIRS LOFT

Dry wall joint separation cracks were observed. These cracks are mainly cosmetic. Cosmetic improvements may be necessary.

Contact a qualified professional.

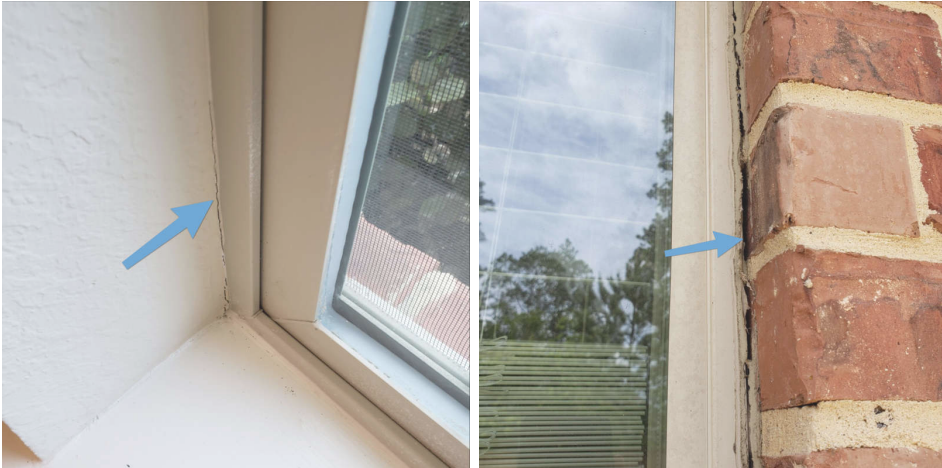
2.8.1 H. Windows

WINDOW CAULK

VARIOUS LOCATIONS

Cracking, deteriorated, and/or missing caulking/sealant was noted around the interior/exterior of windows. Repair/replacement of the caulking/sealant is recommended.

Contact a qualified professional.

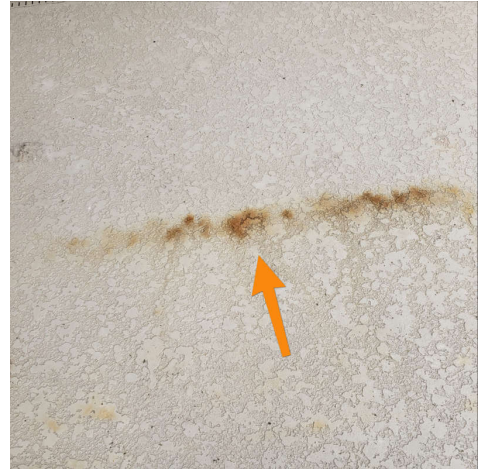
2.11.1 K. Porches, Balconies, Decks and Carports

BACK PORCH UNKNOWN STAINS

Stains were observed on the back porch. The cause of the stains were unable to be determined. Further investigation may be necessary.

Contact a qualified professional.

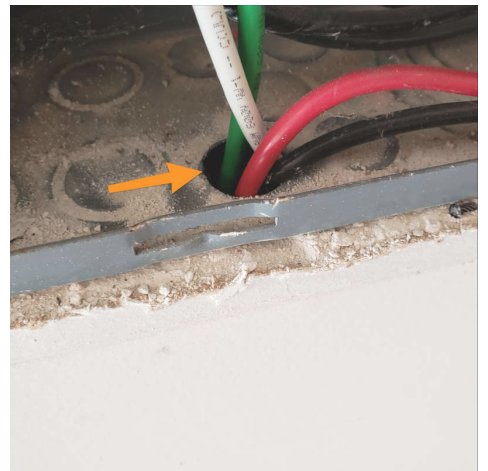
3.1.1 A. Service Entrance and Panels

BUSHING

A bushing was not installed where wiring entered the panel. It is recommended to have this condition corrected to help protect the wires from being damaged by the metal edges of the cabinet or fitting.

Contact a qualified electrical contractor.

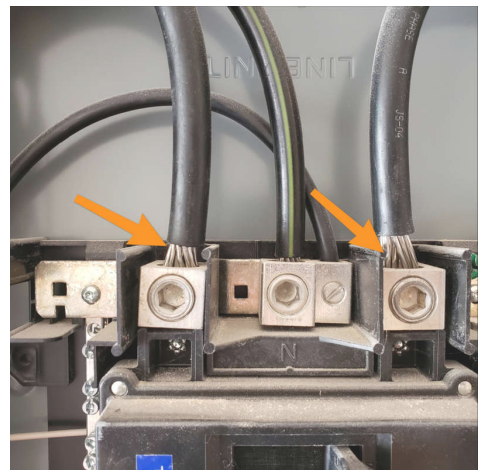
3.1.2 A. Service Entrance and Panels

ANTI-OXIDANT COMPOUND

Anti-Oxidant compound was not visible where aluminum service wires were connected in the panel. This is a maintenance item that should be corrected by a qualified professional to help prevent oxidation of aluminum wires.

Contact a qualified electrical contractor.

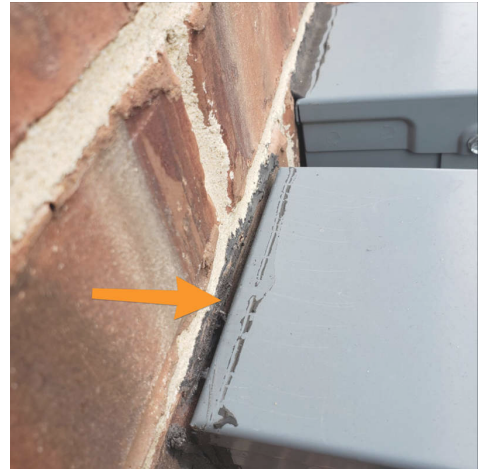
3.1.4 A. Service Entrance and Panels

DISCONNECT NOT SEALED

NORTH EXTERIOR WALL

The electrical disconnect located on the exterior walls should be properly sealed.

Recommendation
Contact a qualified professional.

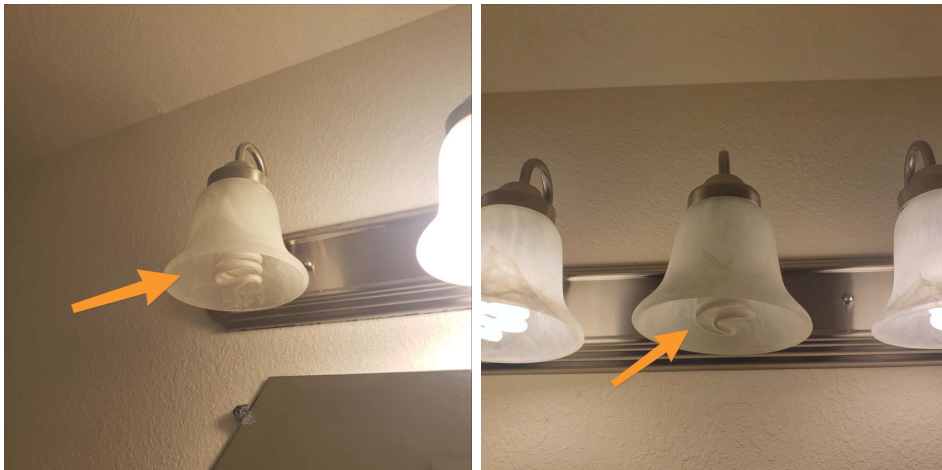
3.2.1 B. Branch Circuits, Connected Devices and Fixtures

NO RESPONSE - LIGHT

BATHROOM #1, UPSTAIRS BATHROOM #2, BACK PORCH

One or more light fixtures did not respond to the switch. The bulb may need to be replaced or there may be a problem with the switch, wiring or light fixture. If after the bulb is replaced this light still fails to respond to the switch, then correction by a qualified professional may be necessary.

Recommendation
Contact a qualified professional.

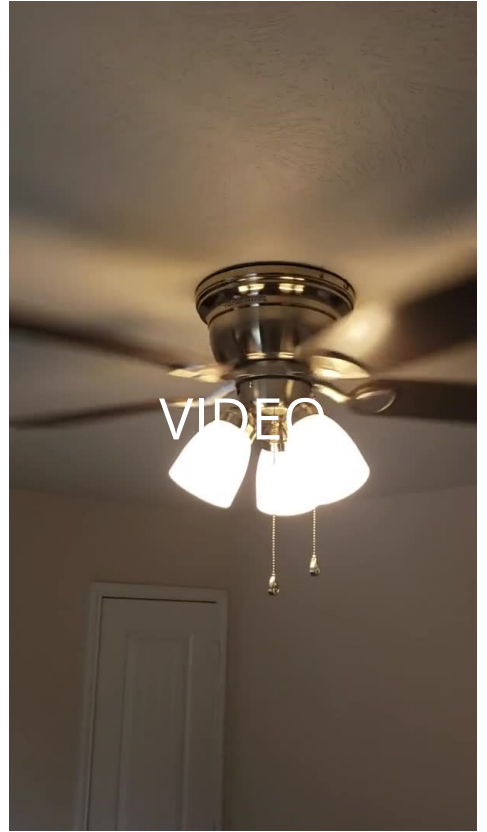
3.2.2 B. Branch Circuits, Connected Devices and Fixtures

CEILING FAN WOBBLED

UPSTAIRS BEDROOM #2

A ceiling fan wobbled during operation and appeared to be out of balance. This condition may eventually cause the fan to come loose from its mounting device and fall. The inspector recommends correction by a qualified contractor.

Recommendation
Contact a qualified professional.

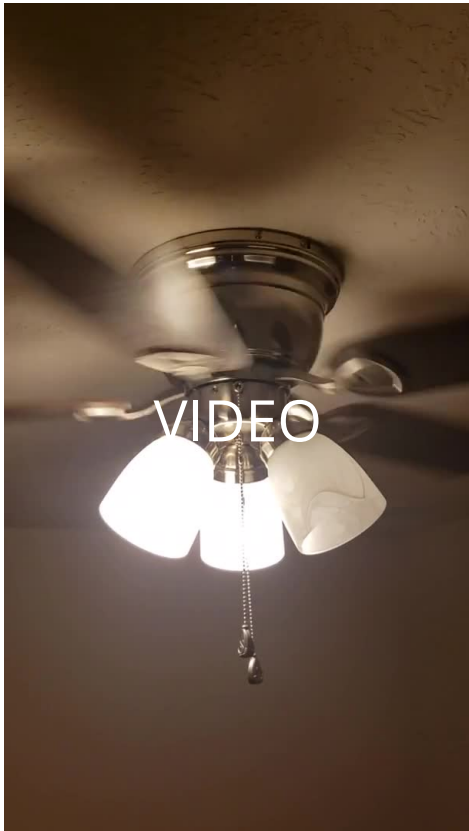
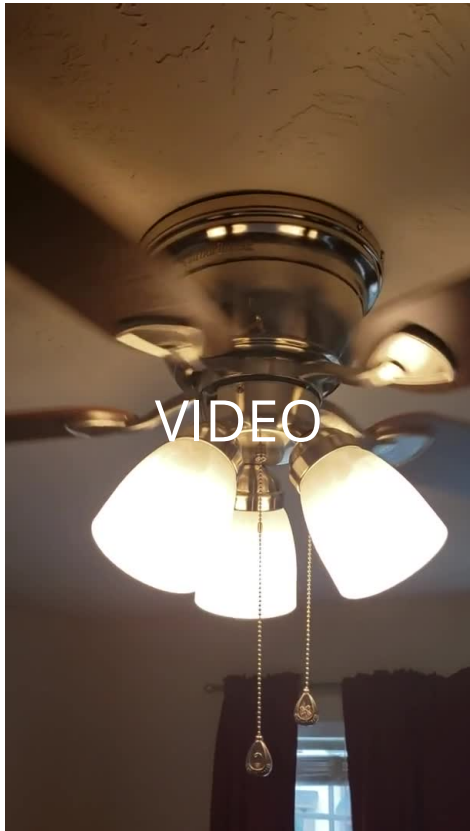
3.2.3 B. Branch Circuits, Connected Devices and Fixtures

CEILING FAN NOISY

UPSTAIRS GAME ROOM, UPSTAIRS BEDROOM #3

A ceiling fan was noisy during operation. This condition is typical of deteriorated fan components. Consider fan repair or replacement.

Contact a qualified professional.

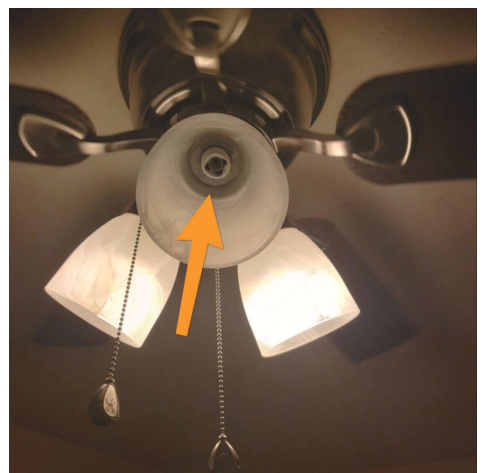
3.2.5 B. Branch Circuits, Connected Devices and Fixtures

MISSING BULBS

UPSTAIRS GAME ROOM

Light fixtures with missing bulbs were observed. The fixtures where bulbs were missing were unable to be tested.

Contact a qualified professional.

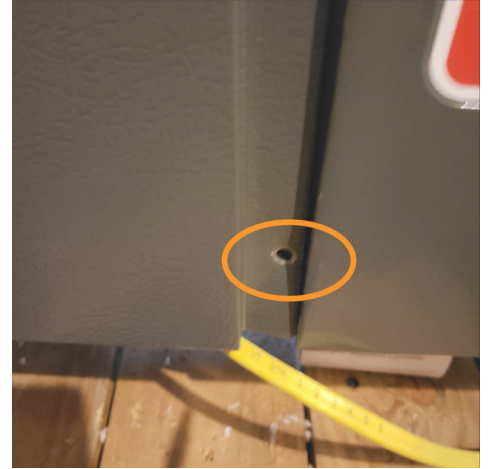
4.1.1 A. Heating Equipment

MISSING COVERPLATE SCREWS

UNIT #1

One or more furnace cover plates were observed to be missing screws. Recommend having the screws to the cover plate replaced by a qualified professional.

Contact a qualified professional.

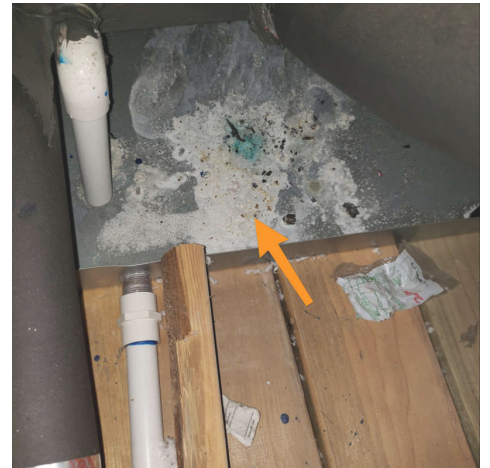
4.2.1 B. Cooling Equipment

RUSTED DRAIN PAN

The drain pan is rusted and may fail prematurely. This should ideally be corrected to help prevent water intrusion into the wall/ceiling structure.

Contact a qualified professional.

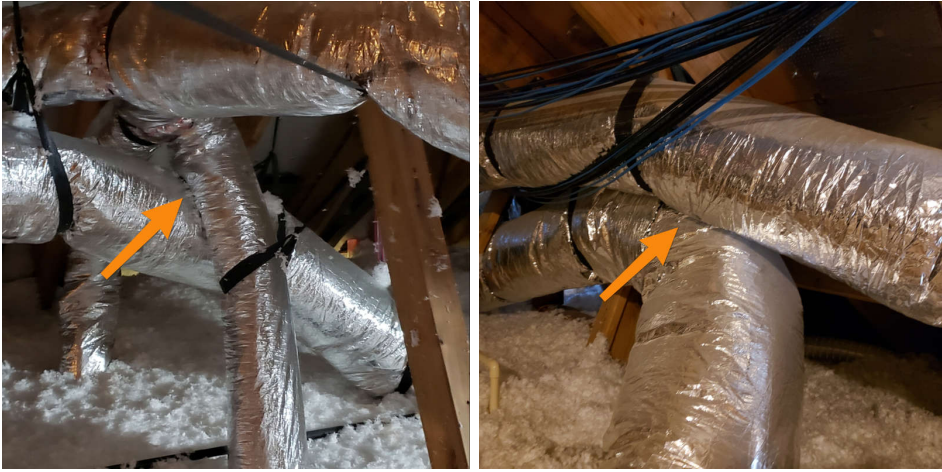
4.3.1 C. Duct Systems, Chases and Vents

DUCTS TOUCHING

Various supply/return ducts were observed to be in contact with each other. Condensation can develop between contacted areas of the duct work. Separation of contacted ducts is recommended.

Contact a qualified professional.

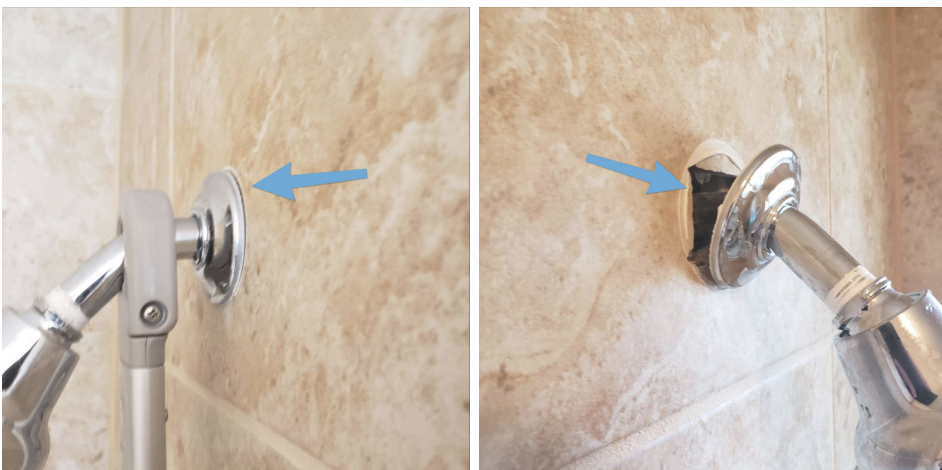
5.1.2 A. Plumbing Supply, Distribution System and Fixtures

DETERIORATED CAULKING

Cracking, deteriorated, and/or missing shower caulk should be replaced.

Recommendation
Recommended DIY Project

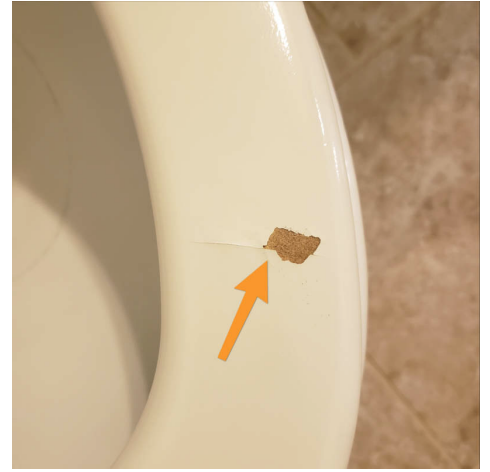
5.1.3 A. Plumbing Supply, Distribution System and Fixtures

TOILET LID DAMAGED

DOWNSTAIRS BATHROOM #1

Toilet lids for one or more toilets were observed to be damaged. Recommend this issue be corrected by a qualified professional.

Recommendation
Contact a qualified professional.

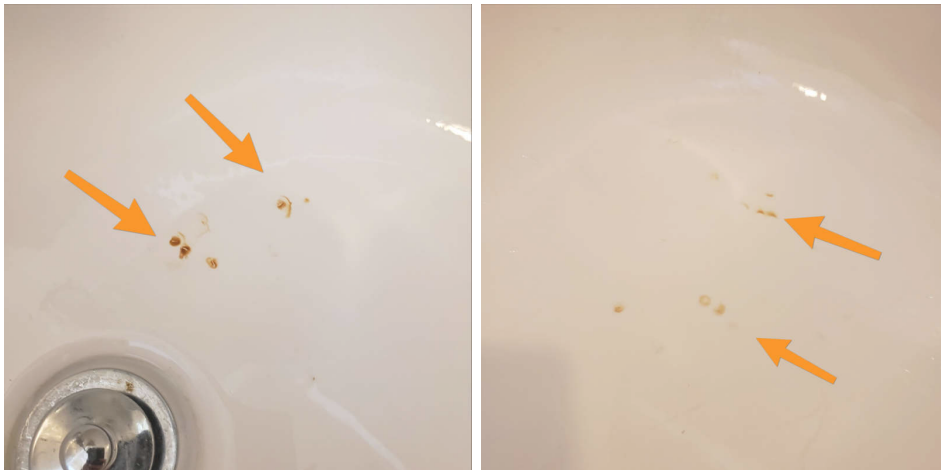
5.1.4 A. Plumbing Supply, Distribution System and Fixtures

RUST STAINS

Rust stains were observed in upstairs bathroom number one bath to up at the time of the inspection. Recommend cleaning.

Recommendation
Contact a qualified professional.

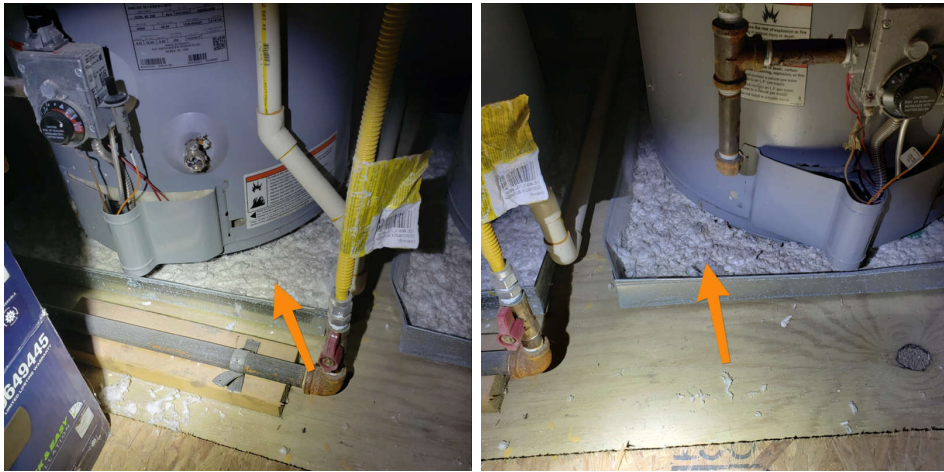
5.3.1 C. Water Heating Equipment

DEBRIS IN WATER HETER DRAIN PAN

Insulation/debris was observed in the drain pan under the water heaters. Insulation/debris should be removed so that the drain line for the drain pan does not become clogged/blocked. (Both Units)

Recommendation
Contact a qualified professional.

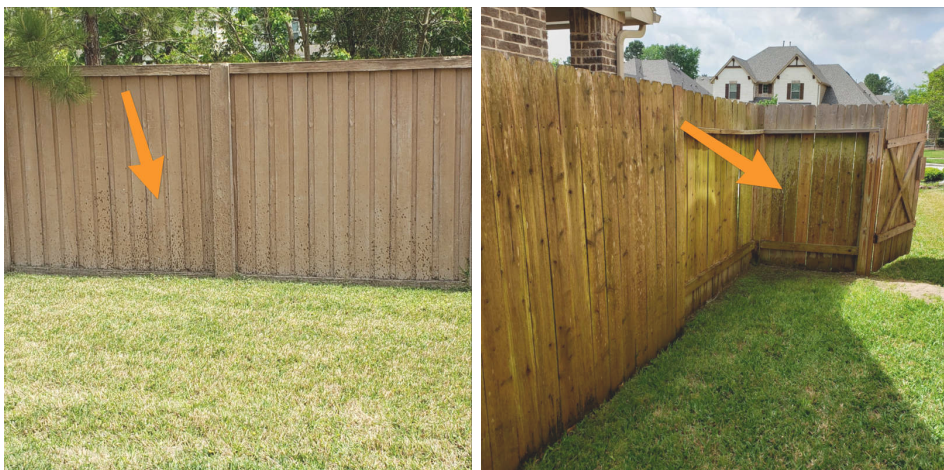
7.1.1 A. Landscape Irrigation (Sprinkler) Systems

RE-DIRECT SPRINKLER HEADS

The water spray from multiple sprinkler heads should be re-directed away from the structure and/or any fencing, decks, etc., to decrease the possibility of damage.

Recommendation
Contact a qualified professional.

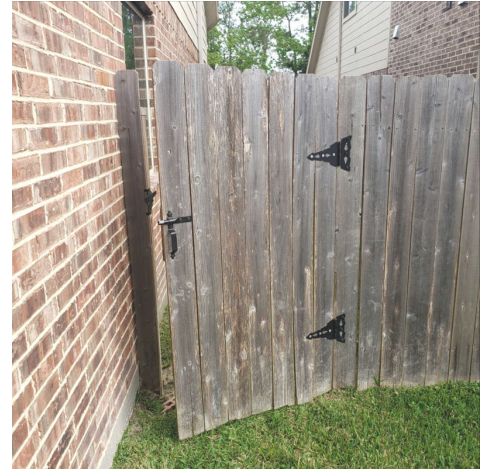
7.2.1 B. Swimming Pools, Spas, Hot Tubs, and Equipment

BACK GATE NOT SELF CLOSING/LATCHING

The back gate should be self closing and self latching as a safety precaution.

Recommendation
Contact a qualified professional.

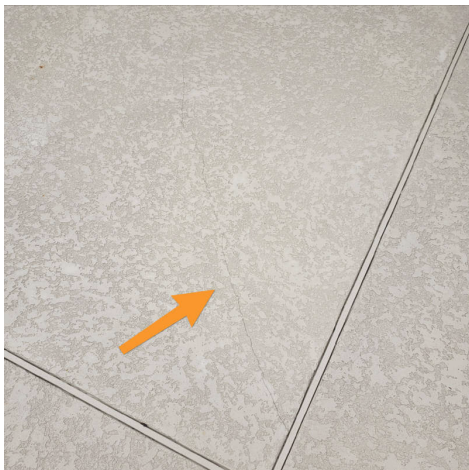
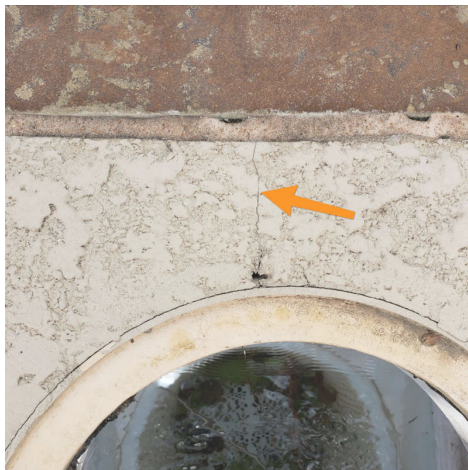
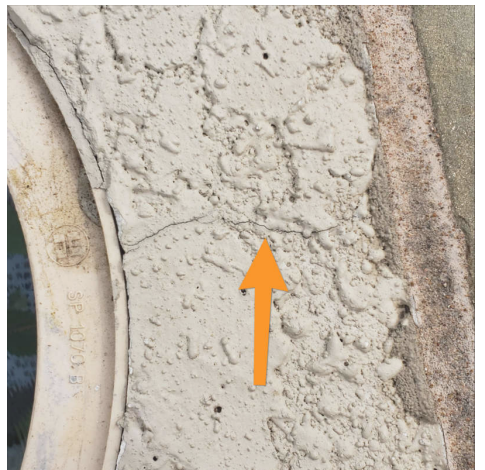
7.2.2 B. Swimming Pools, Spas, Hot Tubs, and Equipment

DECKING CRACKED/DAMAGED

Decking to the pool was observed to be cracked/damaged.

Recommendation
Contact a qualified professional.

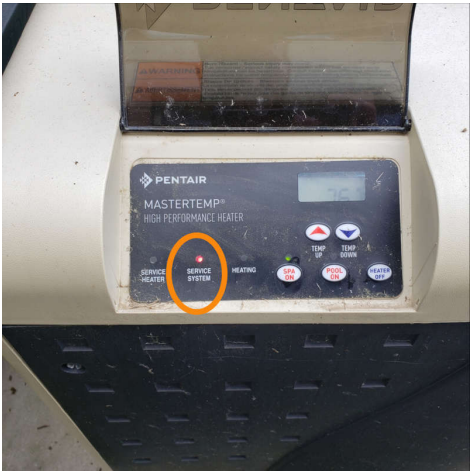
7.2.4 B. Swimming Pools, Spas, Hot Tubs, and Equipment

POOL HEATER

The pool heater service spa system light was on when operated.
Recommend further evaluation by a qualified professional.

Recommendation
Contact a qualified professional.
