SUMMARY
1234 Main St. Columbia MD 21044
Buyer Name
07/06/2019 9:00AM

Steven Madewell
MD License #33112
Madewell Inspection Services, LLC
(301) 404-8437

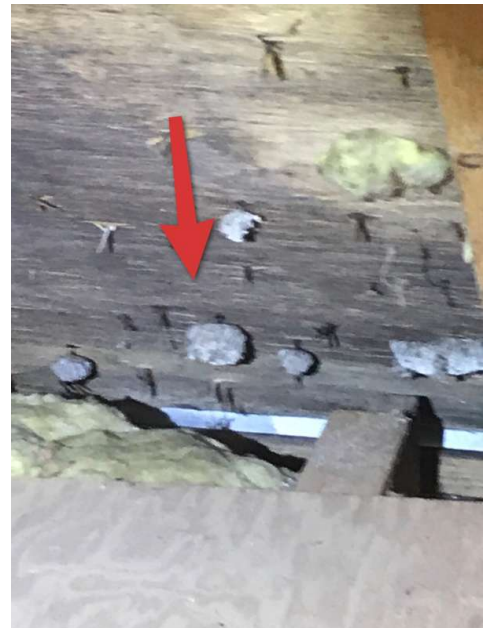
Wasp nests were found in the attic, detached garage, and barn / stable. These can pose a safety hazard. A pest control pro should remove nests or exterminate as necessary.

Active Wasp Nests In Attic

Contact a qualified pest control specialist.

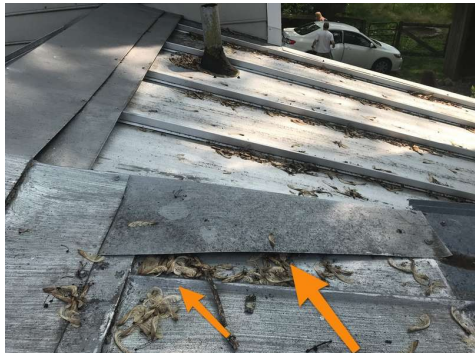
The metal ridge vent covering the first floor roof was made from two sections of metal. The seam along the midline of the ridge vent was not consistently sealed and may allow moisture intrusion. A smaller metal panel over a transition was also unsealed and may collect debris resulting in moisture intrusion or corrosion of the metal roof.

Unsealed Opening

The inspector recommends these openings be evaluated and repaired as needed by a qualified roofing contractor.

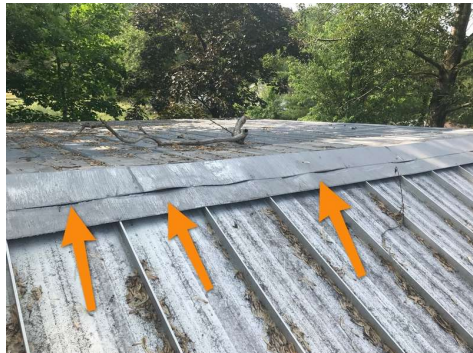
Unsealed Areas Of Ridge Vent

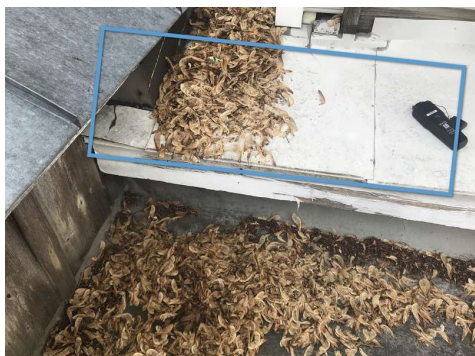
Moisture damage and deterioration of roof sheathing below one section of flashing was visible at the time of the inspection. The moisture meter showed elevated levels of moisture present in these areas indicating recent moisture intrusion.

Moisture Intrusion / Deterioration of Wood Sheathing Beneath Flashing

The inspector recommends a qualified roofing contractor determine the source of the moisture intrusion and repair.

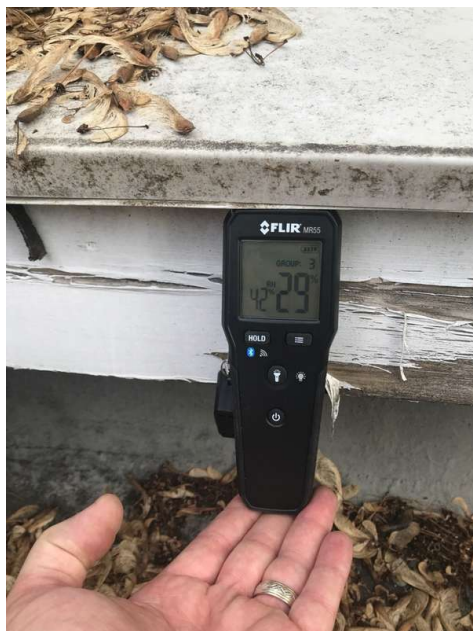
Elevated Moisture Level In Wood Sheathing

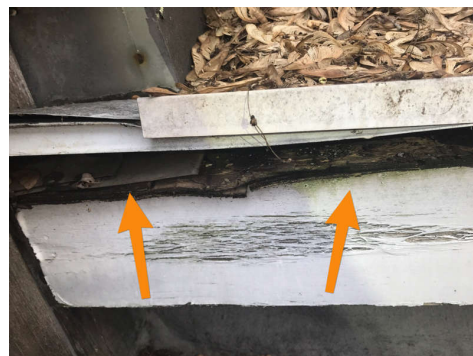
Deteriorated Roof Sheathing

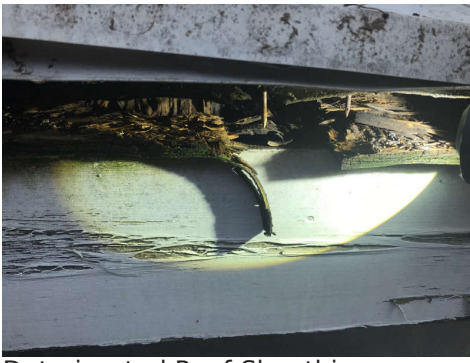
Deteriorated Roof Sheathing

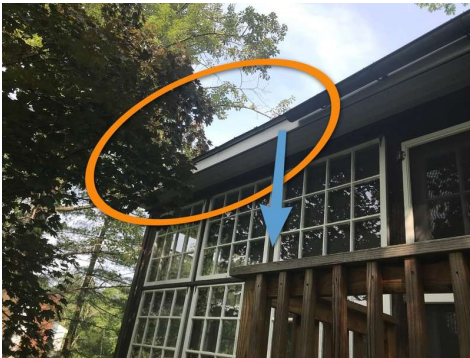
The roof on the rear side of the home had gutters in one portion above the door, with no downspout. Portions of the home without gutters / downspouts may experience excessive moisture levels in soil near the foundation. This condition can result in excessively high moisture levels in soil at the foundation. Excessive moisture levels in soil near the foundation can effect the ability of the soil to support the weight of the structure above. The Inspector recommends repair of the roof drainage system to help protect the home structure and occupants.

Missing Gutter And Downspout

Contact a qualified gutter contractor

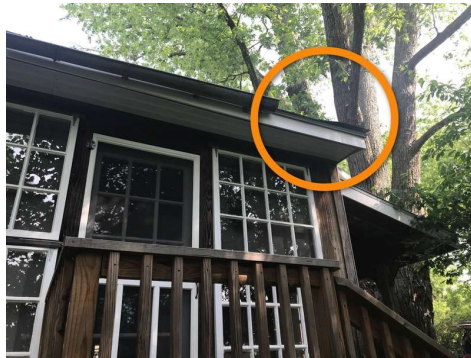
Missing Gutter

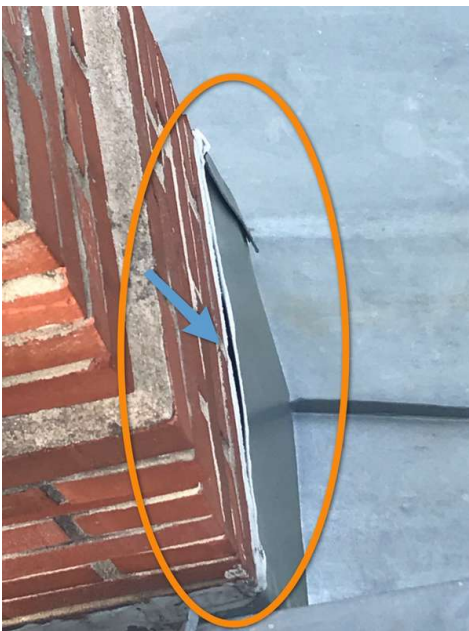
Flashings observed to be loose or separated, which can lead to water intrusion and/or mold. Recommend a qualified roofing contractor repair.

Chimney Flashing Separated From Masonry

Contact a qualified roofing professional.

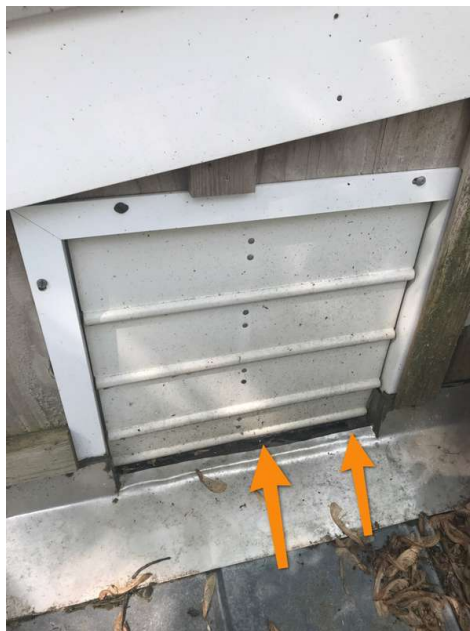
Gap In Flashing Below Sunroom Vent Fan

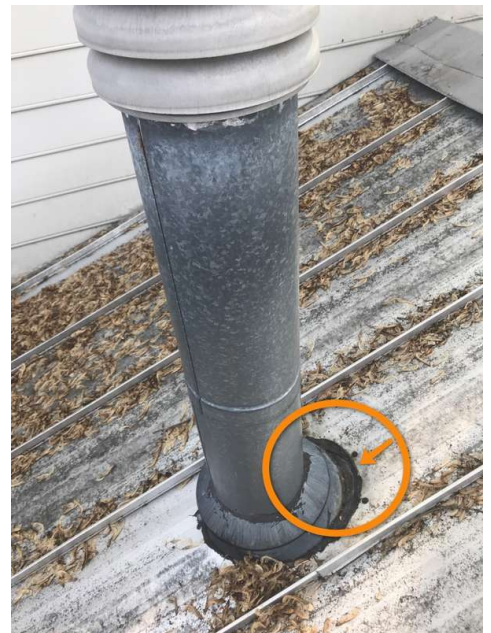
The metal roof penetration for the gas appliance chimney was poorly sealed. The sealant may trap water which can result in leaks or encourage corrosion of the metal roof. Recommend sealing this penetration with flashing or sealant so that water is diverted away from the chimney. Sealant will eventually dry, shrink and crack. These areas should be examined annually and an appropriate sealant re-applied as necessary by a qualified person.

Roof Sealant Traps Water

Contact a qualified roofing professional.

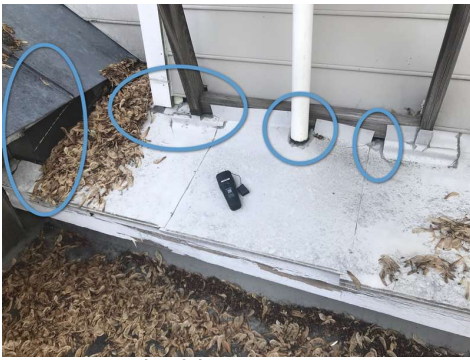
Flashing was installed in a manner that will route runoff beneath the roof-covering material. This condition is improper and may increase the chance of leakage and appears to have caused deterioration of the wood sheathing below the flashing. The Inspector recommends that you consult with a qualified roofing contractor to determine options and costs for correction.

Improper Flashing

Contact a qualified roofing professional.

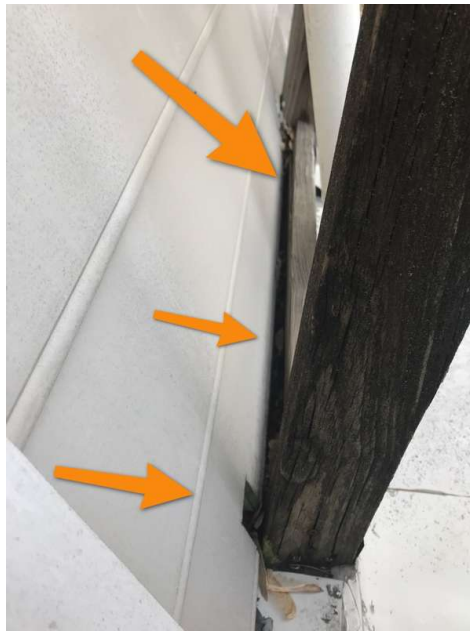
Missing Flashing / Unsealed Penetrations

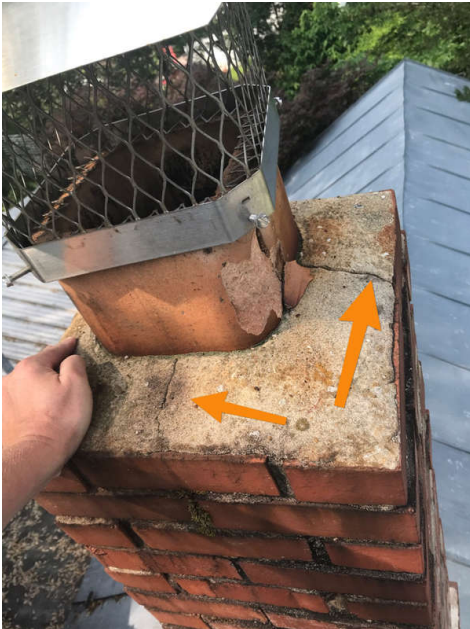
The chimney crown was cracked or damaged at the time of inspection. Cracks or missing mortar can allow moisture intrusion into the chimney and masonry, resulting in further damage to the masonry chimney and liner. Recommend a qualified chimney contractor evaluate and repair the chimney crown.

Cracked Chimney Crown

Contact a qualified chimney contractor.

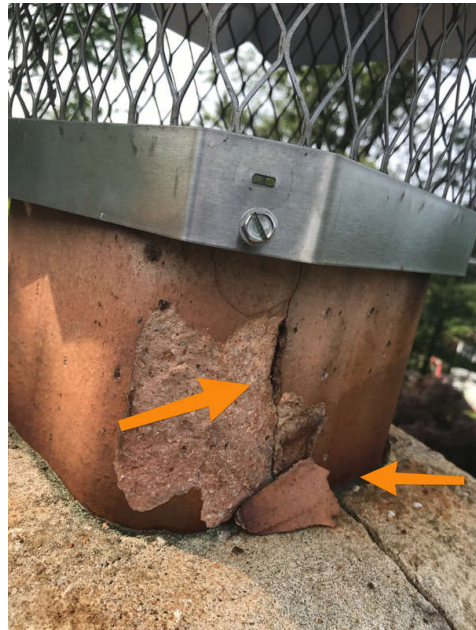
The top chimney flue tile was cracked. Cracked tiles may allow moisture or corrosive gasses to damage the chimney structure. Cracked tiles in the lower sections of the chimney may allow the toxic products of combustion to enter the living space.

Cracked Chimney Flue

The inspector recommends a qualified chimney contractor perform a **Level 2 Chimney Inspection** on the masonry chimney to ensure the chimney is safe for use.

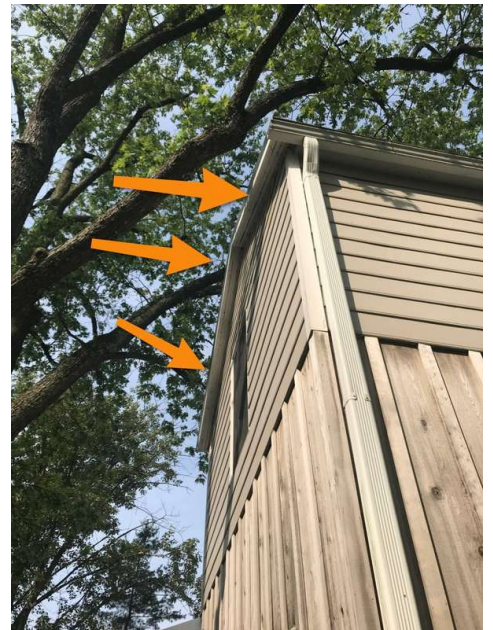
One or more sections of the eaves / fascia may be damaged from what appears to be carpenter bees. Carpenter bee frass was observed on the rear siding below the fascia and eaves. Recommend qualified roofer evaluate & repair.

Contact a qualified roofing professional.

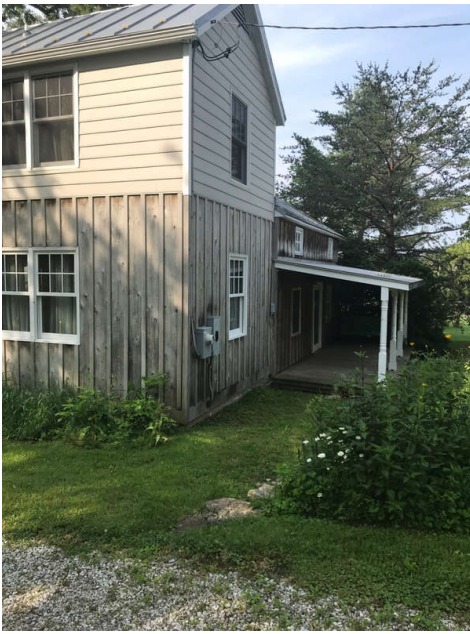
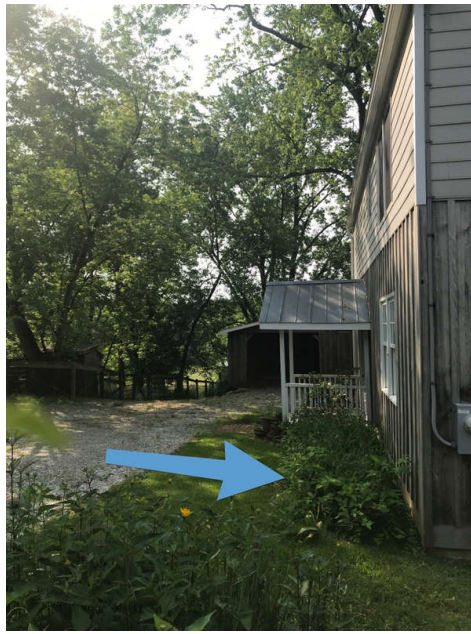
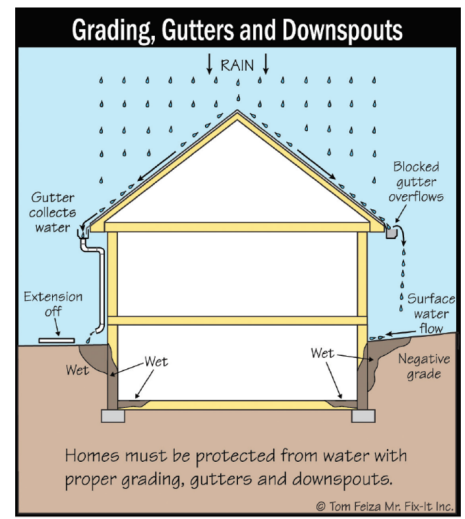
Grading is sloping towards the home in some areas. This could lead to water intrusion and foundation issues. Recommend qualified landscaper or foundation contractor regrade so water flows away from home.

Contact a qualified landscaping contractor

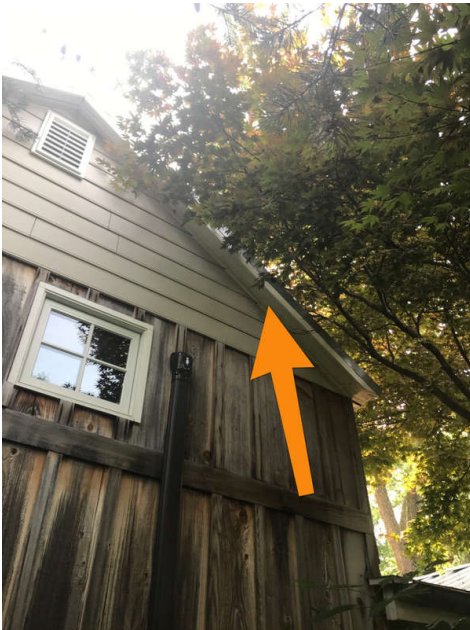
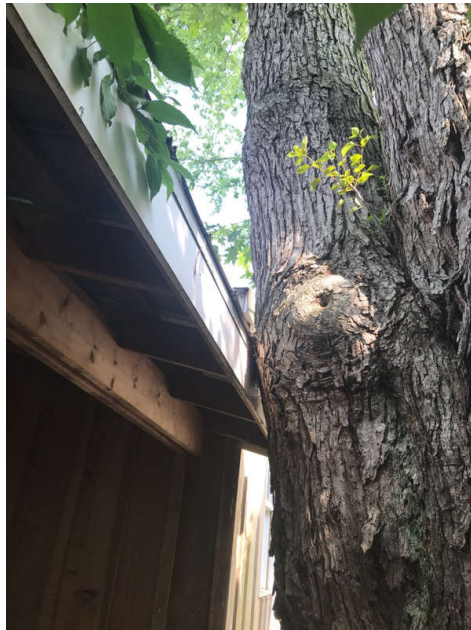
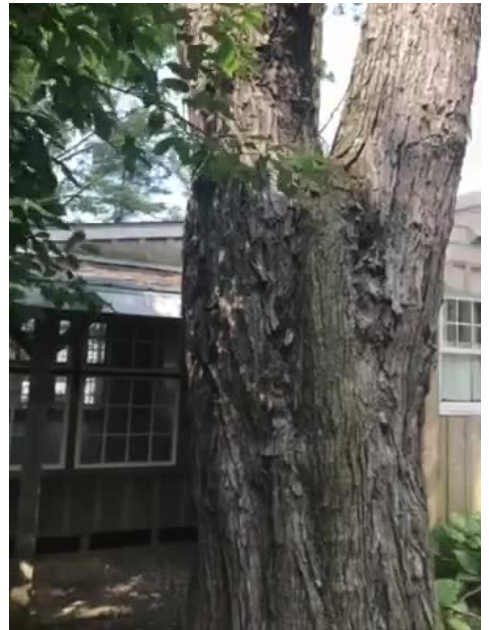
Trees were in contact with or were close to the building at one or more locations. Damage to the building can occur, especially during high winds, or may have already occurred (see other comments in this report if applicable). Recommend that a qualified tree service contractor or certified arborist remove trees as necessary to prevent damage to the building exterior.

Contact a qualified tree service company.

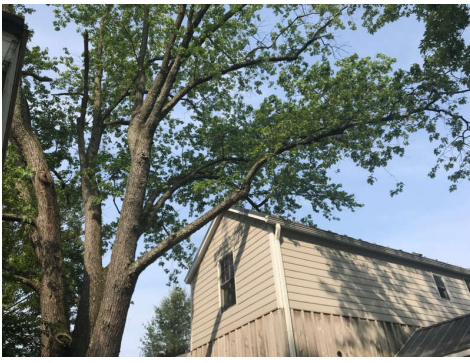
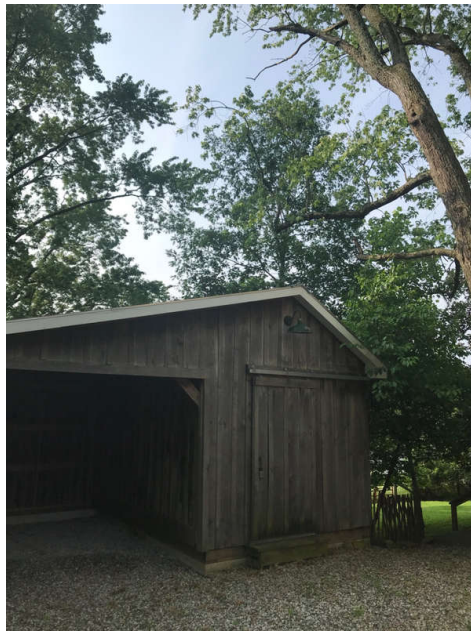
Trees observed overhanging the roof. This can cause damage to the roof and prevent proper drainage. Recommend a qualified tree service trim to allow for proper drainage.

Contact a qualified tree service company.

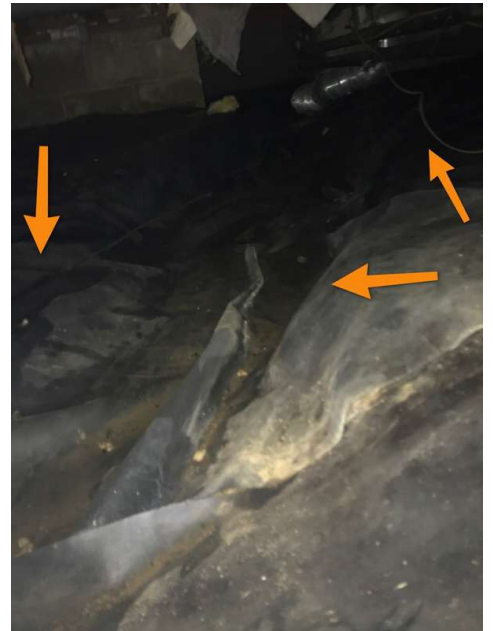
Standing pools (small) of water and condensation were found in multiple areas of the crawl space. Some minor seasonal water accumulation can be normal. However significant amounts of Water may evaporate and enter the structure above causing high levels of moisture in the structure. This can be a conducive condition for wood-destroying organisms. Rain runoff is the most common cause of wet crawl spaces but water can come from other sources such as groundwater or underground springs. Recommend monitoring the crawl space in the future, especially after heavy and/or prolonged periods of rain. Correct any issues related to outside perimeter grading and/or roof drainage (see any other comments about this in this report). Also, review any disclosure statements available and ask the property owner about past accumulation of water in the crawl space.

Standing Water In Crawlspace

If standing water persists or increases in amount, recommend that a qualified contractor who specializes in crawlspace or drainage issues evaluate and repair as necessary. Typically such repairs include:

- Repairing, installing or improving underground footing and/or curtain drains
- Applying waterproof coatings to foundation walls
- Digging trenches in the crawl space to collect or divert water
- Installing dehumidifiers or sump pumps

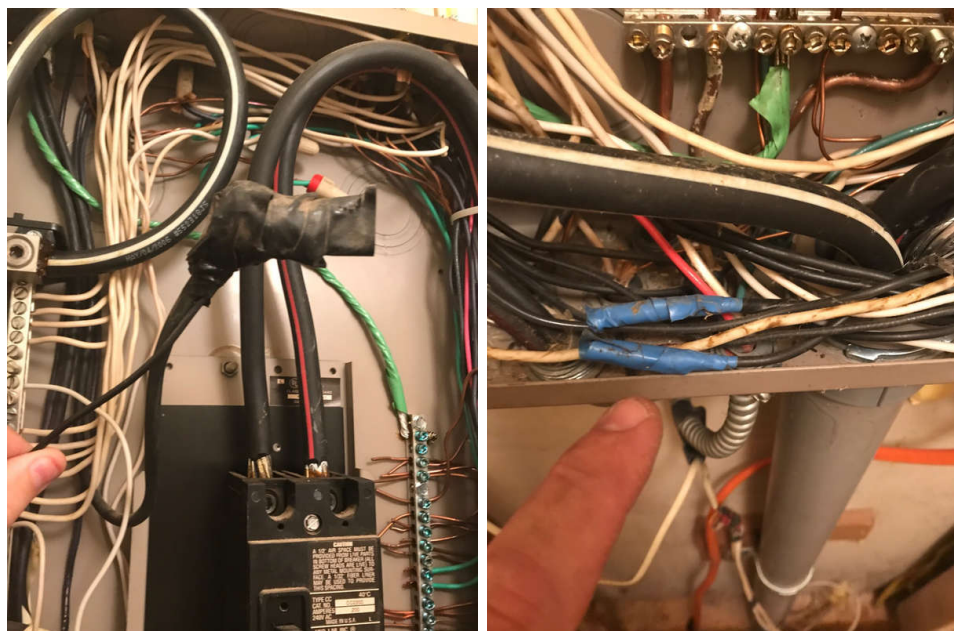
One or more wires inside panel were not properly spliced or terminated. This may pose a safety hazard for shock and/or fire. Recommend that a qualified electrician evaluate and correct to current building standards.

Recommendation
Contact a qualified professional.

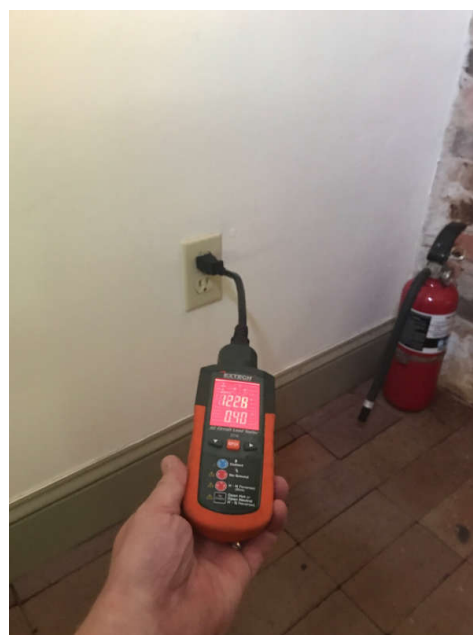
One modern, 3-slot electric receptacle was found with an open ground. This is a shock hazard when appliances that require a ground are used with these receptacles. Examples of such appliances include computers and related hardware, refrigerators, freezers, portable air conditioners, clothes washers, aquarium pumps, and electrically operated gardening tools. Recommend that a qualified electrician repair as necessary so the receptacle is grounded per standard building practices.

Ungrounded Receptacle (Behind Wood Stove)

Recommendation
Contact a qualified electrical contractor.

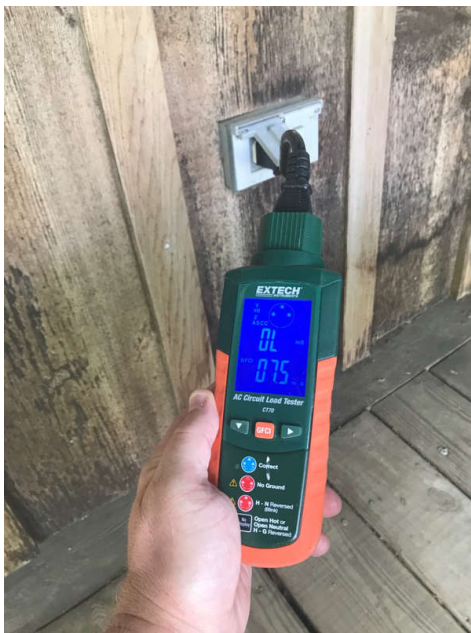
One or more locations at this property were noted as not having GFCI protection.

No GFCI On Front Porch

Adoption of GFCI outlets was generally phased in over numerous years/decades. Recommend client evaluate upgrading these areas to GFCI protection at their discretion.

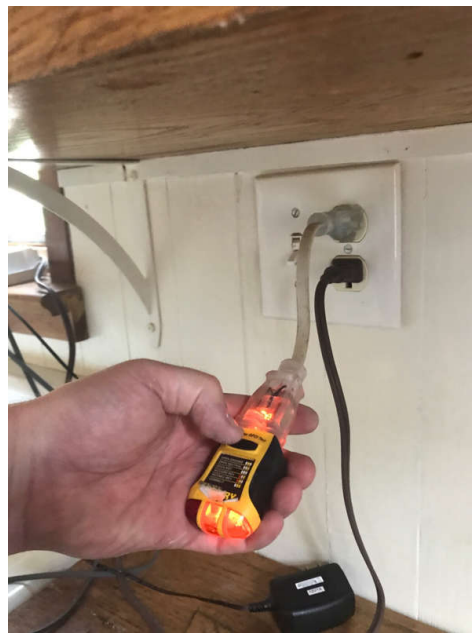
No GFCI In Kitchen (Near Sink)

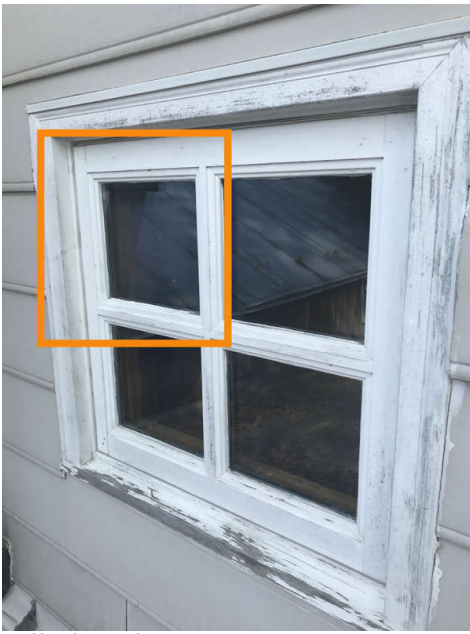
Condensation or staining was visible between multi-pane glass in one window located above the second floor staircase. This usually indicates that the seal between the panes of glass has failed or that the desiccant material that absorbs moisture is saturated. As a result, the view through the window may be obscured, the window's R-value will be reduced, and accumulated condensation may leak into the wall structure below. Recommend that a qualified contractor evaluate and repair windows as necessary. Usually, this means replacing the glass in window frames.

Failed Seal

Contact a qualified window repair/installation contractor.

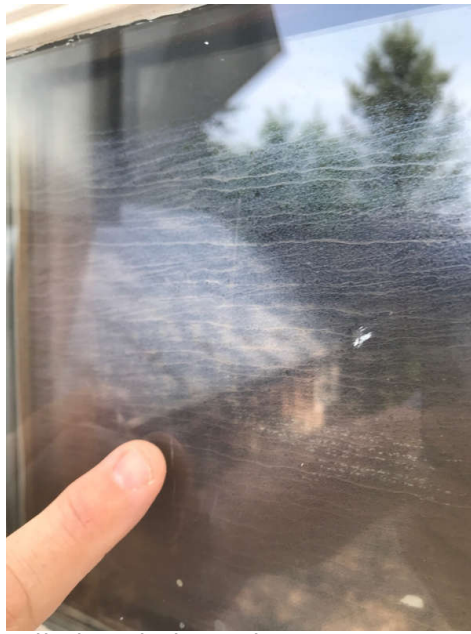
Failed Seal Close View

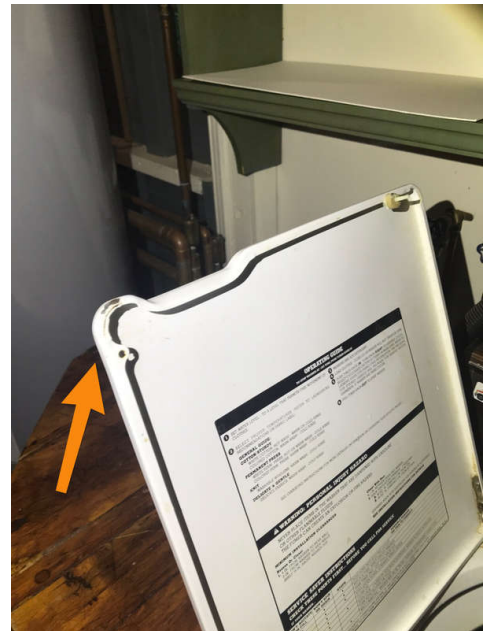
Rubber pad missing on washing machine lid. This allows the lid to rattle. Recommend replacing rubber pad.

Contact a qualified professional.

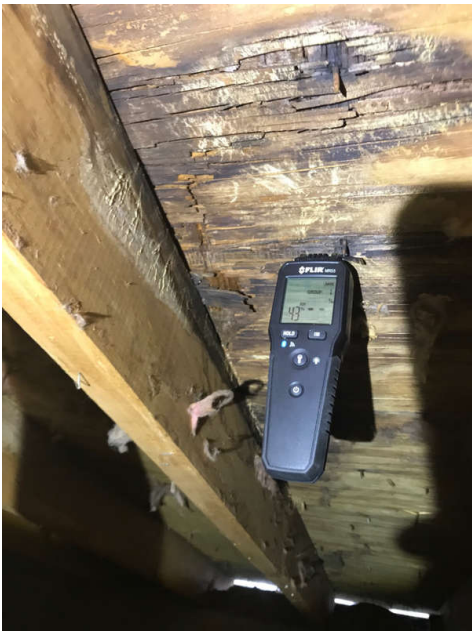
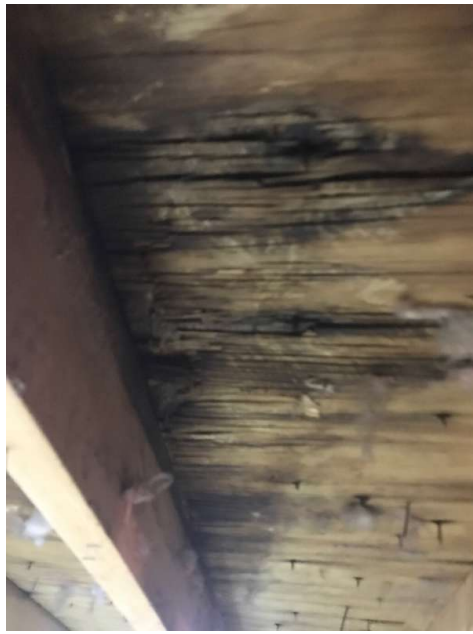
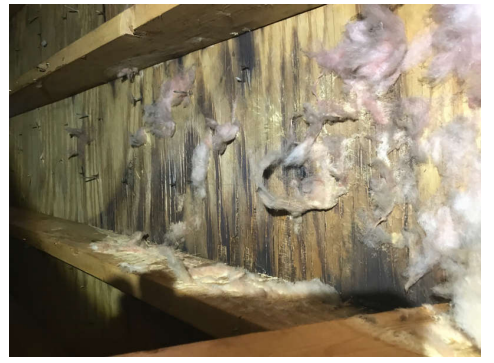
Stains visible in the roof sheathing indicated past roof leakage. The moisture meter showed no elevated levels of moisture present in the stained areas at the time of the inspection. In the Inspector's experience, this type of damage is typical of roof-covering materials which in the past have been allowed to deteriorate to the point at which they leak before being replaced.

Contact a qualified professional.
