SUMMARY

1234 Main St. Defiance Ohio 43512

Buyer Name
11/29/2018 9:00AM

Josh Frederick
InterNachi certified CPI
ASPEC Residential Services, LLC
4197828924
aspecresidential@gmail.com

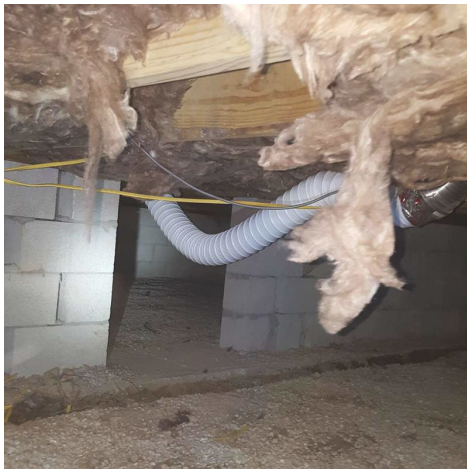
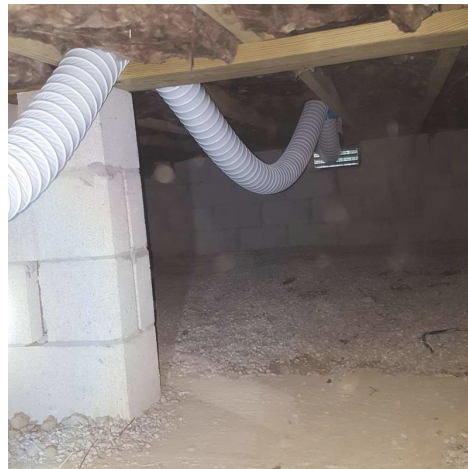
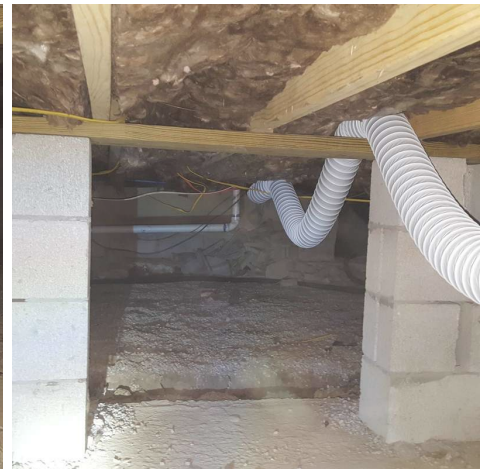
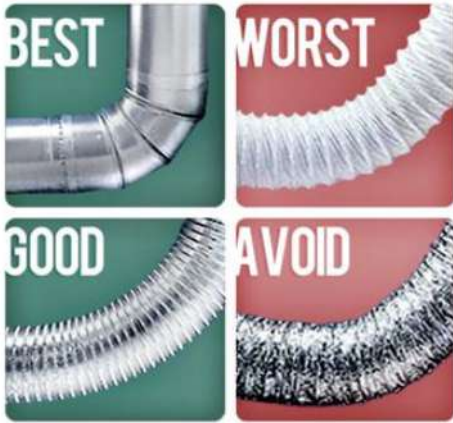
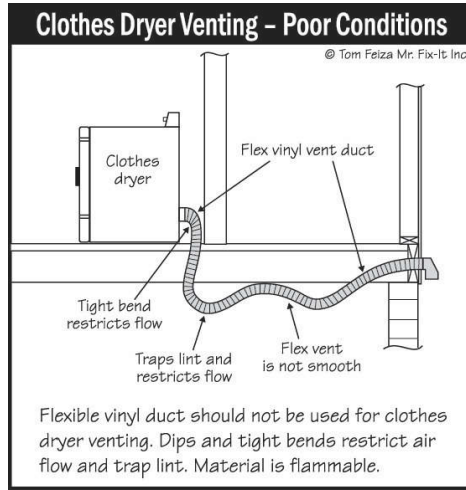
10.2.2 Dryer Vent

MATERIAL (PLASTIC CORRUGATED/ROLLER COASTER)

CRAWLSPACE

The dryer vent was the plastic, flexible type for the majority of the run. This type of dryer vent is not recommended and unsafe, as far as **fire safety**. Material presents a latent fire hazard. "Roller coaster" condition also present which restricts exhaust/air flow, presents water and lint "traps", and has been known to cause dryer fires - **safety concern**. Dryer vents should be smooth, rigid aluminum ducts, connected with appropriate tape (no screws), and vented to the exterior of the home. **Corrective action:** Have replaced with a proper material to reduce the likelihood of damage.

Contact a handyman or DIY project

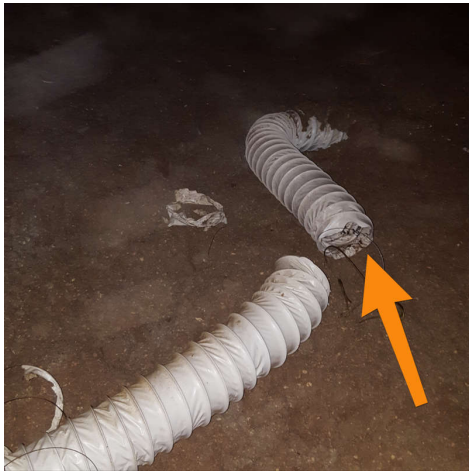
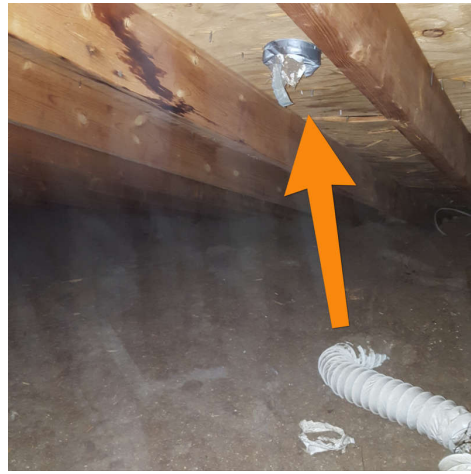
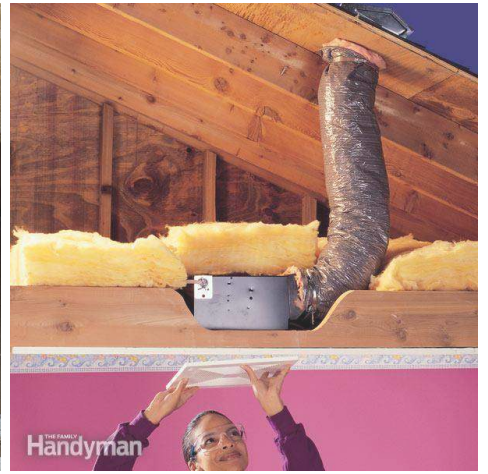
13.7.1 Exhaust Vents/Fans/Systems

BATH FAN (TERMINATION IN ATTIC)

HALL BATH .

Bath fan vented into the attic space or within the building envelope which is a poor practice. Bath fan exhaust/moisture should always be appropriately routed to the exterior to avoid moisture concerns within the attic areas/building envelope. **Corrective action:** Have a qualified contractor properly extend exhaust to the exterior to deter moisture/excess heat concerns. **NOTE:** Vent pipe also needs to be properly insulated when passing through an unconditioned area like the attic.

Contact a qualified professional.

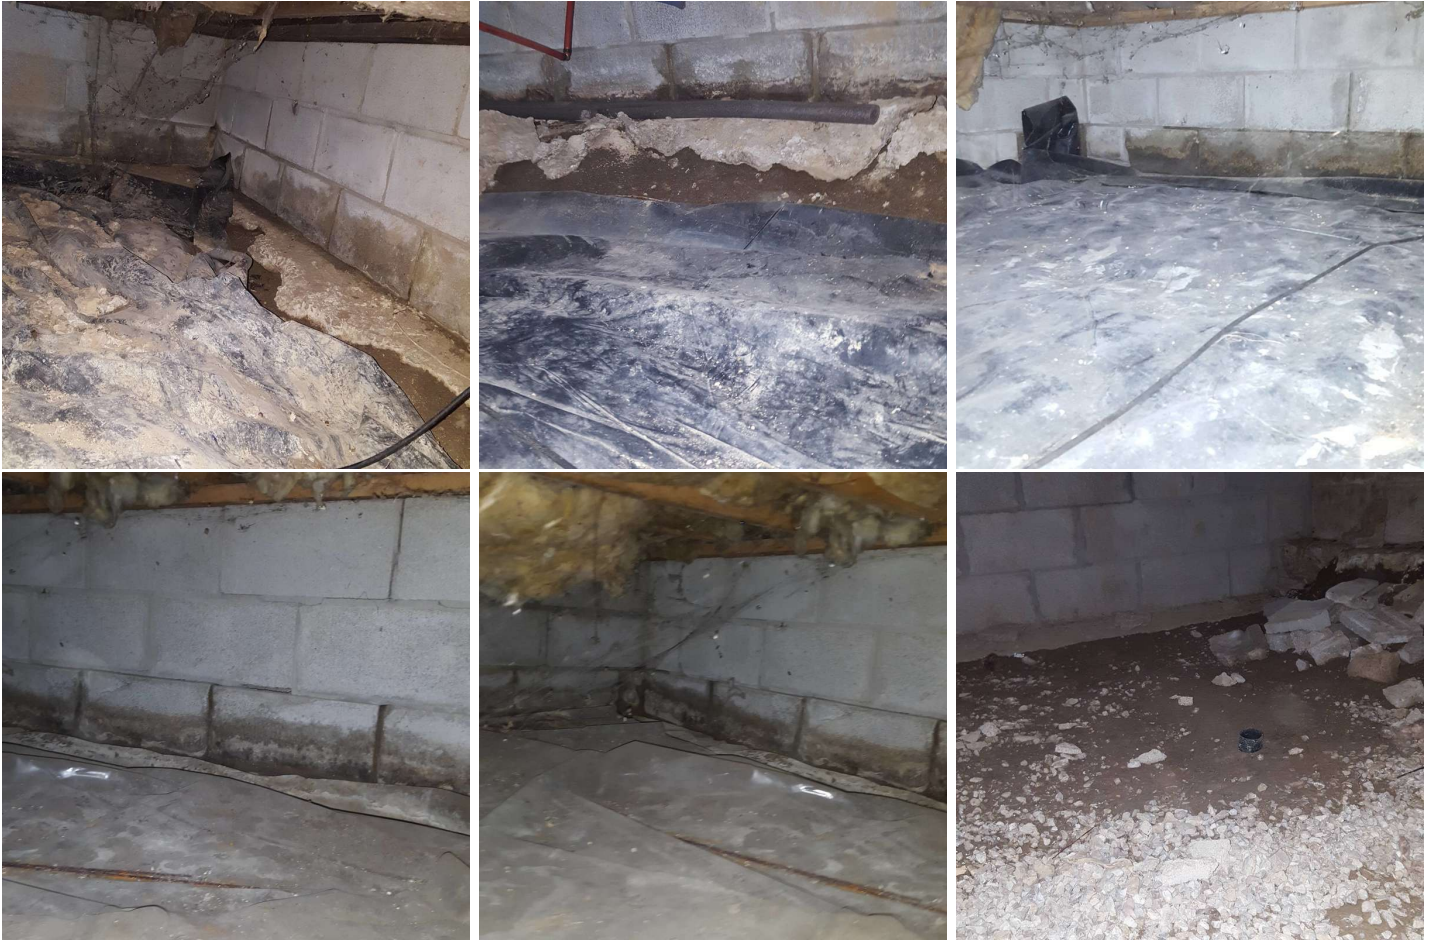
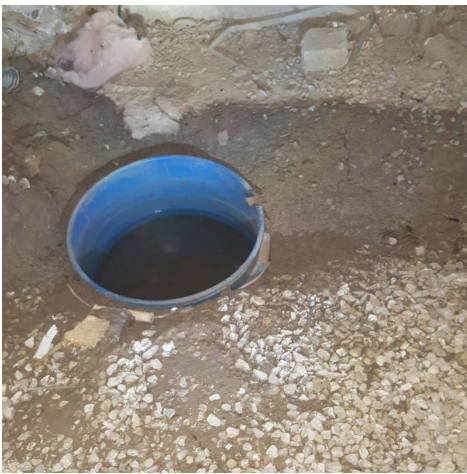
14.5.2 Moisture

SEEPAGE/MOISTURE EVIDENCE (MEDIUM/MODERATE)

MISC. PERIMETER AREAS. ADDITION.

Moisture/Seepage Evidence Crawlspace was overall dry at the time of inspection, however, some staining/seepage evidence was present. There was no major evidence of prolonged moisture intrusion or adverse conditions noted as a result of this observation. In other words, it appeared that the crawlspace has a higher probability of experiencing some moisture intrusion during periods of extended inclement weather, but may dry up or drain relatively quick. You should ask seller for any helpful insight they can provide about this. Condition can be the result of, but not limited to: Less-than-ideal exterior moisture control practices, failed/missing drain tiling, compromised foundation waterproofing, etc. Although no evidence of, prolonged moisture presence can cause structural damage, deterioration to building materials, and support mold growth. I did not note any musty odors at the time of inspection.

Future Seepage Probability - Medium/moderate, Occasional seepage/damp wall possible during inclement weather.

Bucket, full of water, buried in trench in the addition crawl by the sump pit

If possible, you should observe the crawlspace during a period of heavy or prolonged rain prior to the close of escrow or within the contingency period. **Corrective action:** Consult seller's disclosure regarding this (or what was exactly done for drainage/moisture control) and/or have source(s) of moisture eliminated and/or control moisture accordingly to rule out the potential for future issues. NOTE: Sump installed at east side. Some drain tile visible at addition area.

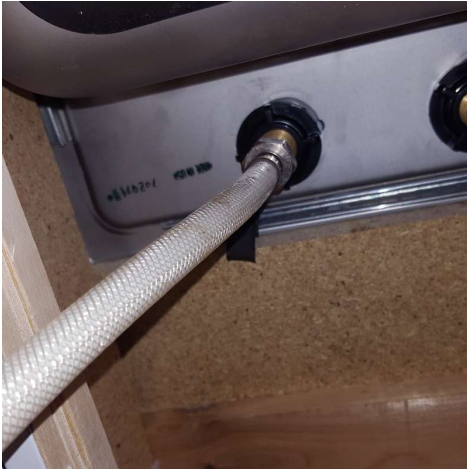
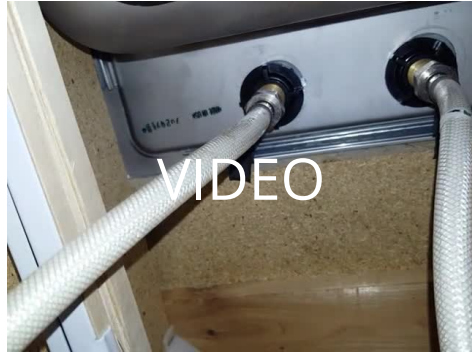
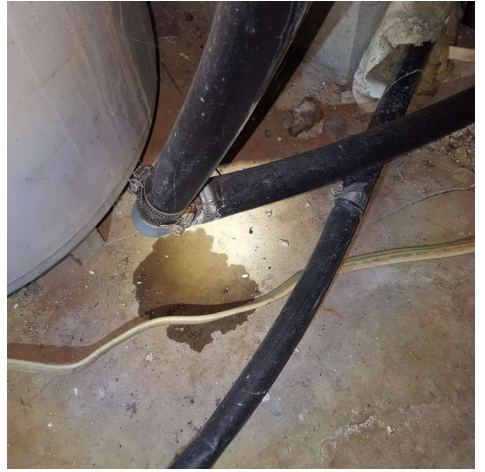
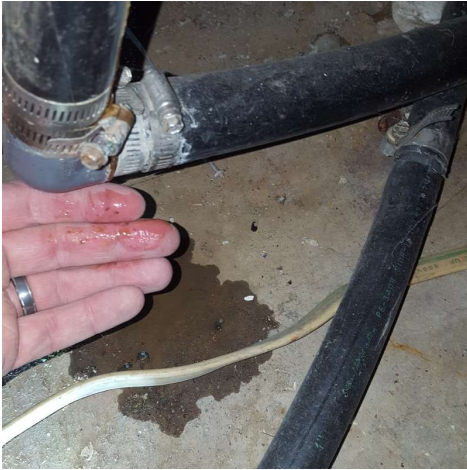
15.2.2 Water Supply/Distribution Systems

CONDITION (LEAKING)

KITCHEN BAR SINK - HOT SIDE FAUCET . WELL PUMP LINE/FITTING BESIDE PRESSURE TANK IN GARAGE .

Water lines/valves/components were leaking (SEE LOCATIONS). **Corrective action:** Have a qualified plumber repair/replace to avoid moisture concerns associated with leaks/moisture.

Contact a qualified plumbing contractor.

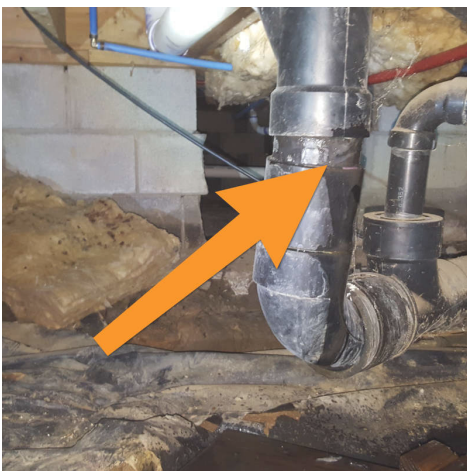
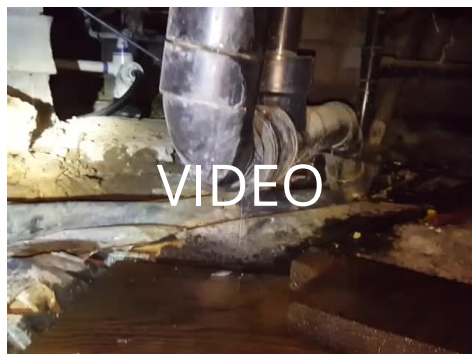
15.3.1 Drain, Waste, and Vent Systems

DRAIN (LEAKING)

TOILET PIPE/FITTING IN CRAWLSPACE .

Drain/fittings/components leaking. **Corrective action:** Have repaired/replaced accordingly to avoid moisture concerns associated with leaks/moisture.

Contact a qualified plumbing contractor.

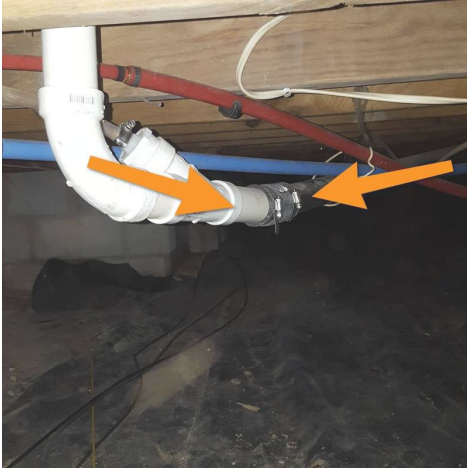
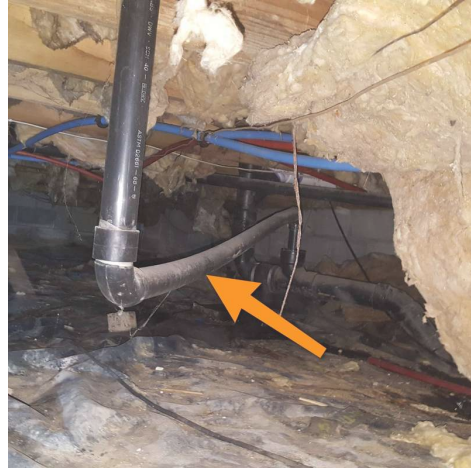
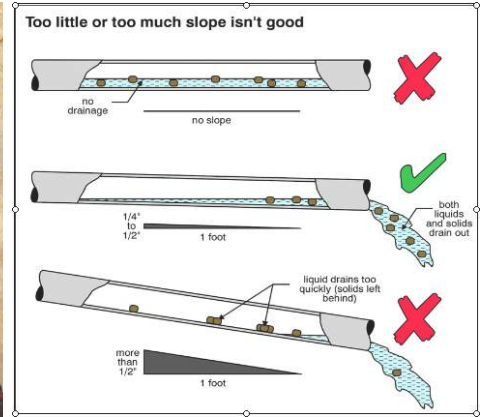
15.3.3 Drain, Waste, and Vent Systems

DRAIN (IMPROPERLY PITCHED)

A FEW IN CRAWL.

Drain and/or vent improperly/negatively pitched. One quarter inch of *fall* per foot of run is recommended as this ratio provides for excellent and/or ideal drainage. **Corrective action:** Repair/replace accordingly to ensure proper drainage.

Contact a qualified plumbing contractor.

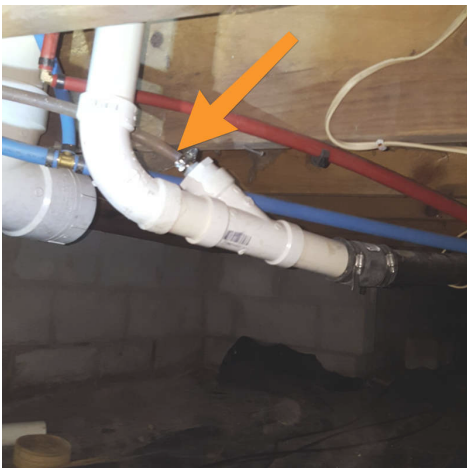
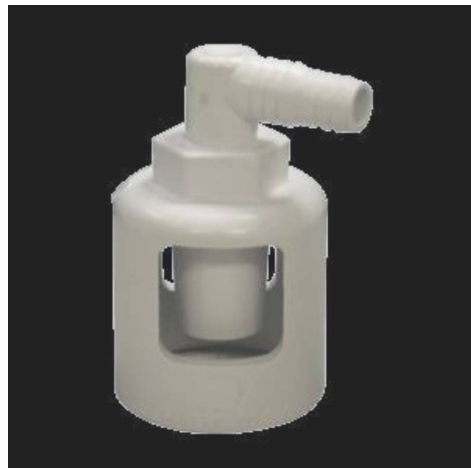
15.6.1 Water Treatment/Conditioning/Softening

DRAIN (SEWER LINE)

The water softener/treatment drain was directly tapped into a wastewater/sewage/drainage pipe/fitting, which is not allowed, potentially **unsafe**, and/or recommended without an air gap. This is considered a cross-contamination/**backflow** practice in the plumbing trade. **Corrective action:** Ensure the line is properly terminated to avoid any possibility of cross-contamination/**backflow**.

Contact a qualified plumbing contractor.

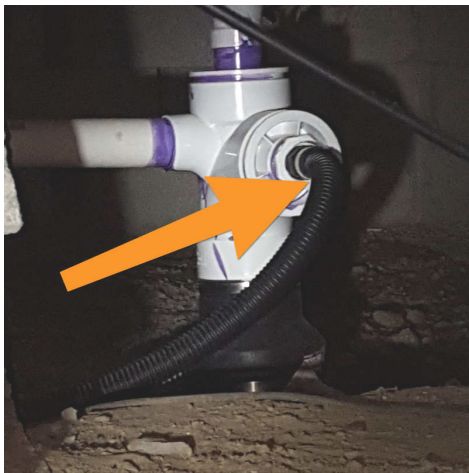
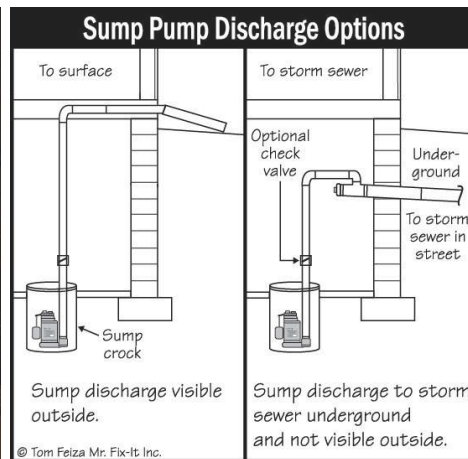
15.7.1 Sump Pump

DISCHARGE (MUNICIPAL SEWAGE SYSTEM)

CRAWLSPACE

Sump pump discharge routed into sewage/wastewater system . Sump pumps are for dispersing rainwater and pumping it into the municipal wastewater system is not allowed and illegal. Please keep in mind, higher homeowner sewer bills result from this practice due to having to treat (cost of chemicals, electricity, etc.) storm water that doesn't need to be treated. **Corrective action:** Have discharge rerouted to the exterior grounds well away from the house (this also allows for routine monitoring) or into approved storm sewer. NOTE: Temporary, flexible, corrugated tubing used for sump discharge - not recommended. Piping is cheap plastic material that is subject to deterioration. Recommend replacing with PVC or similar to rule out any issues.

Contact a qualified plumbing contractor.

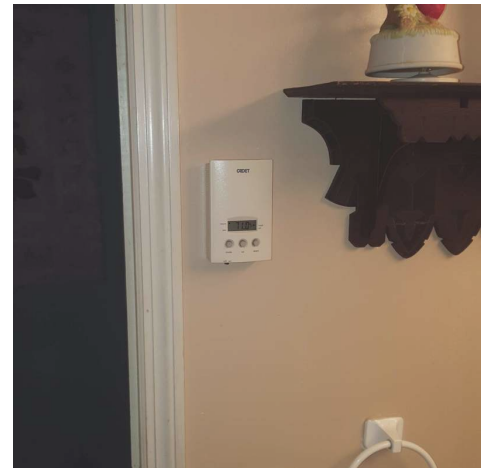
16.2.2 Distribution

THERMOSTAT/HEAT SOURCE (NOT OPERATING)

HALL BATH.

Heat source not operating when thermostat was tested/operated - have **repaired/replaced** accordingly. NOTE: Unknown what type of heat source - ceiling heat? baseboard heater removed during renovations? Consult seller for helpful insight.

Contact a qualified professional.

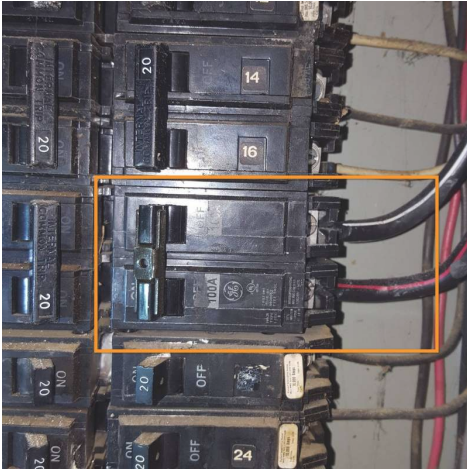
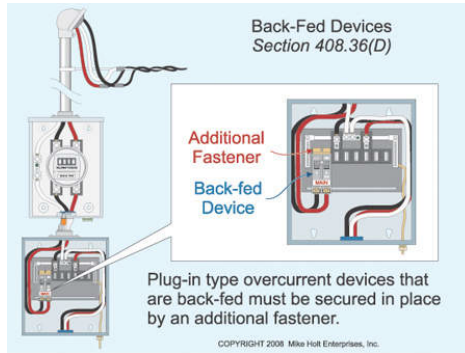
18.2.2 Main Panel (service equipment)

BREAKERS (BACK FED - RETENTION DEVICE)

100 AMP BREAKER IN GARAGE PANEL (FEED BREAKER FOR SUB PANEL)

Back-fed breakers apparently missing retention clips/screws/devices, which ensures breaker can't be easily removed and a secure connection which reduces the potential of arcing. **Corrective action:** Repair/install/replace accordingly to rule out any issues.

Recommendation
Contact a qualified electrical contractor.

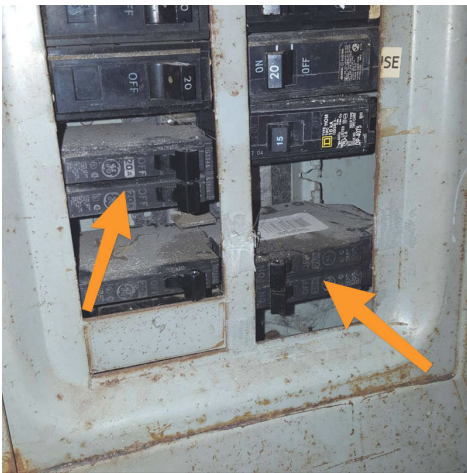
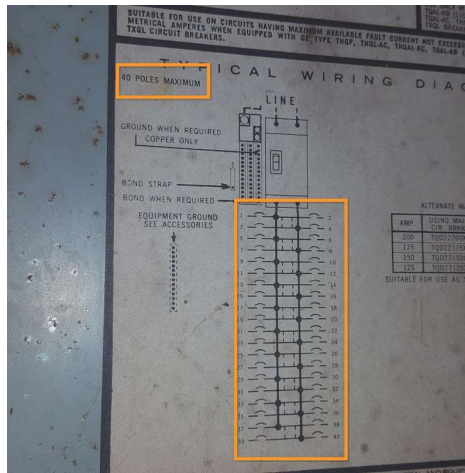
18.2.4 Main Panel (service equipment)
BREAKERS (TANDEM - NOT ALLOWED)

A COUPLE IN GARAGE PANEL.

Tandem breaker(s) installed in the panel that are prohibited by the manufacturer. This condition presents a potential **safety** concern related to connections and panel loads. **Corrective action:** A qualified electrical contractor should repair/replace accordingly to ensure proper/compliant/safe electrical practices.

Recommendation
Contact a qualified electrical contractor.
Estimated Cost
\$50 - \$150

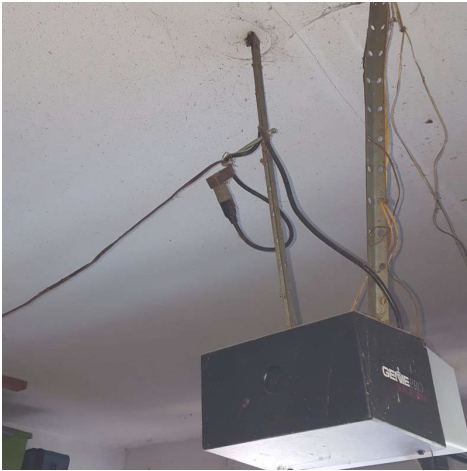
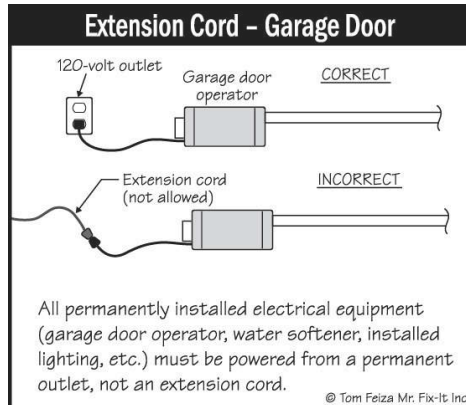
18.3.4 Branch Distribution (wiring & wiring practices)
WIRING (EXTENSION CORDS-PERMANENT WIRING-GARAGE DOOR OPENER)

Extension cord(s) were used as permanent wiring at the garage door opener. This is an **unsafe** practice and strictly prohibited by most cord manufacturers. **Corrective action:** Have repaired/replaced by an electrician accordingly so no extension cords are needed. Some possible solutions may include:

- Replacing the cord on the device/component with a longer cord
- Moving the existing outlet closer to the opener
- Install an additional grounded outlet closer to the opener

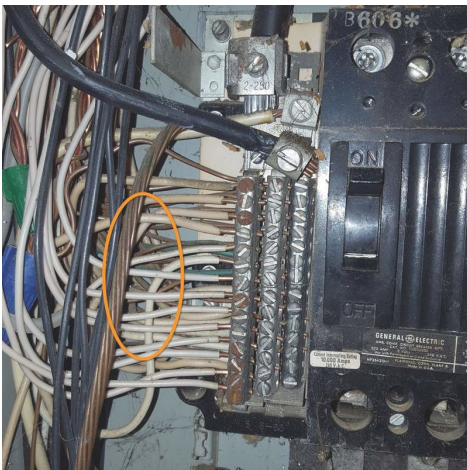
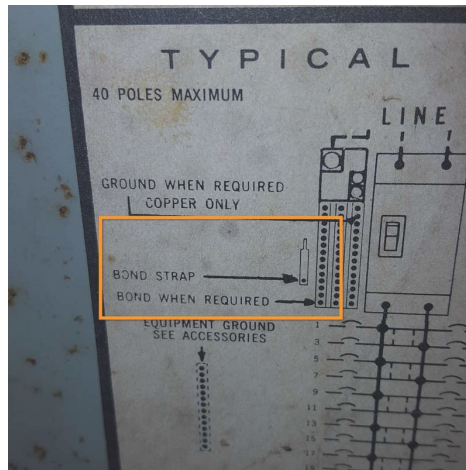
18.7.1 Grounding/Bonding

BONDING (NOT HOOKED UP)

MAIN PANEL IN GARAGE .

Bonding device was not present/installed at main panel/service disconnect. This "joining" or bonding forms a continuous electrical path that ensures that any errant electrical power will be safely conducted back to the ground. **Corrective action:** Ensure bonding device is installed and in place for proper installation and for **safety** purposes.

Bonding strap needs hooked up (behind neutrals/grounds)

Contact a qualified electrical contractor.

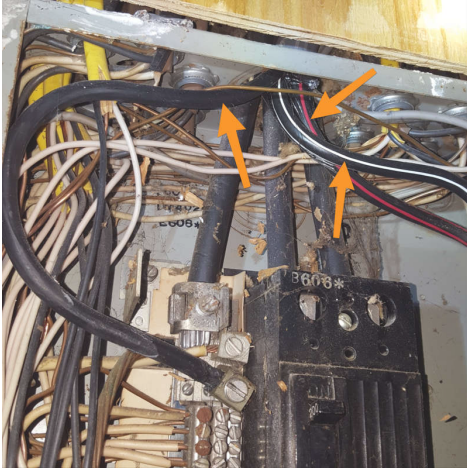
WIRING (NEUTRAL/ GROUNDS COMBINED - 3-WIRE)

FEED FROM MAIN TO SUB

There was only a 3-wire feed present. A 4-wire feeder is needed/recommended for this application as the panel is not equipped with an equipment grounding conductor supplied from the service panel, which is required and should be installed by a qualified electrician. Once panel is accessible, the electrician should ensure that the neutral and grounding conductors aren't connected together as the grounds need to be separated and be bonded to the enclosure accordingly and the neutral bus bar isolated from the panel.

Only a 3 wire feed

Corrective action: A qualified electrician should repair/replace accordingly to ensure proper/ **safe** wiring practices.
