**SUMMARY**  
1234 Main St. Colorado Springs CO  
80907  
Buyer Name  
09/19/2018 9:00AM

Ryan Lewis  
Lifespace Home Inspections  
7197613328  
lifespaceinspections@gmail.com

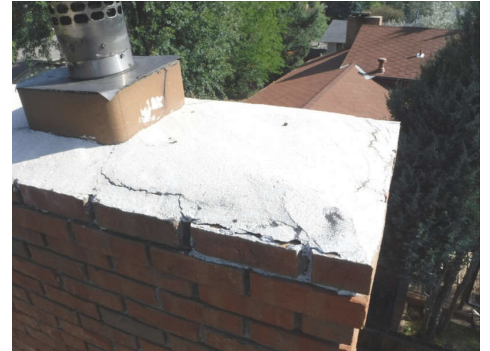
2.6.1 Chimney at Roof

**MODERATE CROWN CRACKING- QC**

Minor Deficiency

Moderate cracking visible in the chimney crown should be filled with an appropriate sealant to prevent worsening damage caused by moisture in the cracks expanding as it freezes. All work should be performed by a qualified contractor.

Contact a qualified chimney contractor.

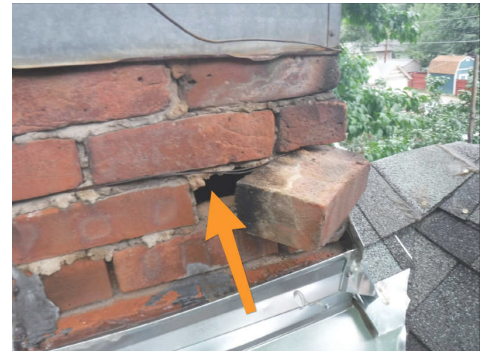
2.6.2 Chimney at Roof

**UNLINED BRICK CHIMNEY**

Major Deficiency

The brick chimney was unlined. This condition may deteriorate the brick and mortar and eventually allow the toxic products of combustion to enter the living space. The Inspector recommends that an evaluation and any necessary work be performed by a qualified masonry contractor.

Contact a qualified chimney contractor.

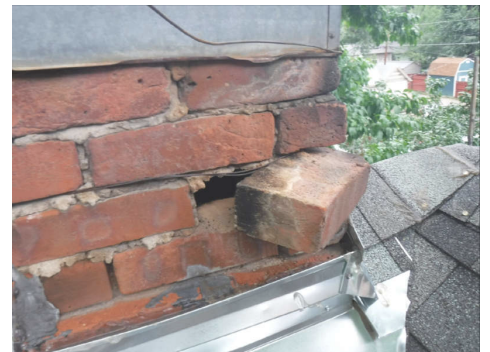
2.6.3 Chimney at Roof

**LOOSE BRICK- QC**

Minor Deficiency

The brick chimney was severely deteriorated and had loose brick. For safety reasons, the Inspector recommends repair by a qualified contractor.

Contact a qualified chimney contractor.

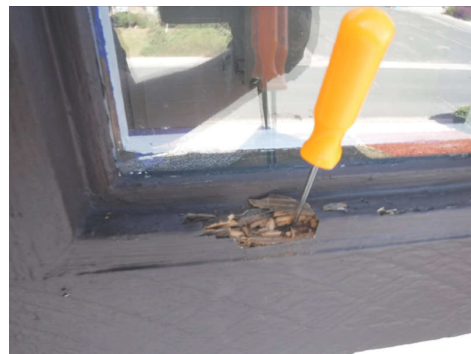
3.2.1 Window Exteriors

**PEELING PAINT, WOOD**

Maintenance or Recommendation

The wood windows had peeling paint and needed maintenance at the time of the inspection. Windows appeared to have suffered some damage from sun and moisture. Wood windows eventually operate poorly if wood is left exposed to sun and moisture. Repair of long-term neglect can be expensive. The Inspector recommends maintenance be performed by a qualified contractor.

Contact a qualified window repair/installation contractor.

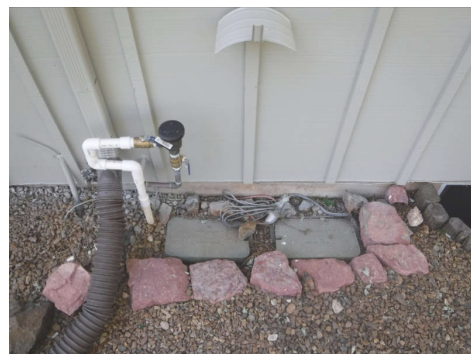
#### 4.10.1 Landscape Irrigation

### BEYOND THE SCOPE

Maintenance or Recommendation

The home was equipped with a landscape irrigation system. Inspection of irrigation systems lies beyond the scope of the General Home Inspection and the Inspector did not inspect the system. You may wish to have this system inspected by a qualified irrigation or landscape contractor. Remember to have the irrigation system winterized before weather cold enough to cause freeze damage arrives.

Contact a qualified landscaping contractor

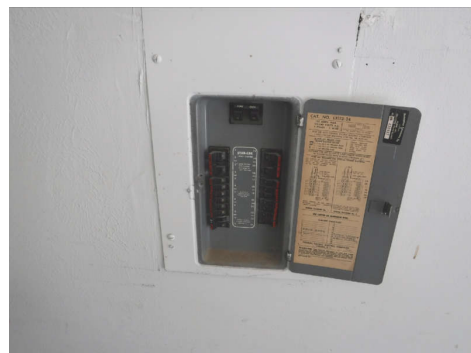
#### 5.6.1 Service Panel Manufacturer

### STAB-LOK

Minor Deficiency

The service panel was made by Federal Pacific and was the Stab-lok model. Federal Pacific Stab-lok model service panels are reputed to have a high rate of circuit breaker failure which can result in a fire or shock/electrocution. The Inspector recommends that you consult with a qualified electrical contractor concerning the necessity for replacing this service panel. Information about defective Federal Pacific Stab-lok panels is widely available on the internet.

Contact a qualified electrical contractor.

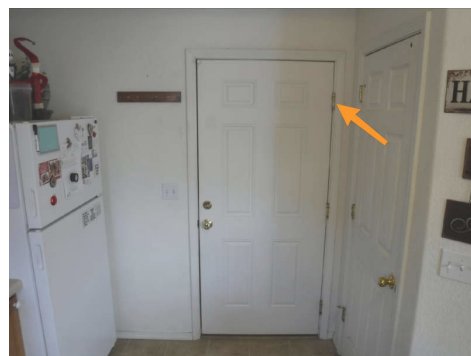
#### 6.6.1 Fire Separation

### NO SELF-CLOSING HINGES

Major Deficiency

The door in the wall between the garage and the home living space did not have operable self-closing hinges. While sometimes not required during construction, the inspector recommends this simple safety upgrade. This helps to contain fires that start in the garage, it also helps to keep harmful exhaust fumes from entering the living space.

Contact a handyman or DIY project

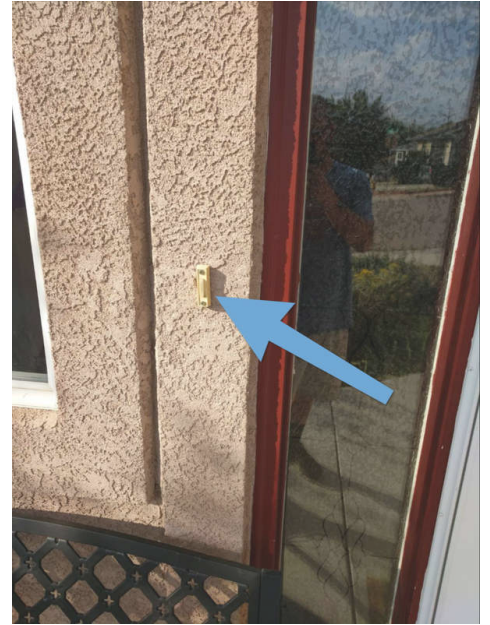
7.5.1 Misc. Components:  
Ceiling fans, doorbells, Env.  
Hazards, Detectors, etc.

Maintenance or Recommendation

### **INOPERABLE DOORBELL**

The doorbell was inoperable at the time of the inspection. The Inspector recommends correction by a qualified electrical contractor.

Contact a qualified professional.

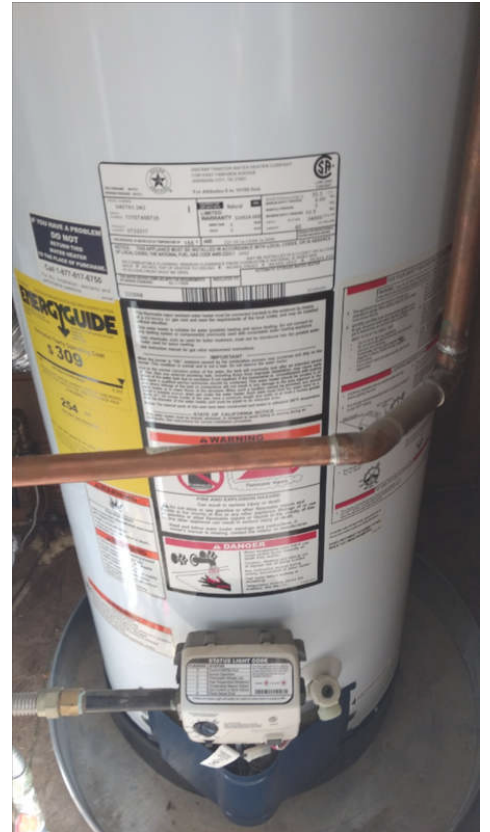
8.4.1 Gas Water Heater

### **PAST DESIGN LIFE**

This water heater appeared to be past its design life and may need replacement soon.

Major Deficiency

Contact a qualified plumbing contractor.

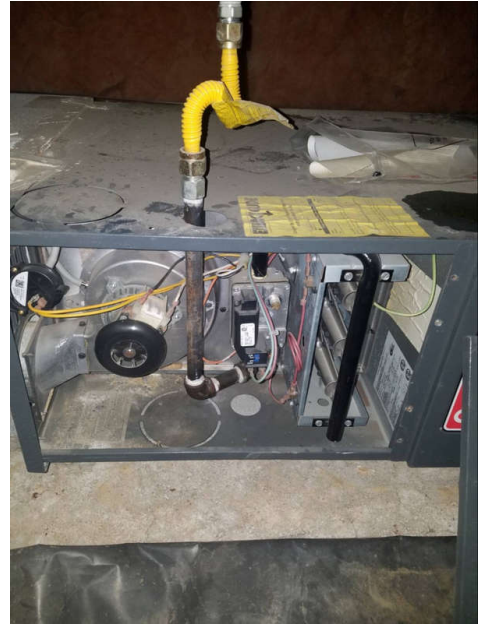
9.2.1 Furnace

### **RECOMMEND SERVICE**

Maintenance or Recommendation

The Inspector recommends that furnace cleaning, service and certification be performed by a qualified HVAC contractor yearly.

Contact a qualified HVAC professional.

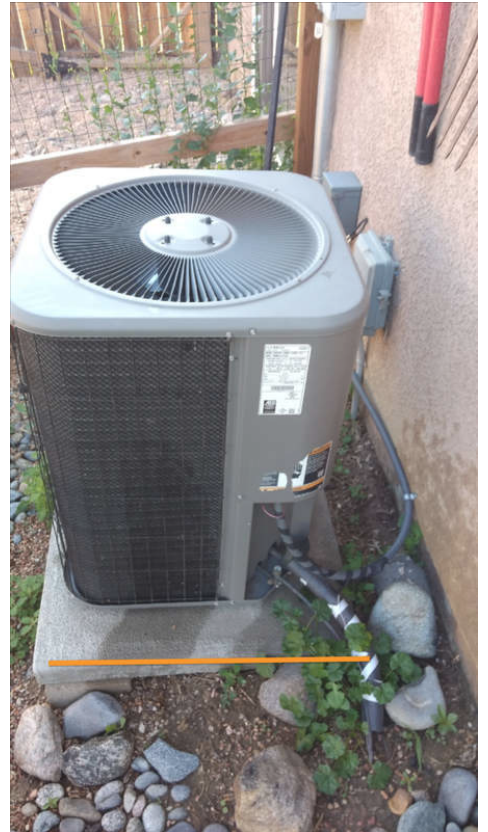
#### 10.1.1 Central Air Conditioner

### OUT OF LEVEL

Minor Deficiency

The pad supporting the air-conditioner compressor housing was not level. Over time, this may result in damage to the fan bearings and a shortened fan lifespan, or it may result in movement of the compressor housing which can stress the refrigerant lines resulting in damage and expensive service. The Inspector recommends that the compressor housing be leveled by a qualified HVAC contractor.

Contact a qualified HVAC professional.

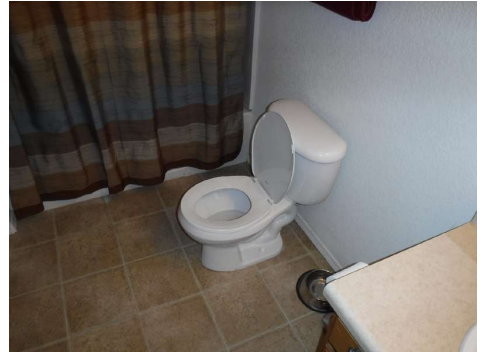
#### 11.10.1 Toilet

### LOOSE AT FLOOR

Minor Deficiency

In the bathroom, the toilet was loose at the floor and should be re-attached by a qualified plumbing contractor.

Contact a qualified plumbing contractor.

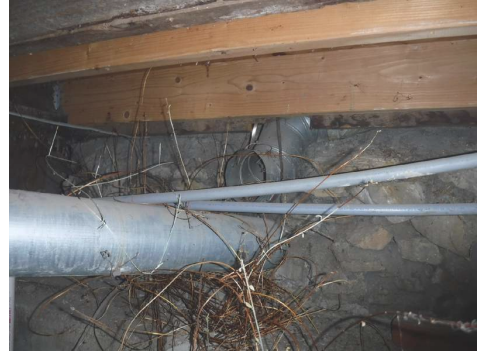
12.3.1 Foundation  
**DISCONNECTED AT REGISTER(S)**

Maintenance or Recommendation

In the basement, a heating duct was disconnected from a register and should be reconnected to supply heat to the affected living space.

Contact a handyman or DIY project

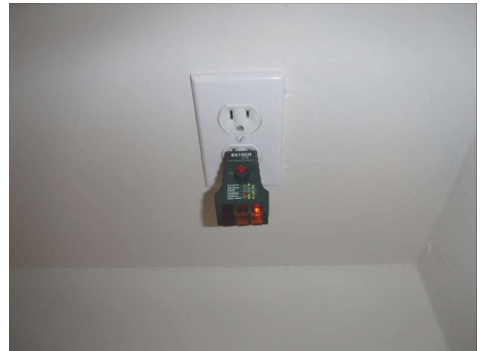
13.7.1 Receptacles and Switches

**HOT AND NEUTRAL REVERSED**

Minor Deficiency

An electrical receptacle in the kitchen had hot and neutral wires reversed. This condition should be corrected by a qualified electrical contractor.

Contact a qualified electrical contractor.

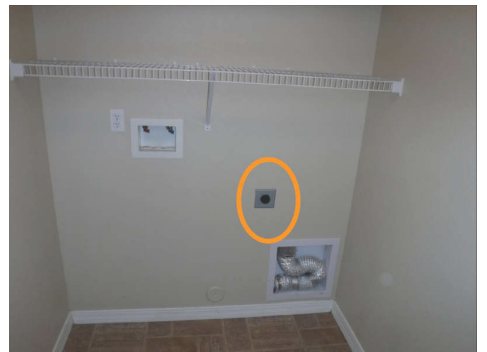
14.6.1 Receptacles, Switches, Connections

**OLDER 3-PRONG RECEPTACLE**

Minor Deficiency

The laundry area had an older-style 3-prong 240 volt dryer receptacle. Newer dryers come equipped with 4-prong plugs. To accommodate a newer dryer, either the electrical receptacle or dryer cord will need to be replaced.

Contact a qualified electrical contractor.

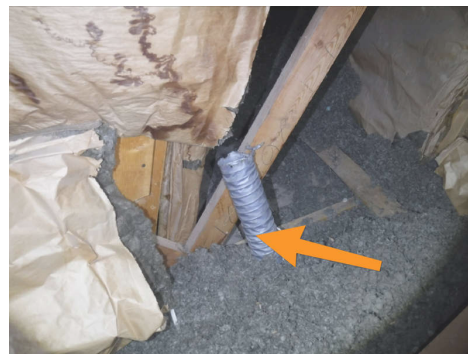
15.9.1 Attic Thermal Envelope

**BATHROOM VENT**

Minor Deficiency

A bathroom exhaust vent terminated in the attic instead of at the home exterior. This condition can cause excessively high moisture vapor levels in the attic with the potential to damage home materials or create unhealthy conditions related to mold. The Inspector recommends correction by a qualified contractor.

Contact a handyman or DIY project

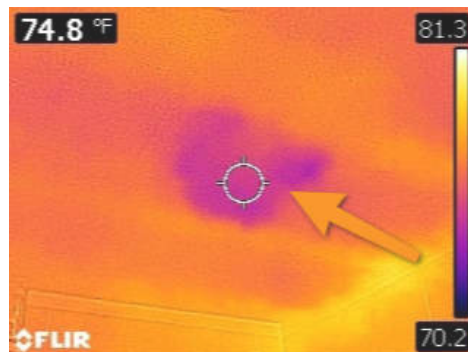
#### 16.2.1 Moisture

### CEILING MOISTURE ROOF LEAKAGE

Minor Deficiency

Thermal imaging indicated excessively high moisture levels in ceiling materials. Conditions indicate that roof leakage may be the source of moisture. The inspector recommends that an inspection be performed by a qualified roofing contractor to confirm and correct the source of moisture.

Contact a qualified general contractor.
