SUMMARY

1234 Main St. Billings Mt 59105

Brad Lindeman
Quality 360 Inspections
4066901507
quality360inspections@gmail.com

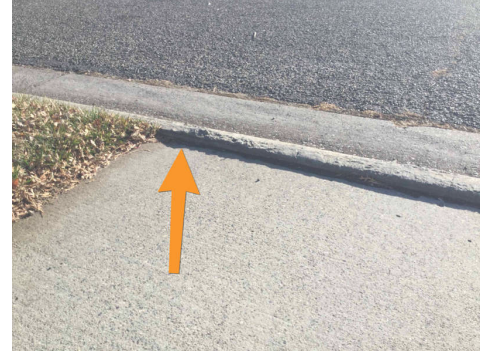
2.2.1 Driveway

DRIVEWAYS - MINOR

Minor deterioration (e.g. cracks, holes, settlement, heaving) was found in the driveway, but no trip hazards were found. The client may wish to have repairs made for cosmetic reasons.

Minor settling

Contact a qualified driveway contractor.

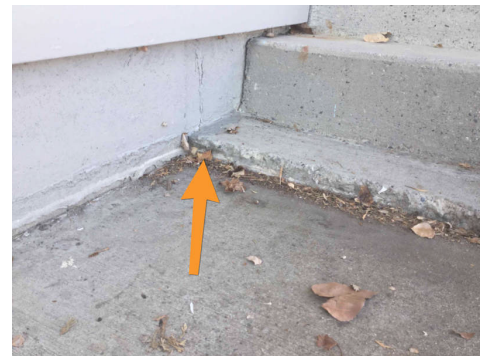
2.3.1 Sidewalks / Patios

REVERSED DRAINAGE ON SIDEWALK/PATIO.

Sidewalk or patio appear to have negative drainage towards recommend replacement or repair to avoid further damage to sidewalk or foundation.

Contact a qualified concrete contractor.

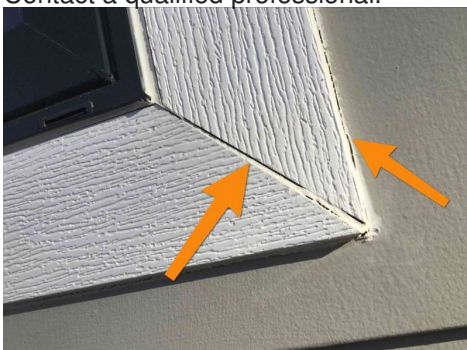
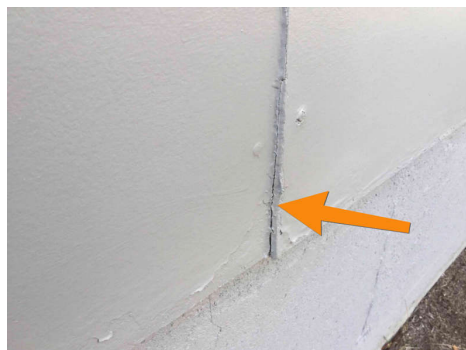
3.1.1 Exterior Walls / Trim

CAULKING

Caulk was *missing / deteriorated / substandard* in some areas. For example, *around windows / around doors / at siding butt joints / at siding-trim junctions / at wall penetrations*. Recommend that a qualified person renew or install caulk as necessary. Where gaps are wider than 1/4 inch, an appropriate material other than caulk should be used. For more information, visit:

Contact a qualified professional.

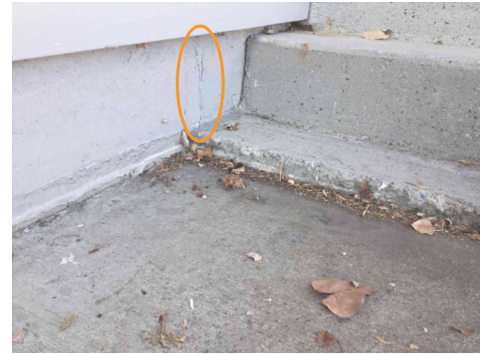
3.2.1 Foundation

CRACKS - MODERATE

Moderate cracks (1/8 inch - 3/4 inch) and/or leaning were found in the foundation. This may be a structural concern or an indication that settlement is ongoing. The client should consider hiring qualified contractors and/or engineers as necessary for further evaluation. Such contractors may include:

At a minimum, recommend sealing cracks to prevent water infiltration. Numerous products exist to seal such cracks including hydraulic cement, resilient caulks and epoxy sealants.

Contact a foundation contractor.

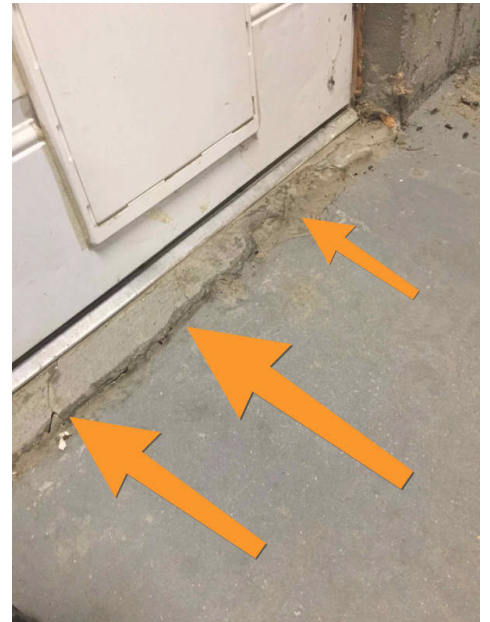
3.2.2 Foundation

GARAGE FLOOR SETTLING

Garage floor appears to be settling. Interior garage settling is generally cosmetic and gradual. If cars are parked in garage during winter, high levels of snow melt off from vehicles can cause quicker settling. Recommend monitoring in the future for rapid settling.

Contact a qualified concrete contractor.

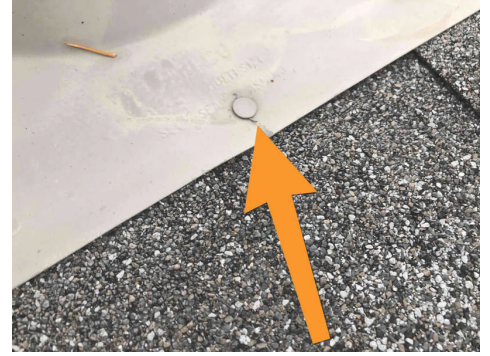
4.2.1 Shingles / Shakes

COMPOSITION - EXPOSED FASTENER HEADS

Nail heads were exposed at one or more shingles. More than just a few exposed nail heads may indicate a substandard roof installation. Recommend applying an approved sealant over exposed nail heads now and as necessary in the future to prevent leaks.

Recommendation
Contact a qualified professional.

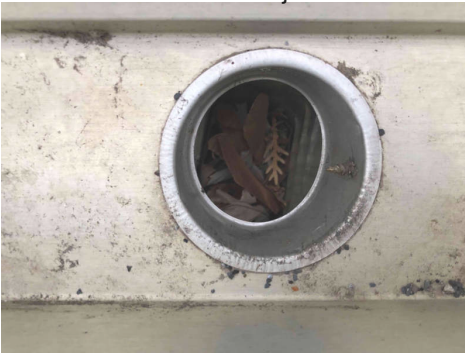
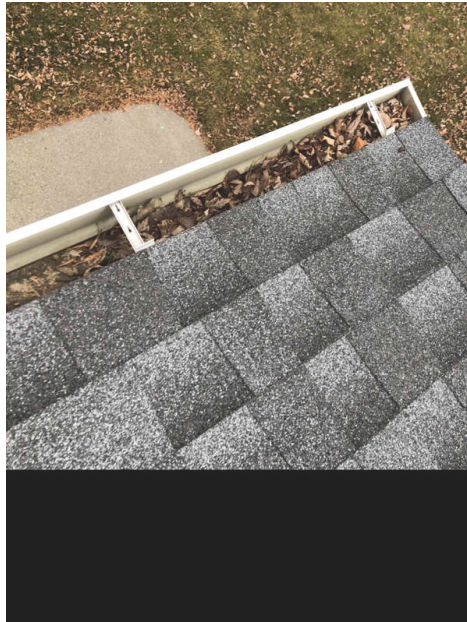
4.3.1 Gutters / Downspouts / Extensions **DEBRIS IN DRAINAGE SYSTEMS**

Debris has accumulated in one or more gutters or downspouts. Gutters can overflow and cause water to come in contact with the building exterior, or water can accumulate around the foundation. Recommend cleaning gutters and downspouts now and as necessary in the future.

Recommendation
Recommended DIY Project

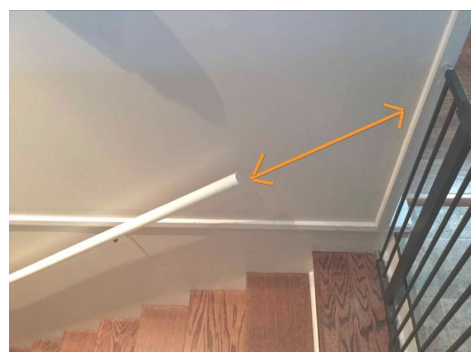
8.3.2 Handrails

NOT CONTINUOUS OR FULL LENGTH

Handrails at one or more flights of stairs were not continuous or did not extend the full length of the stairs. This is a potential fall hazard. Handrails should be continuous for the entire length of the stairs. For increased safety, recommend that a qualified contractor replace or repair handrails per standard building practices.

Contact a qualified professional.

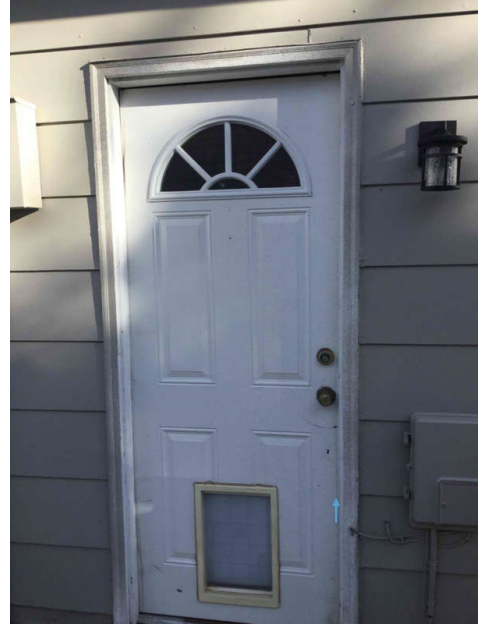
15.1.1 Exterior Doors

DOORS

One or more exterior doors *were difficult to open or close / were difficult to latch / were sticking*. Recommend that a qualified person repair as necessary.

Contact a qualified professional.

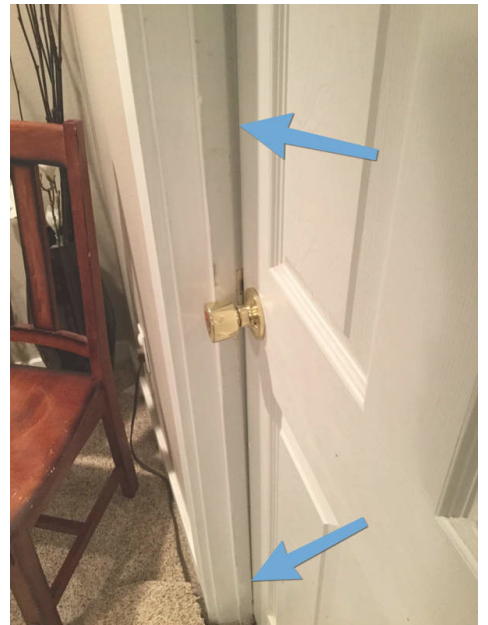
15.2.1 Interior Doors

WOULDN'T LATCH

One or more interior doors wouldn't latch or were difficult to latch. Recommend that a qualified person repair as necessary. For example, by adjusting latch plates or locksets.

Contact a qualified professional.
