SUMMARY

1234 Main St. Freeland MI 48623

Buyer Name
04/01/2019 9:00AM

Steven Owens
InterNACHI Certified...
4SITE Inspections of Michigan
989-423-0074
steve@4siteinspections.com

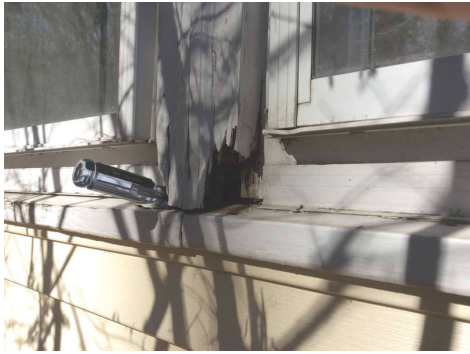
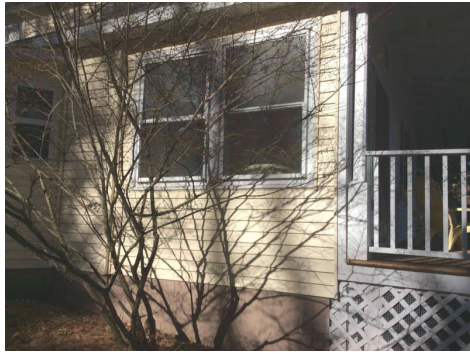
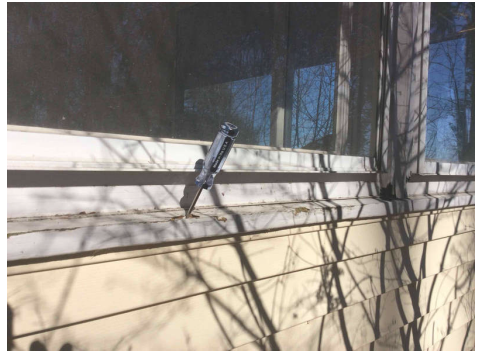
2.1.1 Siding, Flashing & Trim

TRIM- DETERIORATED

Trim around the window has deteriorated. This can allow moisture into the building envelope. Recommend repair or replacement by qualified professional.

Recommendation
Contact a qualified professional.

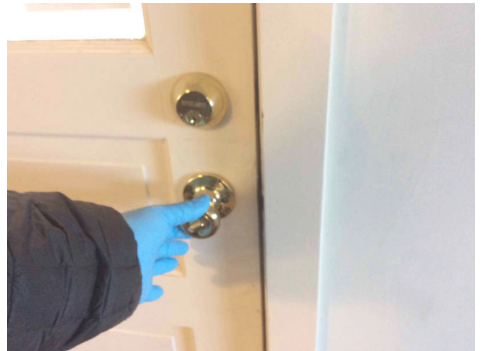
WEST ENTRANCE

HARDWARE STICKING

Door hardware is difficult to use. Recommend lubrication or replacement.

Recommendation
Recommended DIY Project

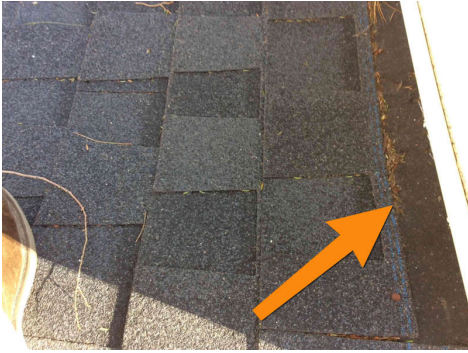
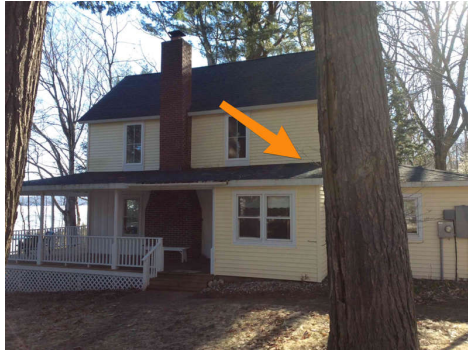
ABOVE PORCH

SHINGLES MISSING

Observed areas that appeared to be missing sufficient coverings. Recommend qualified roofing contractor evaluate & repair.

Recommendation
Contact a qualified roofing professional.

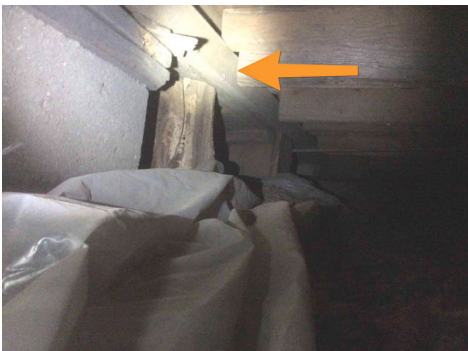
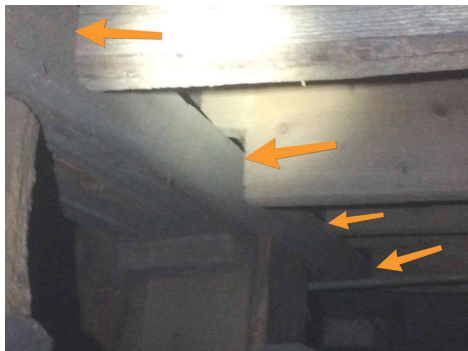
BENEATH LIVING ROOM/STAIRWAY

EVIDENCE OF STRUCTURAL MOVEMENT

Floor joist have been notched to rest on ledger on the main beams of the house. These beams have separated from the notched area leaving less than 1 inch of joist resting on the ledger board. Recommend a structural expert review and make recommendations for repair.

Recommendation
Contact a qualified professional.

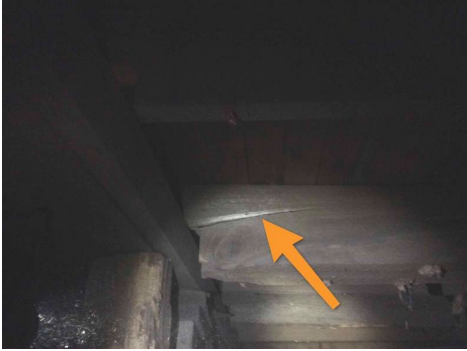
JOISTS NEED REPAIR

One or more floor joists were damaged. This can cause damage to the structural integrity of the home. Recommend a qualified structural expert evaluate and advise on how to correct.

Joist has cracked

Contact a qualified structural engineer.

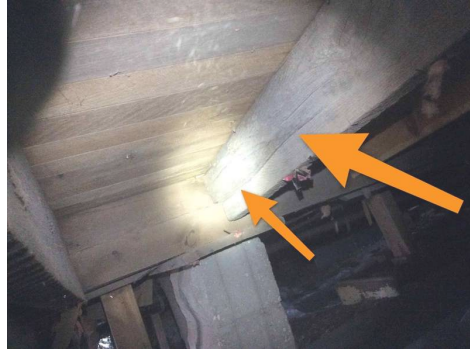
Joist have cracked

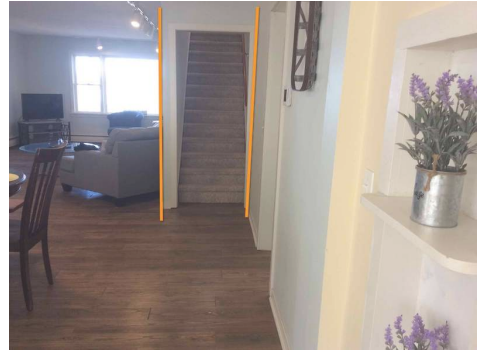
EVIDENCE OF STRUCTURAL MOVEMENT

The right wall of the stairwell is leaning away from the center of the room. This is evidence of structural movement. This area is directly above the mainbeam with the damaged joist. No current cracking was evident to suggest the home is still moving.

Contact a qualified professional.

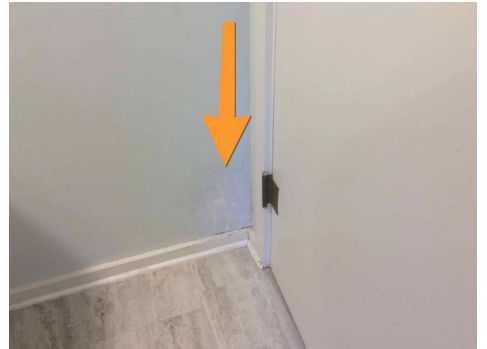
GROUND FLOOR BATHROOM

EVIDENCE OF WATER INTRUSION

Wall structure showed signs of water intrusion, which could lead to more serious structural damage. Recommend a qualified contractor identify source or moisture and remedy.

Contact a qualified professional.

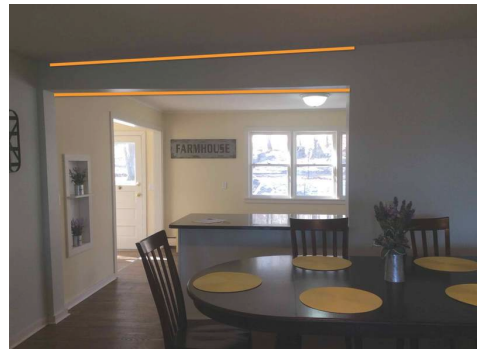
EVIDENCE OF STRUCTURAL MOVEMENT

Evidence of structural movement was found in the ceiling structure. This is common in home of this age. Recommend monitoring for cracking.

Contact a qualified professional.

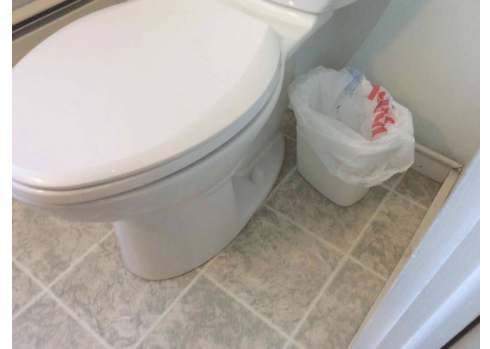
SECOND FLOOR BATHROOM

TOILET LEAKING

Toilet is loose at the base. Recommend a qualified plumber evaluate and repair to prevent water damage.

Contact a qualified plumbing contractor.

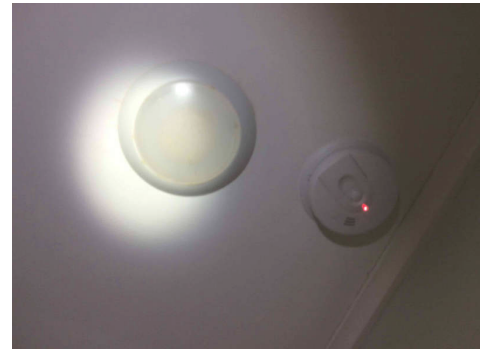
LIGHT INOPERABLE

One or more lights are not operating. New light bulb possibly needed.

Contact a qualified electrical contractor.

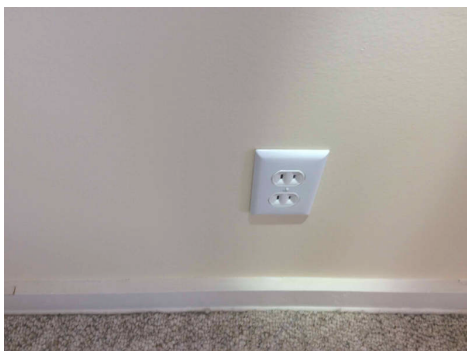
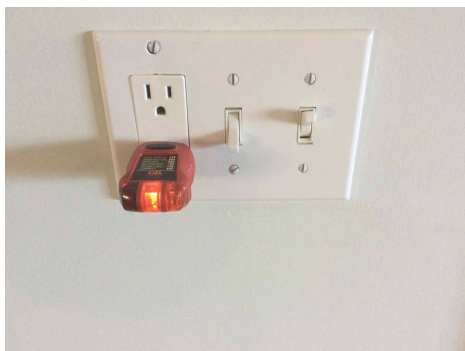
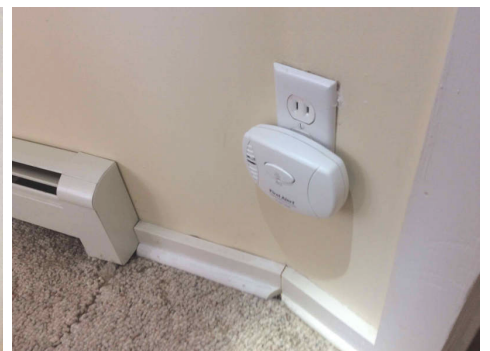
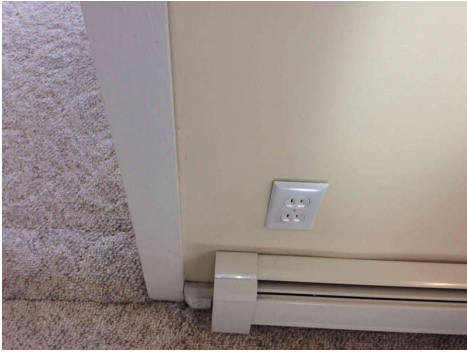
UNGROUND RECEPTACLE

One or more receptacles are ungrounded. To eliminate safety hazards, all receptacles in kitchen, bathrooms, garage & exterior should be grounded.

Contact a qualified electrical contractor.

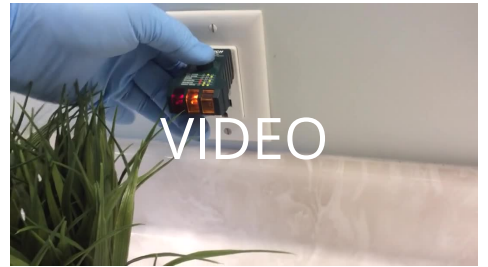
GROUND FLOOR BATHROOM

IMPROPER INSTALLATION

GFCI Outlets in the bathroom are not operating as intended. Recommend an electrical contractor evaluate and correct.

Contact a qualified electrical contractor.

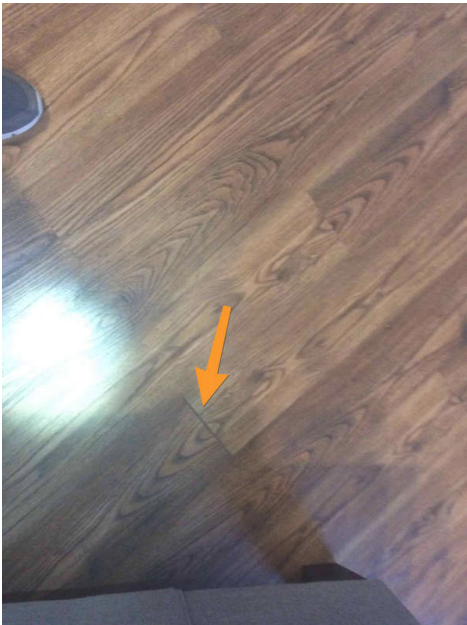
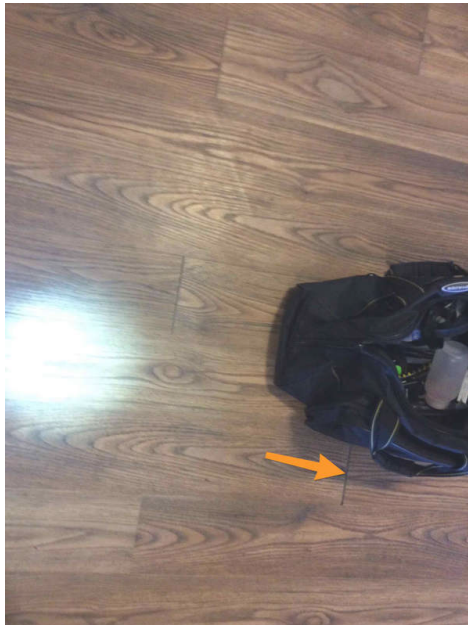
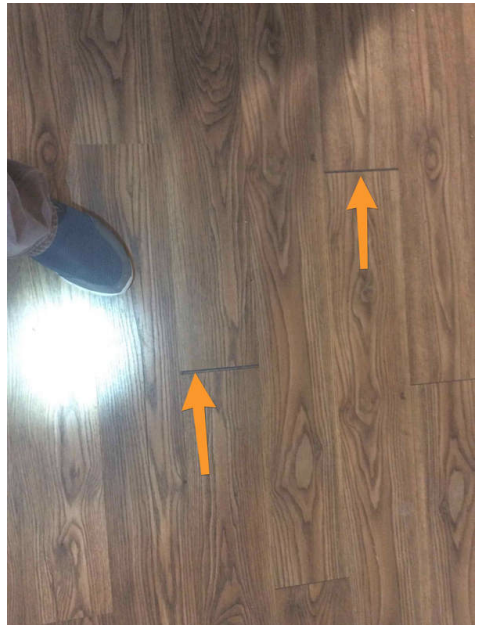
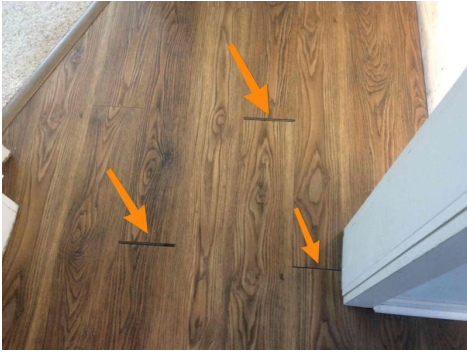
DINING/LIVINGROOM

BOARDS LOOSE

Laminate Boards are not tightly installed. Recommend a flooring contractor correct.

Contact a qualified handyman.

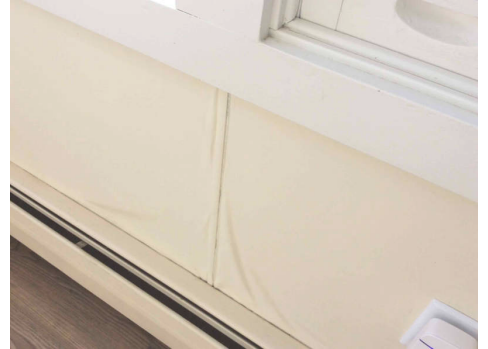
LAUNDRY AREA

MOISTURE DAMAGE

Pillowing on the walls visible at the time of the inspection appeared to be the result of moisture intrusion. The source of moisture may have been corrected. Recommend further examination by a qualified contractor to provide confirmation.

Recommendation
Contact a qualified professional.
