INTEGRI-SPEC INSPECTIONS SUMMARY 1234 Main St.Winona MN 55987 Buyer Name 09/09/2018 9:00AM

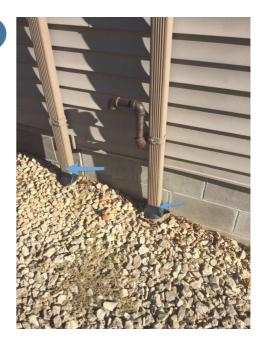
2.3.1 Roof Drainage Systems UNDERGROUND DRAINAGE

Gutters drained underground. Recommend to monitor condition of drainage to ensure water discharges to exterior/daylight.

Recommendation Recommend monitoring.

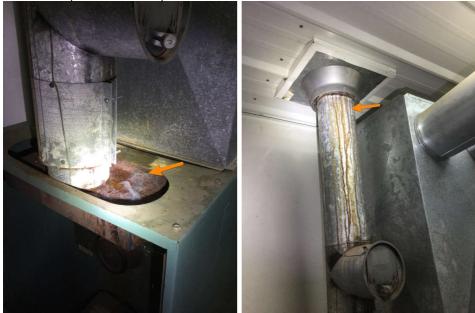
5.2.1 Equipment 2 CORROSION

GARAGE 2

Furnace was corroded in one or more areas. This could be the result of leakage from the roof. Recommend a HVAC contractor and/or roofer evaluate and repair.

Contact a qualified HVAC professional.

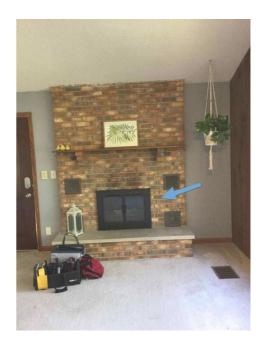
5.6.3 Fireplaces

Observed what appears to be some insulation within the flue as well as damper frame/hardware that appears to be corroded and may be in need of repair.

Fireplace should be cleaned and inspected prior to first use and not less than serviced annually.

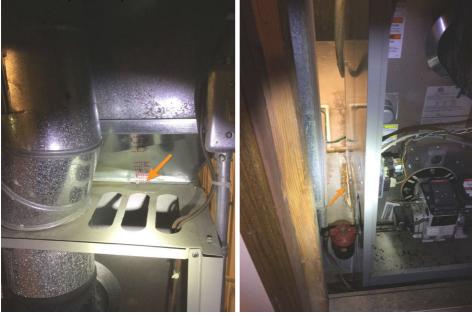
6.3.1 Distribution System **AC CONDENSATE LEAK**

The air conditioner condensate was leaking, recommend repair.

Recommendation Contact a qualified professional.

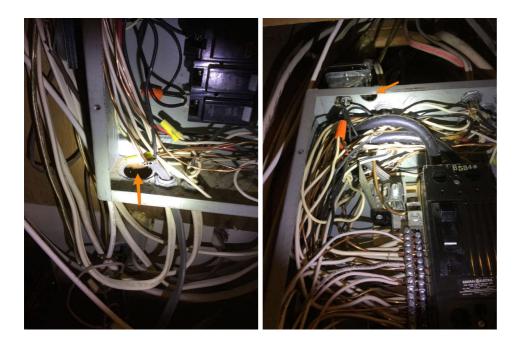
KNOCKOUTS MISSING

"Knockouts" are missing on the electric panel. This poses a safety hazard and it is recommended that the opening in the panel caused by the missing knockout(s) be properly sealed by a licensed electrician. Recommendation

Contact a qualified electrical contractor.

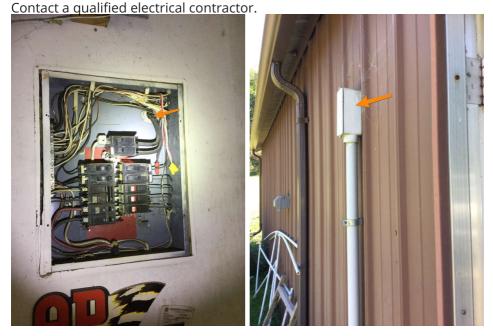
WATER IN ELECTRICAL PANEL

GARAGE 2

Observed water in the electrical panel. Recommend qualified electrical contractor review and provide evaluation of findings.

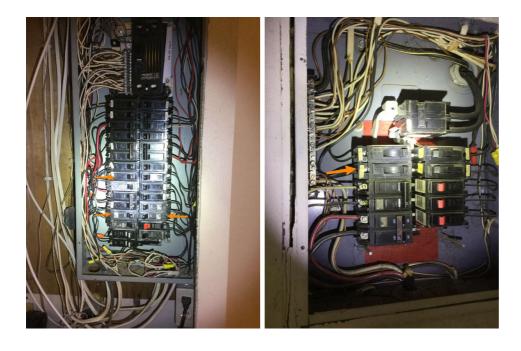
DOUBLE TAPPED HOT CONDUCTORS

One or more electrical circuits were double tapped. This means that two or more wires are connected to a circuit breaker that is only designed to accept one wire. Recommend a qualified professional review and repair as necessary. Recommendation

Contact a qualified electrical contractor.

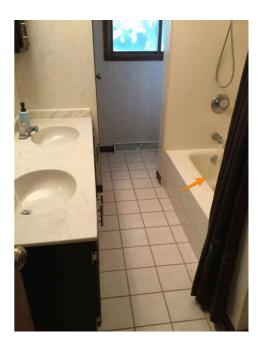
14.2.2 Plumbing & Fixtures TUB - POOR DRAINAGE

1ST FLOOR BATHROOM 1

Tub had slow/poor drainage. Recommend a qualified plumber repair.

Recommendation Contact a qualified plumbing contractor.

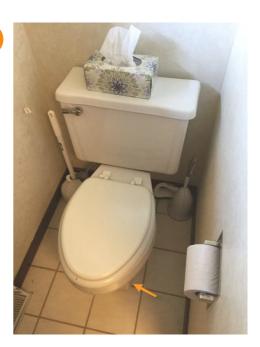
14.2.3 Plumbing & Fixtures **TOILET - LOOSE BOWL**

1ST FLOOR BATHROOM 1

Toilet was not securely fastened to the floor. Recommend a qualified plumber repair. Recommendation Contact a qualified plumbing contractor.

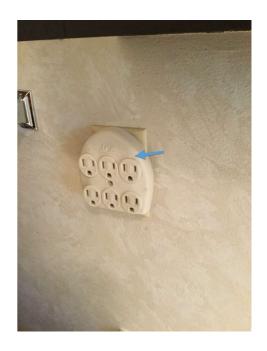
14.3.1 Electrical & Other **BATHROOM GFCI UPGRADE**

1ST FLOOR BATHROOM 1

As a safety upgrade, recommend that the receptacle(s) be upgraded to GFCI receptacles.

Recommendation Contact a qualified electrical contractor.

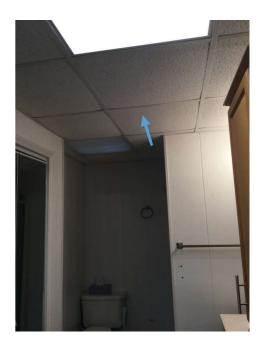
EXHAUST FAN NOT PRESENT

BASEMENT BATHROOM 2

Bathroom exhaust vent was not present. As an upgrade recommend installing vent and exhaust to exterior. Recommendation Contact a qualified professional.

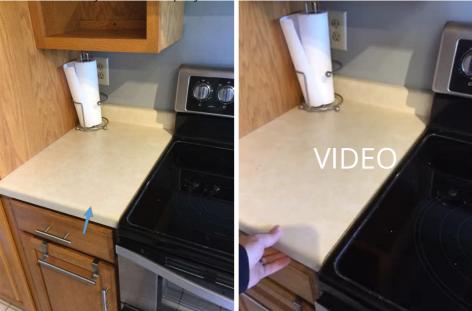
17.1.1 General COUNTERTOP NOT SECURED

KITCHEN

Kitchen countertop appeared insecure. Recommend to secure properly.

Recommendation Contact a handyman or DIY project

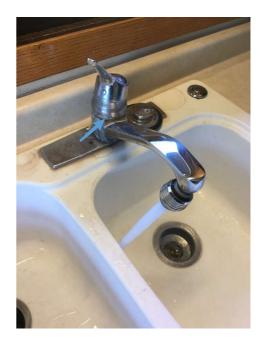
17.2.1 Plumbing & Fixtures
FAUCET LEAKS

KITCHEN

Kitchen Faucet leaks at handle. Recommendation Contact a qualified professional. Maintenance / Comment
