**SUMMARY**  
1234 Main St. Windham NH 03087  
Buyer Name  
06/13/2019 9:00AM

Jenna Roberts-Weeks, CPI  
AHIT & InterNACHI Certified (CPI)  
Summit Home Inspection, LLC  
6039529101  
[contact@summit-homeinspection.com](mailto:contact@summit-homeinspection.com)

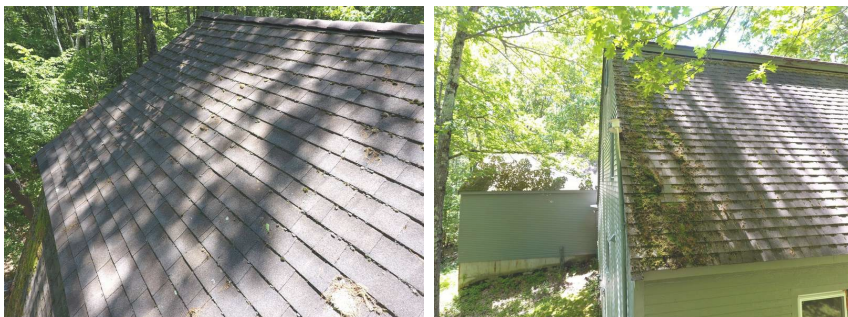
### 2.1.1 Coverings

## ROOF-MOSS OBSERVED

Moss observed on roof covering. This can lead to premature failure of the roof covering and subsequent leaks. Recommend treating moss during its growing season (wet months) with a moss killer.

Contact a qualified professional.

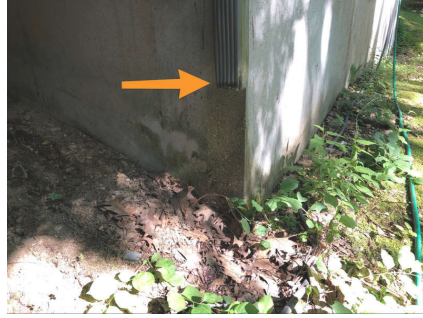
Downspout extension needed

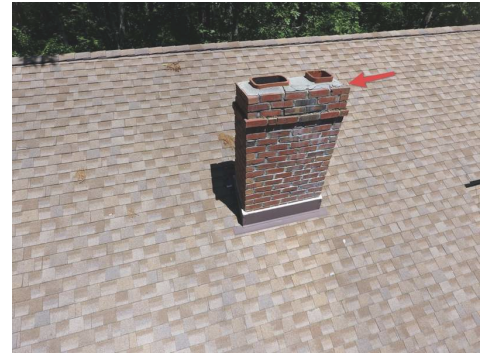
### 2.5.1 Roof Penetrations

Spark arrestor and rain cap missing from masonry chimney.

Mortar cracked on chimney crown.

Chimney crown. Cracked mortar

Contact a qualified roofing professional.

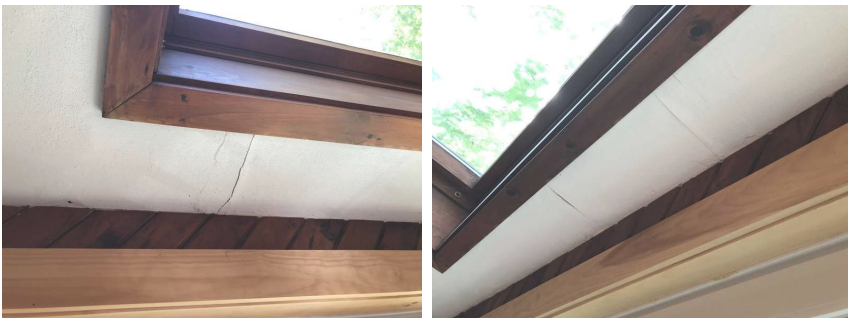
### 2.5.2 Roof Penetrations

#### SKYLIGHT-WATER INTRUSION

There are signs of prior water intrusion at or near the skylight. Skylights, if not properly installed, are prone to leaking. Monitor the condition and if there is sign of leak then have the skylight repaired or replaced.

Proper flashing around the skylight is critical.

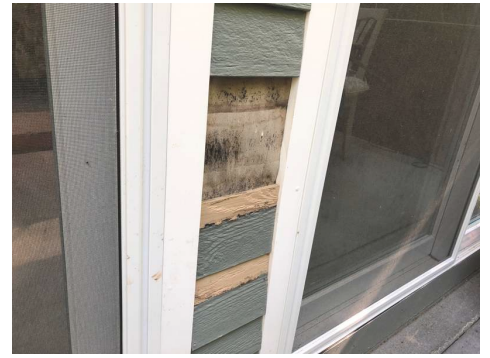
4.1.2 Siding, Flashing & Trim

**SIDING MISSING**

One or more areas were observed missing pieces of siding. This can lead to insect or pest infestations if not repaired and/or sealed. Recommend siding contractor installing siding/trim to keep pests and insects out of home.

Recommendation  
Contact a qualified professional.

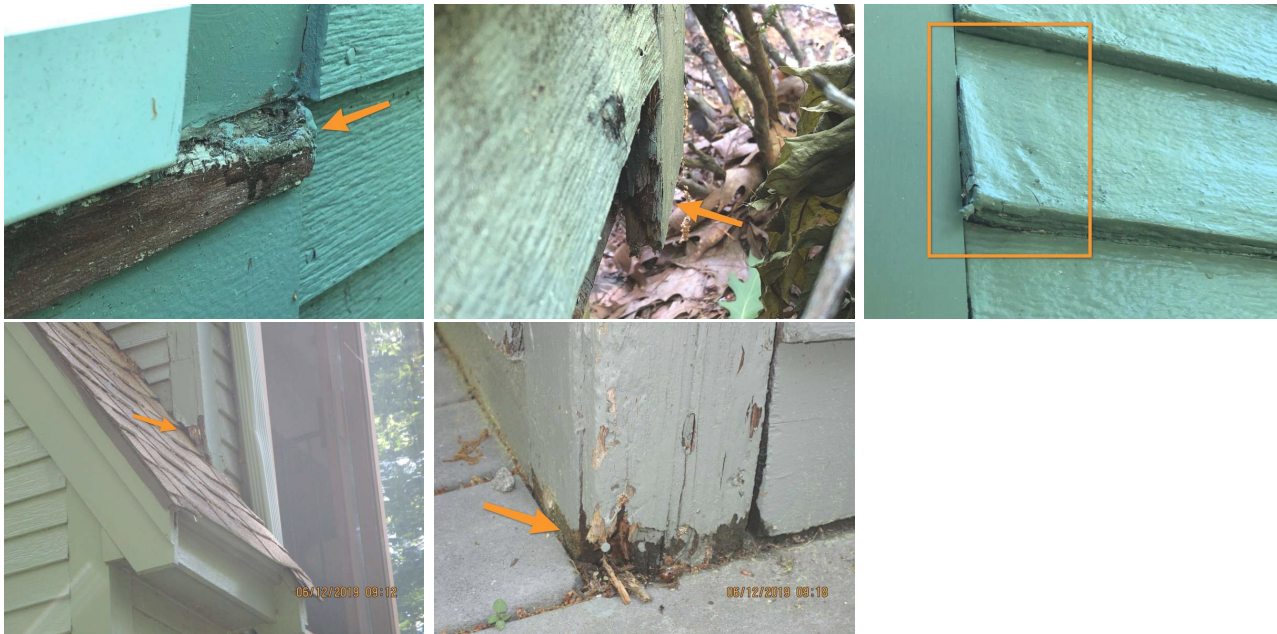
4.1.3 Siding, Flashing & Trim

**SIDING AND TRIM-WOOD ROT**

Wood rot observed on several areas of trim and siding. Some areas may require replacement due to excessive water damage.

Recommendation  
Contact a qualified professional.

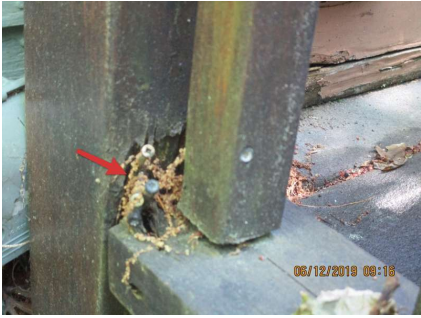
Railing and handrail observed to be loose. Recommend replacing or tightening to withstand at least 200 lb of force.

Railing damaged and loose.

Recommendation  
Contact a handyman or DIY project

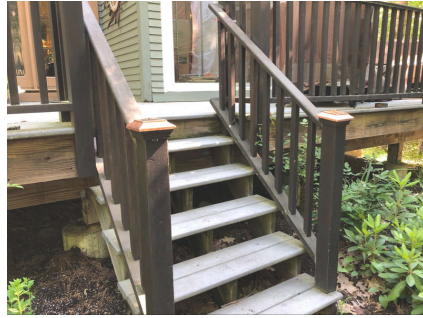
Handrail loose.

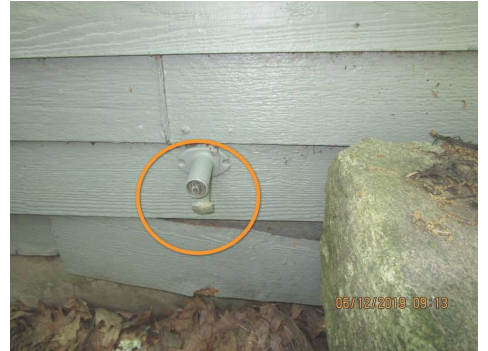
#### 4.6.2 Hose Bibs

Handle/valve missing on hose bib. Recommend replacement.

Missing handle/valve

Contact a qualified plumbing contractor.

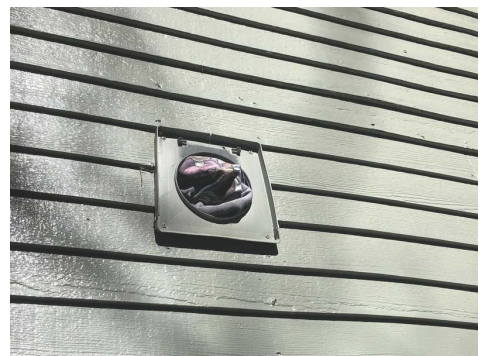
#### 5.4.1 Dryer Ventilation to Exterior

### DRYER VENT-REMOVAL

Dryer vent no longer in use and stuffed with a rag. This is not an acceptable method of sealing the opening. Recommend properly removing exhaust vent and closing the opening to prevent unwanted pests and insects from entering the home.

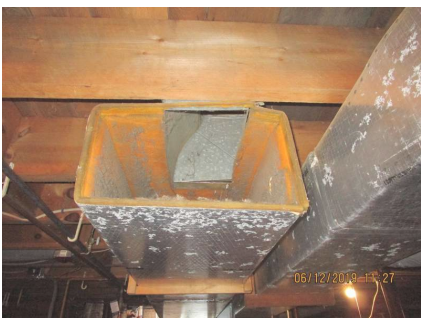
Air supply duct was damaged. Recommend a qualified HVAC contractor repair.

Missing end cap. Return air entering system from unconditioned basement

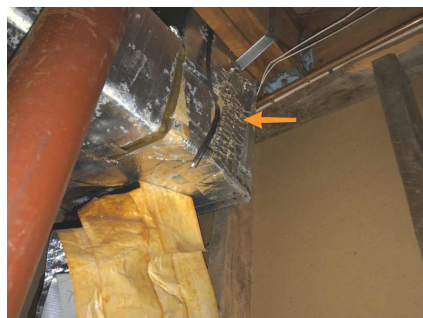
Insulation loose and falling off distribution ducts.

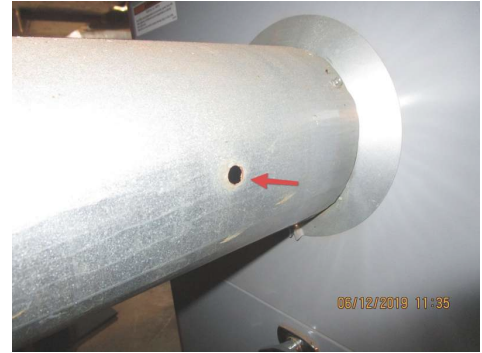
6.4.1 Vents, Flues & Chimneys

Flue vent damaged. Observed a hole in vent pipe. Recommend HVAC specialist replace the vent pipe to ensure no gases are being released into the home. Safety hazard.

hole in flue vent pipe

Recommendation  
Contact a qualified professional.

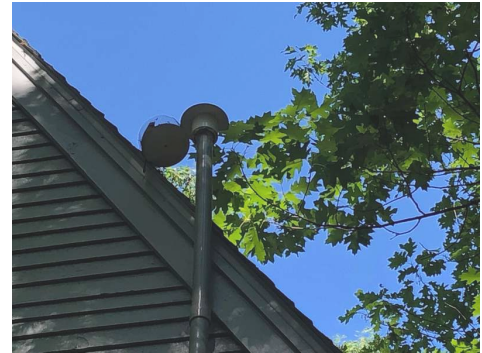
6.4.2 Vents, Flues & Chimneys

**VENT CAP DAMAGED**

Vent cap damaged. Vent pipe (possibly radon water system) discharges above the roof system. Cap is partially disconnected and hanging from pipe.

Recommendation  
Contact a qualified professional.

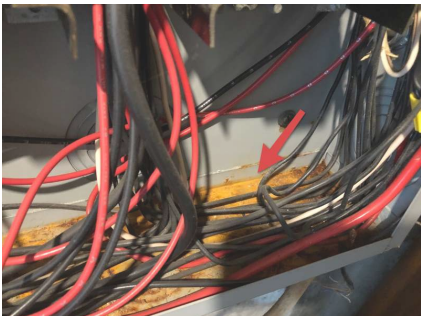
Rust and/or corrosion observed inside electrical panel. This indicates high moisture levels. Recommend licensed electrician evaluate further and replace, if necessary.

Rust inside distribution panel

Recommendation  
Contact a qualified electrical contractor.

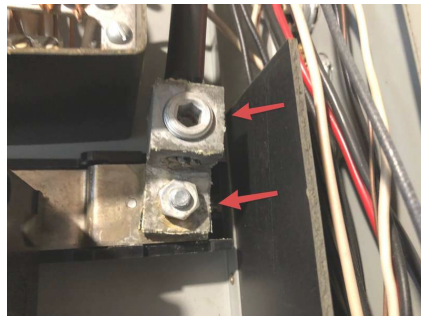
Corrosion on service entrance lug/bolt

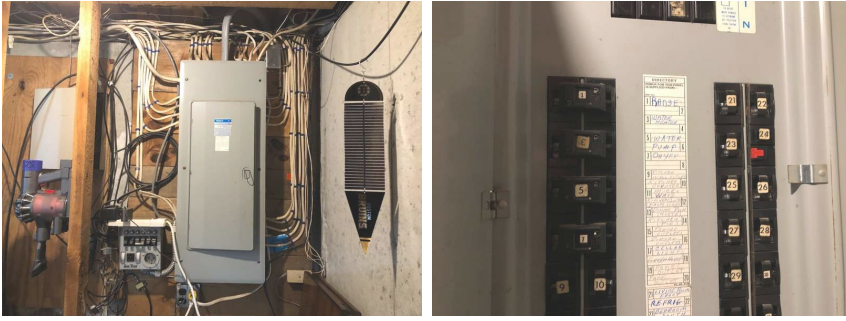
7.2.2 Main & Subpanels, Service & Grounding, Main Overcurrent Device

Observed ITE (Seimens) Push-Matic Electri-Center Panel in home. Push-matic electrical panels have had issues with failing to "trip" or failing to indicate proper status. Although this system has not been recalled, it is no longer used in homes and obtaining replacement parts may be difficult. Recommend consulting with in electrician for full evaluation of system and possible upgrade. This is only a recommendation and not to be confused with a safety issue or hazardous panel.

Recommendation  
Contact a qualified electrical contractor.

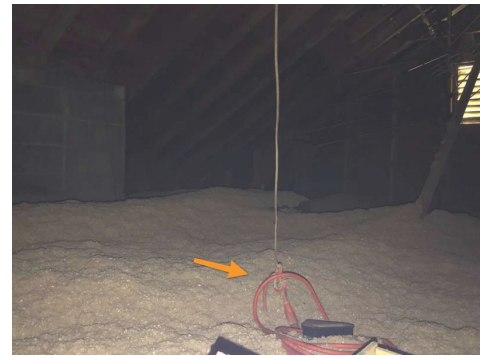
7.4.1 Lighting Fixtures, Switches & Receptacles

Observed extension cord observed in attic. Extension cords and other temporary wiring should never be used for permanent installation. Recommend licensed electrician remove temporary wiring. Safety and fire hazard.

Extension cord connecting clip on lamp

Recommendation  
Contact a qualified professional.

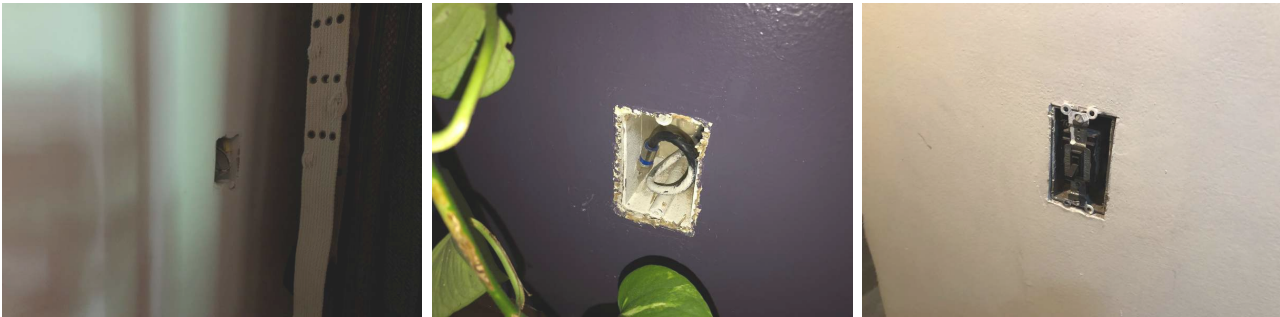
7.4.2 Lighting Fixtures, Switches & Receptacles

One or more receptacles are missing a cover plate.

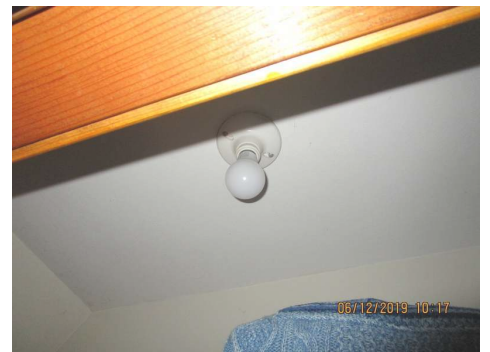
7.4.3 Lighting Fixtures, Switches & Receptacles

One or more improper lighting fixtures were observed inside closets. Incandescent light bulbs should be fully encased if located inside closets. Recommend upgrading light fixtures to surface mounted or recessed lighting.

Improper and no switch located

during inspection to activate fixture

Recommendation  
Contact a qualified electrical contractor.

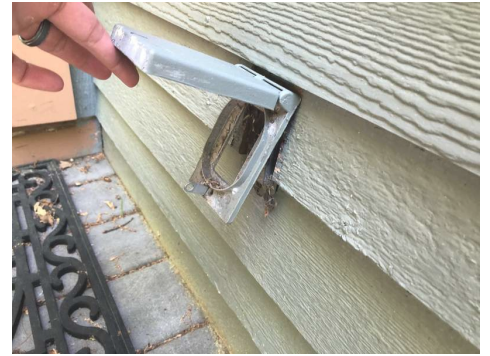
#### 7.4.4 Lighting Fixtures, Switches & Receptacles

Exterior receptacle loose and pulling away from siding. This receptacle was not tested.

Contact a qualified electrical contractor.

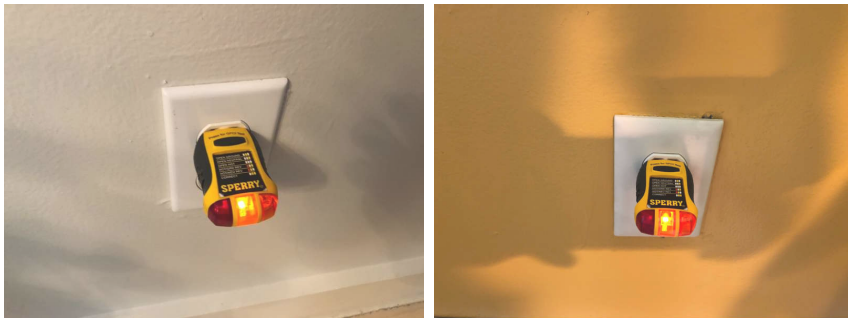
#### 7.4.5 Lighting Fixtures, Switches & Receptacles

One or more receptacles are ungrounded.

Contact a qualified electrical contractor.

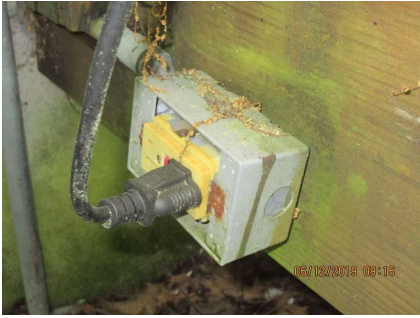
GFCI not protected with weather-proof cover. Not tested.

I strongly recommend installing/upgrading all required receptacles to GFCI for safety.

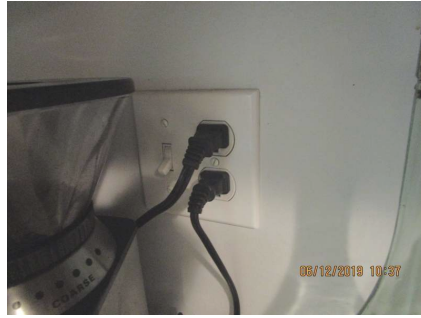
GFCI receptacles are now standard in all wet/damp locations, including kitchen, laundry, bathrooms, garage, exterior, basements, pool/spa areas, and any other locations prone water or high moisture levels.

This home was built prior to many of these requirements and therefore, should be updated to bring it up to today's standards.

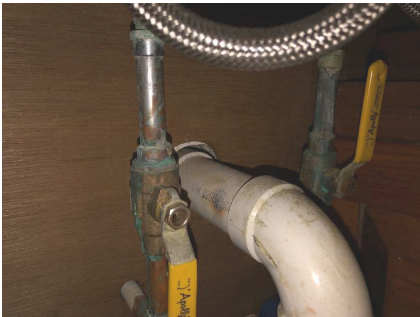
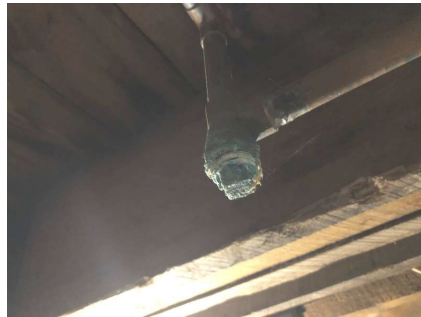
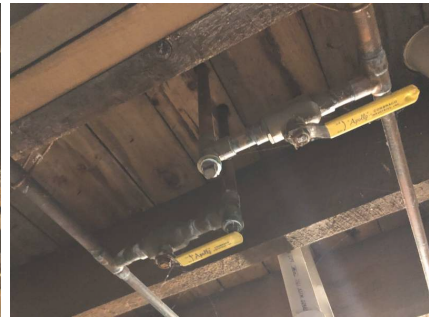
### 8.3.2 Water Supply, Distribution Systems & Fixtures

Corrosion observed on one or more pipes in the plumbing system.

Contact a qualified professional.

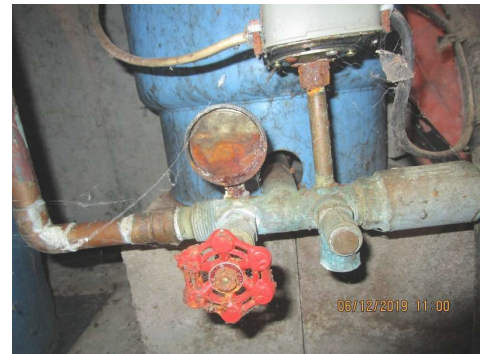
### 8.3.3 Water Supply, Distribution Systems & Fixtures

Corrosion observed on well equipment and pipes.

Pressure gauge damaged and inoperable. Recommend licensed plumbing contractor fully evaluate system and perform maintenance, as necessary.

Contact a qualified plumbing contractor.

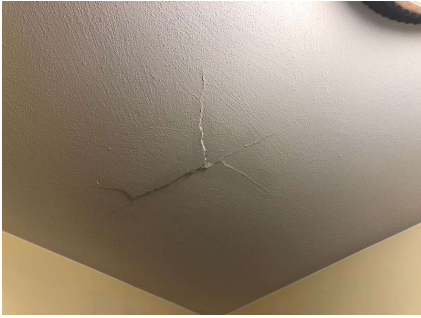
Crack in hallway. 2nd Floor

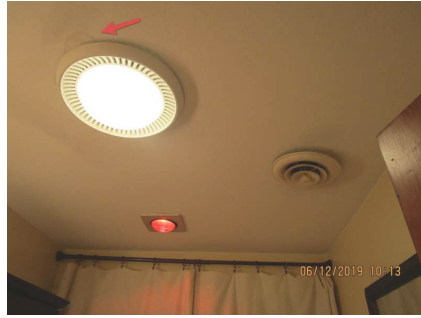
Stain observed in bathroom. 2nd Floor

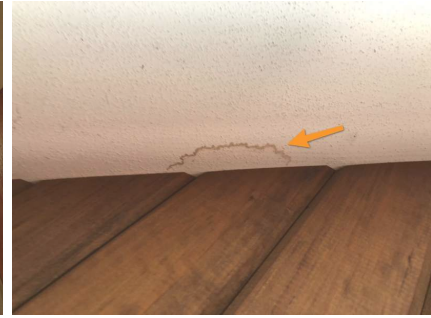
Stain. Sunroom

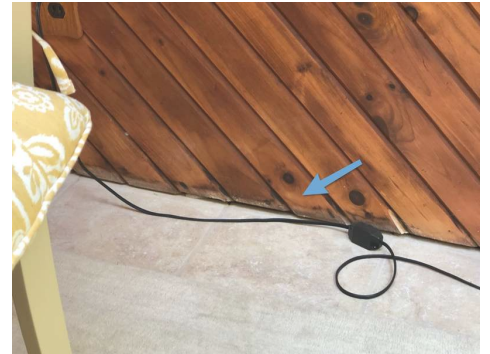
Stains on the walls visible at the time of the inspection appeared to be the result of moisture intrusion. The source of moisture may have been corrected. Recommend further examination by a qualified contractor to provide confirmation.

Floor to wall connection. Sunroom

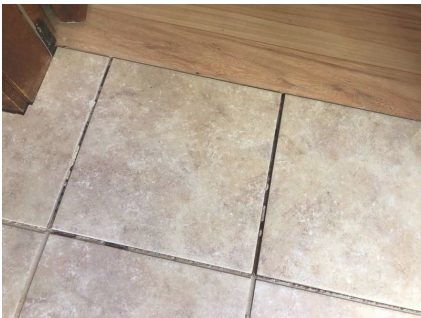
Grout missing around several tiles. Tiles loose.

Grout missing. Tile loose

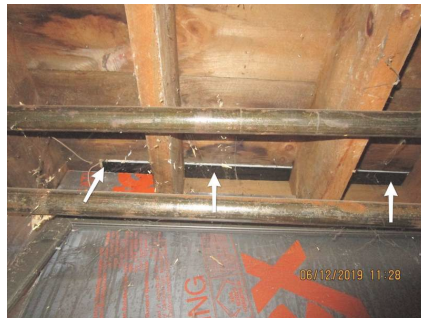
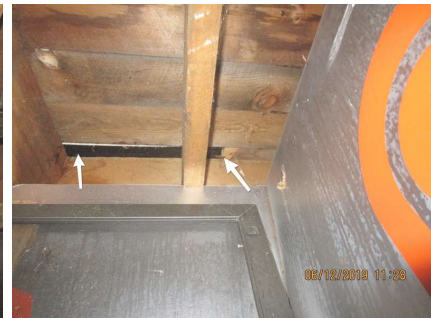
Floor around sliding doors have gaps from basement to 1st floor.

Sliding door. Basement view

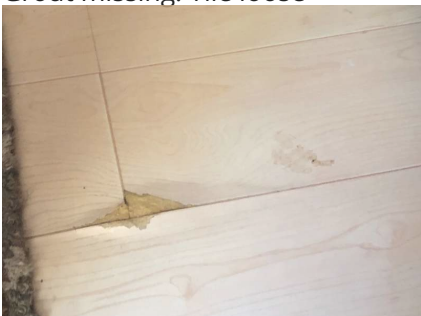
Laminate floor showed signs of water intrusion.

Dining Room. Floor damaged.

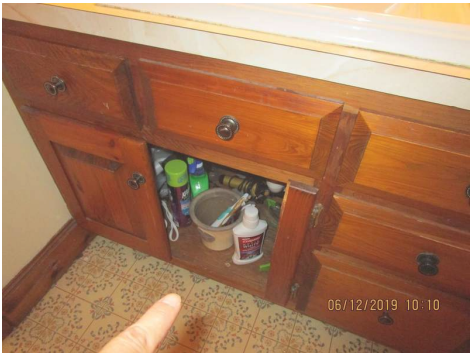
9.4.1 Countertops & Cabinets  
(representative number)

Cabinets had visible damage.

Contact a qualified professional.

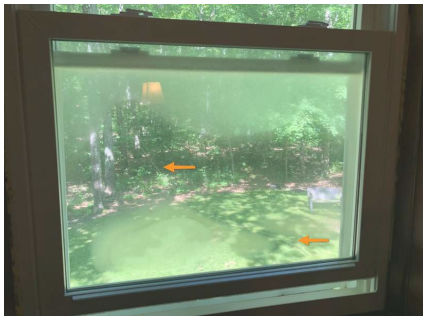
Window cracked through bottom inside pane.

Crack in window. Failed seal

Observed condensation between the window panes, which indicates a failed seal. Recommend qualified window contractor evaluate & replace.

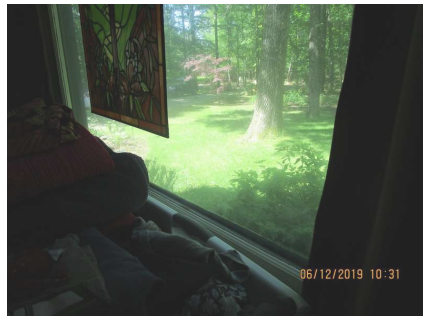
Failed Seal. Living Room

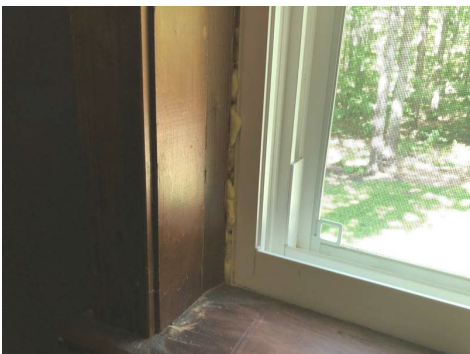
9.6.2 Windows

Foam insulation observed around windows. Possibly due to gaps (energy loss) between original frame work and new window installation. Monitor these areas during heavy rains to ensure a proper seal around trim.

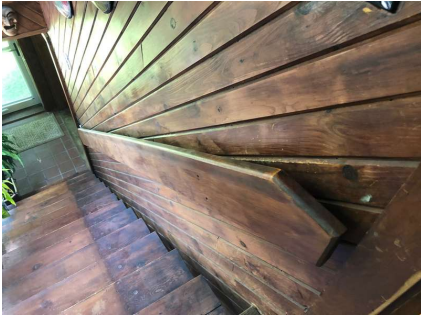
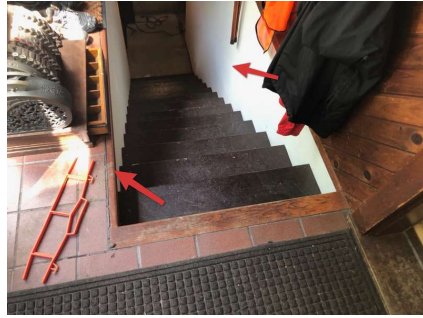
Missing railings and graspable handrails.

Recommend installing graspable handrails on both sets of stairs.

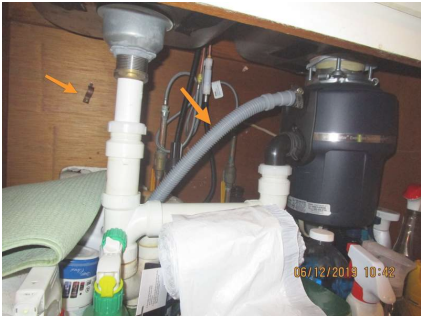
Dishwasher drain hose not installed properly. The drain hose should be secured to the underside of the counter ("high-loop" method) or connected to an air gap.

High-loop not observed

Recommend licensed plumbing contractor properly install drain hose.
