**SUMMARY**  
1234 Main St. Steamboat Springs CO  
80487  
Buyer Name  
01/10/2019 9:00AM

Brian Hickory  
InterNACHI Certified Home Inspector  
Hickory Property Services LLC  
970-367-7255  
brian@hickoryproperty.com

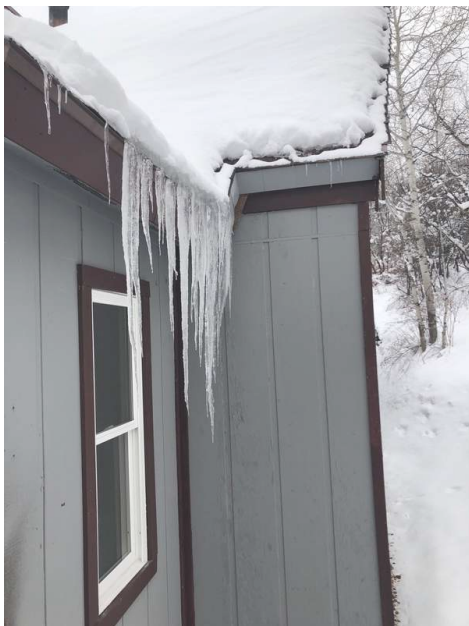
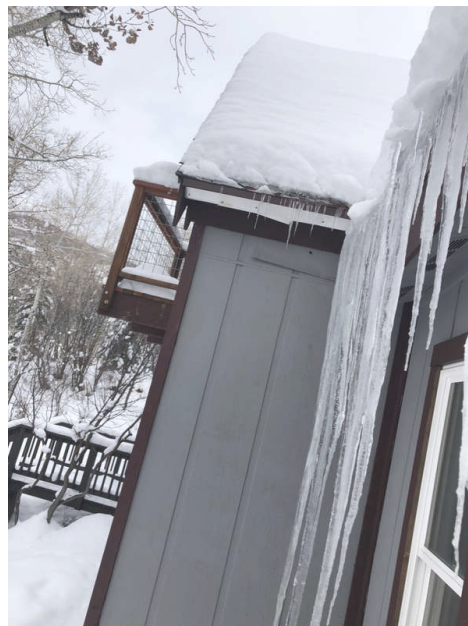
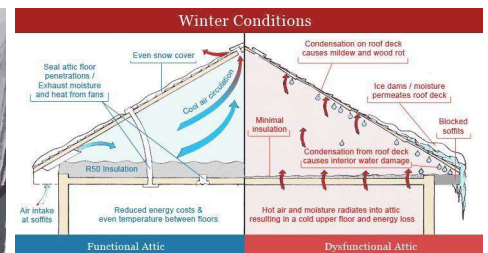
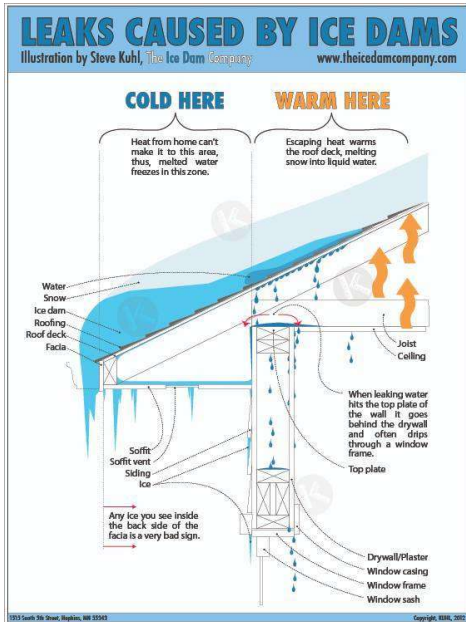
### 2.1.1 Coverings

#### ICE DAMS

Ice dams have formed on the West and East side of the roof. An ice dam is a ridge of ice that forms at the edge of a roof and prevents melting snow from draining. As water backs up behind the dam, it can leak through the roof and cause damage to walls, ceilings, insulation and other areas. Ice dams are formed by an interaction between snow cover, outside temperatures, and heat lost through the roof. Specifically, there must be snow on the roof, warm portions of the upper roof (warmer than 32 F), and cold portions of the lower roof (at freezing or below). Melted snow from the warmer areas will refreeze when it flows down to the colder portions, forming an ice dam. To prevent the ice dams from forming, there are various approaches to take such as adding insulation in the attic, seal air leaks at plumbing pipes & electrical penetrations in attic and adding vents. Recommend a qualified roofing contractor evaluate to determine the best approach to take to prevent this from occurring each winter.

Contact a qualified roofing professional.

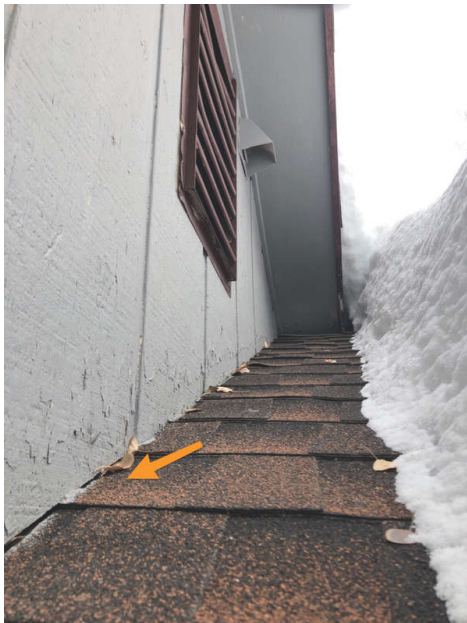
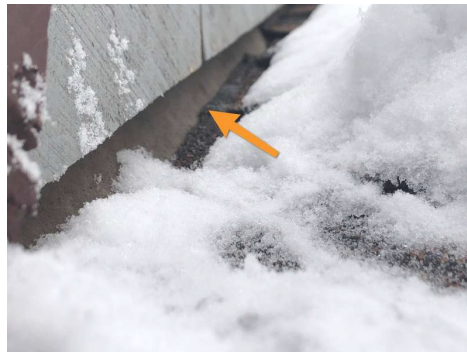
### 2.3.1 Flashings

#### STEP FLASHING MISSING

Step flashing is not installed at the sidewalls and chimney chase; instead just the underlayment is installed. Anywhere roof sections adjoin wall sections, step flashing should be used to keep water from entering the walls. The step flashing should be extended at least 4 inches up the wall from the roof deck and at least 4 inches out along the roof deck (2015 International Residential Code [IRC]) with the house siding installed over the step flashing, ending at least 1 inch above the roof surface. Recommend a qualified roofing contractor install step flashing to prevent water damage to the structure.

Contact a qualified roofing professional.

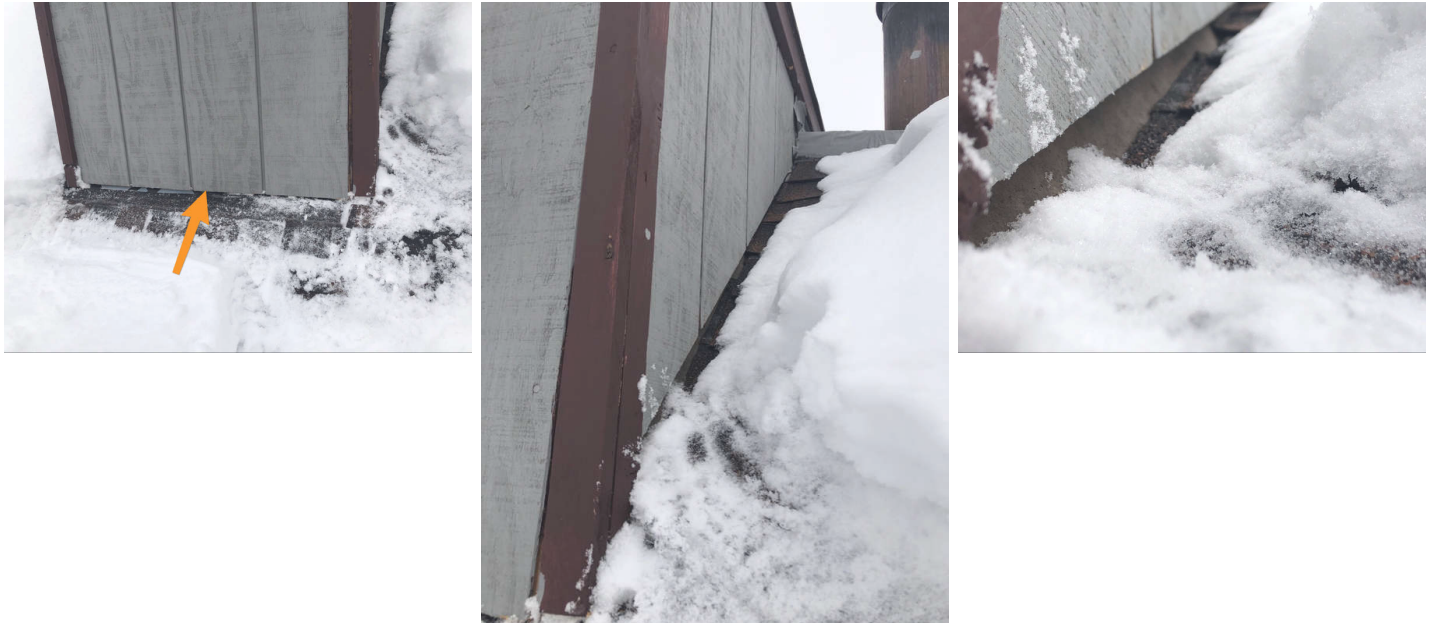
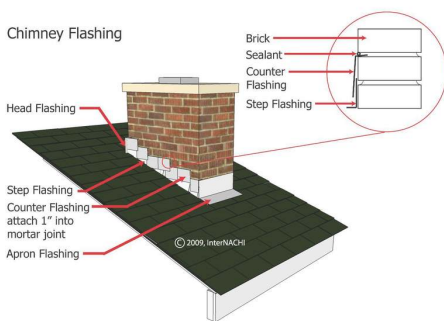
### 2.4.1 Skylights, Chimneys & Other Roof Penetrations

#### INPROPER FLASHING AT ROOF PENETRATION

There is no counter flashing installed at the chimney roof penetration. The point at which the chimney penetrates the roof should be sealed with flashing to prevent leaks and moisture damage. Recommend a roofing contractor install counter flashing.

Contact a qualified roofing professional.

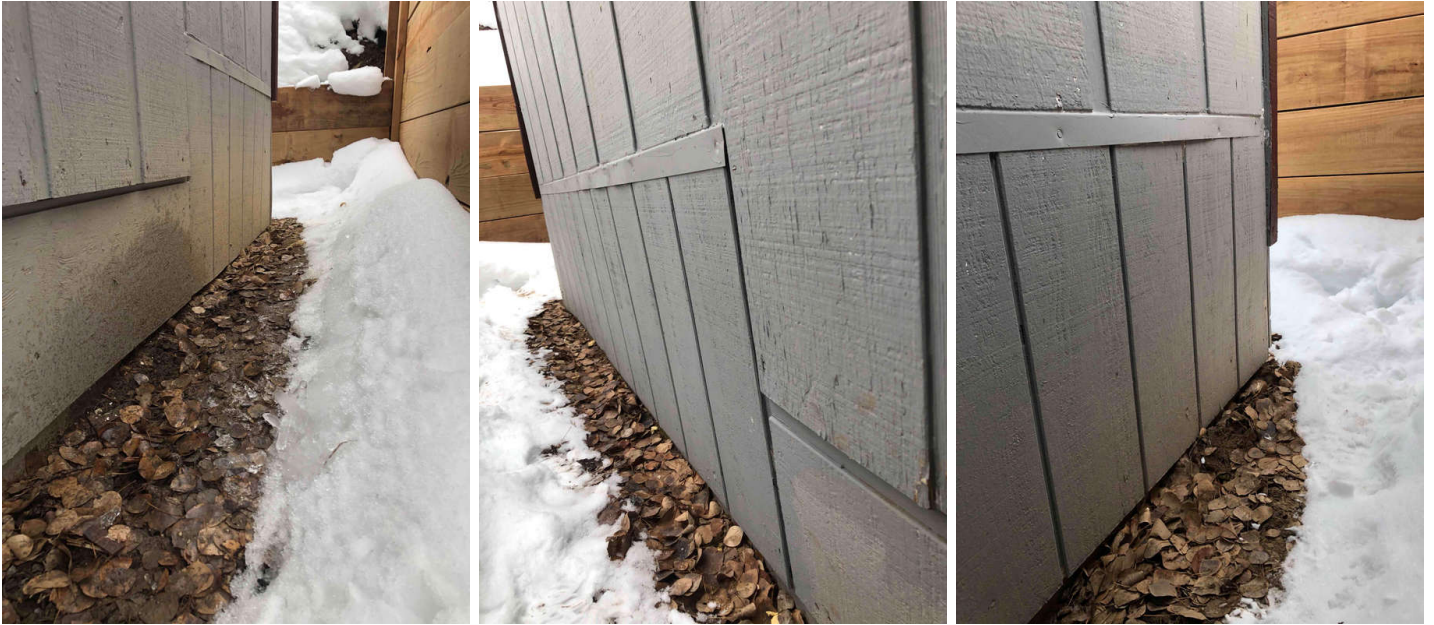
NORTHEAST

## GROUND CLEARANCE

Inadequate clearance between siding and ground on the NE corner of the house. Recommend a minimum ground clearance between bottom of siding and ground of 4". Siding in contact with the ground or soil is a serious concern because that condition can provide direct access for wood destroying insects.

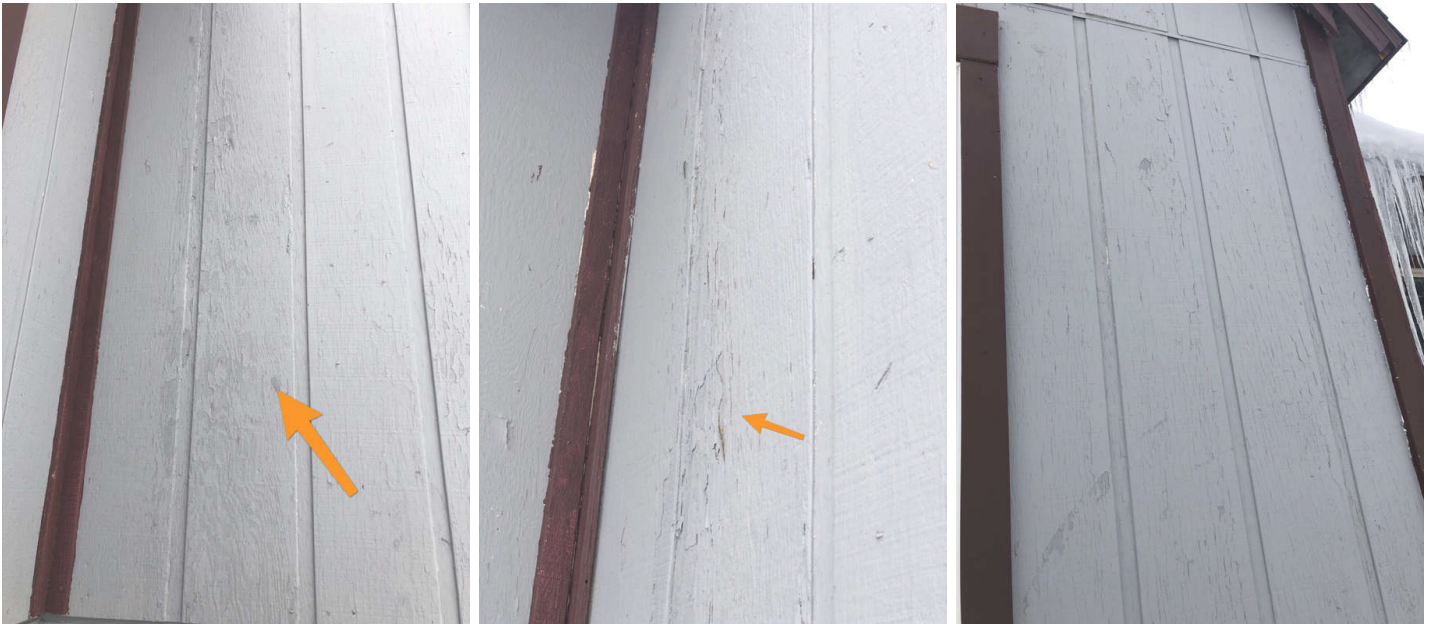
### 3.1.3 Siding, Flashing & Trim

#### **SIDING PAINT/ FINISH FAILING**

The paint or finish is failing on the siding at places, primarily on the East side of the home. This can lead to deterioration and rot of the material. Recommend that the areas be properly prepared and painted / finished.

Contact a qualified painter.

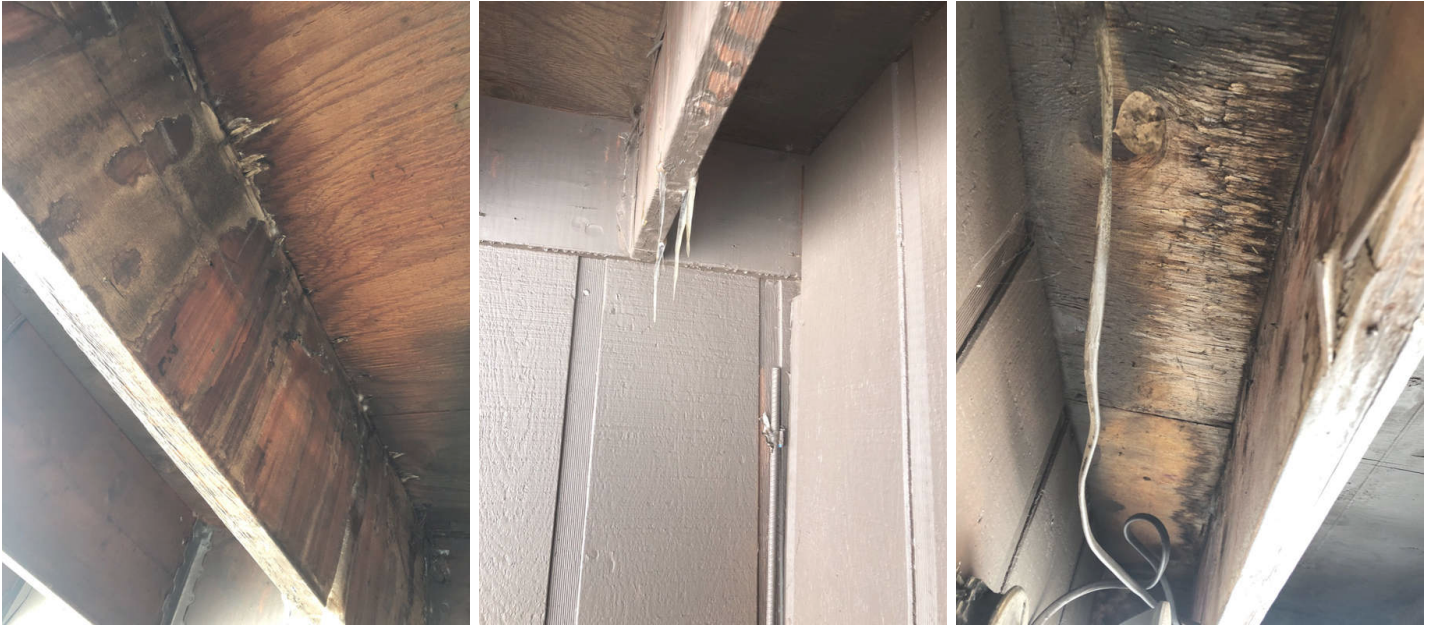
### 3.4.1 Decks, Balconies, Porches & Steps

#### **WEATHERED DECKING BOARDS**

The subflooring on the deck is weathered and showing signs of moisture damage on the East side of the deck. The deck had a membrane installed to keep the underside of the deck waterproof, but these moisture stains indicate the membrane may be compromised and a repair of the membrane could be needed to keep the underside of the deck fully waterproof. I would recommend having a deck contractor evaluate the deck to determine if the membrane needs to be repaired and what the cost would be.

Recommendation  
Contact a qualified professional.

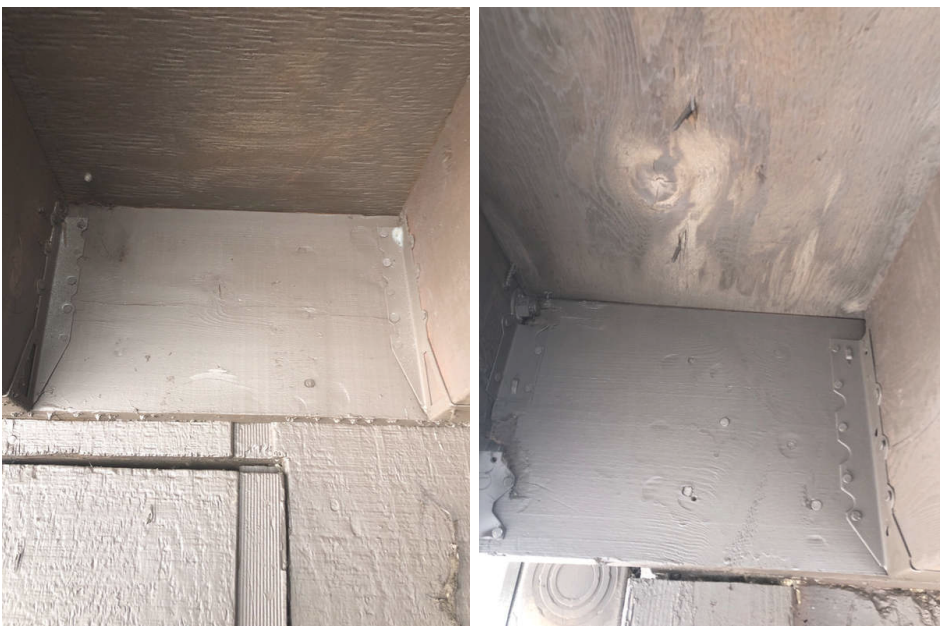
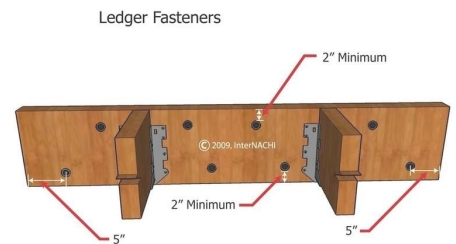
### 3.4.2 Decks, Balconies, Porches & Steps

#### LEDGER BOARD IMPROPERLY INSTALLED

Ledger boards for one or more decks, balconies or porches appeared to be attached with nails only. This method of attachment is substandard and may result in such structures separating from the main building. This is a potential safety hazard. Modern standards call for ledger boards to be installed with 1/2 inch lag screws or bolts into solid backing, and brackets such as [Simpson Strong Tie DTT2 brackets and threaded rod](#), connecting interior and exterior joists. Recommend that a qualified contractor repair per standard building practices. For more information, visit:

Recommendation  
Contact a qualified deck contractor.

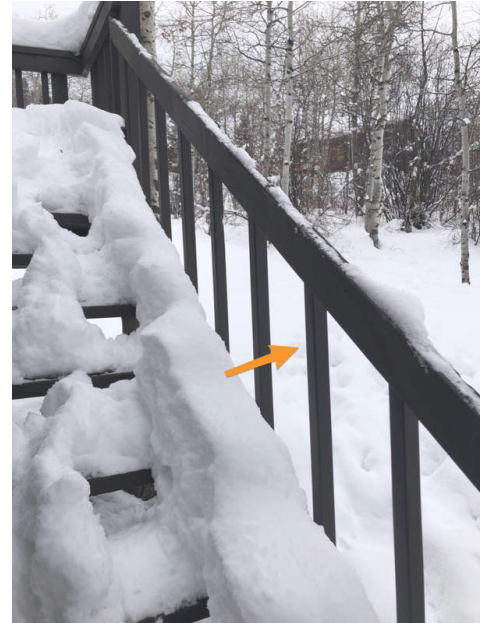
3.4.3 Decks, Balconies, Porches & Steps

**RAILING UNSAFE**

There is an unsafe opening in the railing. The spacing on the rail should not exceed 4". An opening greater than 4" is a serious safety hazard especially for children as their head or other body part can become trapped.

Recommendation  
Contact a qualified deck contractor.

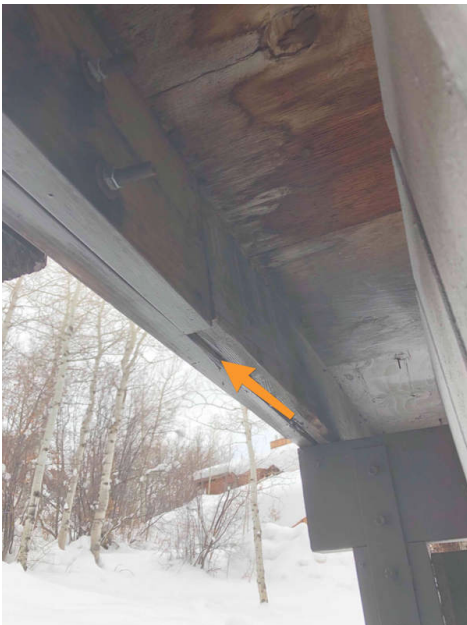
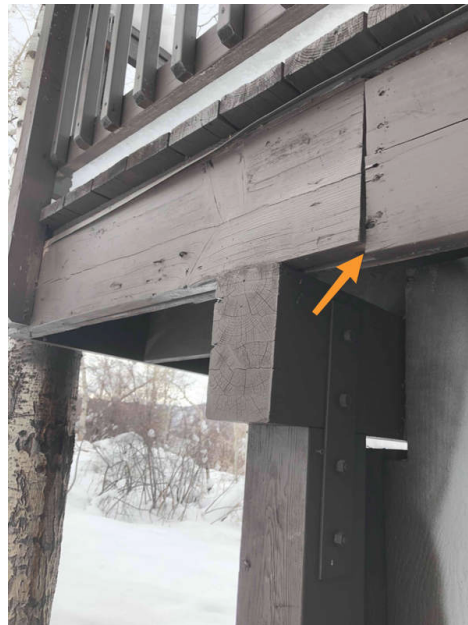
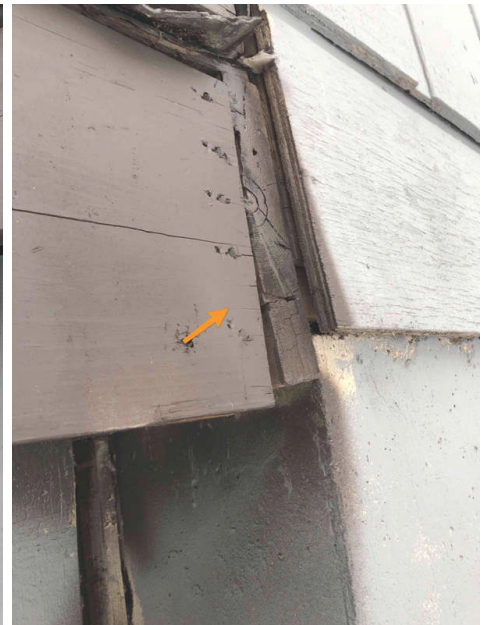
3.4.4 Decks, Balconies, Porches & Steps

**MISSING POST BEAM TIES**

On the a east side of the deck, the rim joist was not positively secured with hangers or supported with a post. Deck beams are commonly connected to support posts by "toenailing," which is inadequate. Decks are subject to movement under live loads and require a positive connection between their support posts and beams. Recommend that a qualified contractor repair per standard building practices. For example, by installing metal plates, plywood gussets or dimensional lumber to connect posts and beams.

Recommendation  
Contact a qualified professional.

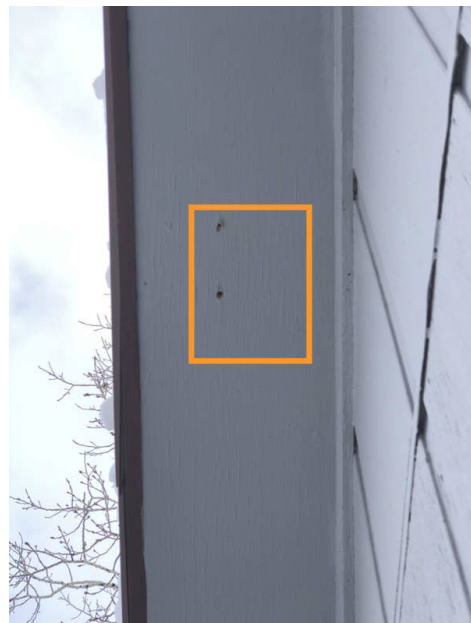
3.5.1 Eaves, Soffits & Fascia

**HOLES IN SOFFIT**

There were a couple of holes in the soffit on the South side of the house which should caulked. This can allow water intrusion and rodent infestation as well as deterioration of the surrounding material.

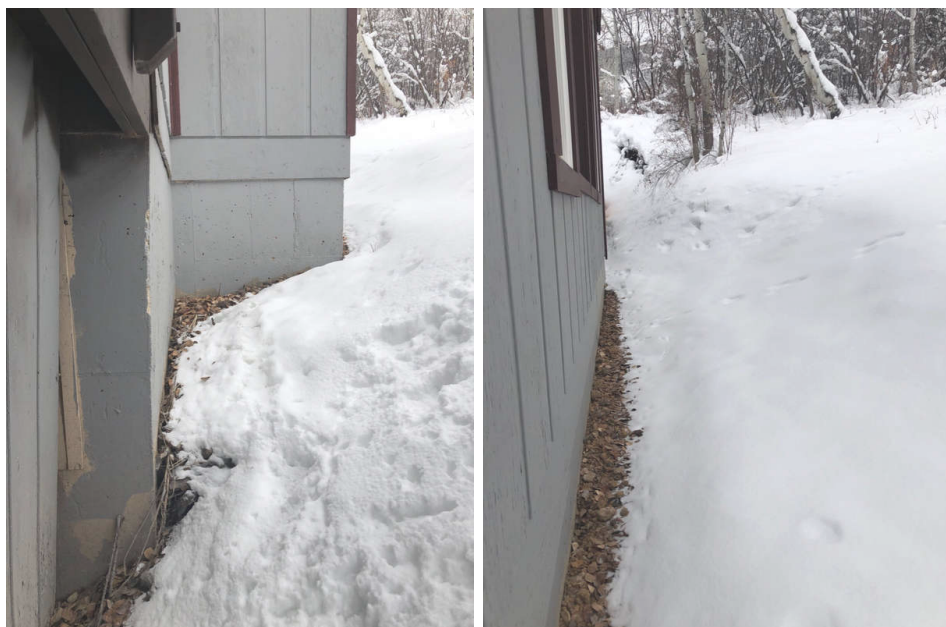
### 3.6.1 Vegetation, Grading, Drainage & Retaining Walls

#### **NEGATIVE GRADING**

Grading is sloping towards the home in some areas. This can result in water accumulating around building foundations or underneath buildings. At a minimum, monitor these areas, and areas under the structure in the future for accumulated water. If water does accumulate, recommend grading soil so it slopes down and away from buildings with a slope of at least 1 inch per horizontal foot for at least 6 feet out from buildings.

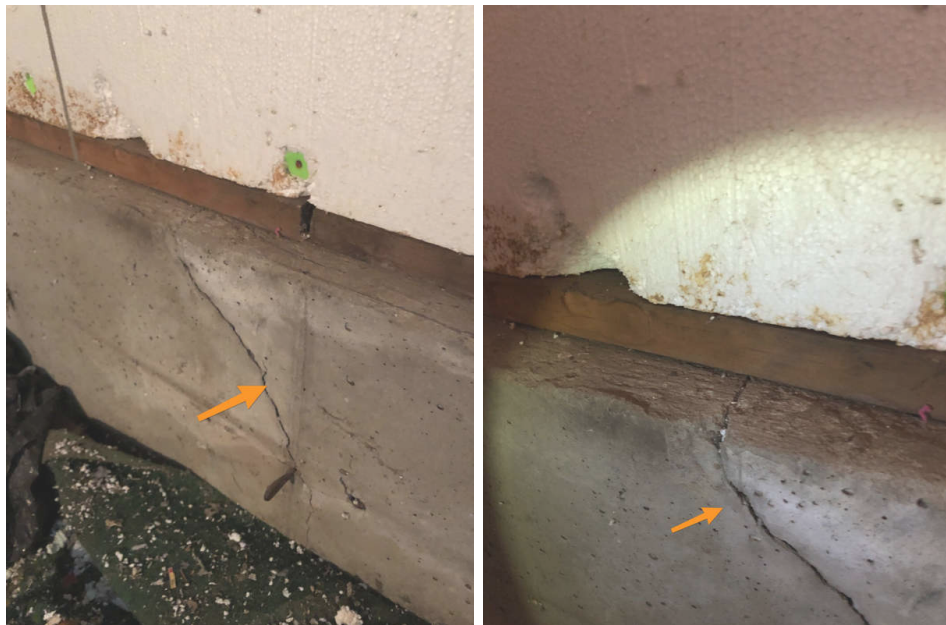
### 4.1.1 Foundation

#### **FOUNDATION CRACKS - MINOR**

A minor diagonal crack was noted at the foundation wall on the South side. The crack is larger on top and reduces to a hairline crack as it continues down the wall of the foundation. This type of crack indicates there is some slight settling or it is a shrinkage crack when the concrete was curing and has grown over time. This part of the foundation wall is the only section that is not backfilled which may be why it has settled. The rest of the concrete foundation did not have any cracks and appears to be in great shape. Recommend monitoring this one diagonal crack for more serious shifting/displacement overtime.

Recommend monitoring.

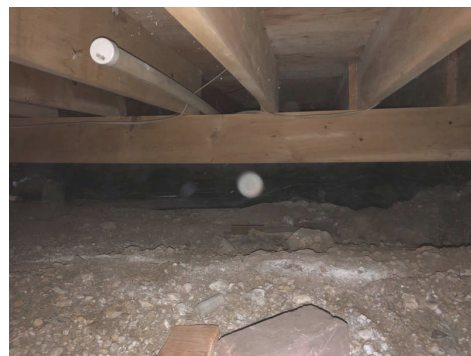
#### 4.2.1 Crawlspace & Basements

##### **NO VAPOR BARRIER**

There is no vapor barrier beneath the flooring in places. This can result in unwanted moisture.

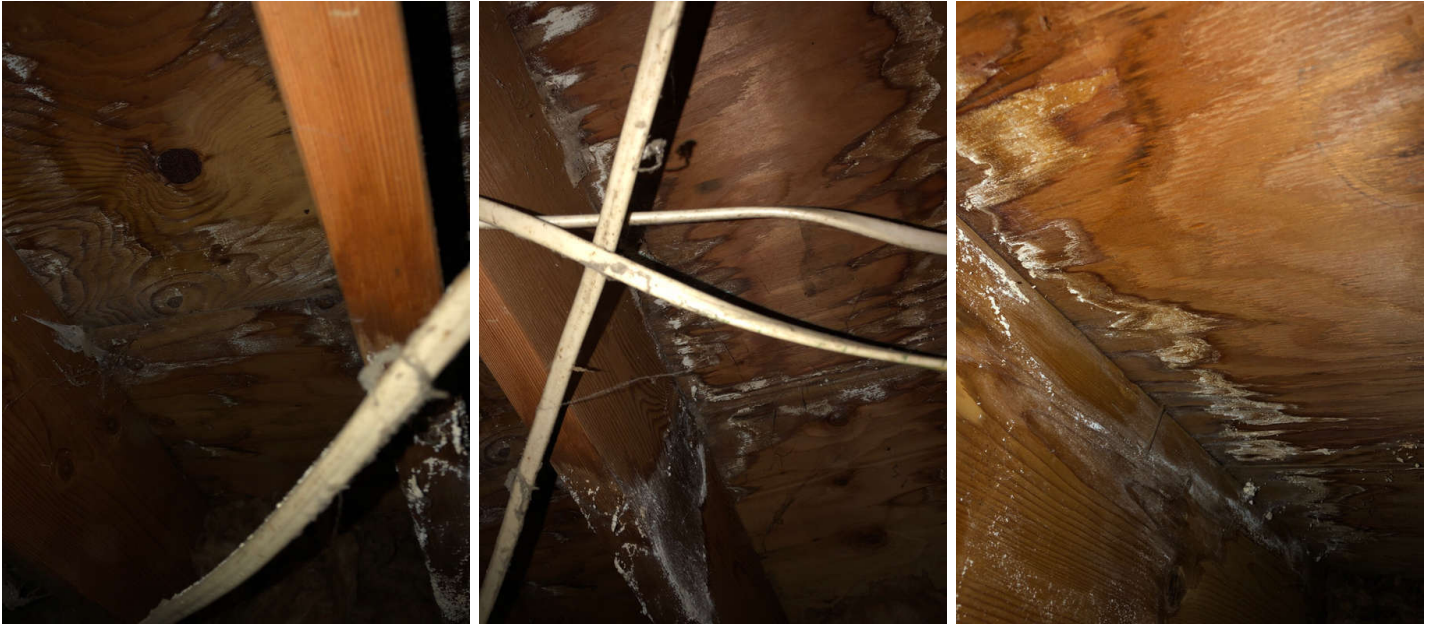
#### 4.3.1 Floor Structure

##### **MOLD**

Observed signs of a white powder on the floor joist and subflooring on the west side of the crawl space. The white powder is most likely a mold or fungus growth due to high humidity or condensation in the crawl space. The moisture meter did not indicate any water was present in the joists or subflooring, but overtime the mold/fungus could cause damage to the wood. A vapor barrier has been installed in places in the crawl space, though it does not cover the whole area and is torn in places. A structural engineer could provide repair requirements along with preventive solutions for this problem.

Contact a qualified structural engineer.

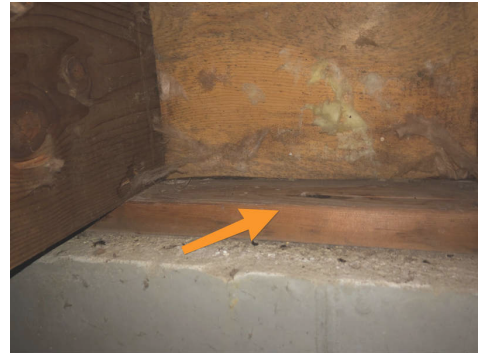
#### 4.3.2 Floor Structure

### SILL PLATE NOT SECURED TO FOUNDATION

The sill plate is not secured to the foundation. I checked along the perimeter in various locations and could not find an anchor bolt or nuts. Recommend repair for proper attachment to the foundation.

Recommendation  
Contact your builder.

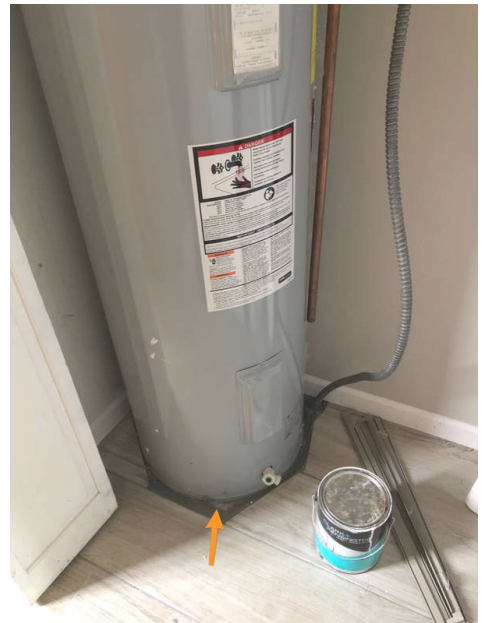
#### 7.2.1 Hot Water Systems, Controls, Flues & Vents

### NO DRIP PAN

No drip pan was present. Recommend installation by a qualified plumber.

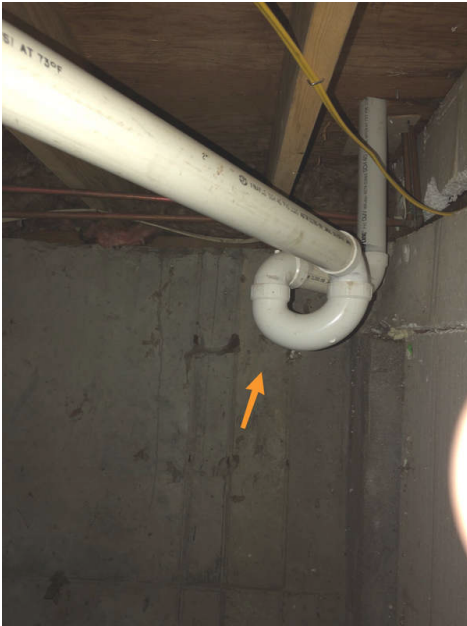
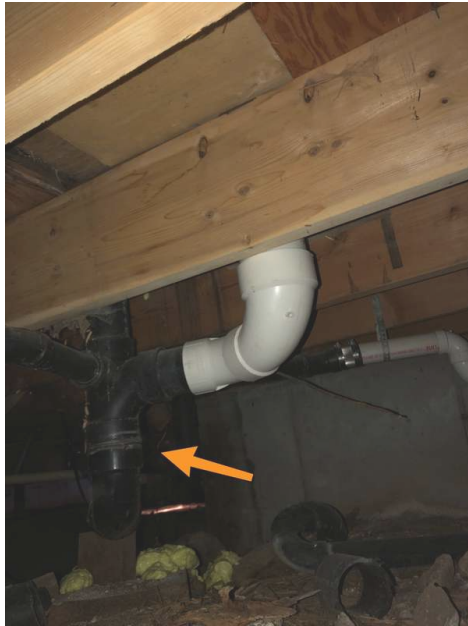
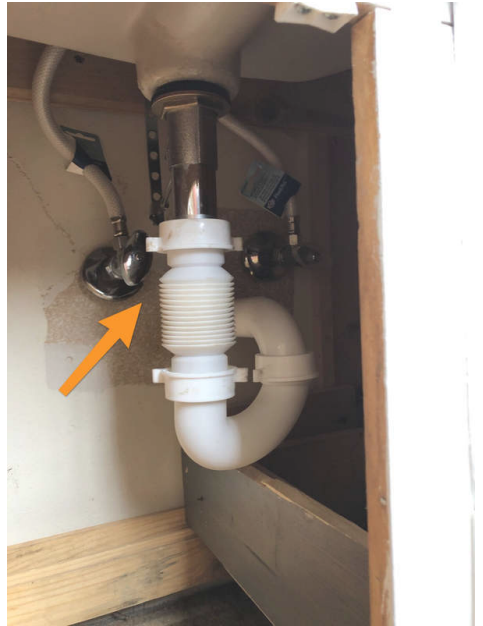
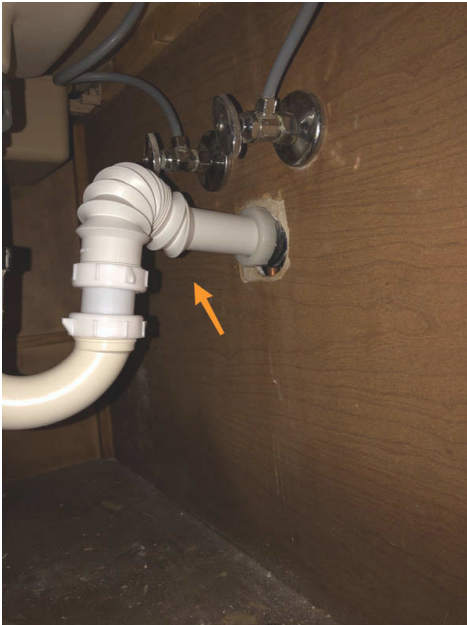
### IMPROPER P-TRAP INSTALLATION

In the crawl space, a "running trap" has been installed which is considered an improper p-trap. A running trap is when a drain line from a fixture runs horizontal then makes a u-shape trap and continues horizontal. It lowers the velocity and turbulence needed to wash (clean/scour) the trap, and causes slow running drains, among other things. The p-trap should be installed at the vertical tailpiece of the fixture.

In the bathrooms, a flexible drain transition pipe is installed. This is not approved by plumbing code because the inside walls are not smooth and will hold gunk. This kind of pipe is thinner and prone to leakage.

Contact a qualified plumbing contractor.

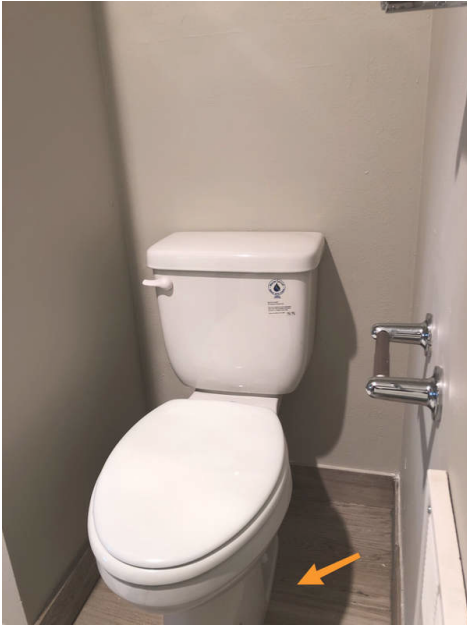
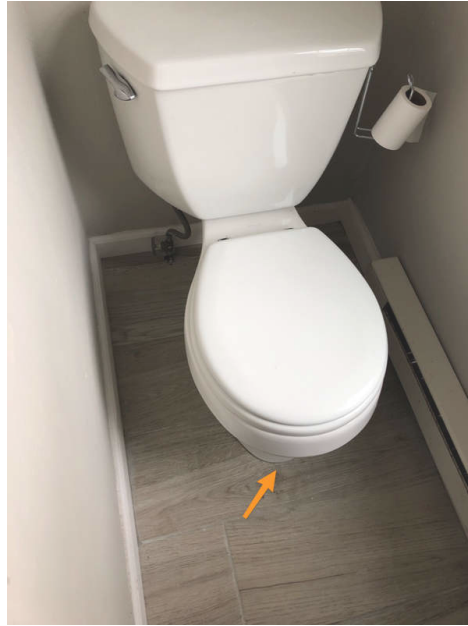
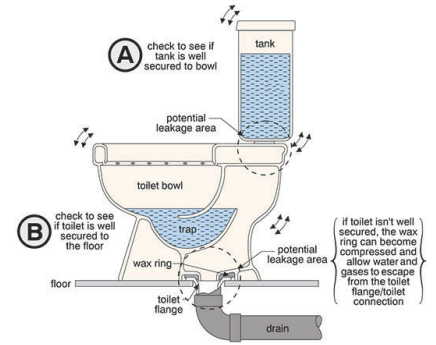
BATHROOM, SOUTH BATHROOM

### TOILET LOOSE

The toilet is not well secured to the floor. Recommend repair to help prevent (further) leaks around the wax ring.

Loose toilet

Recommendation  
Contact a qualified professional.

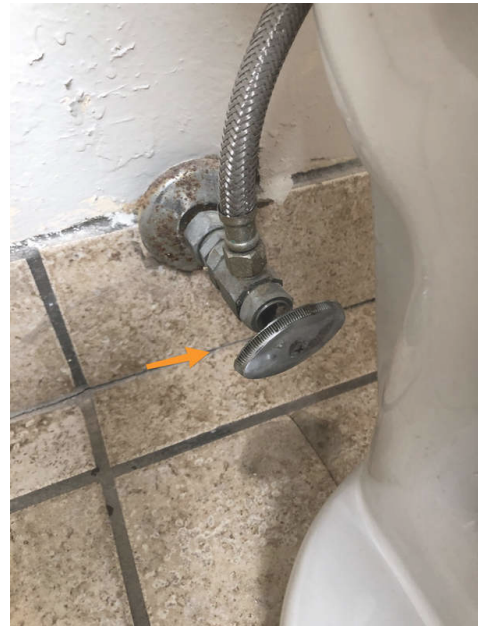
MASTER BATHROOM

## LEAKING SUPPLY LINES

The water shut-off valve at the toilet leaks. It has to be turned a quarter of the way open for it to not leak. Otherwise it leaks fully opened or any one it is turned. A qualified plumber should repair as necessary.

Recommendation  
Contact a qualified plumbing contractor.

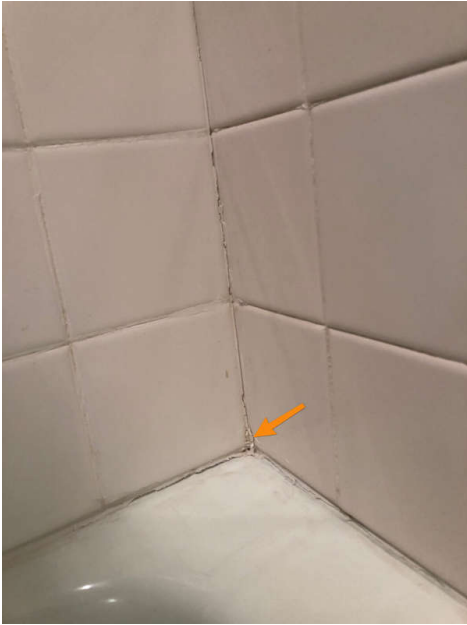
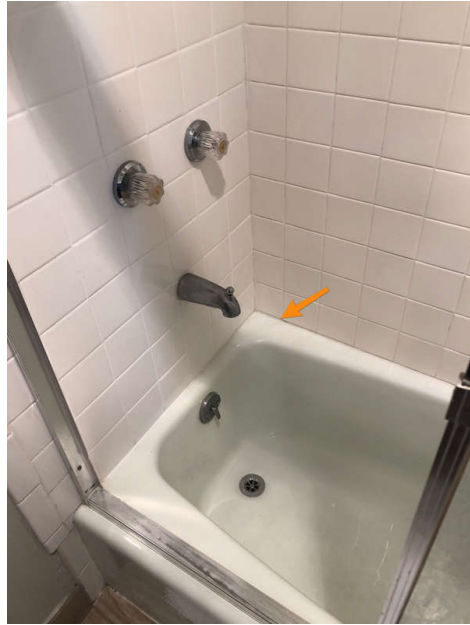
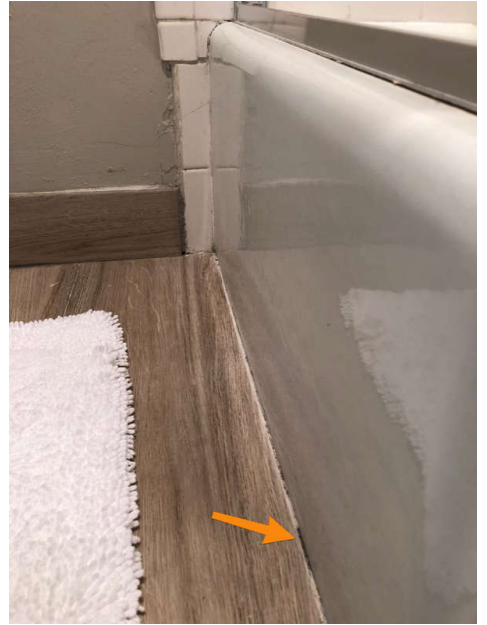
MASTER BATHROOM

## CAULKING DETERIORATED/ MISSING

The caulking around the tub is missing or worn. Water can penetrate these areas and cause damage. Recommend repair to help protect from moisture damage.

Recommendation  
Contact a handyman or DIY project

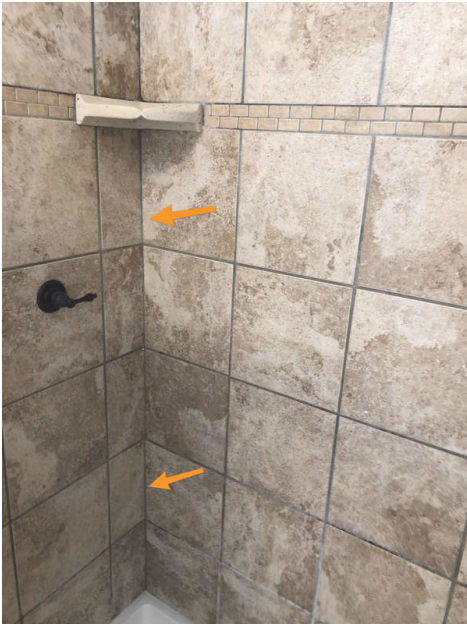
### 7.7.3 Tubs, Shower and Tile

#### **GROUT - GAPS AND CRACKS**

There are cracks and gaps in the grout. Recommend repair to help prevent water damage.

Contact a qualified tile contractor

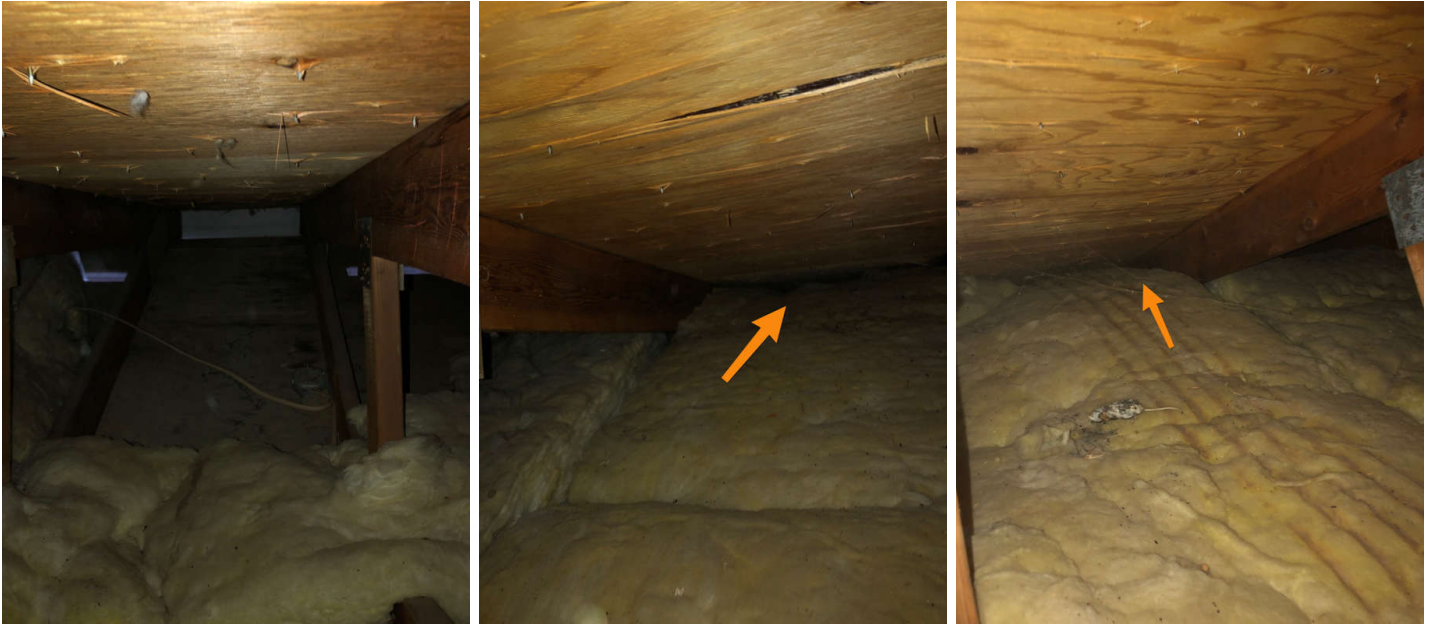
### 8.2.1 Attic Insulation

#### **IMPROPER INSTALLATION**

Attic insulation was too close to the roof sheathing in places along the perimeter of the roof. There should be a minimum of a 1 - 2" gap between the insulation and roof sheathing to allow for proper ventilation. This could be one of the causes for the ice dam build up on the roof. Recommend a qualified insulation contractor evaluate and correct.

Contact a qualified insulation contractor.

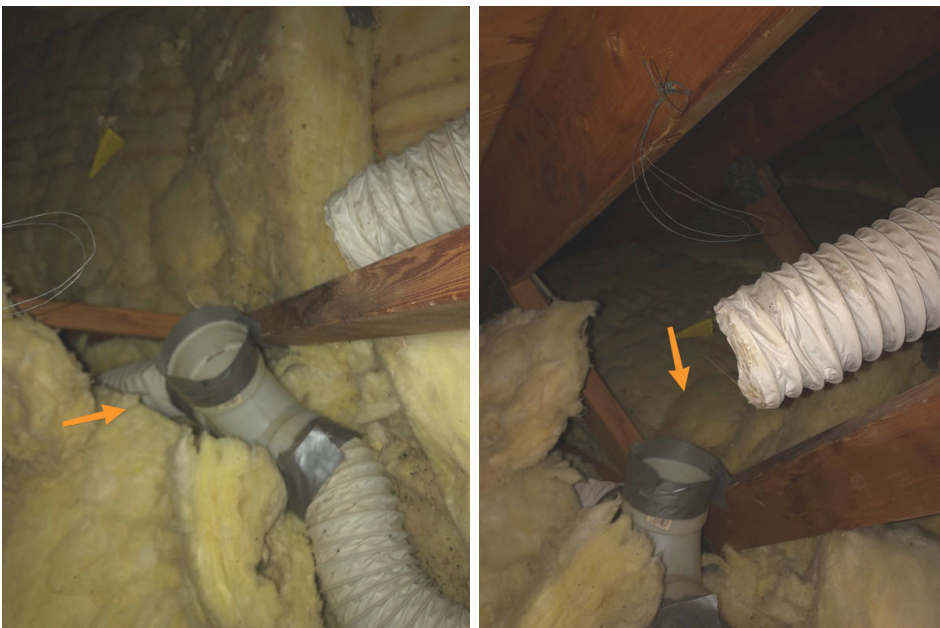
### 8.3.1 Exhaust Systems

#### **BATHROOM VENTS INTO ATTIC**

The flex duct for the vent from the bathroom is disconnected in the attic and vents into the attic, which can cause moisture and mold. Recommend the vent be repaired so it can properly exhaust to the exterior.

Contact a qualified HVAC professional.

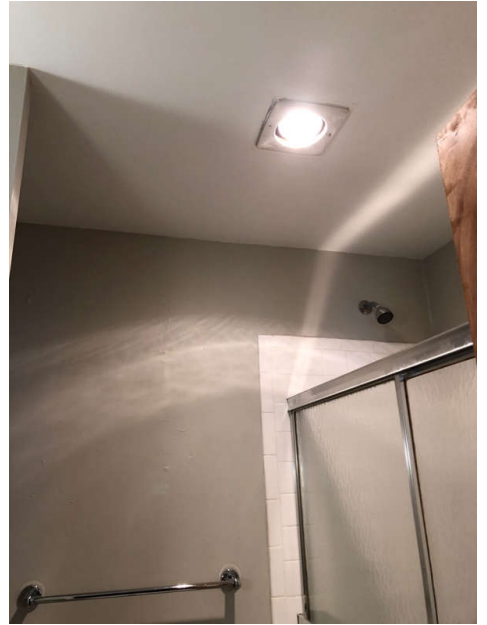
#### HALLWAY BATHROOM

#### **NO EXHAUST FAN IN BATHROOM**

The bathroom does not have an exhaust fan installed. An exhaust fan is recommended to prevent moisture and humidity buildup in the bathroom that will cause damage to walls and ceiling over time.

Contact a qualified HVAC professional.

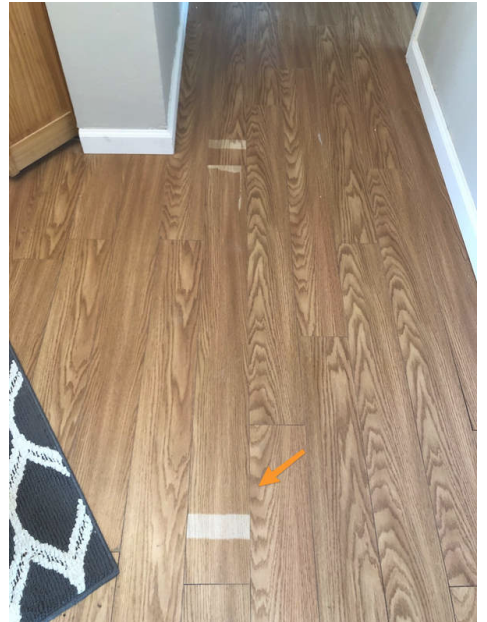
### 9.3.1 Floors

#### **DAMAGED (GENERAL)**

The vinyl wood floors in the hallway had general moderate damage visible at the time of the inspection. Recommend repair by a qualified contractor.

Contact a qualified flooring contractor

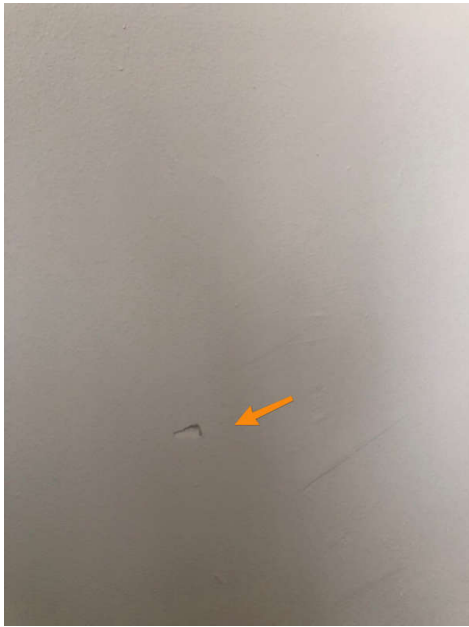
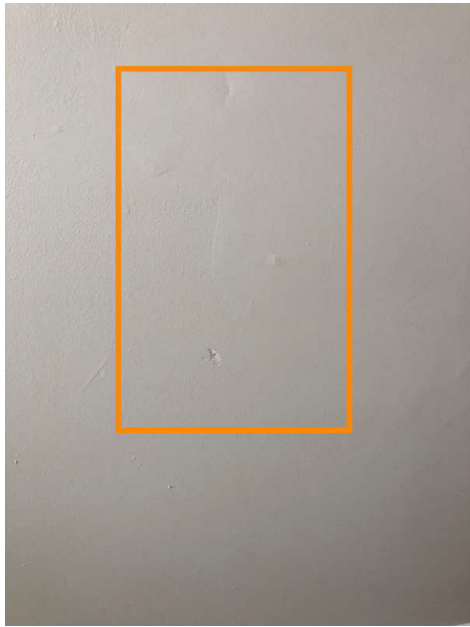
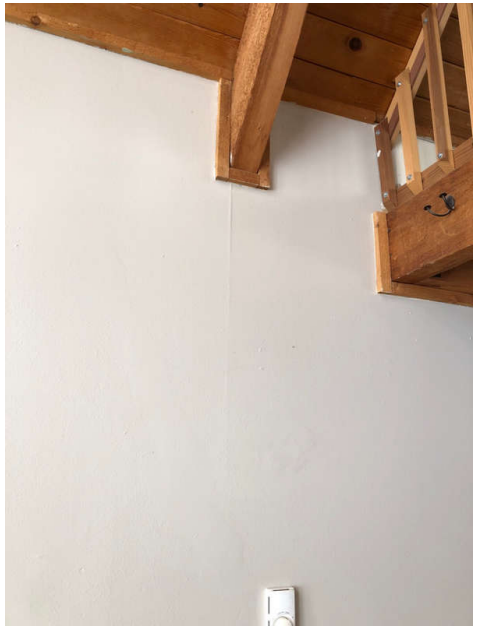
LIVING ROOM

#### **POOR PATCHING**

Sub-standard drywall patching observed at time of inspection. Recommend re-patching.

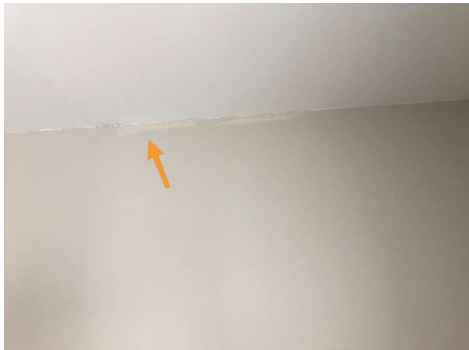
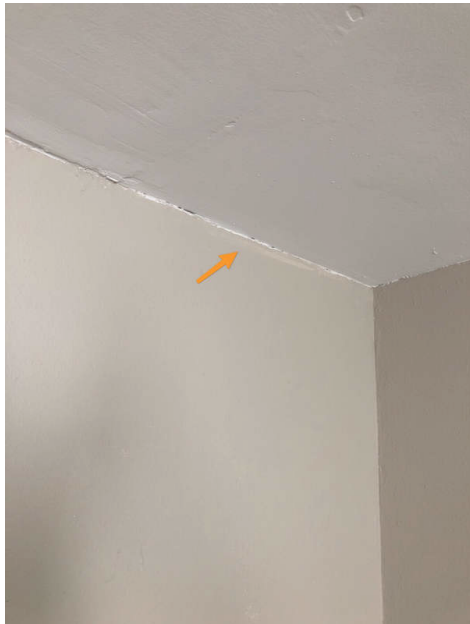
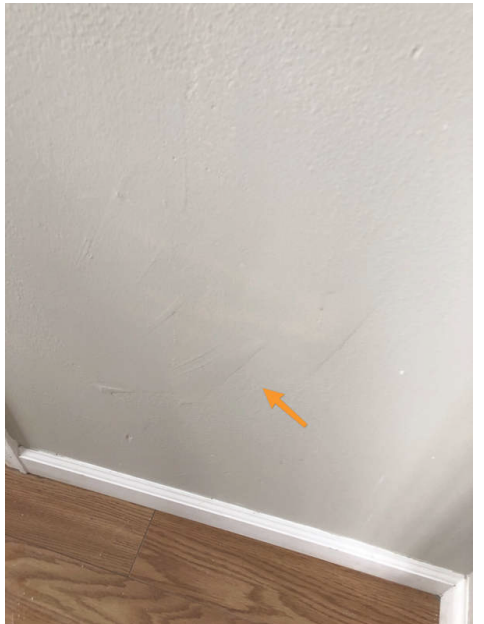
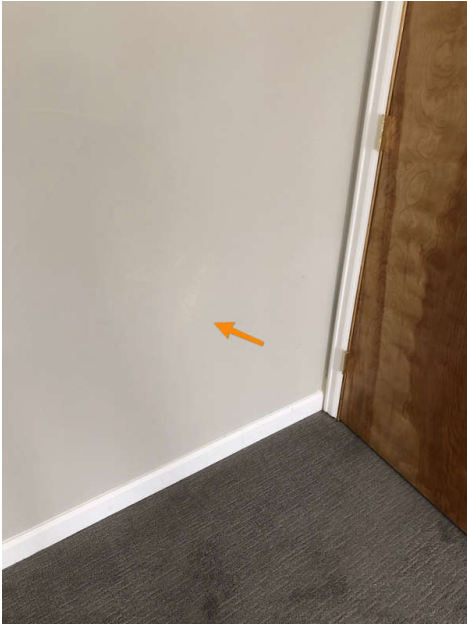
BEDROOMS, BACK DECK ENTRY AREA

**POOR PAINT APPLICATION**

The wall does not have an even coat of paint in their spots where the paint is thin or was not applied properly. Recommend repainting the wall.

Contact a qualified painter.

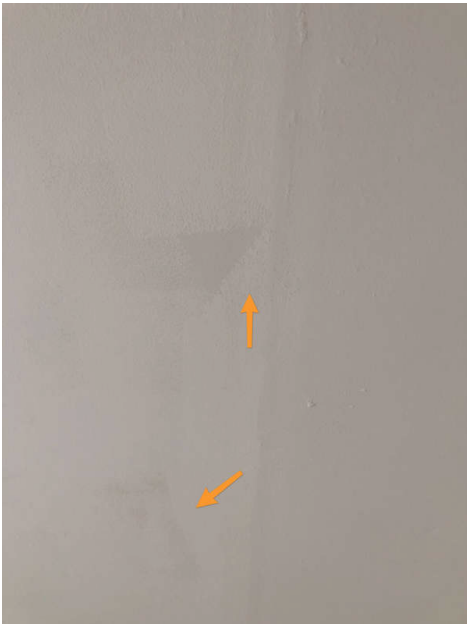
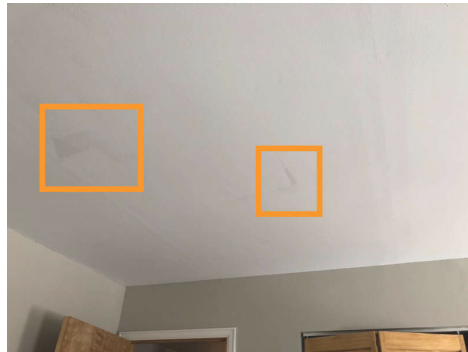
### MASTER BEDROOM

## POOR PAINT APPLICATION

The ceiling does not have an even coat of paint in their spots where the paint is then or was not applied. Recommend repainting ceiling.

Contact a qualified painter.

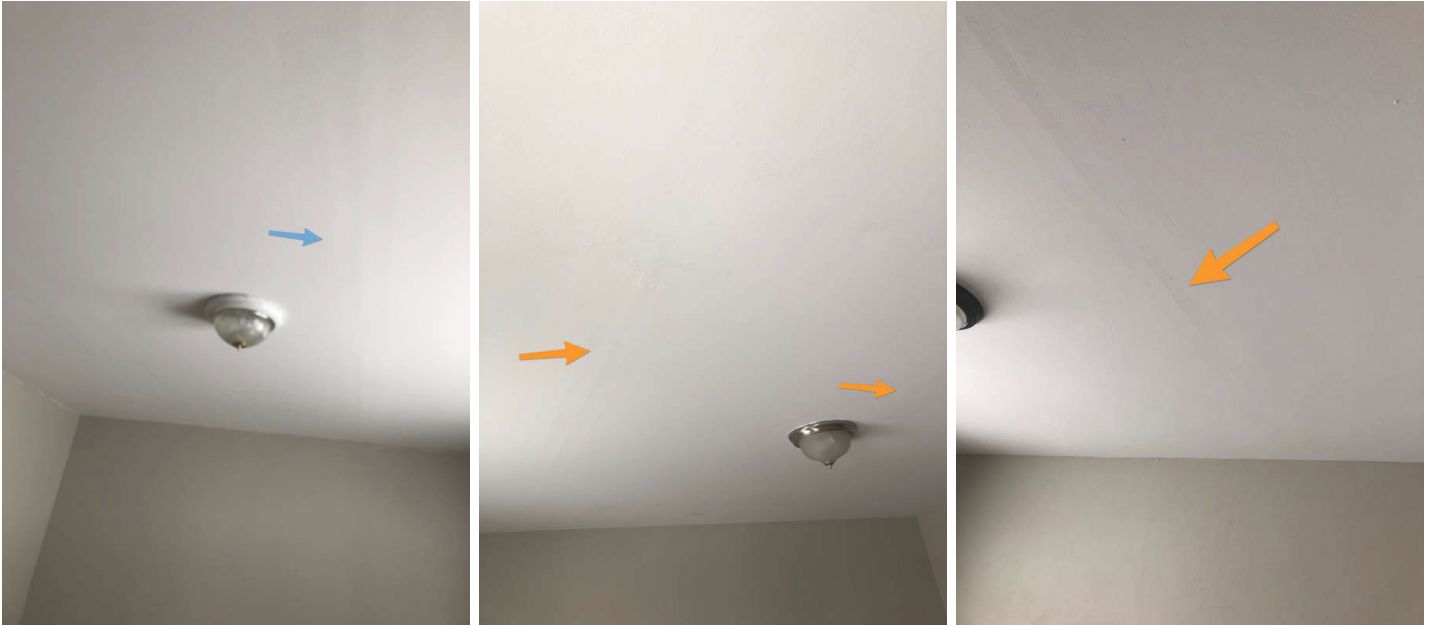
### BEDROOMS

## POOR TAPING

The drywall joints on the ceiling were not taped properly and can be seen. If desired to repair recommend a drywall contractor to re-tape and finish.

Recommendation  
Contact a qualified drywall contractor.

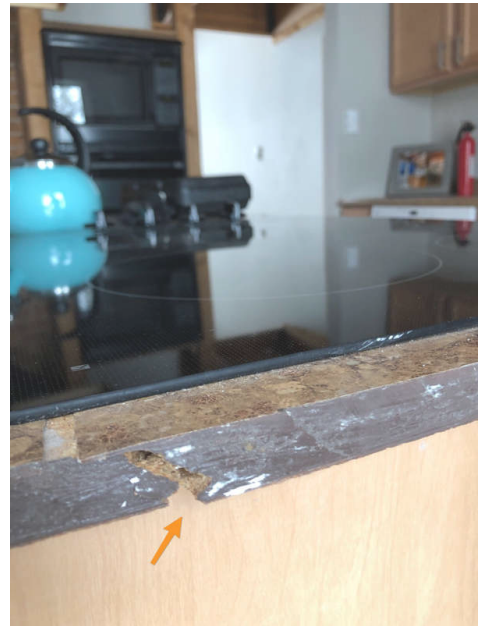
#### 9.7.1 Countertops & Cabinets

### COUNTERTOP CRACKED/CHIPPED

Countertop had one or more cracks or chips. Recommend qualified countertop contractor evaluate and repair.

Contact a qualified countertop contractor.
