**SUMMARY**  
1234 Main St. Steamboat Springs CO  
80487  
Buyer Name  
01/10/2019 9:00AM

Brian Hickory  
InterNACHI Certified Home Inspector  
Hickory Property Services LLC  
970-367-7255  
brian@hickoryproperty.com

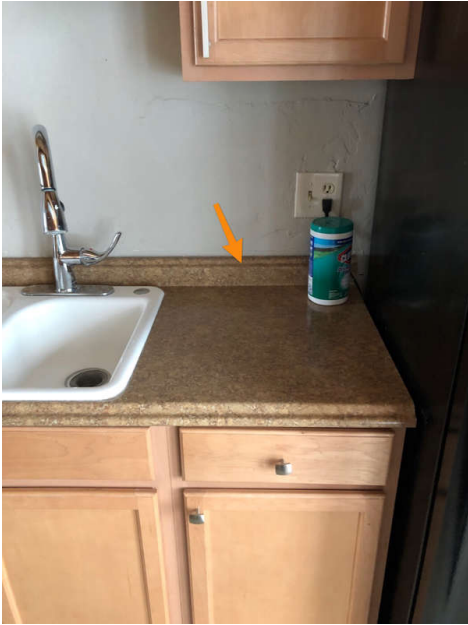
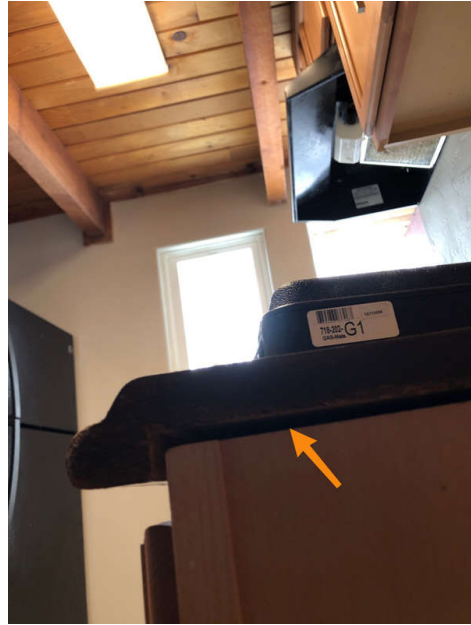
#### 9.7.2 Countertops & Cabinets

### COUNTERTOP NOT SECURED

Kitchen countertop was not secured to the wall or cabinet. Recommend qualified countertop contractor secure countertop properly.

Contact a qualified countertop contractor.

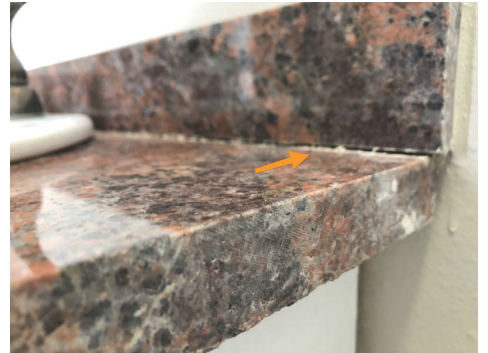
MASTER BATHROOM

9.7.3 Countertops & Cabinets  
**GROUT DETERIORATING**

Grout lines were cracked or severely deteriorated. Recommend a qualified contractor repair or replace grout.

Recommendation  
Contact a qualified countertop contractor.

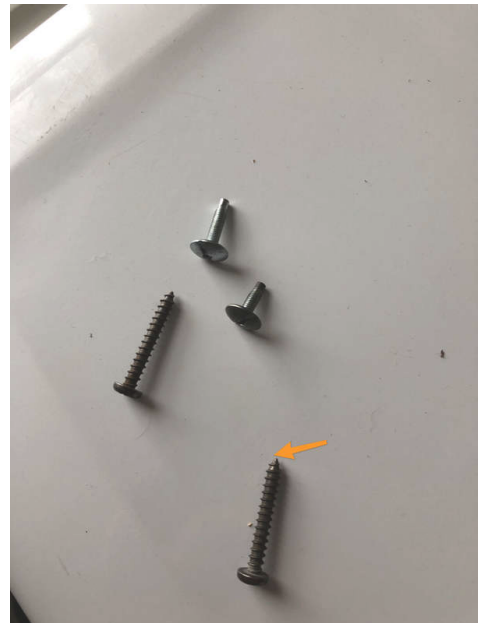
12.2.2 Main & Subpanels, Service & Grounding,  
Main Overcurrent Device

**POINTED SCREWS IN ELECTRICAL  
PANEL**

The panel cover was removed in order to inspect and test the internal components. Two pointed screws were removed from the panel cover. This is a potentially dangerous condition. If one of the screws penetrates the insulation of a wire, a direct short will occur at a minimum popping a breaker or possibly electrocuting someone. Recommend replacing with a flat head tip screw rated for electrical panels.

Recommendation  
Contact a qualified electrical contractor.

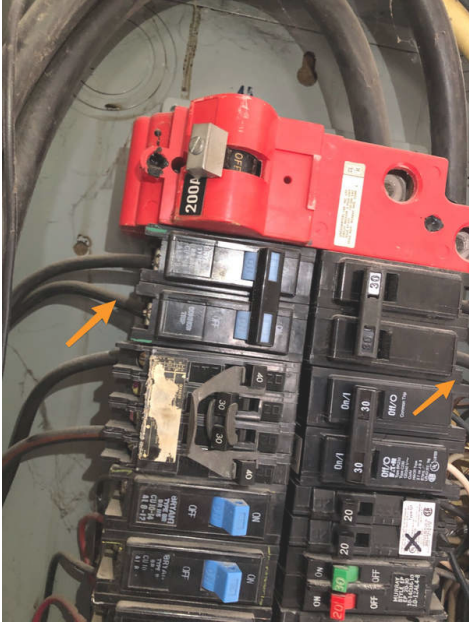
12.3.1 Branch Wiring Circuits, Breakers & Fuses

**ALUMINUM BRANCH CIRCUITS**

Aluminum wire appears to be installed on a couple of the branch electrical circuits. These single strand, branch circuit aluminum wires were used widely in houses during the mid 1960s and 1970s. According to the U.S. Consumer Product Safety Commission, problems due to expansion can cause overheating at connections between the wire and devices (switches and outlets) or at splices, which has resulted in fires. For further information on aluminum wiring contact the U.S. Consumer Product Safety Commission via the Internet at <http://www.cpsc.gov/> . It is recommended that the electrical system be evaluated by a licensed electrician.

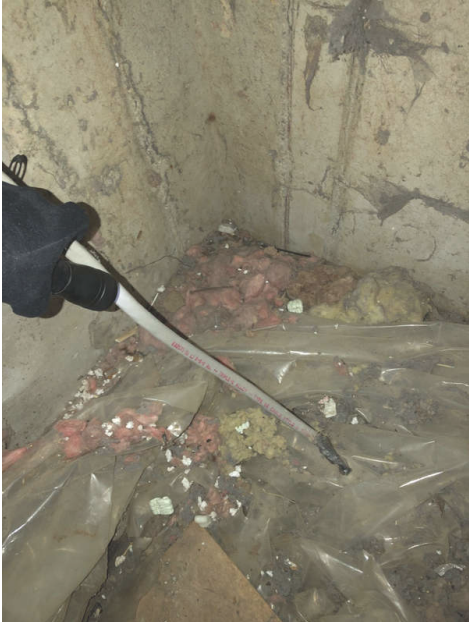
CRAWLSPACE

**BARE WIRE NOT TERMINATED**

Bare wire ends, or wires with a substandard termination, were found at one or more locations. This is a potential shock hazard. Recommend that a qualified electrician repair as necessary. For example, by cutting wires to length and terminating with wire nuts in a permanently mounted, covered junction box.

Recommendation  
Contact a qualified professional.

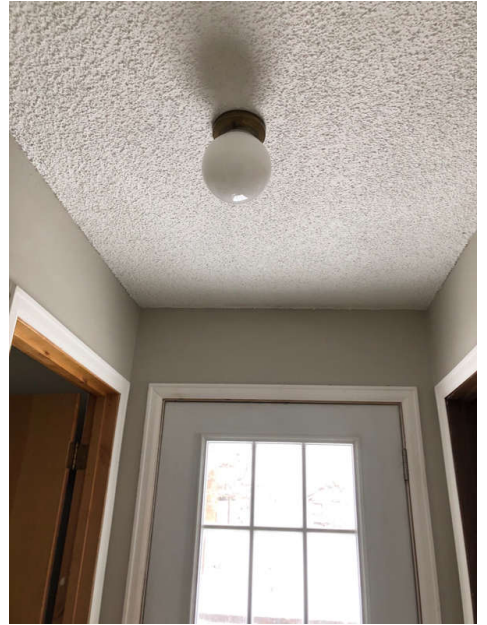
BACK DECK ENTRY

**LIGHT INOPERABLE**

One or more lights are not operating. New light bulb possibly needed.

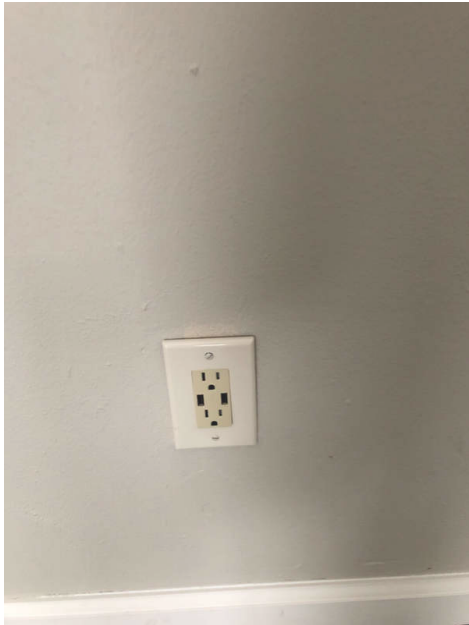
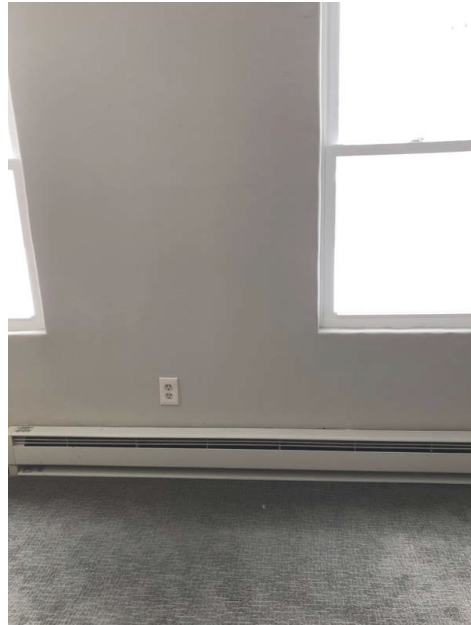
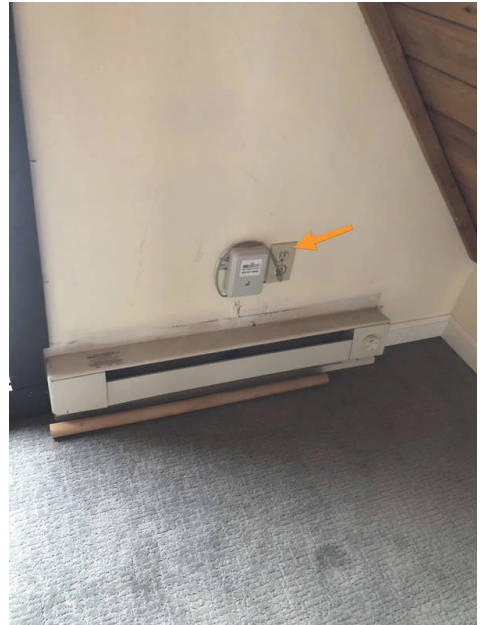
MASTER BEDROOM, NORTHEAST BEDROOM, LOFT

**SWITCHES INSTALLED IMPROPERLY**

One or more receptacles are loose and not well secured. Recommend licensed electrician repair or replace.
