2.1.1 A. Foundations

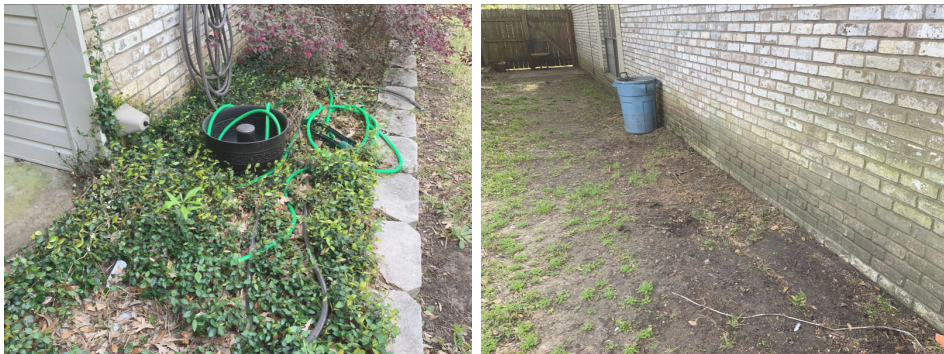
Left side of home

**SLAB FOUNDATION NOT VISIBLE.**

Soil and/or mulch levels and /or foliage against the exterior grade beam were noted to be too high around areas of the foundation making it difficult to view the foundation in various areas. When soil/mulch levels are high against the face of the foundation or foliage is covering the foundation it promotes water penetration of the structure and insect infestation. These areas should be corrected so there is some exposure of the foundation face. It is generally accepted that a brick and stone veneer house should have about 4 inches of clearance. Houses with other types of siding should have approximately 6 inches of clearance.

Recommendation  
 Contact a qualified professional.

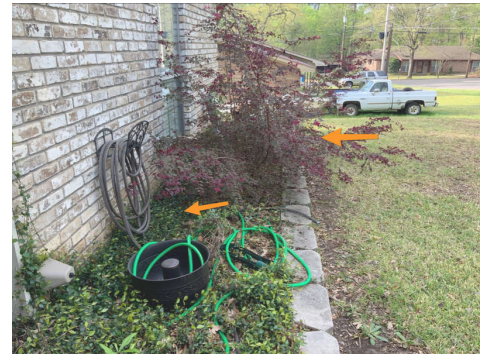
**FOLIAGE- ROOTS ARE CLOSE TO THE FOUNDATION**

There are areas where roots are close to the foundation, these areas should be monitored over time to make sure that damage does not occur to the foundation.

Recommendation  
Recommend monitoring.

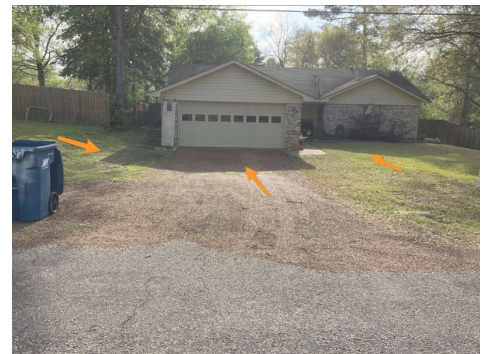
**GRADING- NEGATIVE GRADE SUB SURFACE DRAINS INSTALLED**

Grading is sloped toward the structure in some areas. Low spots and negative grading promote water accumulation near the building, leading to potential foundation problems and if foundation grade beam is currently visible and you should keep it that way to prevent the possibility of moisture intrusion into the home. There appears to be a drainage system installed that visibly appears to be working at the time of inspection. We do recommend that you keep an eye on this drain in the rainy season to make sure it does not get clogged. Eventually it will need cleaning and a plumber would be the best person to call to clear the drain lines when needed.

Recommendation  
Recommend monitoring.

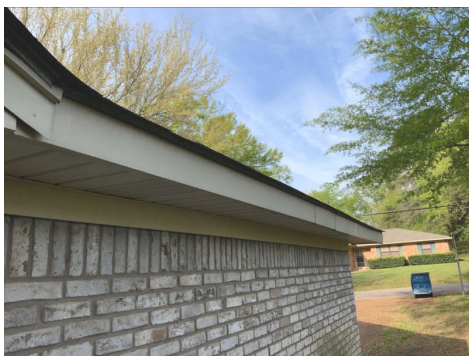
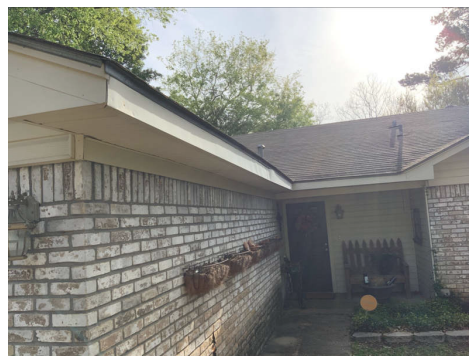
**GUTTER- NONE**

Gutters were not present on horizontal fascia around this structure at the time of inspection. We recommend as a structural upgrade that gutters be installed on all horizontal fascia this home and that downspouts be ran so that they take water at least 3'-5' away from the home to help channel water away from the foundation/crawlspace of the home.

Recommendation  
Contact a qualified gutter contractor

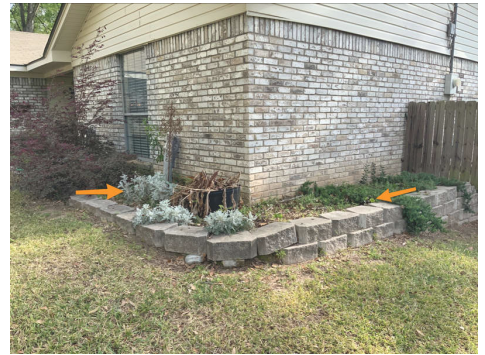
Planters were noted next to the home although planters are pretty they do have issues at times that can negatively impact your home. We recommend that you monitor these areas for moisture intrusion into the home. Also root systems from trees and shrubs could affect the foundation of this home at some point so it is very important to keep an eye on these areas over time.

We also recommend that you make sure your downspouts extend past the planter/flowerbed to prevent excessive moisture accumulation in these areas.

Contact a qualified professional.

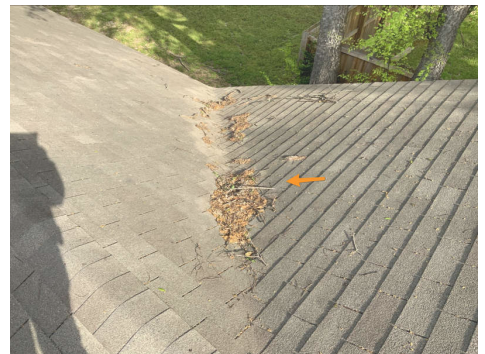
Debris was noted on the roof surface of this home. We recommend that all debris be removed from the roof covering surface periodically.

Leaves and pine needles in this area of the country can allow water to accumulate in valleys and next to side walls of the home (if present) due to debris damming up water flow on the roof. The debris on the roof and against the side walls of the home can cause damage, by allowing water to seep under the roof covering and wick into the siding, causing leaks and damage in various areas where accumulation is present.

In most cases with a single story home or homes with out dormers or sidewalls in contact with the roof structure, twigs and other debris can damage the roof covering more than people realize and it is strongly recommended that the roof covering be cleaned now and periodically in the future.

Contact a handyman or DIY project

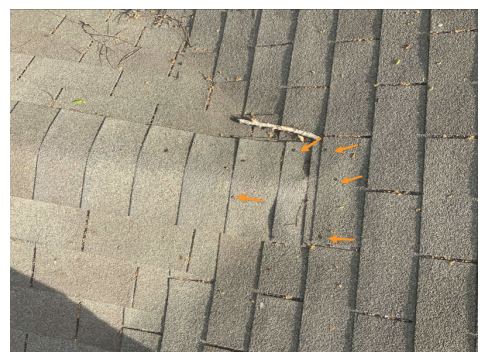
Under-driven or exposed nails were found in one or more areas of the roof coverings. Recommend sealing nail heads periodically to prevent potential leaks in the future.

Contact a qualified roofing professional.

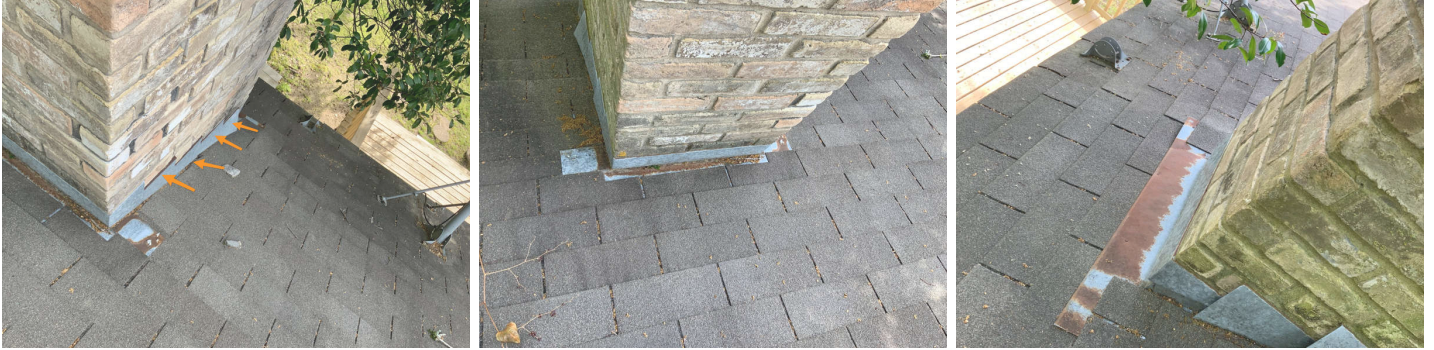
**FLASHING -  
CHIMNEY FLASHING IS RUSTED.**

The flashing around the chimney is rusted and will need replacement in the future. We recommend for the time being that the flashing be cleaned, sealed, primed and painted to prolong its life expectancy.

Recommendation  
Contact a handyman or DIY project

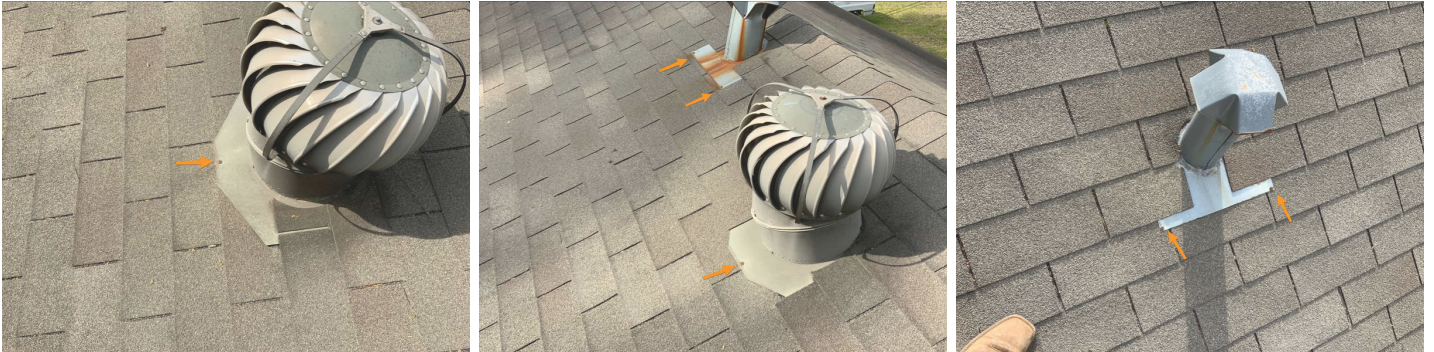
**FLASHING  
EXPOSED NAIL HEADS**

There are exposed fasteners on the flashings of the roof we recommend that these nails be sealed.

Recommendation  
Contact a qualified roofing professional.

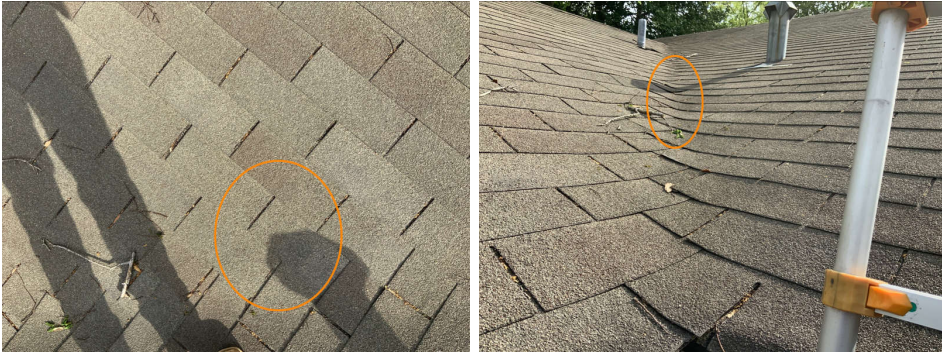
**SHEATHING-  
DECKING SPONGY IN AREAS**

The decking on this roof has areas where the decking is a little spongy.

This is typical in older homes, there may be areas of decking that will need replacement in the future.

Recommendation  
Contact a qualified professional.

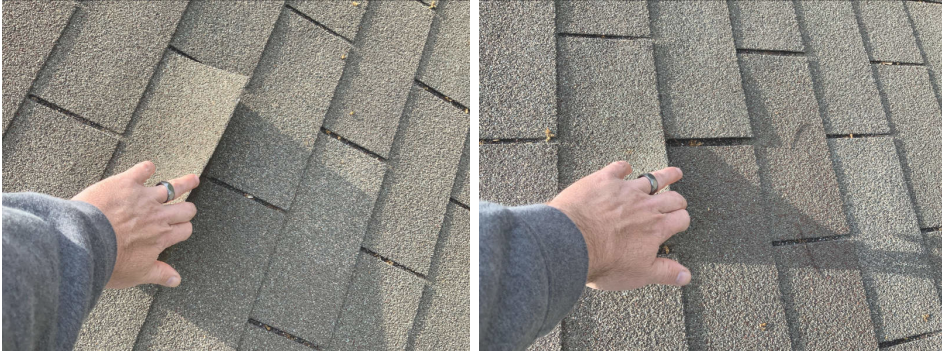
**SHINGLES NEED  
SEALING**

There are areas on the roof surface where shingles are not properly adhered to the surrounding roof covering. We recommend that these shingles be sealed to help prevent wind damage in the future.

Contact a qualified roofing professional.

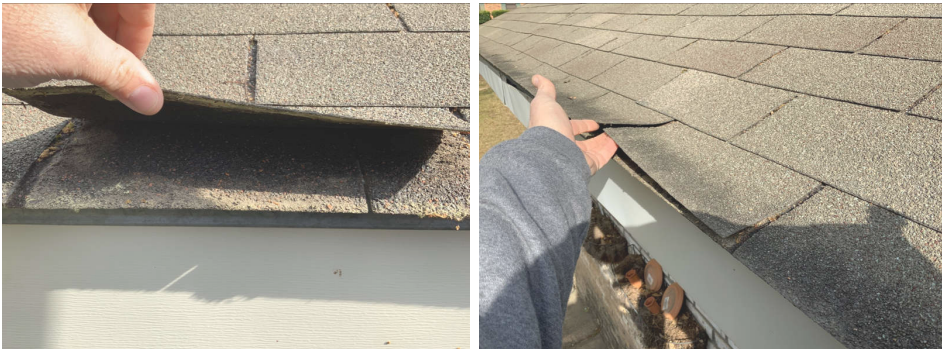
**SHINGLES-  
STARTER COURSE NOT SEALED**

The starter course of shingles on this roof are not sealed. These shingles should be sealed to prevent water and high winds from getting between the starter shingle and the first row of shingles of a roof and causing damage.

Contact a qualified roofing professional.

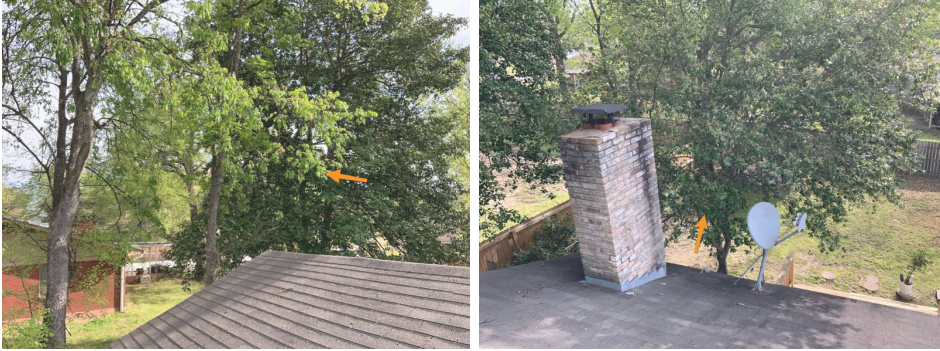
### TREES- IMPINGING ROOF LINE

Tree branches impinging roof line can damage a roof even in a gentle breeze. Whenever a tree is in contact with the roof structure, we recommend trimming the tree or branches back aggressively.

Recommendation  
Contact a qualified tree service company.

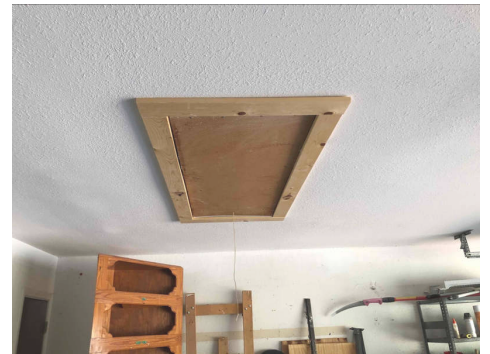
The stairway was not labeled as a fire-rated assembly. The Code addresses separation between the garage and attic, garage and dwelling and habitable areas and attic spaces, in terms of gypsum thickness, door thickness or 20-minute fire rated doors including attic stairs

Recommendation  
Contact a qualified professional.

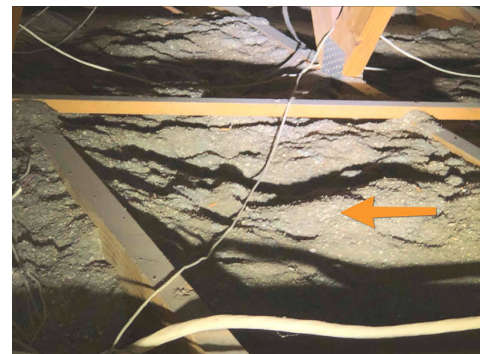
Insulation depth was inadequate. Recommend a qualified attic insulation contractor install additional insulation.

Recommendation  
Contact a qualified insulation contractor.

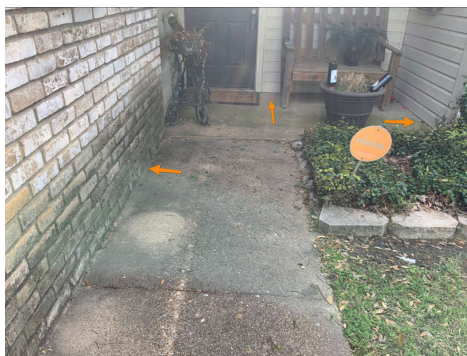
Exterior wall coverings over hardscape (cement, asphalt, and brick ground covering) Should be a minimum of 2" for brick and 6" for wood.

Cladding materials without proper clearances are considered to be conducive to wood destroying Insect (WDI) infiltration, which means that termites and other WDI's could gain undetected access into the home.

Recommendation  
Recommend monitoring.

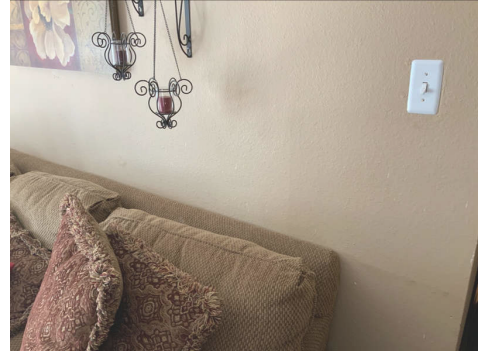
The walls of this home have typical drywall flaws on them, such as dings, scrapes, patching, and touch up paint. These flaws are typical to any home whether new or old and should be repaired during times of maintenance.

Contact a handyman or DIY project

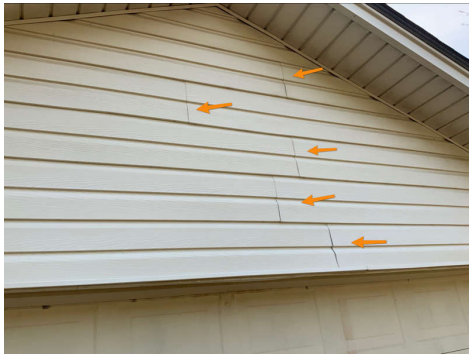
Over garage door

The seams on the vinyl siding need to be sealed to prevent them from detaching from the home the installation of this siding was not performed in the typical professional way. It does work it just needs to be monitored for separation or loosening over time.

Contact a qualified siding specialist.

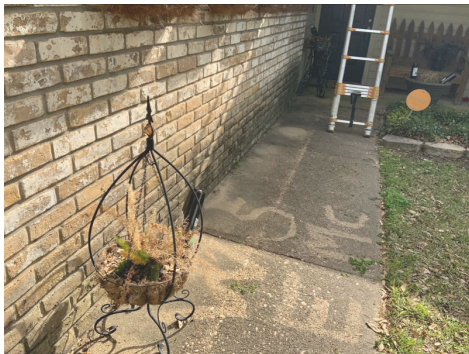
Front of home

**THERE IS STAINING ON EXTERIOR DUE TO SPLASH BACK ON SOIL**

There is staining on the exterior of the home due to splash back from water hitting the adhered masonry.

Contact a qualified professional.

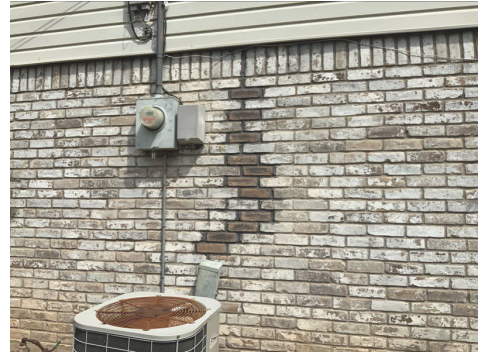
**EXTERIOR WALL REPAIR NOTED**

Repairs were made to the brick on the right side of the home these areas were patched and do not show signs of further movement, we recommend asking seller when repairs were made, so that you will know how long the repair has been there to judge how long it has been since movement has occurred.

Recommendation  
Recommend monitoring.

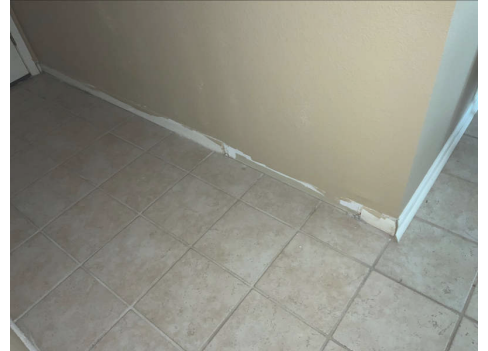
Entryway

**BASE BOARDS ARE IN NEED OF REPAIR/REPLACEMENT**

There are areas of baseboard trim that are in need of painting, caulking, or repair/replacement in one or more areas around the home.

Recommendation  
Contact a handyman or DIY project

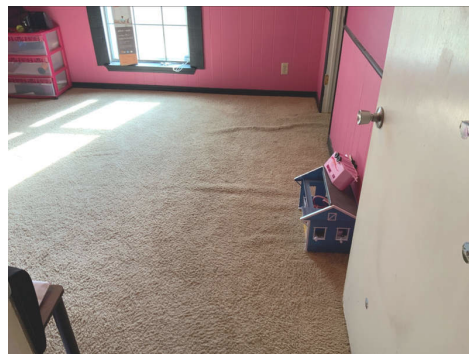
Middle bedroom

There are one or more areas throughout the home where the carpet could use stretching so that it does not become a trip hazard.

Recommendation  
Contact a qualified professional.

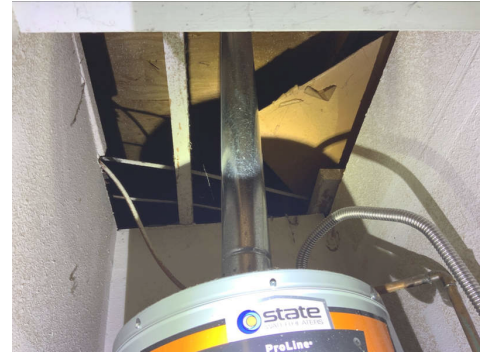
**CEILING IS IN NEED OF PATCHING OR REPAIR**

The ceiling is in need of patching or repair in one or more areas of the home.

The ceiling in the water heater closet in the garage needs to be replaced this is considered lack of fire barrier in the garage and should be replaced for safety.

Contact a qualified drywall contractor.

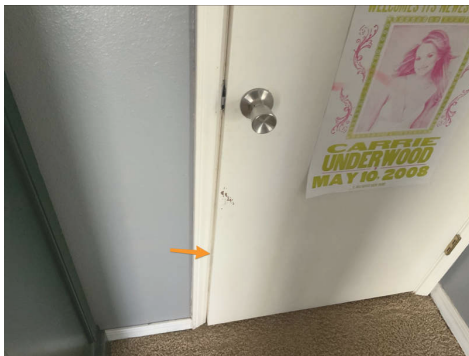
Corner bedroom

There are one or more doors in this home that drag in the frame. These doors could use adjustments so that they close properly.

Recommendation  
Contact a handyman or DIY project

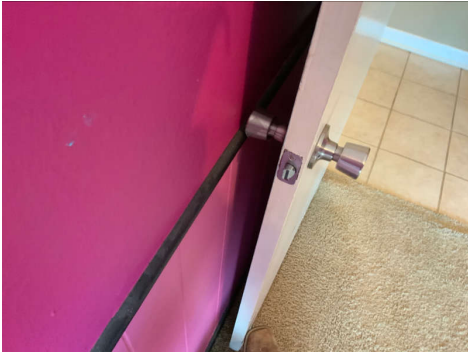
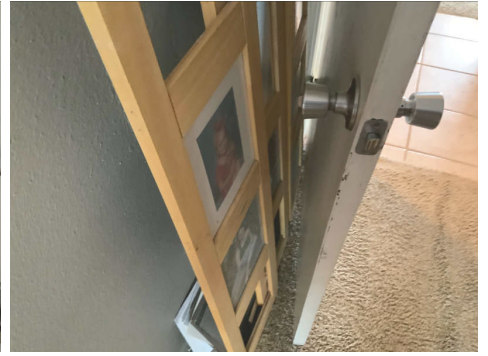
Several of the doors are missing their door stops. This condition will lead to damage of the wall surfaces. We recommend door stops be installed where needed.

Recommendation  
Contact a handyman or DIY project

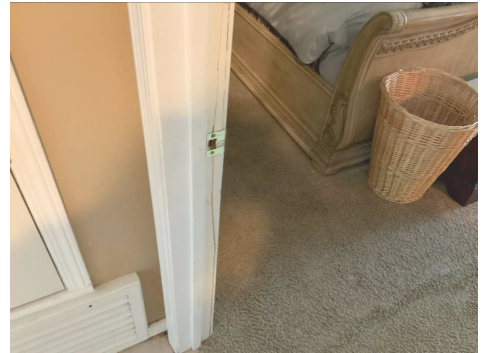
Master Bedroom

**DOOR FRAME IS DAMAGED**

There are one or more door frames in this home that have been damaged and are in need of repair.

Recommendation  
Contact a qualified handyman.

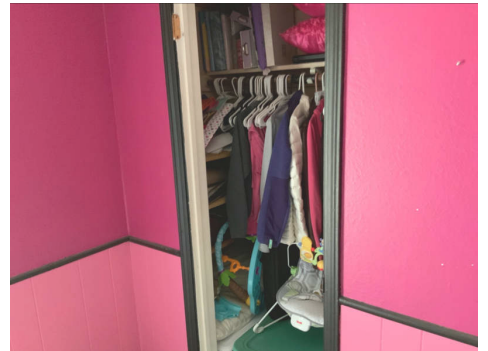
Middle bedroom closet door

**DOOR MISSING**

There are one or more doors that are missing in this home.

Recommendation  
Contact a handyman or DIY project

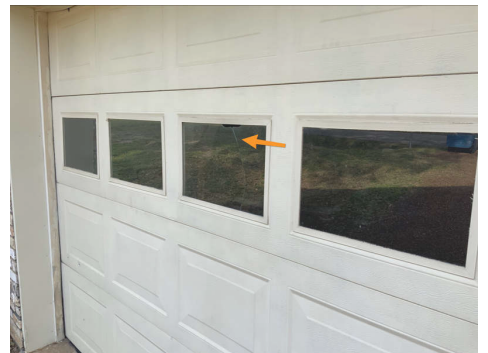
Garage door

**BROKEN WINDOW**

There are one or more windows of the home that have broken glass.  
These windows will need repair or replacement

Recommendation  
Contact a qualified professional.

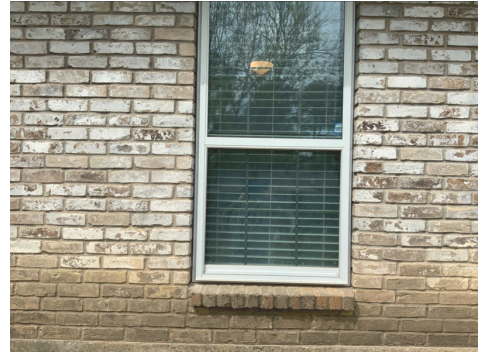
We recommend that all window edges be caulked on the interior and exterior to seal them off and help keep them more energy efficient.

Contact a handyman or DIY project

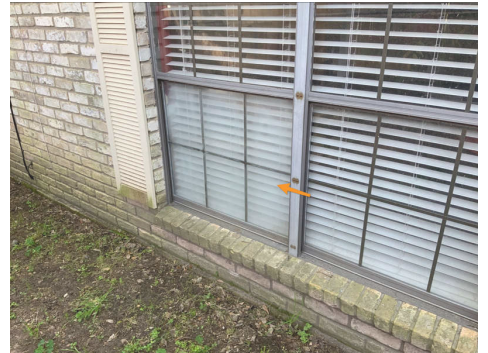
Left side of home

**FAILED SEAL**

Observed condensation and/or fogging between the window panes, which indicates a failed seal. Recommend qualified window contractor evaluate & replace.

Contact a qualified window repair/installation contractor.

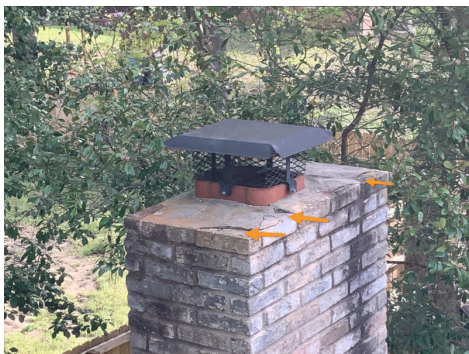
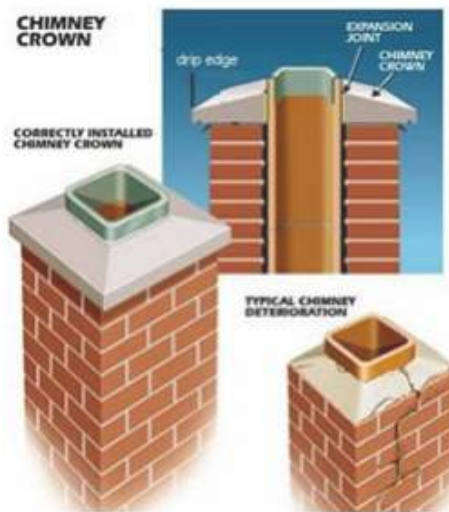
**CHIMNEY MORTAR CAP IS DAMAGED**

Contact a qualified professional.

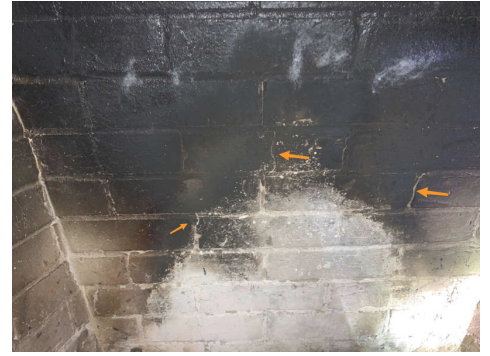
**FIREWALL CRACKED**

The brick lining of the fireplace was cracked in one or more places, which could lead to heat damage and could potentially allow toxic fumes to enter other areas of the home. Recommend a qualified fireplace contractor evaluate and repair.

Contact a qualified fireplace contractor.

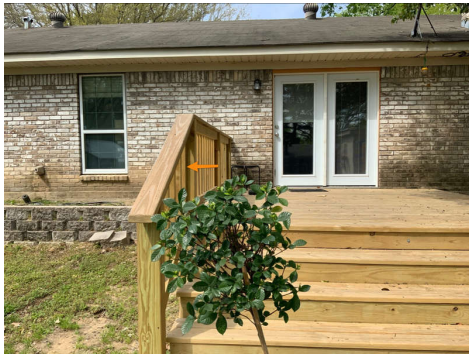
### Handrail Grip

There are no graspable handrails installed on the step railing of this home. We recommend that graspable hand rails be installed for easy grip.

Contact a qualified carpenter.

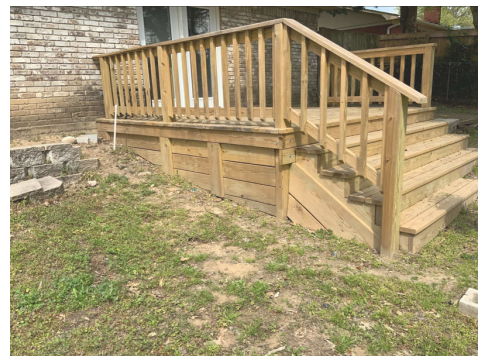
There is wood to ground contact in one or more areas of the property, this is considered a conducive condition that could allow wood destroying insects to gain access to the structure without being seen. We recommend that these areas be treated regularly by a pest control company as often as they recommended, which would be every 5-10 years on average.

Recommendation  
Recommend monitoring.

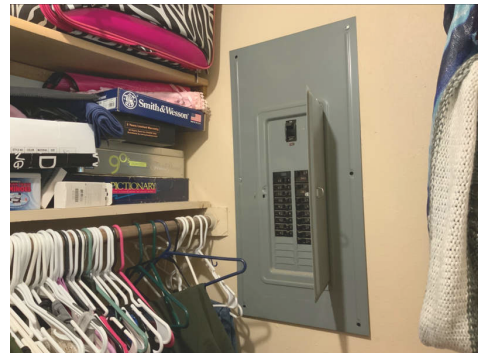
The electrical panel is located in a clothes closet. Under current electrical standards, this is no longer an accepted practice. This is an as-built condition but Per TREC standards of practice we are required to report this condition as a deficiency.

Recommendation  
Contact a qualified professional.

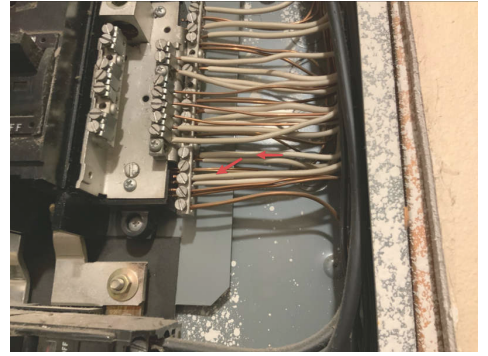
Each neutral conductor should terminate under individual terminations and not share a termination with other neutral or ground wires. When neutral wires share a termination point with another wire it is likely that the connection will become loose due to expansion and contraction of wires.

Contact a qualified electrical contractor.

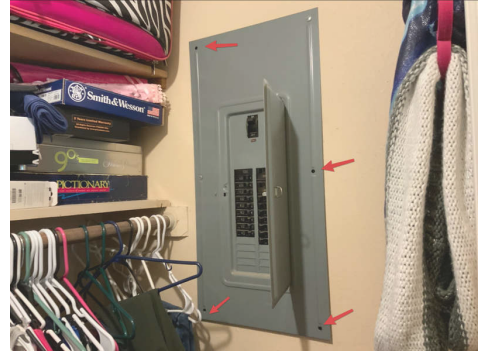
### SCREWS MISSING

One or more of the cabinet cover plate screws are missing and need to be replaced. When screws are replaced they need to be blunt tip screws and not sharp wood screws or self tapping screws for reasons of safety. Sharp tips can pierce the electrical line and cause potential shock hazards.

Contact a qualified professional.

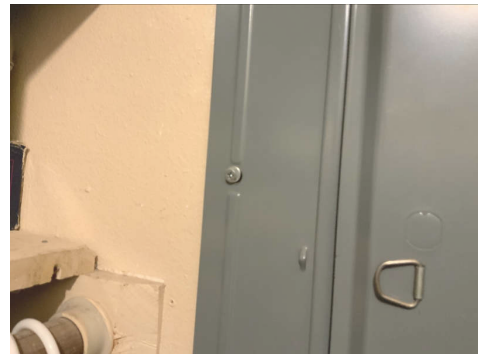
The screws in the electrical panel are sharp tipped, the screw(s) should be replaced with blunt tip screws to prevent piercing wires with sharp tipped screws. We recommend replacing the screws for safety reasons to avoid shock hazard.

Contact a qualified professional.

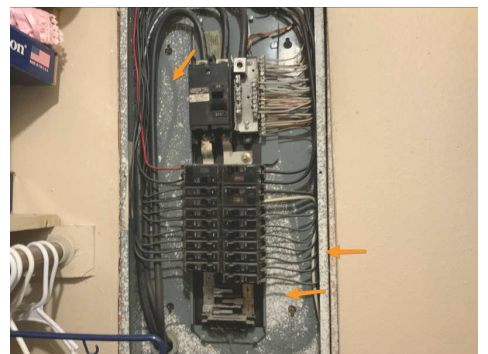
There is drywall texture in the interior of the electrical panel. It is recommended that this be cleaned out of the panel and was a sub standard job from the building contractor.

Contact a qualified professional.

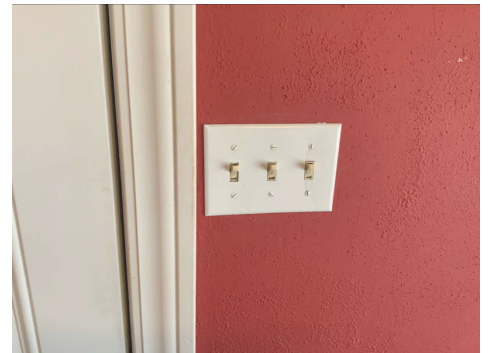
Next to garage door

**COVER PLATES DAMAGED**

One or more receptacles and/or light switches have a damaged cover plate. Recommend replacement.

Contact a qualified electrical contractor.

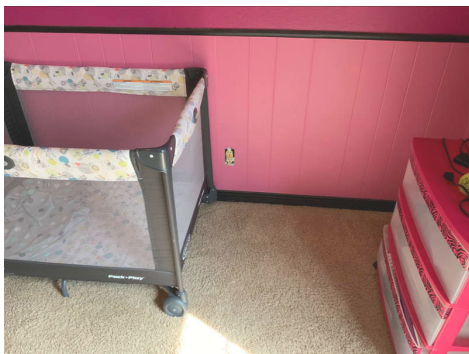
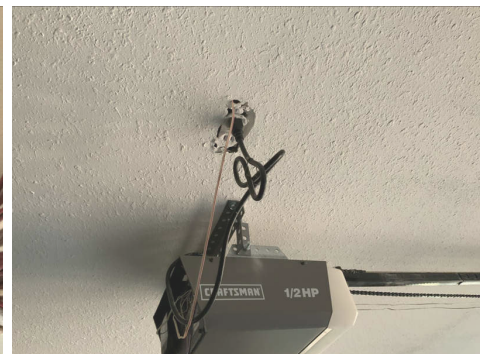
**COVER PLATES MISSING**

One or more receptacles/light switches are missing a cover plate. This causes short and shock risk. Recommend installation of plates.

Contact a qualified electrical contractor.

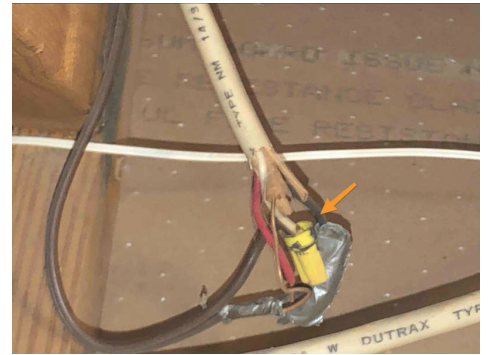
Attic

All wire connections & charged wires with exposed ends and splices should be covered in junction boxes for safety. Recommend a qualified electrician correct.

Contact a qualified electrical contractor.

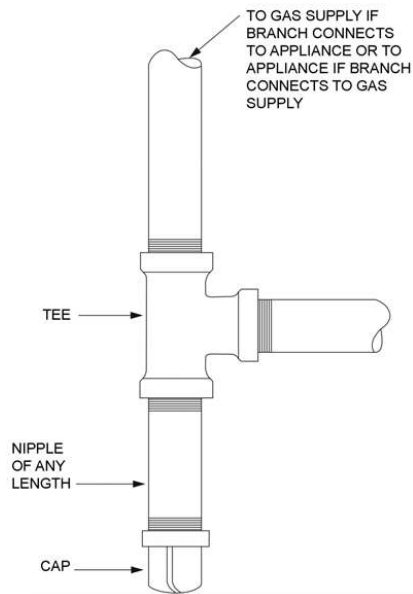
### NO DRIP LEG ON GAS LINE

The water heater and/or furnace gas supply line is not equipped with a sediment trap just before the gas appliance connector. This condition does not meet current installation requirements and should be corrected.

**G2419.4 (408.4) Sediment trap.** Where a sediment trap is not incorporated as part of the appliance, a sediment trap shall be installed downstream of the appliance shutoff valve as close to the inlet of the appliance as practical. The sediment trap shall be either a tee fitting having a capped nipple of any length installed vertically in the bottommost opening of the tee as illustrated in Figure G2419.4 or other device approved as an effective sediment trap. Illuminating appliances, ranges, clothes dryers, decorative vented appliances for installation in vented fireplaces, gas fireplaces and outdoor grills need not be so equipped. FIGURE

Recommendation  
Contact a qualified plumbing contractor.
