About :  
This inspection attempts to identify significant defects, overdue maintenance, future maintenance issues, gradual deterioration, inferior building work, and/or other areas of concern. An inspection carried out in accordance with NZS 4306 2005 is not a statement that a property complies with the requirement of any regulation or bylaw, nor is the report a warranty against any problems developing after the date of the property report. Refer to NZS 4306 2005 for full detail.

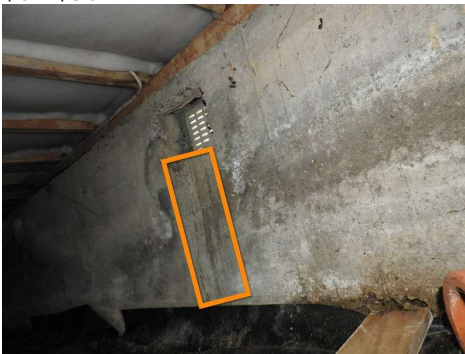
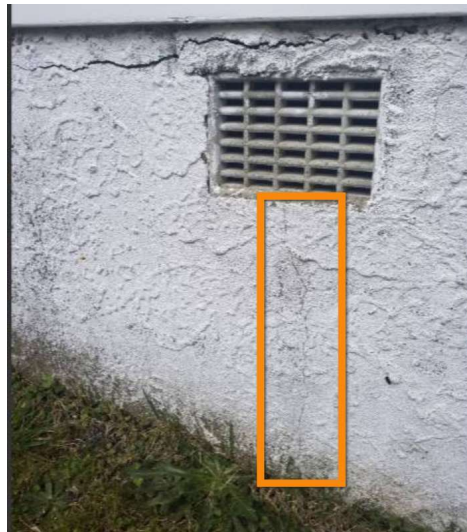
#### 4.1.1 Perimeter wall - Concrete **CRACKING - HAIRLINE FRACTURE**

There is a single crack in the foundation located near the underfloor access. The crack is detected on both sides of the wall in the same place. We don't see this as causing any future problems, everything is straight and level and well supported. If anything, some silicone applied here would help preserve the reinforcing steel from corrosion. Has not impacted verticality or alignment thus far.

Recommendation  
Contact a handyman or DIY project  
Estimated Cost  
\$0 - \$50

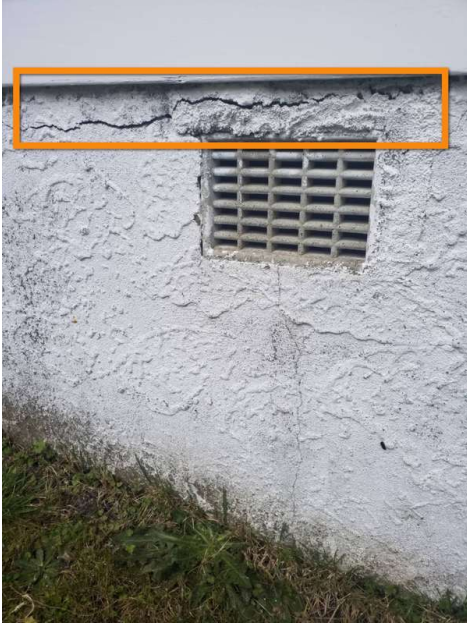
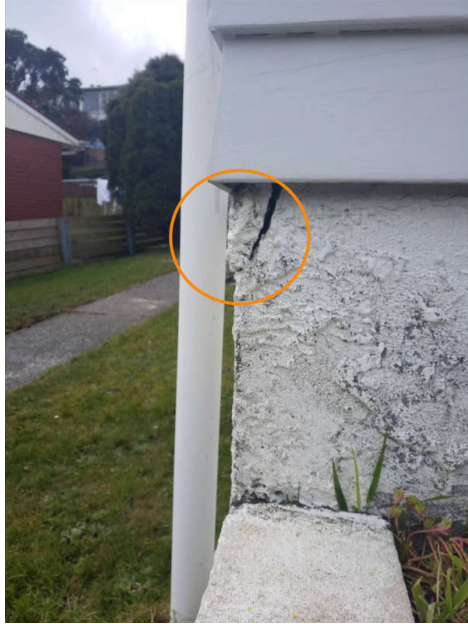
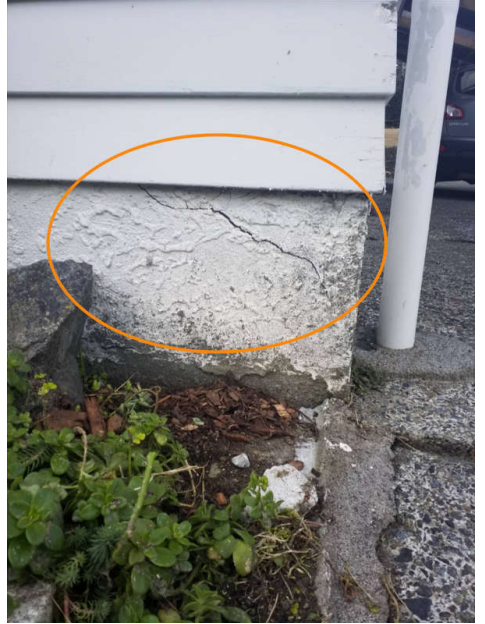
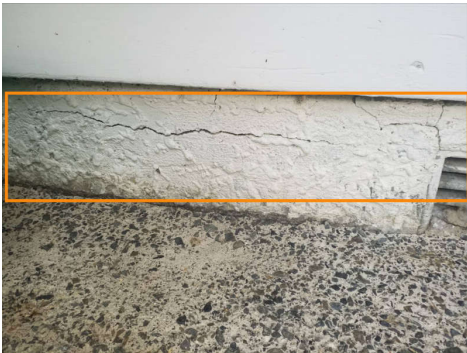
#### 4.1.2 Perimeter wall - Concrete **CRACKING - SUPERFICIAL**

The solid plaster coating in some isolated areas are showing some cracks, these are drumming when tapped. This is superficial, not structural cracking. If left, should not cause any future problems to the foundation itself.

Cosmetic maintenance required in this area.

Recommendation  
Contact a stucco repair contractor  
Estimated Cost  
\$100 - \$300

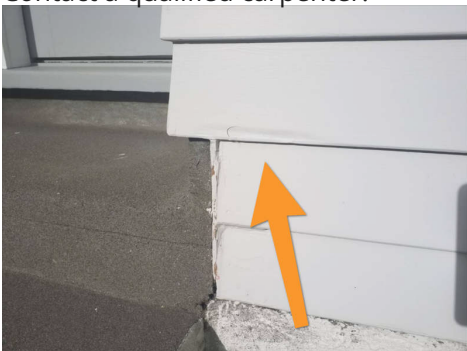
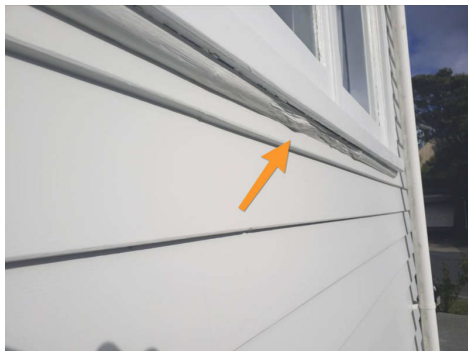
### 6.1.1 Weatherboard - Timber

#### **TIMBER - ROT LOCATED**

Rot is conditional to the environment surrounding the timber. There are many types of rot with many different causes. Change the environment and you will fix the issue. Replace the timber like for like using treated timber this time.

Any rotting timber should be replaced like for like

Recommendation  
Contact a qualified carpenter.

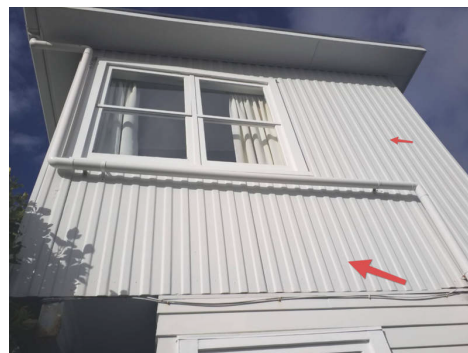
### 6.2.1 Fibre cement sheet product

#### **ACM SUSPECTED.**

##### ASBESTOS PRODUCT SUSPECTED. (ACM)

Primarily for a lab to verify the presence of Asbestos used in any building material, an invasive test sample is required. This will involve removing a small portion of the product (an invasive inspection).

Recommendation

Contact a qualified professional.

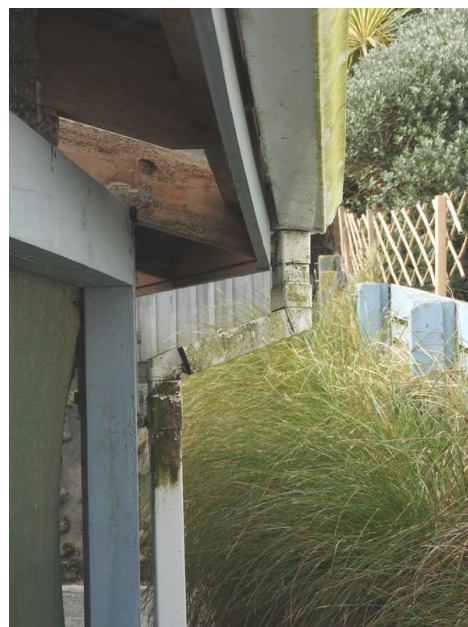
### 8.2.1 Down pipes

#### **DAMAGED OR CRACKED**

This type of defect can be easily fixed with the replacement of inexpensive components.

Recommendation

Contact a qualified handyman.

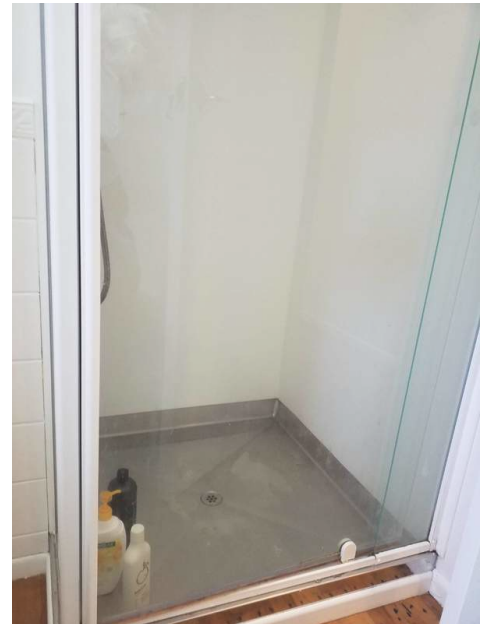
### 13.7.1 Shower

#### **LEAKING - MINOR**

Leaking in this section of the shower, best to get this repaired before it causes bigger problems. Easy fix and quite common for this type of product.

Recommendation  
Contact a handyman or DIY project

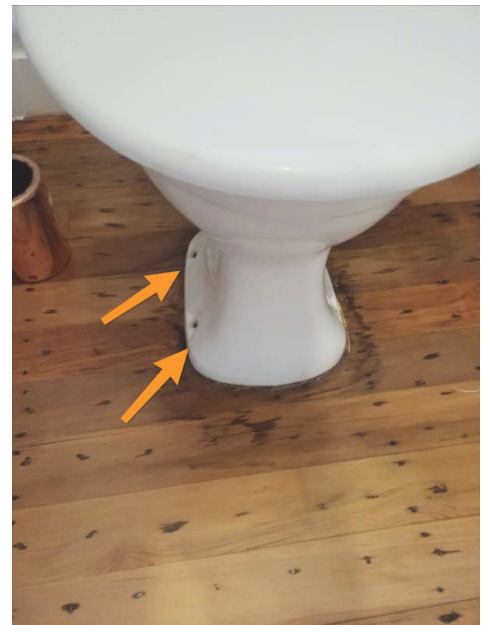
14.3.1 Cistern, pan and seat

### **LOOSE PAN**

Pan is not appropriately fixed to floor.  
This instability can be a hazard for some, it can also cause leaking at the connection to sewer pipe.  
In most cases it's an easy fix, sometimes a good motivation to upgrade to a new loo.

Recommendation  
Contact a qualified plumbing contractor.  
Estimated Cost  
\$0 - \$50

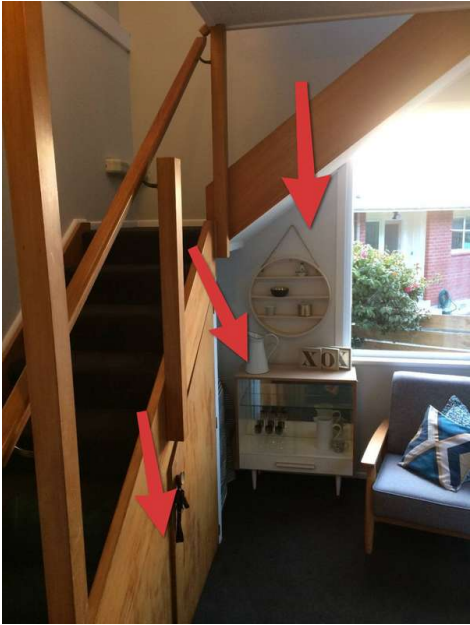
21.2.1 Stair and balustrade

### **SAFETY FROM FALLING**

#### **Risk of falling**

Maintenance or repair required to the balustrade or handrail here .  
The solution would be an inexpensive fix.

Recommendation  
Contact a qualified carpenter.  
Estimated Cost  
\$100 - \$350
