SUMMARY 1234 Main St.Olmsted Falls OH 44138 Buyer Name 02/10/2018 9:00AM

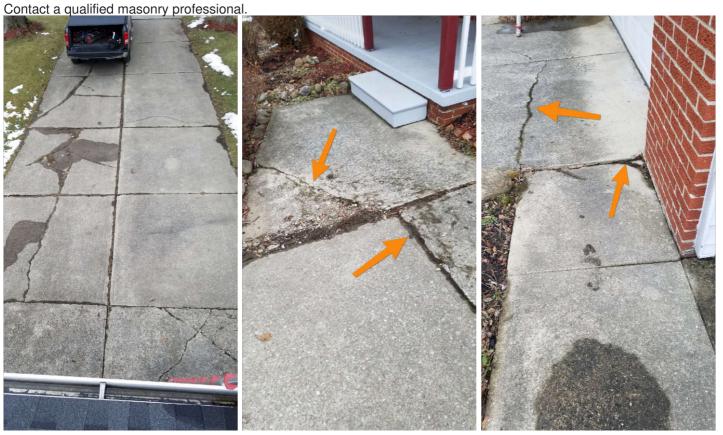
2.2.1 Driveways, Sidewalks, Patios

DRIVEWAY/SIDEWALK TRIP HAZARD

Cracks, holes, settlement, heaving and/or deterioration resulting in trip hazards were found in the driveway, For safety reasons, recommend that a qualified contractor repair as necessary.

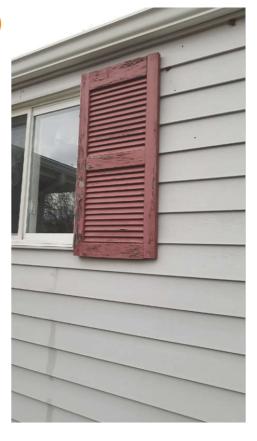
3.2.2 Shutters

FAILING PAINT

Failing paint on one or more shutters was noted. Recommend repair/painting by a qualified person or simply replace them.

Note: seal any holes through the siding that are no longer used.

Contact a qualified professional.

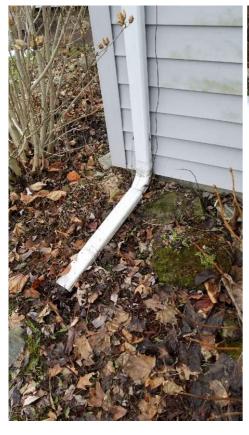
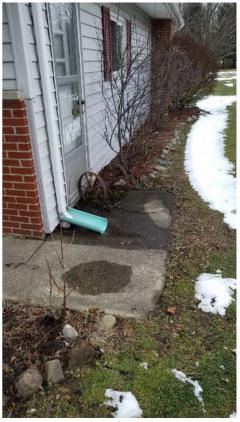
4.4.1 Gutters

EXTENSIONS DAMAGED/MISSING

Extensions such as splash blocks or drain pipes for one or more downspouts were damaged or missing. Recommend that a qualified person install, replace or repair extensions as necessary so rainwater drains away from the structure. Ideally the rain water should drain st least 6ft away from the foundation.

Contact a qualified professional.

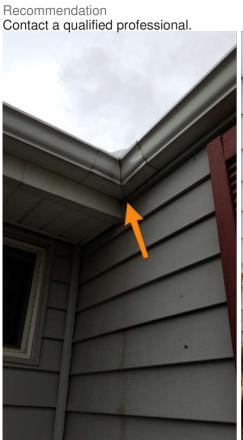
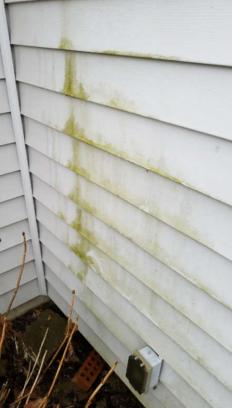
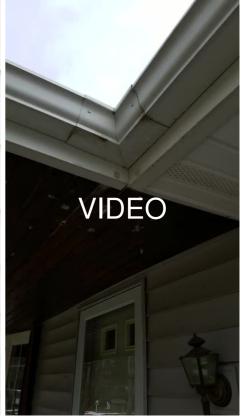
4.4.2 Gutters

LEAKING

One or more portion of the gutters are actively leaking. Recommend repair by a qualified gutter company.

Mildew from leaking gutter

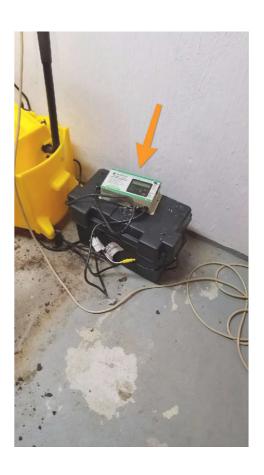
7.1.1 Sump pump

BATTERY BACKUP NOT WORKING

The backup battery system that provides power to the backup pump was not functional at time of inspection. This setup allows for a limited time a way to remove water from the sump pit during a power failure. Recommendation Contact a qualified professional.

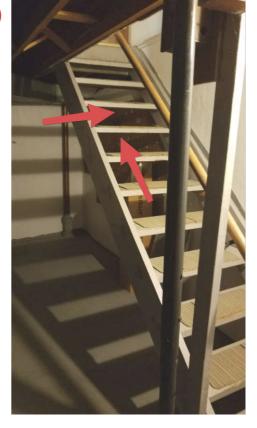
7.2.1 Stairway

GUARDRAIL

No guardrail was present at the stairway that will prevent a little human from falling off and causing bodily harm. Further the stairway also has open risers which is also a hazard to said little human. Recommend a qualified carpenter to close the risers and install a guardrail.

Contact a qualified carpenter.

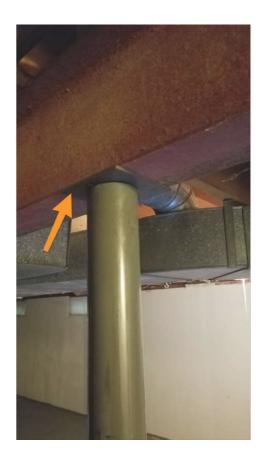
7.3.1 Support post(s) **NOT SECURED**

The top of the steel support posts are not secured to the steel support beam as required to prevent movement should a seismic event occur. Recommend repair by a qualified handyman.

Recommendation
Contact a handyman or DIY project

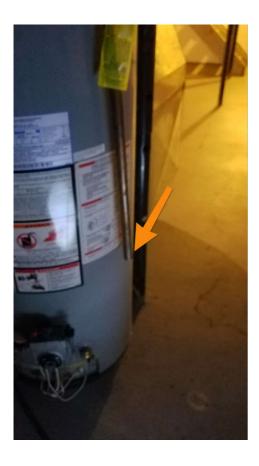
8.4.2 Hot Water Heater

TPR TOO SHORT

The TPR (temperature-pressure relief) valve drain line was too short. This is a potential safety hazard due to the risk of scalding if someone is standing next to the water heater when the valve opens. Recommend that a qualified plumber repair per standard building practices. For example, by extending the drain line to within 6 inches of the floor for indoor hot water heaters.

Contact a qualified plumbing contractor.

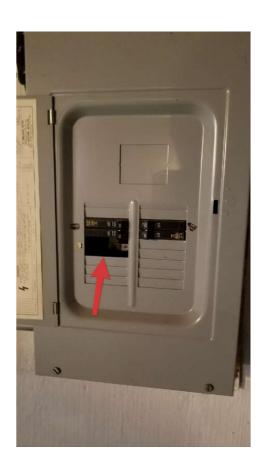
9.2.2 Panels

ONE OR MORE SLOTS WHERE CIRCUIT BREAKERS ARE NORMALLY INSTALLED WERE OPEN IN PANEL

One or more slots where circuit breakers are normally installed were open in panel. While they have been covered with duct tape, it is recommend that a more permanent solution be implemented for safety.

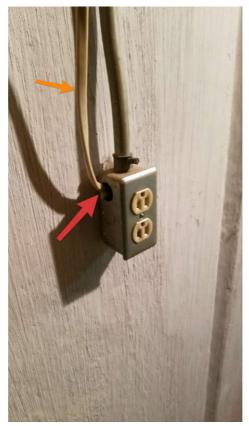
9.4.1 Wiring

EXPOSED NM CABLE

p. Exposed NM was noted in the basement. All NM cable must be protected from damage. Also note the missing cable clamp. Recommend licensed electrician to repair as needed.

Also note missing cable clamp

Contact a qualified electrical contractor.

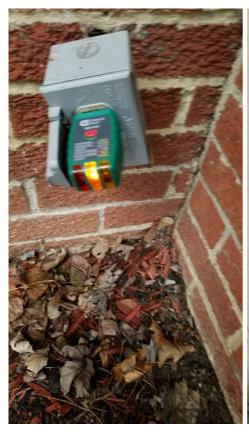
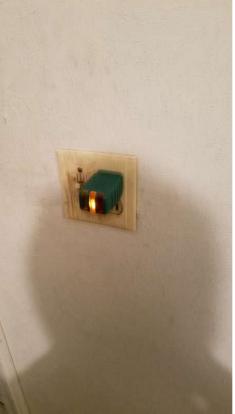
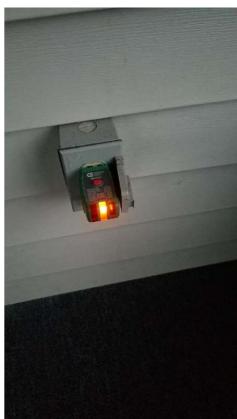
9.5.1 Receptacles

3 PRONG UNGROUNDED 3 WIRE

3-slot receptacles (outlets) were installed in one or more areas and tested as not having a ground wire hooked up. As this electric system appears mostly or all grounded, it is likely the wire could be loose, or not hooked up, or a splice somewhere is loose. Recommend a qualified electrician evaluate and repair.

Contact a qualified electrical contractor.

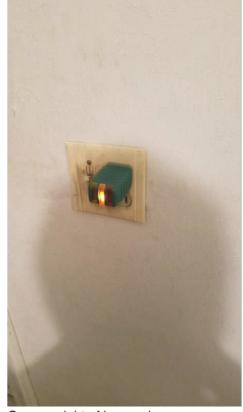
Garage, right of house door

9.5.2 Receptacles

DAMAGED

GARAGE, RIGHT SIDE OF HOUSE DOOR

Recommendation Contact a qualified electrical contractor.

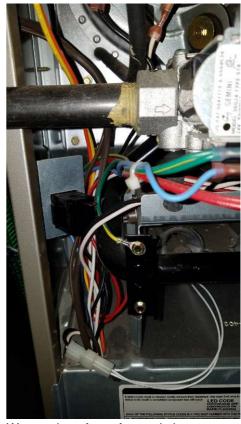
10.1.1 Equipment

FURNACE COVER SAFETY SWITCH

The safety switch that will shut the furnace off if the cover is removed is not functioning properly or is missing. Recommend repair by a qualified HVAC tech next time the furnace is serviced.

Wrong place for safety switch.

Contact a qualified HVAC professional.

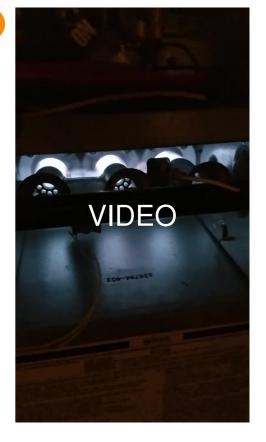
10.1.2 Equipment

GAS FLAME

The boiler burner flame was not blue in color. Various conditions can cause incorrect flames including incorrect drafting, dirty burner orifices and improper gas pressure. Recommended that a qualified heating contractor evaluate and repair as necessary

Contact a qualified professional.

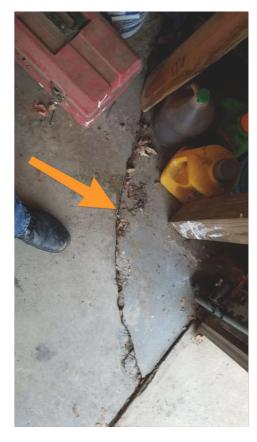
11.3.1 Floor, Walls, Ceiling **CRACKING MAJOR**

Significant cracks, heaving and/or settlement were found in one or more sections of concrete slab floors. Uneven surfaces can pose a trip hazard. Recommend that a qualified contractor repair or replace concrete slab floors where necessary.

Contact a qualified masonry professional.

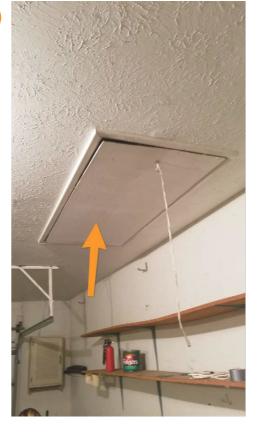
11.3.2 Floor, Walls, Ceiling

ATTIC PULL DOWN STEPS

Substandard attic pull down steps are installed that compromised the fire barrier of the garage. Attic pull down steps need to be fire resistant if they're to be installed in a garage. Recommend qualified person to install proper pull down steps or close of opening with 5/8 ths drywall and finish to match.

Recommendation Contact a qualified professional.

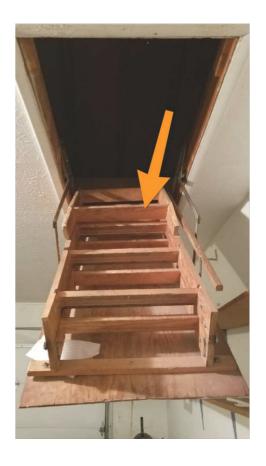
11.3.3 Floor, Walls, Ceiling

ATTIC PULL DOWN STEPS DAMAGED

The attic pull down steps were damaged and pose a severe safety hazard. Recommend replacement bu a qualified contractor. Note that since they are in the garage, they will need to be fire rated.

Contact a qualified professional.

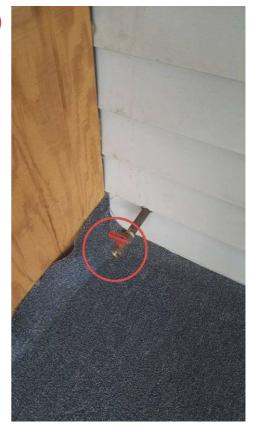
17.1.1 Type

UNUSED GAS VALVE NOT PLUGGED.

One or more propane or natural gas supply terminations were unused and no cap was installed on the gas shut off valve. Gas can flow directly out of the termination if the shutoff valve is opened. This is a potential fire hazard. Recommend a qualified person install caps were missing for Standard Building practices.

Contact a handyman or DIY project
