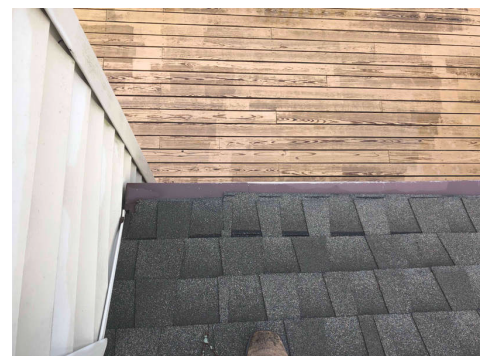
2.1.2 Coverings

LOOSE / MISSING

One or more of the shingles were loose or missing. This will allow for moisture intrusion. This will also increase the likelihood of additional wind damage. The cause may or may not be related to poorly bonded shingles, age, or improperly nailed shingles. Further review of the entire roof is recommend for this reason. Repairs, depending on location and other factors, are not typically hard to accomplish.

Recommendation
Contact a qualified roofing professional.

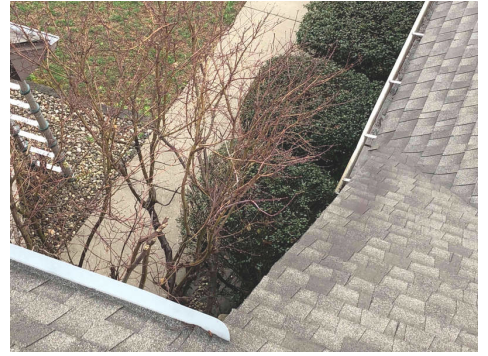
2.1.3 Coverings

TREE BRANCHES - NO DAMAGE

Be sure to keep the tree branches trimmed back to prevent damage to the roof.

Contact a handyman or DIY project

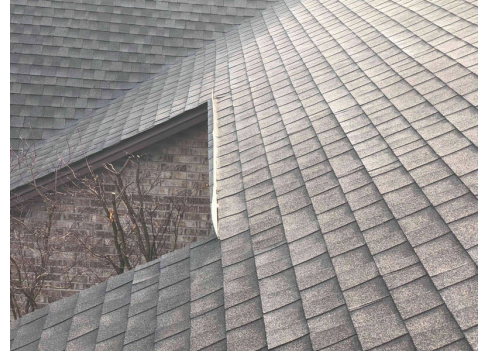
2.1.4 Coverings

POSSIBLE ICE DAMMING

The wide flashing here could allow for ice damming. It's designs to eliminate the need for a gutter here but ice damming could occur.

Recommend monitoring.

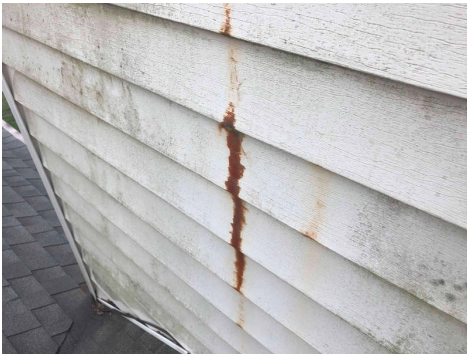
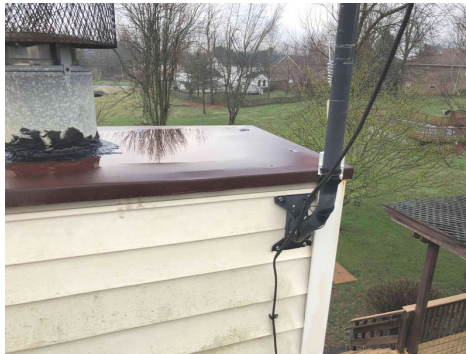
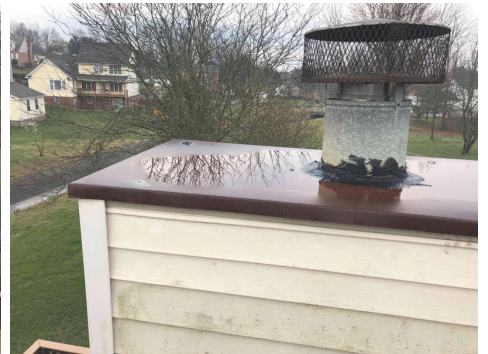
2.6.1 Chimney

METAL CHIMNEY CAP

The cap was damaged or in need of maintenance. Recommend further review and repair to mitigate the risk of pest intrusion.

Contact a qualified chimney contractor.

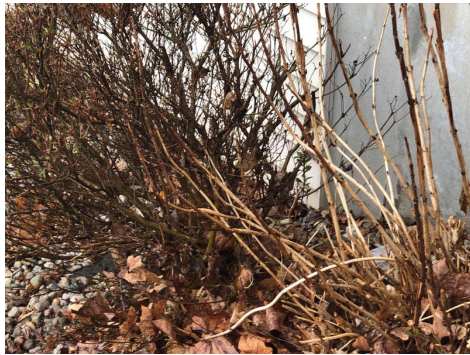
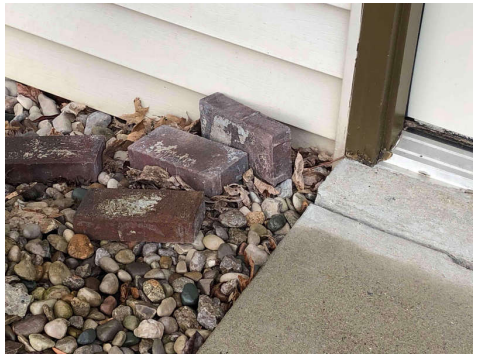
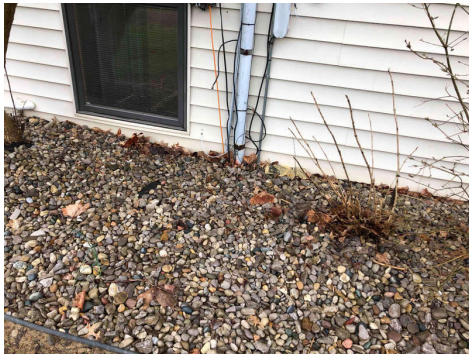
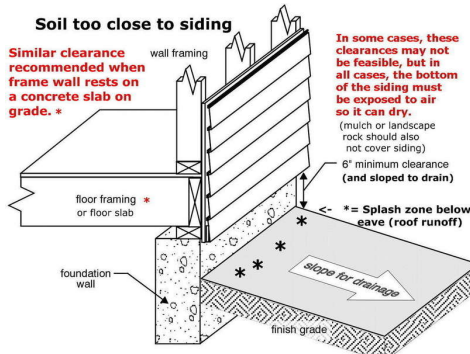
3.1.1 Siding, Flashing & Trim

SIDING - CLOSE TO GROUND

There should be a gap between the siding and the soil/ground. There is a risk of moisture wicking as well as a pathway for wood destroying insects.

Contact a qualified professional.

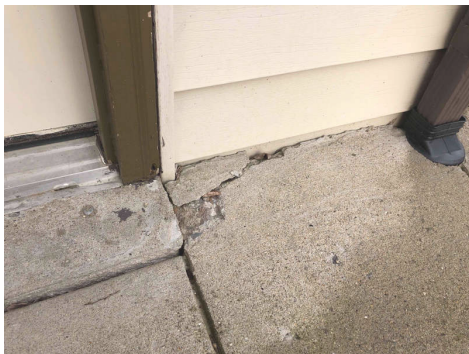
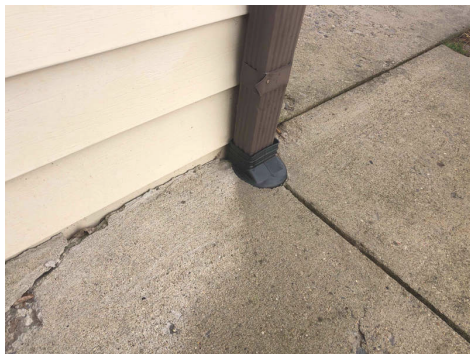
3.1.2 Siding, Flashing & Trim **CONCRETE CLEARANCE**

There should be a gap between the siding and the concrete and flashing. No major concerns observed but moisture could get trapped between or behind.

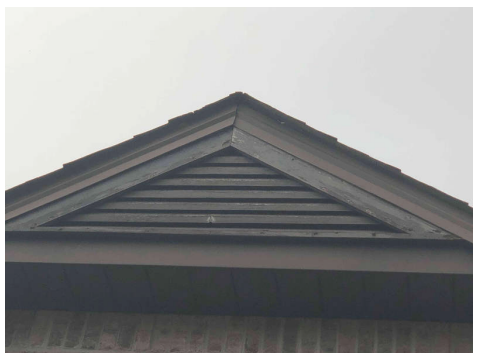
3.1.3 Siding, Flashing & Trim **FAILING PAINT**

The paint was damaged or failing and preventative measures are needed to mitigate further damage to the siding. Recommend further by a paint or siding contractor for repair costs and options.

Recommendation
Contact a qualified professional.

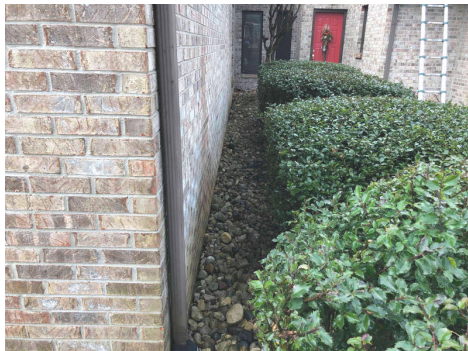
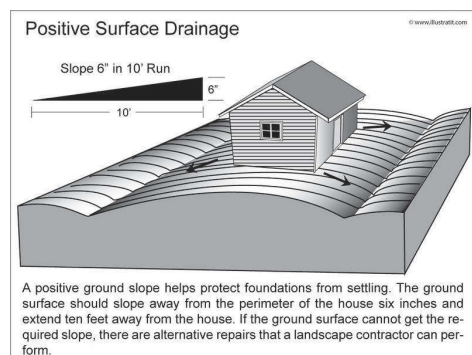
3.3.1 Vegetation, Grading, & Drainage

NEGATIVE GRADING

Grading is sloping towards the home in some areas. This could lead to water intrusion and foundation issues. Recommend qualified landscaper or foundation contractor regrade so water flows away from home.

Contact a qualified landscaping contractor

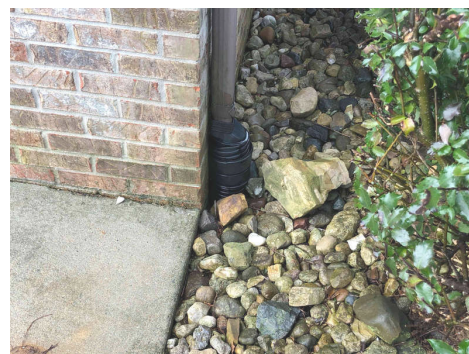
3.3.2 Vegetation, Grading, & Drainage

DOWNSPOUTS - BURIED

Buried downspouts are not recommended because they can become detached without the homeowners knowledge. That situation would lead to water against the foundation and potential problems.

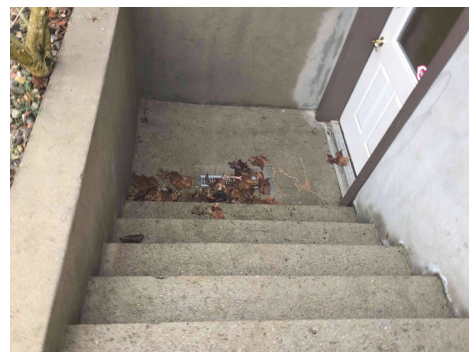
3.3.3 Vegetation, Grading, & Drainage

EXTERIOR DRAIN CLOGGED

The exterior drain appeared to be clogged or at the risk of. Recommend clearing out as needed.

Recommended DIY Project

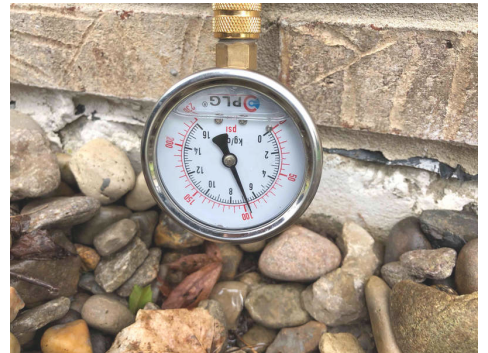
3.4.2 Gas, Water, & Electric

WATER PRESSURE - HIGH

The water pressure inside the residence exceeds 80 psi and the regulator should be adjusted so that the static pressure is between 60 and 75 psi. However, it may be that the regulator has failed, or is failing, or not present and the pressure cannot be reduced, in which case the regulator should be replaced or installed by a qualified plumber.

Contact a qualified plumbing contractor.

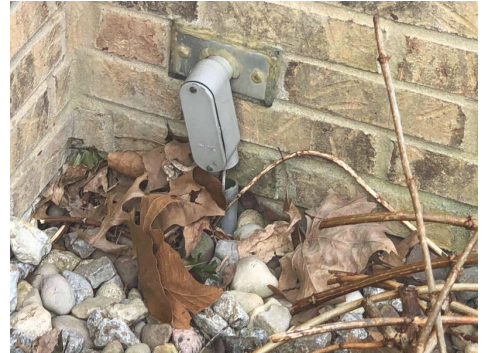
3.4.3 Gas, Water, & Electric

EXPOSED WIRES

Exposed wires are subject to damage and should be protected and or bury/exterior rated material.

Contact a qualified electrical contractor.

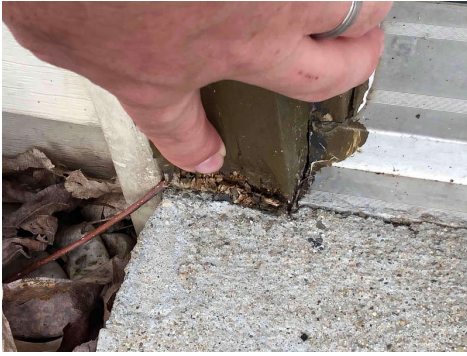
3.5.1 Exterior Doors

JAMB - MOISTURE DAMAGE

Some moisture induced degradation was noted at one or more exterior jambs and door. Though this is typical, attempts to prevent furthering and repair damage should be considered. [Here is some more information that may be useful.](#)

Contact a qualified handyman.

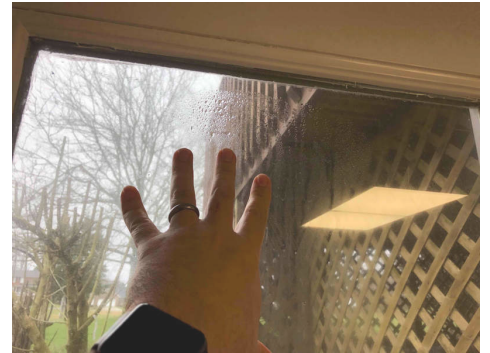
3.5.2 Exterior Doors

DOOR GLASS HAZING - FAILED SEAL

The sliding glass door had double-pane glazing in which condensation was visible. This indicates a loss of thermal integrity. The door should be repaired or replaced as necessary by a qualified contractor. Replacement is more typical.

Contact a qualified door repair/installation contractor.

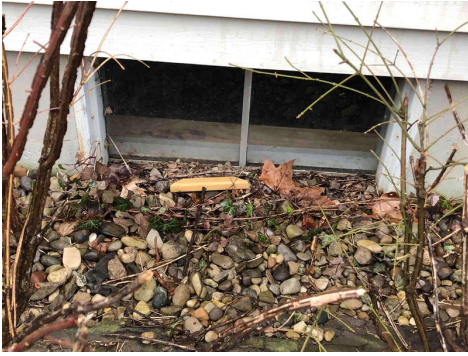
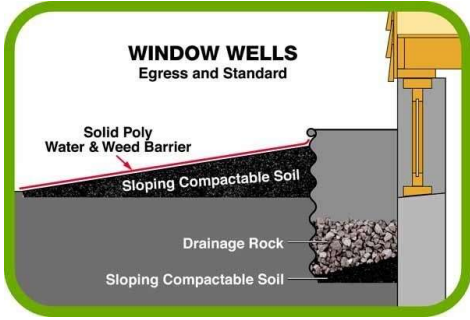
3.6.1 Windows

WINDOW WELL NEEDED

A window well should be installed and the grading should be improved so that water is going away from the foundation.

Contact a handyman or DIY project

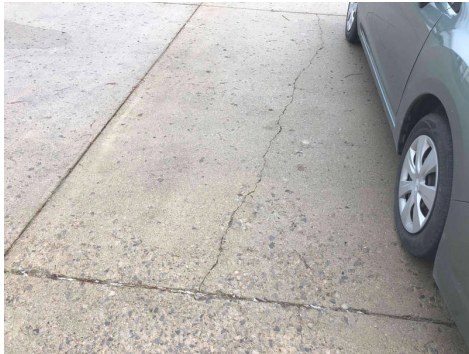
3.7.2 Driveways & Walkways

TYPICAL CRACKING

Some typical cracking observed. No significant deficiencies were observed.

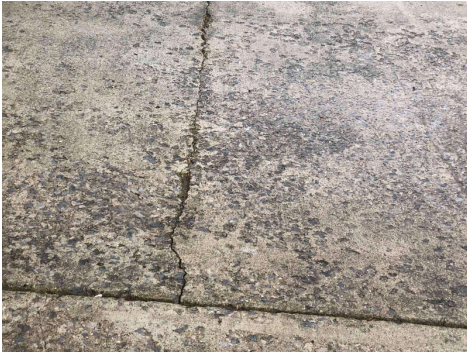
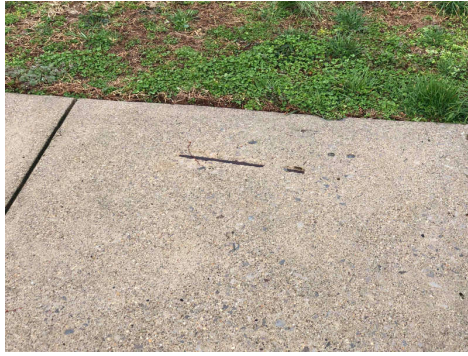
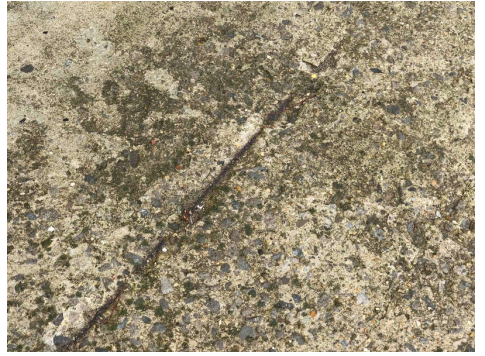
3.7.3 Driveways & Walkways

DAMAGE

There was some damage noted at the drive/sidewalk. Some continuation is probable. This appeared to be rebar too close to the surface.

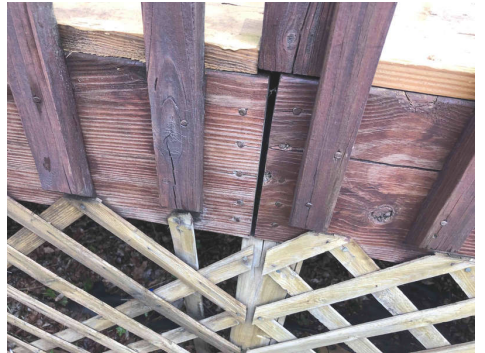
3.8.1 Decks & Balconies

RIM JOIST MISSING LAG BOLTS

SAFETY The rim joist on the deck should be bolted to the post. Or the post should be notched. Failure is possible and the deck could collapse. Repair is needed.

Contact a qualified deck contractor.

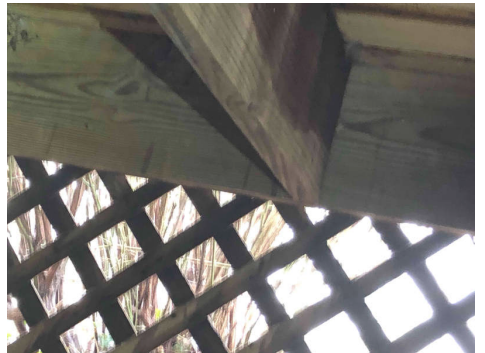
3.8.2 Decks & Balconies

JOIST HANGERS - MISSING

Joist hanger(s) are missing or improperly installed. This could cause the deck structure to fail. Recommend that joist hangers be properly installed by qualified contractor.

Contact a qualified deck contractor.

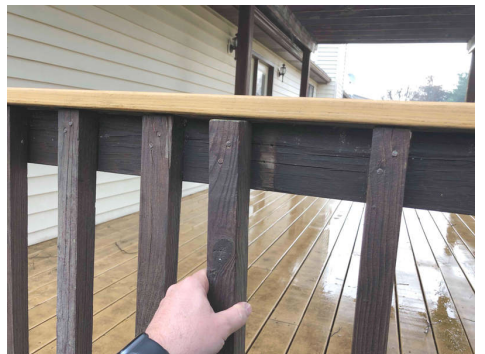
3.8.3 Decks & Balconies

SPINDLES MISSING/DAMAGE

SAFETY Spindles were damaged, missing, or loose in one or more locations. Fall hazards exist as well as other concerns. Recommend further review and repair.

Contact a qualified deck contractor.

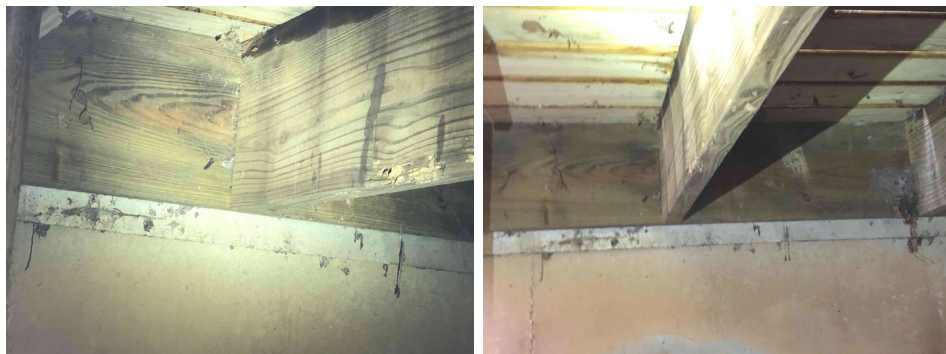
3.8.4 Decks & Balconies

LEDGER BOARD IMPROPERLY INSTALLED

SAFETY The ledger board did not appear to be adequately attached to the building. This can cause the deck to pull away from the building and possibly collapse. Recommend that the deck and/or ledger board be properly attached by qualified contractor. [Here is an article explaining how a ledger board should be installed.](#)

Contact a qualified deck contractor.

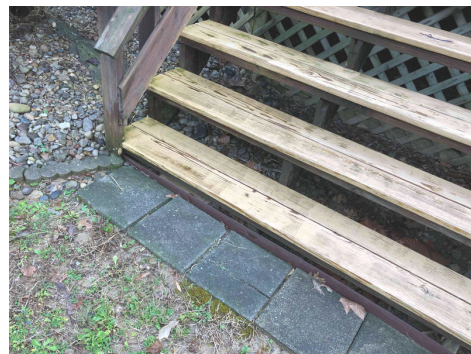
3.10.1 Stairs

STAIRS - GROUND CONTACT

Stringers should not be resting on the ground. They are not rated for ground contact. Monitor. Repair as needed.

Contact a qualified deck contractor.

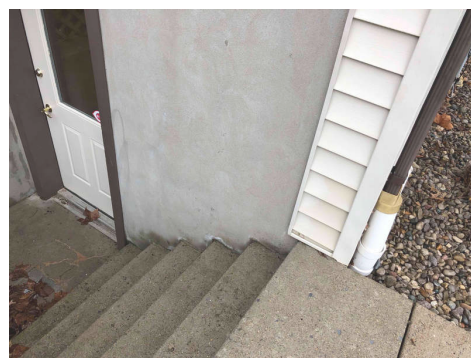
3.10.2 Stairs

STAIRS - HANDRAIL MISSING

SAFETY There should be a handrail installed that allows for one handed grasping. This helps minimize the fall hazard. This handrail is too low.

Contact a handyman or DIY project

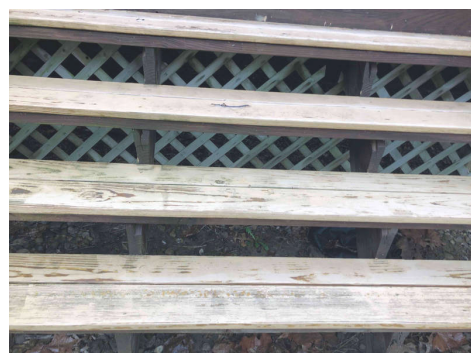
3.10.3 Stairs

STAIRS - RISERS

SAFETY There were no risers installed. Risers are recommended because of the potential fall hazard.

Contact a handyman or DIY project

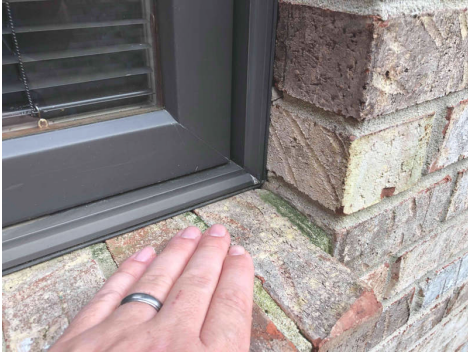
3.11.1 Masonry

GAPS - WINDOWS/DOORS

Any gaps around windows or doors should be sealed to mitigate moisture intrusion. Moisture intrusion between the masonry and framing could cause damage to the framing that would be difficult to observed. Recommend making corrections as needed.

Contact a handyman or DIY project

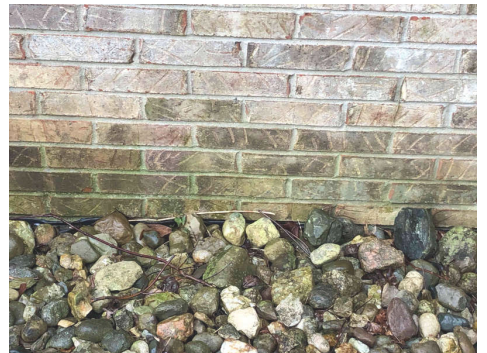
3.11.2 Masonry

WEEP HOLES

No means was provided for ventilating the air space behind the brick (weep holes). Good building practice requires ventilating the air space behind the brick to help prevent moisture problems.

Under certain circumstances, this condition can create moisture problems resulting from condensation and excessive moisture levels in wall assembly materials. This condition may also trap any moisture which finds its way into this space from roof or plumbing leaks. Excessive moisture levels in wall materials can also encourage the growth of microbes such as mold fungi.

There is not typically a way to correct this condition because it requires flashing that can not be installed after the fact. Recommend monitoring the area.

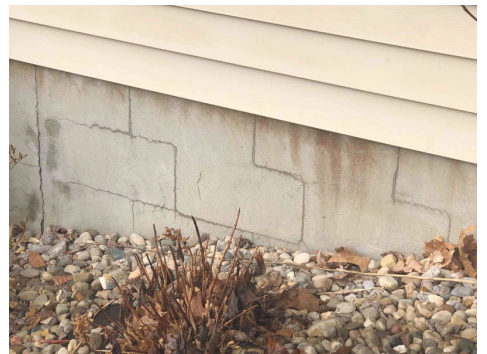
3.12.1 Foundation Perimeter

CMU CRACKING - MINOR

Concrete Masonry Unit (CMU) foundation walls had minor stepped cracking visible in mortar joints. Cracking was normal and there were no major concerns. Consider sealing gaps to prevent further damage. Monitor horizontal cracking for any widening and take additional measures if the gap increases.

Contact a handyman or DIY project

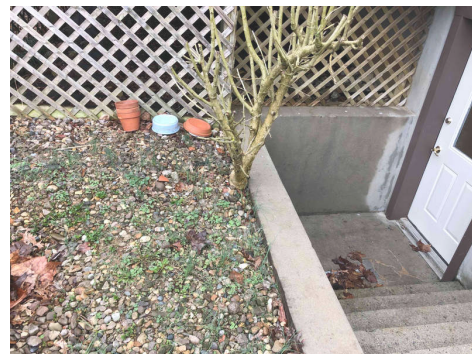
3.13.1 Fence / Retaining Wall

FALL HAZARD

SAFETY There were fall hazards noted. Use caution and consider measures to mitigate the risk.

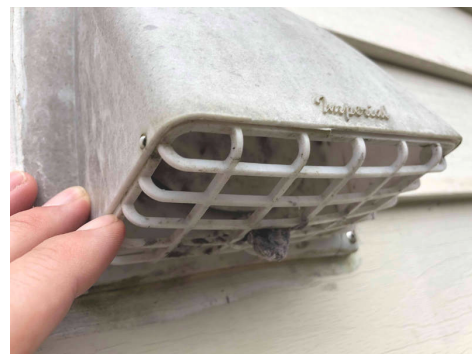
3.14.1 Vents

SCREEN

There should not be a screen installed on the dryer vent. Recommend making corrections.

Contact a handyman or DIY project

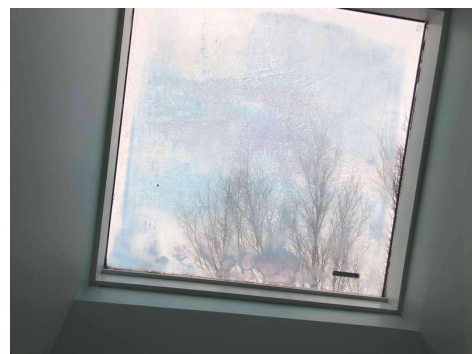
4.2.1 Windows

E-COATING

There were some slight signs of damage to the E-coating between the panes. This is an early sign of loss off seal. Recommend budgeting for replacement.

Contact a qualified window repair/installation contractor.

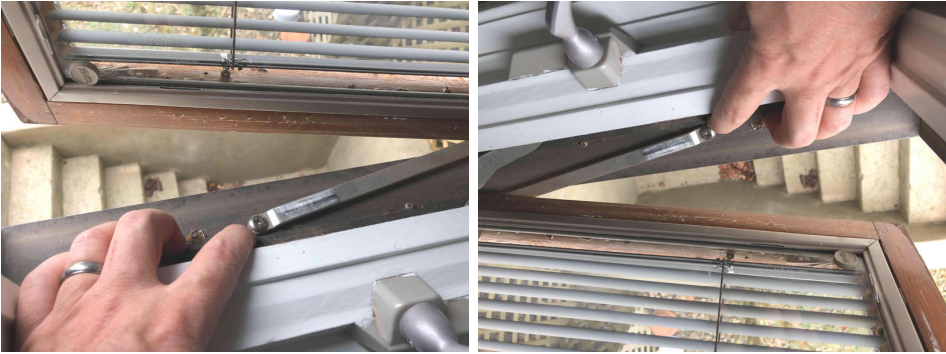
4.2.3 Windows

HARDWARE - MISSING/DAMAGED

Some of the windows had damaged or missing hardware. Repair as needed.

Recommendation
Contact a qualified window repair/installation contractor.

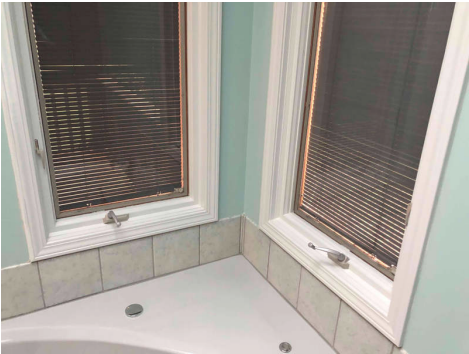
4.2.4 Windows
SAFETY GLASS NEEDED

SAFETY Safety glass is recommended for windows that are located close to the ground or within a shower stall/tub. I could not identify any indication that this was safety glass. Recommend making improvements for safety reasons.

Recommendation
Contact a qualified window repair/installation contractor.

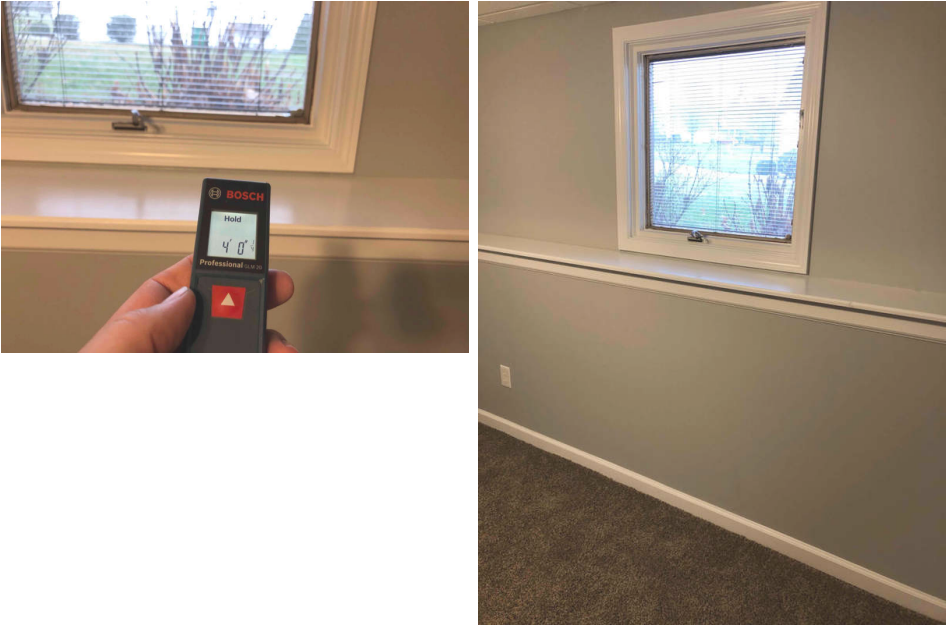
4.2.5 Windows
WINDOW EGRESS

SAFETY Window did not meet currently accepted guidelines for egress. Commonly observed in older homes. Recommend understanding the limitations.

Recommendation
Contact a qualified window repair/installation contractor.

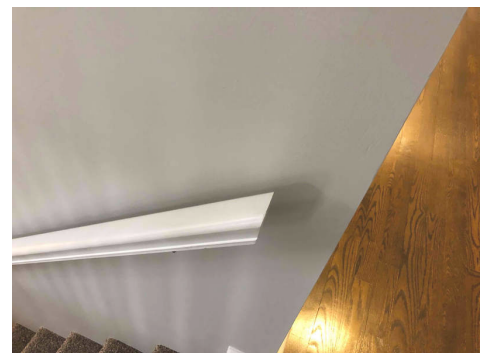
4.6.2 Steps, Stairways & Railings

HANDRAIL - TURN TOWARDS WALL

SAFETY Hand rails should turn towards the wall to mitigate the fall risk.

Contact a qualified handyman.

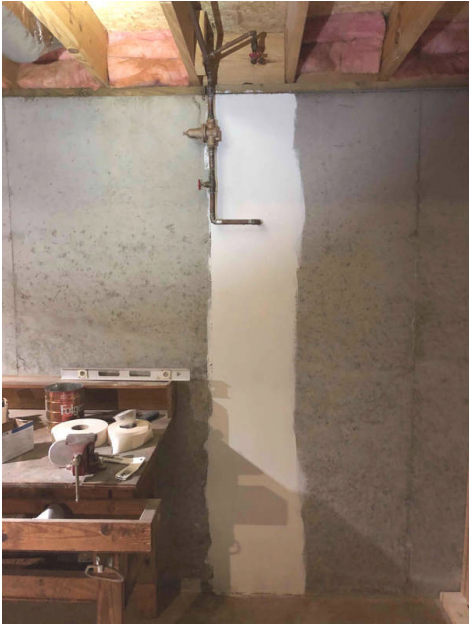
5.1.1 Foundation

EVIDENCE OF PREVIOUS REPAIRS

There was evidence of previous repairs noted to the foundation. Possible moisture intrusion. No leaks observed.

Recommendation
Recommend monitoring.

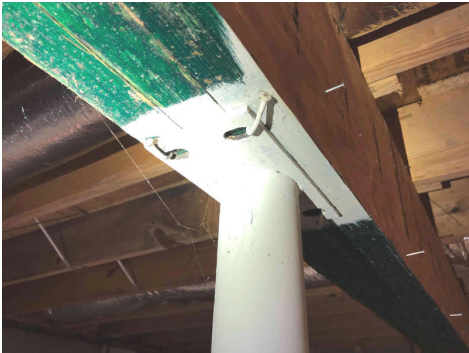
5.2.1 Posts, Piers, & Beams
POSTS - NOT SECURED

Posts should be secured to the girder and/or the floor. This would minimize the risk of failure during a seismic event or keep the girder from rotating.

Recommendation
Contact a qualified handyman.

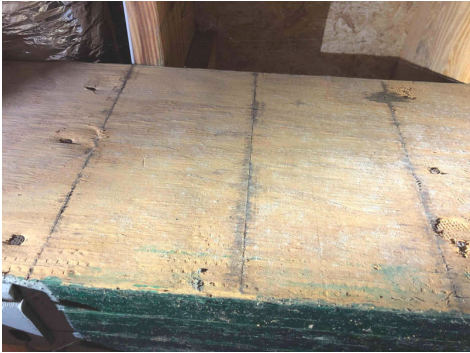
5.4.1 Floor, Sill, Rim Joist
MICROBIAL GROWTH - NO ELEVATED MOISTURE

The floor joists showed evidence of microbial growth. No elevated moisture levels were detected. Laboratory testing would be needed to confirm.

Recommendation
Contact a qualified professional.

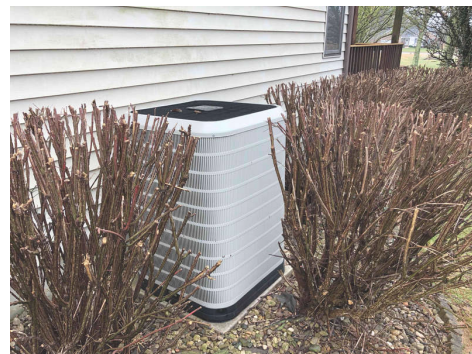
6.1.1 Outside Unit
VEGETATION TOO CLOSE

Vegetation was too close to the compressor, which can limit heat dissipation and limit effectiveness. Recommend cutting back vegetation to avoid overheating compressor.

Recommended DIY Project

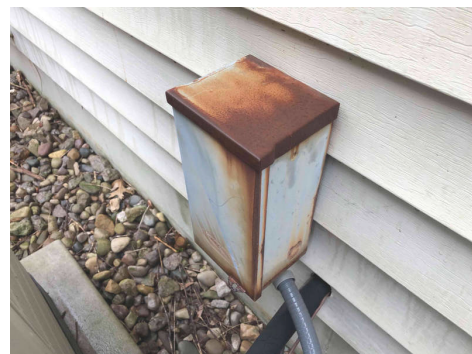
6.1.2 Outside Unit

DISCONNECT RUSTED

The disconnect was rusted and correction is recommended.

Contact a qualified electrical contractor.

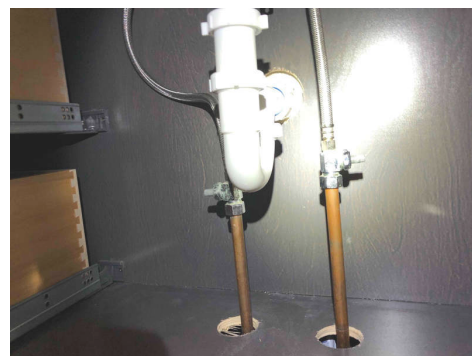
7.3.1 Water Supply

HANDLE MISSING/LOOSE

One of the handles was missing or loose. Repair.

Recommended DIY Project

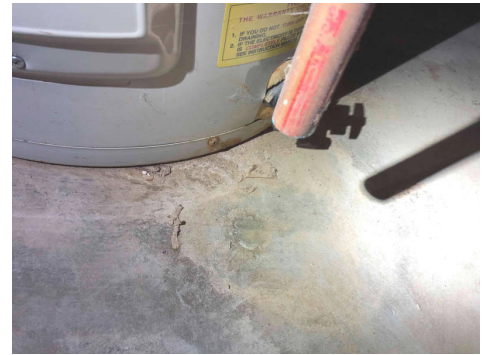
7.4.1 Hot Water - Tank

T&P LEAK

The temperature and pressure relief valve showed signs of previous leaks. This is a sign of failure and the valve should be replaced.

Recommendation
Contact a qualified plumbing contractor.

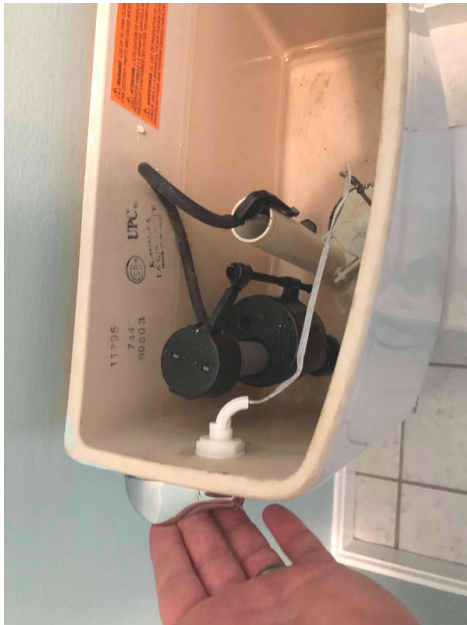
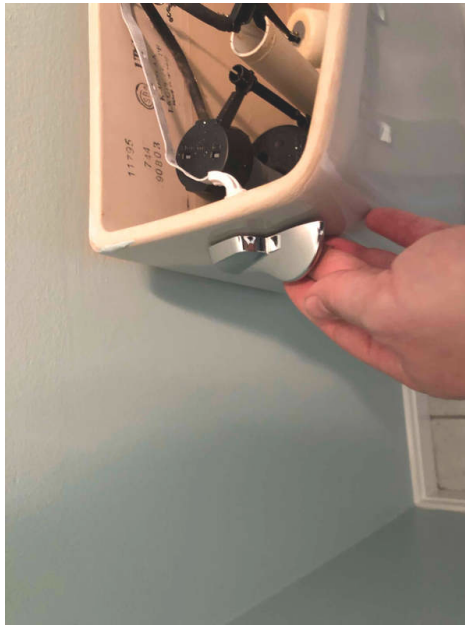
7.6.1 Toilets

IMPROPER FLUSH

The toilet was not flushing correctly. Further review and repair is needed.

Recommendation
Contact a qualified plumbing contractor.

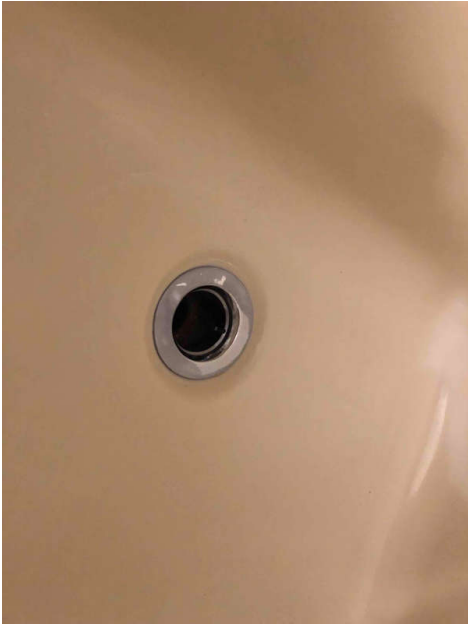
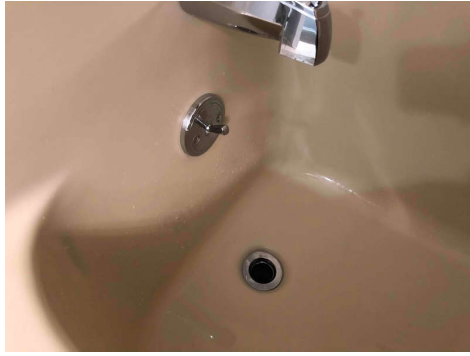
7.7.1 Tubs/Showers

STOPPER DAMAGED

The stopper was damaged or removed. Repair as needed.

Recommendation
Contact a qualified plumbing contractor.

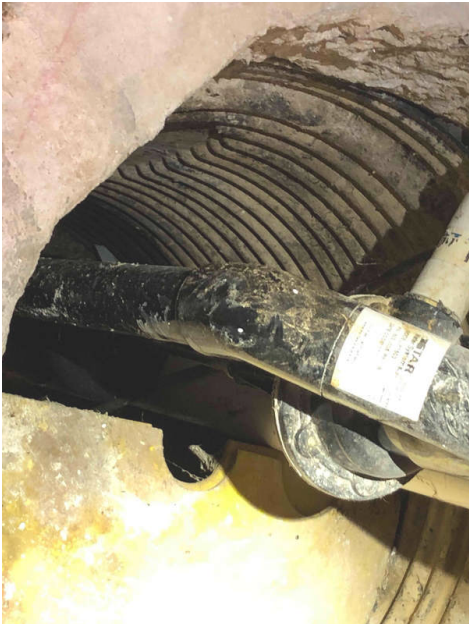
7.8.1 Sump Pump

SUMP PIT LID

SAFETY Sump pump lid should be secured or installed to mitigate potential drowning hazard.

Recommendation
Contact a handyman or DIY project

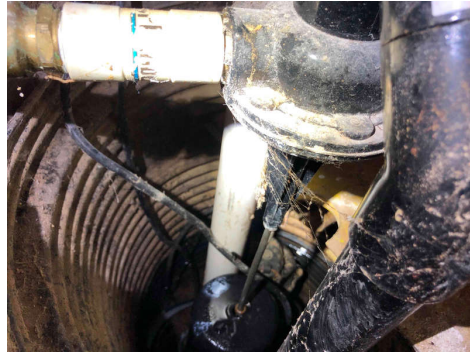
7.8.3 Sump Pump

BACKUP FAILED

The back up pump was leaking and causing the system to operate more frequently.

Recommendation
Contact a qualified plumbing contractor.

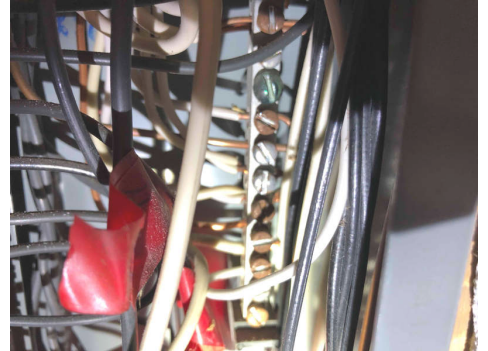
8.1.1 Panels

NEUTRALS - SHARED TERMINAL

The neutrals and ground should not share the same terminal because it is important to keep the circuit grounded even when the neutral is disconnected. Neutrals should not share the same terminal. These conditions may have been acceptable when this panel was installed but they are now considered unsafe. Recommend making corrections.

Contact a qualified electrical contractor.

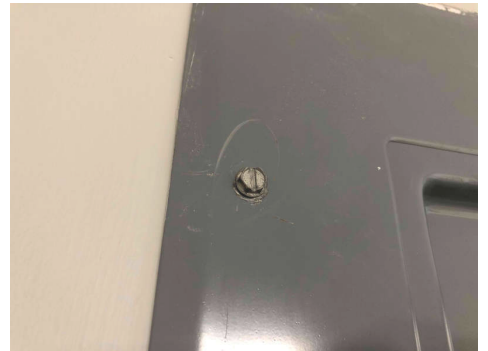
8.1.2 Panels

SCREWS MISSING OR WRONG TYPE

SAFETY Sharp pointed screws were noted or screws were missing. Sharp pointed screws can potentially penetrate a wire. This is a safety hazard. Recommend replacing with the proper machine screw.

Contact a qualified electrical contractor.

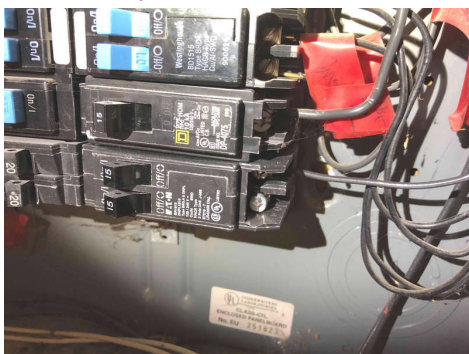
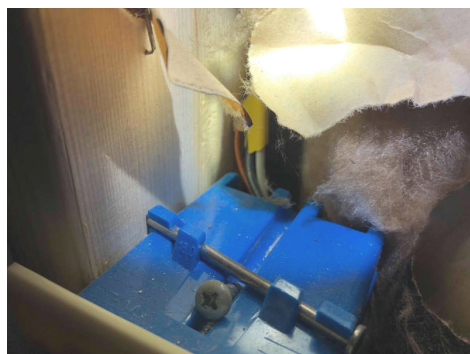
8.2.1 Breakers / Fuses

NO PERMIT FOR NEW CIRCUITS

There were a few circuits added but no additional inspection stickers noted. Consider further review.

Contact a qualified electrical contractor.

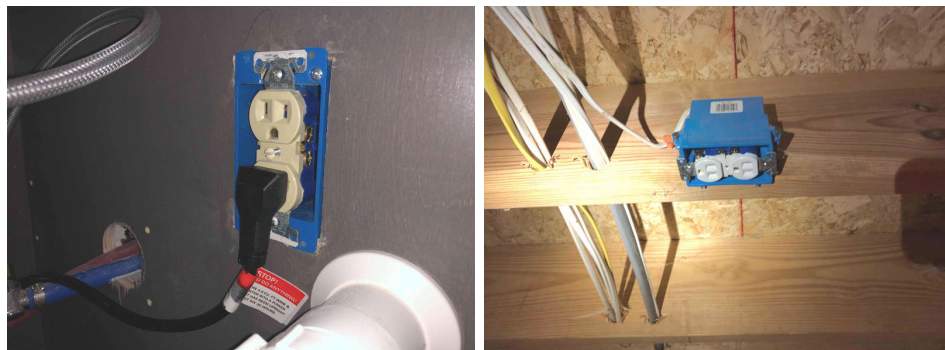
8.4.1 Receptacles & Switches

COVER PLATES MISSING

SAFETY One or more receptacles are missing a cover plate or the cover was damaged/loose. This causes short and shock risk. Recommend installing plates where needed.

Contact a handyman or DIY project

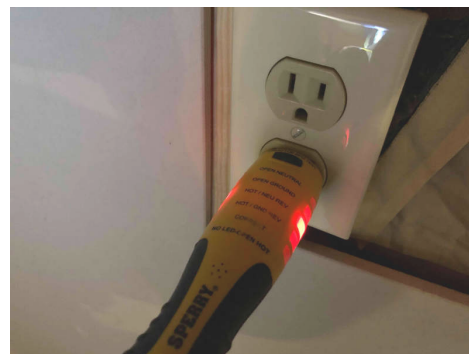
8.4.2 Receptacles & Switches

REVERSE POLARITY

One or more receptacles have been wired with reverse polarity. This can create a shock hazard. Recommend licensed electrician evaluate & repair.

Contact a qualified electrical contractor.

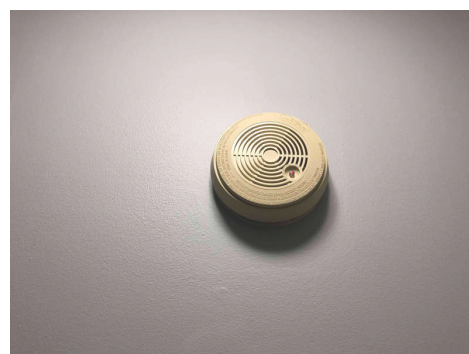
8.7.2 Smoke Detectors

OLDER SMOKE DETECTORS

It is recommended that smoke detectors be changed every 10 years.

Contact a handyman or DIY project

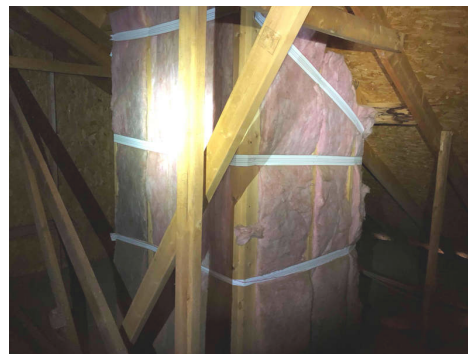
9.2.1 Attic Insulation

BATT INSULATION - NOT ENCAPSULATED

Insulation is diminished in R-value when installed vertically and not encapsulated. Convection impedes its ability to insulate. Consider encapsulating to increase efficiency.

Contact a qualified insulation contractor.

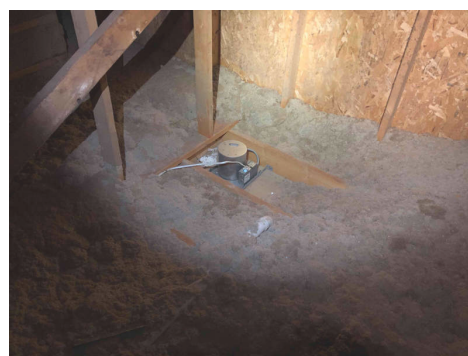
9.2.2 Attic Insulation

INSULATION - GAPS

There were gaps noted in the insulation. This can enable energy loss and make some areas more difficult to regulate.

Contact a qualified insulation contractor.

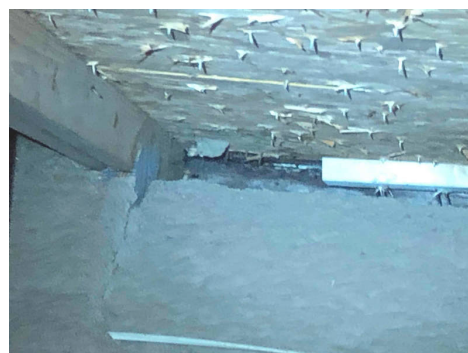
9.5.1 Attic/Structure

FACIA DAMAGE/STAINS NOTED

There was some staining/damage noted at the fascia. Cause not determined. Further review recommended.

Contact a qualified professional.

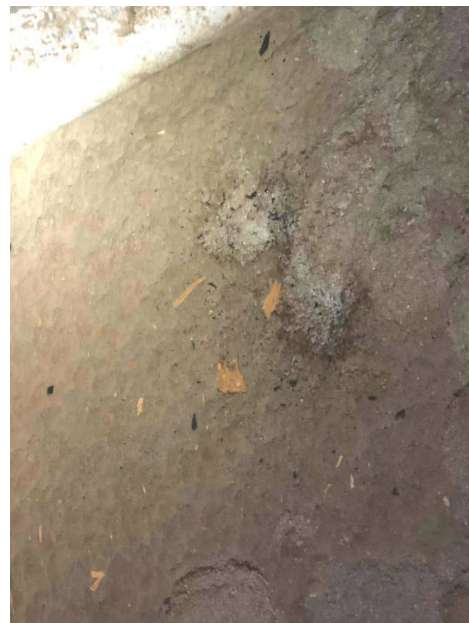
9.6.1 Leaks

PREVIOUS LEAKS

There was some water staining indicating previous water leaks. Previous leaks around plumbing boots.

Recommendation
Recommend monitoring.

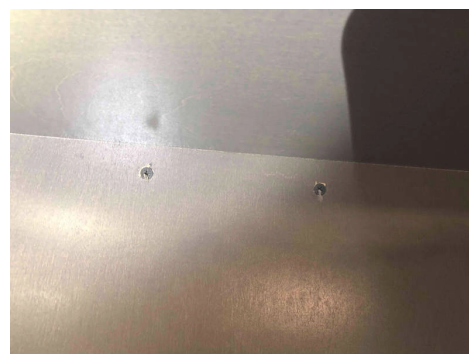
10.1.1 Countertops & Cabinets

CABINET SCREWS

One or more cabinet screws are missing or the wrong type of screws were used. Recommend further review and installing as needed. Drywall screws are tapered and can pull thru the cabinet. Truss head screws should be used.

Recommendation
Contact a handyman or DIY project
