SUMMARY
 1234 Main St. Leominster Ma 01453
 Buyer Name
 02/15/2018 9:00AM

Mark Fratoni
 License # 821
 Wachusett Home Inspection, LLC
 (978) 990-3200
mark@wachusettinspection.com

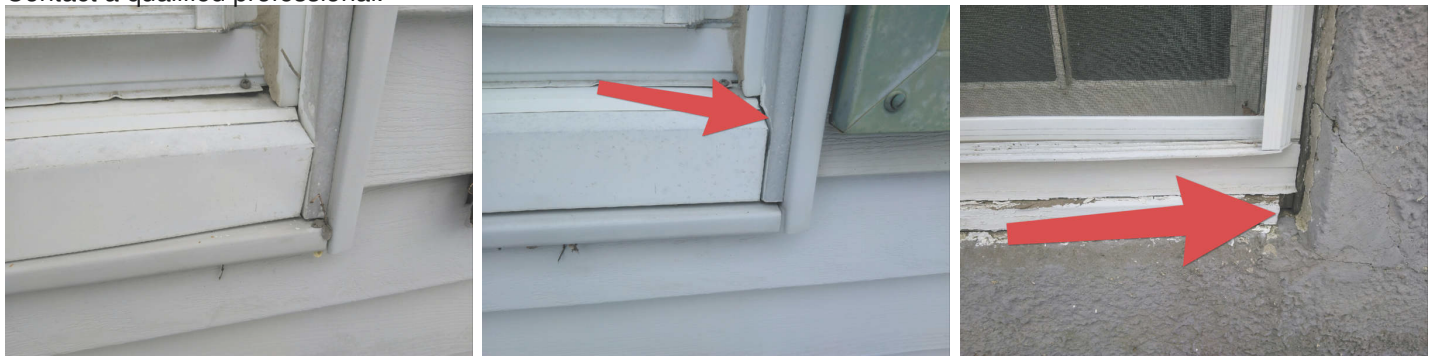
2.1.1 Siding, Flashing & Trim

WINDOW TRIMS NOT PROPERLY SEALED

Seams that may allow moisture intrusion should be properly sealed.

Recommendation
 Contact a qualified professional.

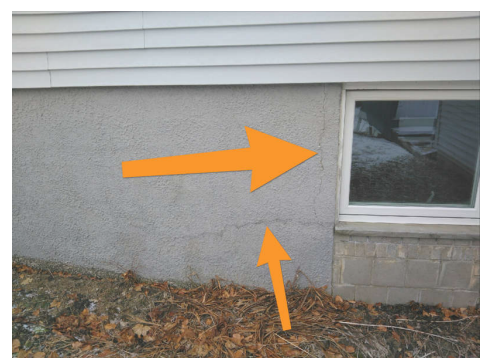
2.1.2 Siding, Flashing & Trim

CRACKS

Several cracks and loose material was observed on parged areas of the foundation.

Recommendation
 Contact a qualified professional.

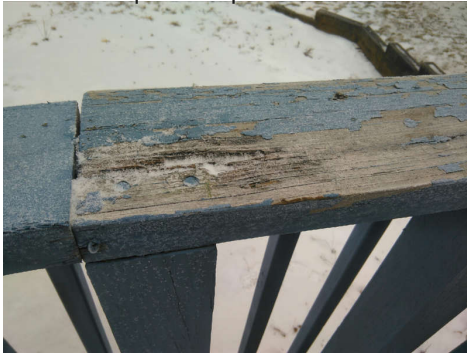
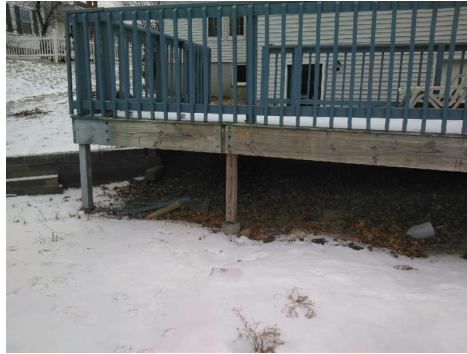
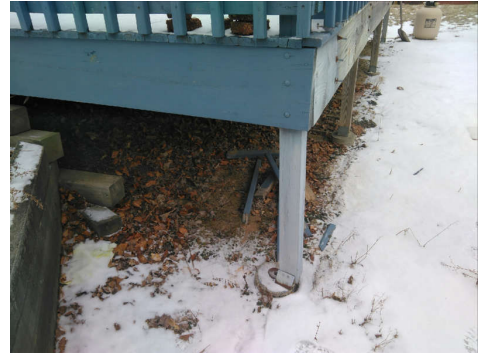
2.3.1 Decks, Balconies, Porches & Steps

DECK

Improper support and corroded fasteners were noted. Correction by licensed contractor is recommended.

Recommendation
Contact a qualified professional.

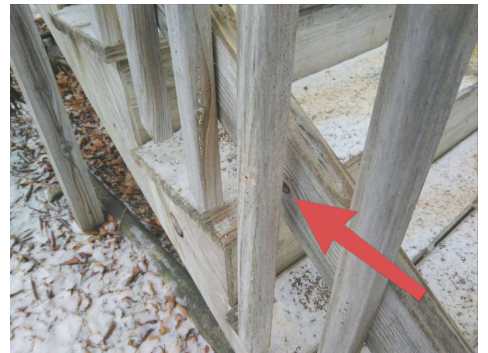
2.3.2 Decks, Balconies, Porches & Steps

IMPROPERLY SECURED BALUSTERS

The balusters at the left side stairs with landing were not properly secured and represent a safety hazard.

Recommendation
Contact a qualified professional.

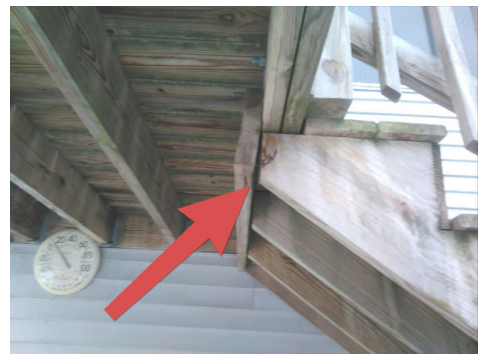
2.3.3 Decks, Balconies, Porches & Steps

POOR ATTACHMENT

The steps were poorly attached to the landing and should be properly secured.

Recommendation
Contact a qualified professional.

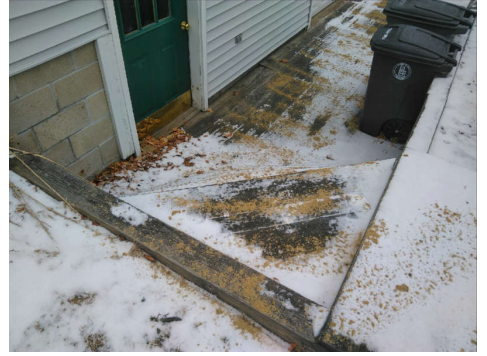
2.3.4 Decks, Balconies, Porches & Steps

UNSAFE STAIRS

Consider adding a handrail to the rear landscaped stairs for safety.

Recommendation
Contact a qualified professional.

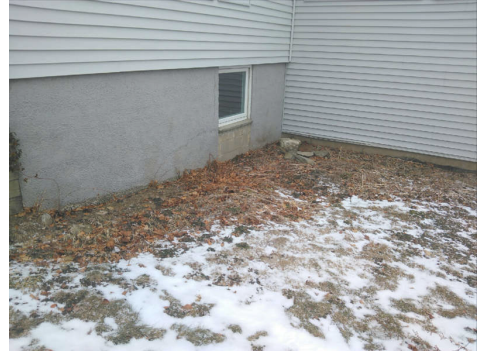
2.5.1 Vegetation, Grading, Drainage & Retaining Walls

NEGATIVE GRADING

Grading is sloping towards the home in some areas. This could lead to water intrusion and foundation issues. Recommend qualified landscaper or foundation contractor regrade so water flows away from home.

Contact a qualified professional.

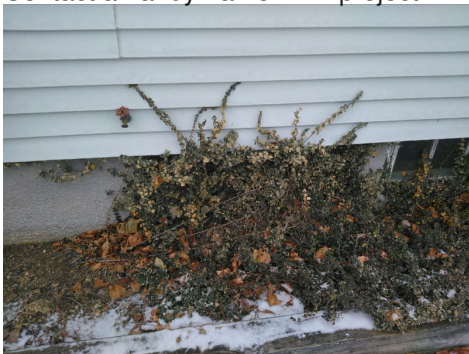
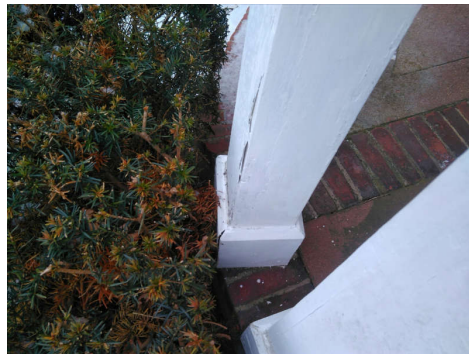
2.5.2 Vegetation, Grading, Drainage & Retaining Walls

FOUNDATION PLANTINGS OVERGROWN

Vegetation was in contact with the structure and should be trimmed back.

Contact a handyman or DIY project

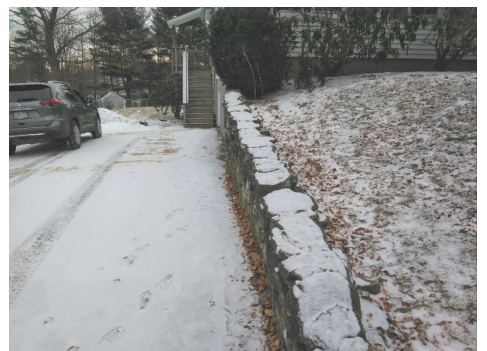
2.5.3 Vegetation, Grading, Drainage & Retaining Walls

LEANING RETAINING WALL

The retaining wall was leaning and in need of repair.

Contact a qualified professional.

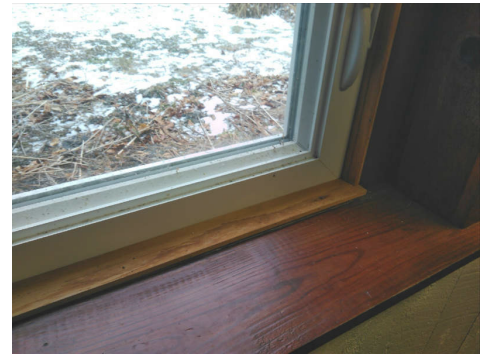
2.7.1 Window Wells and Areaways

WINDOW NOT OPERABLE

The right rear corner window was not operable.

Recommendation
Contact a qualified professional.

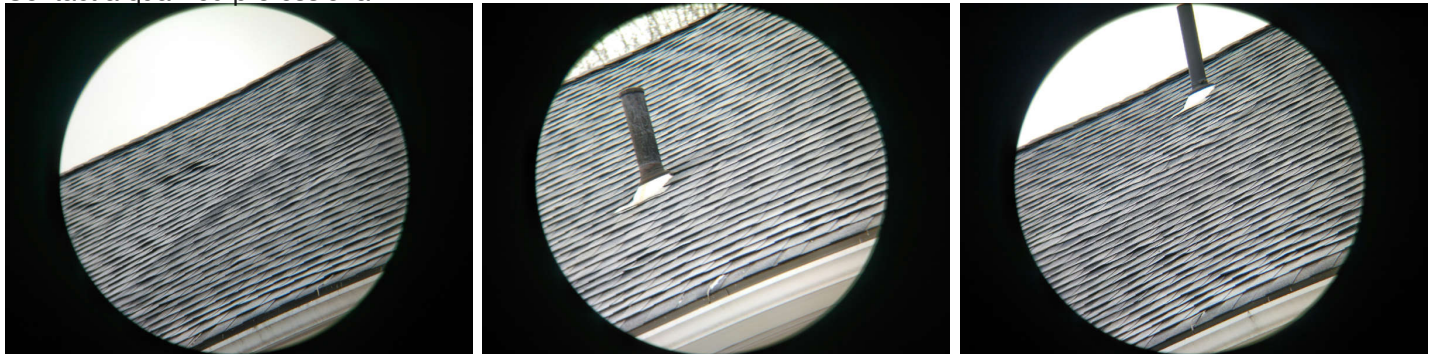
3.1.1 Coverings

CURLED SHINGLES AND RAISED AREAS

Several areas at the left side roof plane exhibited curling shingles and lifted sections. Further investigation recommended.

Recommendation
Contact a qualified professional.

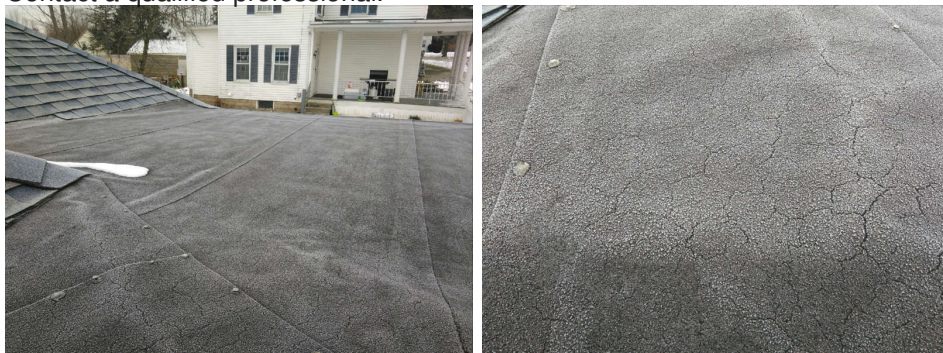
3.1.2 Coverings

MATERIAL AT THE END OF ITS LIFE

The rolled roofing material over the front porch was in poor condition and appeared to be toward the end of its useful life.

Recommendation
Contact a qualified professional.

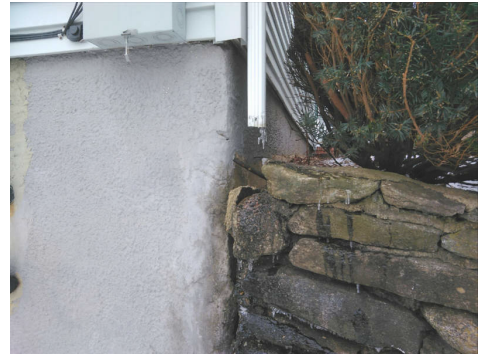
3.2.1 Roof Drainage Systems

DOWNSPOUTS DRAIN NEAR HOUSE

One or more downspouts drain too close to the home's foundation. This can result in excessive moisture in the soil at the foundation, which can lead to foundation/structural movement. Recommend a qualified contractor adjust downspout extensions to drain at least 6 feet from the foundation.

Contact a qualified professional.

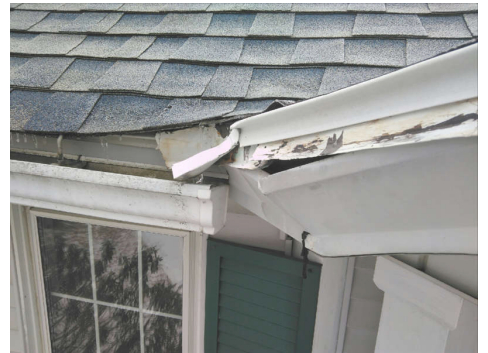
3.2.2 Roof Drainage Systems

MECHANICAL DAMAGE

Apparent mechanical damage observed, possibly from past issues with ice. Damaged trim was also noted in this area.

Contact a qualified professional.

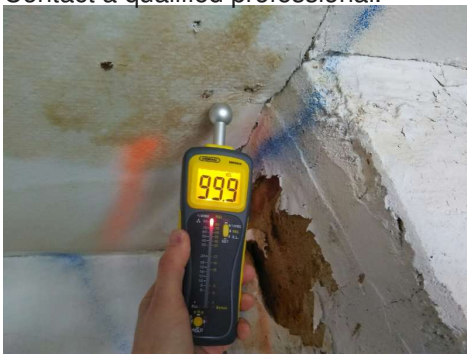
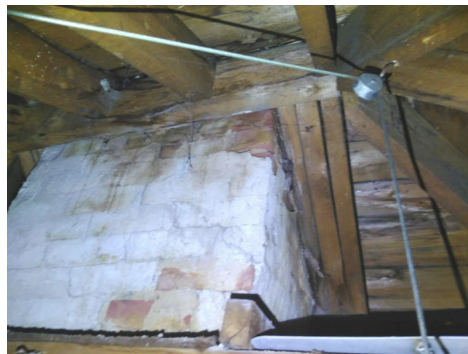
3.3.1 Flashings

ACTIVE MOISTURE INTRUSION

Active moisture intrusion was noted at the chimney penetration in the attic. This is likely a flashing issue but should be further investigated to determine the cause.

Moisture meter showed elevated levels of moisture.

Contact a qualified professional.

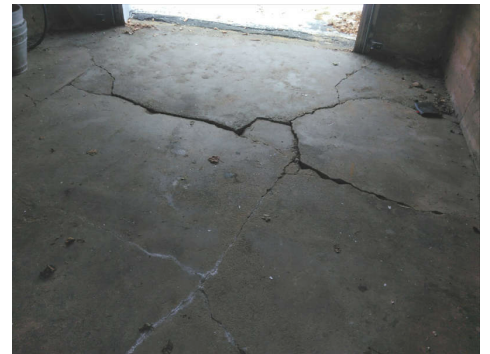
4.1.1 Foundation, Basement & Crawlspaces

HEAVING/SETTLING

The left side garage floor had significant cracks and evidence of heaving/settling.

Contact a qualified professional.

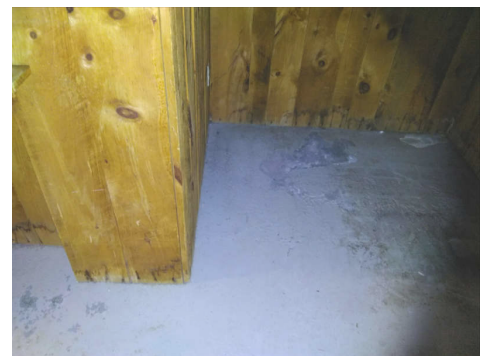
4.1.2 Foundation, Basement & Crawlspaces

HISTORIC STAINING

Evidence of past moisture intrusion was apparent on several wood wall sections in the basement.

Recommend monitoring.

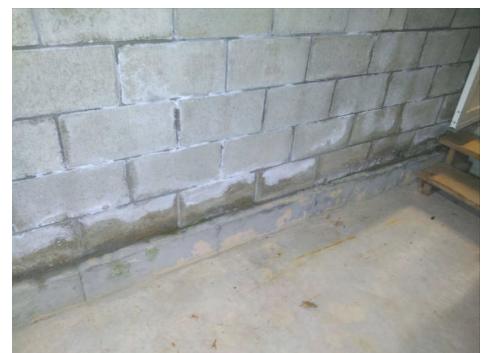
4.1.3 Foundation, Basement & Crawlspaces

MOISTURE INTRUSION

Active moisture intrusion noted at the right rear corner.

Contact a qualified professional.

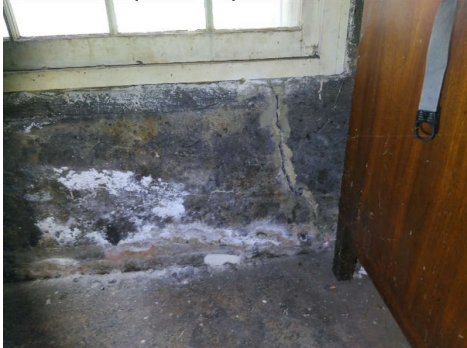
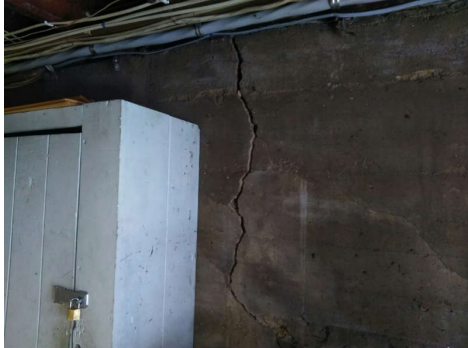
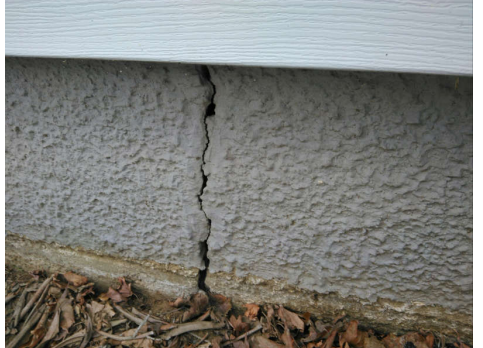
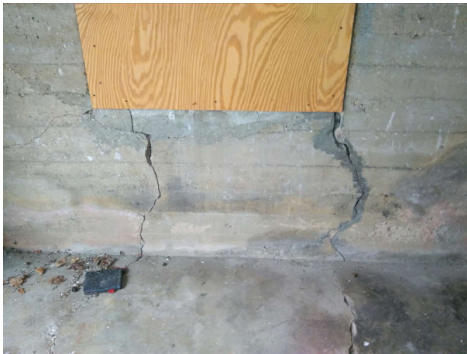
4.1.4 Foundation, Basement & Crawlspaces

SIGNIFICANT FOUNDATION CRACKS

Significant foundation cracks were noted in several areas. Further investigation by structural engineer is recommended.

Recommendation
Contact a qualified professional.

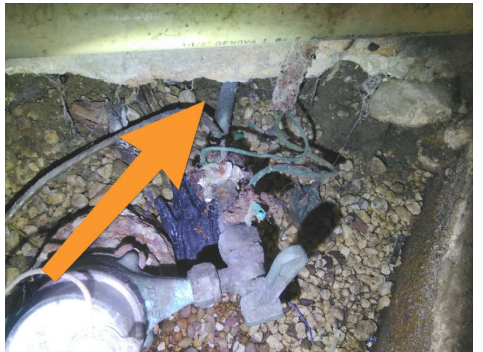
4.1.5 Foundation, Basement & Crawlspaces

UNDERCUT FOUNDATION

The lack of a proper footing was observed at the open sump pit in the basement.

Recommendation
Contact a qualified professional.

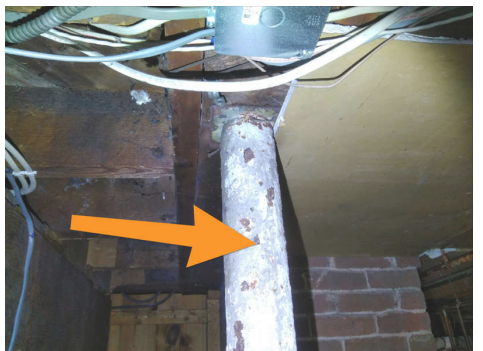
4.2.1 Floor Structure

CORRODED POST

Support post was severely corroded and should be replaced.

Recommendation
Contact a qualified professional.

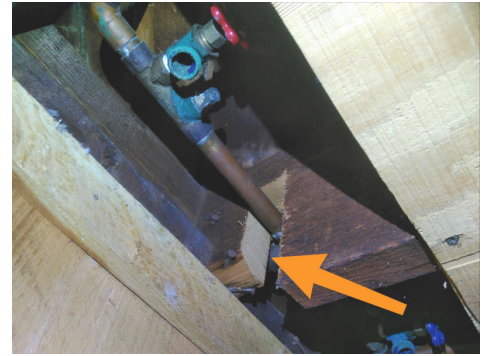
4.2.2 Floor Structure

NOTCHED JOIST

An excessively notched floor joist was noted.

Recommendation
Contact a qualified professional.

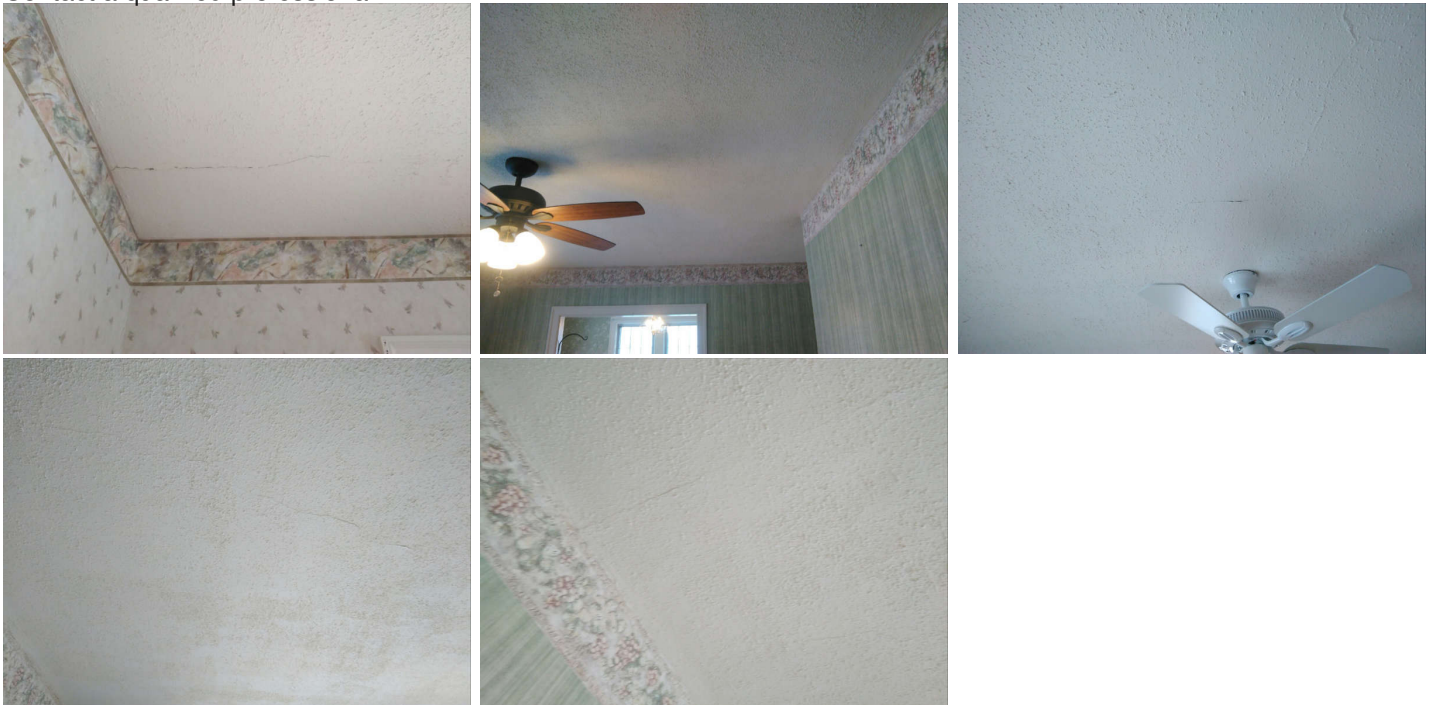
4.4.1 Ceiling Structure

SIGNIFICANT CRACKING

Many ceilings throughout the living space were significantly crack and some sagging was observed.

Recommendation
Contact a qualified professional.

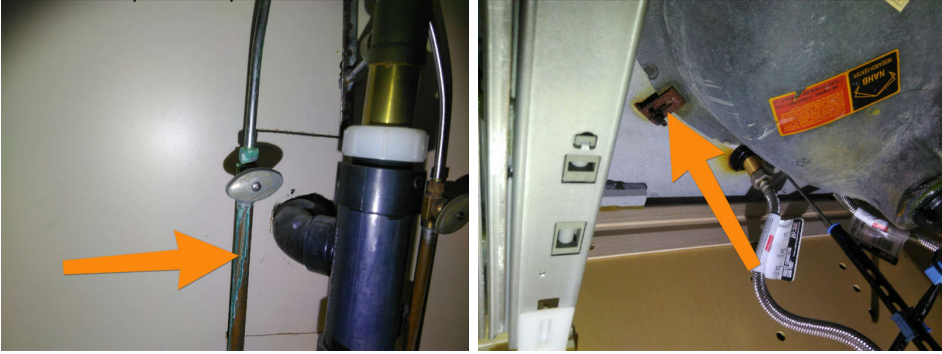
5.1.1 Fixtures / Faucets

CORROSION

Corrosion noted at under sink plumbing.

Recommendation
Contact a qualified professional.

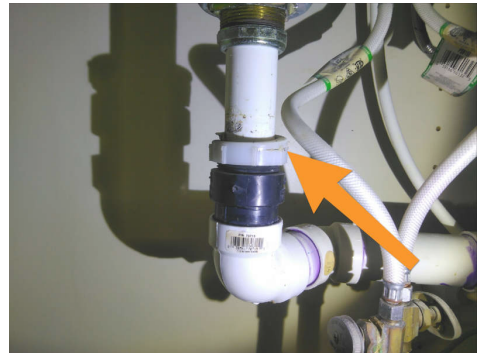
5.1.2 Fixtures / Faucets

CRACKED COMPRESSION NUT

Repair recommended to prevent a leak at the drain.

Recommendation
Contact a qualified professional.

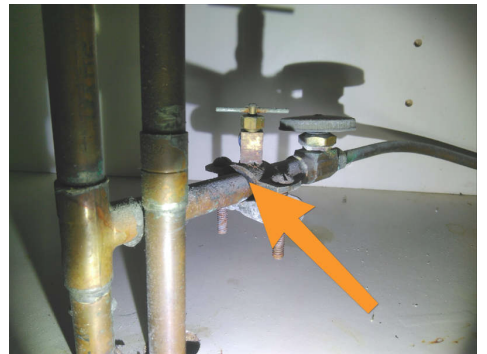
5.1.4 Fixtures / Faucets

SADDLE VALVE

The presence of a saddle valve was noted underneath the kitchen sink. These valves are notorious for leaking, recommend removal.

Recommendation
Contact a qualified professional.

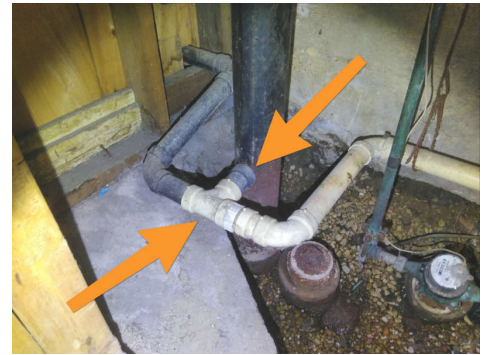
5.2.1 Drain, Waste, & Vent Systems

IMPROPER CONFIGURATION

The laundry drain system was not properly configured and should be evaluated by licensed plumber for correction.

Recommendation
Contact a qualified professional.

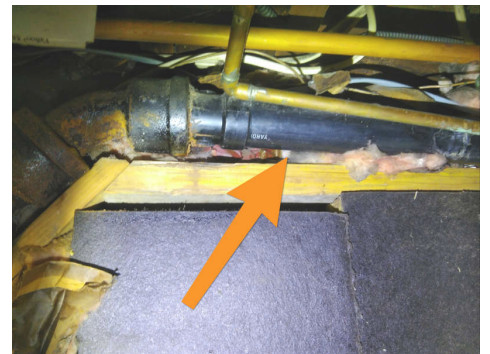
5.2.2 Drain, Waste, & Vent Systems

IMPROPER PITCH

Improper pitch noted that a section of ABS drain pipe. The pipe was negatively and may not flow correctly.

Recommendation
Contact a qualified professional.

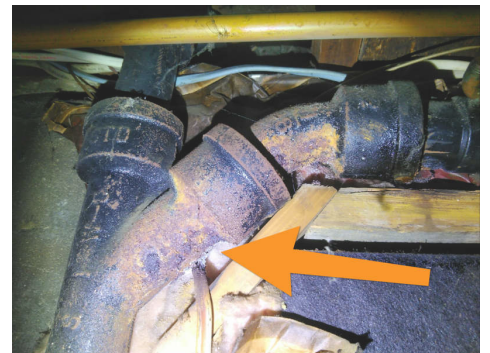
5.2.4 Drain, Waste, & Vent Systems

PITTING

Pitting was observed at the cast iron drain pipe. Pitting is an indication that the pipe has corroded from the inside out and should be replaced.

Recommendation
Contact a qualified professional.

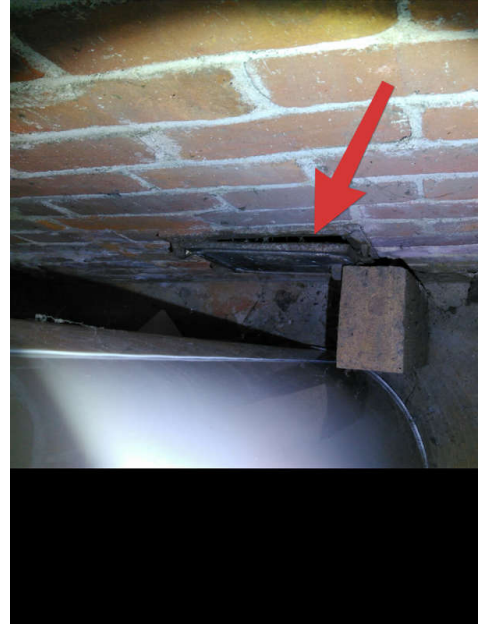
5.4.1 Vents, Flues, & Chimneys

IMPROPERLY SEALED CLEANOUTS

There should be no open gaps in a chimney structure.

Recommendation
Contact a qualified professional.

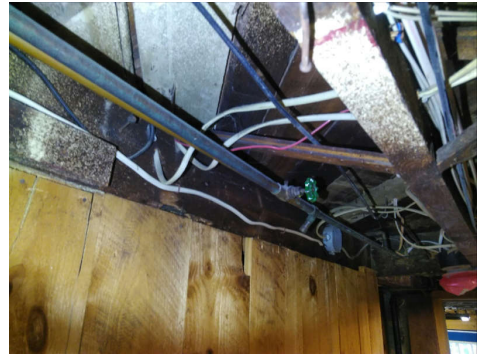
5.7.2 Miscellaneous

IMPROPER SUPPORTS

Sections of piping were not supported properly which can impose additional strain on the pipe and may cause premature failure.

Contact a qualified professional.

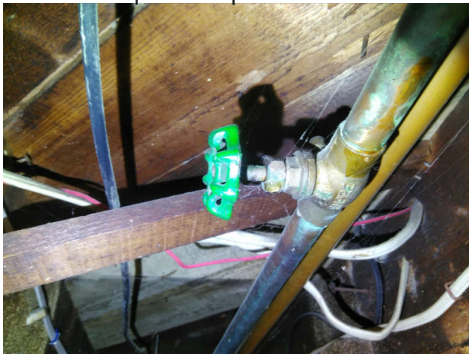
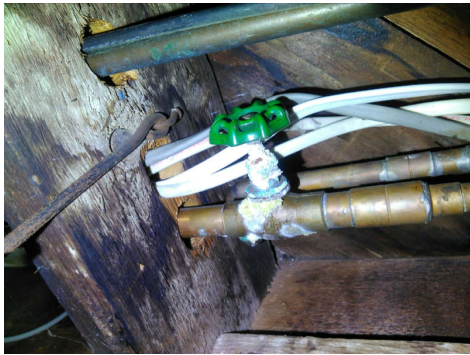
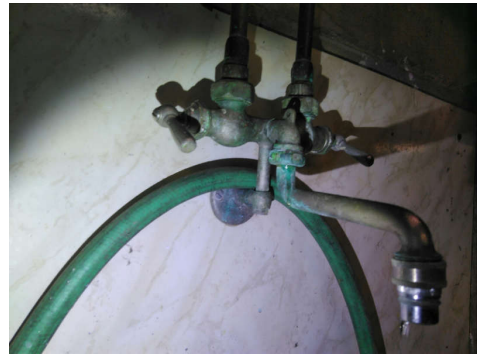
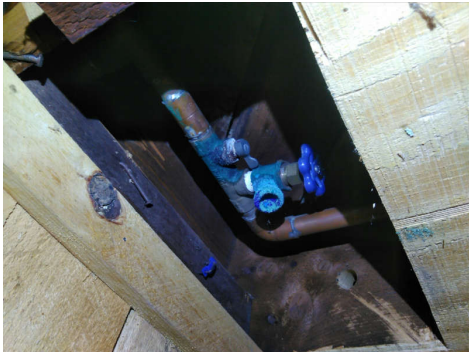
5.7.3 Miscellaneous
MINOR LEAKS

Several minor plumbing leaks and/or corrosion was observed, and should be repaired.

Recommendation
Contact a qualified professional.

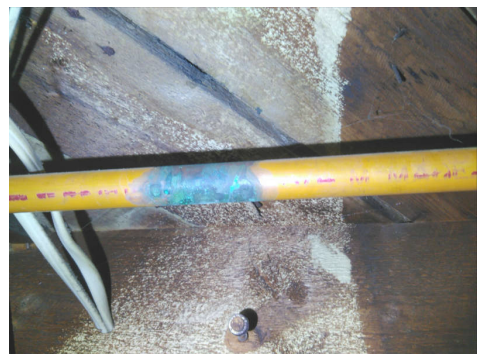
5.7.4 Miscellaneous
PINHOLE LEAK

A pinhole leak in a copper pipe was observed. Pinhole leaks should be repaired immediately to prevent a larger problem from occurring.

Recommendation
Contact a qualified professional.

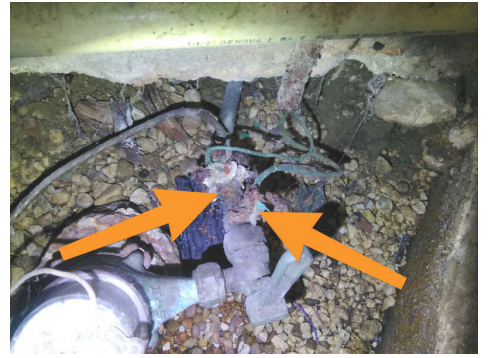
6.2.1 Service and Grounding Equipment, Main Overcurrent Device, Main and Distribution Panels

CORRODED GROUND

Grounding connections at the main water supply were corroded severely and should be replaced.

Recommendation
Contact a qualified professional.

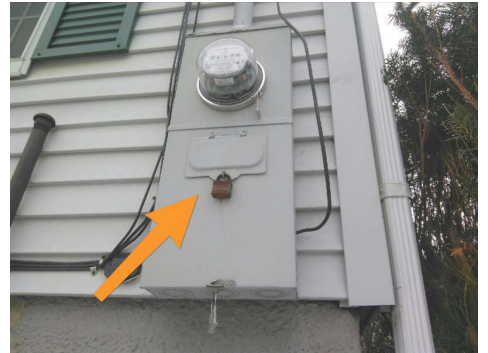
6.2.2 Service and Grounding Equipment, Main Overcurrent Device, Main and Distribution Panels

MAIN DISCONNECT

Main disconnect was not accessible due to a padlock.

Recommendation
Contact a qualified professional.

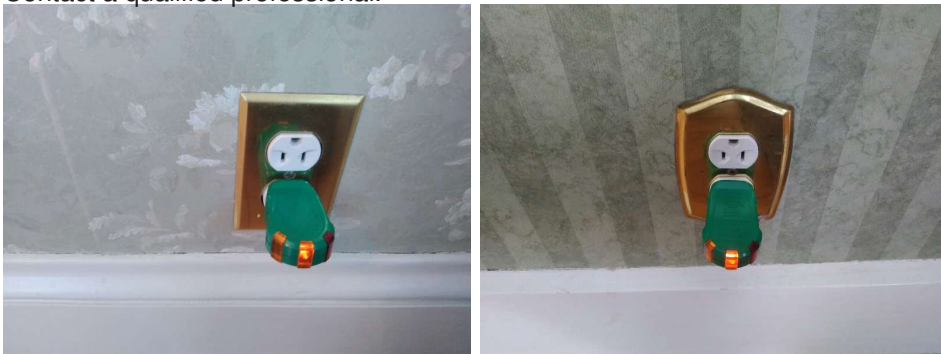
6.5.1 Polarity and Grounding of Receptacles

OUTLET(S) NOT GROUNDED

One or more three prong receptacle were not properly grounded and should be corrected. Further evaluation to determine scope of repair needed is recommended.

Recommendation
Contact a qualified professional.

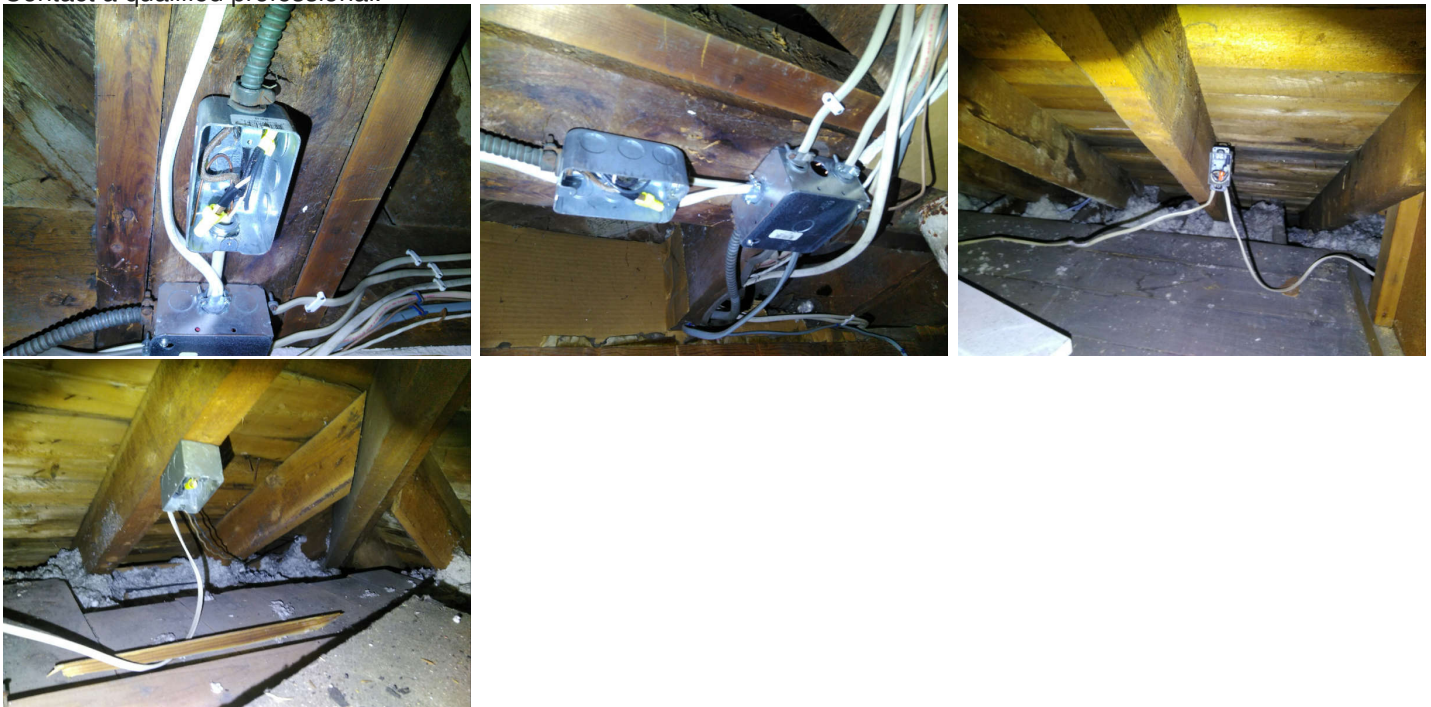
6.9.3 Miscellaneous

OPEN JUNCTION BOXES

Several open junction boxes were noted throughout the basement and attic. Junction boxes should be properly sealed.

Recommendation
Contact a qualified professional.

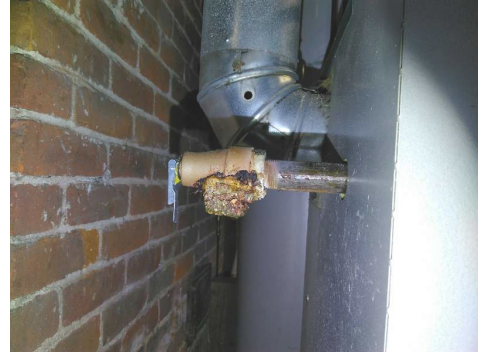
7.1.1 Heating Equipment

LEAK

The pressure temperature relief valve was leaking. The cause of the league should be investigated and repaired.

The relief valve was also not properly routed to the floor.

Recommendation
Contact a qualified professional.

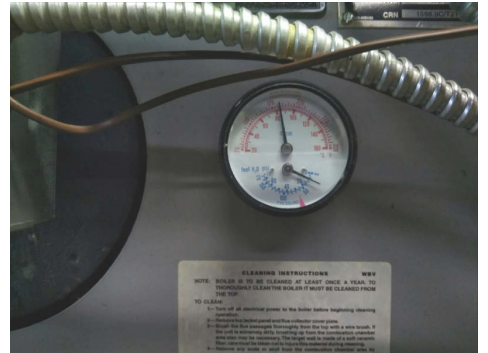
7.1.2 Heating Equipment
LOW WATER PRESSURE

According to the gauge on the front of the boiler if the water pressure was low and should be checked.

Recommendation
Contact a qualified professional.

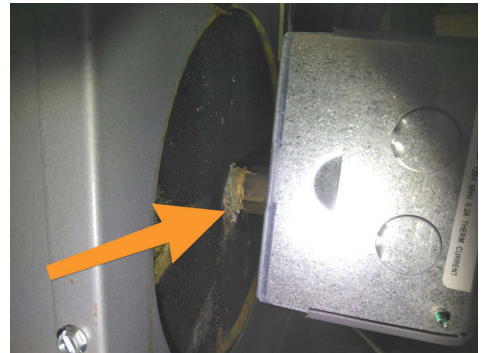
7.1.3 Heating Equipment
SEEPAGE

Evidence of historic leakage was noted and should be repaired.

Recommendation
Contact a qualified professional.

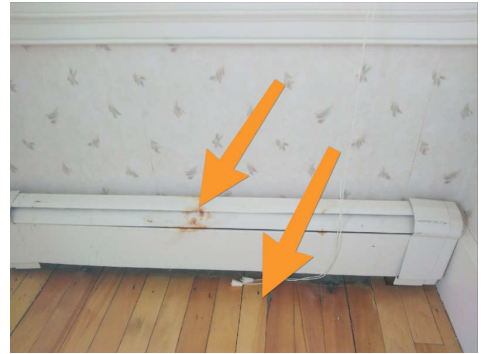
9.3.1 Floors

MINOR WATER DAMAGE

Apparent water damage noted at right rear bedroom at right side wall. Monitor for future water intrusion. The source was not readily apparent.

Recommendation
Contact a qualified professional.

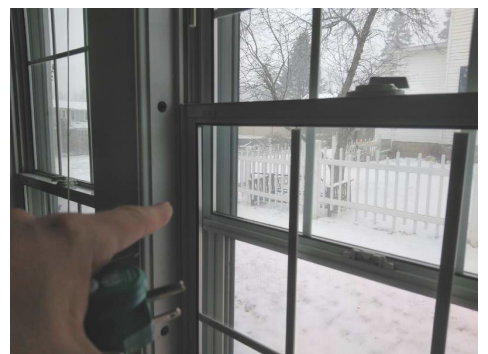
9.7.1 Windows

FAILED SEAL

Observed condensation between the window panes, which indicates a failed seal.

Recommendation
Contact a qualified professional.

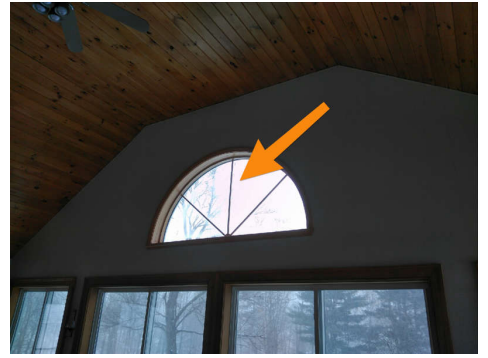
9.7.2 Windows

FAILED THERMAL SEAL

The large ornamental window at the rear of the home had an apparent failed thermal seal.

Recommendation
Contact a qualified professional.

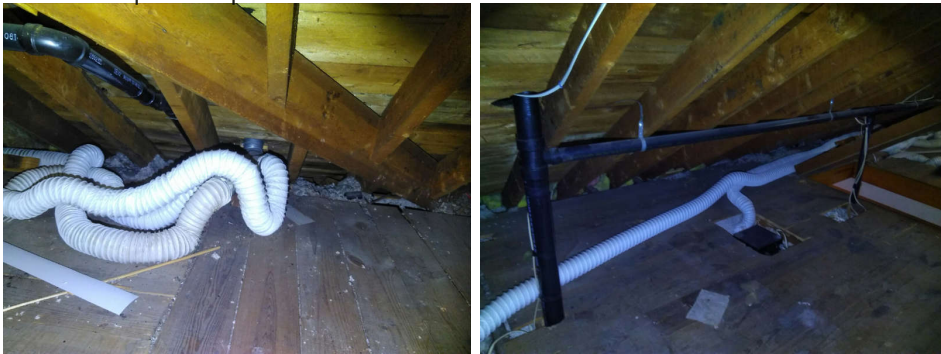
11.3.1 Exhaust Systems

POOR CONFIGURATION

The exhaust venting system had long runs of tubing that were uninsulated and may not work as efficiently as designed.

Recommendation
Contact a qualified professional.

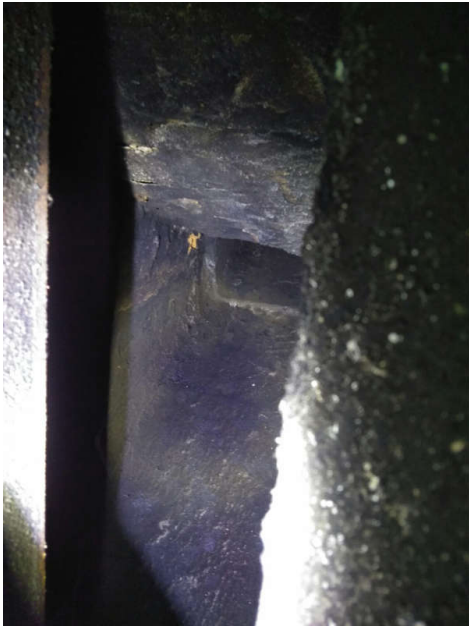
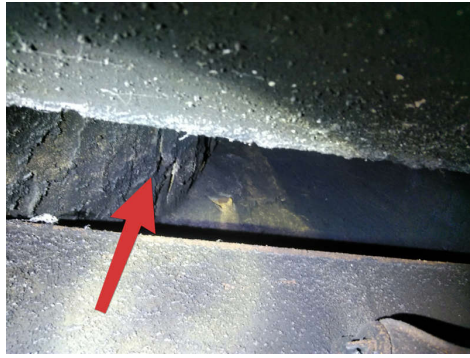
12.1.3 Fireplaces, Stoves & Inserts

LOOSE MASONRY

Loose masonry was noted in the smoke chamber and should be evaluated by a qualified mason. The fireplace should not be used until further evaluation has been performed.

Recommendation
Contact a qualified professional.

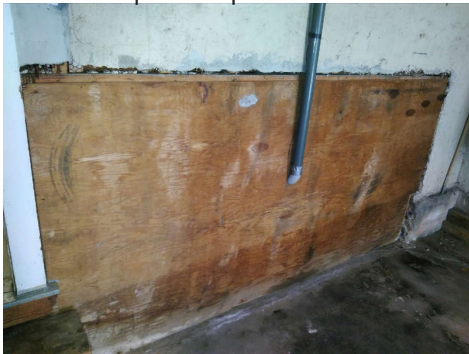
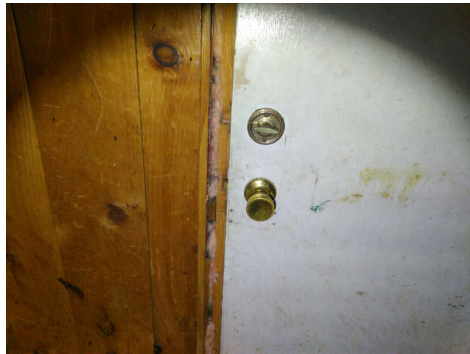
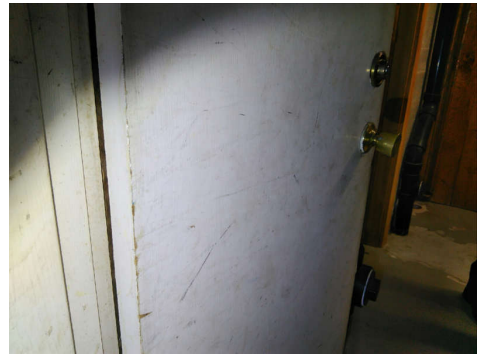
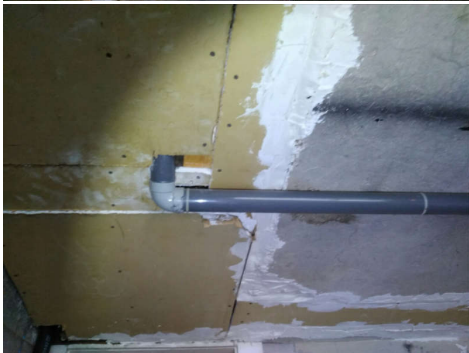
13.5.1 Fire safety
INADEQUATE

Open gaps, combustible materials, and an inadequate fire door we observed and should be corrected.

Recommendation
Contact a qualified professional.
