**SUMMARY**

1234 Main St. Marine on St. Croix MN
55047

Buyer Name
11/12/2018 9:00AM

Michael
ASHI Certified, WAHI Licensed,
InterNachi Certified
Weber Home Inspection Services
612-741-7420

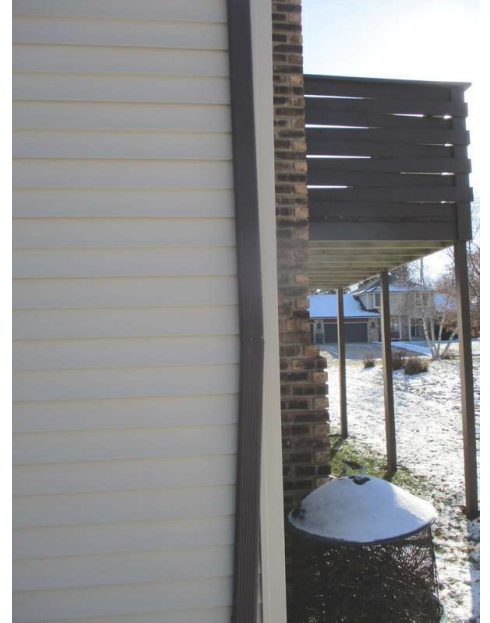
2.2.2 Roof Drainage Systems

LOOSE DOWNSPOUTS

Downspouts that are loose should be resecuring to the side of the house.

Contact a qualified professional.

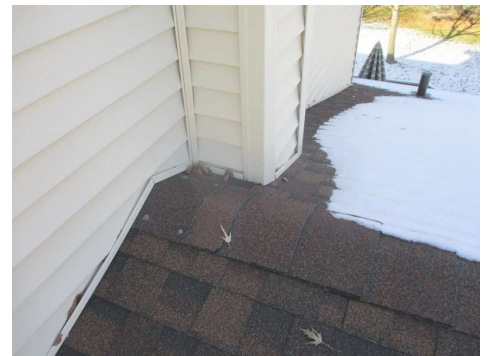
2.3.1 Flashings

LOCATION VULNERABLE

AT THE EAST SIDE

The location of flashings leaves them vulnerable to leakage. They should be carefully monitored.

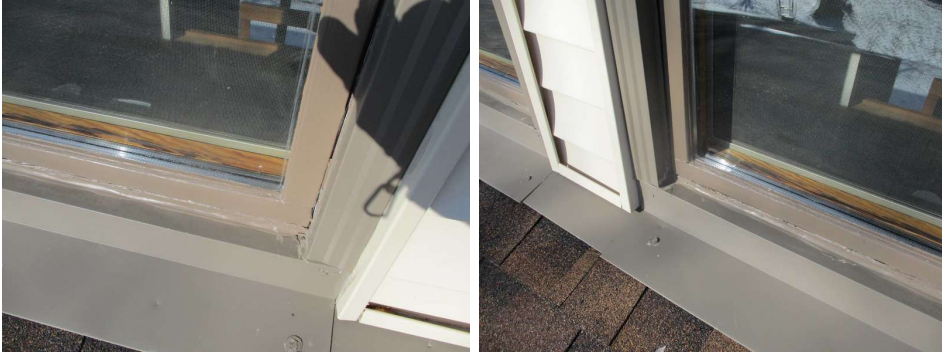
3.4.3 Windows

CLERESTORY WINDOWS

The clerestory windows are old and vulnerable. They have previously been caulked shut.

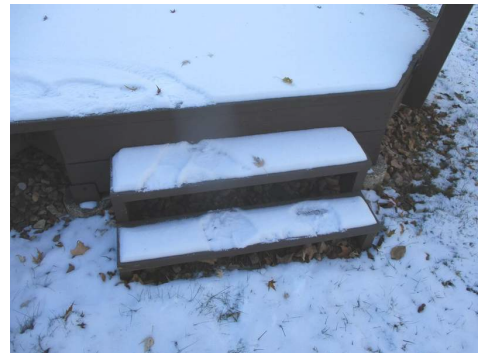
3.6.1 Decks, Balconies, Porches and steps

STAIRS

AT THE LOWER REAR DECK STAIRS

The size or orientation of stairs will make them difficult to navigate.

Contact a qualified professional.

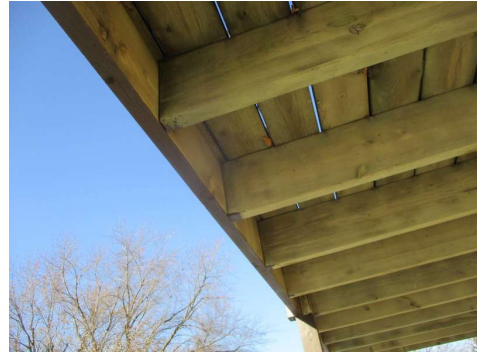
3.6.2 Decks, Balconies, Porches and steps

JOIST HANGERS

AT THE WEST ELEVATED DECK

Joist hanger(s) are missing or improperly installed. This could cause the deck structure to fail. Recommend that joist hangers be properly installed by qualified contractor.

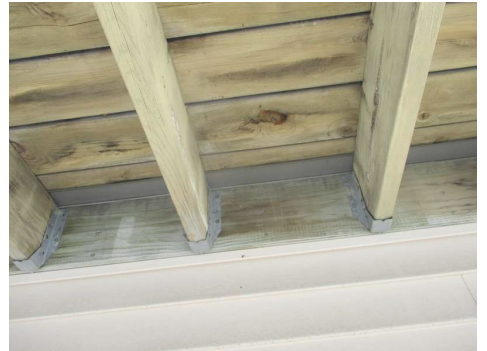
3.6.3 Decks, Balconies, Porches and steps

LEDGER BOARD IMPROPERLY INSTALLED

The ledger board is not properly attached to the building. This can cause the deck to pull away from the building and possibly collapse. Recommend that the deck and/or ledger board be properly attached by qualified contractor using through bolts or lag screws.

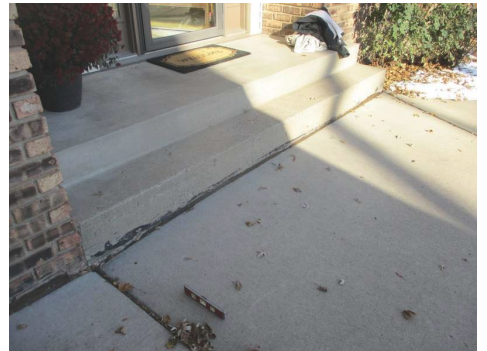
3.6.5 Decks, Balconies, Porches and steps

TRIP HAZARD

AT THE FRONT ENTRY

Heaving or settling of the concrete can create a trip hazard. Often, the step down at the stoop exceeds what is typical or normal for a step. This also creates a trip hazard. Improvements should be undertaken as necessary.

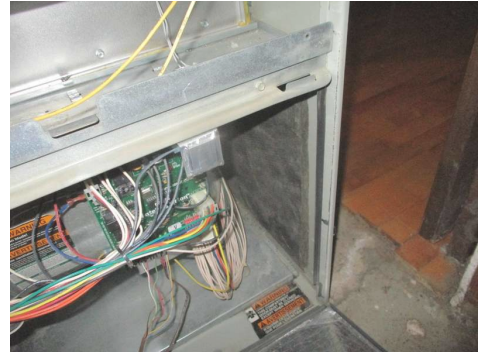
6.2.1 Furnace

DOOR INTERLOCK SWITCH

The safety interlock switch for the fan compartment ensures that the fan cannot run if the fan compartment is open. This switch has been bypassed. It should be restored.

Contact a qualified professional.

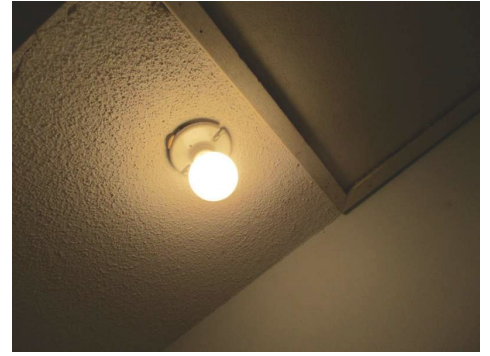
9.4.1 Lighting Fixtures, Switches & Receptacles

CLOSET LIGHTS

IN THE MASTER BEDROOM AND LAUNDRY

Exposed light bulb fixtures in closets or storage spaces can be a fire hazard. Covered fixtures should be used.

Contact a qualified professional.

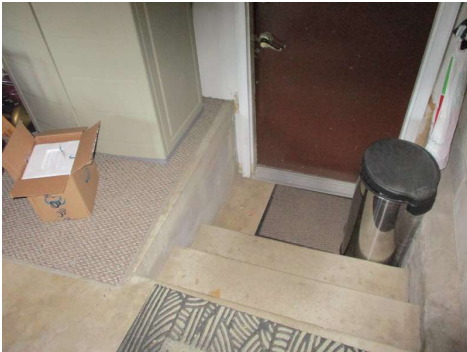
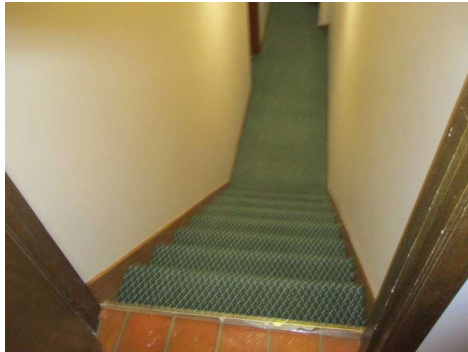
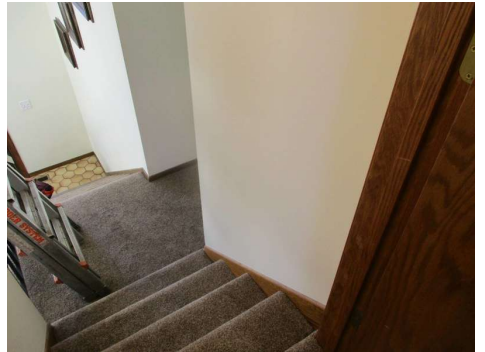
12.7.2 Steps, Stairways & Railings

NO HANDRAIL

AT THE GARAGE, THE LOFT AND AT THE BASEMENT

Staircase had no handrails. This is a safety hazard. Recommend a qualified handyman install a handrail.

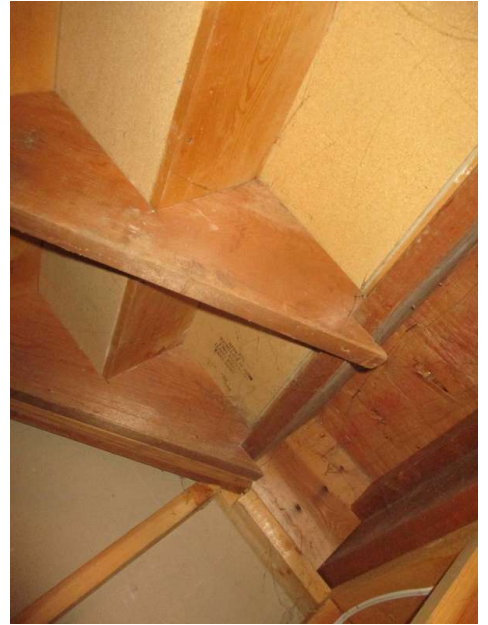
12.7.5 Steps, Stairways & Railings

STAIR ATTACHMENT

IN THE BASEMENT MECHANICAL ROOM

For safety and stability, stairs stringers should be attached via metal straps or hangers.

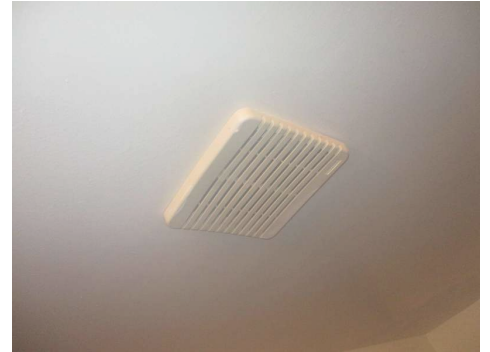
12.9.9 Bathrooms

BATHROOM FAN INADEQUATE IN THE HOT TUB ROOM

Exhaust fans with inadequate flow should be repaired or replaced.

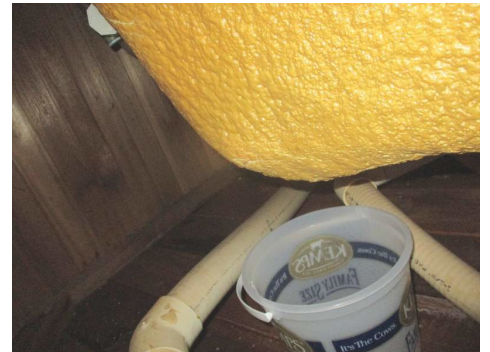
12.9.10 Bathrooms

WHIRLPOOL TUB LEAK

Leaks in the whirlpool tub should be repaired as required.

Recommendation
Contact a qualified professional.

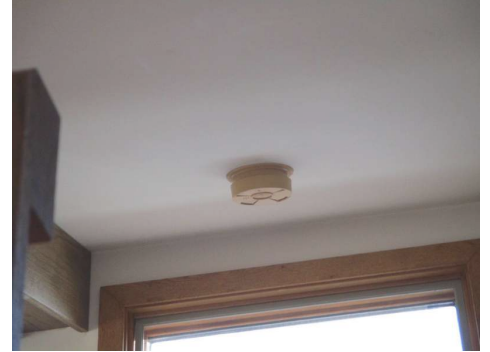
12.10.1 Smoke Detectors

OLD SMOKE DETECTORS

AT THE TOP OF THE LOFT

Old smoke detectors lose their effectiveness and should be replaced.
