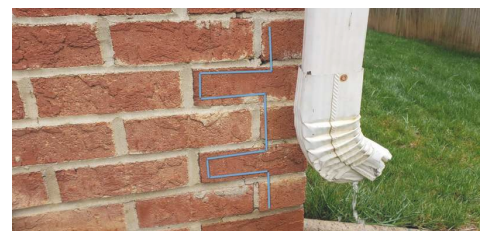
FRONT RIGHT OF HOME

BRICK STEP CRACKS

There are stair-step cracks in the brick veneer. This may indicate differential settlement of the home, differential brick expansion or be in response to steel lenth expansion or sag. Brick veneer is a protective exterior siding (weather barrier) and does not provide structural support to the home. Repair is recommended to prevent further cracking and allow water penetration behind the brick leading to potential damage of the exterior wall assembly. Please consult a general contractor for further evaluation and direction for repair as necessary.

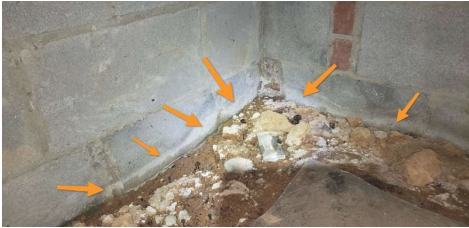
CRAWLSPACE MULTIPLE LOCATIONS

EFFLORESCENCE

Efflorescence (salt stains) was noted on the foundation wall. The stains indicate that the foundation has been cyclically wet and dry. While efflorescence is a common cosmetic issue that does not pose a problem itself, it can be an indication of moisture intrusion possibly due to an absent or damaged waterproofing and/or foundation drain system. Please consult a water proofing contractor for further evaluation and direction for repairs as necessary.

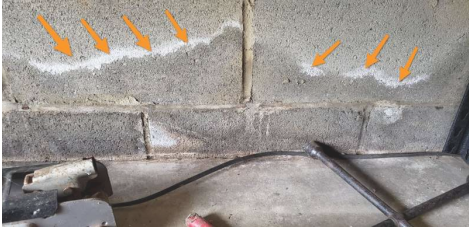
GARAGE LEFT WALL

EFFLORESCENCE (GARAGE)

Efflorescence (salt stains) was noted on the foundation wall in the garage. The stains indicate that the foundation has been cyclically wet and dry. Garage slabs typically have more shallow depth foundations and are more subject to movements in the soil, based upon seasonal changes in temperature, humidity and ground water conditions. Efflorescence is a common cosmetic issue and should not pose a problem unless the capillary (water wicking) actions comes into contact with the framing. The current visible evidence suggests that it does not come into contact with the framing. Please monitor this condition over time and if the efflorescence starts to contact wood framing, please consult a waterproofing contractor for further evaluation.

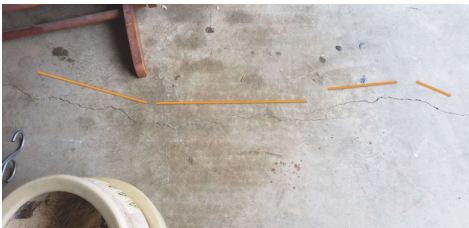
GARAGE FLOOR

MINOR CRACKING, GARAGE

When concrete cures (dries and hardens) it shrinks and wants to crack, which is a reason why control joints are used (i.e. provide a weak spot where the concrete can crack without affecting aesthetics, strength, or safety). Cracks may form with or without control joints. Garage slabs typically have more shallow depth foundations and are more subject to movements in the soil, based upon seasonal changes in temperature, humidity and ground water conditions. These cracks should be sealed to prevent potential water penetration into the slab, which can lead to further cracking. Please monitor these cracks over time and if they become larger than 1/8 inch in width, vertical/horizontal displacement is evident on either sides of the crack further evaluation by a general or concrete contractor is recommended.

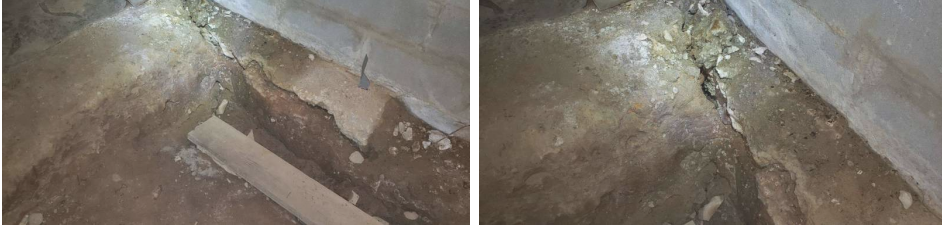
CRAWLSPACE BACK WALL

SOIL EROSION

There is moderate soil erosion in the back of the crawlspace along the footing that is a result of excessive water intrusion at some point in time. Recommend a qualified contractor evaluate and repair as needed.

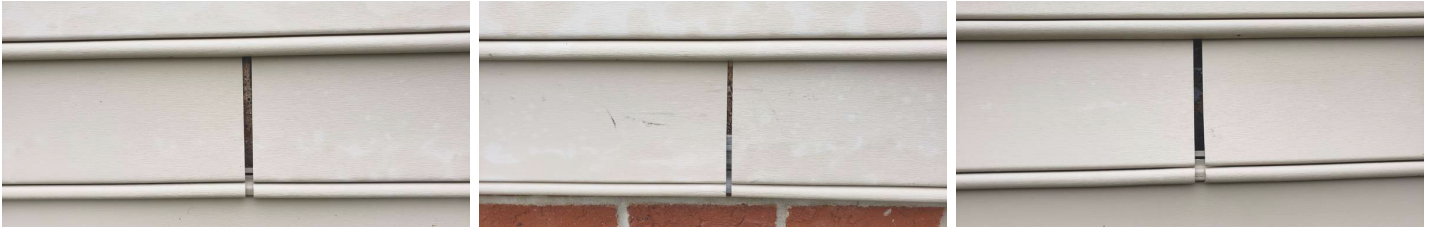
RIGHT SIDE OF HOME

SIDING - GAP VINYL

There are gaps in the siding planks, which can allow water penetration behind the siding causing damage to the exterior wall assembly and possibly entering the interior of the home. Please consult a siding or general contractor for further evaluation and repair.

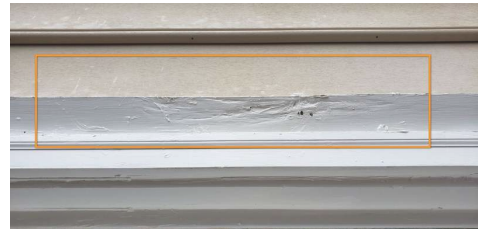
ABOVE BACK DOOR

TRIM ROTTED

The trim above the back door is soft to the touch and decayed/damaged, which can allow additional water penetration behind the siding causing damage to the exterior structure or interior of the home. Recommend a qualified contractor repair or replacement as needed.

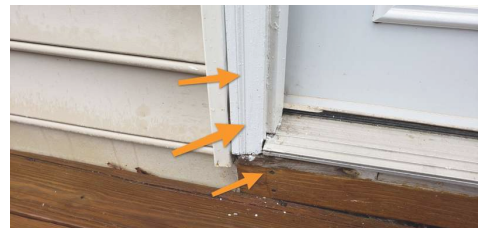
BACK DOOR

TRIM LOOSE

The trim on the left side of the back door is loose, which can allow water penetration behind the siding causing damage to the exterior structure or interior of the home. Recommend a qualified contractor repair or replacement as needed.

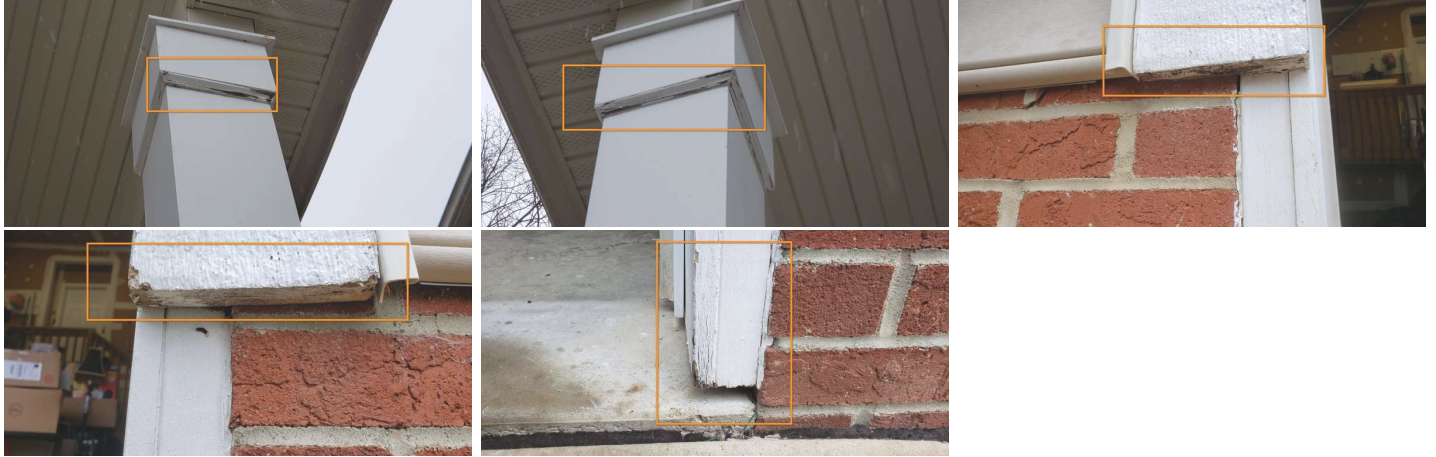
FRONT PORCH AND GARAGE DOOR

TRIM DAMAGE

The wood trim above the front porch and around the garage overhead door appears to show visible signs of mild decay/rot. If unrepaired, this can allow water penetration behind the trim causing damage to the structure behind it. Recommend consulting a general contractor for repair or replacement of the damaged materials.

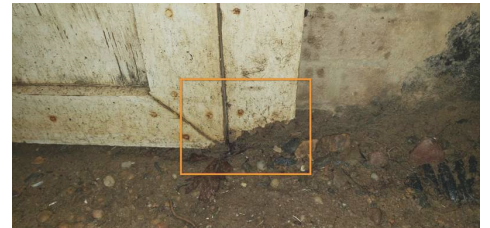
BACK RIGHT OF HOME

CRAWSPACE DOOR DAMAGE

The crawl space door has minor damage, which currently does not prevent it from functioning as intended. Please monitor the condition of the door over the life of the home and consult a general contractor for repair when necessary.

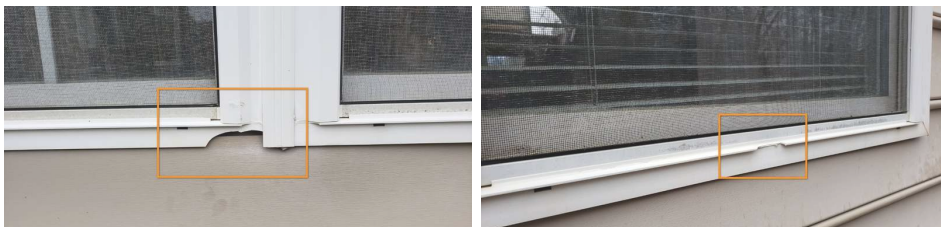
FRONT LEFT, BACK LEFT

WINDOW - VINYL - DAMAGED

The vinyl window casing has some minor damage, which may allow water penetration behind the siding. Please consult a general contractor for repair to prevent potential water penetration.

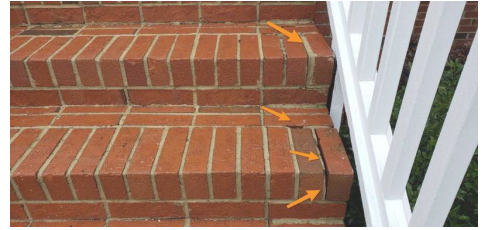
FRONT STEPS

BRICK STEPS REPOINT

The bricks on the steps are missing mortar between the bricks, which can allow the bricks to become loose over time and allow water penetration into the steps. Please have any missing mortar repointed by a general contractor.

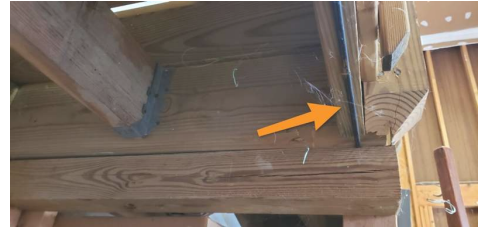
GARAGE ENTRY DECK

DECK - JOIST HANGER

A joist on the garage deck is missing a joist hanger. This could cause the deck structure to fail. Recommend that joist hanger be properly repaired by qualified contractor.

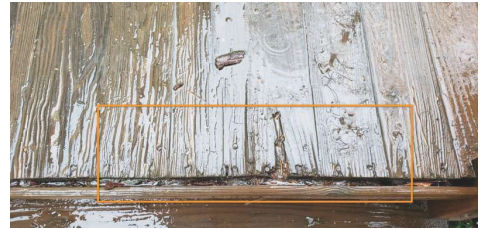
BACK DECK

DECK - DAMAGED

Some of the deck flooring boards are damaged/decayed, which means they are not offering the appropriate support. Please have any damaged flooring boards replaced. Please consult a general contractor for further evaluation and repair.

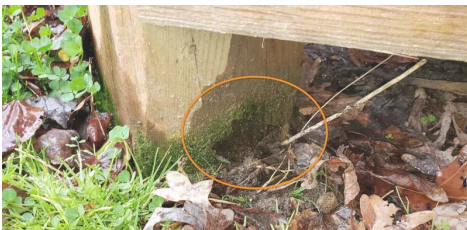
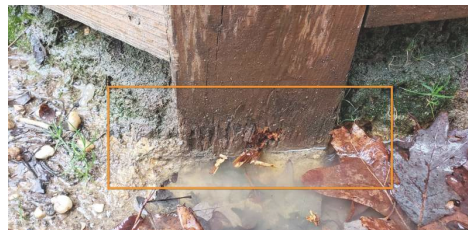
RIGHT BACK

DECK SUPPORT DECAY

The deck support posts are deteriorated where they contact the ground and can be easily probed through the post. The affected posts may no longer bear the appropriate weight from the remainder of the deck, which is a safety concern. Please consult a general contractor for further evaluation and repair or replacement of the damaged support posts.

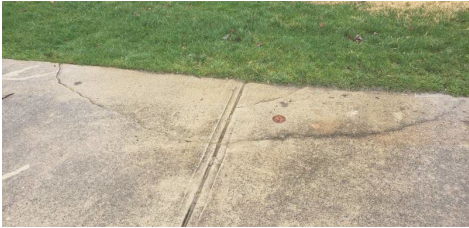
RIGHT SIDE OF DRIVEWAY

DRIVEWAY CRACKING - MINOR

The concrete has minor cracking, which is a common occurrence and does not affect the functionality of the concrete. This cracking may fluctuate based upon seasonal variations in temperature and humidity. The cracks should be repaired using concrete patching or sealant.

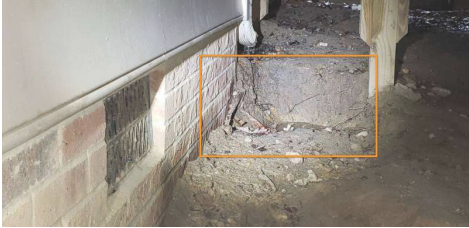
EROSION

There is major erosion under the deck due to the gutter draining directly below the deck. Erosion can lead to structural defects if enough soil is displaced. Please consider installing gutter extensions and/or yard drainage systems to prevent excessive erosion.

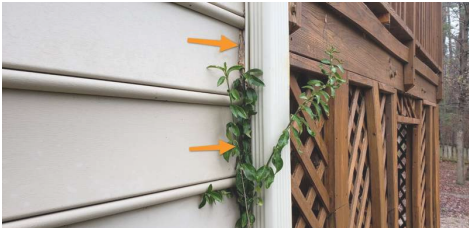
RIGHT BACK CORNER OF HOME

VEGETATION ON SIDING

Vegetation was noted growing into and/or against the vinyl siding. Vegetation can separate the siding from the home and possibly allow moisture intrusion behind the siding. Recommend removal and monitoring.

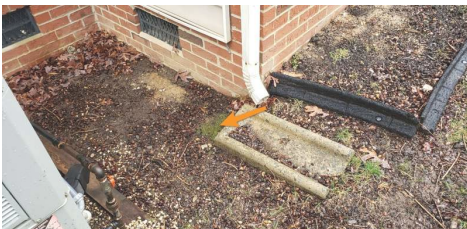
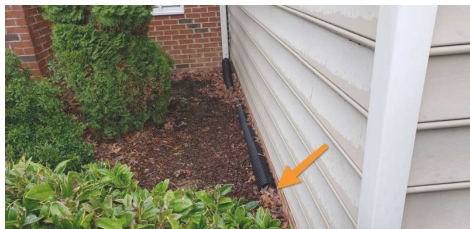
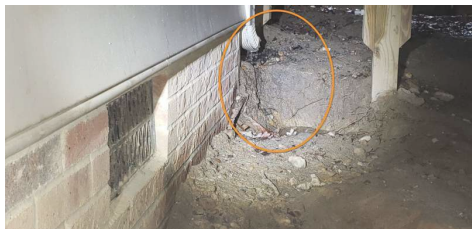
LEFT SIDE OF HOME, FRONT OF HOME, UNDER BACK DECK

DOWNSPOUTS DRAIN NEAR FOUNDATION

One or more downspouts drain too close to the foundation which may cause water to enter into the home. Recommend a general contractor add/adjust downspout extensions to drain at least 6 feet from the foundation.

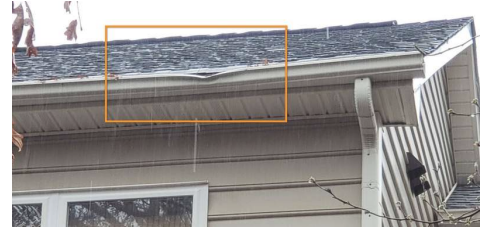
BACK LEFT CORNER OF HOME

GUTTER DAMAGED

The gutter is damaged, which may allow water to spill over the front of the gutter, which prevents the intended drainage of rain water. Please consult a general contractor for repair.

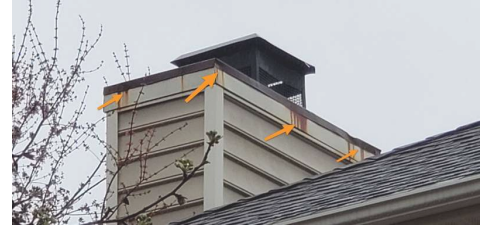
CHIMNEY CROWN RUST

The chimney crown top plate shows visible moderate/substantial rusting, which can lead to leaking at the chimney. Please consult a general contractor for repair/replacement of the top plate.

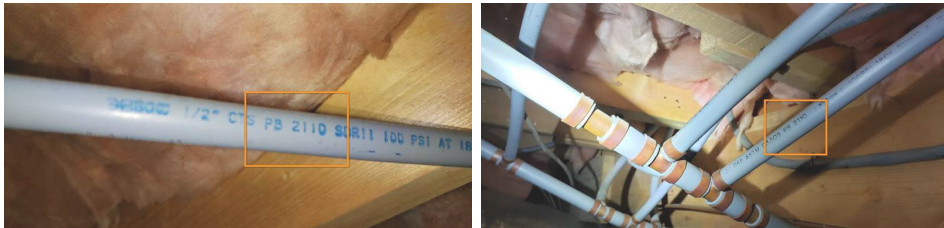
PB

The following is recommended language provided by the NCHILB: Polybutylene plumbing supply lines (PB) are installed in this house. PB was used as water distribution piping in many homes built from the mid 1980s until the mid 1990s. The piping and associated fittings have had a failure rate and subsequent leakage sufficient to have been the subject of several nationwide class action lawsuits. Copper and brass fittings used in later years seem to have reduced the failure rate, but the piping may still fail due to problems with poor installation, improper handling, or chemical reaction with the water supply. The piping in this house has copper fittings. You may wish to have the plumbing system evaluated by a licensed plumbing contractor.

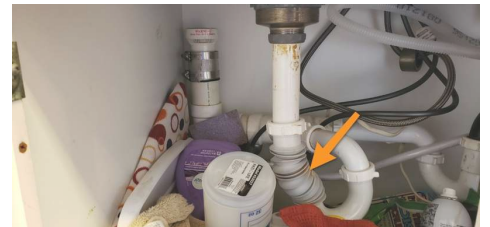
KITCHEN SINK

ACCORDIAN PIPE

The sink drain uses an accordion style drain pipe, which is not approved for drain or waste applications since it can harbor debris and bacterial growth. The drain pipe should be replaced with a smooth wall PVC type material. Please consult a plumbing contractor for repair.

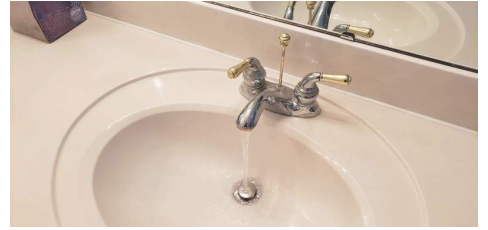
MASTER BATHROOM RIGHT

**FIXTURE STOPPER
INOPERABLE**

When the faucet lift arm is raised the stopper for the sink will not close. Please have the stopper assembly and lift arm repaired so that the stopper can be raised and properly seal the sink as intended.

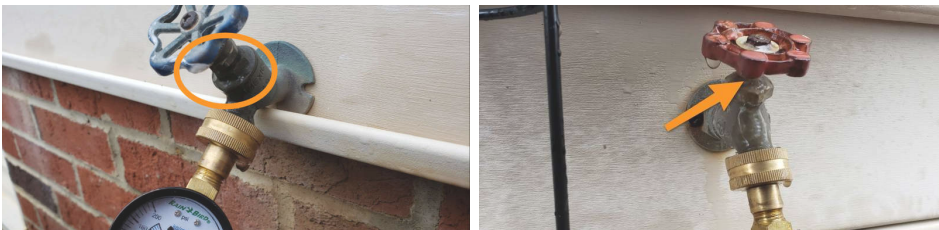
FRONT LEFT ,BACK LEFT

HOSE BIBB LEAKING

Multiple hose bibb valves were noted as leaking when turned on. Recommend a qualified contractor repair or replace as necessary.

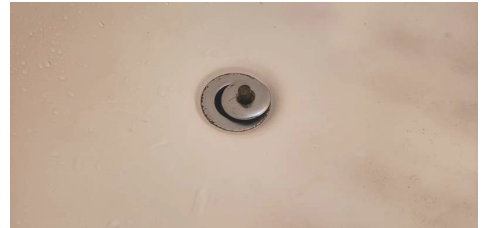
2ND FLOOR HALL BATHROOM

TUP STOP BROKEN

The tub stop in the 2nd floor hallway bathroom was damaged/ not connected. Recommend qualified contractor repair or replace and ensure it is functioning properly.

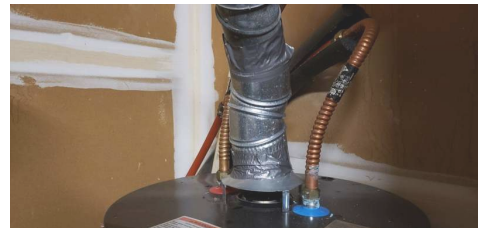
GARAGE

DRAFT HOOD LOOSE

The draft hood for the hot water heater is loose and appears to be secured with duct tape, which can prevent the proper flow of combustion gases and carbon monoxide from entering the vent and exiting the home. This can potentially allow higher levels of carbon monoxide in the home, which is a safety concern. Please consult a plumbing contractor for repair.

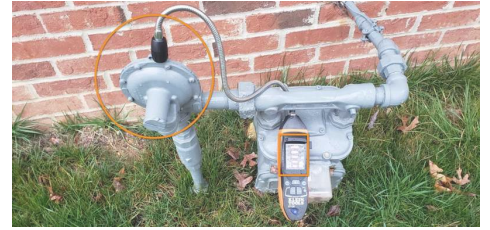
RIGHT SIDE OF HOME

GAS ODOR - SEVERE

A gas leak was noted at the regulator of the gas meter on the right side of the home. Recommend consulting with your local utility company or qualified gas company to repair and evaluate for potential leaks.

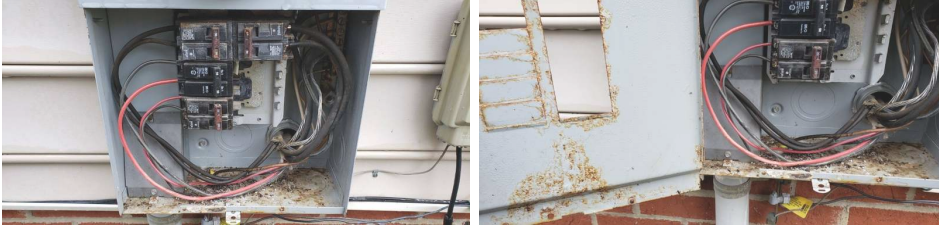
LEFT SIDE OF HOME

MOISTURE IN ELECTRICAL PANEL

The interior of the electrical panel has dust/debris and rust build up on some of the circuit breaker components. This dust/debris and indications of water penetration (from the rust/moisture) can act as a conductor, which can lead to electric shock, arc flash accidents and potentially cause a fire. Please consult an electrical contractor to clean the interior of the panel and repair/replace components as necessary to prevent these conditions.

Major Concern / Safety Hazard

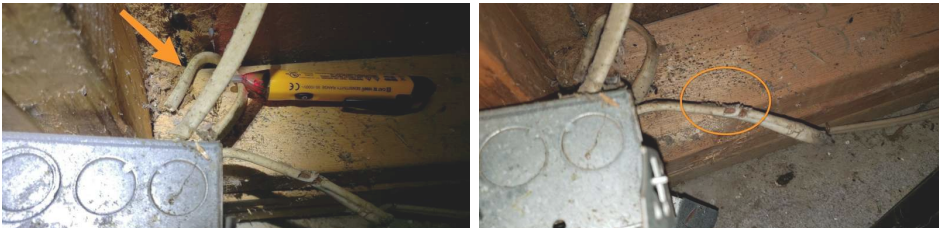
GARAGE RIGHT SIDE

DAMAGED SHEATHING/ EXPOSED ELECTRICAL

There are loose, uncapped, live electrical wires as well as wire with damaged sheathing, which is a safety hazard. Please consult an electrical contractor to properly terminate the wiring in an approved junction box and repair any damaged wire.

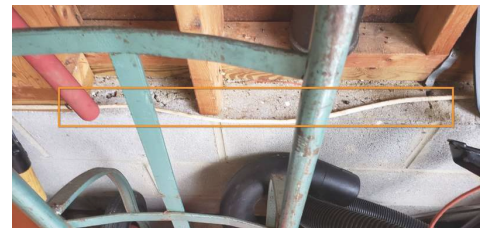
GARAGE RIGHT

SURFACE MOUNTED WIRING

The electrical wires are not properly secured at the appropriate intervals to the framing or are surface mounted, which can lead to damage of the wiring. Please consult an electrical contractor to review the current configuration and make repairs as necessary.

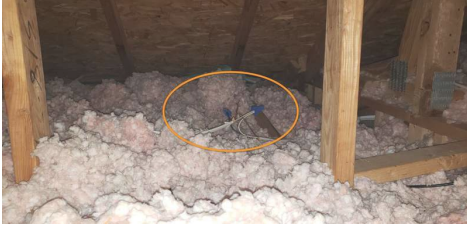
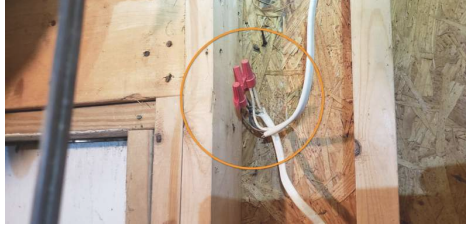
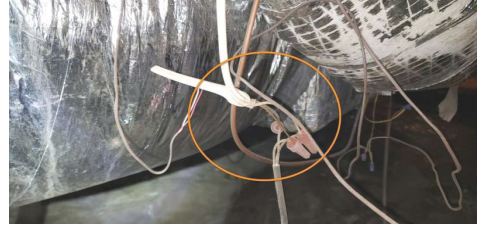
ATTIC REAR OF HOME , BASEMENT BACK DOOR, BASEMENT LEFT SIDE

EXPOSED CONNECTION

There is an electrical wire connection made outside of a junction box, which is a shock hazard and safety concern. Please consult an electrical contractor for repair.

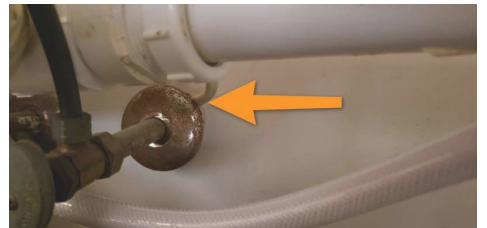
UNDER KITCHEN SINK

IMPROPER WIRING - GARBAGE DISPOSAL

Electrical feeder for garbage disposal is not properly secured and is run behind a plumbing flange. This could lead to problems including electrical shorts if something would snag the cable. Recommend qualified contractor repair/secure as needed.

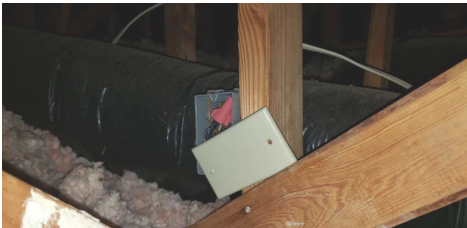
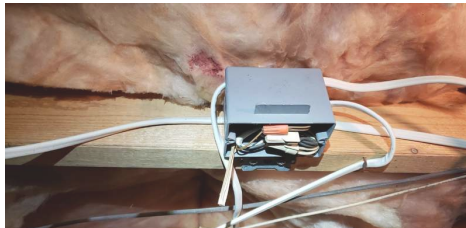
ATTIC BY ENTRANCE, CRAWLSPACE BACK MIDDLE

COVER PLATES MISSING/LOOSE

Electrical box cover plates are not secured or are missing, which is a potential shock hazard and safety concern. Please have the missing/loose face plate replaced/repaired.

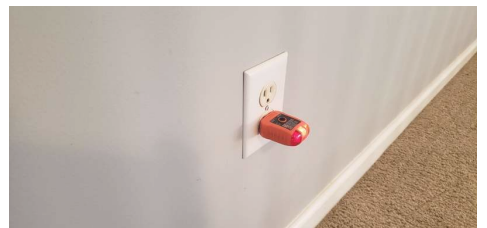
2ND FLOOR LOFT HALL

RECEPTACLES - LOOSE INTERIOR

The receptacle box is loose, which can cause damage to the wiring and is a safety concern. Please consult a general contractor for repair.

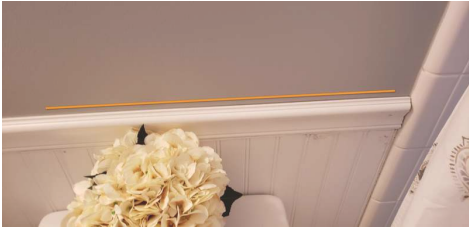
2ND FLOOR HALLWAY BATHROOM

TRIM LOOSE

The trim in the 2nd floor hallway bathroom behind the toilet is loose. Recommend repair by a qualified contractor.

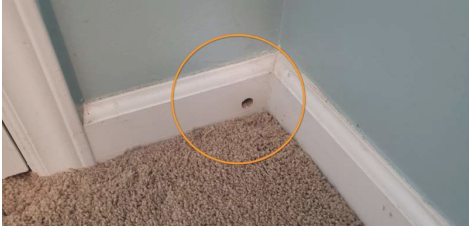
2ND FLOOR FRONT RIGHT BEDROOM

HOLE IN TRIM

There is a hole in the baseboard in the 2nd floor right bedroom. Recommend repair by a qualified contractor.

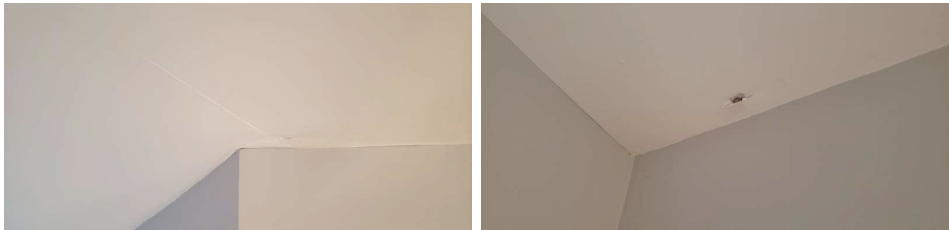
2ND FLOOR LOFT ABOVE CLOSET 2ND FLOOR HALLWAY NEAR BEDROOMS

CEILING (MINOR DAMAGE/SPECIFIC)

Minor damage or deterioration to the ceiling was visible in the 2nd floor loft and 2nd floor hallway at the time of the inspection. Recommend repair by a qualified contractor.

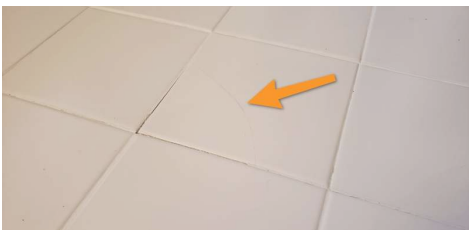
TILES (CRACKED)

The master bathroom had a cracked floor tile visible at the time of the inspection. Recommend repair by a qualified contractor to reduce further damage and possible moisture intrusion in the floor.

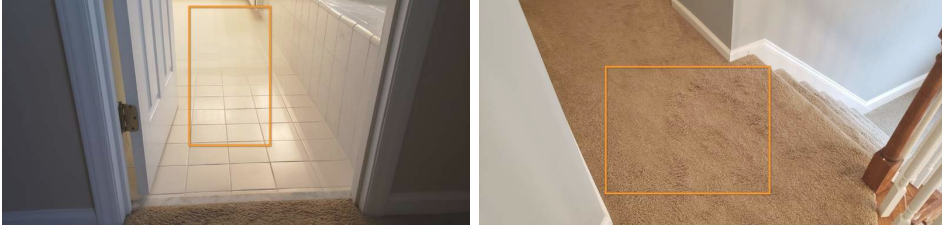
MASTER BATHROOM, TOP OF STAIRS

CREAKING

The floor makes a creaking and popping sound when being walked on. This is not usually a structural concern and may be due too loose subfloor materials or subfloor attachment to the floor joists. Please consult a general contractor for further evaluation to determine the cause for the concern and repair as necessary.

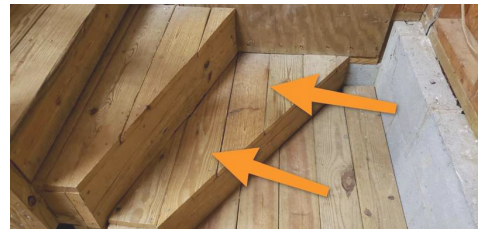
GARAGE

STAIR STEP LOOSE

One of the steps in the garage stairwell is loose and could pose a trip hazard. Recommend a qualified contractor repair as needed to secure.

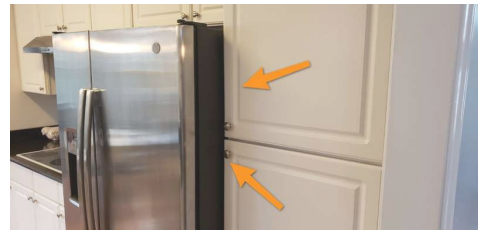
KITCHEN

**CABINET DOOR(S)
WON'T CLOSE**

Cabinet doors are not closing all the way on 1 or more of the cabinets. This may be due to poor hinges or normal usage wear and tear. Recommend qualified contractor repair as needed.

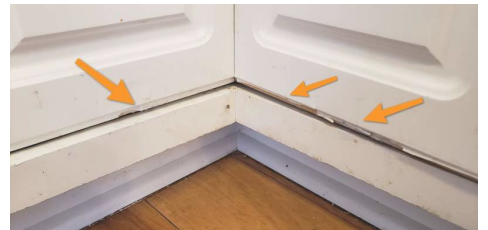
KITCHEN ROTATING HUTCH

**CABINETS (MINOR
DAMAGE)**

The rotating corner cabinet in the kitchen has minor damage along the bottom of the door. Recommend repair by a qualified contractor as necessary.

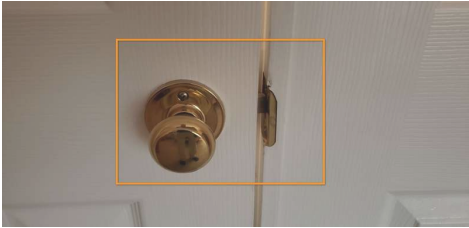
MASTER BEDROOM

DOOR DOESN'T LATCH

The double doors leading into the master bedroom would not close and latch as intended (i.e. the latch mechanism is not aligned with the strike plate on the door frame). Please consult a general contractor to adjust the alignment of the strike plate.

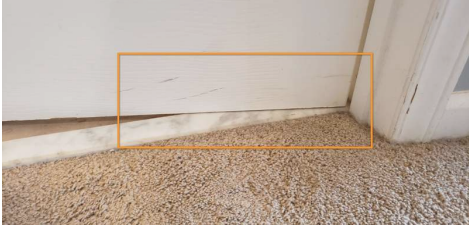
2ND FLOOR HALLWAY BATHROOM

INTERIOR DOOR (RUBBING ON THRESHOLD)

The 2nd floor bathroom door rubs on the threshold during operation, which can damage the flooring and/or the door. Please consult a general contractor for repair.

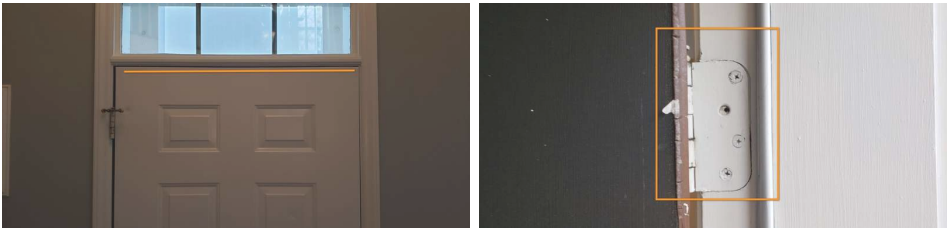
FRONT DOOR

INTERIOR DOOR (OUT OF SQUARE)

The front door is visibly out of square/ not aligned properly possibly due to the top hinge not being properly secured to the frame. Recommend a qualified contractor repair as necessary to prevent future damage to the door or frame.

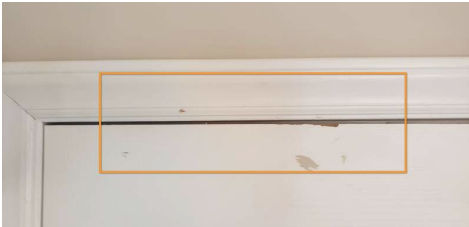
2ND FLOOR FRONT LEFT BEDROOM

SURFACES (LIGHT DAMAGE/SPECIFIC)

There is minor damage to the closet door in the 2nd floor left bedroom. Please consult a general contractor for repair.

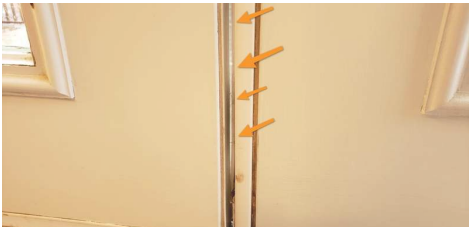
DOOR NOT SEALING

The exterior door in the family room is not sealing completely at the bottom when closed as daylight can be seen through the crack. Recommend a qualified contractor repair as needed to reduce possible moisture intrusion and conditioned air leakage.

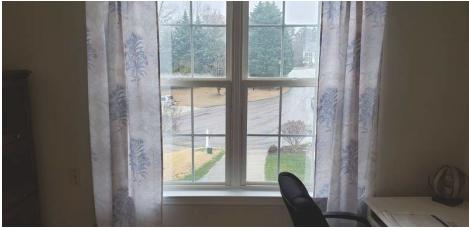
2ND FLOOR FRONT LEFT BEDROOM

DIFFICULT TO OPEN/CLOSE

Windows were difficult to open/close during inspection which may cause damage to the window during opening if not repaired. Recommend a qualified contractor repair the window so that it may easily open.

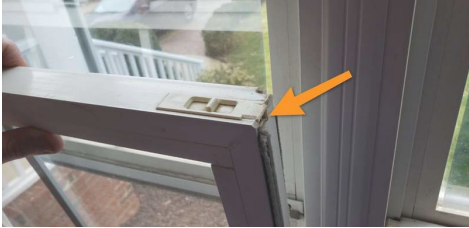
LIVING ROOM MIDDLE FRONT

HARDWARE DAMAGED

Multiple windows had hardware was damaged and the window would not "click" or lock in. Please consult a window or general contractor for further evaluation and repair.

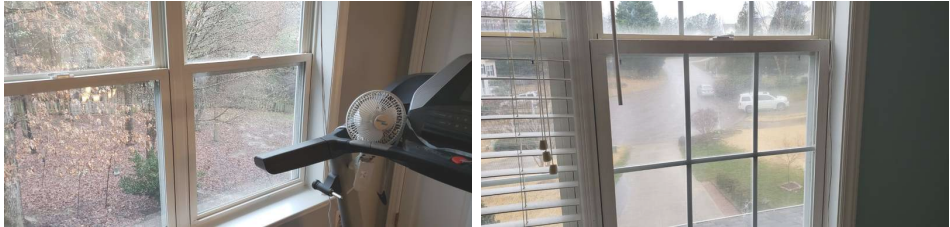
2ND FLOOR LOFT RIGHT WINDOW, 2ND FLOOR FRONT RIGHT BEDROOM

WINDOW DOES NOT STAY OPEN

The window will not stay open when raised, which can cause damage when the window falls back down. Please consult a window or general contractor for further evaluation and repair.

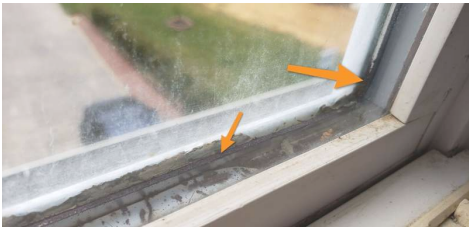
2ND FLOOR FRONT RIGHT BEDROOM

WINDOWS SEAL

The window has visible condensation, fogging and/or rust between the panes of glass, which indicates a broken seal. A broken seal can reduce the insulation capabilities of the window and in severe cases lead to leaking. Also, please note that other windows in the home may also have broken seals, but were not readily visible at the time of the inspection. Please consult a window specialist or general contractor for review of the windows and repair or replace any windows with broken seals.

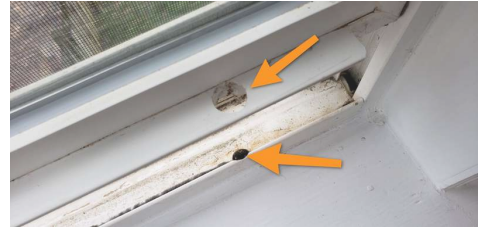
FAMILY ROOM LEFT OF FIREPLACE

**WINDOW FRAME
DAMAGED**

The window frame and sash of the window to the left of the fireplace have holes drilled in them which could allow moisture intrusion into the wall below the window. Recommend a qualified contractor repair as needed.

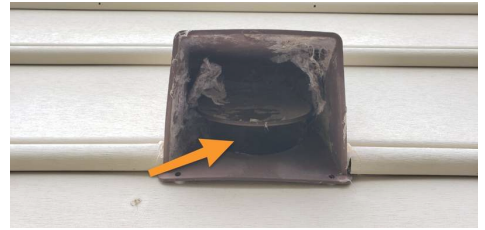
RIGHT SIDE OF HOME

DRYER VENT STUCK

The dryer exhaust vent appears to be clogged, which is preventing the damper from closing when it is not exhausting. This can cause pest intrusion into the ducts. The vent exhaust should be cleaned and then check to ensure the damper can properly close the duct.

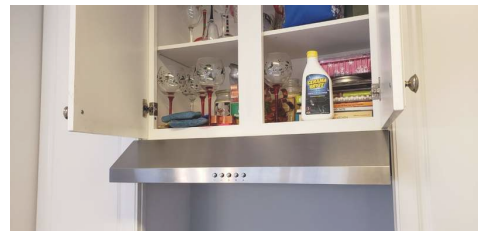
KITCHEN

**VENT FAN IS NOT
VENTED**

The vent fan above the cook top is not vented to the exterior and there is no duct work. This will allow smoke and fumes from the stove top to be released into the kitchen. This vent hood should be replaced with a recirculating vent hood or vented to the exterior of the home. Recommended qualified contractor repair/install vent work as needed.
