SUMMARY
1234 Main St. Moncks Corner SC 29461
Buyer Name
01/10/2019 9:00AM

Robert Wiggins
ASHI & InterNACHI Certified Home...
Carolina Premier Inspections LLC
843-226-3640
bob@carolinapremierinspections.com

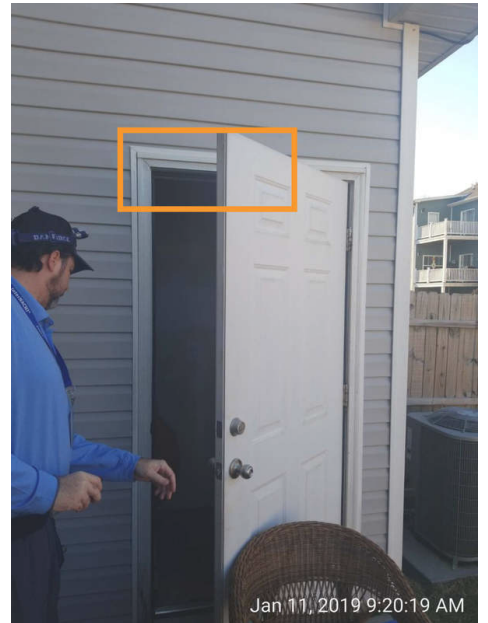
REAR - EXTERIOR

BINDING DOOR - EXTERIOR

A exterior door that rubs the frame jamb was observed. Exterior doors that stick, rub, hit the door frame or do not perform as intended are indications of movement, settlement or other installation defects. The cause of exterior doors that rub, stick or hit door frames should be determined and repaired as needed.

Contact a qualified door repair/installation contractor.

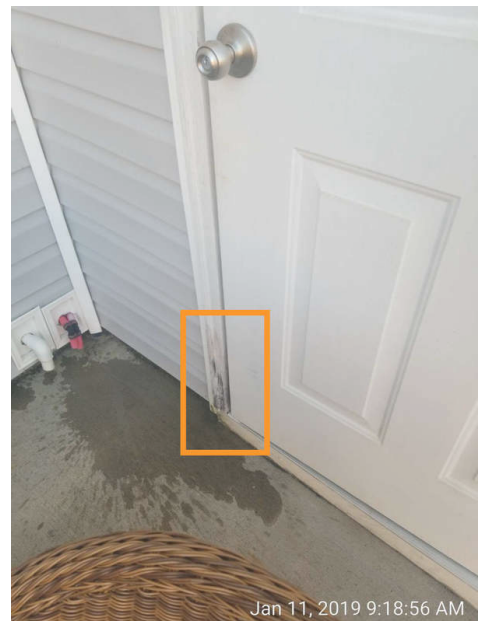
REAR - EXTERIOR

ROT - DOOR TRIM/JAMB (CL-100 RELEVANT)

Exterior door framing had decayed sections from excessive moisture at the time of inspection. I recommend repair by a qualified contractor. **This is a condition disclosed in a CL-100 report.**

Contact a qualified professional.

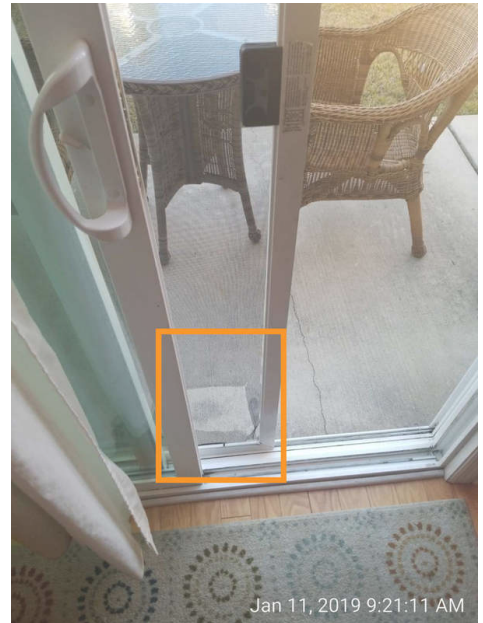
REAR ENTRY

DAMAGE - SCREEN DOOR

The screen on the rear sliding door was damaged. Recommend replacement of the screen.

Contact a qualified professional.

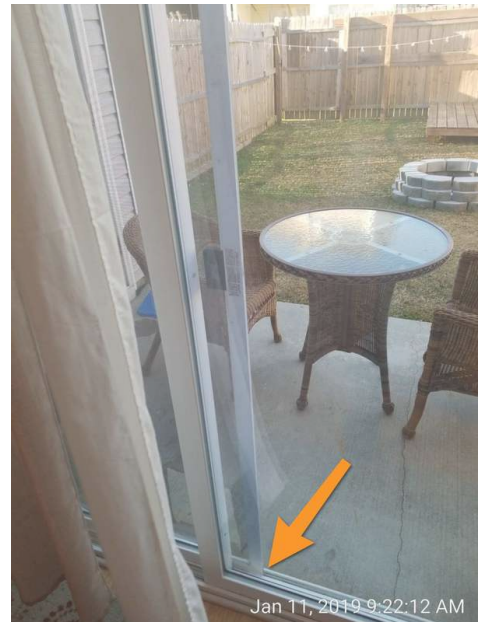
REAR ENTRY

SLIDING SCREEN CONCERNS

The sliding screen door revealed poor sliding function at the time of inspection. I recommend maintenance service to the track by a qualified professional to improve function and prevent damage to the unit.

Contact a qualified professional.

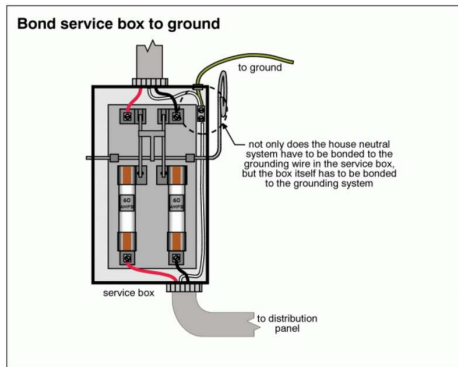
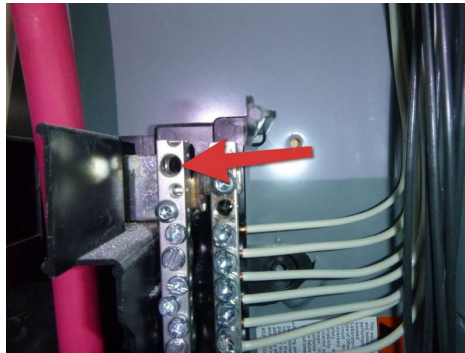
MAIN PANEL

MISSING BONDING SCREW

The bonding screw was missing at the neutral bus bar of the service panel. Without a bonding screw (or other bonding device), the neutral bus bar, metal cabinet, and grounding system are not bonded (electrically connected). This condition is a safety concern and can present an electrical shock/electrocution hazard. The inspector recommends correction by a licensed electrical contractor.

Contact a qualified electrical contractor.

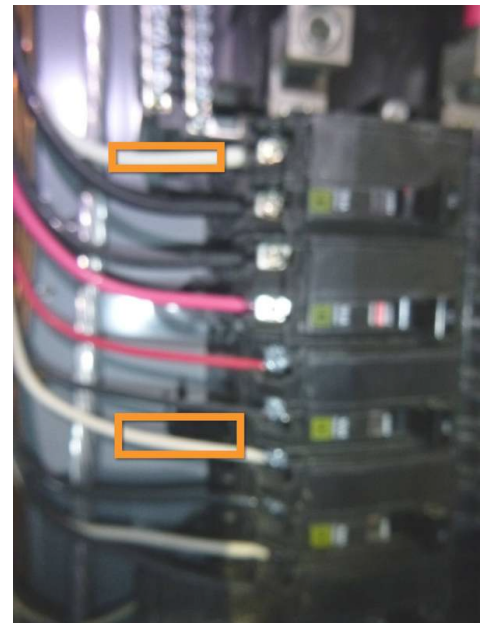
MAIN PANEL

RE-IDENTIFY WIRES

One or more energized conductors in panel had white, gray or green insulation. Insulation on energized conductors (hot wires) should be black or red in color to identify them as energized wires. Recommend that a qualified electrician re-identify wires per standard building practices. For example, by wrapping in black vinyl tape or marking with a black permanent marker.

Contact a qualified electrical contractor.

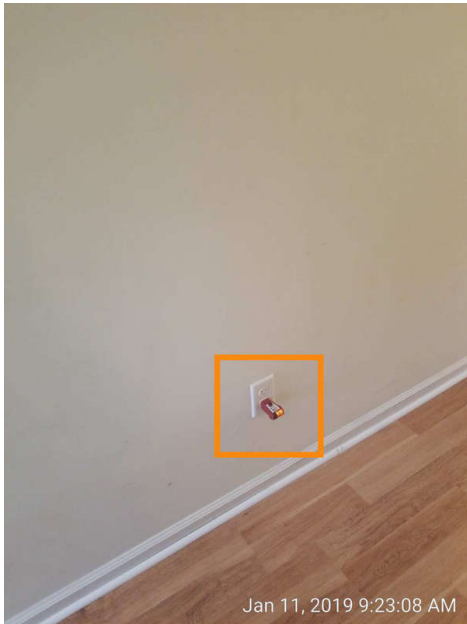
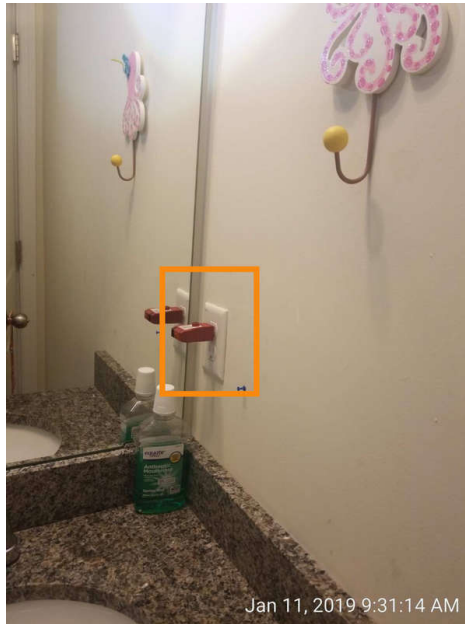
LIVING ROOM, 2ND FLOOR HALLWAY BATHROOM

LOOSE RECEPTACLE (POOR CONDITION)

One or more electric receptacles were observed to be loose or in poor condition. Noted electrical receptacles should be repaired by a certified, licensed electrical specialist.

Contact a qualified electrical contractor.

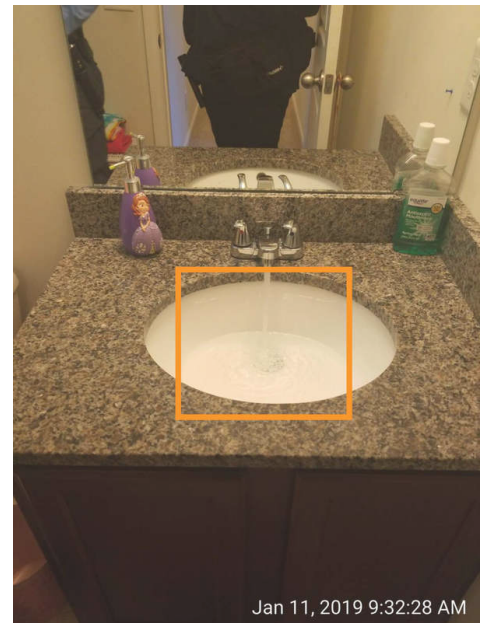
2ND FLOOR HALLWAY BATHROOM

SLOW DRAINAGE

A lavatory was slow to drain. A drain cleaner may correct this issue. If it does not then blockage should be located and cleared by a qualified plumbing contractor.

Contact a qualified plumbing contractor.

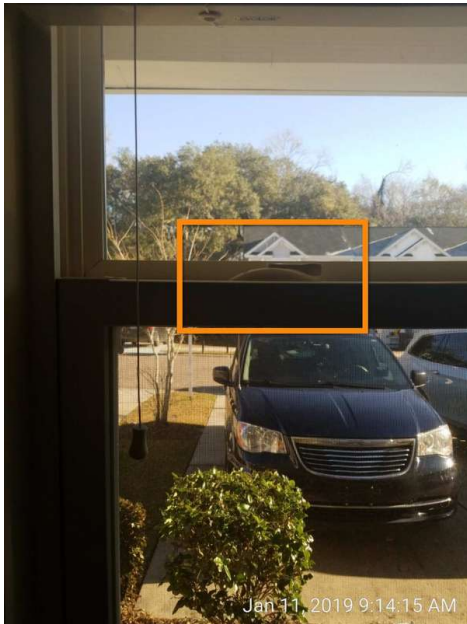
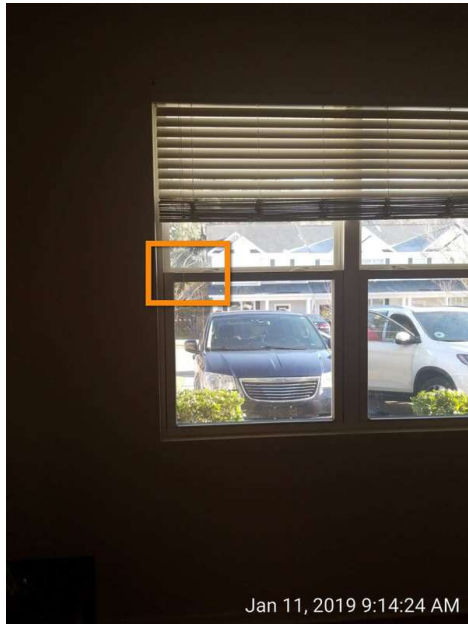
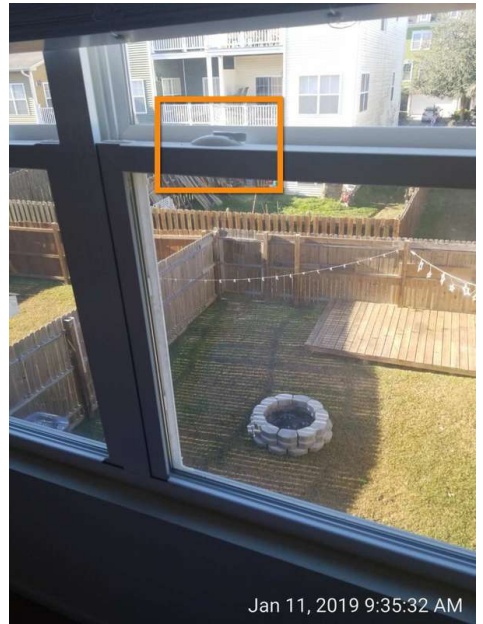
LIVING ROOM, BEDROOM #3

LOCKING HARDWARE CONCERNS - INTERIOR WINDOW

Some window lock(s) were difficult to latch. I recommend repair by a qualified professional to restore proper function. Windows that do not latch can be a security issue and contribute to heat loss or gain.

Contact a qualified window repair/installation contractor.

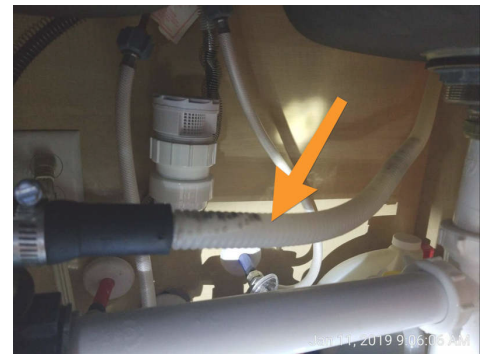
KITCHEN

11.2.1 Dishwasher
HIGH LOOP NEEDED

The high loop or air gap must be used to prevent potential back-flow contamination of the dishwasher. This also keeps the drain hose dried out and keeps any odors from backing up into the dishwasher. Some newer dishwashers may have built in anti-siphon devices that are not visible. The buyer is encouraged to consult the owners manual or contact the manufacturer if an anti-siphon device is not visible. Although new dishwashers come from the manufacturer with the drain looped up at the side of the dishwasher, every installation manual still requires this high loop underneath the sink. We recommend correction by a qualified professional.

Recommendation
Contact a qualified professional.

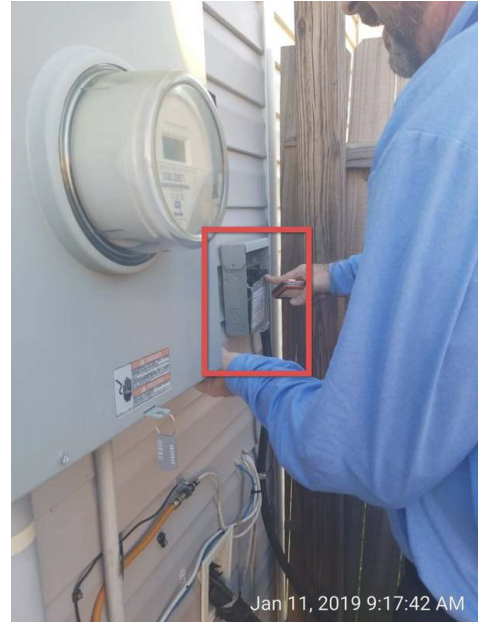
13.2.1 Disconnect Observations
UNSECURED SHOCK SHEILD
REAR - EXTERIOR

Safety Issue

Recommendation
Contact a qualified electrical contractor.

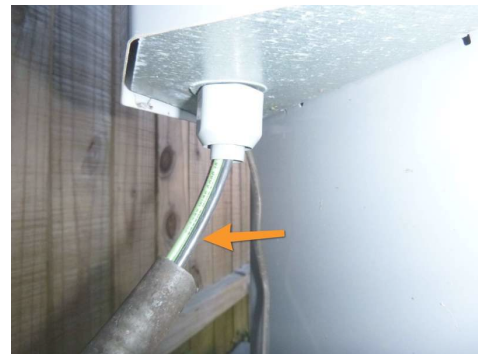
REAR - EXTERIOR HVAC

13.3.1 Exterior Equipment **DAMAGED CONDUIT**

The flex conduit for the electrical wiring of the condenser unit is damaged. I recommend a qualified licensed electrical contractor repair or replace the conduit to protect exterior HVAC wiring.

Recommendation
Contact a qualified professional.

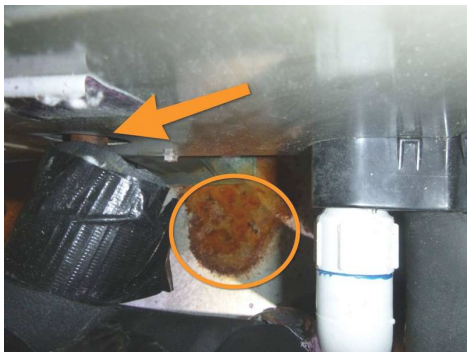
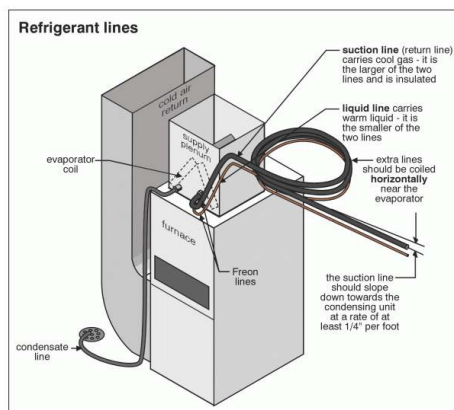
ATTIC

13.4.1 Refrigerant Line Set **INADEQUATE INSULATION - SUCTION LINE**

The HVAC refrigerant lines was not properly insulated at the interior equipment. Inadequate cooling line insulation at the interior HVAC equipment has caused localized rusting to the safety pan. The pan does not need replacement at this time however failure to improve insulation at the air handler will create condensation and further corrosion. Repair by a licensed HVAC tech is recommended.

Recommendation
Contact a qualified HVAC professional.

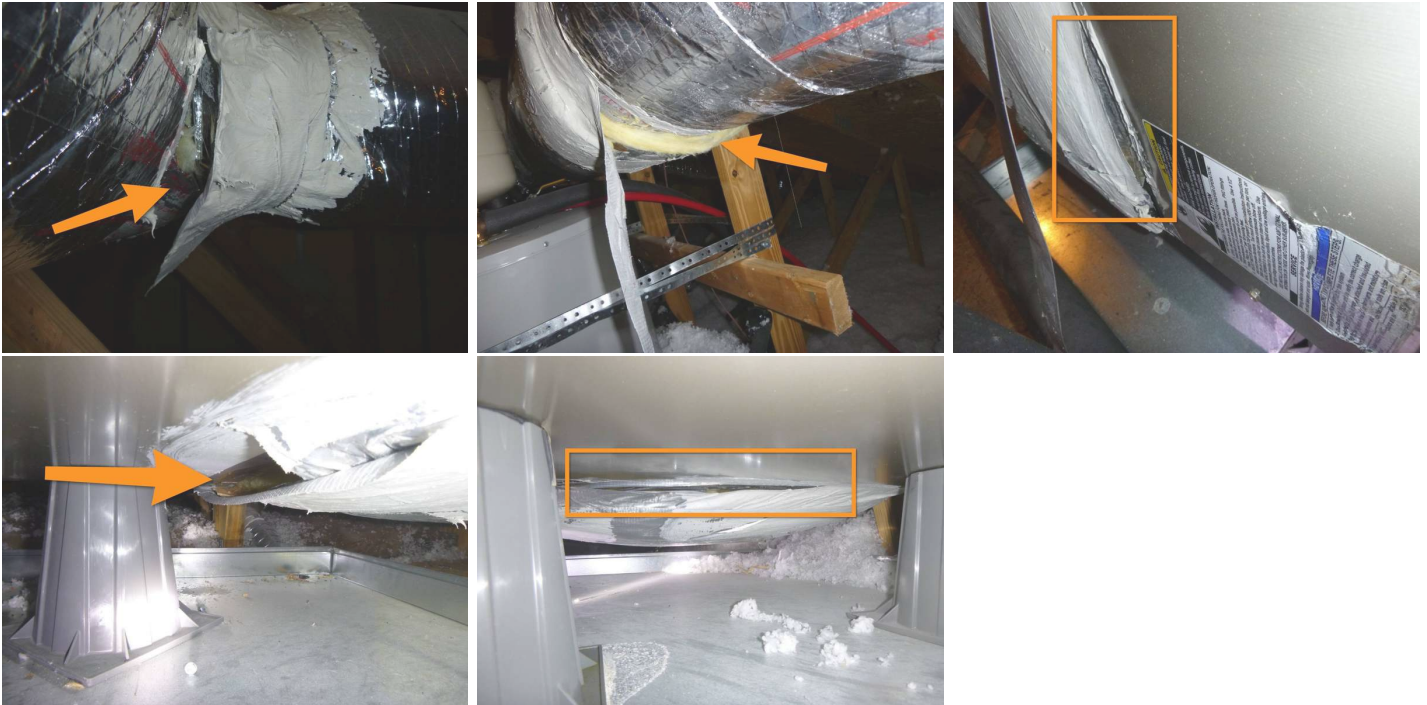
ATTIC

POOR SEAL AT CONNECTIONS

The heating/cooling distribution ducts were not properly sealed. Inadequate air plenum and duct connections may allow unwanted air, vapors or debris to be pulled into the cooling equipment. Inadequate air handler plenum seals can create excessive condensation that causes water damage and microbial amplification. Loss of conditioned air also results in energy efficiency reduction. Improperly sealed cooling equipment air handler plenum and ducts should be repaired by a qualified HVAC tech.

Recommendation
Contact a qualified HVAC professional.
