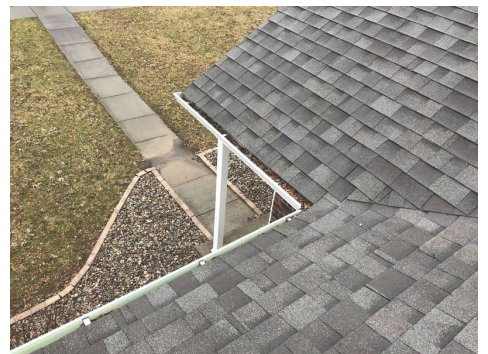
2.2.1 Roof Drainage Systems

DEBRIS

Debris has accumulated in the gutters. Recommend cleaning to facilitate water flow.

Contact a handyman or DIY project

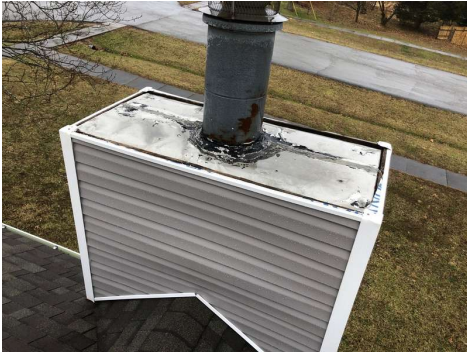
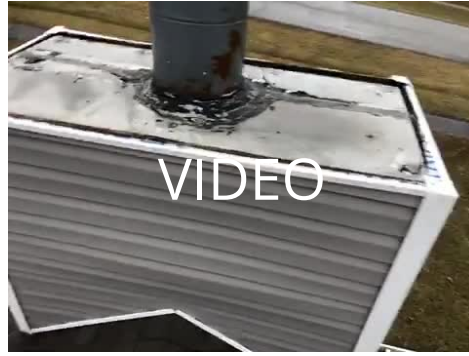
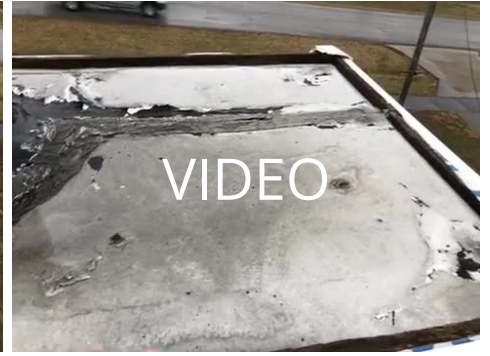
2.6.1 Chimney

METAL CHIMNEY CAP

The cap was damaged or in need of maintenance. Recommend further review and repair to mitigate the risk of pest intrusion.

Contact a qualified chimney contractor.

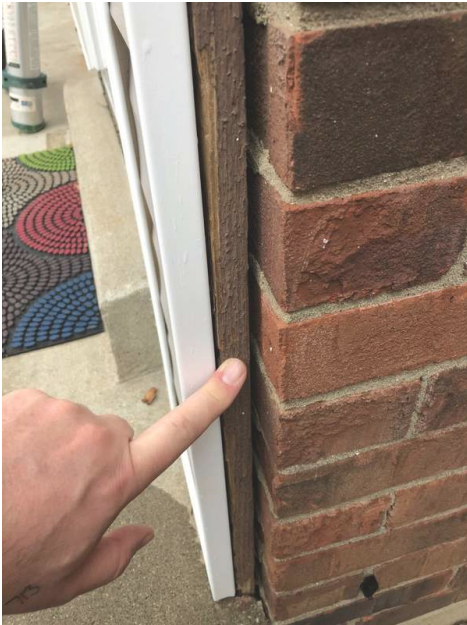
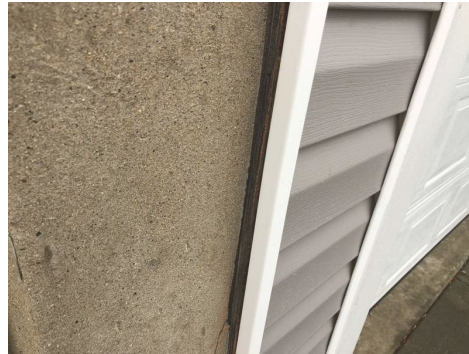
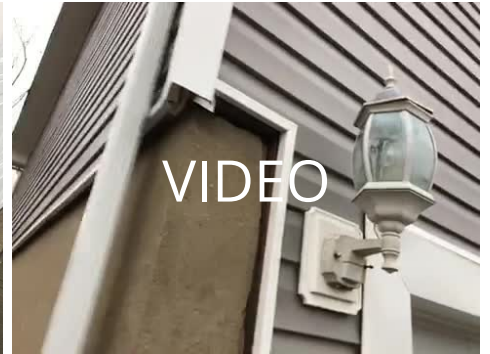
3.1.1 Siding, Flashing & Trim **GAPS / PENETRATIONS**

There were one or more locations where gaps might allow for moisture intrusion. Recommend [sealing](#) any such gaps or installing flashing as needed.

Recommendation
Contact a handyman or DIY project

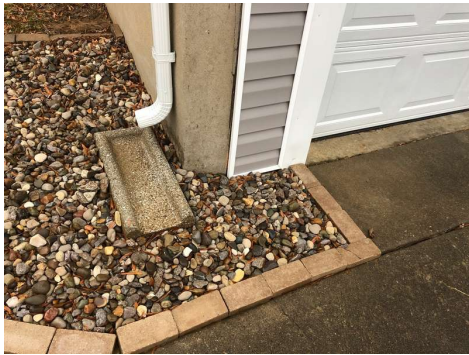
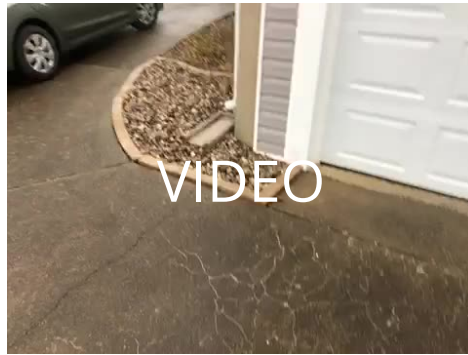
3.1.2 Siding, Flashing & Trim **SIDING - CLOSE TO GROUND**

There should be a gap between the siding and the soil/ground. There is a risk of moisture wicking as well as a pathway for wood destroying insects. Repair.

Recommendation
Contact a qualified professional.

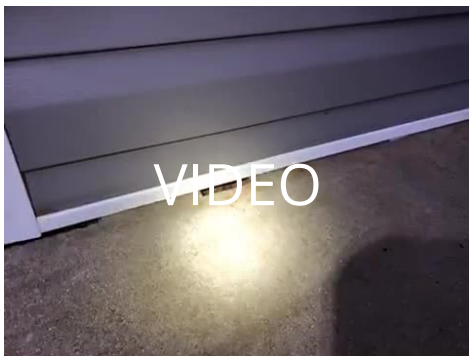
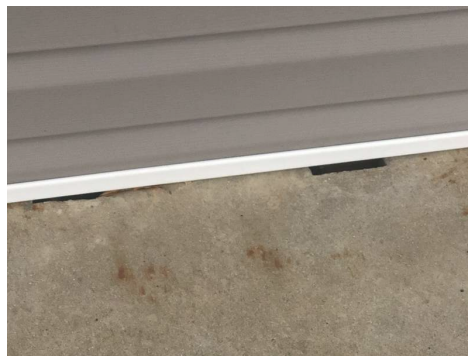
3.1.3 Siding, Flashing & Trim **CONCRETE CLEARANCE**

There should be a gap between the siding and the concrete and flashing. No major concerns observed but moisture could get trapped between or behind. Heavier rains may impact this area. This is also a potential spot for termite intrusion.

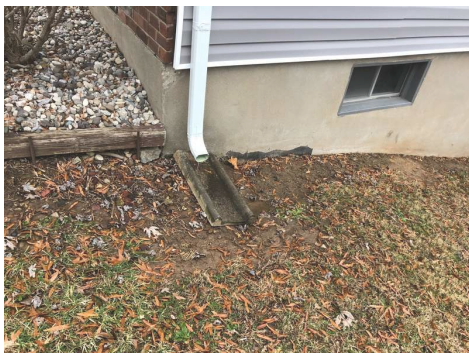
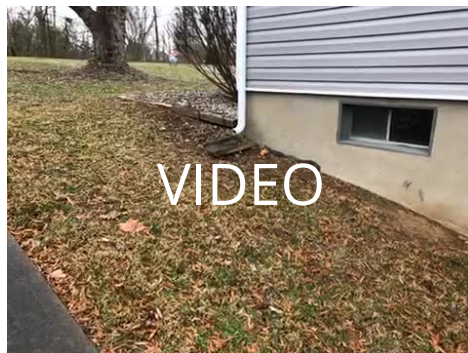
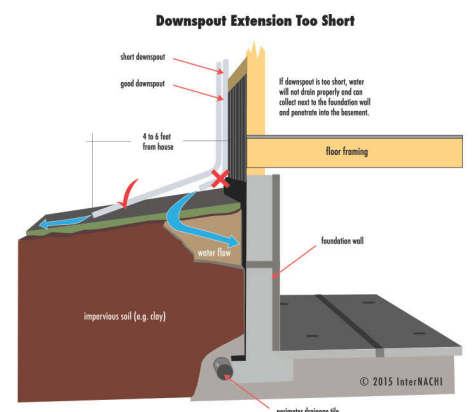
3.3.1 Vegetation, Grading, & Drainage **DOWNSPOUTS - DRAIN NEAR HOUSE**

One or more downspouts drain too close to the home's foundation. This can result in excessive moisture in the soil at the foundation, which can lead to foundation/structural movement. Recommend a qualified contractor adjust downspout extensions to drain at least 6 feet from the foundation.

Contact a handyman or DIY project

Recommend extending the downspouts further away from the foundation.

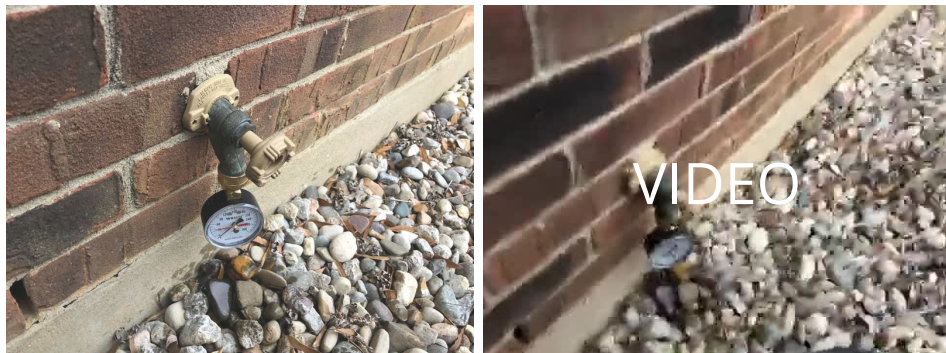
3.4.1 Gas, Water, & Electric

DAMAGED - IN WALL

The hydrant appeared to be damaged inside the wall this is typically caused by freezing. When operating water is dumping inside the wall and there will be no pressure. Replacement is needed. Recommend a frost proof wall hydrant like the one [found here](#). (This is rated major mainly because of the potential for damage. It most likely will not be terribly expensive to fix but it needs to be and may be somewhat difficult to access.)

Contact a qualified plumbing contractor.

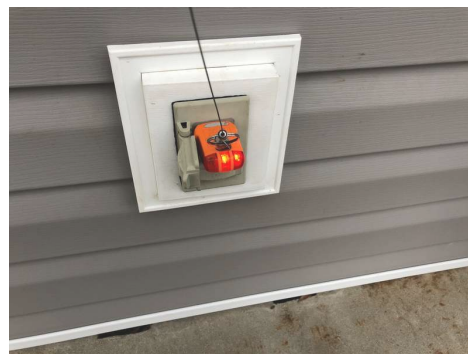
3.4.2 Gas, Water, & Electric

GFCI - EXTERIOR/GARAGE

SAFETY All exterior/garage receptacles should be GFCI protected. Have an electrician update or repair.

Contact a qualified electrical contractor.

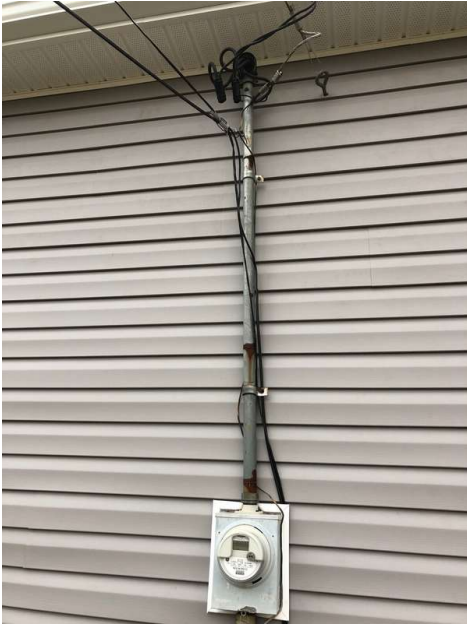
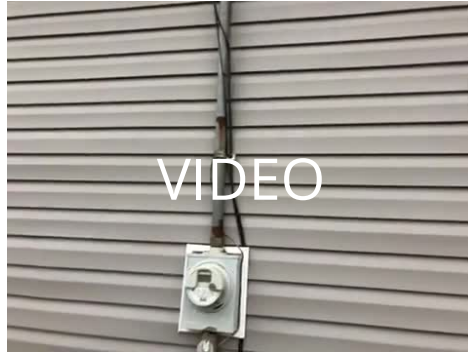
3.4.3 Gas, Water, & Electric

MAST OR METER NOT SECURED OR LOOSE

The service mast or meter appeared loose or inadequately secured. Further review and correction is needed to prevent failure.

Contact a qualified electrical contractor.

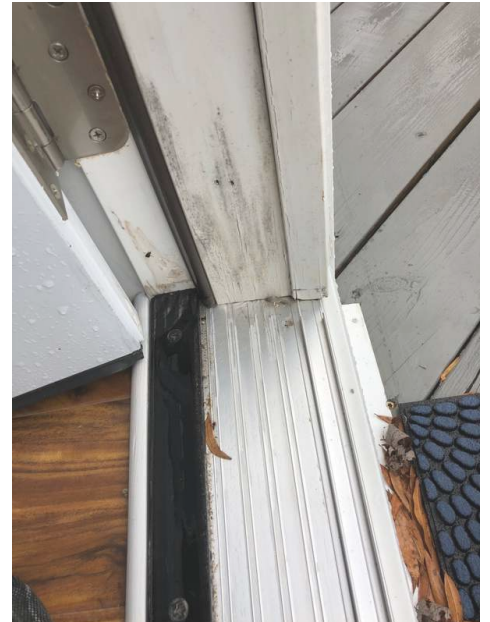
3.5.1 Exterior Doors

JAMB - MOISTURE DAMAGE

Some moisture induced degradation was noted at one or more exterior jambs and door. Though this is typical, attempts to prevent furthering should be considered. [Here is some more information that may be useful.](#)

Contact a qualified handyman.

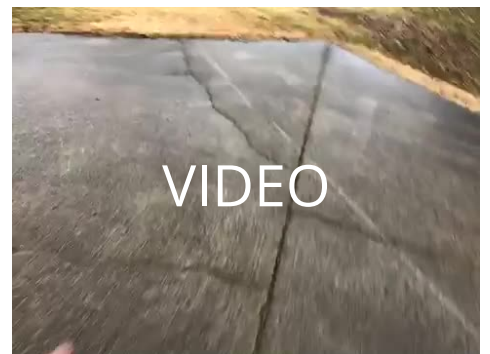
3.7.1 Driveways & Walkways

CRACKING/SETTLING

Major cracks and/or settling observed. This may indicate inadequate soil prep or erosion. It may be a lack of reinforcing bar. Some trip hazards may exist.

Contact a qualified concrete contractor.

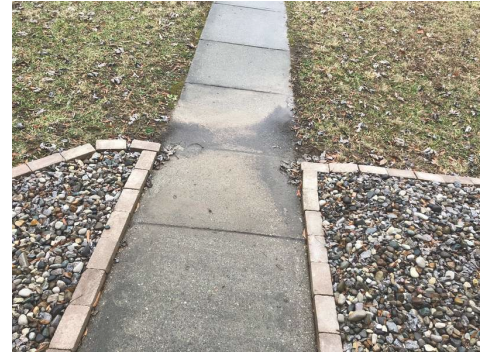
3.7.2 Driveways & Walkways

STANDING WATER

Standing water, or the potential for, was noted.

Contact a qualified landscaping contractor

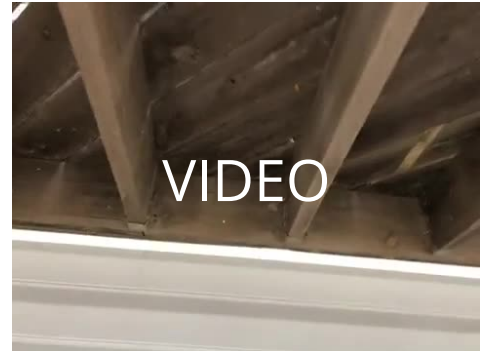
3.8.1 Decks & Balconies

FLASHING IMPROPER

Where the deck abuts the home should be flashed to keep moisture from penetrating the exterior wall. [Here is an article that explains how a ledger should be installed.](#) Sometimes it is difficult to assess if flashing exists.

Contact a qualified deck contractor.

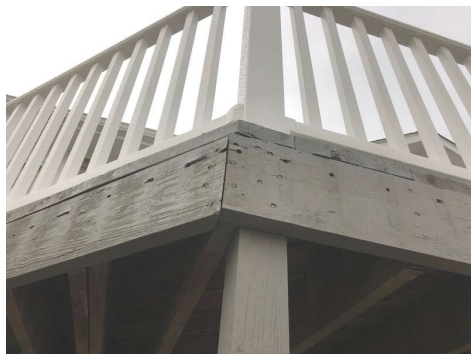
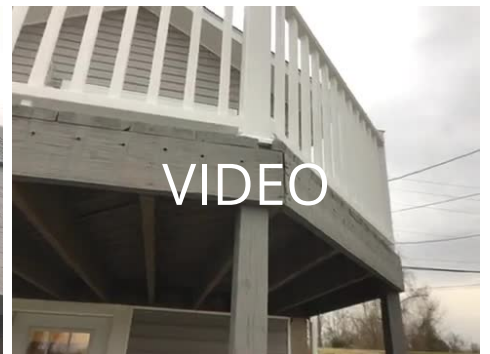
3.8.2 Decks & Balconies

RIM JOIST MISSING LAG BOLTS

SAFETY The rim joist on the deck should be bolted to the post. Or the post should be notched. Failure is possible and the deck could collapse. Repair is needed.

Contact a qualified deck contractor.

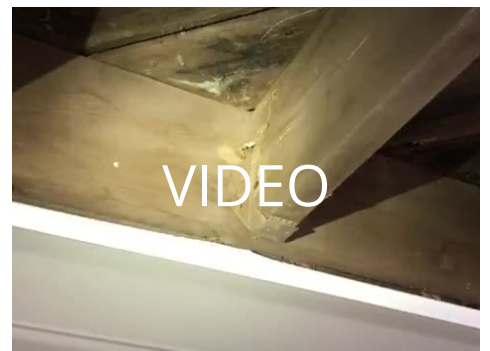
3.8.3 Decks & Balconies

JOIST HANGER - UNDERSIZED

SAFETY Joist hangers are engineered connectors that will not work as intended if they are undersized or modified on site. If a particular span requires a 2x10 joist to carry the load, for example, then you have to use a 2x10 joist hanger; a smaller hanger doesn't have enough capacity. The reason they make larger hangers is that a larger hanger provides for more nails, which can support a larger load. The hanger also keeps the joist from rotating at the end, which helps to stiffen the floor. If the hanger is too short, it won't resist rotation as well as a taller hanger. All the nail holes need to be utilized and they are not.

Contact a qualified deck contractor.

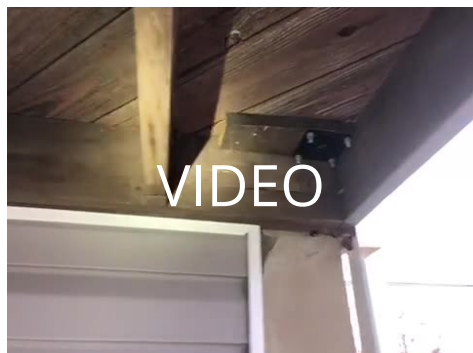
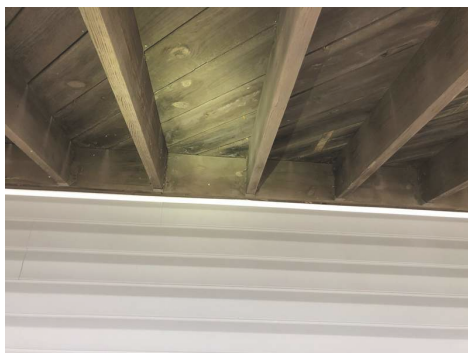
3.8.4 Decks & Balconies

LEDGER BOARD IMPROPERLY INSTALLED

SAFETY The ledger board did not appear to be adequately attached to the building. This can cause the deck to pull away from the building and possibly collapse. Recommend that the deck and/or ledger board be properly attached by qualified contractor. [Here is an article explaining how a ledger board should be installed.](#)

Contact a qualified deck contractor.

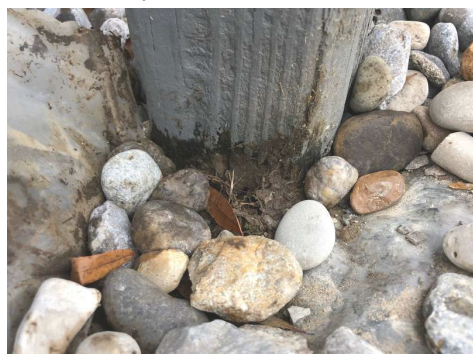
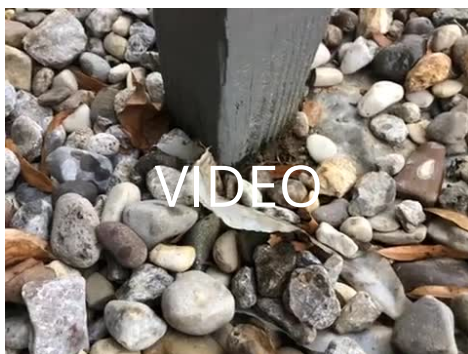
3.8.5 Decks & Balconies

POST FOOTINGS

The covered deck was constructed using buried 4x4 posts. These posts are carrying a larger load and should ideally be resting on footers and piers. The posts are subject to degradation being buried. They may also not be rated for the load. Some slight damage was noted.

Contact a qualified deck contractor.

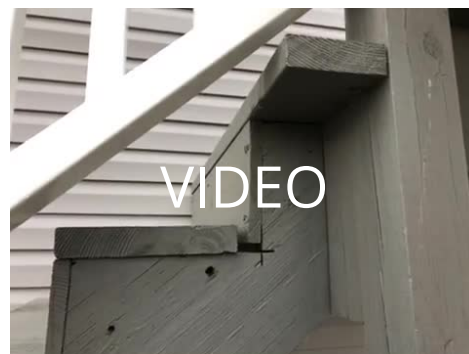
3.10.1 Stairs

RAILING UNSAFE

SAFETY There is an unsafe opening in the railing. The spacing on the rail should not exceed 4". An opening greater than 4" is a serious safety hazard especially for children as their head or other body part can become trapped.

Contact a qualified deck contractor.

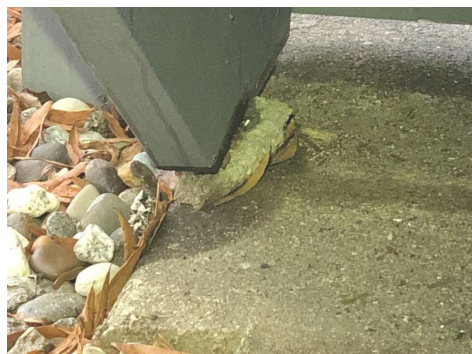
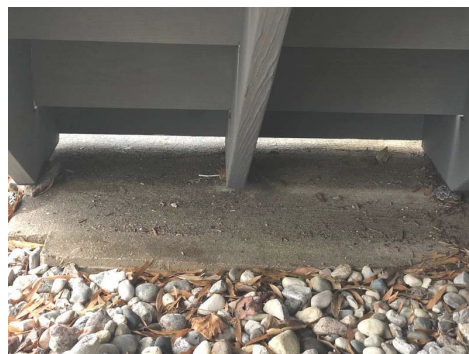
3.10.2 Stairs

IMPROPER BEARING

The steps should ideally be resting on something solid other than the rock shims. The heel of the stringer should be resting on something solid.

Contact a qualified handyman.

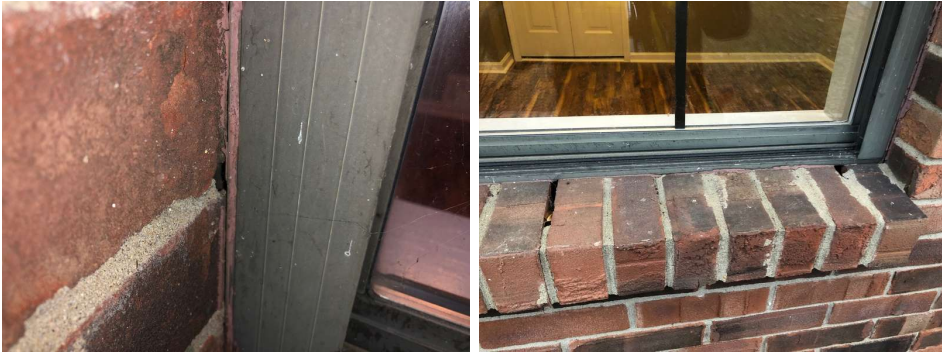
3.11.1 Masonry

GAPS - WINDOWS/DOORS

Any gaps around windows or doors should be sealed to mitigate moisture intrusion. Moisture intrusion between the masonry and framing could cause damage to the framing that would be difficult to observe. Recommend making corrections as needed.

Contact a handyman or DIY project

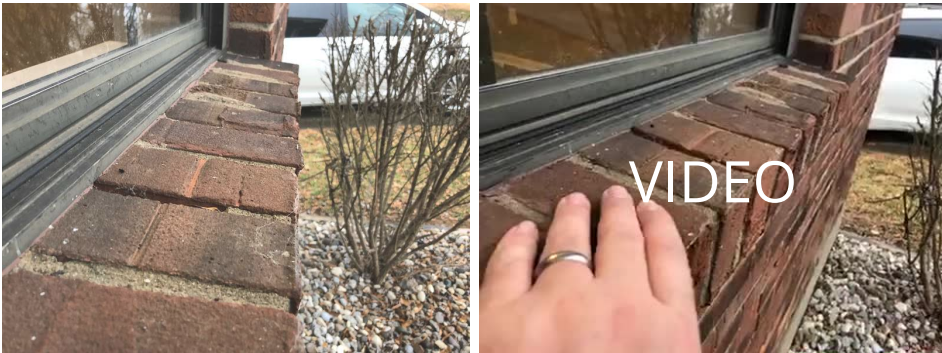
3.11.2 Masonry

SILL SLOPE INCORRECT

There should be a 15 slope on the window sill and it should protruding least 1. The concern is moisture draining back towards the window and behind the brick wall. Monitor area and address condition as needed.

Recommendation
Recommend monitoring.

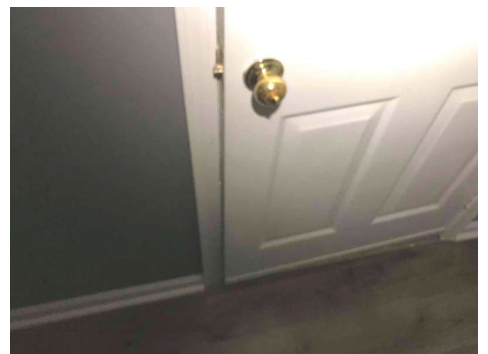
4.1.1 Doors

DOES NOT LATCH - MINOR

One or more of the doors did not latch properly. While this can be an indication of movement, it appeared to need a simple adjustment.

Recommendation
Contact a qualified handyman.

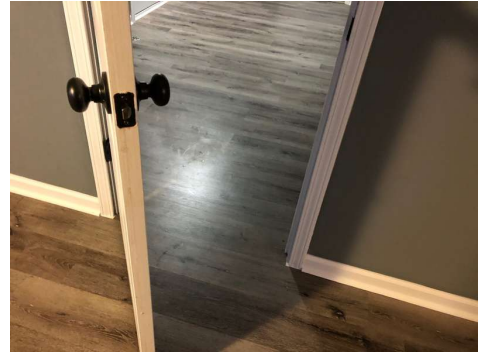
4.1.2 Doors

DOOR DRAGS

Door drags slightly, or worse. Recommend sanding down offending sides.

Recommendation
Contact a handyman or DIY project

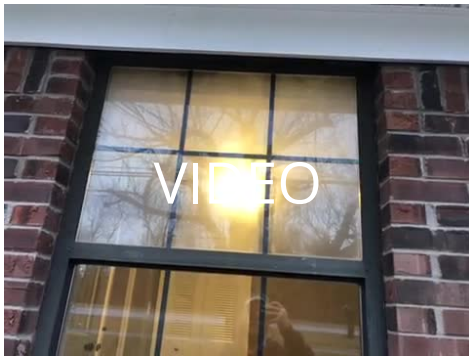
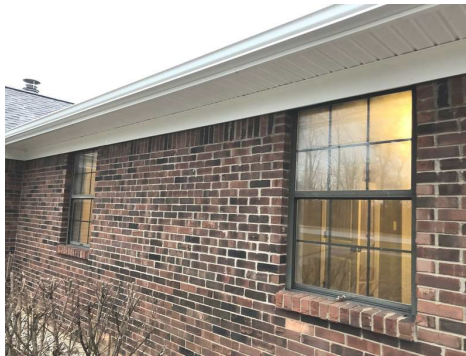
4.2.1 Windows

HAZING

One more of the windows had a damaged seal and condensation was noted in between the panes of glass. Recommend further review and correction.

Contact a qualified window repair/installation contractor.

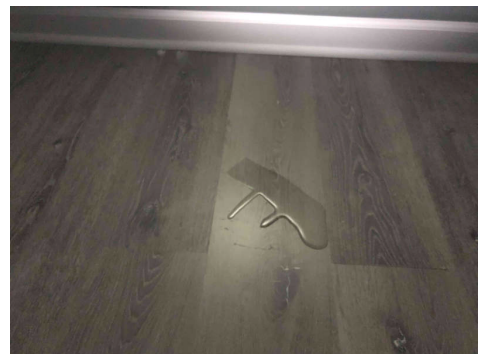
4.3.1 Floors

WATER

There was water on the floor in the basement. It appeared to most likely be related to the damaged wall hydrant on the front wall. Further review and correction is needed.

Contact a qualified professional.

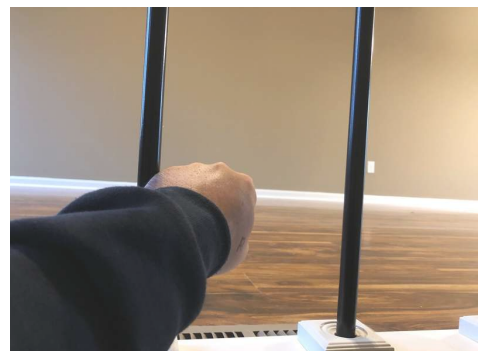
4.6.1 Steps, Stairways & Railings

BALUSTER SPACES TOO WIDE

SAFETY The baluster space is not up to modern safety standards. The space between balusters should not allow passage of a 4 3/8-inch sphere for child safety. Recommend making improvements to mitigate fall risks. (This is major mainly because of the hazard posed to children.)

Contact a qualified handyman.

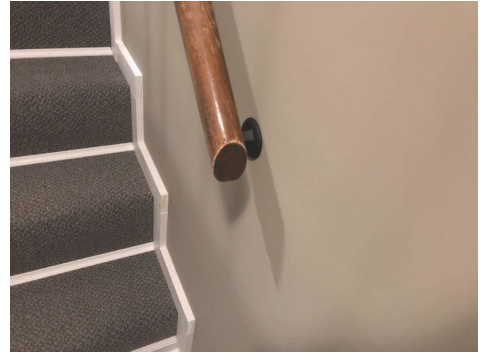
4.6.2 Steps, Stairways & Railings

HANDRAIL - TURN TOWARDS WALL

SAFETY Hand rails should turn towards the wall to mitigate the fall risk.

Contact a qualified handyman.

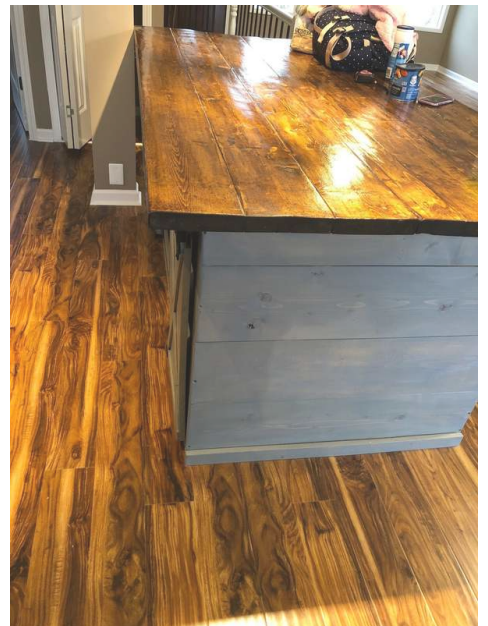
4.7.1 Countertops & Cabinets

ISLAND - NOT SECURED

SAFETY Island was loose and it presents a tip over hazard. Recommend securing.

Contact a qualified handyman.

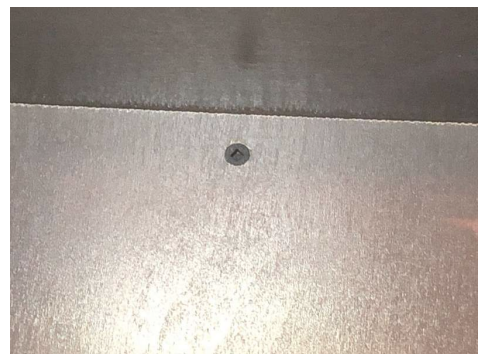
4.7.2 Countertops & Cabinets

CABINET SCREWS

One or more cabinet screws are missing or the wrong type of screws were used. Recommend further review and installing as needed. Drywall screws are tapered and can pull thru the cabinet. Truss head screws should be used.

Contact a handyman or DIY project

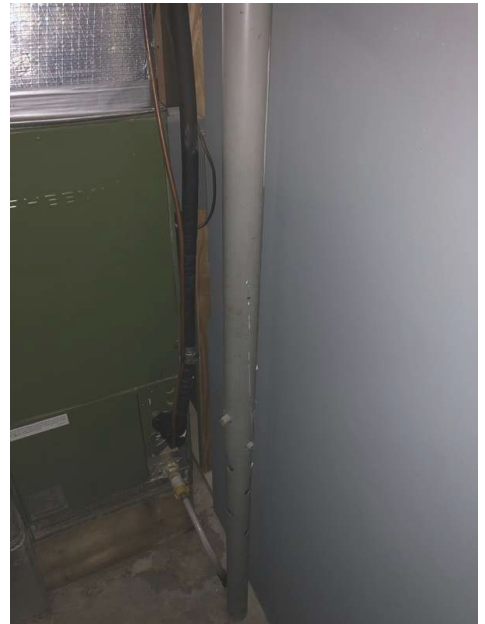
5.2.1 Posts, Piers, & Beams

ADJUSTABLE STEEL POSTS

Adjustable post are not typically rated for permanent use. Recommend further review by a qualified professional. [Here are some of the guidelines.](#)

They should also be secured to the girder and they are upside down.

Contact a qualified professional.

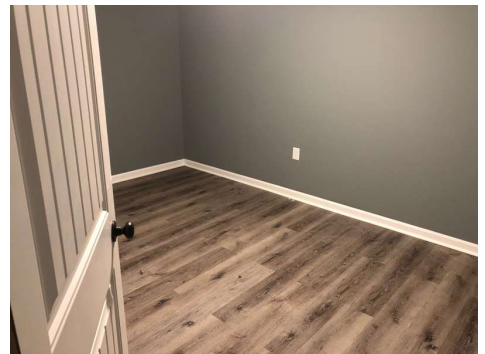
5.3.1 Basements

BASEMENT BEDROOM

"Bedrooms" without an egress window are not considered safe because they lack egress. There should be a second way to get out in case of a fire. These windows do not meet the requirements. [Here is some more information.](#)

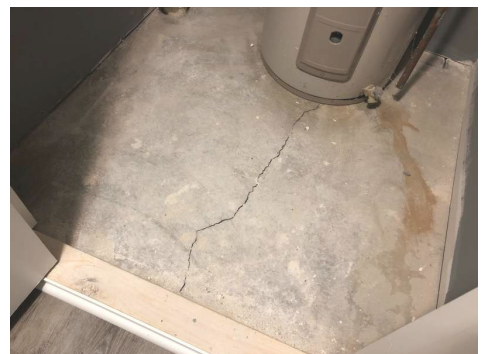
5.3.2 Basements

FLOOR CRACKS

Typical cracking of floor noted. This is sometimes caused by lack of control joints and an insufficient amount of reinforcement. No major concern at this time.

Contact a qualified professional.

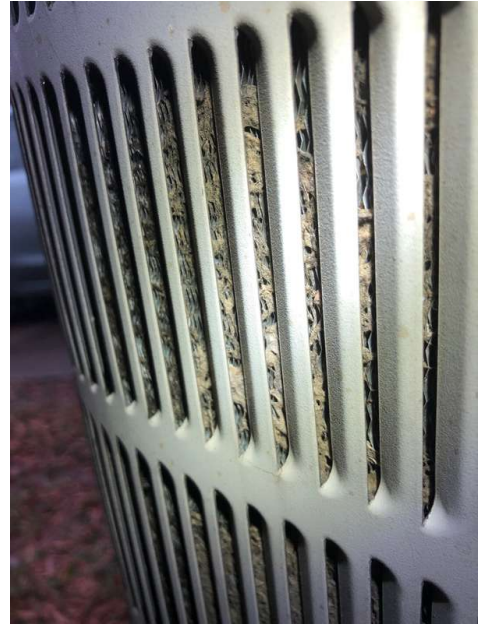
6.1.1 Outside Unit

FINS DAMAGED/DIRTY

The fins were dirty or damaged. This may inhibit their ability to dissipate heat. Recommend further review by an HVAC professional.

Contact a qualified HVAC professional.

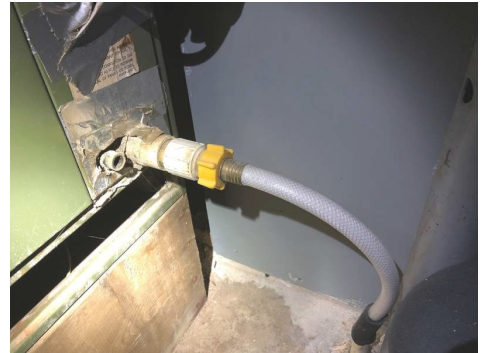
6.2.1 Inside Unit

CONDENSATE OVERFLOW SWITCH

Recommend installing a [condensate overflow switch](#). Otherwise, the condensation could backup and get the area wet. This is more problematic if the unit is in or above a finished area as the potential for damage is greater.

Contact a qualified HVAC professional.

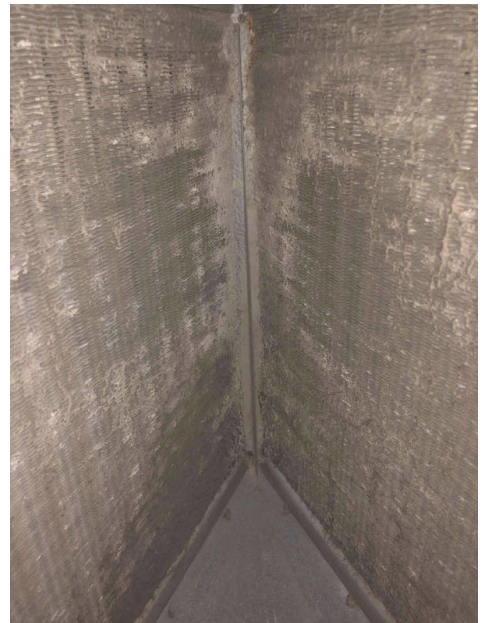
6.2.2 Inside Unit

COIL - DIRTY

The coil was dirty and needed to be cleaned at the time of the inspection. Air filters should be changed monthly while the air-conditioning system is in operation. Dirty coil can cause the following problems: - Reduced blower life due to dirt build-up on vanes, which increasing operating costs. - Reduced effectiveness of air filtration resulting in deterioration of indoor air quality. - Frost build-up on air-conditioner evaporator coils, resulting in reduced cooling efficiency and possible damage. - Reduced air flow through the home.

Contact a qualified HVAC professional.

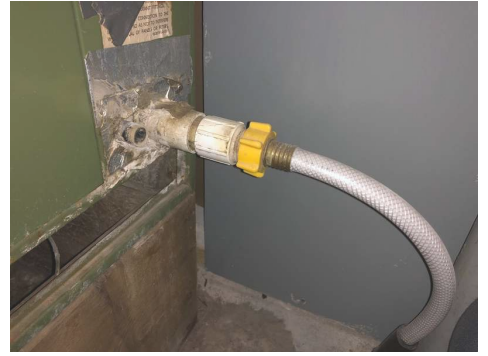
6.2.3 Inside Unit

CONDENSATE TUBE DAMAGED

Condensate tube was improper because no trap was installed. This can allow air moving in and out of the air handler at this location.

Contact a qualified HVAC professional.

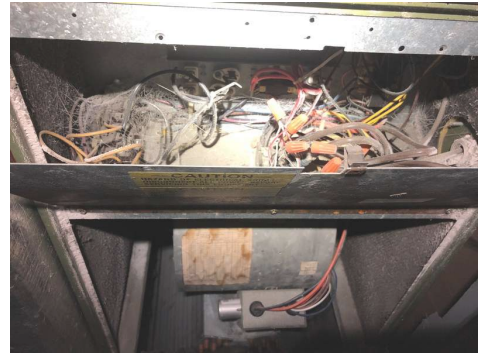
6.2.4 Inside Unit

NEEDS SERVICING/CLEANING

Furnace should be cleaned and serviced annually. Recommend a qualified HVAC contractor clean, service and certify furnace.

Contact a qualified HVAC professional.

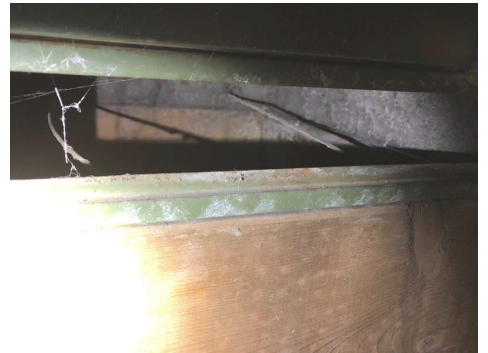
6.3.1 Filters

FILTER MISSING

There was no filter observed. This can cause several different issues as follows.

- Reduced blower life due to dirt build-up on vanes, which increasing operating costs.
- Reduced effectiveness of air filtration resulting in deterioration of indoor air quality.
- Increased resistance resulting in the filter being sucked into the blower. This condition can be a potential fire hazard.
- Frost build-up on air-conditioner evaporator coils, resulting in reduced cooling efficiency and possible damage.
- Reduced air flow through the home.

Contact a handyman or DIY project

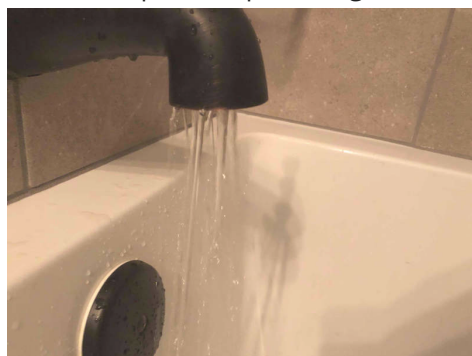
7.3.2 Water Supply

VOLUME/PRESSURE LOW

The volume/pressure was low at one or more of the fixtures. This may impact the use of some of the fixtures, mainly the tub.

Contact a qualified plumbing contractor.

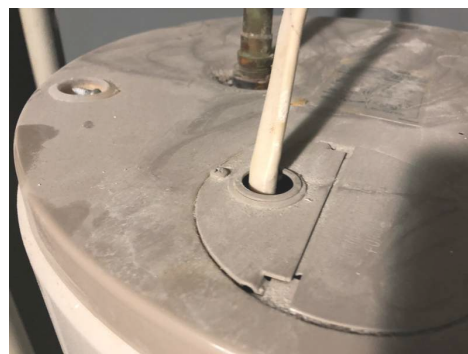
7.4.2 Hot Water - Tank

CONNECTOR MISSING

There should be a romex connector installed where the wire enters the water heater.

Contact a qualified electrical contractor.

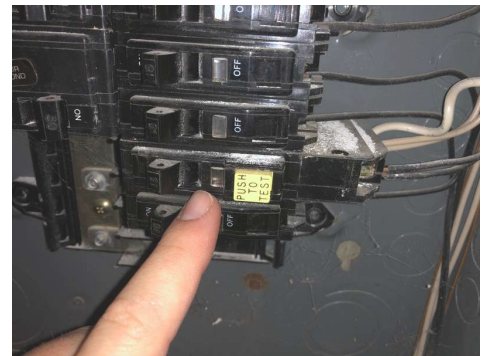
8.2.1 Breakers / Fuses

BREAKER FAULTY

One or more of the breakers did not trip when tested. Recommend further review and replacement as needed.

Contact a qualified electrical contractor.

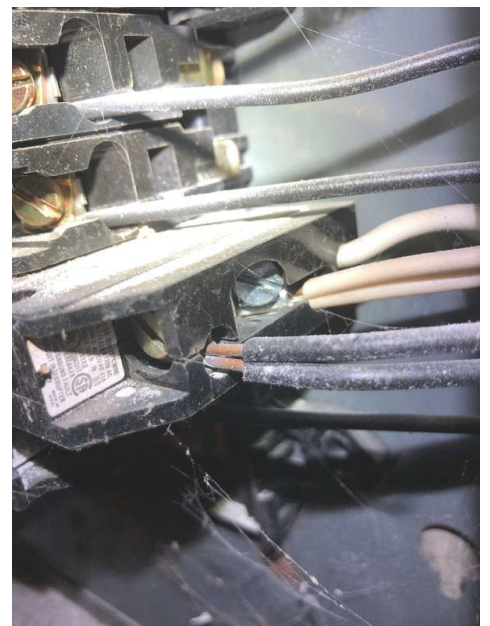
8.2.2 Breakers / Fuses

LUG DOUBLE TAPPED

The lug was double tapped. Not all lugs are rated for more than one wire. Recommend correcting as needed.

Contact a qualified electrical contractor.

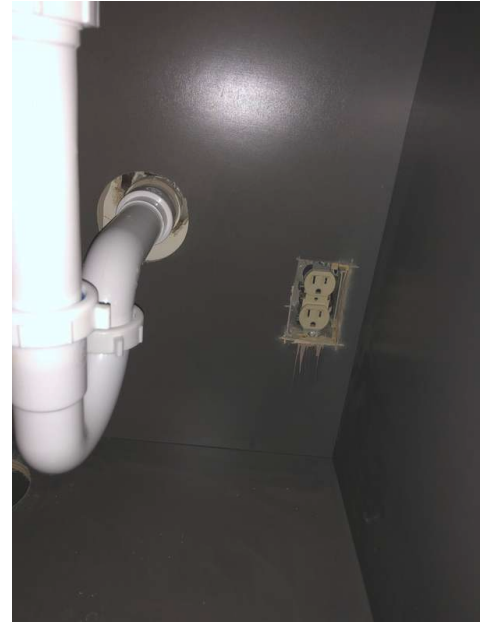
8.4.1 Receptacles & Switches

COVER PLATES MISSING

SAFETY One or more receptacles are missing a cover plate or the cover was damaged/loose. This causes short and shock risk. Recommend installation of plates.

Contact a handyman or DIY project

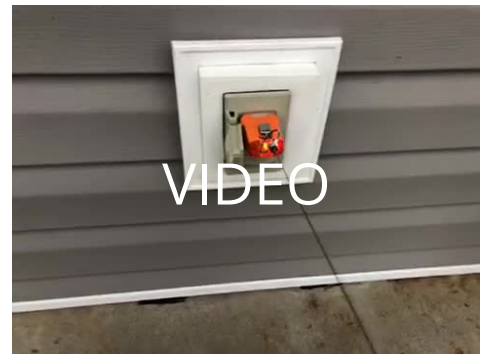
8.4.2 Receptacles & Switches

REVERSE POLARITY

One or more receptacles have been wired with reverse polarity. This can create a shock hazard. Recommend licensed electrician evaluate & repair.

Contact a qualified electrical contractor.

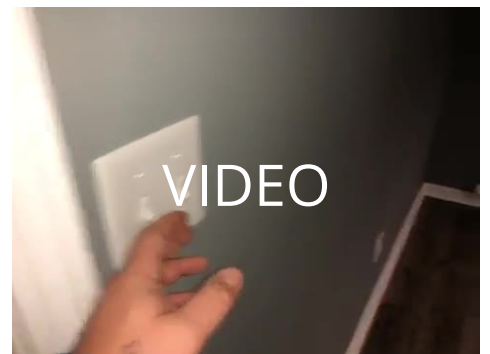
8.4.3 Receptacles & Switches

PURPOSE NOT IDENTIFIED

There was one or more switches where the purpose was not identified. Based on the homes age, sometimes switches controlled receptacles.

Recommend monitoring.

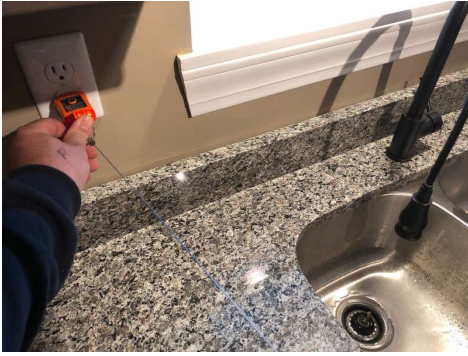
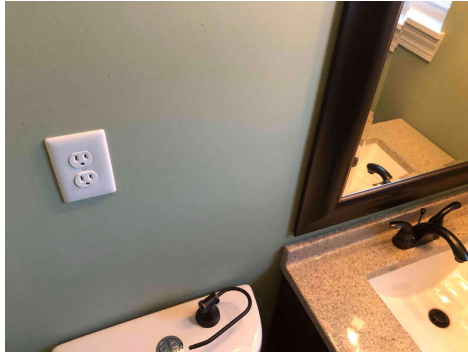
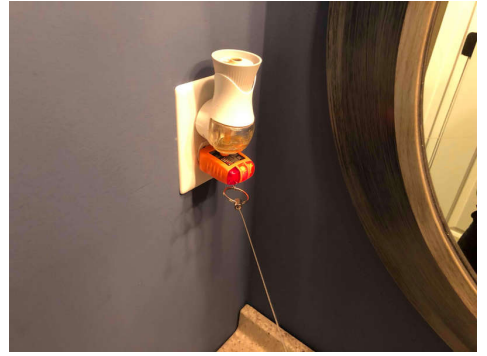
8.6.1 GFCI & AFCI

GFCI - INTERIOR

SAFETY It is recommended that GFCI receptacles be installed and functioning in any location within 6 foot of water. This includes all bathroom, kitchen, outside, or laundry receptacles.

Contact a qualified electrical contractor.

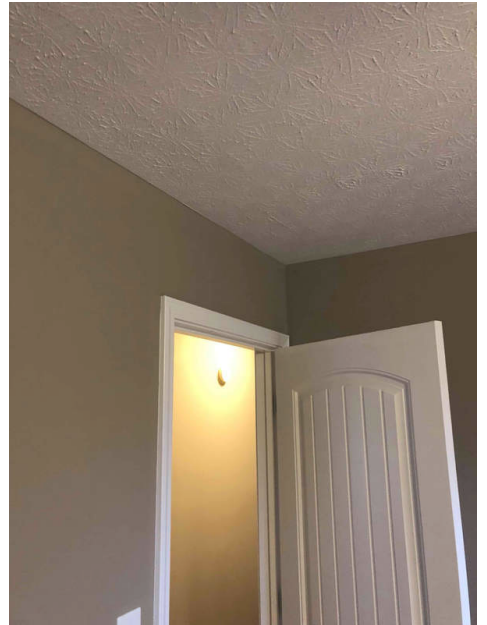
8.7.1 Smoke Detectors

SMOKE DETECTORS

SAFETY Recommend installing smoke detector batteries prior to moving in. Every bedroom should have a functioning smoke detector in addition to other areas. Here is some information on the current recommendations.

Recommendation
Recommended DIY Project

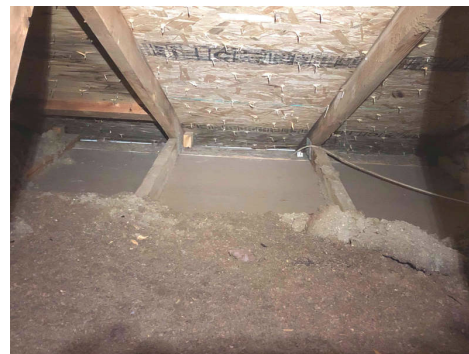
9.2.1 Attic Insulation

INSULATION - GAPS

There were gaps noted in the insulation. This can enable energy loss and make some areas more difficult to regulate.

Contact a qualified insulation contractor.

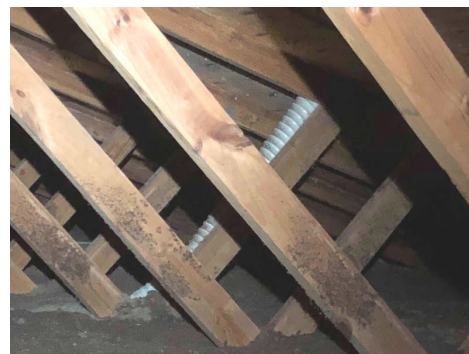
9.4.1 Exhaust Systems

BATHROOM VENTS INTO ATTIC

Bathroom fan vents into the attic, which can cause moisture and mold. Recommend a qualified attic contractor properly install exhaust fan to terminate to the exterior.

Contact a qualified HVAC professional.

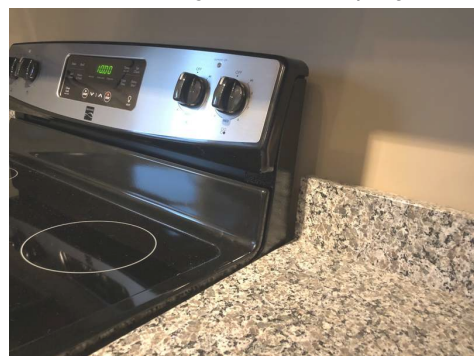
10.2.1 Range/Oven/Cooktop

ANTI-TIP DEVICE MISSING

SAFETY There was no anti-tip device installed. Consider installing one like [this](#) to mitigate the risk of a tip over. Not having one installed is a safety hazard.

Contact a handyman or DIY project

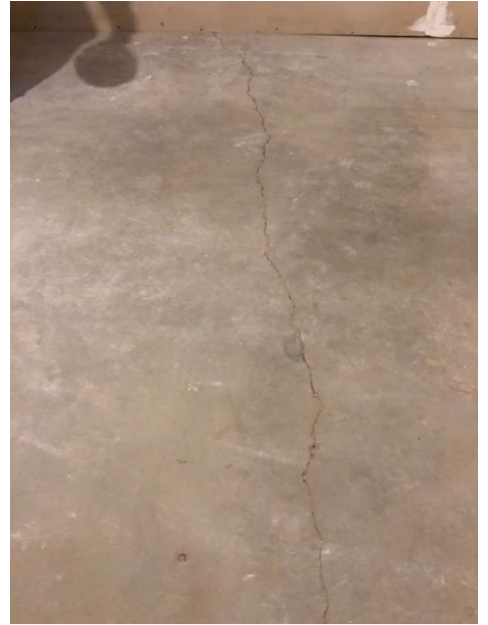
11.2.1 Floor

CRACKING - NORMAL

Cracking of the floor was noted. This is caused by a lack of control joints and/or insufficient reinforcement. No major concerns observed at this time.

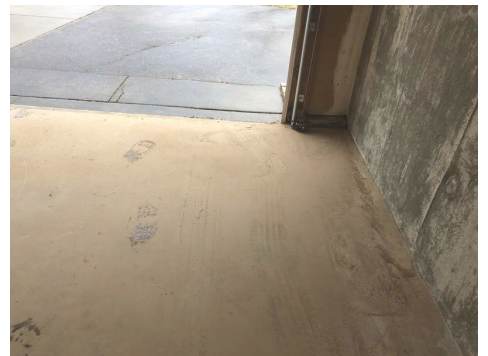
11.2.2 Floor

STANDING WATER

There were signs of standing water noted in one or more locations. The cause was not determined. It looks like water may have been coming through the wall at this corner at some point. The area was currently dry.

Contact a qualified professional.

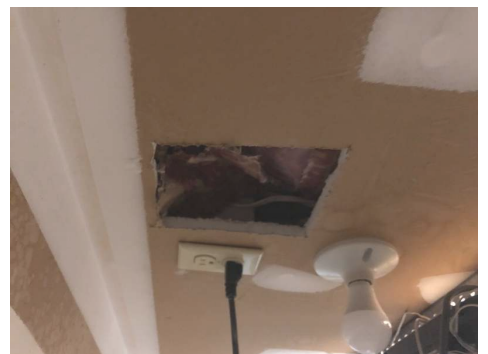
11.3.1 Walls & Firewalls

DAMAGED DRYWALL

Garage wall had damaged drywall. Recommend drywall contractor repair.

Contact a qualified drywall contractor.
