SUMMARY

1234 Main St. Moore OK 73160

George Carpenter
OK License # 70001319
Kingdom Inspections LLC
405-596-7038
george@kingdominspectionsllc.com

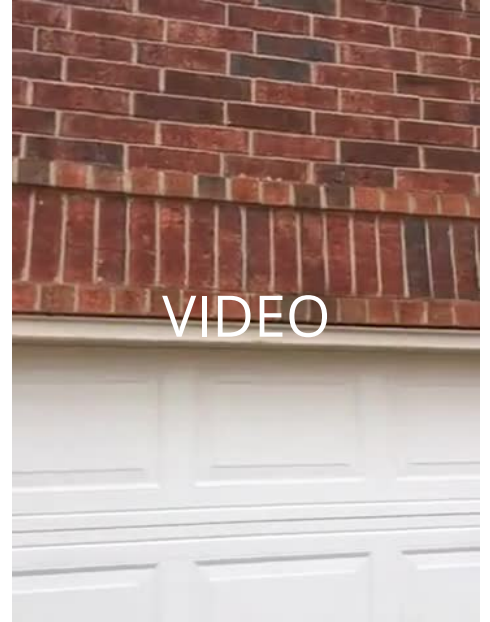
ABOVE GARAGE - NORTHEAST CORNER

GARAGE WALL MOVEMENT NOTED

There was movement noted at the sides of the garage door. This is a common area for cracks and gaps at the brick veneer. This home had movement noted that was patched, the movement has continued above the garage, at the garage door header, along with shifting at the top right corner of the wall. Have evaluated and repaired by a qualified foundation specialist.

Contact a foundation contractor.

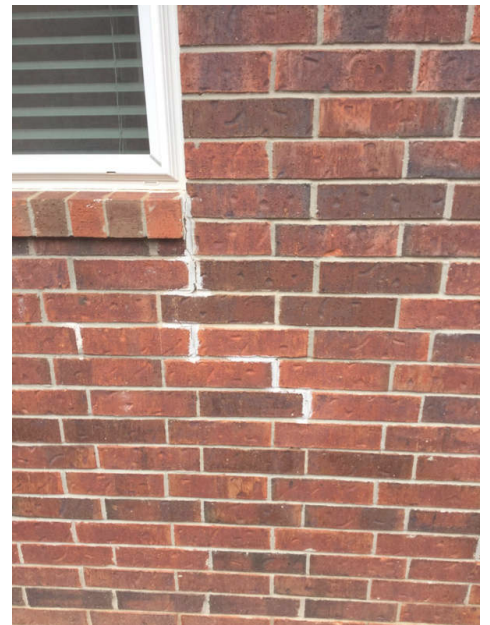
South Wall

STEP CRACK

This typically is an indication of structural movement. We recommend patching and monitoring unless otherwise stated in the structural section of the report.

Contact a qualified masonry professional.

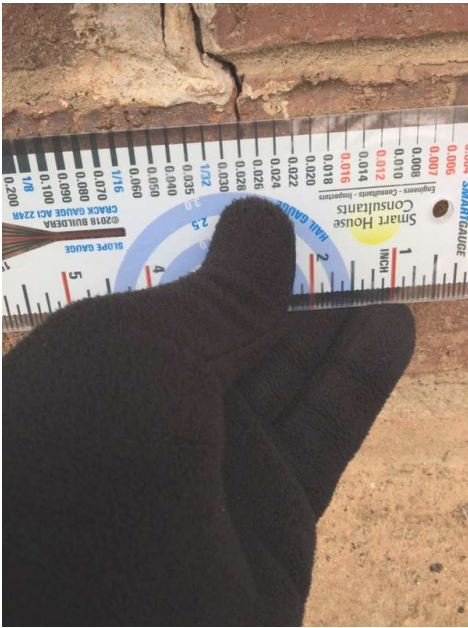
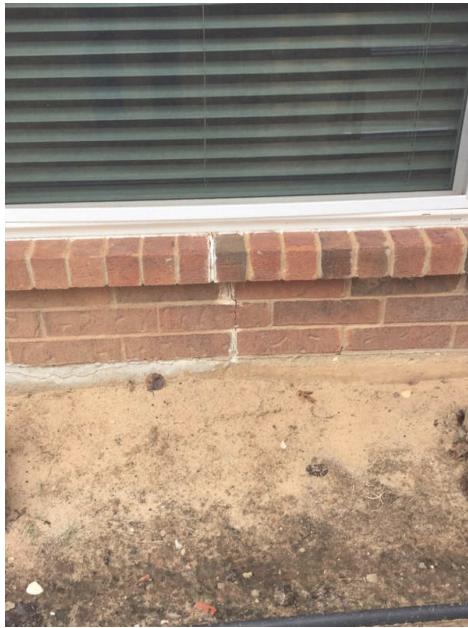
MORTAR/BRICK CRACKING - UNDER 1/4"

Siding showed cracking in one or more places. This cracking appears to be above average for this area. See Structure section under the wall area for recommendations.

Contact a foundation contractor.

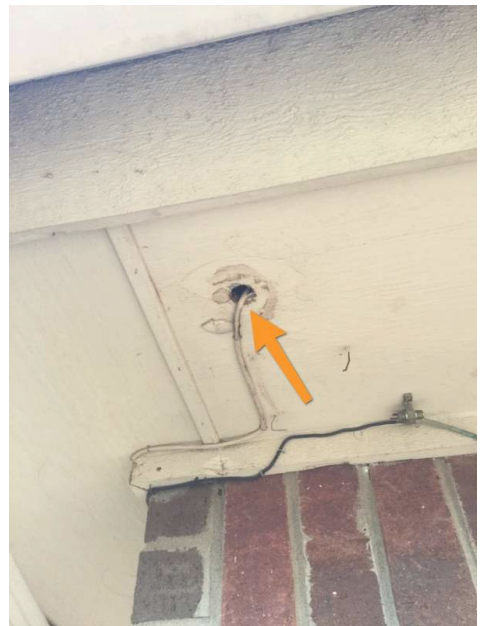
Northwest Corner Soffit

HOLES / GAPS AT EXTERIOR ENVELOPE

A hole was observed in an exterior wall. We recommend having this patched to prevent pest intrusion into.

Contact a handyman or DIY project

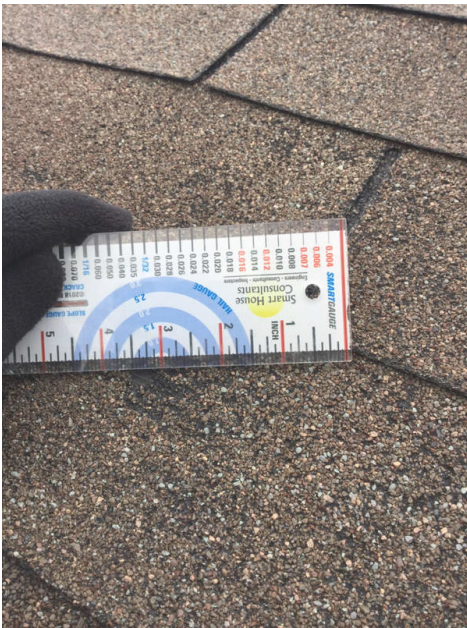
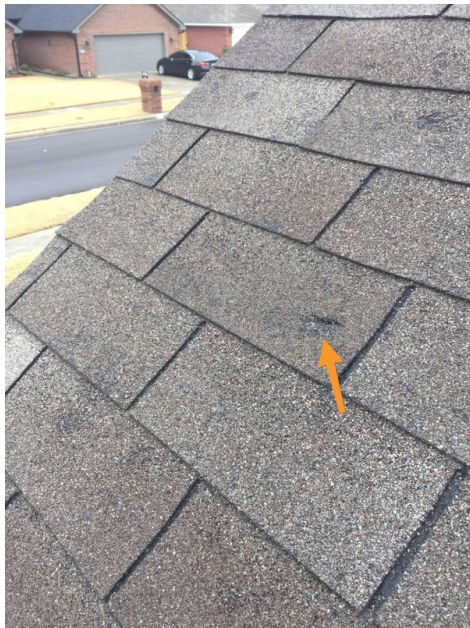
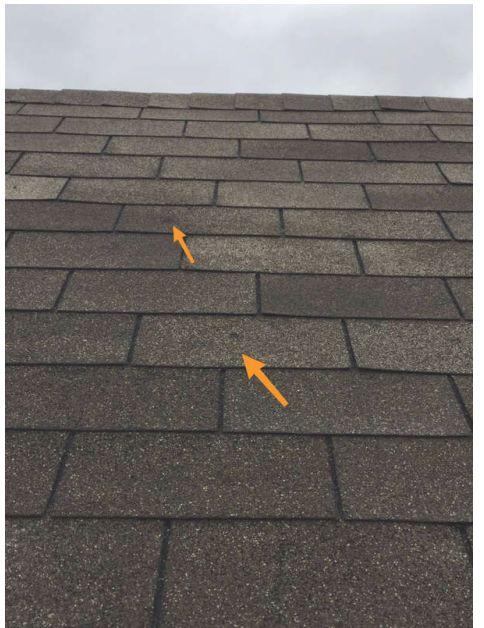
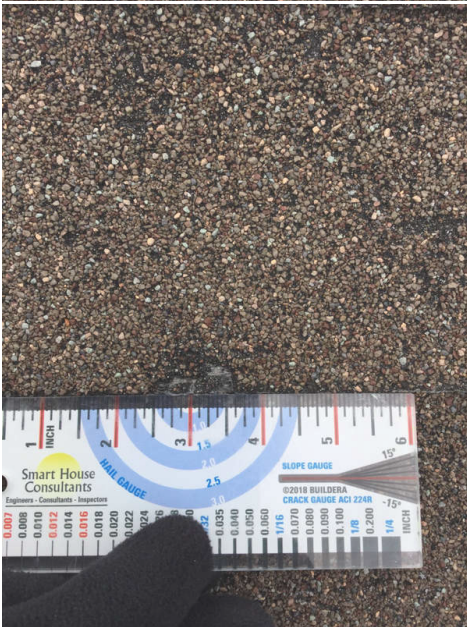
DAMAGED (GENERAL)

Roof coverings showed general shingle damaged with a hole extending to the decking, hail damage, and significant granule loss around the roof. Recommend a qualified roofing professional evaluate and repair.

Recommendation
Contact a qualified roofing professional.

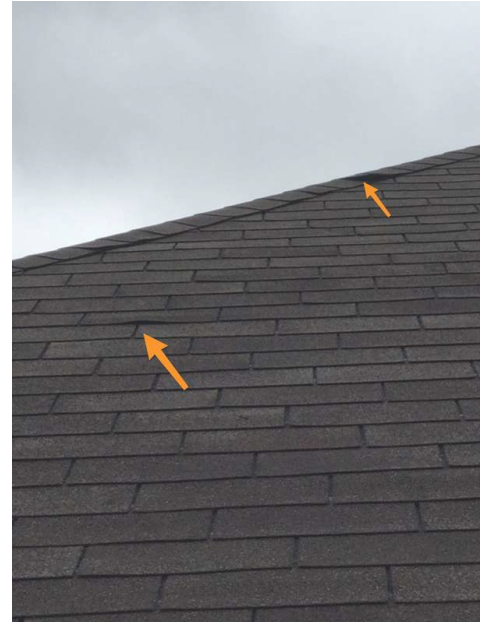
East Slope

NAIL POPS

The roofing material showed signs of nail pops. This is evident by shingles lifting from nails that back out over time. Left un-repaired these will often lead to shingle damage and holes from the nail head. Have these areas repaired as needed

Contact a qualified roofing professional.

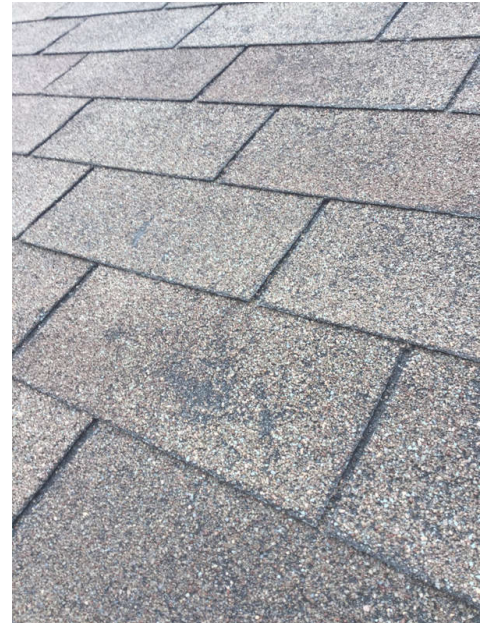
LOSS OF GRANULES

The roofing appears to have severe granule loss noted. Replacement will become necessary in the future. It would be wise to budget for the replacement.

Contact a qualified roofing professional.

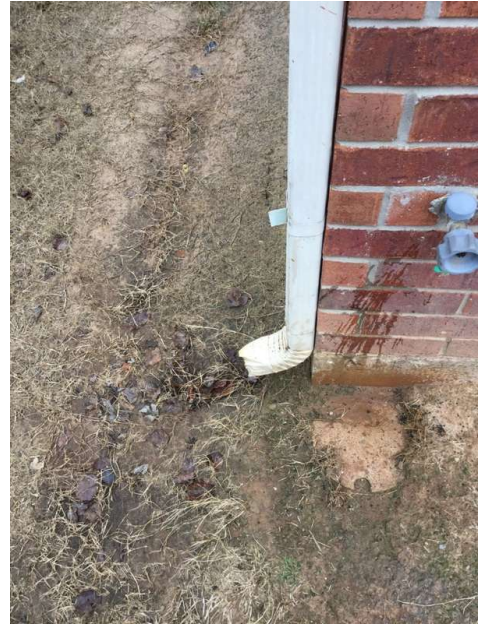
Northwest Corner

DOWNSPOUTS DRAIN NEAR HOUSE

One or more downspouts drain too close to the home's foundation. This can result in excessive moisture in the soil at the foundation, which can lead to foundation/structural movement. Recommend a qualified contractor adjust downspout extensions to drain at least 6 feet from the foundation.

Contact a qualified gutter contractor

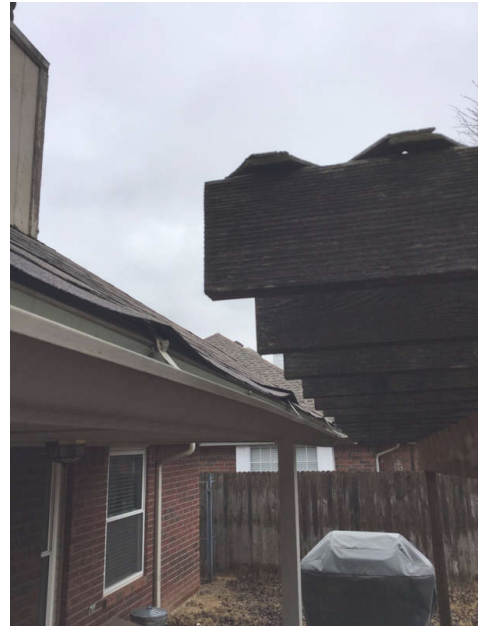
West Wall

GUTTER DAMAGED

Gutters were damaged. This can result in excessive moisture in the soil at the foundation, which can lead to foundation/structural movement. Recommend a qualified contractor evaluate and repair.

Contact a qualified gutter contractor

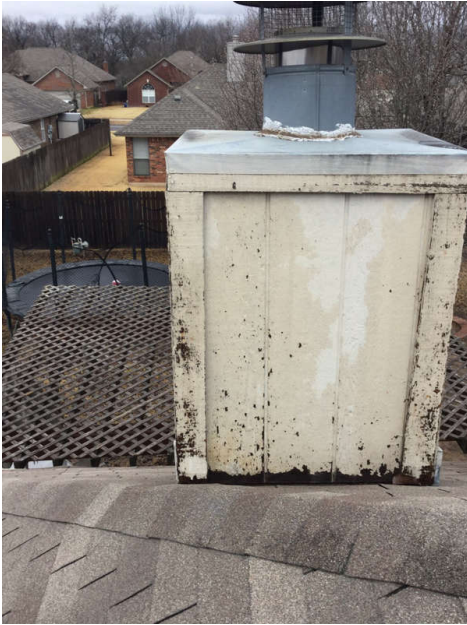
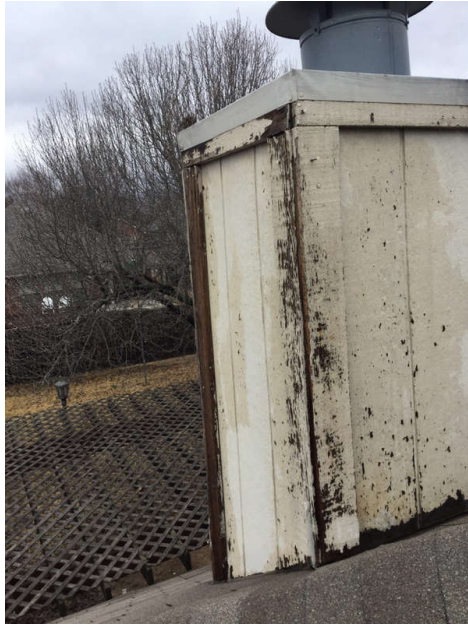
WOOD DECAYING / PEELING PAINT

Wood decay was observed on the fireplace trim. We recommend repairs/replacement to all decayed wood and repainting to properly prevent further deterioration and creating conducive conditions for wood destroying insect activity.

Contact a qualified carpenter.

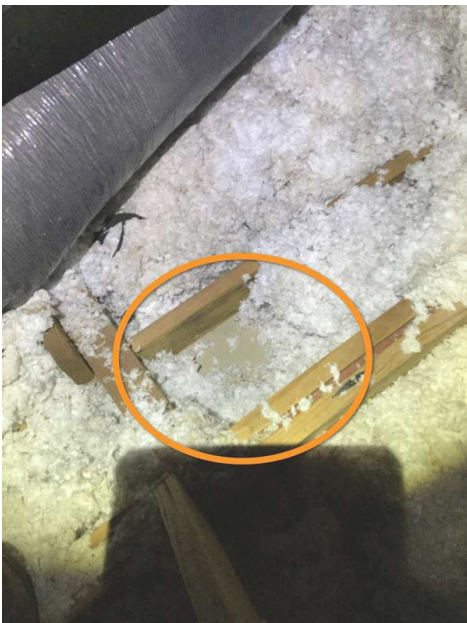
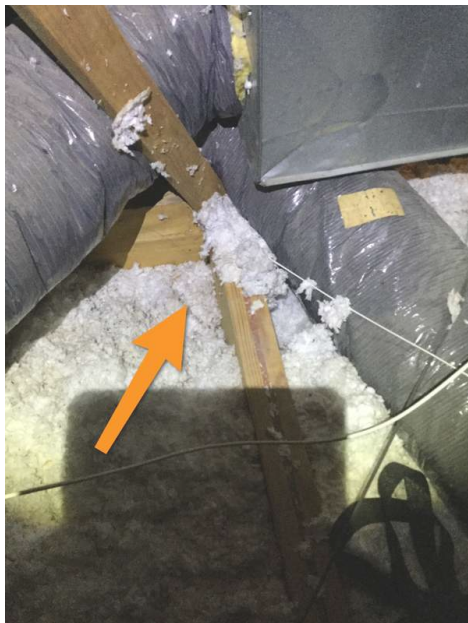
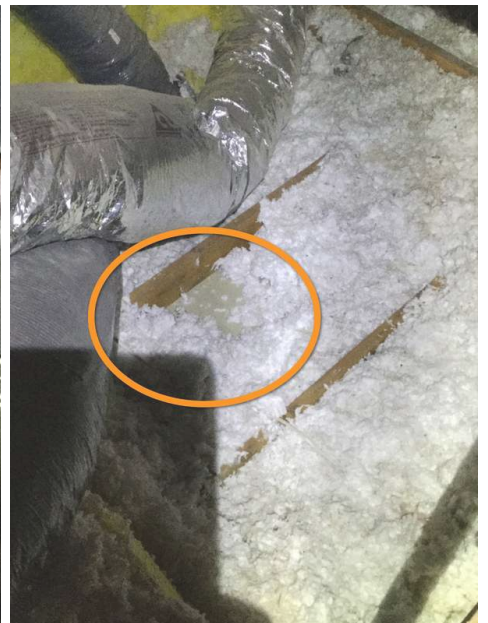
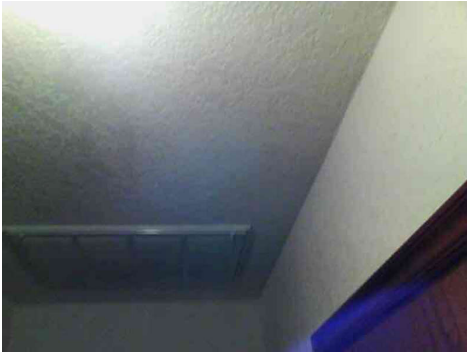
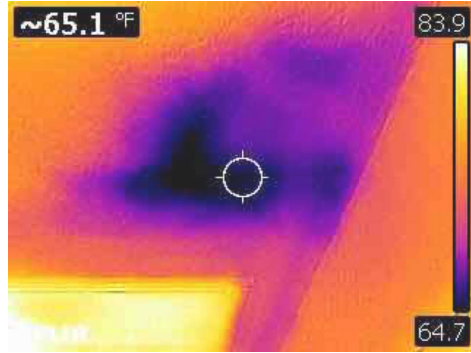
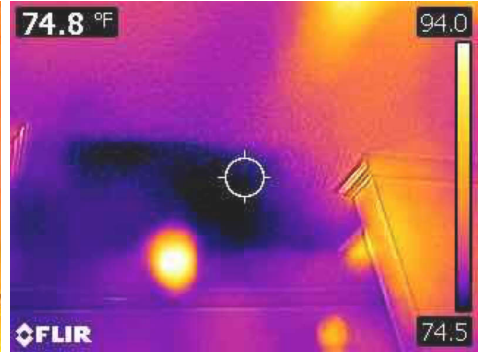
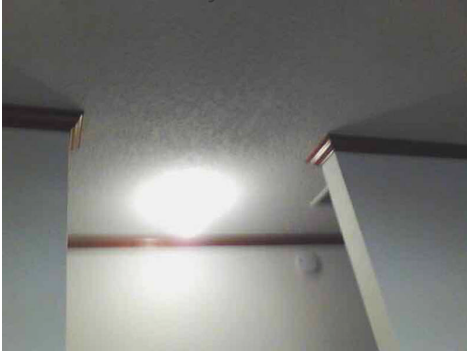
DISTURBED/UNLEVELED INSULATION

Insulation had areas where it was not as thick as others. Without insulation, the thermal boundary is incomplete causing the loss of heating and cooling and increasing utility costs

Contact a qualified insulation contractor.

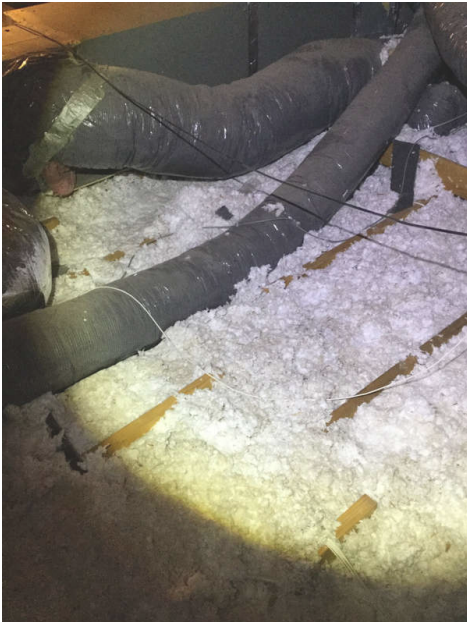
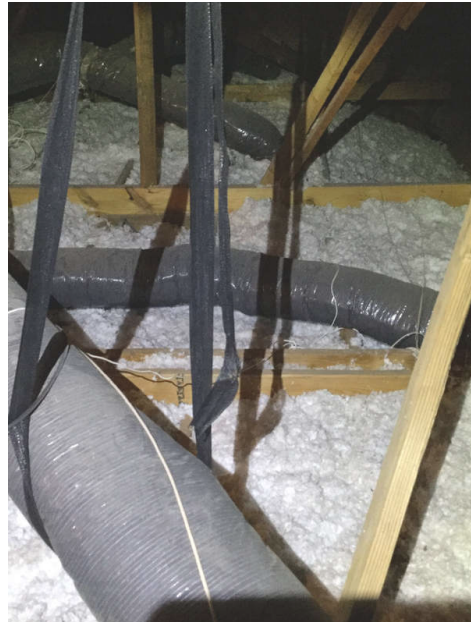
DUCT ON ATTIC FLOOR

Air ducts were placed on the attic floor. Today's standards do not allow this practice anymore as thermal bridging could create condensation inside the ductwork. We recommend having the strapped and elevated.

Contact a qualified heating and cooling contractor

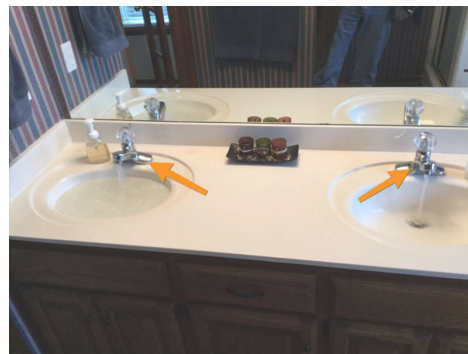
BLOCKED AERATOR

A blocked aerator was noted at a faucet during the inspection. We recommend cleaning to allow for proper flow.

Contact a qualified plumbing contractor.

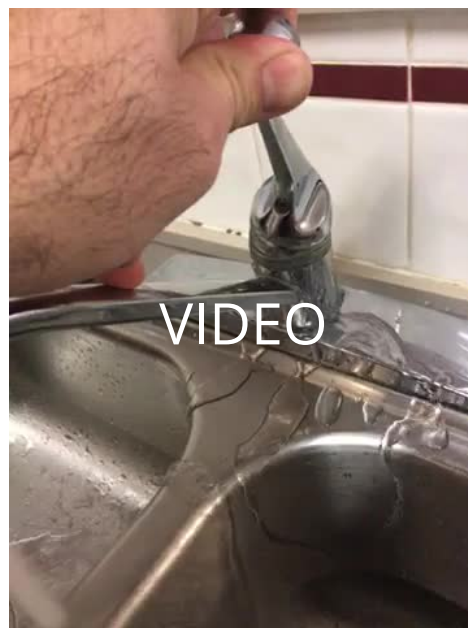
FAUCET STEM LEAKING

The faucet stems were leaking when the tub was operating. This may allow water intrusion into the wall and we recommend this be corrected.

Contact a qualified plumbing contractor.

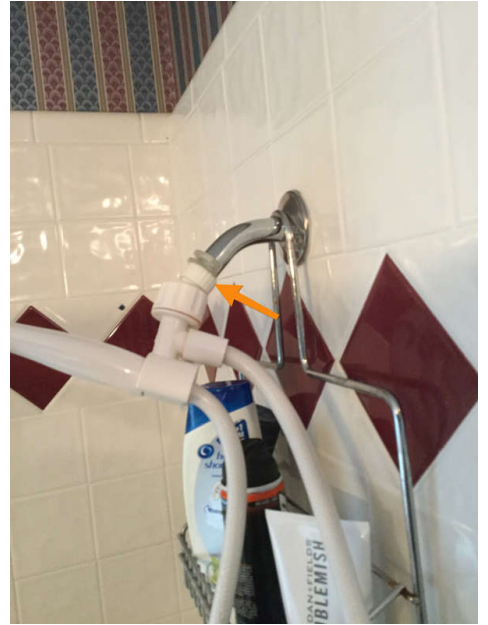
Master Bathroom

LEAK AT SHOWER HEAD

We observed a leak at a shower head at the time of inspection. We recommend having this repaired.

Contact a handyman or DIY project

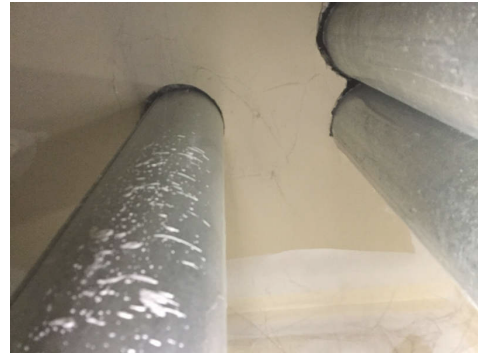
FLUE HAS IMPROPER CLEARANCE

Exhaust flue was improperly installed needs 1" clearance around combustibles. Recommend a qualified Plumbing contractor evaluate and repair.

Contact a qualified plumbing contractor.

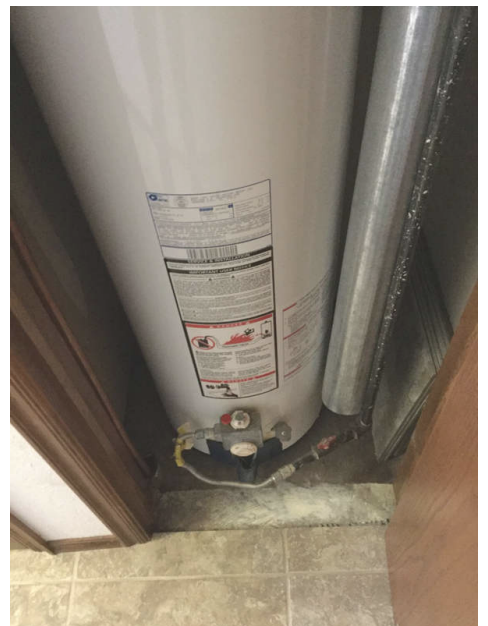
NO DRIP PAN

No drip pan was present. Recommend installation by a qualified plumber.

Contact a qualified plumbing contractor.

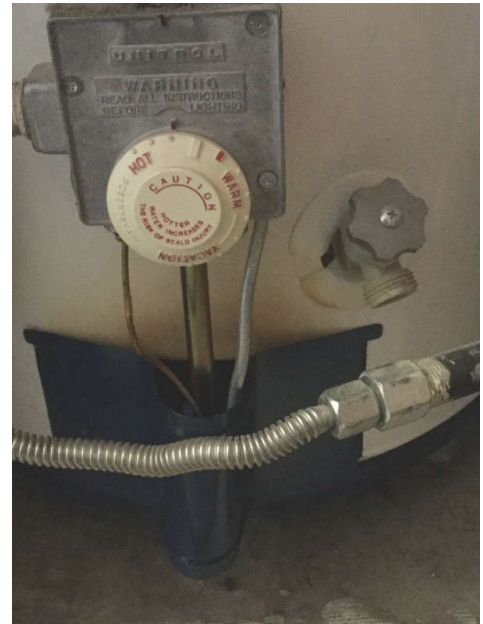
VISIBLE SCORCHING

Scorching of the water heater exterior visible near the burn chamber access cover indicated a need for servicing. We recommend repair.

Contact a qualified plumbing contractor.

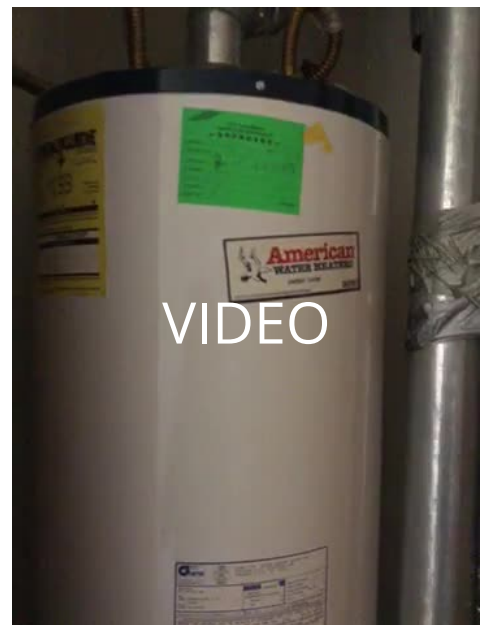
NOISY WATER HEATER

The water heater appeared to be excessively noisy during the inspection with gurgling sounds. This is common with sediment build up on the inside of the water heater. I recommend budgeting for replacement.

Contact a qualified professional.

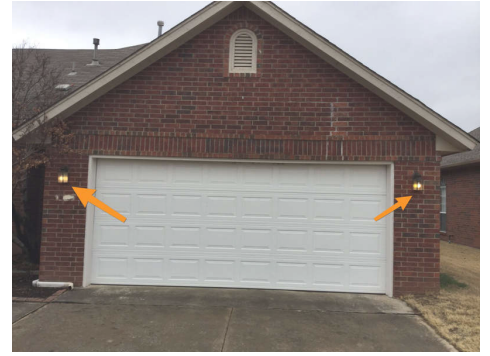
EAST WALL

LOOSE EXTERIOR LIGHT FIXTURE

Loose fixtures can result in damage to the wiring for the fixture. Have this securely attached.

Recommendation
Contact a qualified electrical contractor.

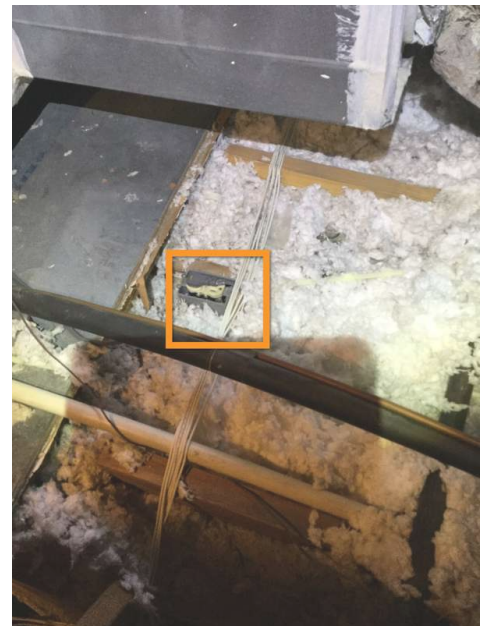
Front right of furnace

COVER PLATES MISSING

One or more receptacles are missing a cover plate. This causes short and shock risk. Recommend installation of plates.

Recommendation
Contact a handyman or DIY project

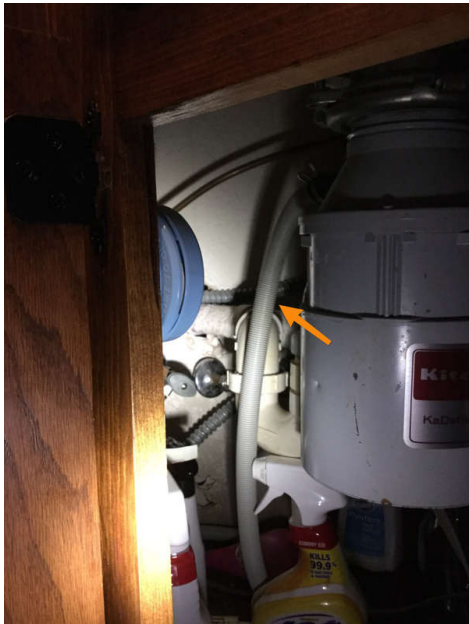
NO HIGH LOOP INSTALLED

The dishwasher drain line (discharge hose) did not have an air gap or a high loop. The dishwasher drain line usually attaches to the garbage disposal. The drain line should either arch above the level of the sink drain, have an anti-siphon valve, or have a vacuum break. This keeps debris in the disposal from siphoning back to the clean dishes. We recommend the drain line be elevated or a back flow device installed.

Recommendation
Contact a qualified appliance repair professional.

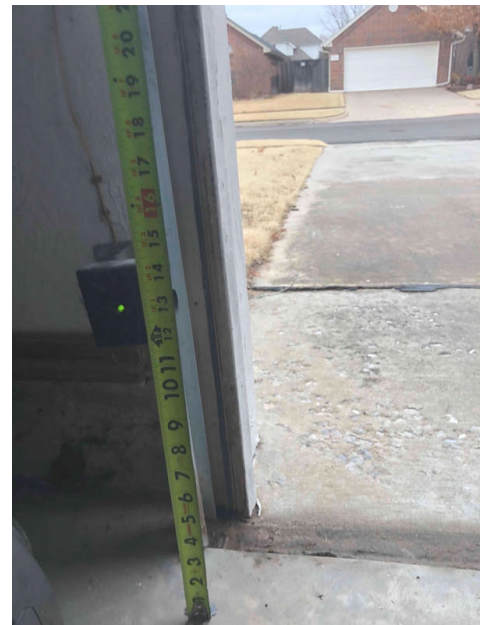
SAFETY REVERSING SENSOR IS NOT MOUNTED IN ITS CORRECT LOCATION

Safety reversing sensors installed anywhere but 6-8 inches above the floor on either side of the overhead door offer no safety protection whatsoever. Reposition to its correct location to improve safety effectiveness.

Contact a qualified garage door contractor.

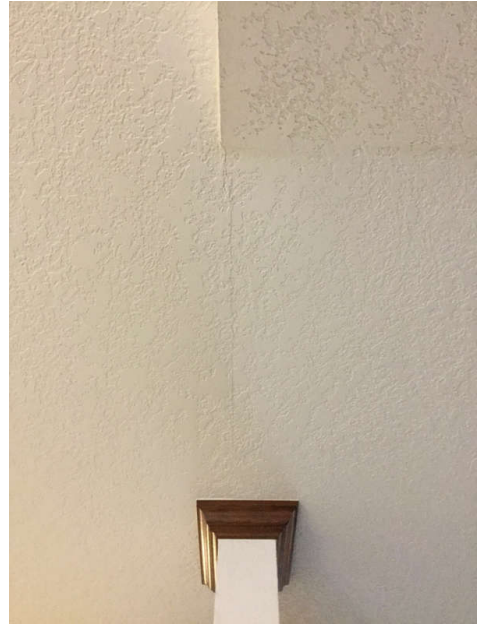
Living Room

HAIRLINE CRACKS

Hairline cracks which were by nature mainly cosmetic were noted on the ceiling. We recommend having these caulked and painted.

Contact a qualified drywall contractor.

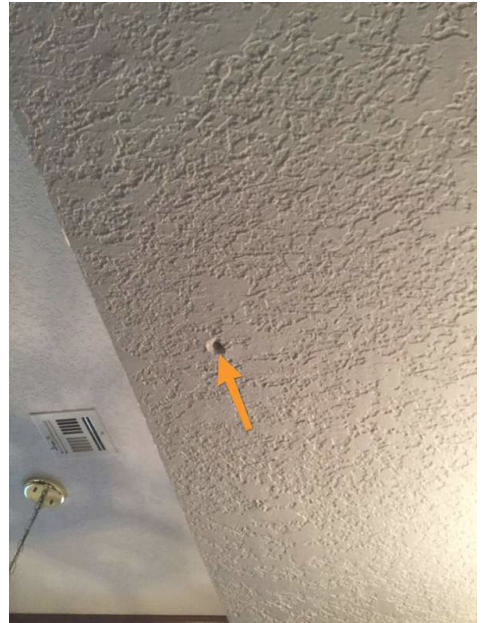
NAILPOPS

Nailpops which are by nature cosmetic were noted. We recommend these be re-secured, caulked and painted.

Contact a qualified drywall contractor.
