SUMMARY
1234 Main St. Uniontown OH 44685
Buyer Name
09/12/2018 9:00AM

Ron Fast
Certified Master Inspector, ASHI,
InterNACHI, Radon, Pest, Thermal
First-In Home Inspection
3307600094
ron@firstinohio.com

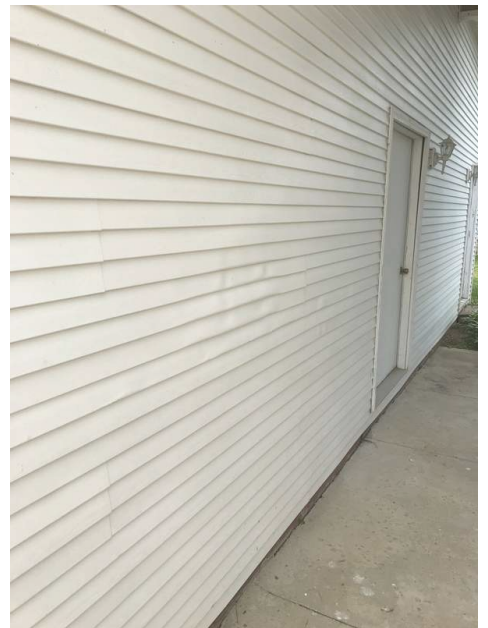
2.5.1 Siding & Trim

WARPING/BUCKLING

Vinyl siding was warping or buckling in areas. This is often as a result of nailing siding boards to tight to the home, preventing expansion/contraction. Recommend a qualified siding contractor evaluate and repair.

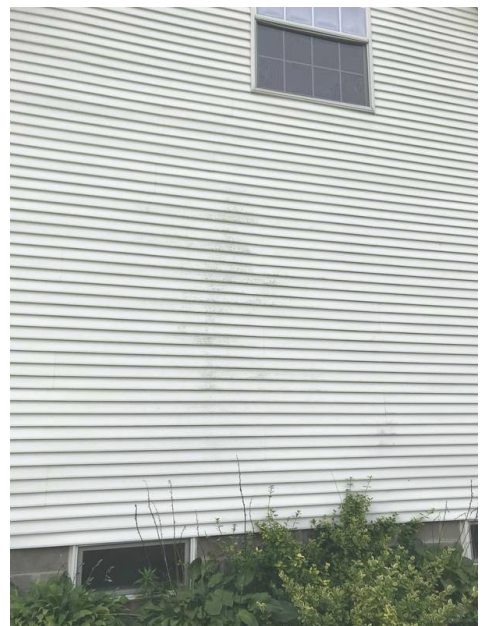
2.5.2 Siding & Trim

MOSS/ALGAE (SIDING)

Moss/Algae present on exterior covering. Recommend removal to prevent premature wear.

Recommendation
Recommended DIY Project

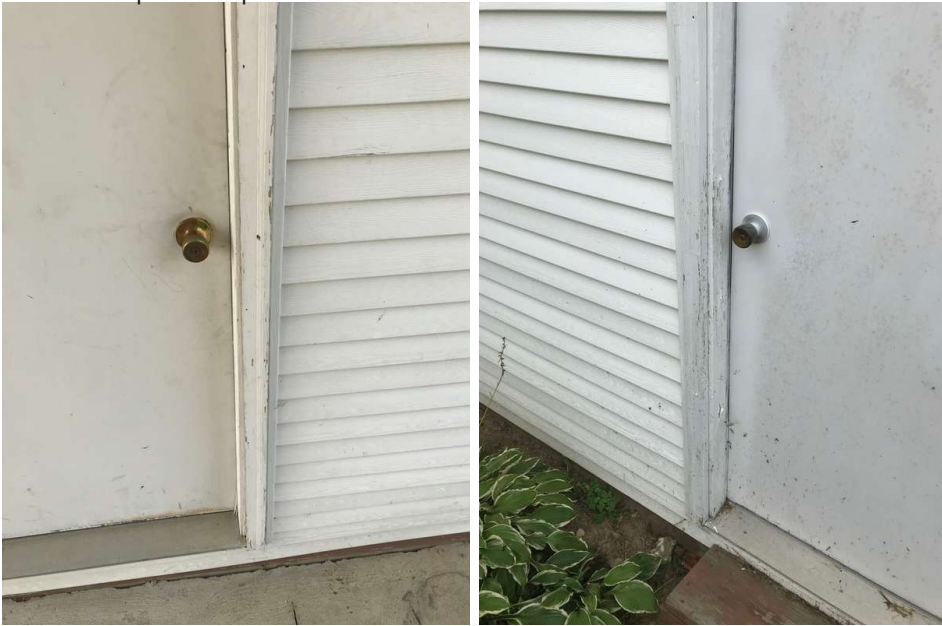
2.5.3 Siding & Trim

WEATHERED WOOD TRIM

Areas of wood trim had peeling paint or were weathered and in need of fresh paint.

Contact a qualified professional.

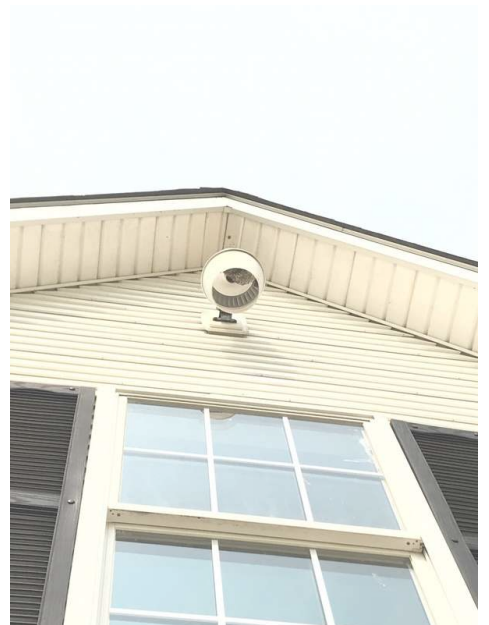
2.5.4 Siding & Trim

BEE NEST

Recommend removal of bee nest.

Contact a qualified professional.

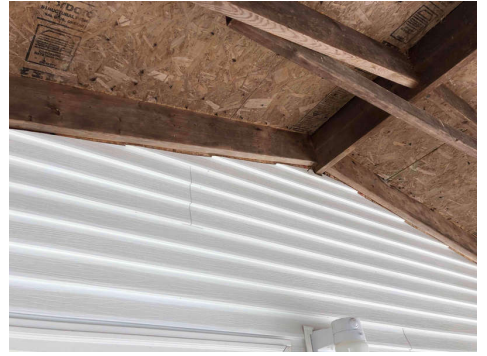
2.5.5 Siding & Trim

MISSING J-CHANNEL AT EXTERIOR SIDING

Contact a qualified professional.

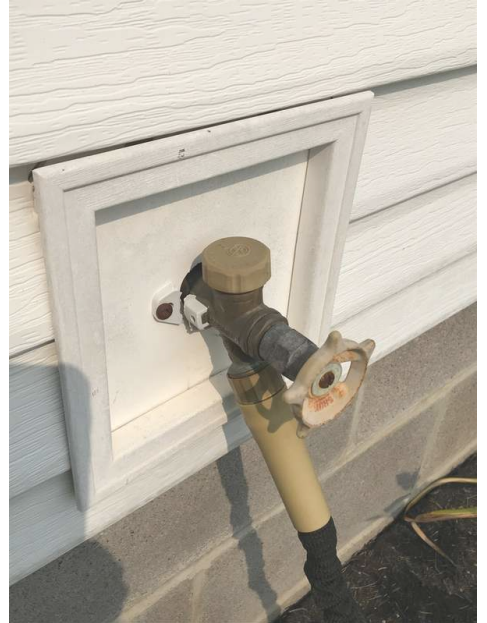
2.12.1 Exterior Plumbing

LOOSE HOSE BIB

The exterior faucet was loose and needs properly secured to prevent damage to the water lines. Recommend repair.

Contact a qualified professional.

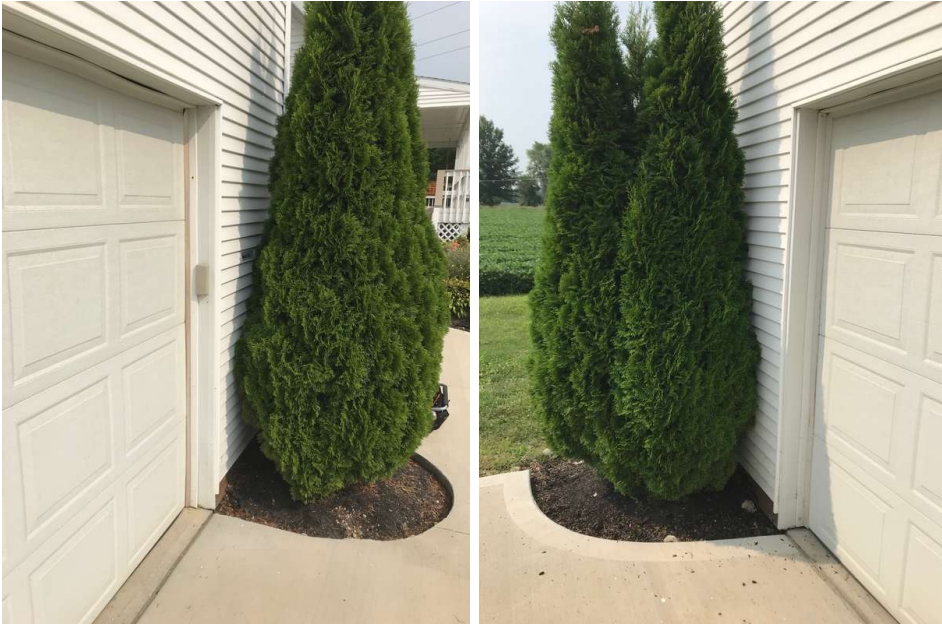
2.14.1 Vegetation

VEGETATION (CONTACT W/ EXTERIOR)

There was vegetation in contact with the exterior of the dwelling. Vegetation in contact with the exterior can cause premature deterioration of roof and siding, and make an easy entry point for pest. Recommend clearance of 12 inches of the vegetation from exterior walls.

Contact a qualified professional.

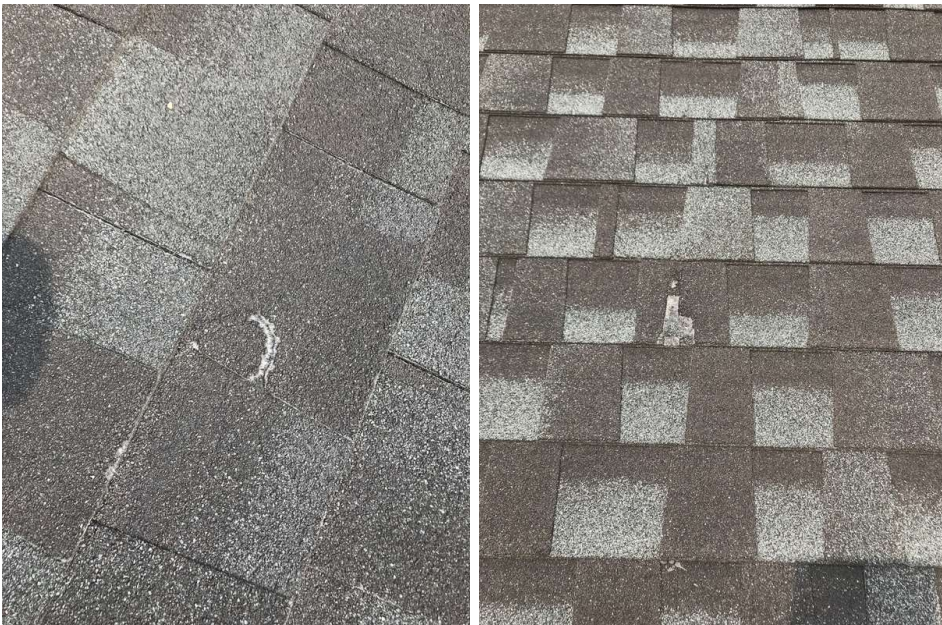
3.1.1 Shingles

DAMAGE (WIND)

Creased or torn tabs

The roof had areas of wind damage such as broken adhesive strips and creased or torn shingle tabs. The Inspector recommends replacement of the damaged shingles by a qualified roofing contractor to avoid damage from moisture intrusion.

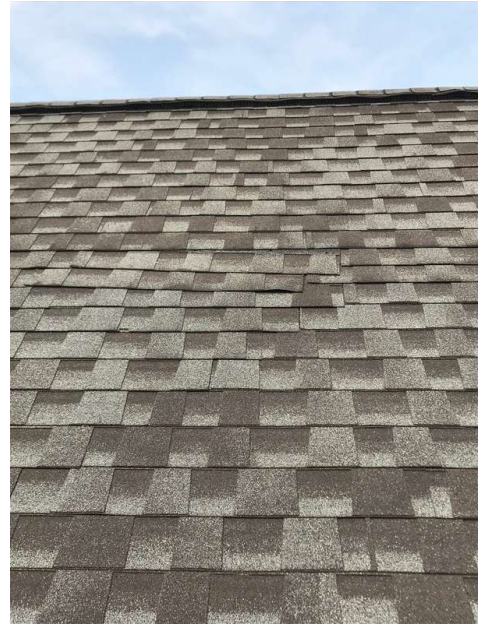
3.1.2 Shingles

LOOSE OR MISSING SHINGLES (WIND)

The roof had loose or missing shingles.

The Inspector recommends replacement of any loose or missing shingles by a qualified roofing contractor to avoid damage from moisture intrusion.

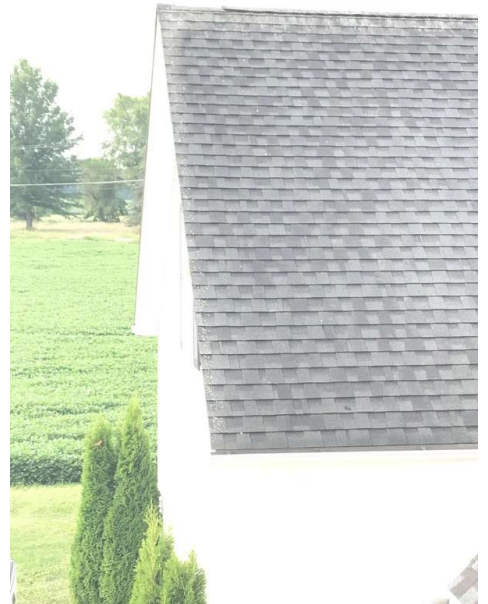
3.1.3 Shingles

MOSS BUILD-UP

Moss build up on the roof usually results from excessive shade and can lead to shortened roof life and increased risk of leaks.

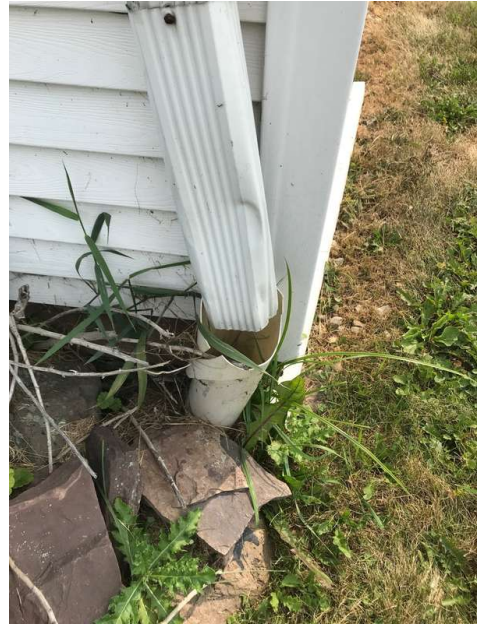
3.6.1 Roof Drainage Systems

GUTTERS (DISCONNECTED)

One or more gutter sections needed to be re-connected in order to properly control roof run-off. This condition can result in excessively high moisture levels in soil at the foundation. Excessive moisture levels in soil near the foundation can effect the ability of the soil to support the weight of the structure above and can cause damage related to soil/foundation movement. The Inspector recommends repair to help protect the home structure and occupants. All work should be performed by a qualified contractor.

Recommendation
Contact a qualified professional.

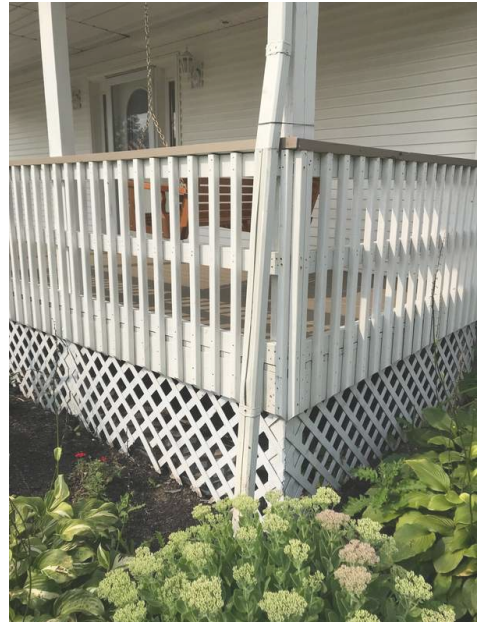
3.6.2 Roof Drainage Systems

GUTTERS (LOOSE)

Gutters were loose in areas and should be securely re-attached by a qualified contractor.

Recommendation
Contact a qualified professional.

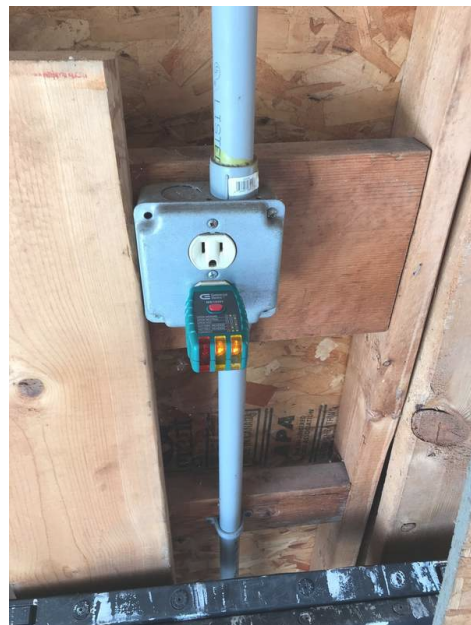
4.3.1 Electrical

OUTLETS (OK/NO GFCI)

Electrical receptacles in the garage appeared to be in serviceable condition at the time of the inspection but had no Ground Fault Circuit Interrupter (GFCI) protection. Although this condition may have been commonly considered safe or acceptable at the time the home was originally constructed, as general knowledge of safe building practices has improved with the passage of time, building standards have changed to reflect current understanding. Consider having GFCI protection installed as a safety precaution. This can be achieved by: 1. Replacing the current standard receptacles with GFCI receptacles 2. Replacing the receptacle in the garage circuit which is nearest the main electrical service panel with a GFCI receptacle. 3. Replacing the breaker currently protecting the electrical circuit that contains these garage receptacles with a GFCI breaker.

Recommendation
Contact a qualified professional.

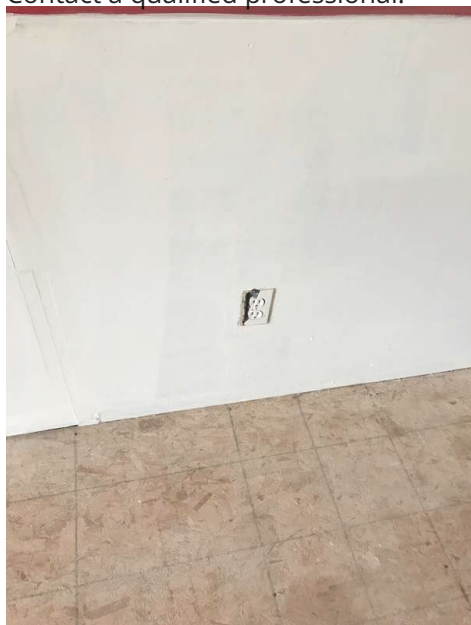
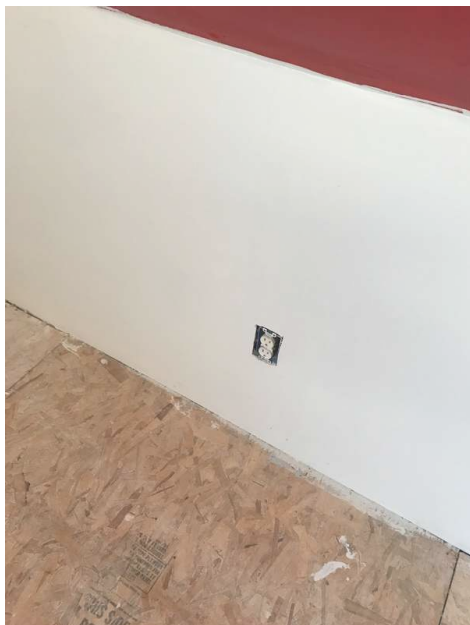
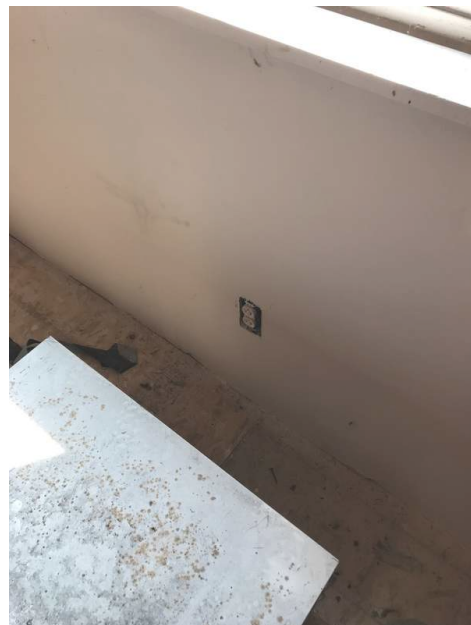
4.3.2 Electrical

COVER PLATES (MISSING)

At the time of the inspection, electrical receptacle cover plates were missing in the garage. This condition left energized electrical components exposed to touch, a shock/electrocution hazard. The Inspector recommends that cover plates be installed by a qualified contractor.

Recommendation
Contact a qualified professional.

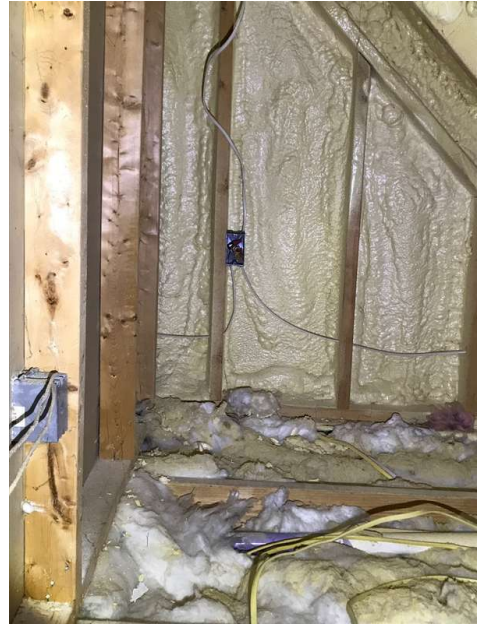
5.6.1 Electrical

COVER PLATE MISSING

Cover plate(s) are missing from one or more electric boxes, such as for receptacles, switches and/or junction boxes. They are intended to contain fire and prevent electric shock from exposed wires. This is a safety hazard due to the risk of fire and shock. Cover plates should be installed where missing.

Contact a qualified electrical contractor.

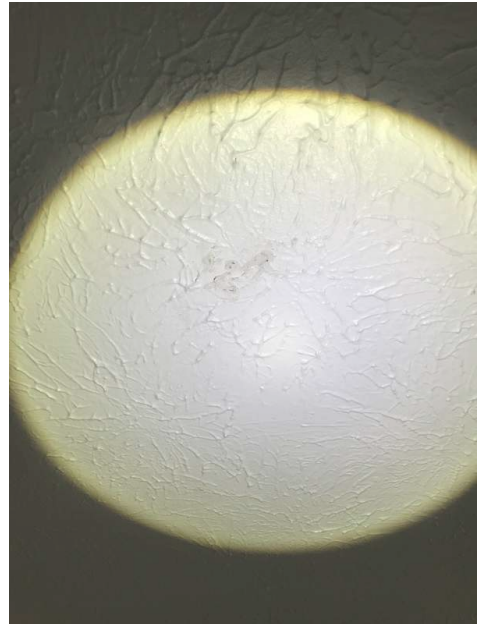
6.1.1 Floors, Walls, Ceilings
CEILING PATCH
2ND FLOOR NORTH BEDROOM

Recommendation
Recommend monitoring.

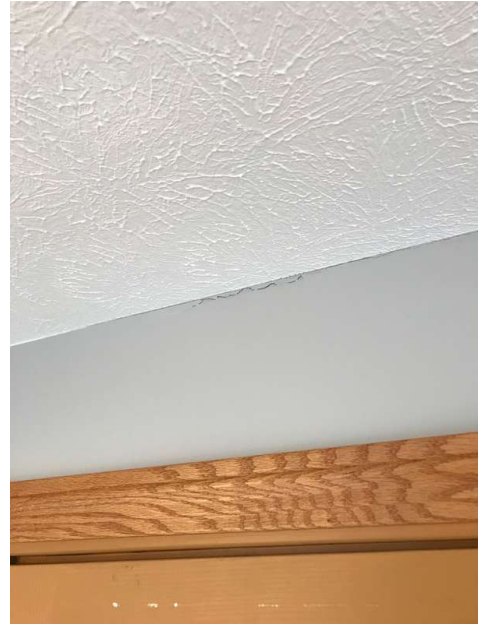
6.1.2 Floors, Walls, Ceilings
CEILING-MINOR CRACKS

Minor cracks were found in ceilings in one or more areas. They do not appear to be a structural concern, but the client(s) may wish to repair these for aesthetic reasons.

Recommendation
Contact a qualified drywall contractor.

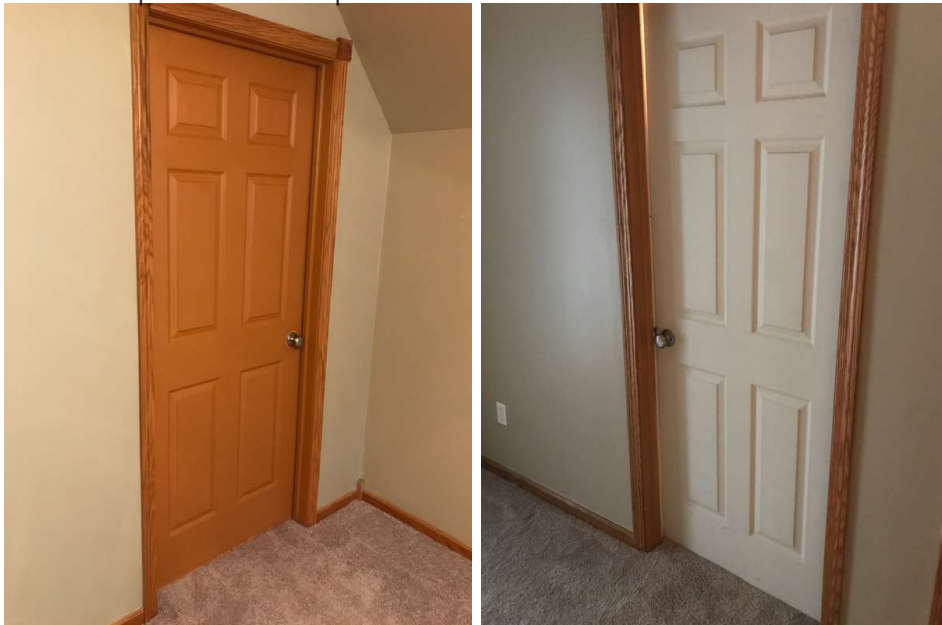
6.3.1 Windows and Doors

DOOR-BINDS IN JAMB

2ND FLOOR SOUTH BEDROOM, 2ND FLOOR CLOSET

One or more doors bind in their jamb and cannot be closed and latched, or are difficult to open and close. A qualified contractor should evaluate and repair as necessary. For example, adjusting jamba or trimming doors.

Contact a qualified door repair/installation contractor.

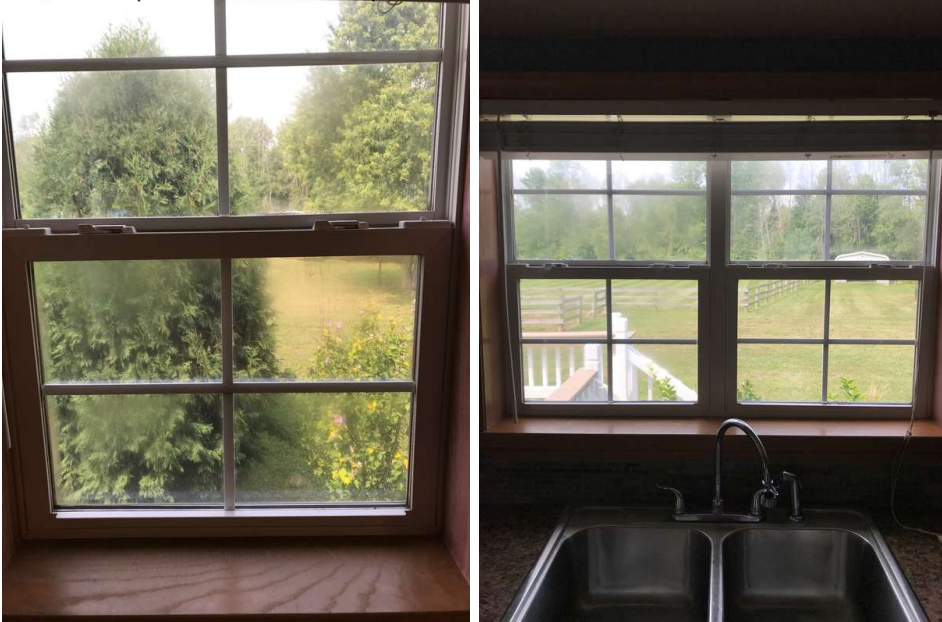
6.3.2 Windows and Doors

WINDOW-DOUBLE PANE SEAL

Seals between double-pane glass in one or more windows appear to have failed based on condensation or stains between the panes of glass. A qualified contractor should evaluate and replace glass where necessary.

Contact a qualified window repair/installation contractor.

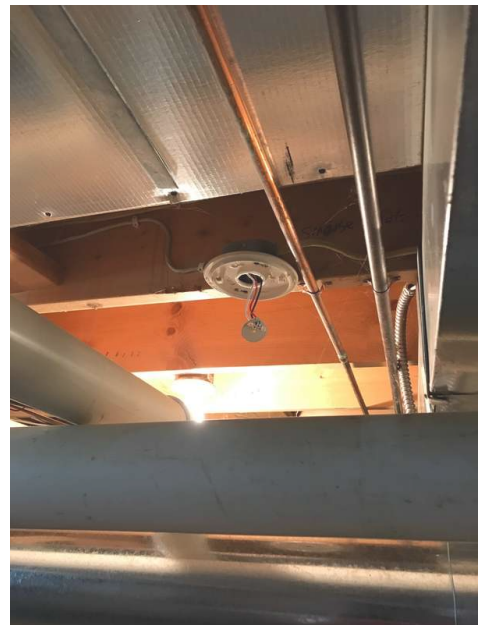
6.5.1 Smoke and CO alarms

SMOKE ALARMS MISSING

Smoke alarms were missing from one or more bedrooms / from one or more hallways leading to bedrooms / on one or more levels. Smoke alarms should be installed as necessary so a functioning alarm exists in each hallway leading to bedrooms, in each bedroom, on each level, in rooms with a fireplace and in any attached garage.

Recommended DIY Project

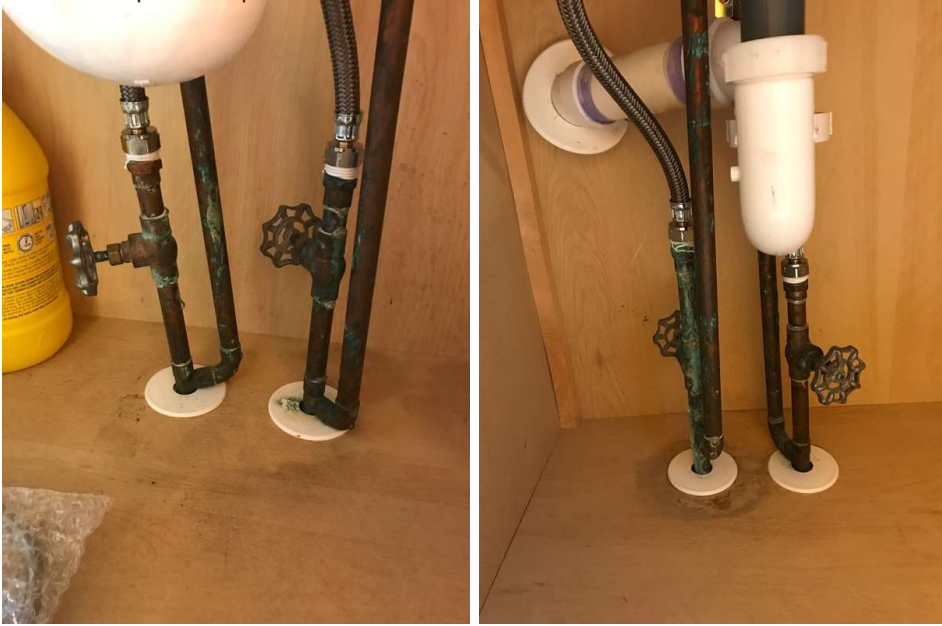
7.1.1 General

SUPPLY PIPES (CORRODED/NOT ACTIVELY LEAKING)

Heavily corroded faucet supply pipes beneath the sink in this bathroom are liable to leak soon. The Inspector recommends replacement by a qualified contractor to prevent future damage to the cabinet floor and possibly the home wall/floor structures.

Recommendation
Contact a qualified professional.

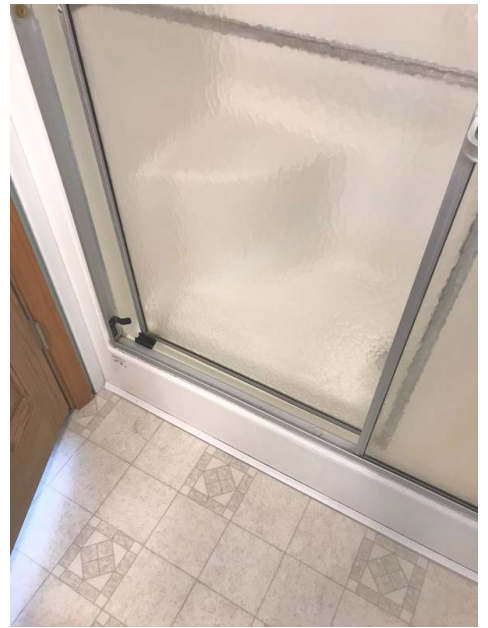
7.1.2 General

SHOWER DOOR LOOSE

The shower door is loose. Recommend repair.

Recommendation
Contact a qualified professional.

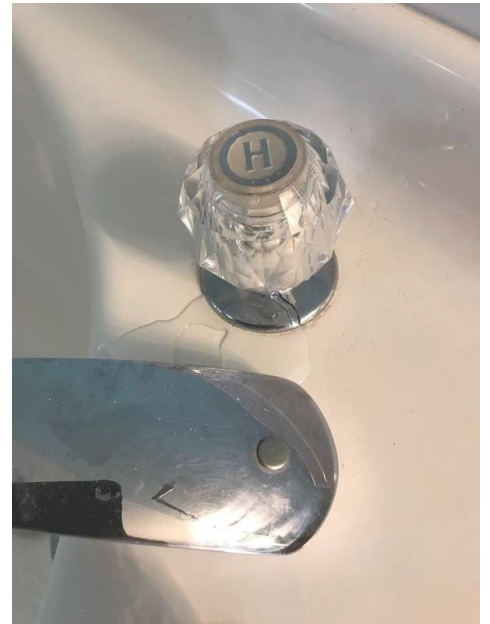
7.3.1 Sinks and Faucets

FAUCET LEAKING

A fixture is leaking which is causing wasted water. Recommend correction by replacing faucet.

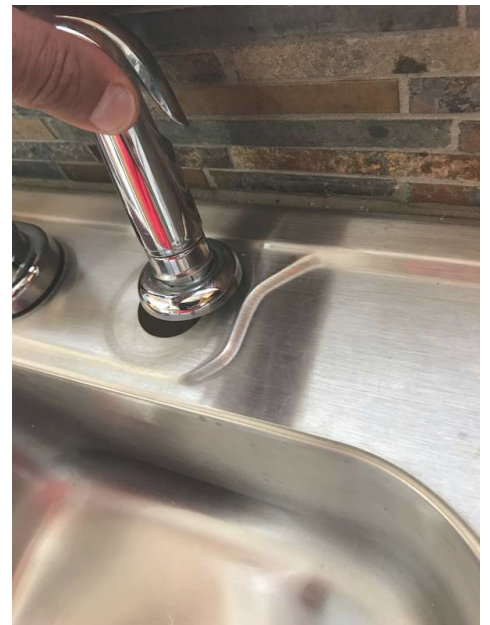
9.2.1 Sink

SPRAY WAND IS LOOSE

The spray wand is loose and needs secured.

Contact a qualified professional.

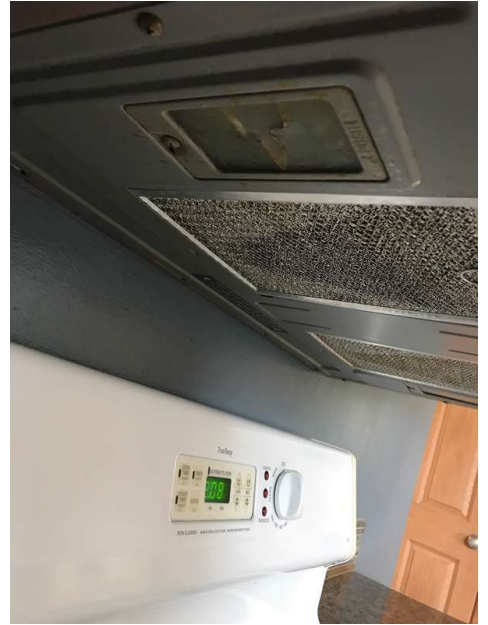
10.4.1 Microwave

LIGHT DID NOT OPERATE

The lights on the microwave did not operate when tested. The bulbs may need replaced. And the the plastic cover is damaged.

Contact a qualified professional.

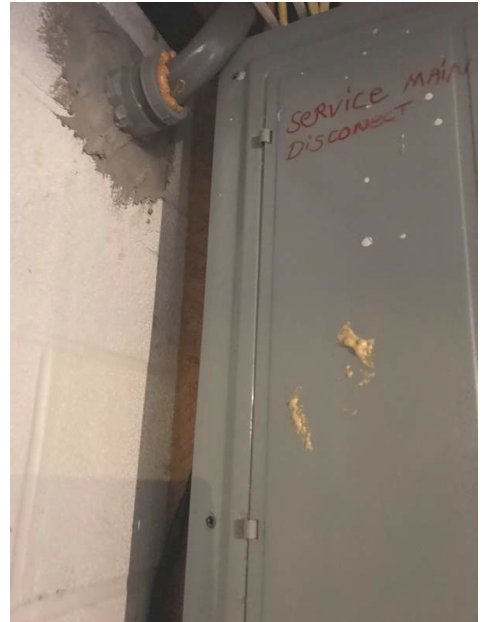
11.1.1 Main & Sub Panels

PANEL SCREWS (IMPROPER/MISSING)

Improper and/or missing panel screws. Recommend use of proper panel screws for the dead front cover.

Contact a qualified professional.

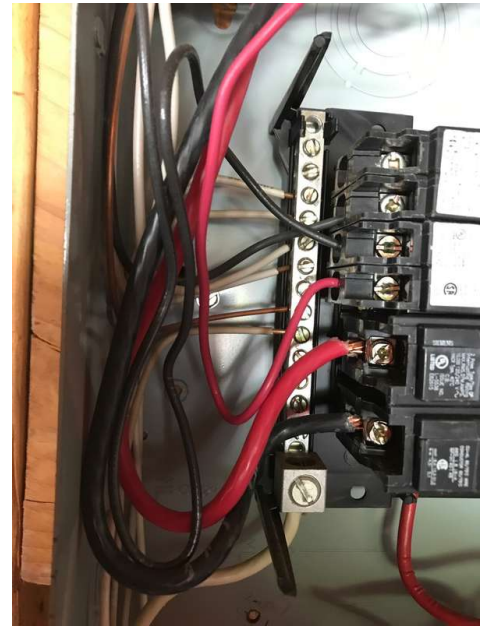
11.1.2 Main & Sub Panels

SUBPANEL (NEUTRAL/GROUND BOND)

Neutral and equipment ground wires were bonded (connected) at sub-panel(s). This should only occur in the main service panel, not sub-panels, and is a shock hazard. Neutral wires should be attached to a "floating" neutral bar not bonded to the panel, and grounding wires should be attached to a separate grounding bar bonded to the sub-panel. Recommend that a qualified electrician repair per standard building practices.

Contact a qualified professional.

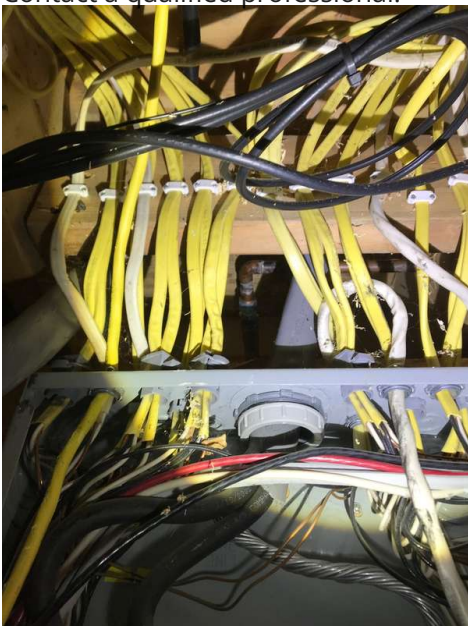
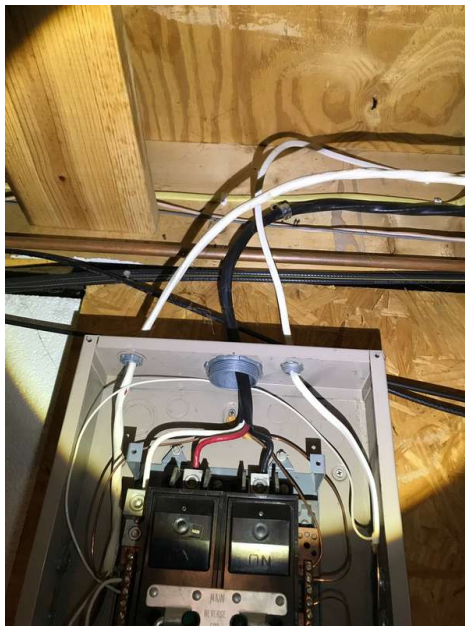
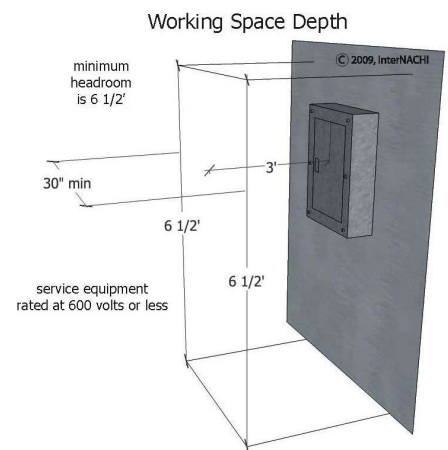
11.1.3 Main & Sub Panels

WATER LINES ABOVE PANEL

(a) Dedicated Electrical Space. The space equal to the width and depth of the equipment and extending from the floor to a height of 1.8 m (6 ft) above the equipment or to the structural ceiling, whichever is lower, shall be dedicated to the electrical installation. No piping, ducts, leak protection apparatus, or other equipment foreign to the electrical installation shall be located in this zone.

(b) Foreign Systems. The area above the dedicated space required by 110.26(F)(1)(a) shall be permitted to contain foreign systems, provided protection is installed to avoid damage to the electrical equipment from condensation, leaks, or breaks in such foreign systems.

Contact a qualified professional.

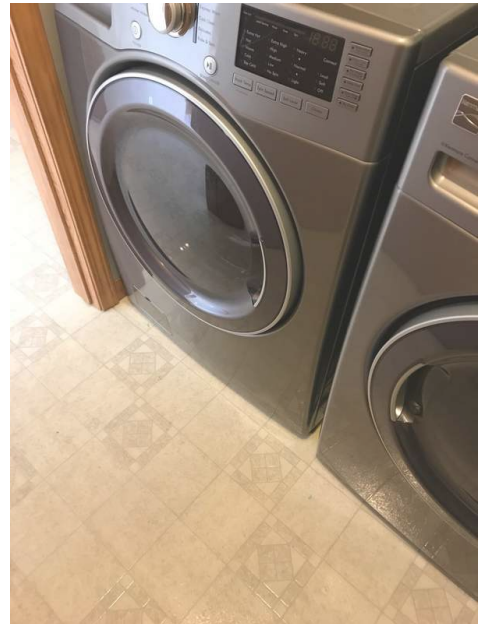
12.1.1 General

NO CATCH PAN

The washing machine is installed over a finished living space and has no catch pan or drain installed. These are not commonly installed, but they are recommended to prevent water damage to finished interior spaces below if or when the washing machine leaks, overflows or is drained. Recommend having a qualified contractor install both a catch pan and drain.

Contact a qualified professional.

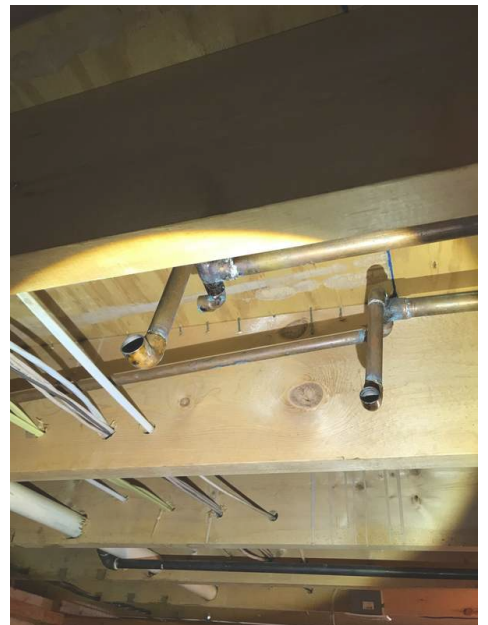
13.2.1 Distribution Pipes

UNCAPPED WATER LINE

Recommend capping unused water lines to prevent a leak.

Contact a qualified plumbing contractor.

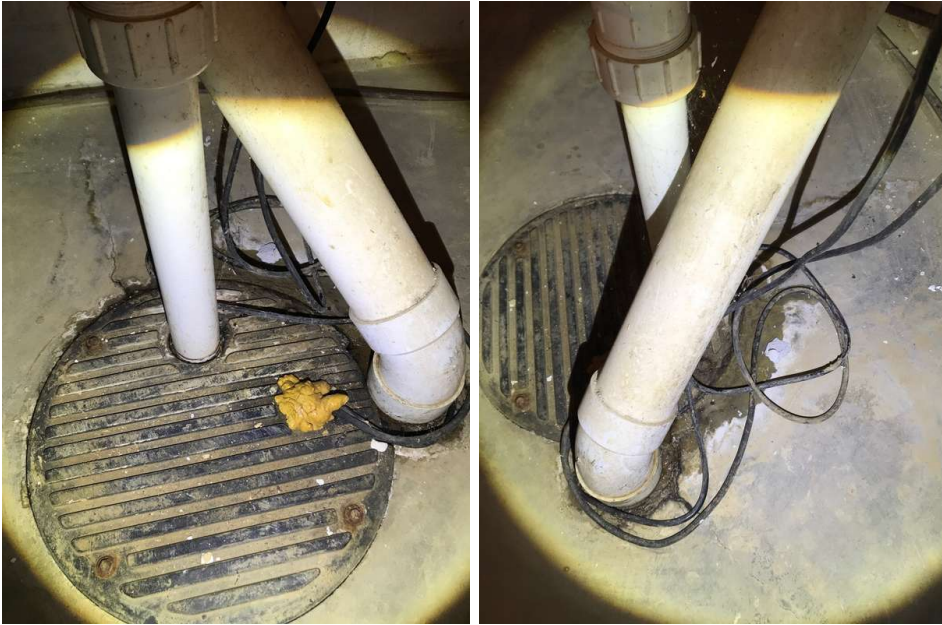
13.4.1 Sump Pumps / Sewage Ejectors

SEWAGE EJECTOR PUMP (LEAKING/FUMES)

The area around the sewage ejector pump had a strong odor, indicating that sewer gas is leaking into the living space. This condition should be corrected by a qualified contractor.

Contact a qualified professional.

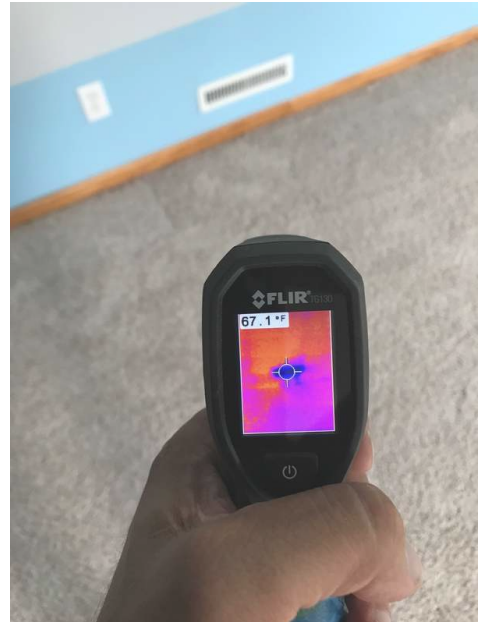
14.1.1 Cooling Equipment
SYSTEM (INADEQUATE COOLING)
2ND FLOOR

The air-conditioning system operated, but the air produced by the system was not cool enough. The Inspector recommends service by a qualified HVAC technician.

Recommendation
Contact a qualified professional.

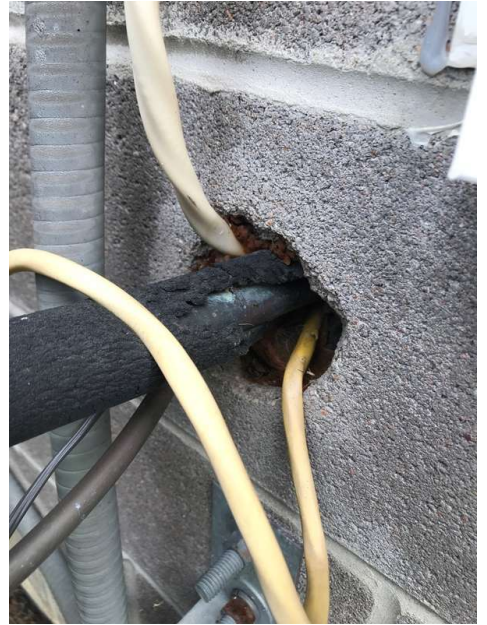
14.1.2 Cooling Equipment
WALL PENETRATION (SEAL)

The hole in the exterior wall-covering cut to allow penetration of air-conditioning lines should be sealed with an appropriate sealant to prevent moisture and insect entry.

Recommendation
Contact a qualified professional.

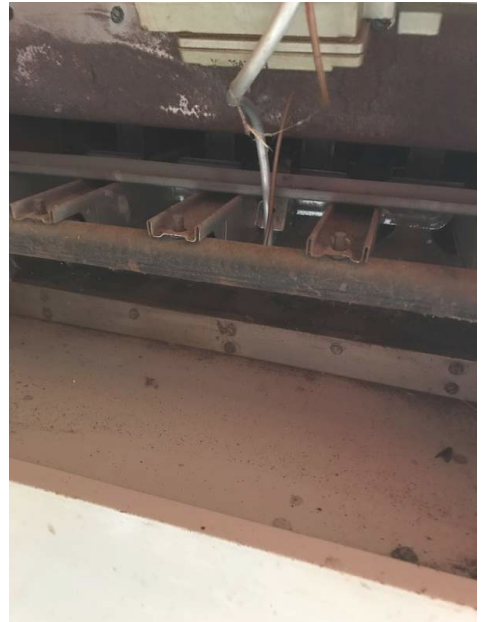
15.1.1 Heating Equipment

NO RESPONSE

This furnace did not respond to the thermostat. The Inspector recommends that before the expiration of the Inspection Objection Deadline you have this furnace serviced by a qualified HVAC contractor.

Recommendation
Contact a qualified professional.

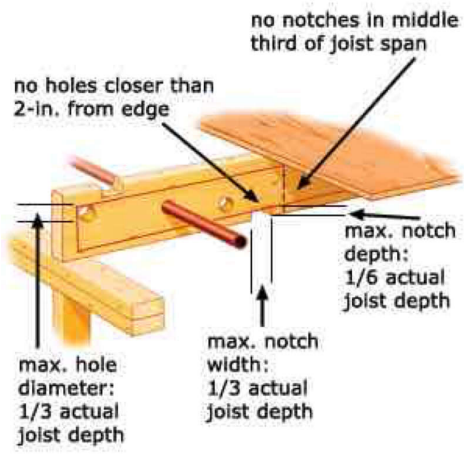
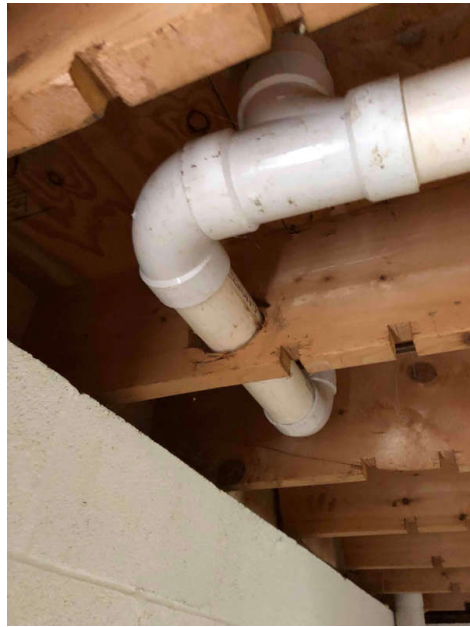
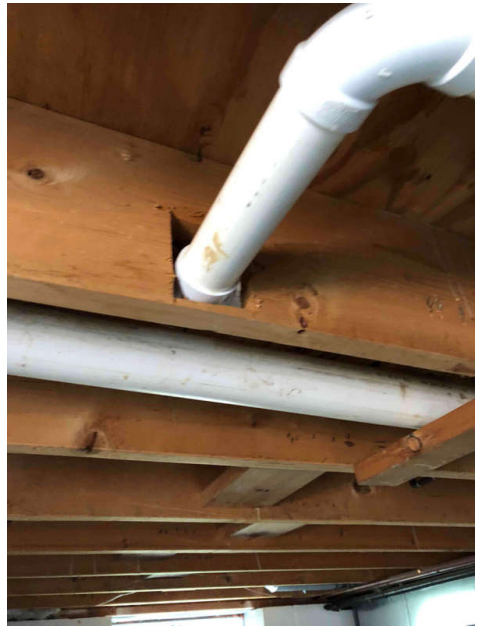
17.6.1 Joists And Trusses

IMPROPER NOTCHING

Recommendation
Contact a qualified professional.
