SUMMARY

1234 Main St. Spokane wa 99205

Aaron Storer
WA License #1936
Golden Star Home Inspections
509-720-6279

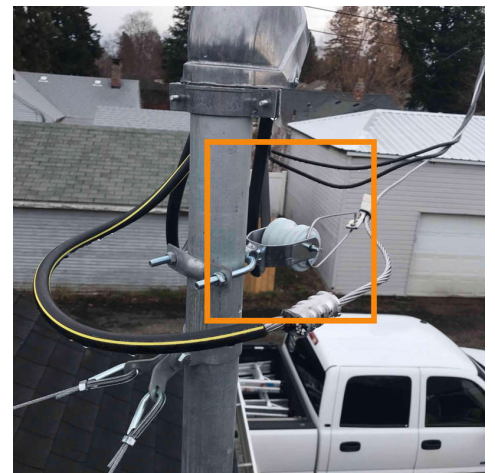
2.9.1 Service Entrance Conductors

IMPROPERLY SUPPORTED

SOUTH

The overhead service entrance conductors were not properly secured. Recommend repair by a licensed electrical contractor.

Moderate Observation

Contact a qualified electrical contractor.

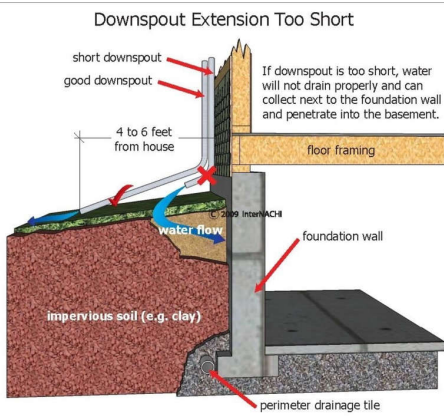
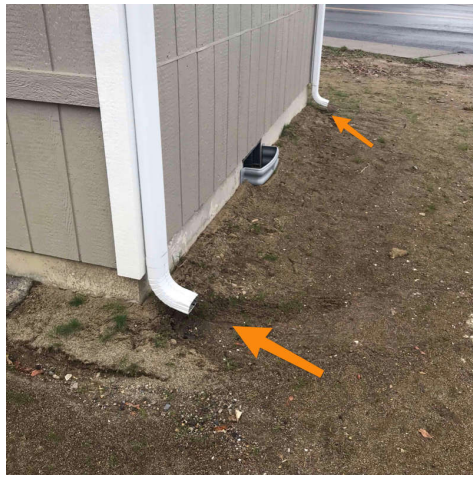
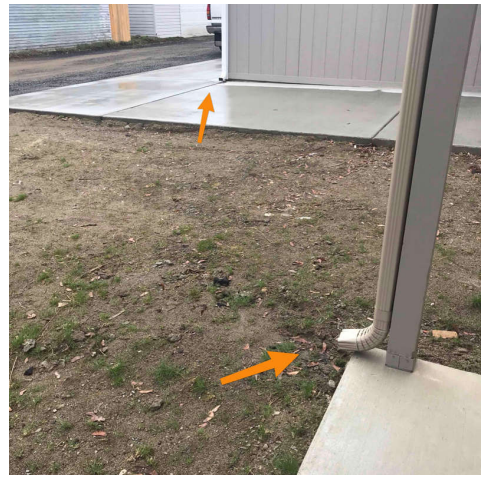
3.2.1 Roof Drainage Systems

DOWNSPOUTS DRAIN NEAR HOUSE

One or more downspouts drain too close to the home's foundation. This can result in excessive moisture in the soil at the foundation, which may lead to foundation/structural damage. Recommend a qualified contractor adjust downspout extensions to drain at least 6 feet from the foundation.

Moderate Observation

Contact a qualified professional.

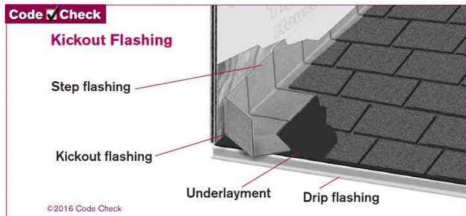
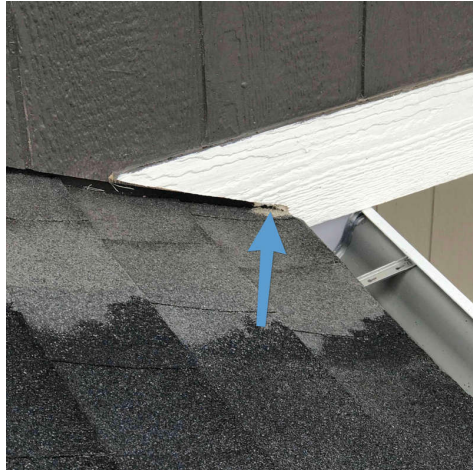
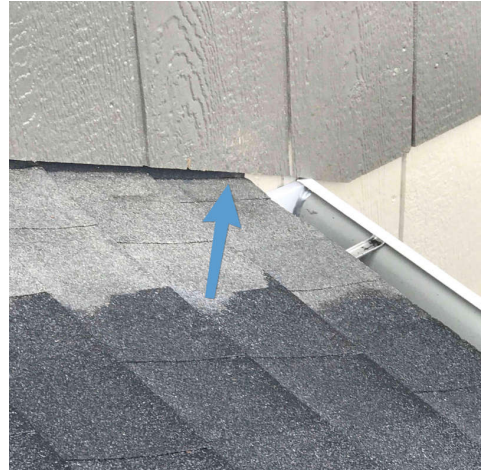
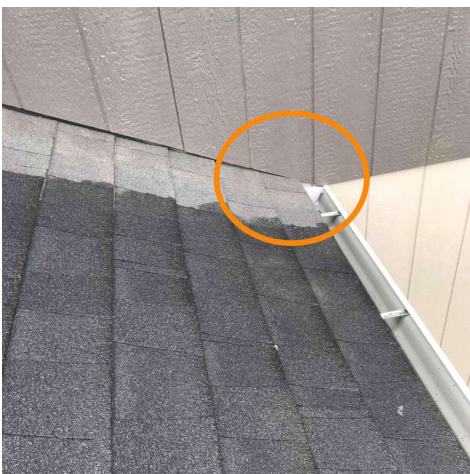
3.3.1 Flashings

KICKOUT FLASHING

Moderate Observation

Some kick-out flashing appeared to be missing where the roof meets the siding. Some siding was too close or touching the roofing materials. This may allow for faster deterioration of siding and trim or possible moisture intrusion. Recommend repair by a licensed roofing contractor.

Contact a qualified roofing professional.

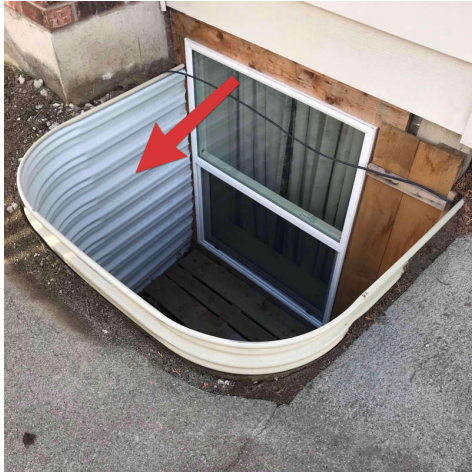
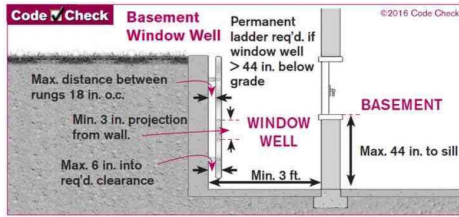
7.1.1 Exterior Doors, Windows

BASEMENT EGRESSABLE WINDOW

Significant Observation

Basement egressable window well appeared to be deeper than 44 inches. A permanently affixed ladder is recommended when higher than 44 inches. Recommend repairs and painting the trim by a qualified professional.

Recommendation
Contact a qualified professional.
