Summary Report outlines **Moderate Concerns** and **Significant and/or Safety Concerns**. It does not include **MINOR/Maintenance or Upgrades**.

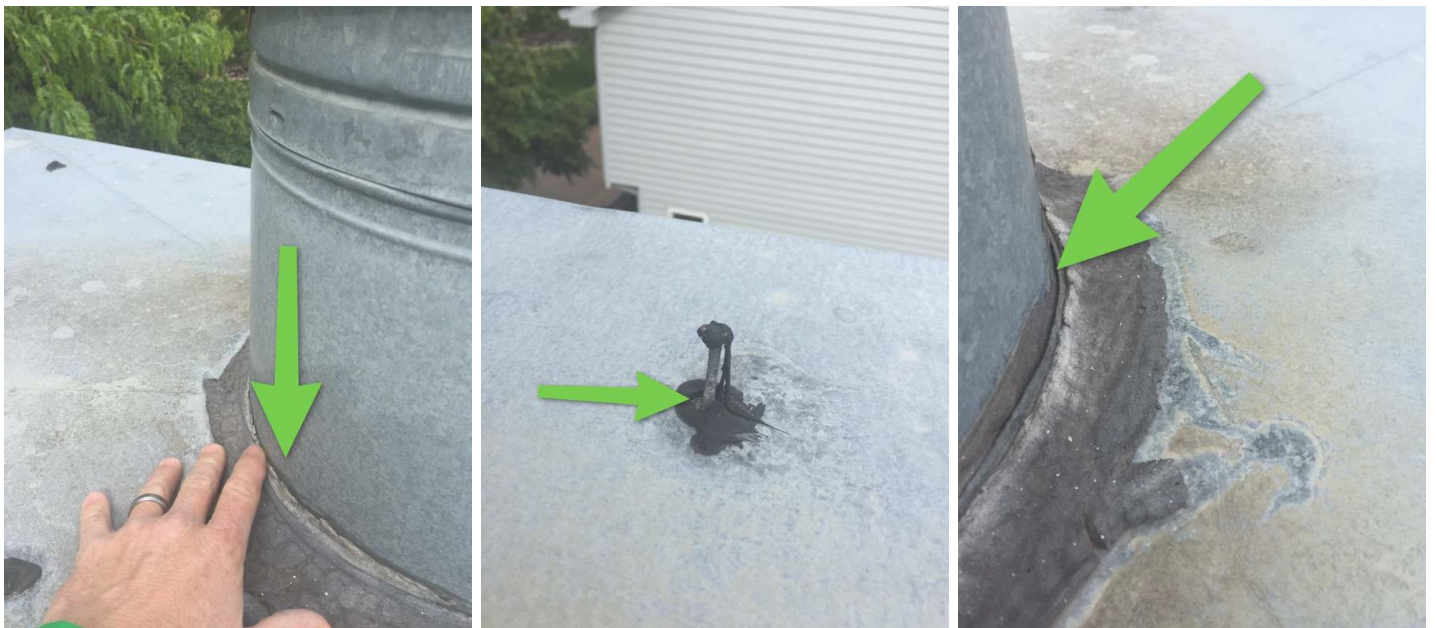
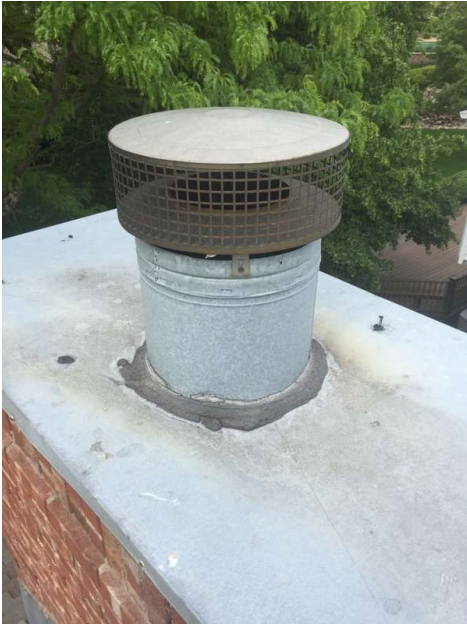
UPPER ROOF SOUTHWEST

CHIMNEY TERMINATION CAP

Chimney Termination Cap seal has cracked allowing water penetration. This condition can lead to water or ice penetrating mortar joints damaging the brick veneer. Additionally, water intrusion can lead to structural damage as well as the formation and growth of mold. Recommend repair as necessary by qualified professional.

Recommendation
Contact a qualified professional.

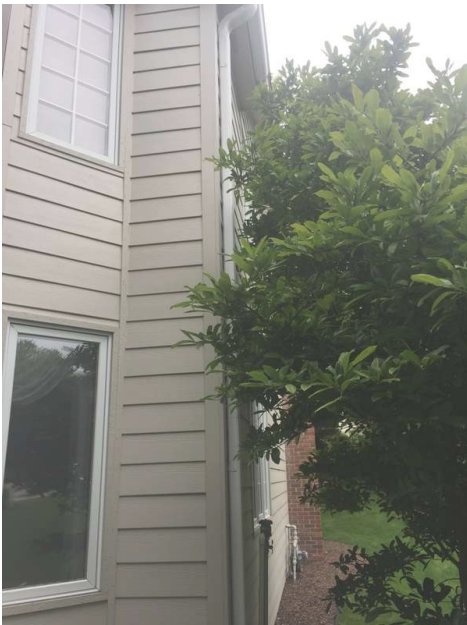
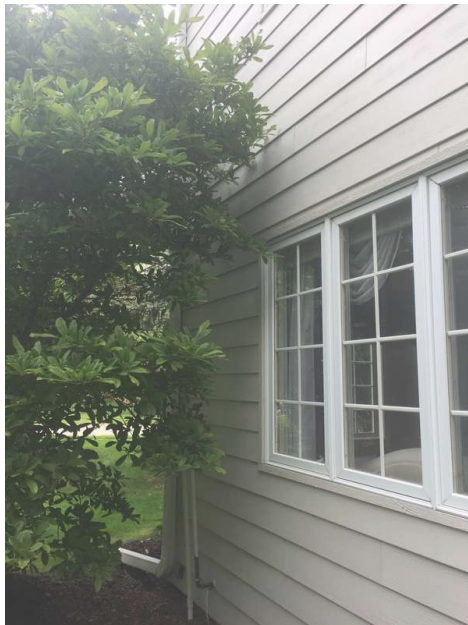
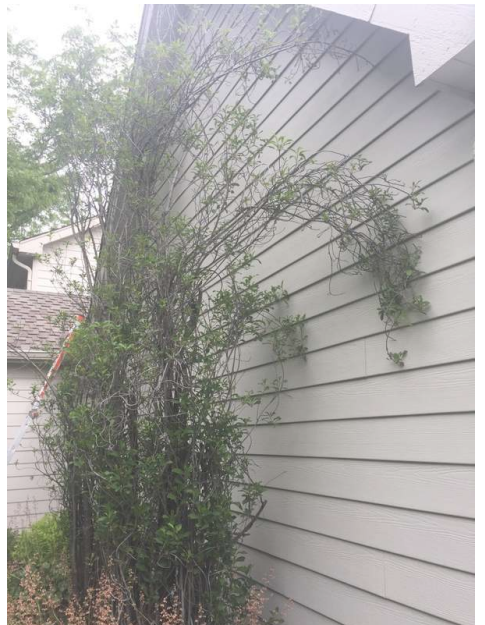
NORTHWEST SOUTHEAST

VEGETATION

Vegetation such as trees, shrubs and/or vines was in contact with or close to the building exterior. Vegetation can serve as a pathway for wood-destroying insects, retain moisture against the exterior, and wear the finish. Recommend pruning, moving or removing vegetation as necessary to maintain at least 6 inches of space between it and the building exterior. A 1-foot clearance is better.

Contact a qualified landscaping contractor

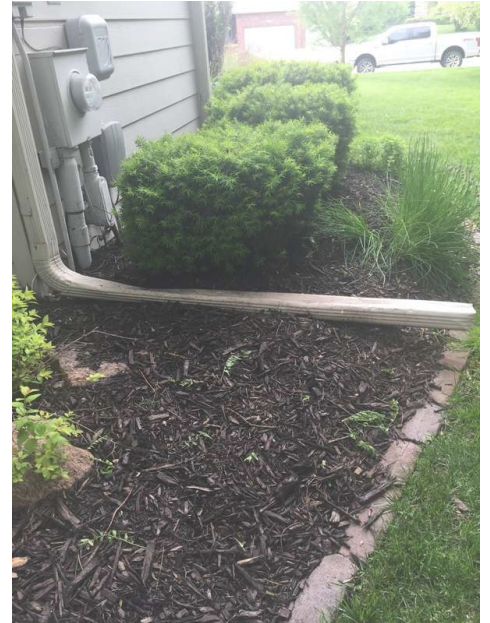
DOWNSPOUT PITCH

Downspout extension pitch is level or reversed causing water to leak at elbow. Recommend repositioning or replacement.

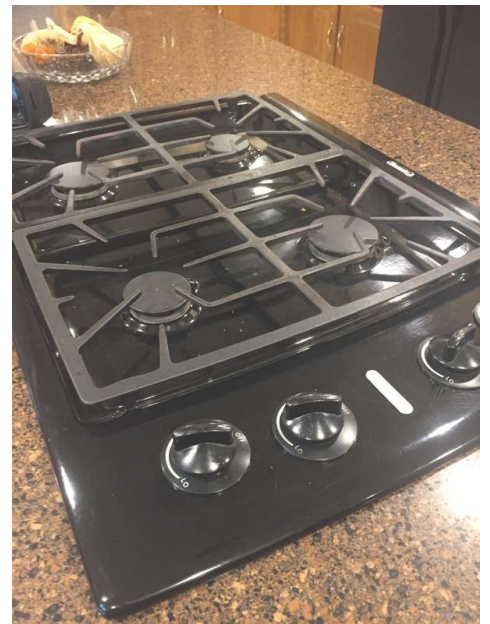
VENTILATION FAN

Range/Cooktop ventilation was inoperable. Recommend repair or replacement.

Contact a qualified professional.

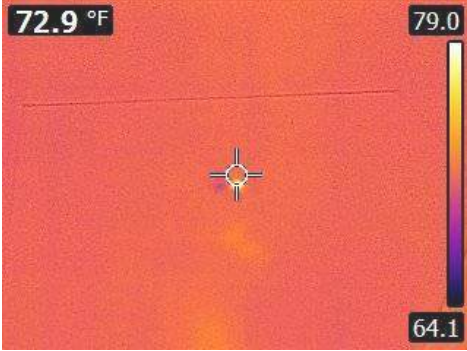
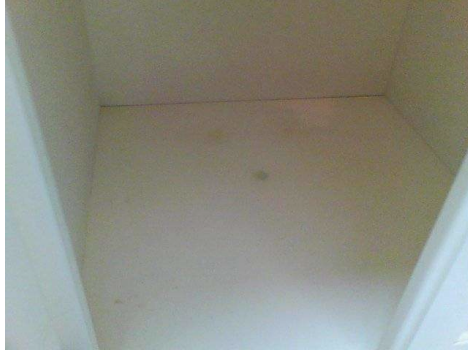
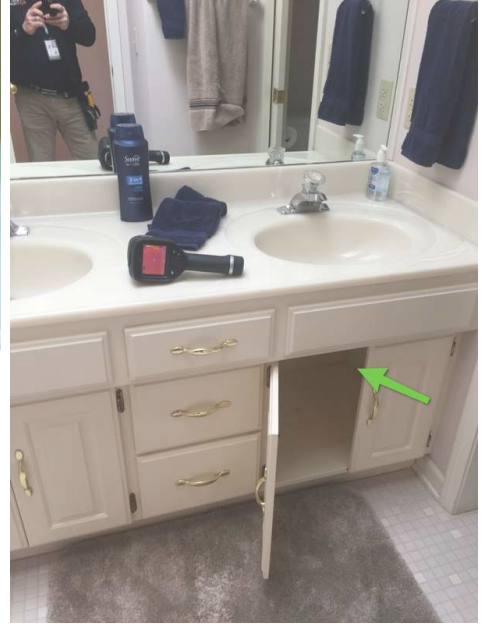
UPSTAIRS MAIN - RIGHT SIDE SINK

SINK DRAIN - LEAK

The sink drain was leaking at location specified. A qualified person should repair as necessary.

Contact a qualified professional.

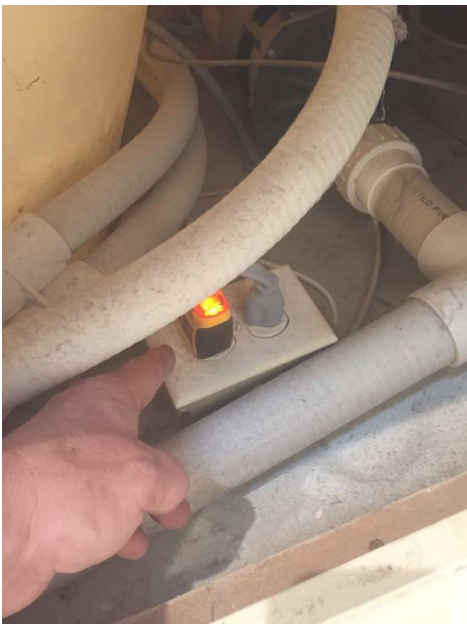
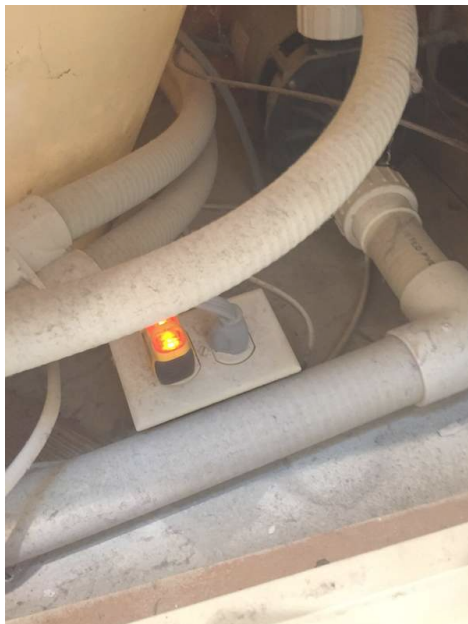
MASTER BATH

RECEPTACLE - LOSE/NOT SUPPORTED

The receptacle located within the whirlpool bath enclosure was laying on the floor. Recommend it be permanently fastened to a support member eliminating contact with the floor. v

Contact a qualified electrical contractor.

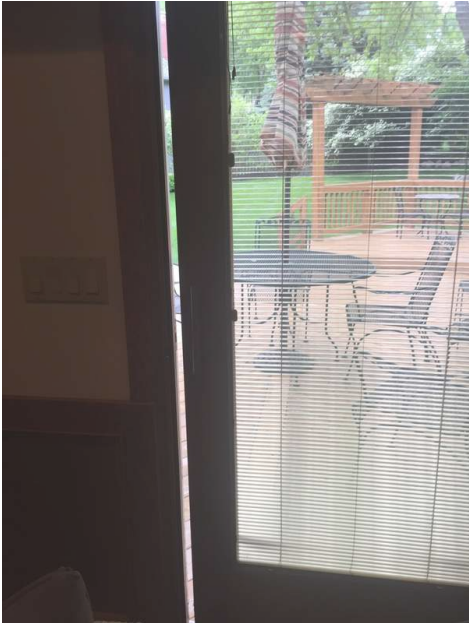
SLIDING DOOR SOUTHWEST

DIFFICULT TO OPEN

The sliding door was difficult to open. Recommend repair.

Contact a qualified professional.

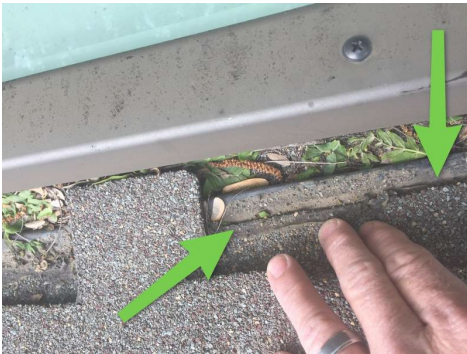
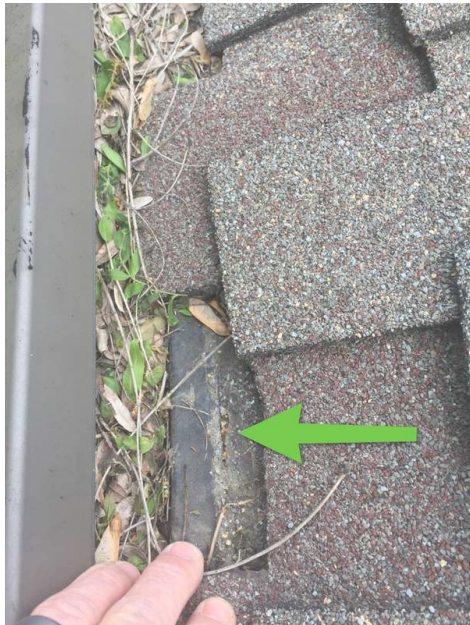
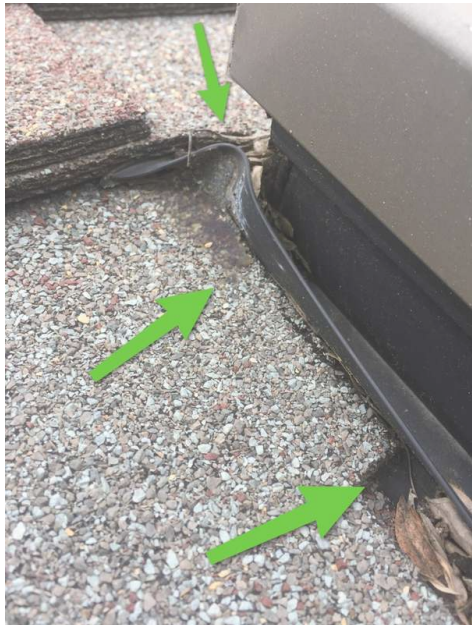
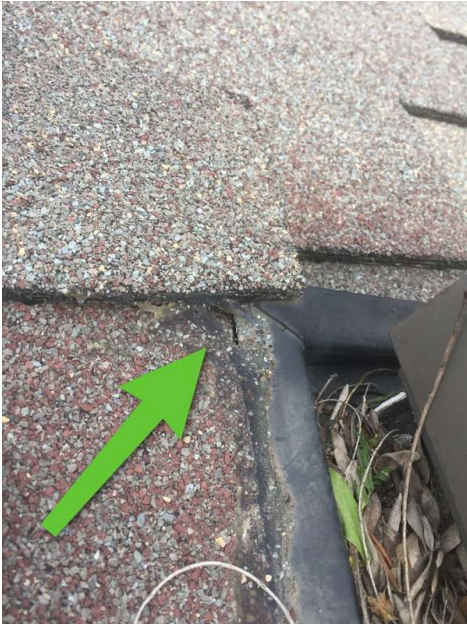
ROOF SOUTH WEST

**CAULK AND RUBBER LINER - DETERIORATED OR
WARN**

The surround boot/rubber membrane had irregularities as shown in the photos. The caulk sealing this membrane has deteriorated in some areas creating potential for water penetration and structural damage. Recommend a qualified roofing contractor evaluate further and repair as necessary.

Contact a qualified professional.

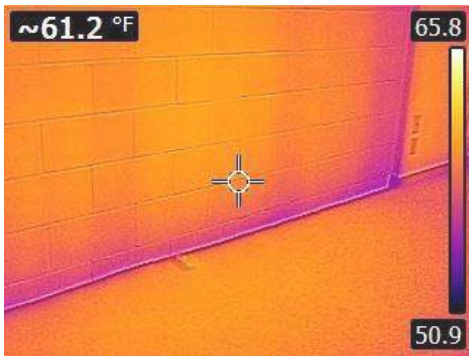
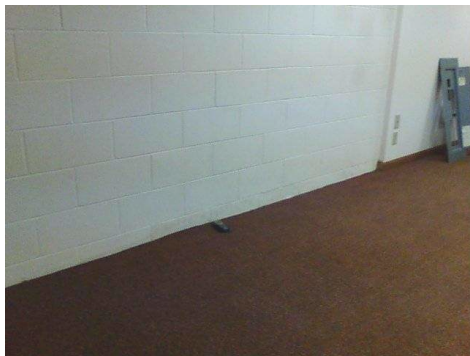
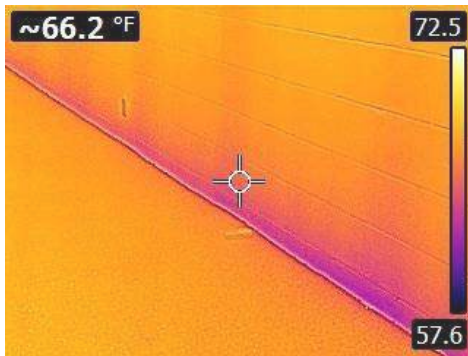
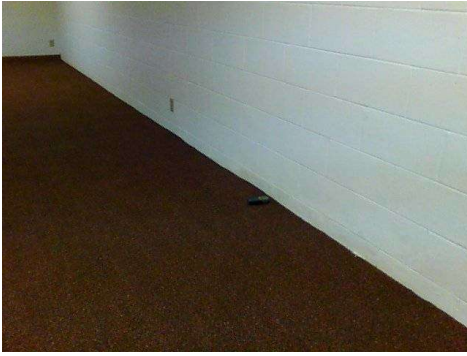
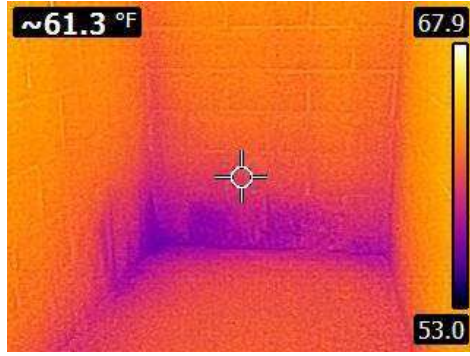
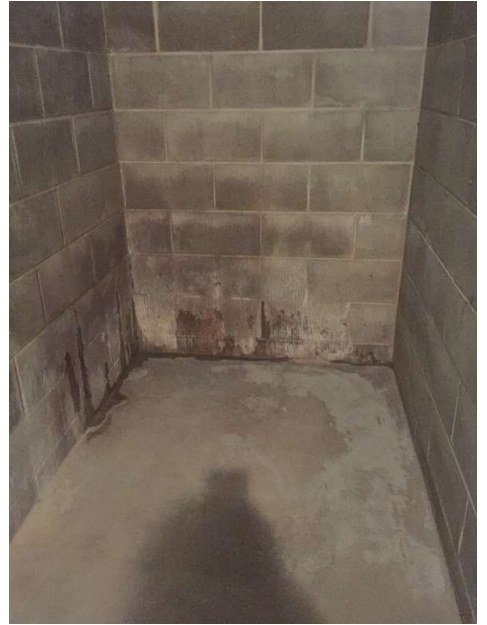
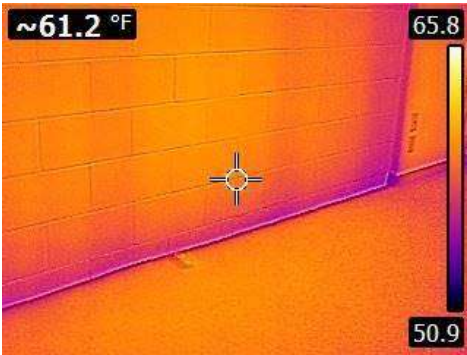
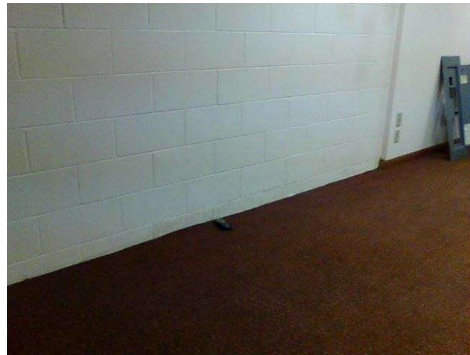
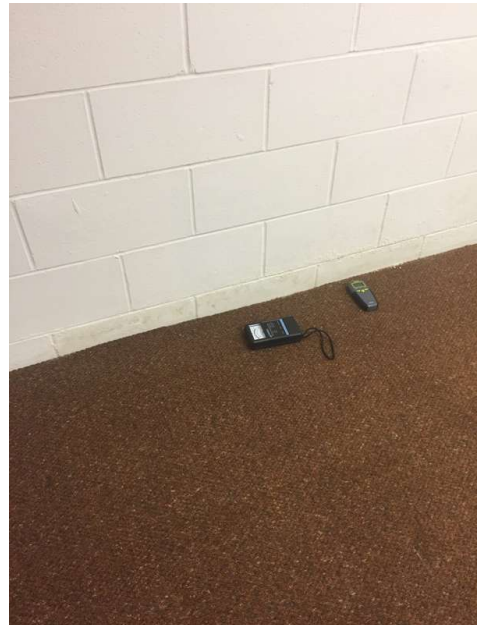
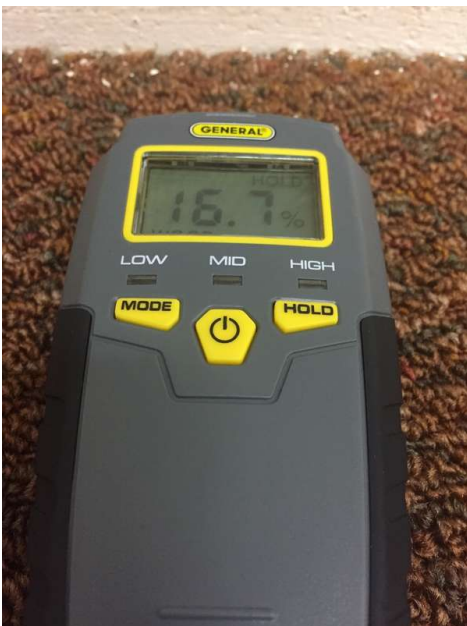
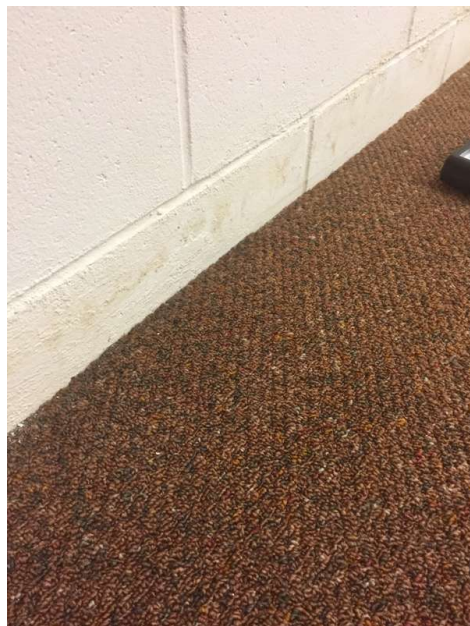
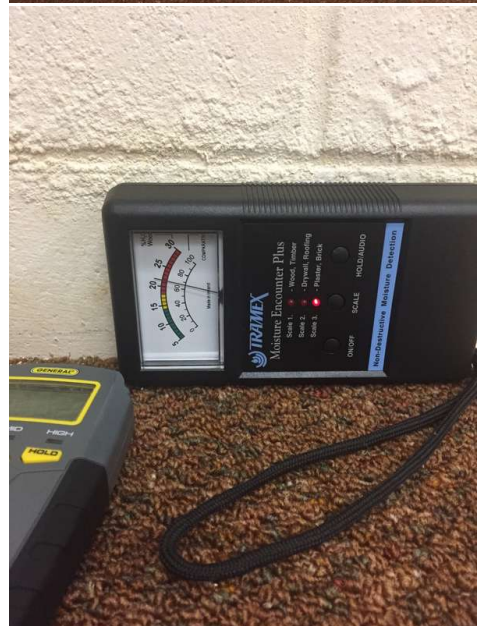
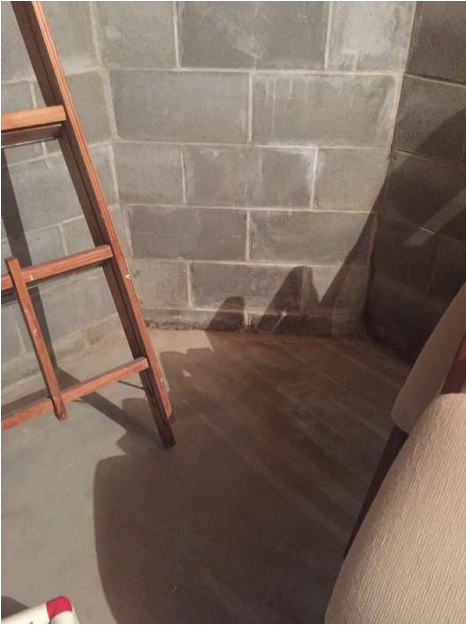
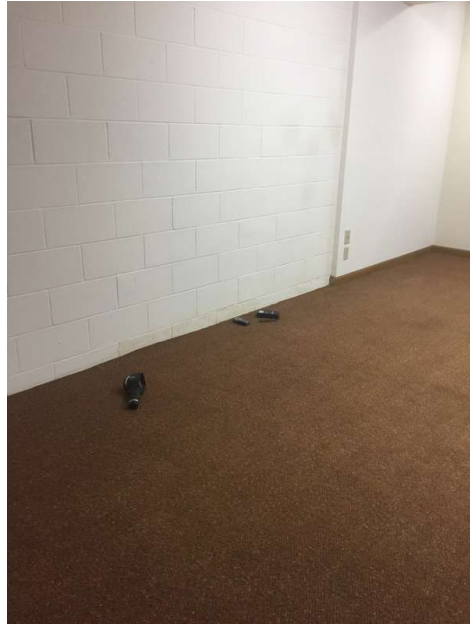
10.2.1 Foundation
WATER INTRUSION
SOUTHEAST SOUTH

Moisture was both seen and detected in multiple areas of the basement. [North, Southeast, and south walls] Possible sources for the water intrusion include but are not limited to, defective gutter/drainage design and installation, improperly sloped landscaping, patios, sidewalks or walkout concrete landings. Recommend consulting both a qualified water intrusion specialist and landscape professional for further evaluation and repair as necessary.

Recommendation
Contact a qualified professional.

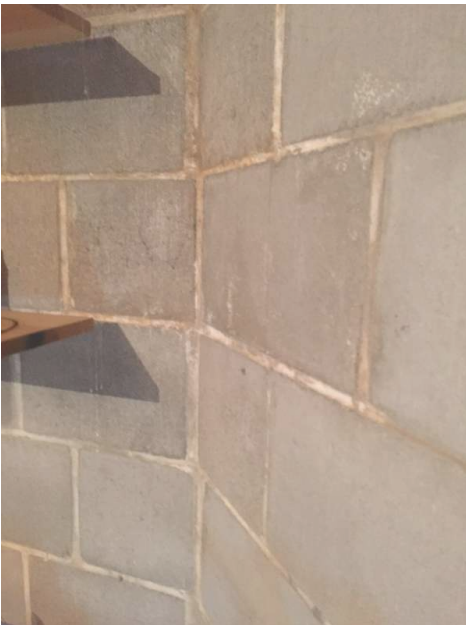
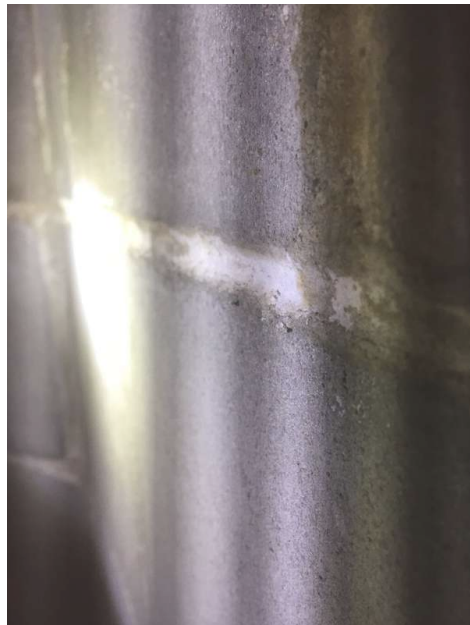
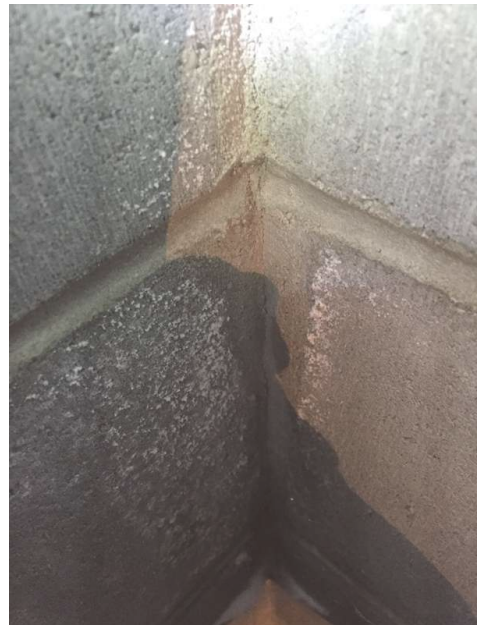
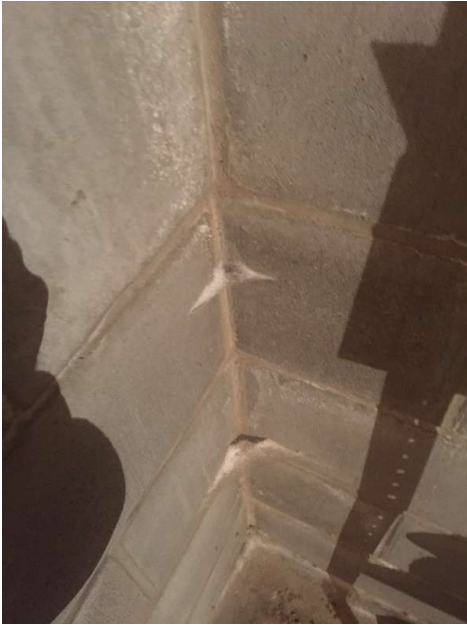
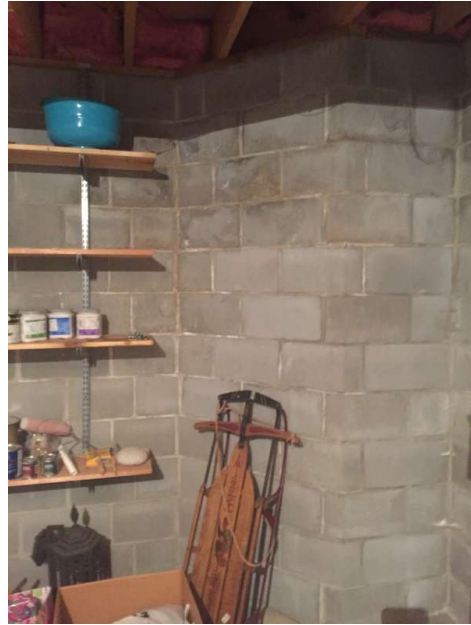
NORTHWEST NORTHEAST BASEMENT

10.2.2 Foundation
EFFLORESCENCE

Efflorescence is the dissolved salts deposited on the surface of a porous material (such as concrete or brick) that are visible after the evaporation of the water in which it was transported. Efflorescence can be a cosmetic issue, or it can be an indication of moisture intrusion that could lead to major structural and indoor air quality issues. Recommend a qualified professional evaluate further.

Recommendation
Contact a qualified professional.

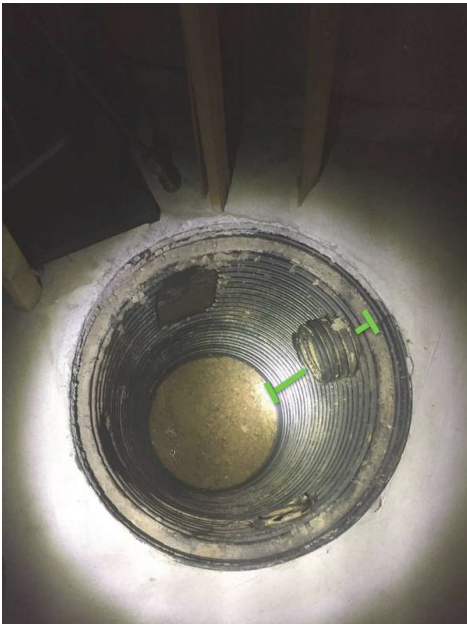
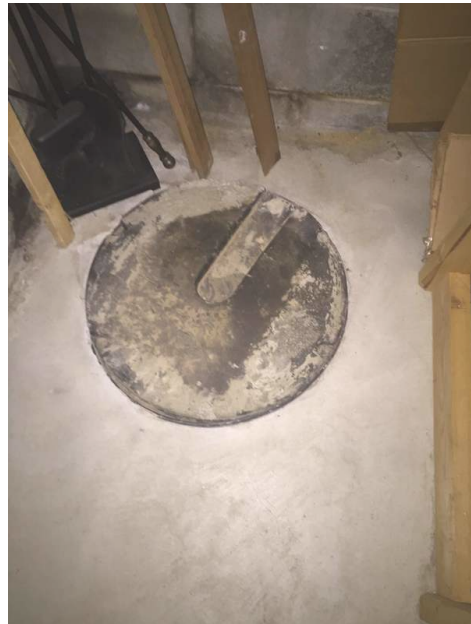
SUMP - DRAIN TILE ENTRY ELEVATION

The elevation of the interior perimeter drain tile at the point of entry into the sump containment pit, did not appear to be low enough. Drain tile should slope a min 1/8" per foot in order to move water toward the containment point. Recommend consulting a qualified professional for further evaluation.

Contact a qualified professional.

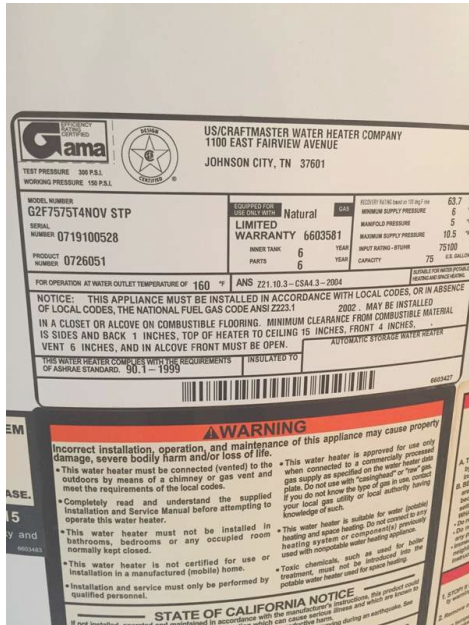
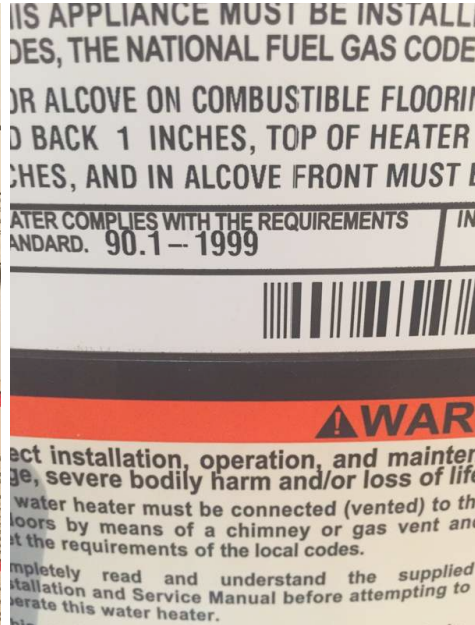
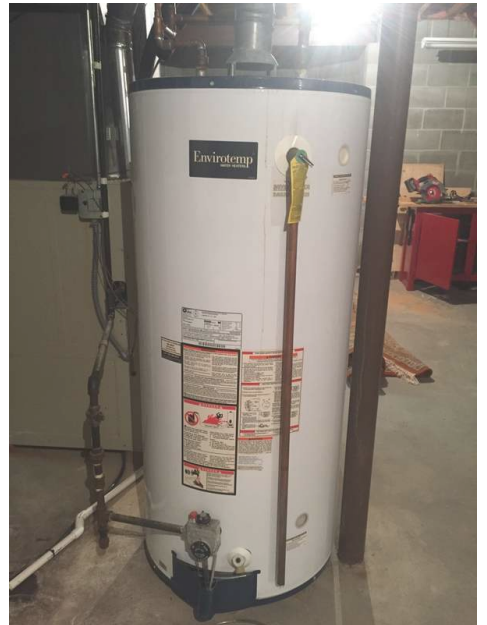
LIFESPAN (8-12 YRS)

The estimated useful life for most water heaters is 8-12 years. This water heater appeared to be *near / at / beyond* this age and/or its useful lifespan and may need replacing at any time. Recommend budgeting for a replacement in the near future, or considering replacement now before any leaks occur. The client should be aware that significant flooding can occur if the water heater fails. If not replaced now, consider having a qualified person install a catch pan and drain or a water alarm to help prevent damage if water does leak.

Recommendation
Contact a qualified plumbing contractor.

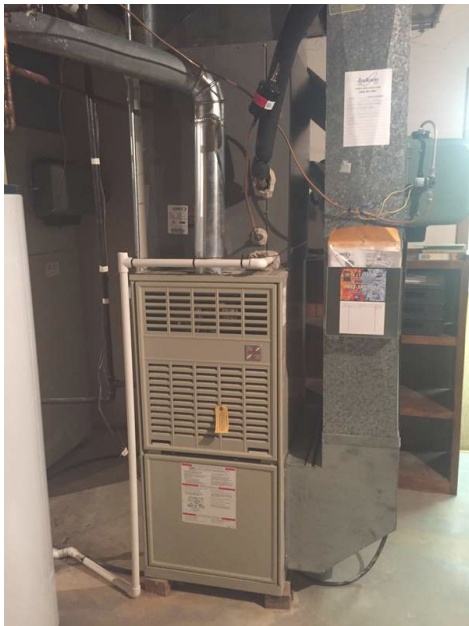
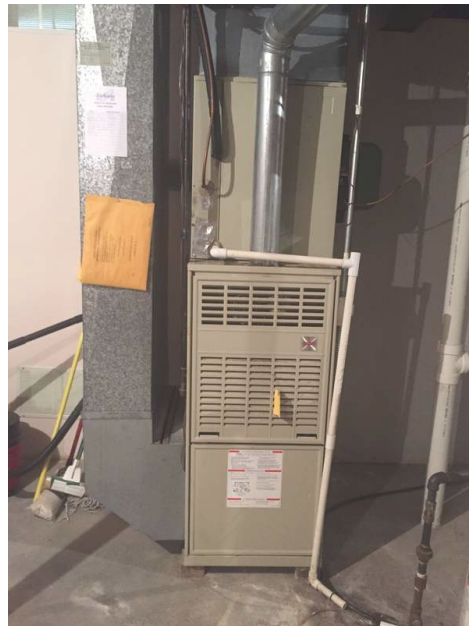
14.2.1 Heating LIFESPAN (15-20 YRS)

At the time of inspection, the furnace was functioning as designed, however the estimated useful life for most forced air furnaces is 15-20 years. This furnace appeared to be *near / at / beyond* this age and/or its useful lifespan and may need replacing or significant repairs at any time. Recommend budgeting for a replacement in the near future.

Recommendation
Contact a qualified professional.
