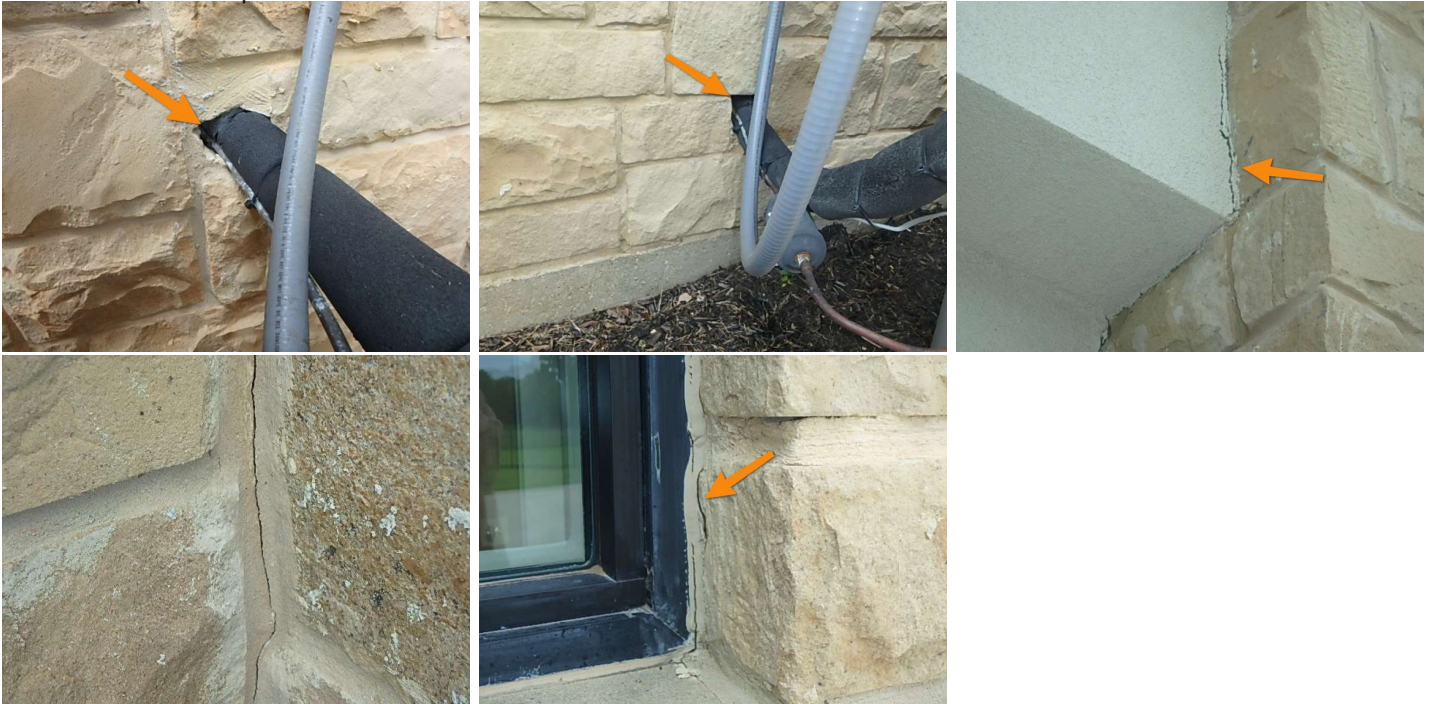
AC REFRIGERANT PIPES, VARIOUS EXTERIOR WALL JOINTS

GAPS AT EXTERIOR WALL

Small gaps were noted at window and door frame joints, and at other wall joints. Seal all gaps at joints and utility penetrations to prevent moisture and pest intrusion.

Contact a qualified professional.

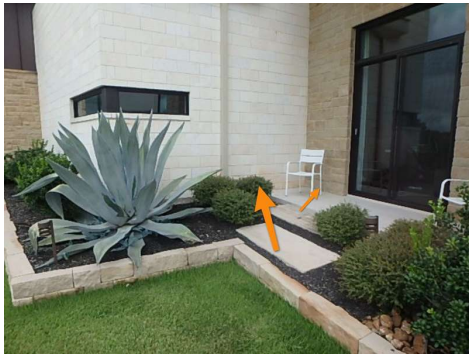
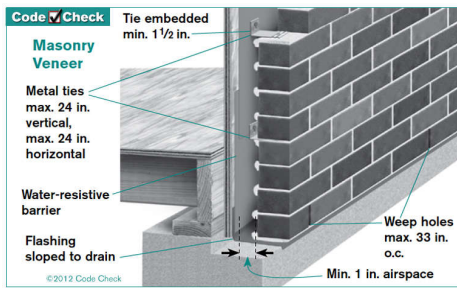
WALLS OUTSIDE OFFICE

NO WEEP HOLES AT MASONRY WALLS

When water gets through a masonry wall it collects at the bottom and is released through "weep holes," small openings in the bottom of the masonry wall. 3/16-inch-diameter weep holes should be installed every 33 inches at minimum.

Contact a qualified masonry professional.

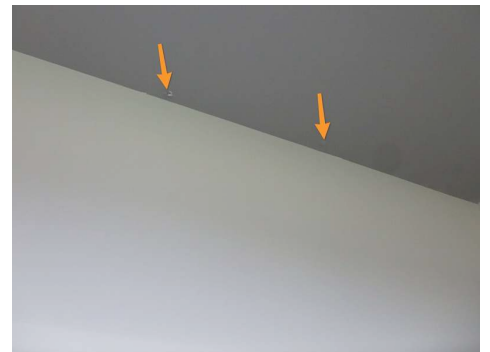
MASTER BATHROOM

CEILING - MINOR DAMAGE

Several nail pops were noted in the ceiling at small closet entry. Appears to be the result of structural settling. Cosmetic repairs needed.

Recommendation
Contact a qualified drywall contractor.

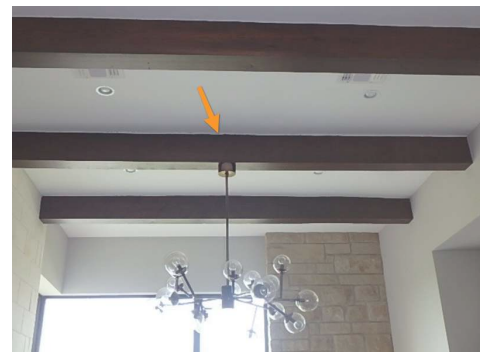
SAG IN COSMETIC BEAM

The beam supporting the dining room light fixture is pulling away from the ceiling. The fixture may need additional support from the ceiling framing.

Recommendation
Contact a qualified professional.

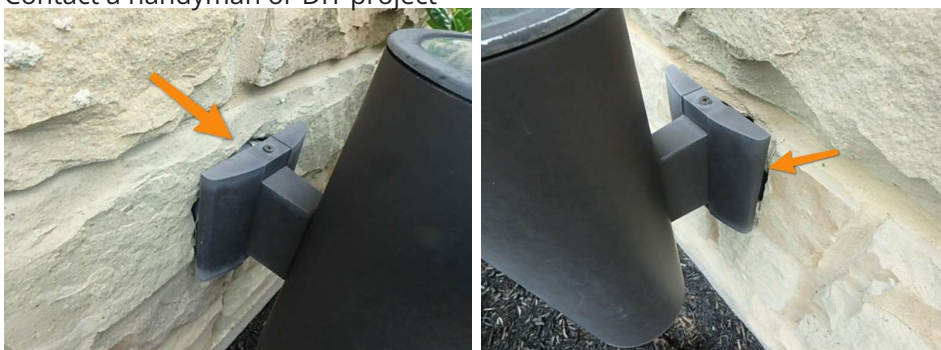
VARIOUS

GAPS AT EXTERIOR FIXTURE BASE

Seal around the base of exterior light fixtures to prevent water penetration into wiring box.

Recommendation
Contact a handyman or DIY project

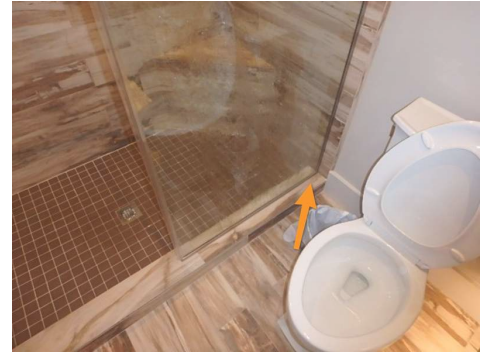
2ND FLOOR REAR BATHROOM

LEAK AT SHOWER PANEL

Small leak noted at bottom of glass panel. Clean joints before applying new sealant.

Contact a handyman or DIY project

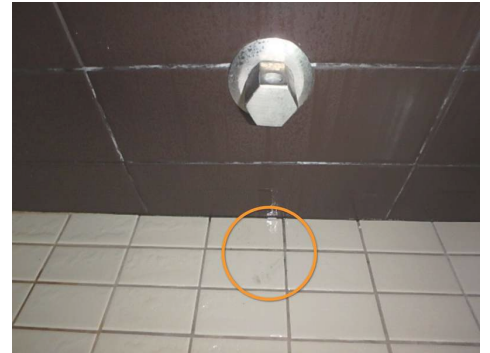
DEBRIS AT STEAM JET IN MASTER SHOWER

Small amount of debris was emitted from one of the steam jets when the steam sauna was activated. The system should be evaluated by the installer or a qualified plumber.

Contact a qualified professional.

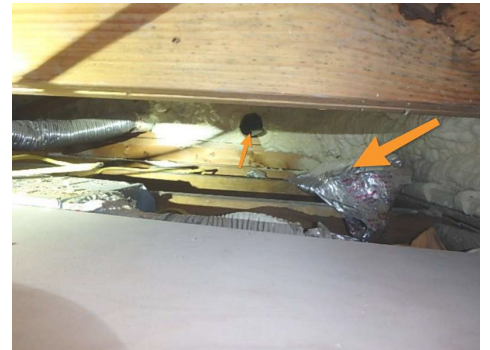
ABOVE FIRST FLOOR MIDDLE BEDROOM

DAMAGED DUCT IN ATTIC

Bathroom exhaust fan duct is damaged and vents to the attic instead of to the exterior, which will cause excessive moisture buildup on the framing. Replace damaged duct and attach to the damper assembly on the side wall.

Contact a qualified professional.

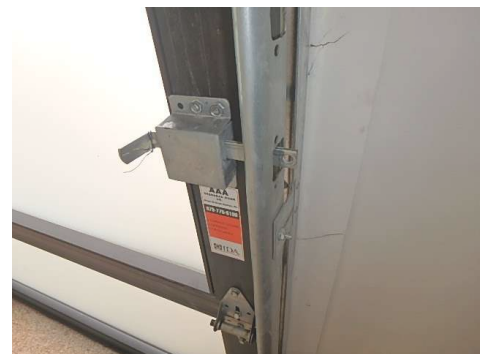
DISABLE MANUAL LOCKS

Garage overhead door lock need to be made inoperable in the open position or removed when opener is installed to prevent damage if opener is operated when lock is engaged.

Contact a handyman or DIY project
