## SUMMARY

1234 Main St. Greenville South Carolina  
29615

Buyer Name  
01/23/2019 9:00AM

TRAVIS CLARKE  
InterNACHI Certified...  
Apple Tree Inspections L.L.C.  
(864) 501-7593  
[Travis@AppleTreeInspections.com](mailto:Travis@AppleTreeInspections.com)

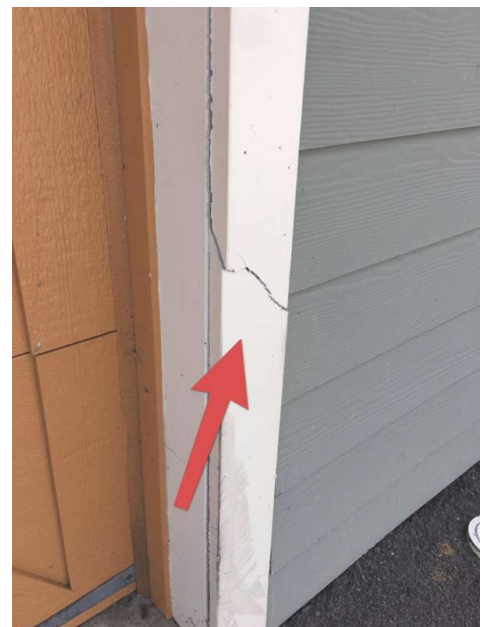
Garage Door Trim

### 4.3.1 Trim, Soffits & Fascia

#### DAMAGED TRIM

There is some damage or deterioration to the exterior trim (*mainly shown in the attached images*). Consider repair or replacement as needed.

Contact a handyman or DIY project

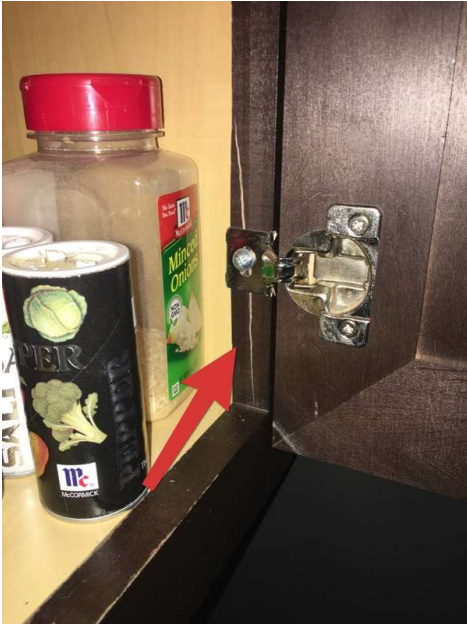
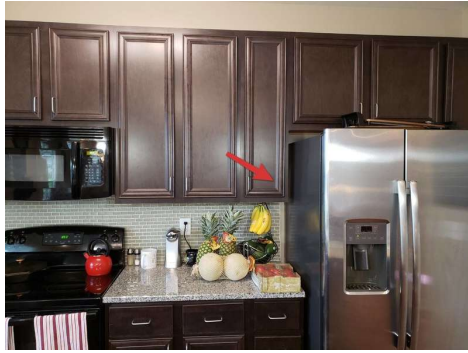
### 6.6.1 Cabinets

#### CABINETS DAMAGED

There was damage observed to the kitchen cabinets in one area. (*see the attached images*) The damage did not affect the operation of the cabinet door.

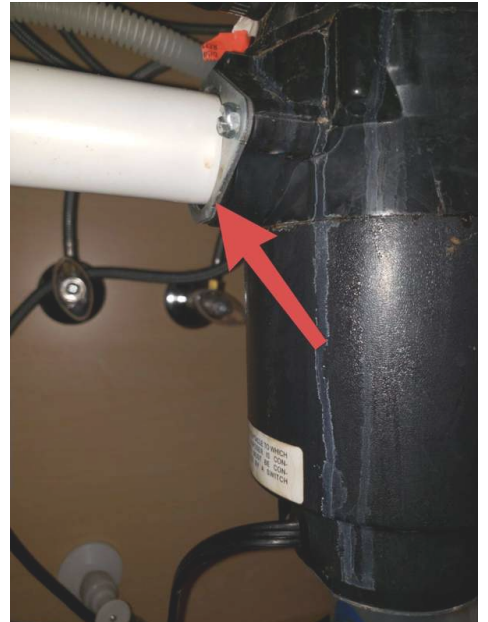
### 7.2.1 Food Waste Disposal **DISPOSAL LEAKING**

The leak which was observed at the garbage disposal appeared to be the result of poor attachment at the sink drain or drain line connection. (see photos) I recommend correction to help prevent water damage to the cabinet and surrounding materials.

Recommendation  
Contact a qualified professional.

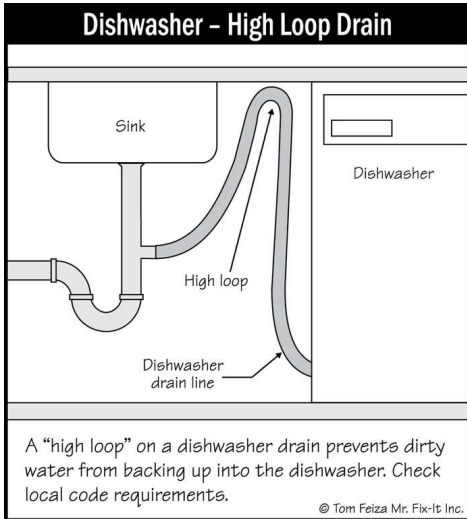
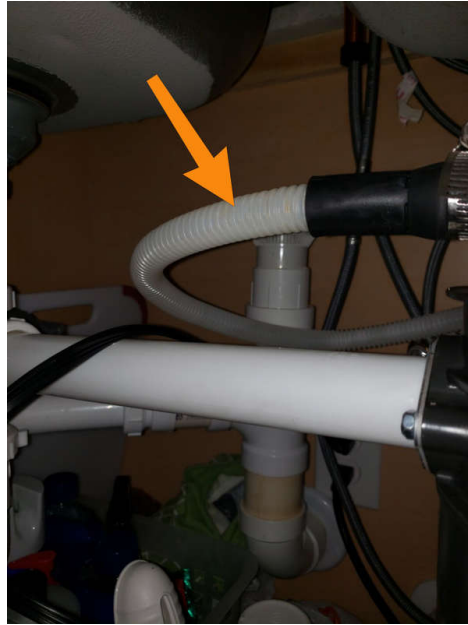
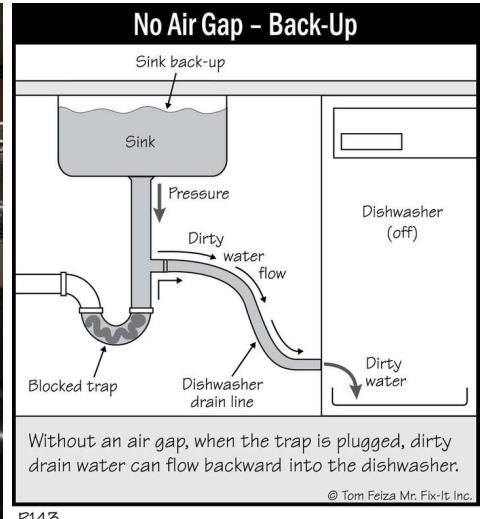
### 7.3.1 Dishwasher **NO ANTI-SIPHON DEVICE (LOOP)**

An anti-siphon loop was not visible at the dishwasher drain line. (see photos) This is a concern because water from the sink can potentially siphon and flood through the dishwasher. Some newer dishwashers may have a built in anti siphon device directly behind the dishwasher. This is a simple and inexpensive item to verify and / or correct if needed.

Recommendation  
Contact a handyman or DIY project

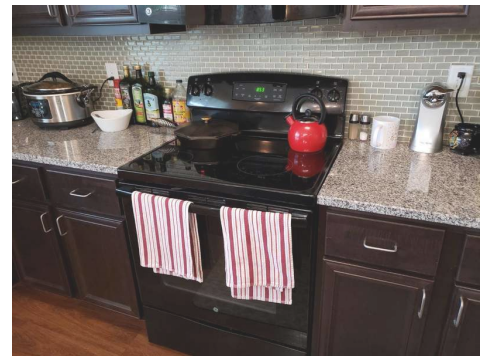
## RANGE ANTI - TIP BRACKET

I recommend that the range be fastened to the floor with a anti tip bracket. An anti tip bracket is a safety device installed on the back leveling foot of the range. It is intended to prevent the range from tipping over if a child were to stand on the open oven door. Here is an link to a helpful article online [Article Link](#)

Contact a handyman or DIY project

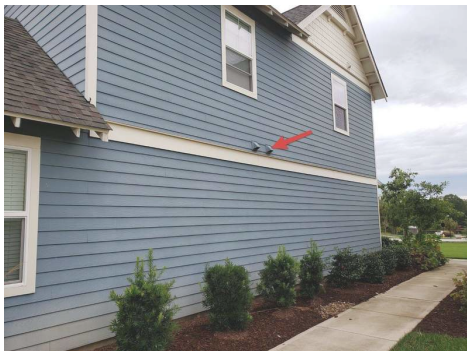
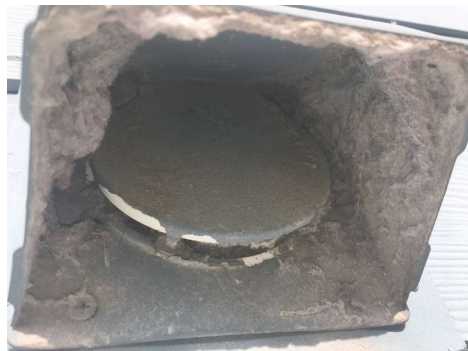
## DRYER VENT CLEANING

Lint and other debris should be removed from the dryer vent cover and duct work. Although cleaning is a relatively minor maintenance / repair item, it is classified as a *(Material Defect)* because this item is a **safety concern**. Here is a link to a helpful article online [Article Link](#)

Contact a handyman or DIY project

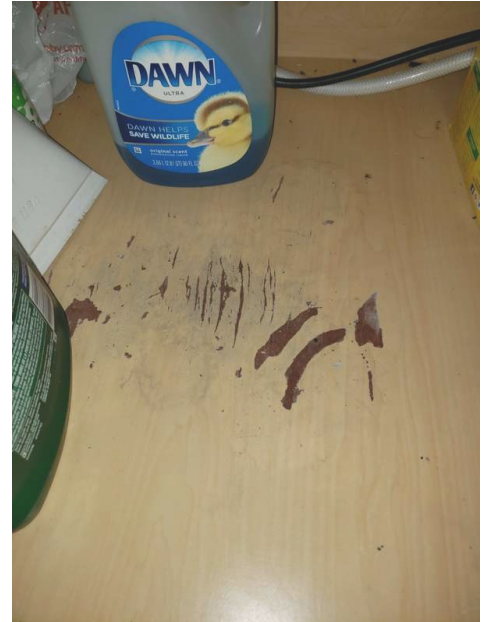
**WATER DAMAGE  
KITCHEN SINK CABINET**

Water damage was observed inside the kitchen sink cabinet. (see photos) There was a leak at the garbage disposal which is likely responsible for the water damage.

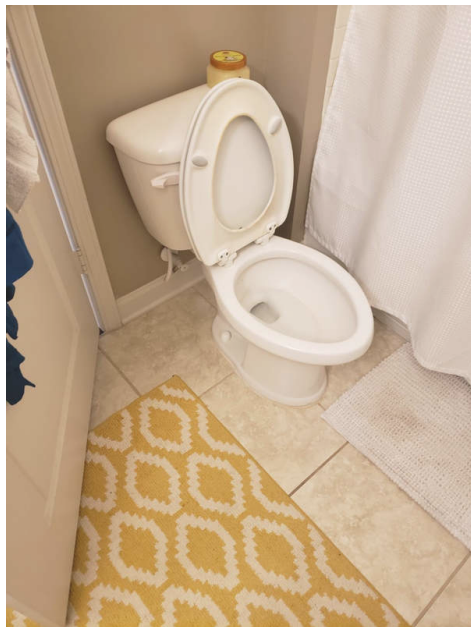
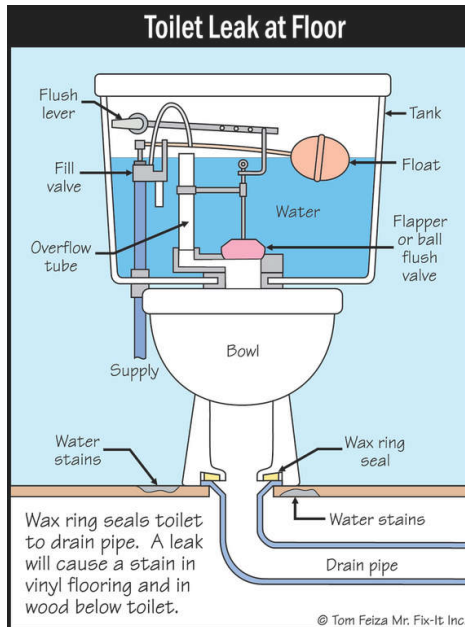
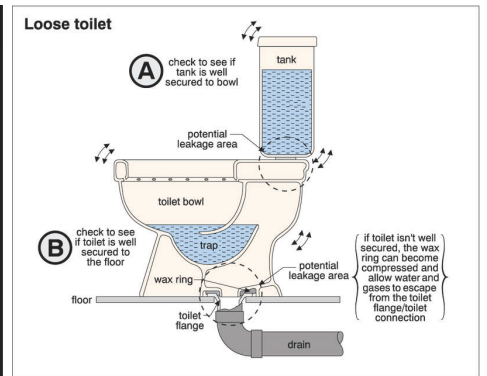
Master Bathroom

**TOILET LOOSE AT FLOOR**

The toilet(s) (shown in the attached images) is loose at the floor and should be properly secured. Loose toilets are important to correct because the wax seal at the base of the toilet can break with movement causing moisture related problems or damage. No water damage was observed at the time of the inspection. Here is a link to a helpful article online [Toilet Loose](#)

Contact a qualified professional.

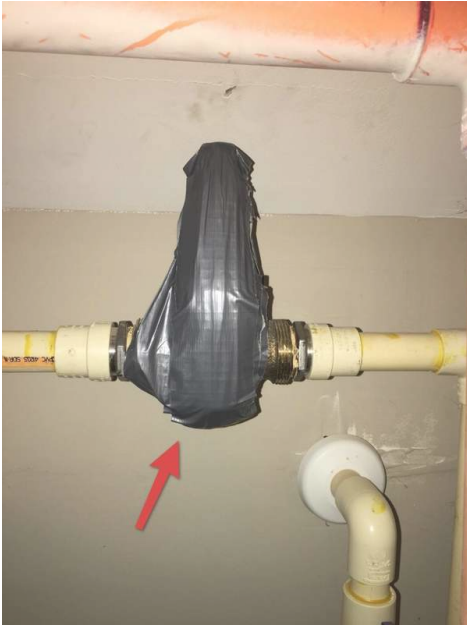
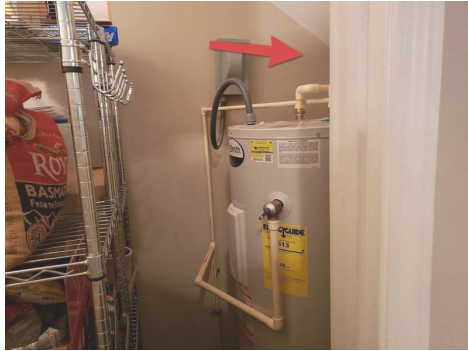
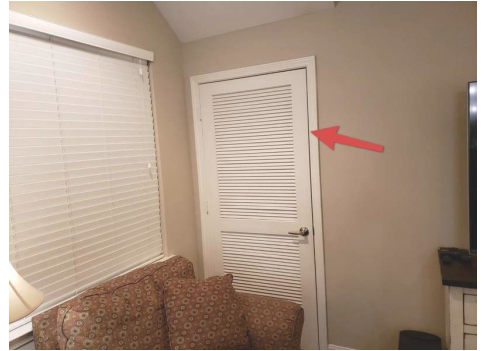
**IMPROPER REPAIR**

There were indications of a improper plumbing repair observed at the time of the inspection. (see photos) Repairs performed with improper materials or methods may fail and cause water damage to the home. I recommend immediate correction by a qualified professional.

Recommendation  
Contact a qualified plumbing contractor.

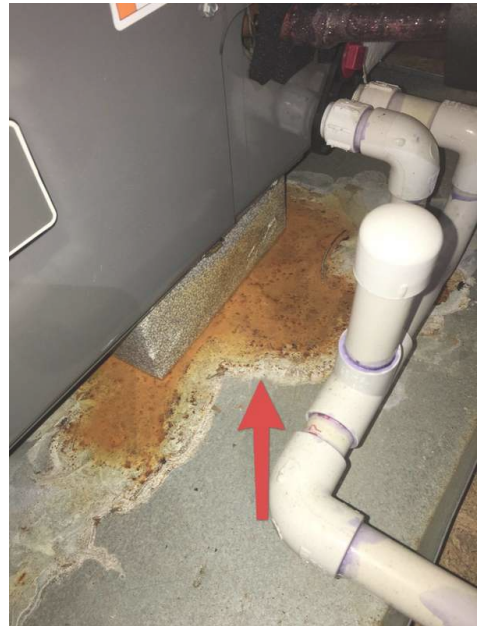
## SECONDARY CONDENSATE DRAIN PAN RUST

The auxiliary or secondary drain pan located under the furnace or air handler, had water staining, discoloration and / or rust build up (see photos). This condition indicates that the pan holds water at times. It's possible that the staining / rust is from a past problem which may have been corrected. I suggest asking the seller about this condition. The cooling equipment may be in need of service and possible repair. It is generally recommended that heating and air conditioning equipment be serviced annually. The air conditioner performed as expected at the time of the inspection. Here is a link to a helpful article online [Article Link](#)

Recommendation  
Contact a qualified heating and cooling contractor
