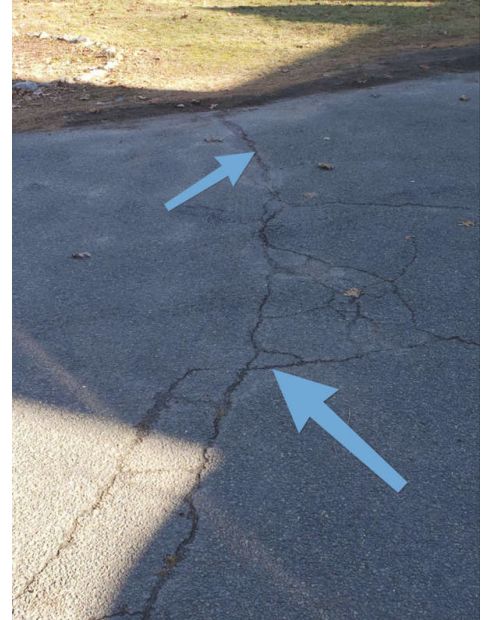
2.1.1 Driveway/Parking Lot

CRACKS (LARGE)

Significant cracks were visible in the surface material at the time of the inspection. Large cracks should be filled with an appropriate sealant to avoid continued damage to the driveway surface from freezing moisture.

Contact a handyman or DIY project

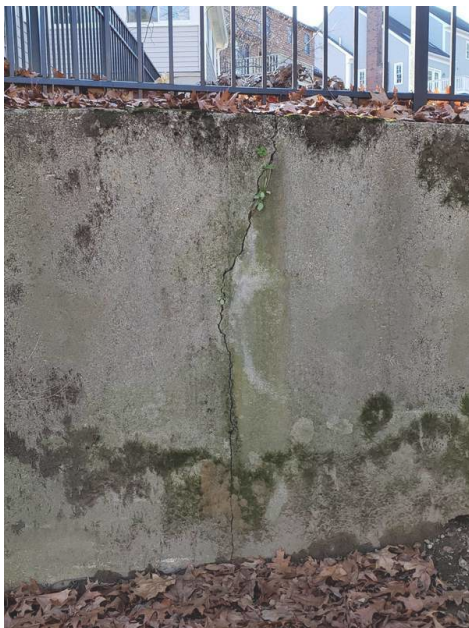
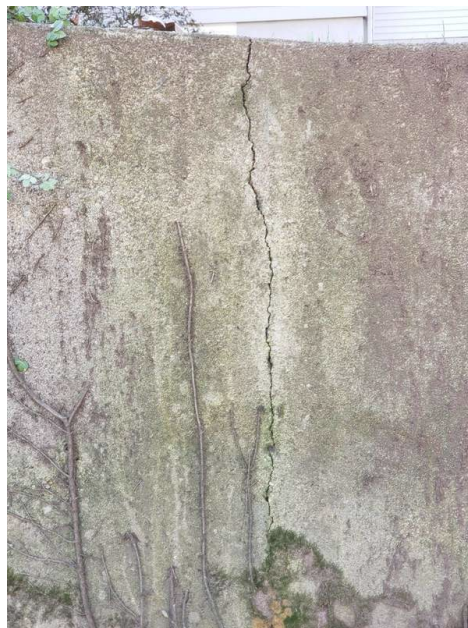
2.3.1 Retaining Wall(s)

CRACK(S) (TYPICAL)

Displacement or cracks are typical. Recommend you repair and monitor in the future. If the situation continues, contact landscape contractor for cost options to repair or replace.

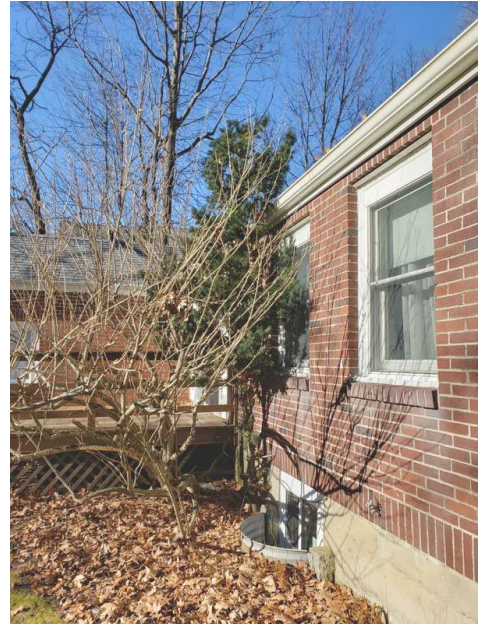
2.5.1 Landscaping

TOO CLOSE TO HOME

Landscaping is in contact or too close to the home. Trim plants away from the structure by at least 8 - 12". This space is recommended to prevent direct access to the structure by insects and to keep the bushes from damaging the siding.

Contact a handyman or DIY project

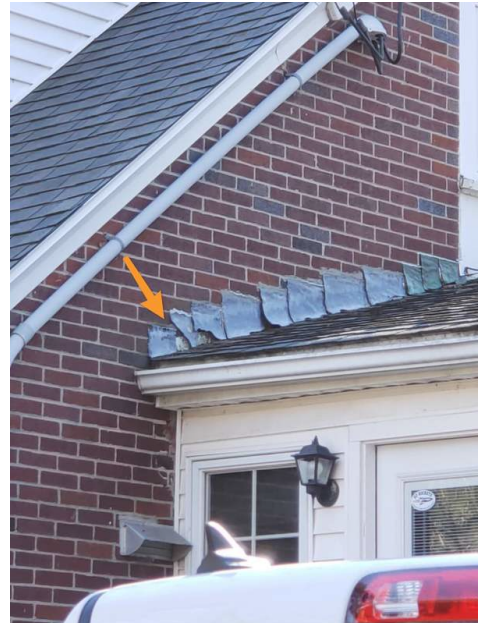
3.2.1 Roof Flashings

EXPOSED EDGES

Areas of the metal flashing are exposed to the weather and a potential of leakage could occur in wind-driven rain, usually, the side and top edges are covered by the roofing shingles. Further investigation and cost estimates to repair or replace are recommended.

Contact a qualified roofing professional.

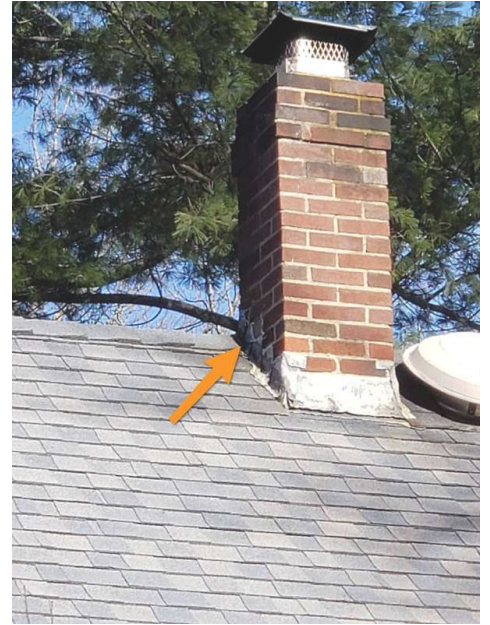
3.2.2 Roof Flashings

SQUIRREL DAMAGE

Squirrel damage is noted. Repair is recommended to prevent water intrusion.

Recommendation
Contact a qualified chimney contractor.

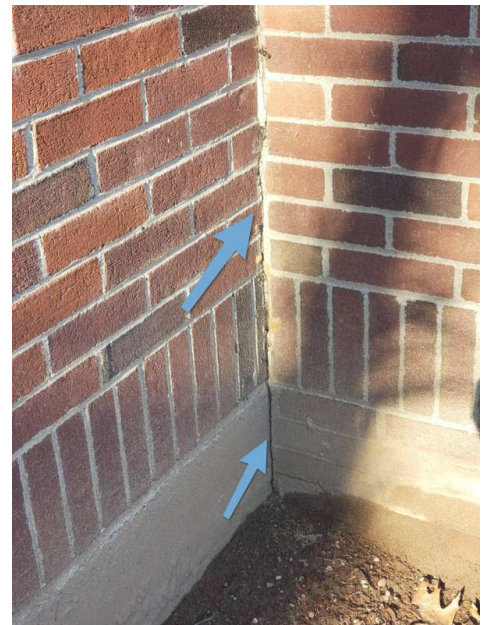
3.5.2 Chimney
FOUNDATION CRACK (MINOR)

A small crack is noted where the chimney foundation meets the house foundation. Recommend monitoring for future movement.

Recommendation
Contact a qualified professional.

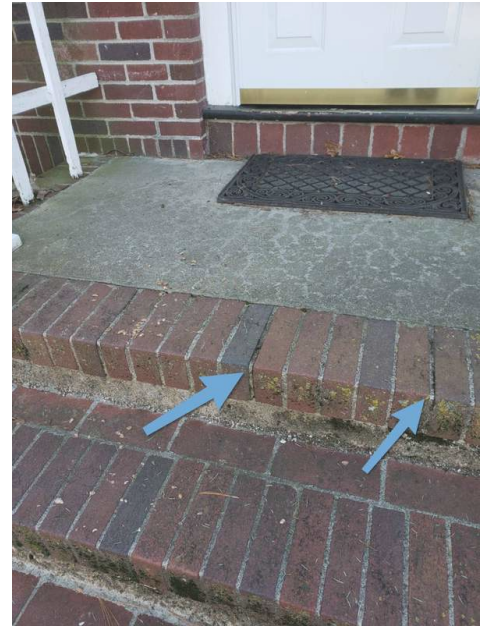
4.2.1 Exterior Stairs

REPOINT (MINOR)

The stair(s) have some minor separation. Repair is recommended to prevent moisture intrusion and freezing that could possibly damage the stair material.

Recommendation
Contact a qualified handyman.

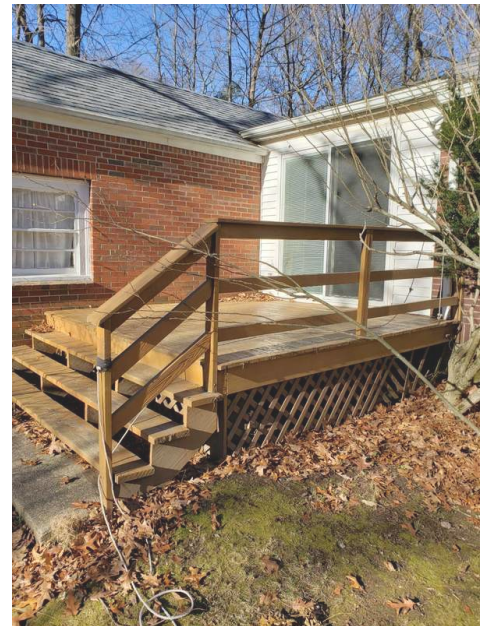
4.6.1 Decks, Balconies & Porches

GUARDRAIL (CLIMBABLE)

Railing design made the handrail system climbable. Balusters should be installed with spacing no more than 4" between vertical balusters. Safe building practices dictate that the handrail system should not be climbable (especially by children). This condition may be hazardous to small children. Repair as needed

Recommendation
Contact a qualified professional.

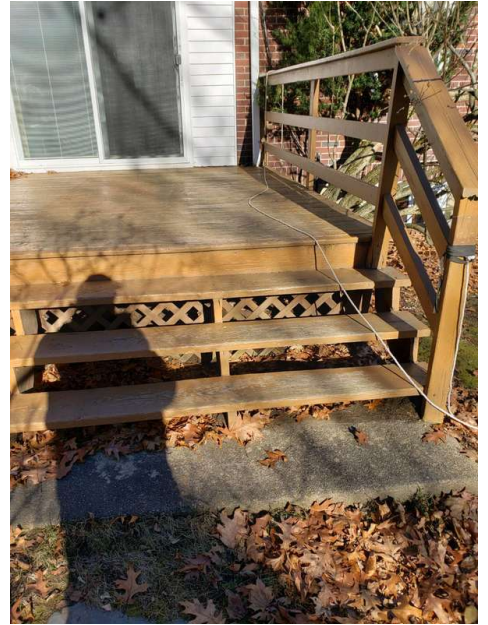
4.6.2 Decks, Balconies & Porches

STAIRS (NO RISERS)

The wooden stair(s) are missing risers. Risers are the vertical boards that rise up from one tread to the next. Repair is recommended.

Recommendation
Contact a qualified handyman.

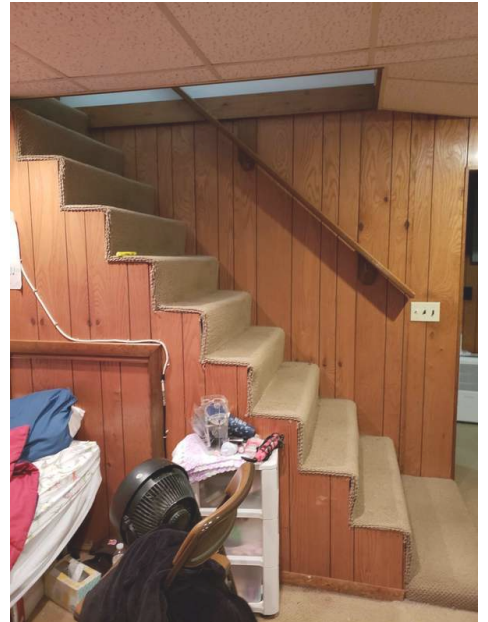
5.1.1 Basement Staircase

NO HANDRAIL (OPEN SIDE)

The open side of the stairway is missing a graspable handrail. When the handrail is installed, balusters should be included and spaced no further than 4" apart for safety. Repair is recommended.

Contact a qualified carpenter.

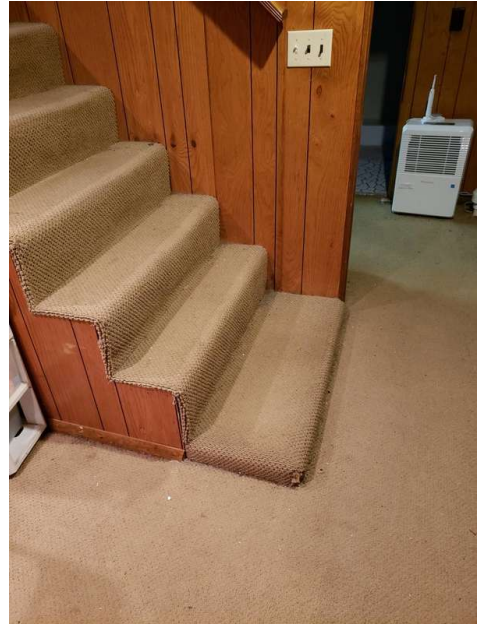
5.1.2 Basement Staircase

STAIRS (UNEVEN RISERS)

The stair risers are of various heights and pose a potential tripping situation, all risers should be no more than 8-1/4" in height. You may get used to these conditions but may have difficulty navigating stairway. If possible, updating to present standards is recommended.

Contact a qualified professional.

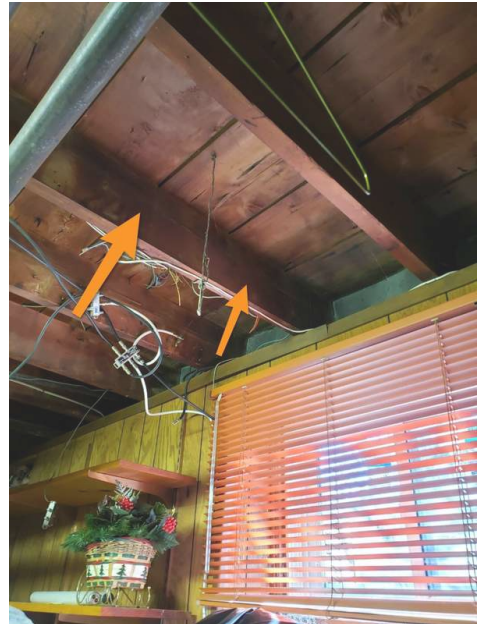
5.3.1 Floor Joists

CRACKED

Cracks in one or more joists were noted. Additional support or replacement may be needed. Repair is recommended.

Contact a qualified carpenter.

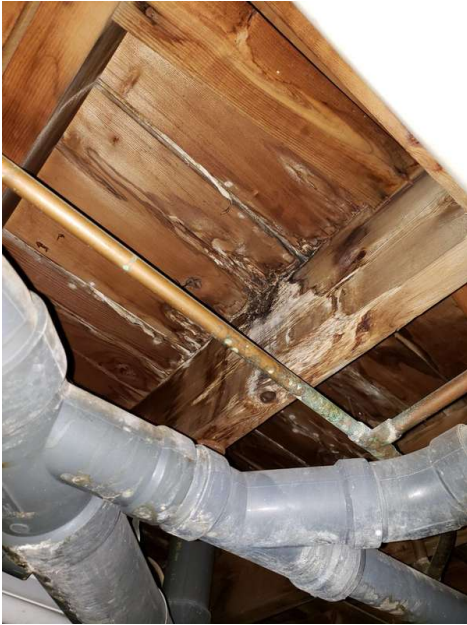
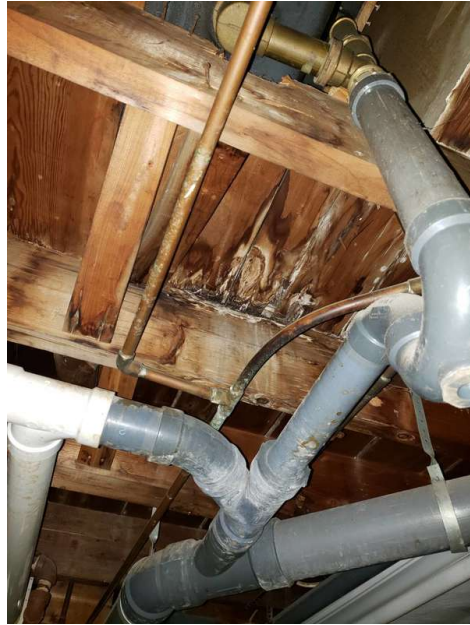
5.4.1 Subfloor

MOISTURE DAMAGE

One or more areas of moisture damaged wood were noted. Further investigation and or repair is recommended.

Contact a qualified carpenter.

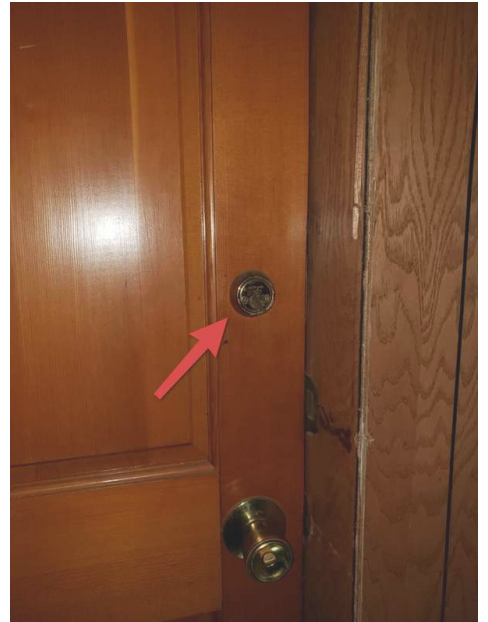
5.8.1 Basement Entry/Exit Door **DOUBLE KEYED DEADBOLT**

The door has a deadbolt that is keyed on both sides. This is a potential safety hazard if you need to exit the house quickly and there is no key readily available. Repair is recommended.

Recommendation
Contact a handyman or DIY project

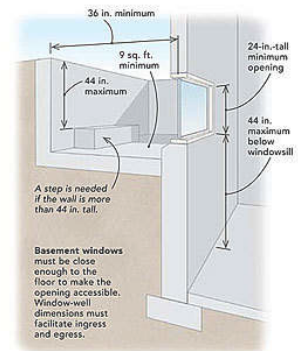
5.9.1 Means Of Basement Egress **NO WINDOW EGRESS**

This basement had no means of window egress. As a result of the lack of egress, the areas should not be considered as living space nor used as a sleeping area for safety reasons.

To comply with generally-accepted current standards, this basement should have a means of egress in addition to the stairway to the main floor. Means of egress are safe pathways to the exterior such as windows, window wells, etc. installed to allow escape and rescue in the event of an emergency such as a fire in which escape using the stairway is not possible. Proper egress openings have the following requirements:

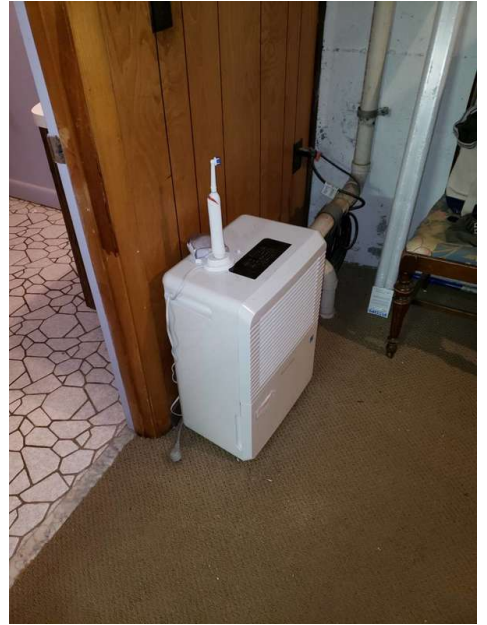
5.11.1 Dehumidifier

PRESENT BUT NOT WORKING

A dehumidifier was installed at the time of the inspection. It was not on or not working at the inspection.

The dehumidifier is easier to maintain if it drains constantly. If there is no sink that can be used as a drain, sometimes the heating system or A/C system in the basement will have a small condensate pump. This is a good location to allow drainage from the dehumidifier tank to drain into, the pump will come on as needed to evacuate any dehumidifier condensation. Pumps can also be purchased separately.

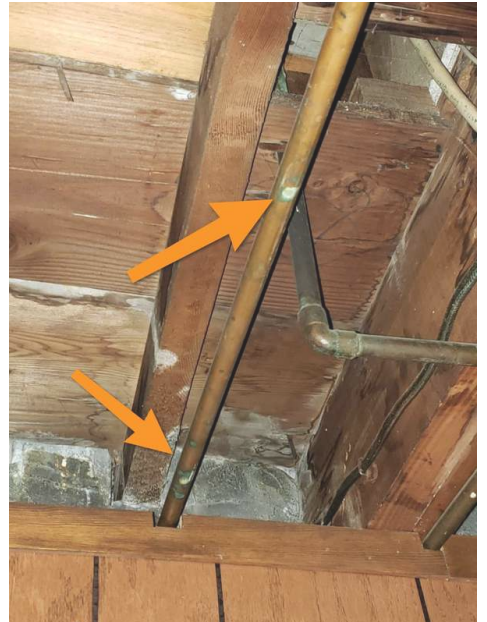
6.2.1 Domestic Water Supply Distribution System

CORROSION (NOT LEAKING)

Corrosion was noted in one or more areas of the water supply system. A visible build-up of mineral deposits or encrustation is an early warning sign of future leakage. Consider repair of the affected areas before leakage becomes an issue.

Contact a qualified plumbing contractor.

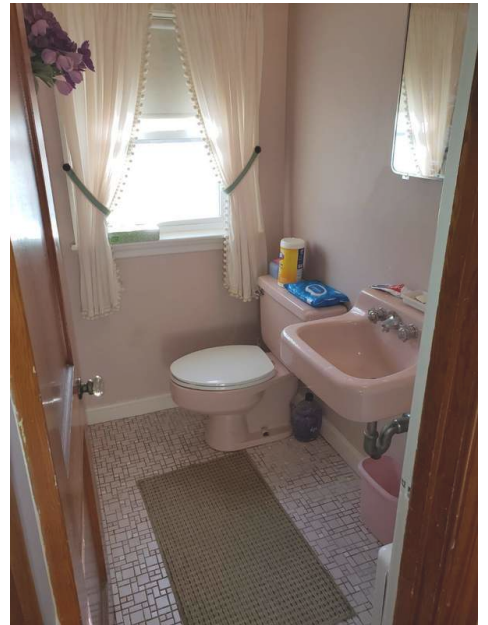
6.6.1 Toilet

STRANGE NOISE

The toilet made a high pitch screeching noise while refilling the tank. Further investigation and or repair is recommended.

Contact a qualified professional.

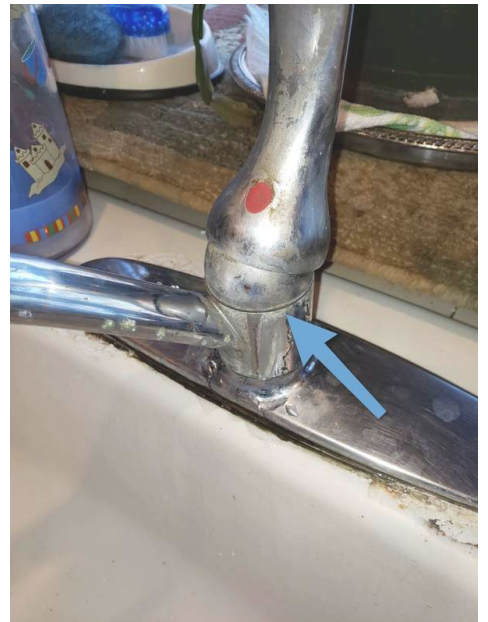
6.8.1 Sinks/Vanity

FAUCET (LEAKING)

The faucet was leaking. Repair is recommended.

Contact a handyman or DIY project

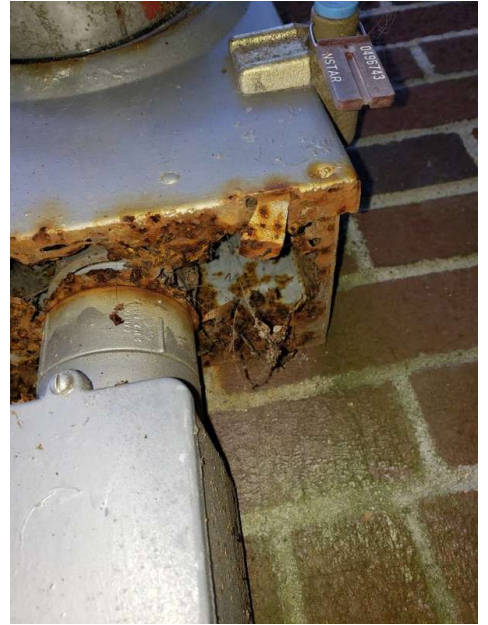
7.1.1 Service Entry

SERVICE ENTRANCE (METER SOCKET ROTTED)

The meter socket was rotted thru in one or more areas. The source of moisture needs to be identified and resolved. Replacement is needed.

Contact a qualified electrical contractor.

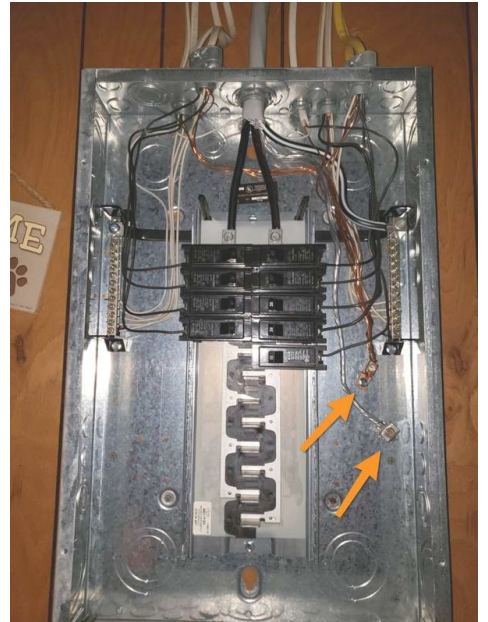
7.2.1 Panel Enclosure, Cover, & System Grounding

GROUNDING (FOOTLUG)

Multiple grounds are attached to a single "foot lug" screwed into the panel. This is not up to current standards. Further evaluation and or repair is recommended.

Recommendation
Contact a qualified electrical contractor.

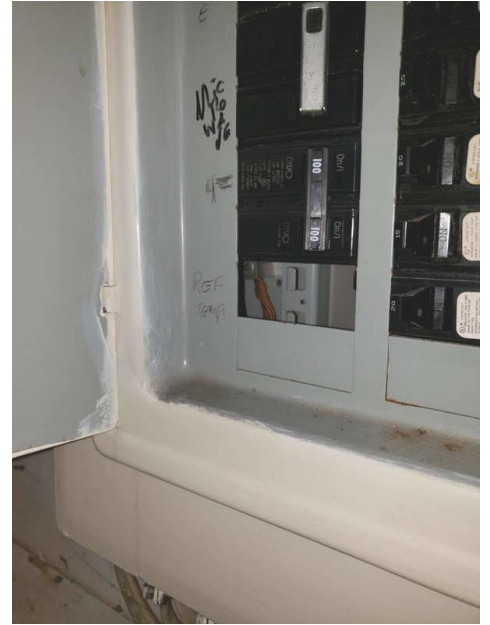
7.2.3 Panel Enclosure, Cover, & System Grounding

PANEL COVER (MISSING FILLER PLATES)

One or more filler plates were missing from the panel cover. A gap in the dead front cover of the main electrical service panel where a circuit breaker was missing may allow a person to come into contact with energized electrical components. Repair is recommended.

Contact a qualified electrical contractor.

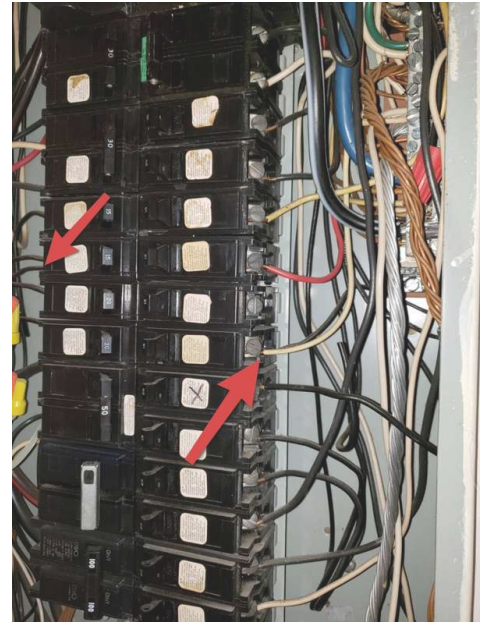
7.3.1 Condition Of Wiring In Panel

BREAKER (MULTI TAP)

Two or more wires were connected to a breaker designed for only one wire. This is known as a "multi-tap" and is a defective condition. Further evaluation and or repair is recommended.

Contact a qualified electrical contractor.

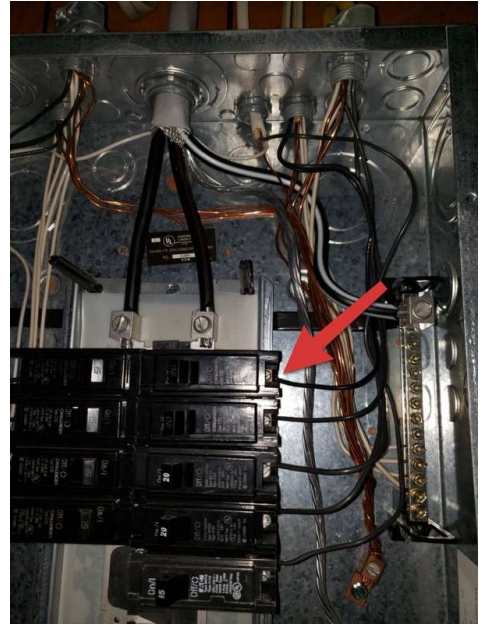
7.3.2 Condition Of Wiring In Panel

BREAKER (OVER AMPED)

One or more over-amped breakers were found. Over-amped means that the breaker is rated to carry more amperage than the wire attached to it. An overdraw condition could cause melting, insulation overheating, or fire. Further evaluation and or repair is recommended.

Contact a qualified electrical contractor.

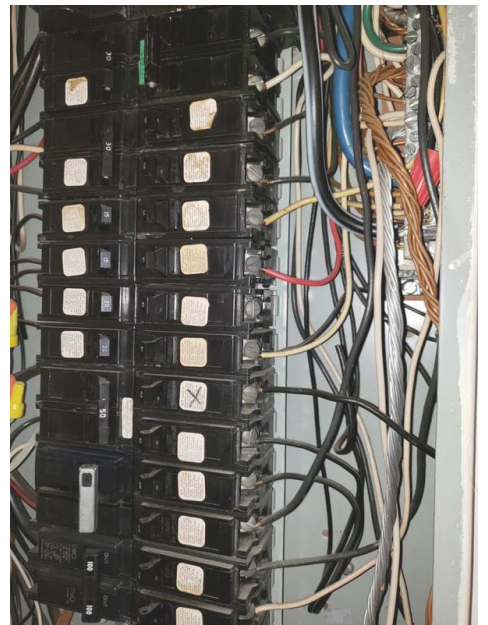
7.3.3 Condition Of Wiring In Panel
NEUTRAL BAR (MULTIPLE NEUTRALS, SAME SCREW)

One or more neutral (white) wires are under a single screw, this is not up to current standards. There should only be one neutral wire under each screw. Further evaluation and or repair is recommended.

Recommendation
Contact a qualified electrical contractor.

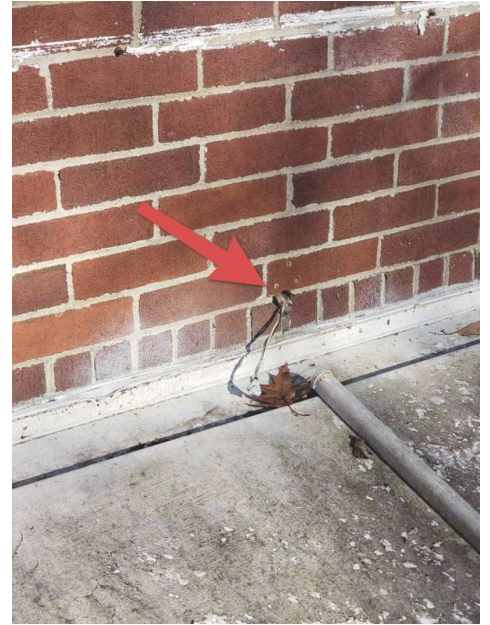
7.4.1 Branch Circuit Wiring
WIRES (EXPOSED, UNCAPPED)

One or more uncapped wires are noted. Further evaluation and or repair is recommended.

Recommendation
Contact a qualified electrical contractor.

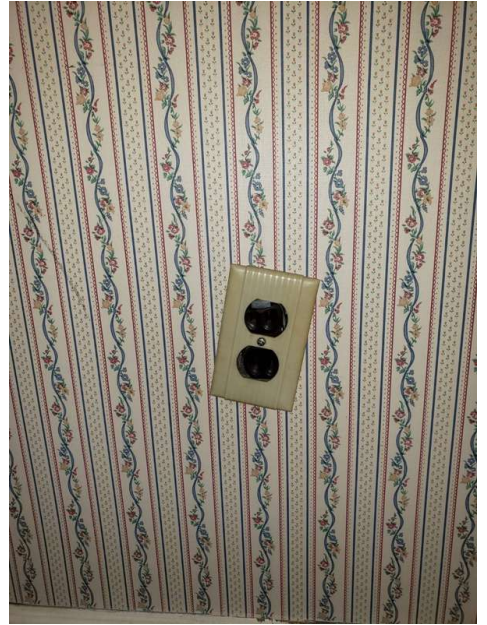
2nd Floor Bedroom

7.5.3 Switches, Receptacles & Lighting Fixtures
OUTLET (DAMAGED)

One or more outlets are damaged. Replacement is needed.

Recommendation
Contact a qualified electrical contractor.

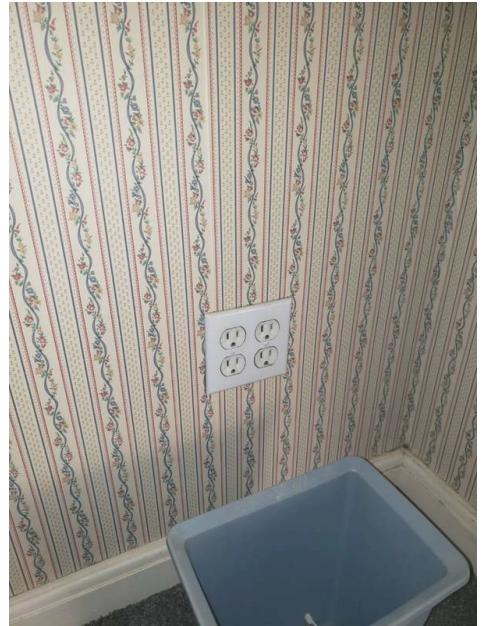
2nd Floor Bedroom

7.5.4 Switches, Receptacles & Lighting Fixtures
OUTLET (UNGROUND 3 PRONG)

One or more outlets are not grounded. Repair is recommended.

Recommendation
Contact a qualified electrical contractor.

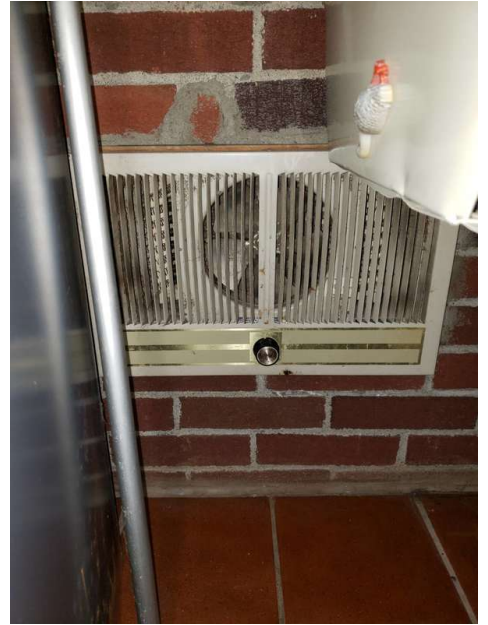
8.2.1 Electric Wall Heater
NO RESPONSE

One or more electric wall heaters did not respond when tested.
Further investigation and or repair is recommended.

Recommendation
Contact a qualified professional.

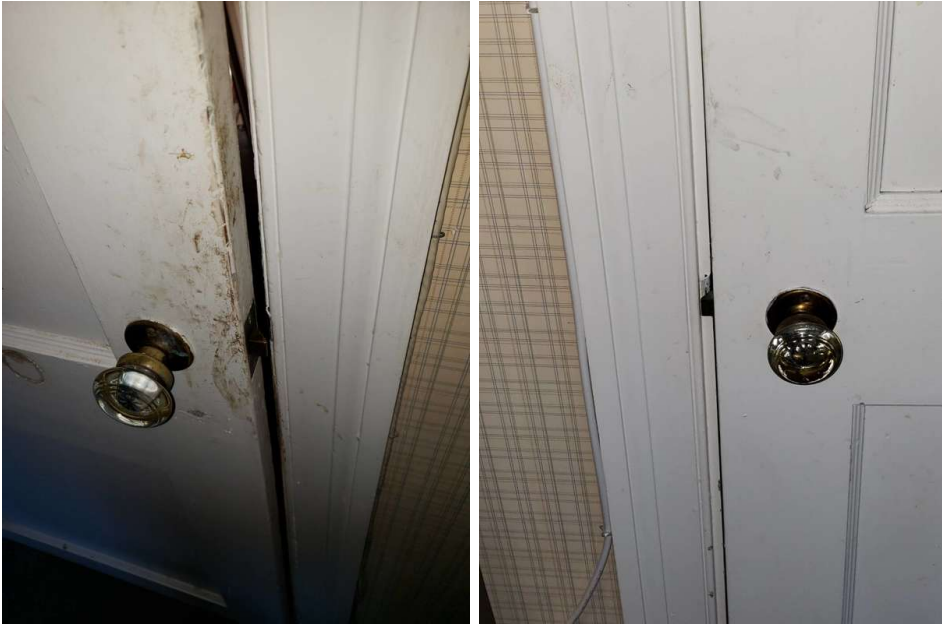
10.1.2 Interior Doors

STRIKER PLATE (ADJUST)

One or more striker plates need adjustment to latch door closed, repair is recommended.

Contact a handyman or DIY project

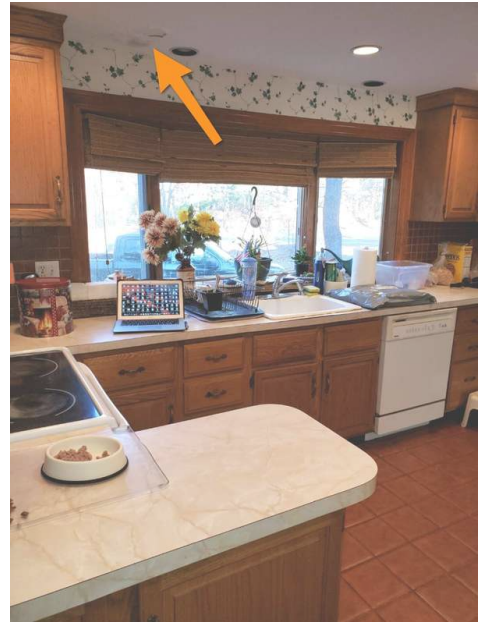
10.4.1 Ceilings

MOISTURE STAIN (DRY)

One or more areas of the ceiling had unrepaired staining that indicates current or past moisture leakage at the ceiling(s). The stain(s) was dry at the time of inspection.

Check with current owner as to the history of moisture and or repair in these areas.

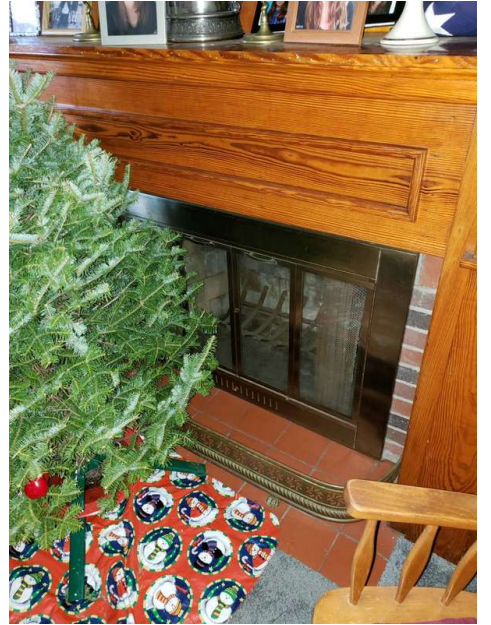
12.1.1 Damper Doors

ADJUSTMENT NEEDED

One or more fireplace dampers need to be adjusted so that it will have the full range of movement. Repair as needed.

Contact a qualified chimney contractor.
