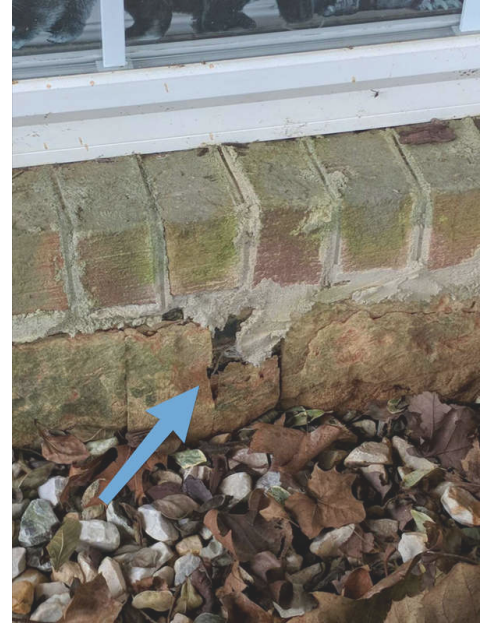
PARGE COAT CRACKING

The parge coat is cracking and showing signs of deterioration. A parge coat is generally for decorative / aesthetic purposes but may also lead to water intrusion. Recommend repair or re-coat.

Recommendation
Contact a qualified professional.

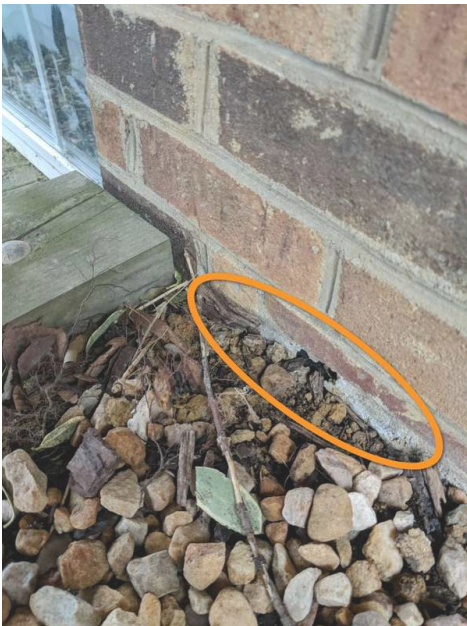
North

BRICK/MORTAR CRACKING

The brick exterior walls had cracking visible in one or more locations around the home in areas where the brick meets the ground. Recommend further evaluation and repair as needed.

Recommendation
Contact a qualified professional.

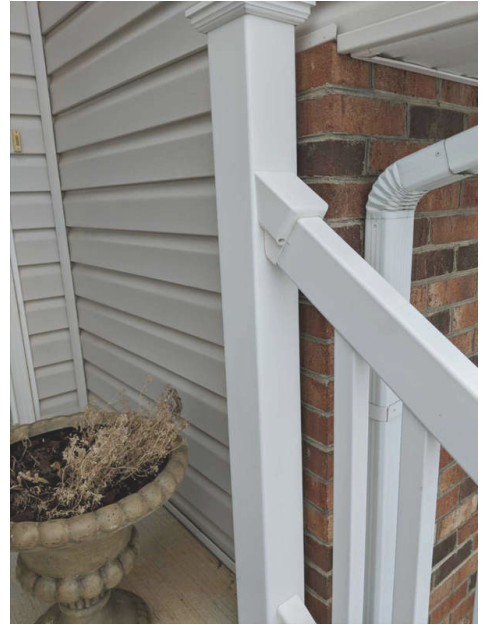
LOOSE NEWEL POST

A newel post at this staircase was loose at the time of the inspection. For safety reasons, the Inspector recommends that the newel post be made secure by a qualified contractor.

Recommendation
Contact a qualified professional.

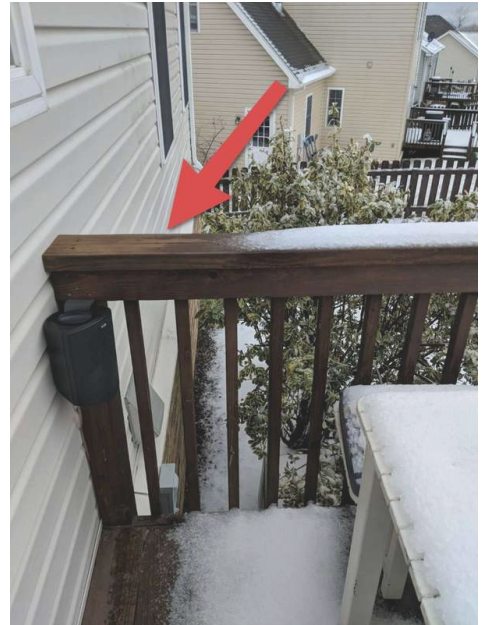
RAILING LOOSE

Based on the inspector's past experience, the handrail assembly did not appear to be of adequate strength to safely protect the deck/stairs. Physical testing for compliance with any building standards or building codes lies beyond the scope of the General Home Inspection. The Inspector recommends that additional support be installed by a qualified contractor.

Recommendation
Contact a qualified professional.

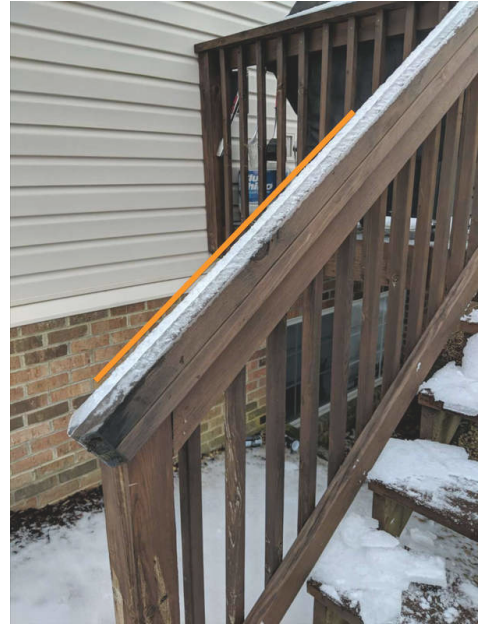
HANDRAIL LOOSE

Recommend repair or replace.

Contact a handyman or DIY project

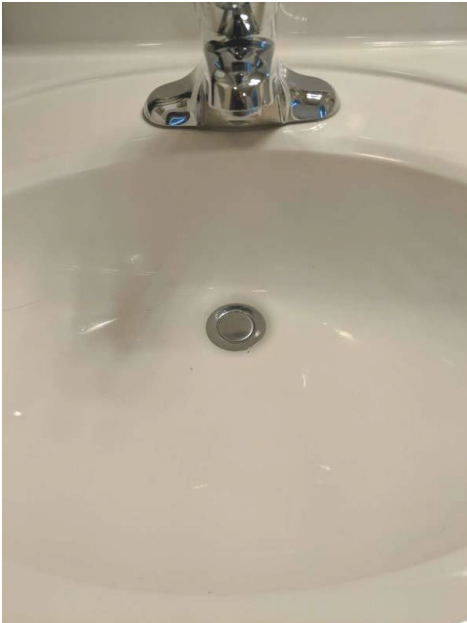
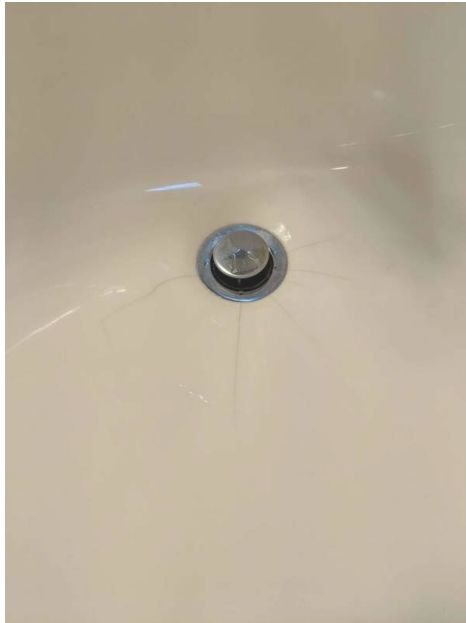
FIXTURE - DAMAGED OR MISSING HARDWARE

The sinks in the master bathroom were damaged or in disrepair. The sink on the left and a drain stopper that was inoperable and limited the inspection of that sink. Recommend repairing the mechanism. The sink on the right had cracks in the basin. Although not leaking at the time of the inspection, these cracks may lead to leaking or further damage. Recommend to repair or replace the sink / countertop. The Inspector recommends repair or replacement by a qualified contractor.

Contact a qualified professional.

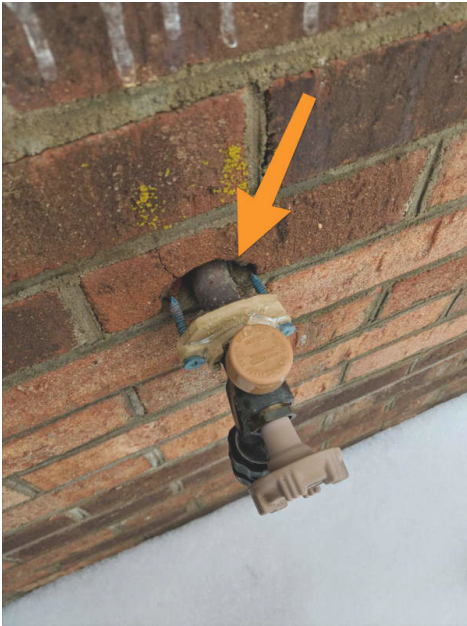
East

FIXTURE LOOSE

The fixture was loose and needed maintenance. All work should be performed by a qualified contractor.

Contact a qualified professional.

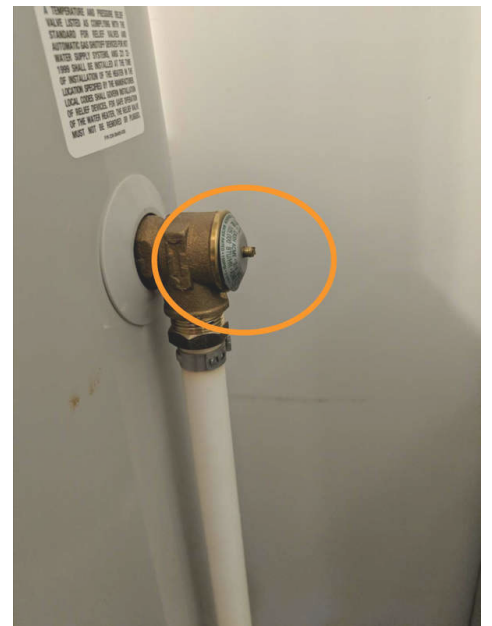
TPR VALVE - DAMAGED

The easing lever on the TPR valve was broken off or has been removed. Here is a link to a video explaining [TPR Valve](#) . Recommend further evaluation from a qualified plumber and repair or replace as needed.

Contact a qualified plumbing contractor.

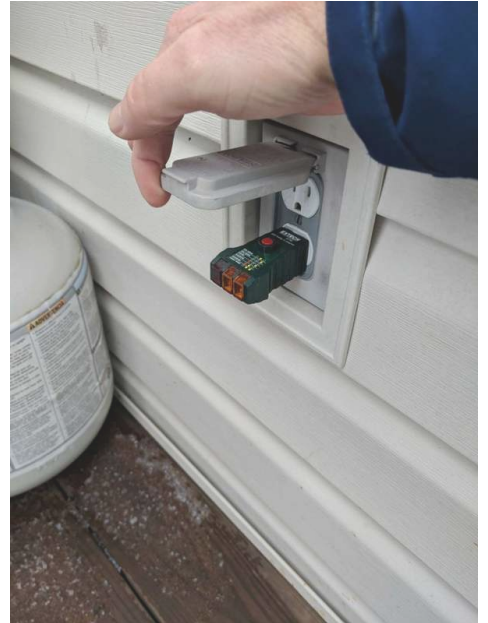
Exterior

NO GFCI PROTECTION INSTALLED

No GFCI protection present in all locations.

For safety reasons, the Inspector recommends that receptacles located within 6 feet of a plumbing fixture or located on the exterior of the home to be provided with ground fault circuit interrupter (GFCI) protection in good working order to avoid potential electric shock or electrocution hazards.

Recommend licensed electrician upgrade by installing ground fault receptacles in all locations.

Contact a qualified electrical contractor.

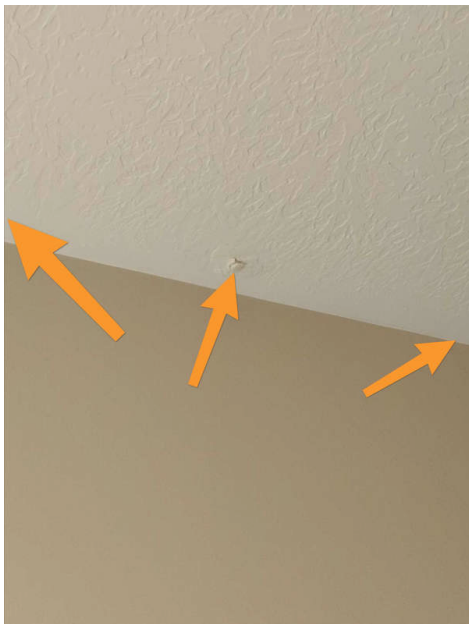
1st Floor Bathroom

NAIL POPS

Protruding nail heads visible in several locations throughout the home . Protruding nails should be removed, drywall re-fastened and the drywall finished to match the existing wall surfaces. All work should be performed by a qualified drywall or painting contractor.

Contact a qualified drywall contractor.

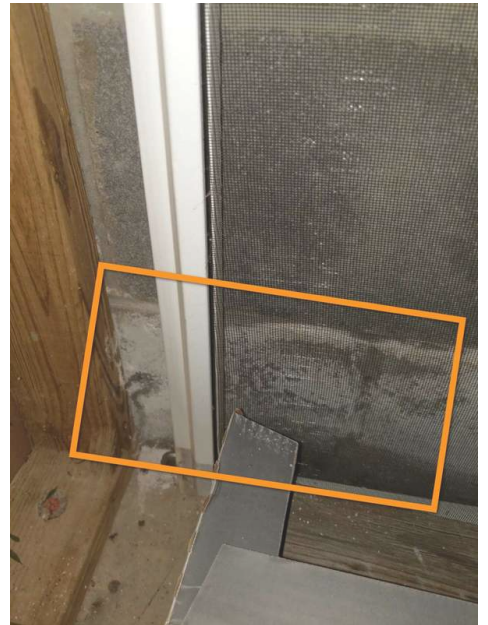
Basement Bedroom Closet

EFFLORESCENCE

Efflorescence noted on the basement foundation wall surface. This is a white, powdery deposit that is consistent with moisture intrusion. This can compromise the soil's ability to support the home structure and/or lead to mold growth. Recommend a qualified contractor identify source of moisture and correct.

Contact a qualified professional.

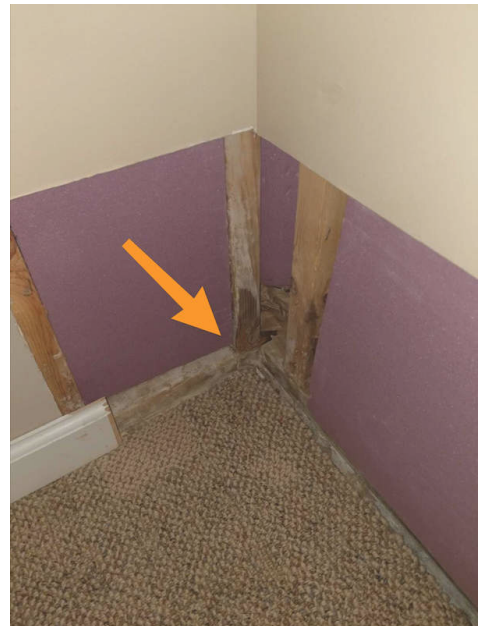
Northeast Basement

WATER INTRUSION

Wall structure showed signs of water intrusion, which could lead to more serious structural damage. It appeared that the home owner has made recent attempts to address this situation. This area was inspected using a moisture meter and elevated levels of moisture were found at this location. Recommend a qualified contractor identify source of moisture and remedy.

Contact a qualified professional.
