SUMMARY
1234 Main St. Bakersfield California
93306
Buyer Name
05/06/2019 9:00AM

Mike Hazelwood
InterNACHI #0731201
Cal-Pro Real Estate Inspections
(661) 873-5200
calpro@calproinspections.com

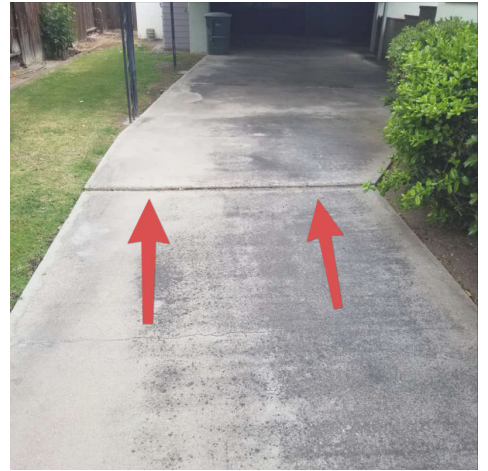
4.3.1 Driveways, Sidewalks, Patios

DRIVEWAY CRACKS / DETERIORATION - TRIP HAZARD - REPAIR

Safety / Major

Cracks, holes, settlement, heaving and/or deterioration resulting in trip hazards were found in the driveway, For safety reasons, recommend that a qualified contractor repair as necessary.

Contact a qualified concrete contractor.

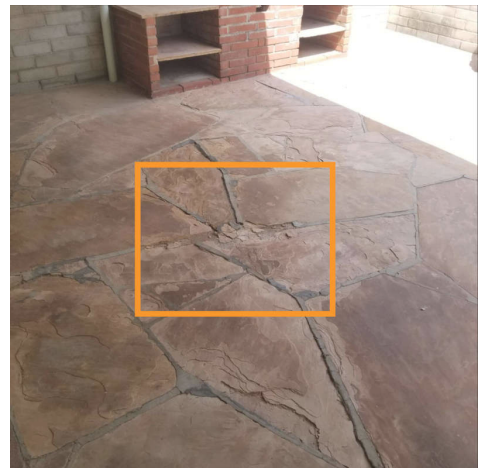
4.3.2 Driveways, Sidewalks, Patios

SIDEWALK / PATIO CRACKS / DETERIORATION - REPAIR

Moderate

REAR

Cracks, holes, settlement, heaving and/or deterioration were found in sidewalks and/or patios. Recommend that qualified contractor repair as necessary.

Contact a qualified concrete contractor.

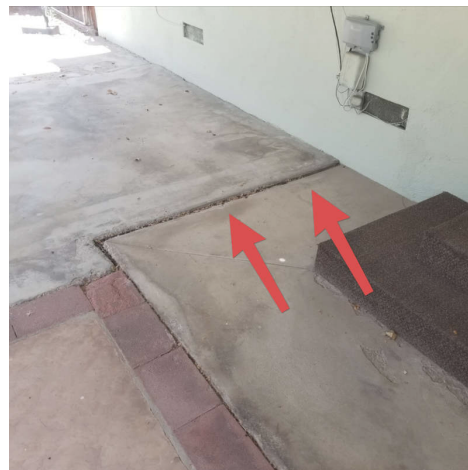
4.3.3 Driveways, Sidewalks, Patios

SIDEWALK / PATIO CRACKS / DETERIORATION - TRIP HAZARD - REPAIR

Safety / Major

RIGHT REAR

Cracks, holes, settlement, heaving and/or deterioration resulting in trip hazards were found in the sidewalks or patios. For safety reasons, recommend that a qualified contractor repair as necessary to eliminate trip hazards.

Contact a qualified concrete contractor.

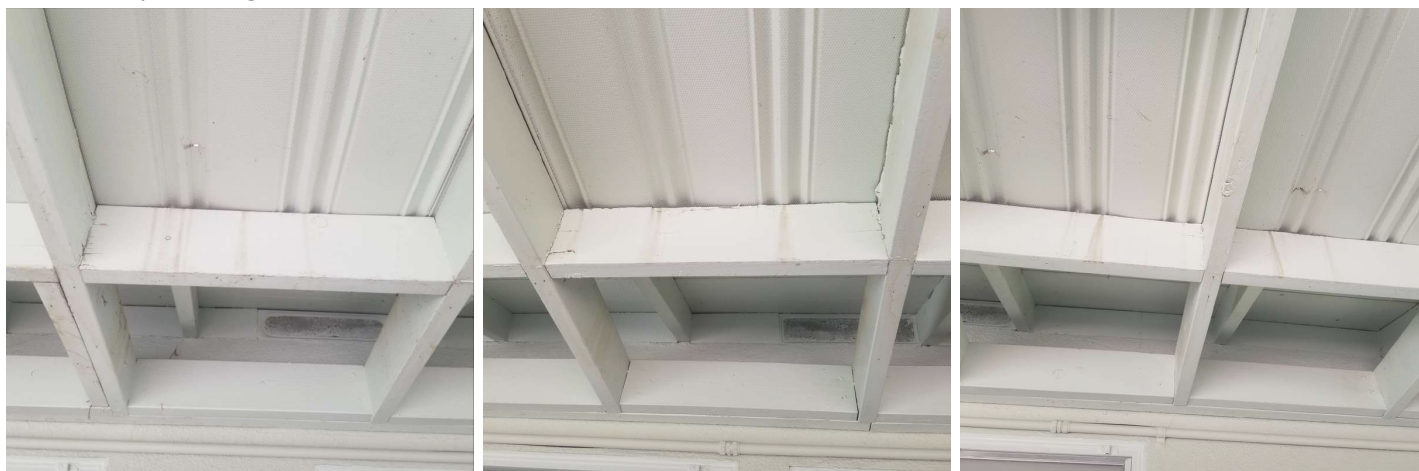
4.5.1 Patio / Porch Covers

WATER STAINS AT UNDER-SIDE

Moderate

Stains were found at one or more covered patio areas. The inspector was unable to determine if an active leak exists (e.g. recent dry weather, inaccessible height). Recommend asking the property owner about this, monitoring the stains in the future, and/or having a qualified contractor evaluate and repair if necessary.

Contact a qualified general contractor.

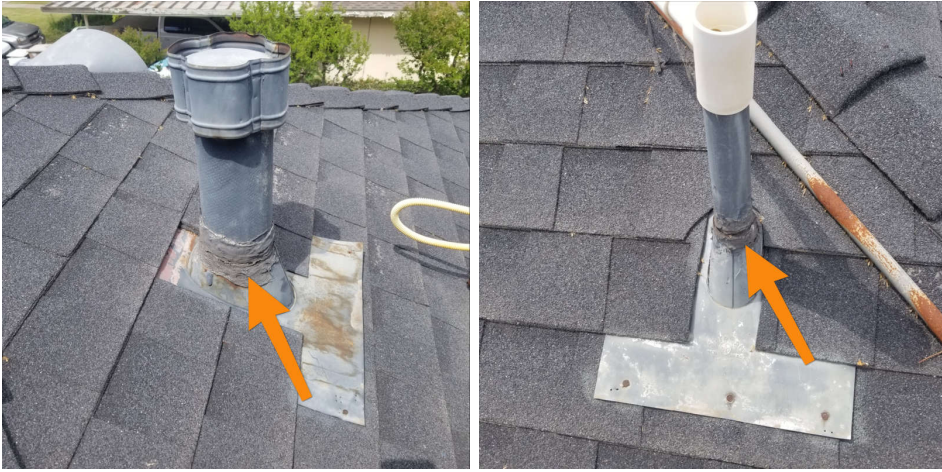
6.4.1 Skylights, Chimneys & Other Roof Penetrations

SEAL ROOF JACK FLASHING AT PENETRATION(S)

Moderate

VARIOUS

One or more roof jacks in need of tar maintenance at pipes and/or other penetrations. Leaks can occur as a result. This is a conducive condition for wood-destroying organisms. Recommend that a qualified contractor seal roof jack flashing where necessary.

Contact a qualified roofing professional.

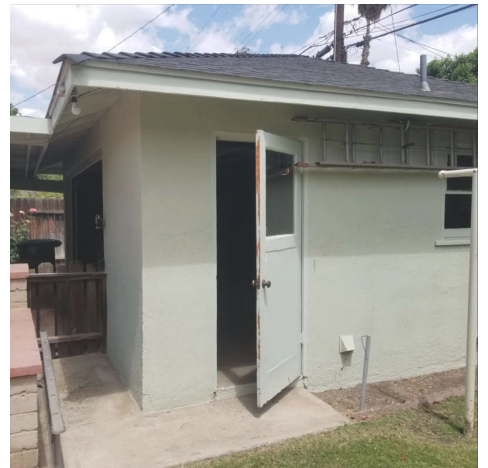
7.1.3 Exterior Doors

EXTERIOR DOOR HOLLOW CORE TYPE

GARAGE RIGHT SIDE

Safety / Major

One or more exterior entrance doors were of hollow-core or thin panel construction rather than solid core or metal. This may represent a security hazard since these doors are easily broken or can easily become deteriorated and/or weathered over time. Recommend that a qualified contractor replace hollow-core / thin panel exterior entrance doors with solid core or metal doors.

Contact a qualified door repair/installation contractor.

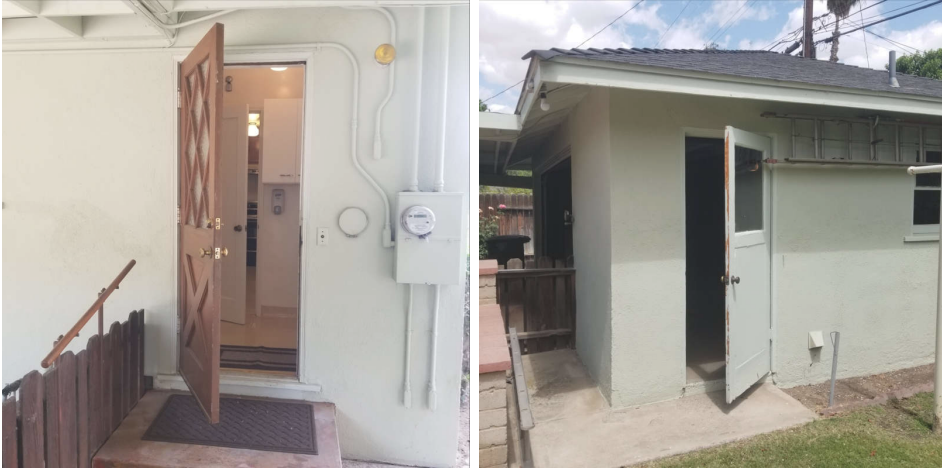
7.1.4 Exterior Doors

EXTERIOR DOOR OPENS OUTWARD

Moderate

LEFT REAR / GARAGE RIGHT SIDE

One or more exterior entry doors opened outwards and didn't appear to have security hinges and/or an anti pry plate over the lockset area. Doors that open outwards have hinges oriented so the pins are exposed outside and can easily be removed also strikers and/or deadbolts can be pried open. Without security hinges, the door can also be removed allowing someone to gain entry. Recommend that a qualified person install security hinges and an anti pry plate on outward-opening doors where needed for better security.

Contact a qualified door repair/installation contractor.

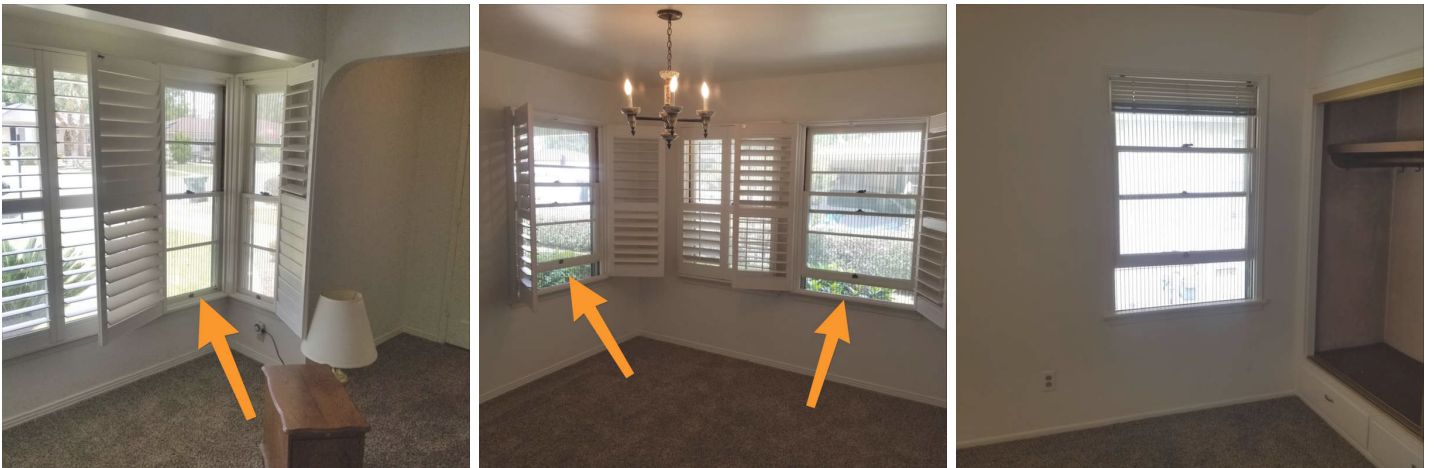
7.3.1 Windows

DIFFICULT TO OPEN,CLOSE

Moderate

LIVING ROOM / FORMAL DINING AREA / RIGHT REAR BEDROOM

One or more windows were difficult to open and close. Recommend repair by window contractor.

Contact a qualified window repair/installation contractor.

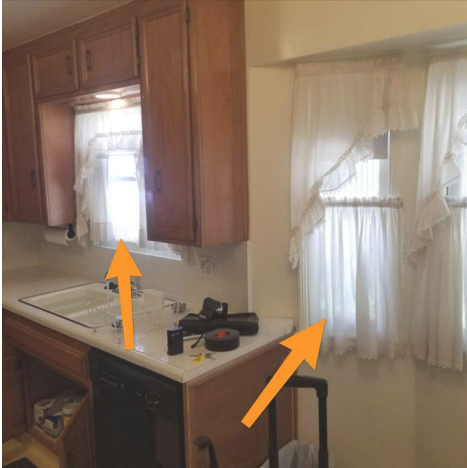
Kitchen / Kitchen Nook

WOULDN'T OPEN

One or more windows wouldn't open or were painted shut (older homes). Recommend that a qualified person repair windows as necessary so they open and close easily.

Contact a qualified window repair/installation contractor.

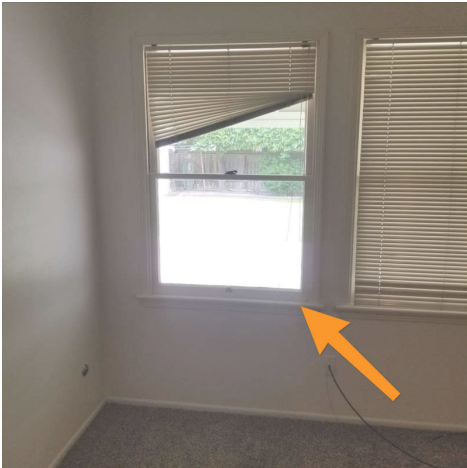
Right Rear Bedroom

SINGLE / DOUBLE-HUNG WINDOW DOES NOT STAY OPEN

Single / Double-Hung window does not stay in the open position (no friction / latch not engaging). Recommend repairs be made by a window specialist.

Contact a qualified window repair/installation contractor.

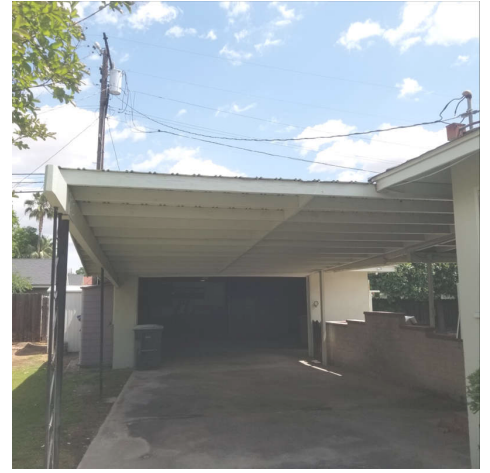
8.2.1 Structure

CARPORT SUBSTANDARD / OVER-SPANNED

Moderate

One or more carport covers were substandard, non-standard and/or over-spanned. Recommend that a qualified licensed contractor repair or replace as necessary, and per standard building practices.

Contact a qualified general contractor.

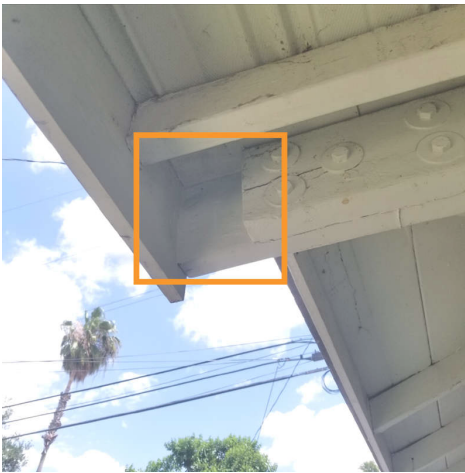
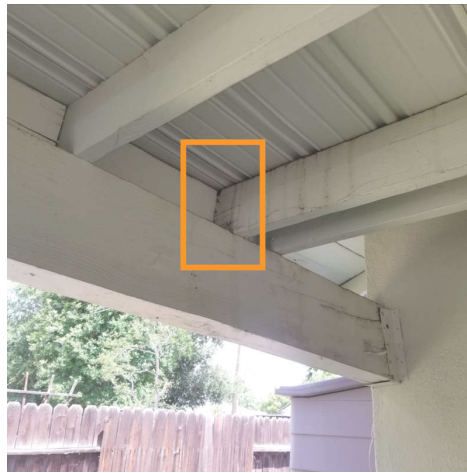
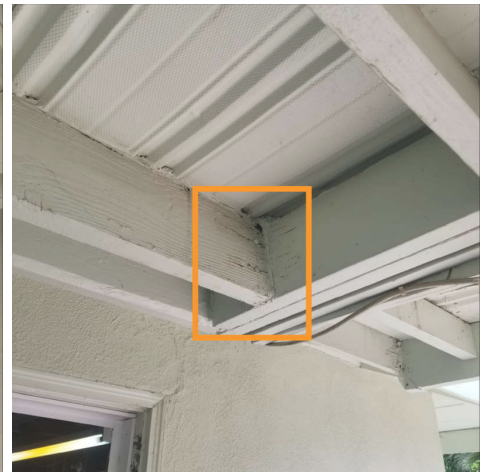
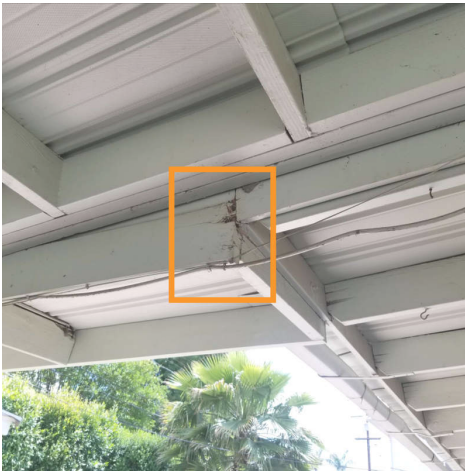
8.2.2 Structure

DAMAGED FRAMING

Moderate

Framing members damaged at one or more areas. Recommend repairs be made by a qualified licensed contractor.

Contact a qualified general contractor.

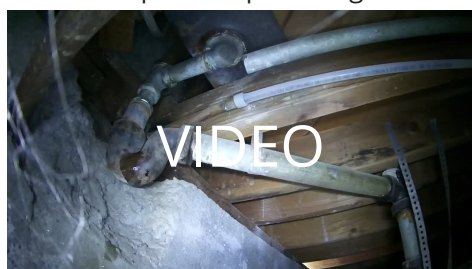
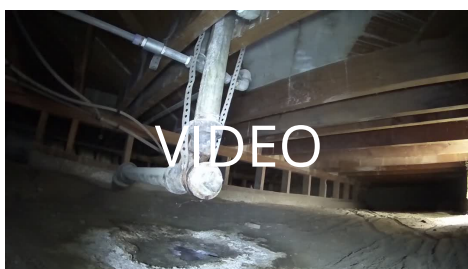
9.4.2 Drain, Waste, & Vent Systems

LEAKS

Safety / Major

CRAWL SPACE UNDER HALLWAY BATHTUB AND SINK

A leak was found in drain or wastepipes or fittings. A qualified plumber should evaluate and repair as necessary.

Contact a qualified plumbing contractor.

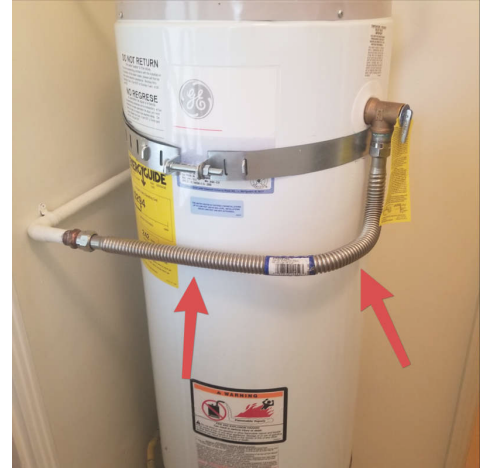
9.5.1 Water Heater

TPR DRAIN LINE / FLEX CONNECTOR

Safety / Major

One or more flexible connectors were used for the temperature-pressure relief valve drain line. Flex connectors can be bent or kinked so as to restrict the flow of the drain line and impair the operation of the valve. They typically are not rated for the temperature and pressure of water being discharged (potentially 150 psi and 210 degrees F). Flex connectors used this way pose a potential safety hazard for explosion. Recommend that a qualified plumber repair per standard building practices. For example, by installing a drain line made of rigid copper or CPVC plastic pipe.

Contact a qualified plumbing contractor.

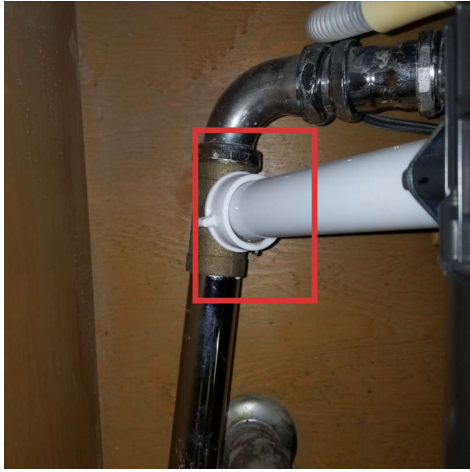
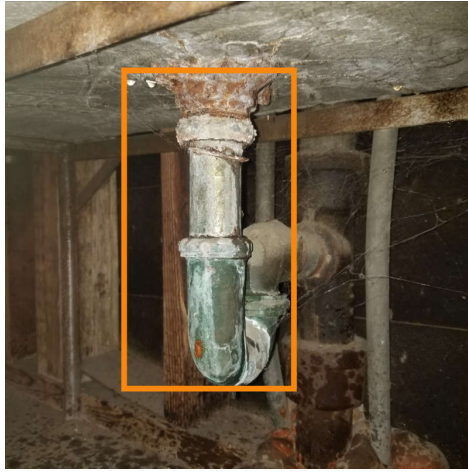
9.6.1 Sinks / Fixtures

DRAIN LEAK

Safety / Major

KITCHEN / GARAGE LAUNDRY

One or more leaks were found at the sink drain. A qualified plumber should repair as necessary.

Contact a qualified plumbing contractor.

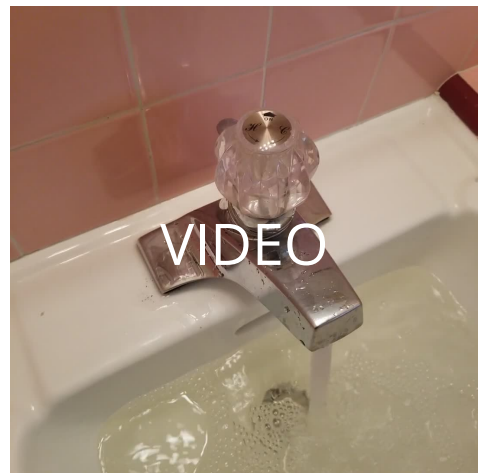
9.6.2 Sinks / Fixtures

LEAKING FAUCET BASE / HANDLES

HALLWAY BATH

Water was leaking at one or more sink faucet base or handles. Recommend that a qualified plumber repair as necessary.

Safety / Major

Contact a qualified plumbing contractor.

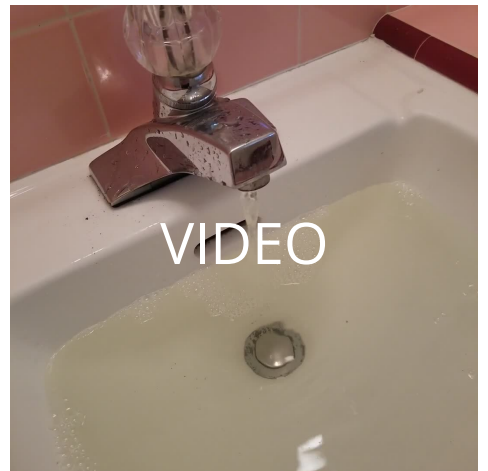
9.6.3 Sinks / Fixtures

LOW / NO FLOW

HALLWAY BATH (HOT SIDE)

The flow from one or more water supply areas was low or inoperable. Recommend that a qualified person evaluate and repair as necessary. Shut-off valves may be partially or fully closed. Note that the inspector may or may not operate shut-off valves. If repairs are needed, a qualified plumber should make them.

Moderate

Contact a qualified plumbing contractor.

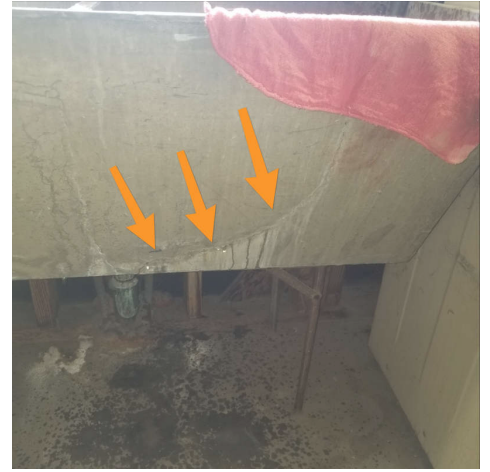
9.6.4 Sinks / Fixtures

SINK DAMAGED - REPAIR OR REPLACE

GARAGE LAUNDRY

The sink was damaged or significantly deteriorated. Recommend that a qualified plumber repair or replace the sink.

Safety / Major

Recommendation
Contact a qualified plumbing contractor.

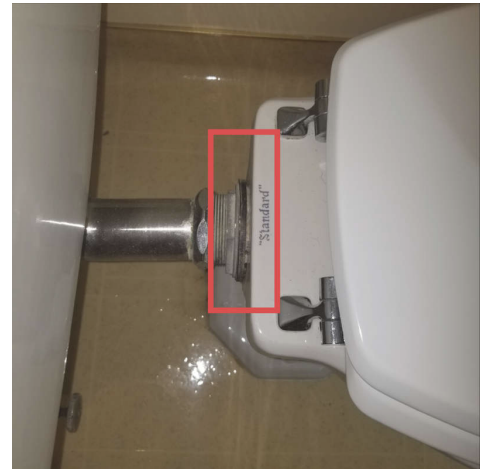
Rear Bath

TOILET TANK LEAKS

The toilet tank was leaking where it attached to the toilet. Flooring, the sub-floor or areas below may get damaged. Recommend that a qualified contractor remove the tank(s) and install a new rubber ring and tank(s) should be securely anchored to the toilet to prevent movement and leaking.

Safety / Major

Recommendation
Contact a qualified plumbing contractor.

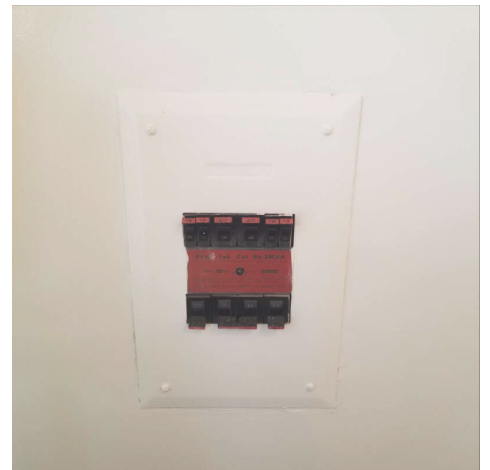
10.3.1 Panels

FEDERAL PACIFIC / STAB-LOK

Safety / Major

UTILITY SUB PANEL

One or more panels were manufactured by the Federal Pacific Electric company and used "Stab-Lok" circuit breakers. There is evidence that both double and single pole versions of these circuit breakers fail by not tripping when they are supposed to, which in term often leads to breakers overheating and in some cases, electrical fires. However, in 2011 the Consumer Products Safety Commission (CPSC) closed an investigation into this product because they did not have enough funding to establish that the circuit breakers pose a risk of injury/fire to consumers. Regardless, and due to other evidence of safety issues, it is recommended that a qualified electrician carefully evaluate all Federal Pacific panels and make recommendations. Some insurance companies in the state are not offering property insurance with this manufacturer's panel installed in single family homes that require a 4 point insurance inspection.

Contact a qualified electrical contractor.

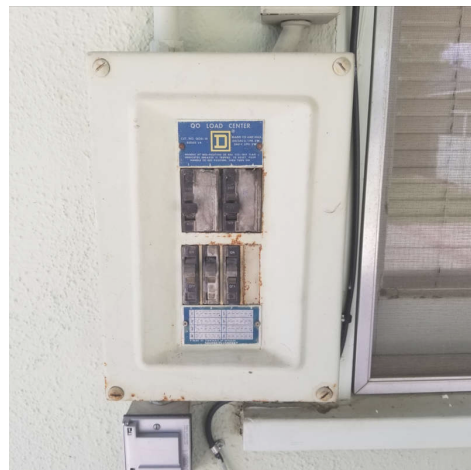
10.3.2 Panels

PANEL NOT DESIGNED FOR EXTERIOR INSTALLATION

Safety / Major

EXTERIOR RIGHT REAR SUB PANEL

The electrical panel that is installed at the exterior of the building is not designed for exterior installation. This is a safety issue due to the risk of electrical shock. Recommend that repairs be made by a qualified licensed electrical contractor.

Contact a qualified electrical contractor.

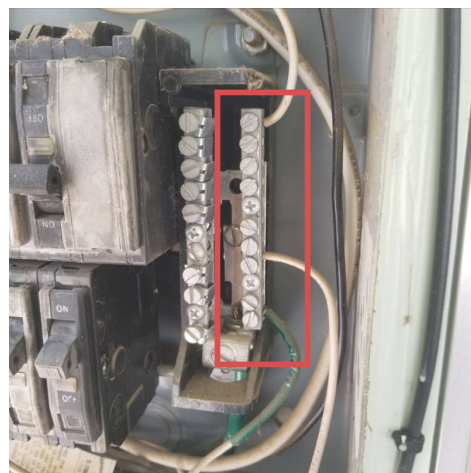
10.4.2 Panel Wiring & Breakers

SUBPANEL NEUTRAL/GROUND BONDED

EXTERIOR RIGHT REAR SUB PANEL

Safety / Major

Neutral and equipment ground wires were bonded (connected) at sub-panel(s). This should only occur in the main service panel, not sub-panels, and is a shock hazard. Neutral wires should be attached to a "floating" neutral bar not bonded to the panel, and grounding wires should be attached to a separate grounding bar bonded to the sub-panel. Recommend that a qualified electrician repair per standard building practices.

Contact a qualified electrical contractor.

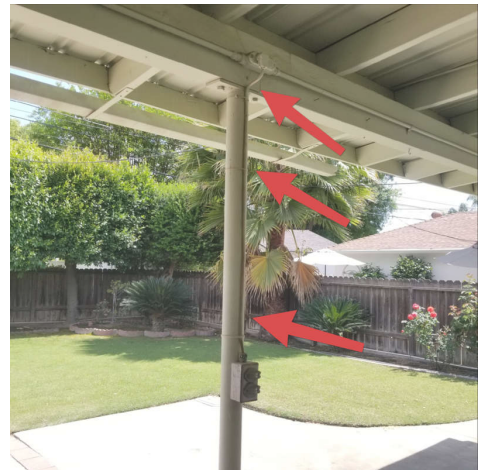
10.6.2 Wiring

SUBSTANDARD WIRING

Safety / Major

EXTERIOR REAR

Substandard wiring practices were found (e.g. exposed sheathed wiring, exposed splices, improperly installed lighting / receptacles etc.) Recommend repairs be made by a qualified licensed electrical contractor.

Contact a qualified electrical contractor.

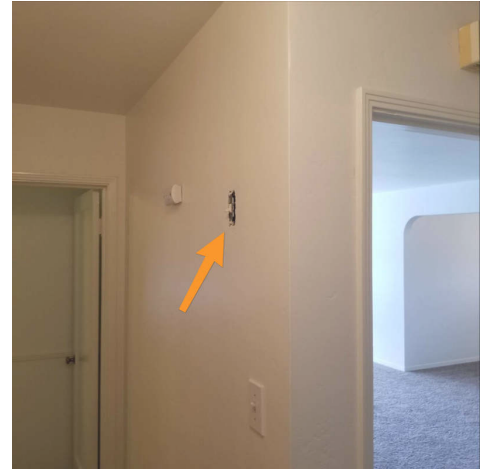
10.7.1 Switches / Receptacles

COVER PLATE LOOSE / MISSING / DAMAGED

Safety / Major

HALLWAY

A cover plate for a switch and/or a receptacle (outlet) were missing and/or damaged. These plates are intended to contain fire and prevent electric shock from occurring due to exposed wires. Recommend that a qualified person install cover plates where necessary.

Recommendation
Contact a handyman or DIY project

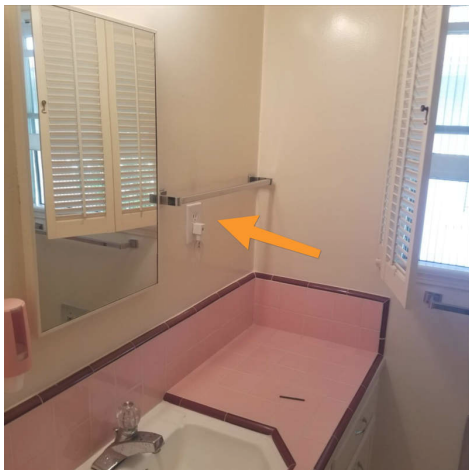
Hallway Bath

REVERSE POLARITY

One or more electric receptacles (outlets) had reverse-polarity wiring, where the hot and neutral wires were reversed. This is a shock hazard. Recommend that a qualified electrician repair as necessary.

Recommendation
Contact a qualified electrical contractor.

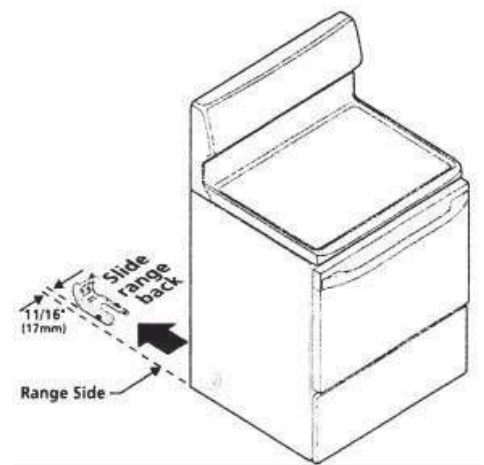
The range could tip forward. An anti-tip bracket may not be installed or may be ineffective. This is a potential safety hazard since the range can tip forward when weight is applied to the open door, such as when a small child climbs on it or if heavy objects are dropped on it. Anti-tip brackets have been sold with all free-standing ranges since 1985. Recommend installing an anti-tip bracket to eliminate this safety hazard.

Contact a qualified professional.

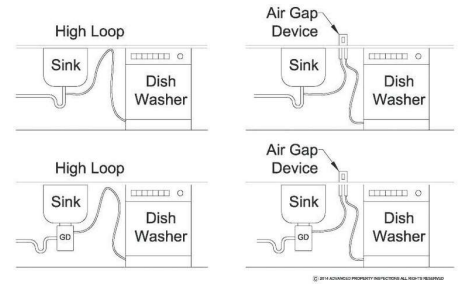
No air gap or high loop was visible for the dishwasher drain. An air gap is a device that makes the drain line non-continuous or the drain line is looped high up under the countertop, and prevents wastewater backflow from entering the dishwasher, and possibly flooding out of the dishwasher if/when a siphon occurs. Some newer dishwashers have this device built in. Recommend determining if an air gap device is built in to this brand and model of dishwasher (e.g. review installation instructions). If not, or if this cannot be determined, then recommend that a qualified contractor install an air gap or a high loop per standard building practices.

Contact a qualified appliance repair professional.

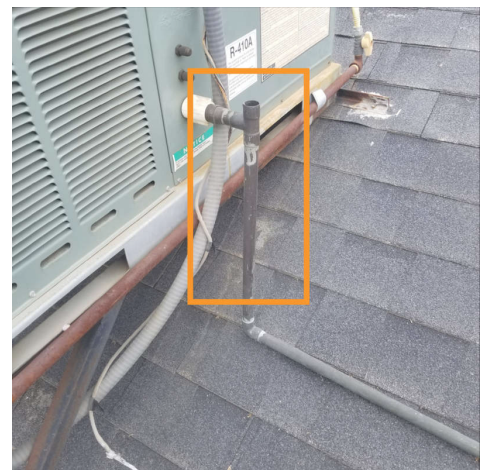
12.4.1 Air Conditioner

CONDENSATE DRAIN LINE TRAP MISSING / SUBSTANDARD

The air conditioner's primary condensate drain line trap was missing and/or substandard. A U-shaped trap with a 2-inch drop should normally be installed to prevent air from moving in or out of the air handler during operation. Without a correctly configured trap, efficiency can be reduced, or condensate water can be pulled into the equipment resulting in wet insulation or components, or microbial growth. Recommend that a qualified HVAC contractor repair per standard building practices.

Contact a qualified HVAC professional.

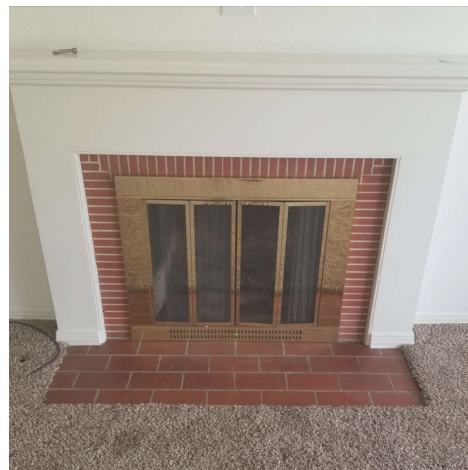
13.1.1 Fireplaces, Stoves & Inserts

"LEVEL 2" CHIMNEY INSPECTION

One or more wood-burning fireplaces or stoves were found at the property. When such devices are used, they should be professionally inspected and cleaned annually to prevent creosote build-up and to determine if repairs are needed. The National Fire Protection Association states that a "Level 2" chimney inspection should be performed with every sale or transfer of property with a wood-burning device. Recommend consulting with the property owner about recent and past servicing and repairs to all wood-burning devices and chimneys or flues at this property. Recommend that a qualified specialist evaluate all wood-burning devices and chimneys, and clean and repair as necessary. Note that if a wood stove insert is installed, it may need to be removed for such an evaluation

Contact a qualified chimney contractor.

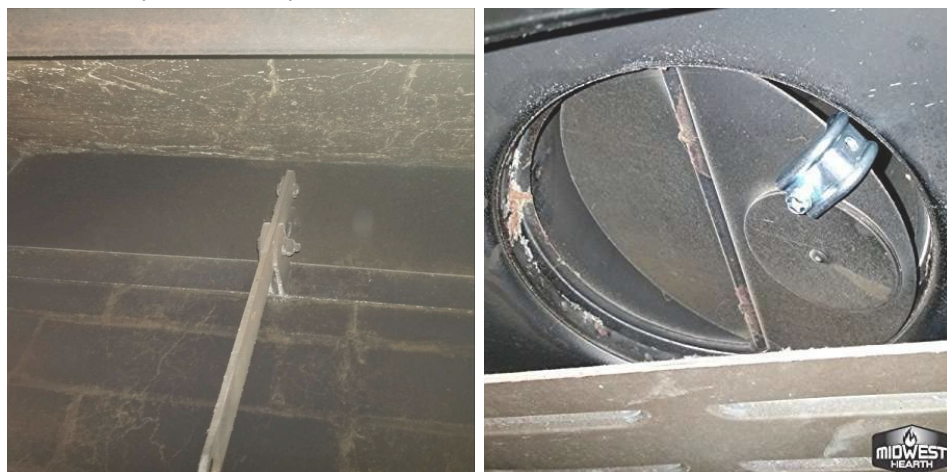
13.1.2 Fireplaces, Stoves & Inserts

DAMPER CAN CLOSE

A fireplace was equipped with a gas burner and the chimney damper could close. This is a safety hazard due to the possibility of burner or pilot light exhaust gases entering living spaces. Modifications should be made to prevent the damper from ever closing to prevent this. A qualified contractor should repair per standard building practices so the damper cannot close

Contact a qualified fireplace contractor.

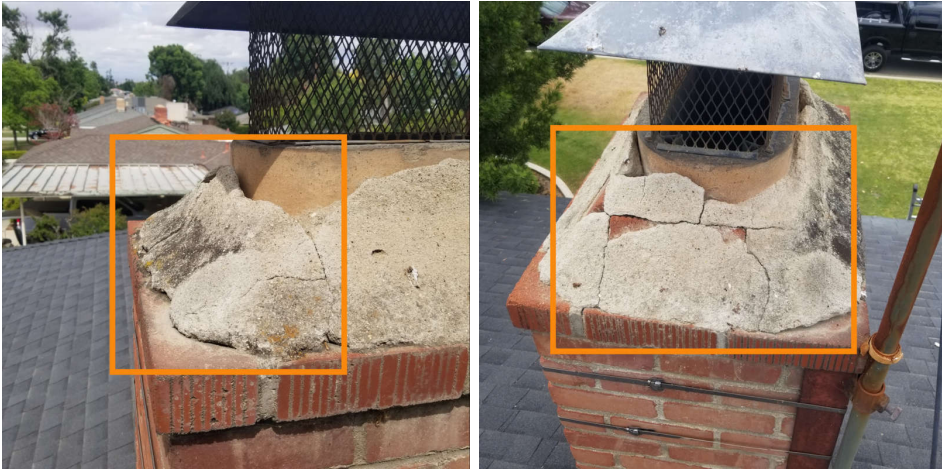
13.2.1 Chimney(s)

CHIMNEY CROWN WAS WORN, CRACKED, MISSING, DETERIORATED

One or more masonry chimney crowns were worn, cracked, missing, deteriorated and/or unstandard. Crowns are meant to keep water off of the chimney structure and prevent damage from freeze-thaw cycles. Recommend that a qualified contractor repair or replace crowns as necessary, and per standard building practices.

Contact a qualified chimney contractor.
