SUMMARY

Equity Building Inspection

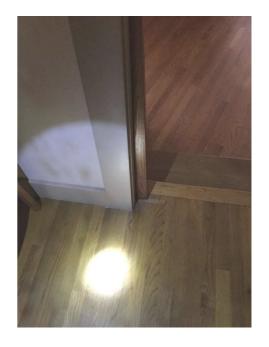
6.4.1 Interior Doors

CLOSET DOOR OFF TRACK

DINING ROOM

The dining room pocket doors in one or more locations were off track. Recommend repair for proper functionality.

Recommendation

Contact a qualified handyman.
