SUMMARY
1234 Main St. Margate Florida 33063
Buyer Name
02/18/2019 9:00AM

Matthew Miller
InterNACHI Certified...
Bless This Nest Inspections, LLC
9545930601
mattmiller1513@gmail.com

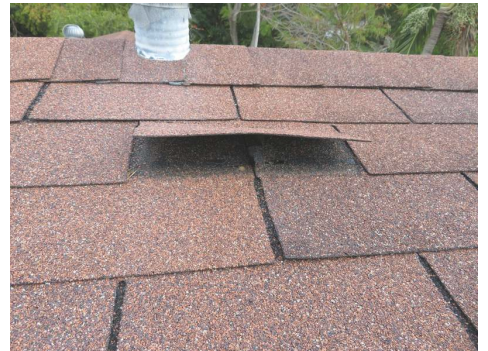
2.2.1 Shingles

SELF SEAL STRIPS LOOSE

Composition shingles were loose because the adhesive, self-sealing strips weren't sealed. Leaks can occur as a result. Self-sealing strips secure the lower edge of shingles and reduce vulnerability to wind damage. Strips may not be sealed because the sealant has failed or because the sealant never activated and cured after the original installation. Recommend that a qualified contractor repair as necessary. For example, by hand sealing shingles with an approved sealant.

Recommendation
Contact a qualified roofing professional.

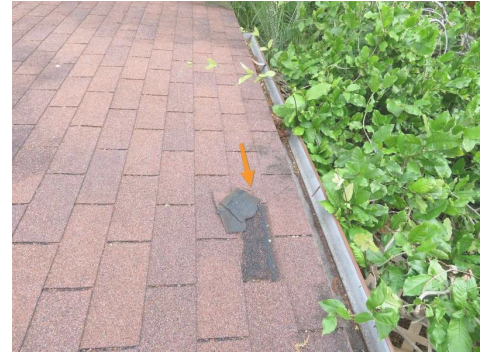
2.2.2 Shingles

SHINGLES DAMAGED

One or more composition shingles were Damaged. Recommend that a qualified contractor repair as necessary. For example, by repairing or replacing shingles. This can reduce the life expectancy of the roofing material.

Recommendation
Contact a qualified roofing professional.

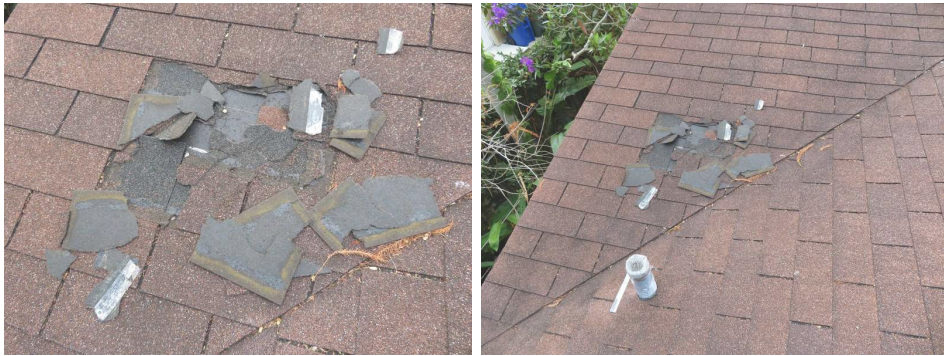
2.2.3 Shingles

SHINGLES MISSING

Roofing shingles were missing. This can cause deterioration and moisture intrusion. Leaks can occur as a result. Recommend that a qualified contractor repair as necessary. For example, by replacing shingles.

Recommendation
Contact a qualified roofing professional.

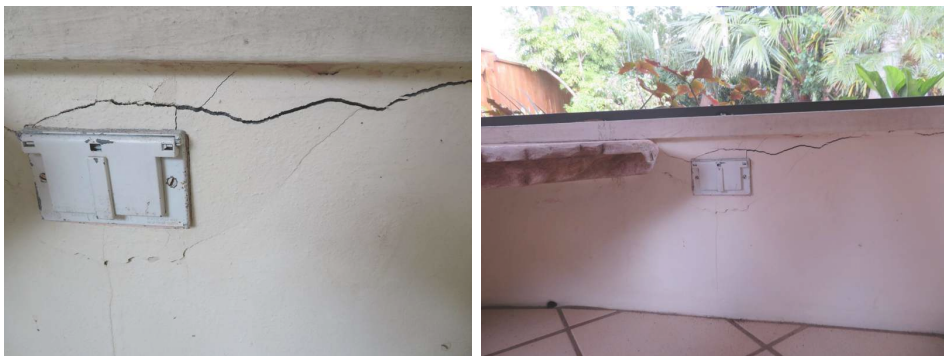
3.2.1 Driveway, Walkway, Patio

SIGNIFICANT CRACKS

One area on the interior side of the the exterior wall of the enclosed porch has a significant crack that appears to be structural. Due to the size and gapping at the cracks, a structural engineer should evaluate. *We recommend Troy Bishop of Axiom Structures.*

Recommendation
Contact a qualified structural engineer.

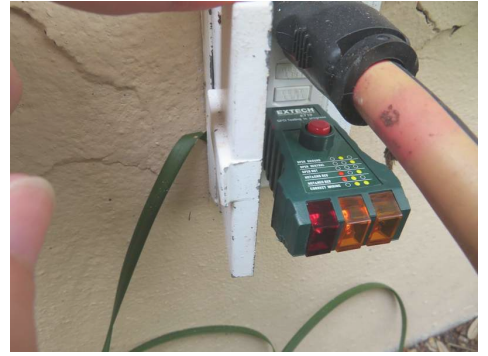
3.4.1 Electrical

GFCI ISSUE

One or more ground fault circuit interrupter (GFCI) receptacles (outlets) were not functioning properly (would not trip/would not reset). Recommend a licensed electrical contractor replace with new GFCI outlet.

Contact a qualified electrical contractor.

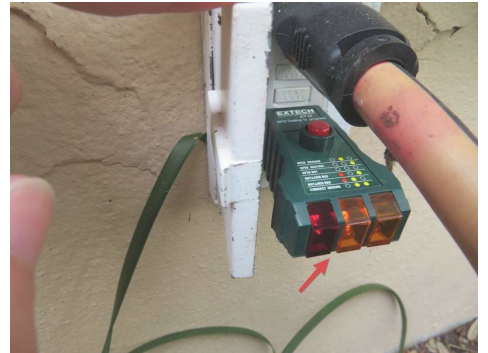
3.4.2 Electrical

HOT-NEUTRAL REVERSE

One or more electric receptacles had reverse-polarity wiring, where the hot and neutral wires were reversed. Sensitive electronics may result in damage. Recommend that a qualified electrician repair as necessary.

Contact a qualified electrical contractor.

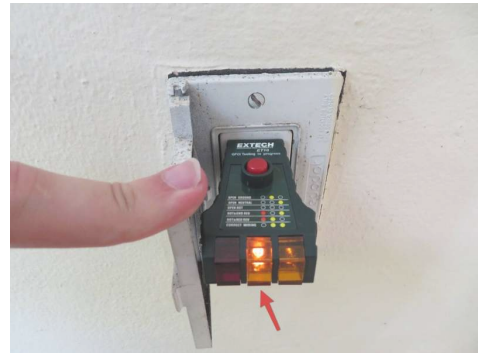
3.4.3 Electrical

OPEN GROUND

One or more modern, 3-slot electric receptacles were found with an open ground. This is a shock hazard when appliances that require a ground are used with these receptacles. Examples of such appliances include computers and related hardware, refrigerators, freezers, portable air conditioners, clothes washers, aquarium pumps, and electrically operated gardening tools. Recommend that a qualified electrician repair as necessary so all receptacles are grounded per standard building practices.

Contact a qualified electrical contractor.

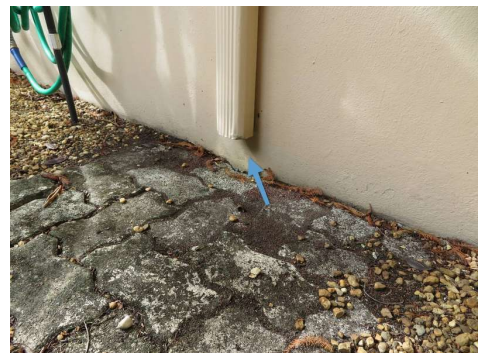
3.7.1 Gutters and Flashing

DOWNSPOUT EXTENSIONS

Extensions such as splash blocks or drain pipes for one or more downspouts were *missing / poorly sloped / misaligned / clogged / substandard / damaged*. Water can accumulate around the building foundation or inside crawl spaces or basements as a result. Recommend the installation of downspout extensions to discharge roof drainage a minimum of 6 feet from the foundation.

Contact a qualified professional.

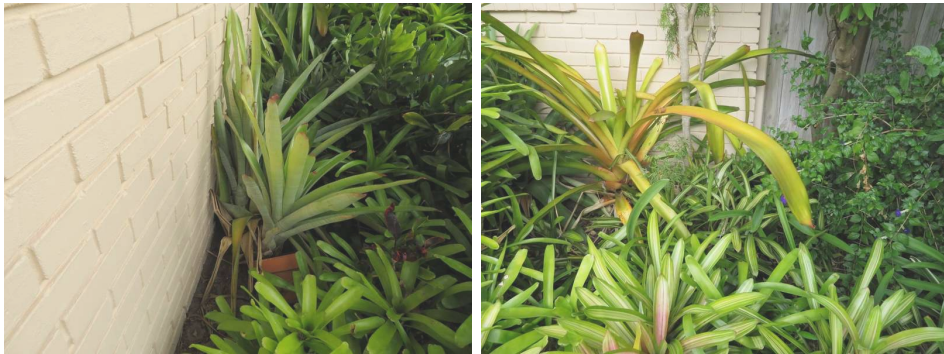
3.9.1 Vegetation and Grading

VEGETATION

Vegetation such as trees, shrubs and/or vines was in contact with or close to the building exterior. Vegetation can serve as a pathway for wood-destroying insects and can retain moisture against the exterior after it rains. This is a conducive condition for wood-destroying organisms. Recommend pruning, moving or removing vegetation as necessary to maintain at least 6 inches of space between it and the building exterior. A 1-foot clearance is better.

Contact a handyman or DIY project

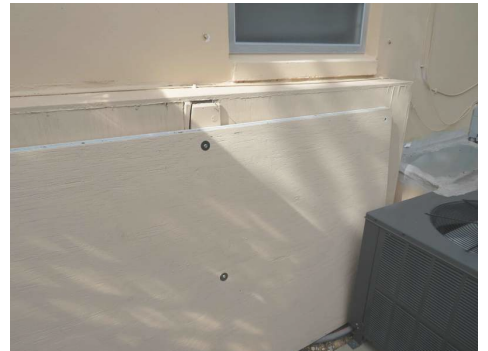
3.10.1 Shutters(decorative and storm)

SHUTTER STORAGE

The storm shutters are stored in an area that is not protected from the elements of the weather. Per the Insurance standards, storm shutters are to be stored in a location that is protected from the elements of the weather. It is recommended to have the storm shutters located in a protected area from the elements of the weather.

Contact a handyman or DIY project

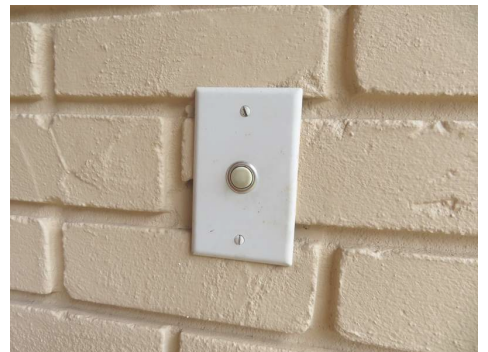
4.1.1 Electrical

DOORBELL INOPERABLE

The doorbell appears to be inoperable. It does not ring when pressed. Recommend having a qualified electrician evaluate and repair as necessary.

Contact a qualified electrical contractor.

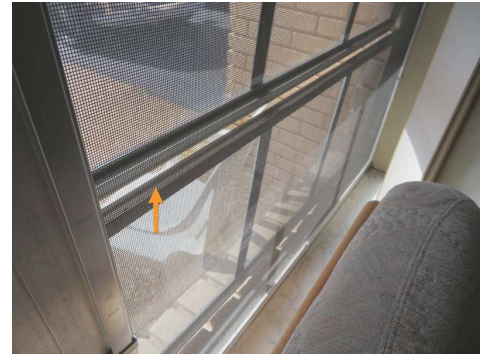
4.4.1 Windows and Door

WINDOW HARD TO OPEN

One or more windows are difficult to open and close. The windows should be adjusted so that they will open and close freely all necessary repairs should be made.

Contact a qualified professional.

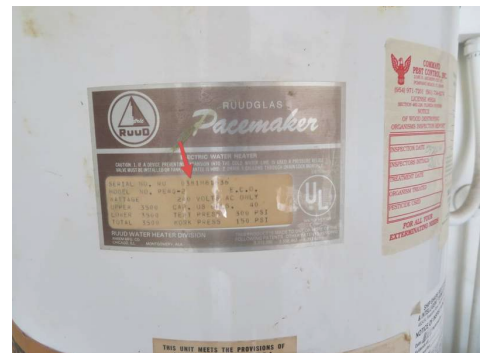
6.1.1 Water Heater

EXCEEDS LIFE EXPECTANCY

Water heater was operable during time of inspection and no signs of rust or leaks. However, the estimated useful life for most water heaters is 8 to 12 years. This water heater appears to be much older and could need replacing at any time. Recommend budgeting for a replacement in the near future.

Contact a qualified plumbing contractor.

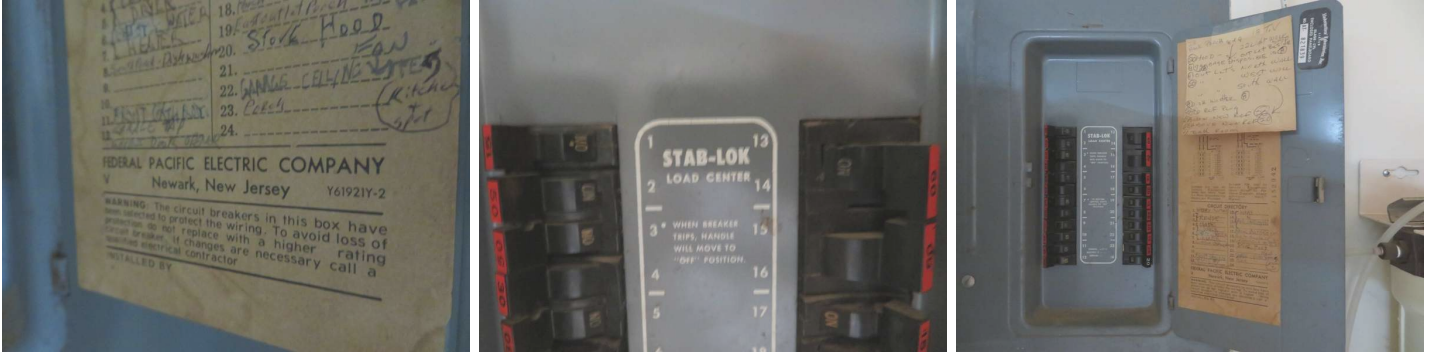
7.1.1 Electric Panel

FPE/CHALLENGER

An electric panel was manufactured by the Federal Pacific Electric/Challenger company and used "Stab-Lok" circuit breakers. There is evidence that both double and single pole versions of these circuit breakers fail by not tripping when they are supposed to. However, in 2011 the Consumer Products Safety Commission (CPSC) closed an investigation into this product because they did not have enough data to establish that the circuit breakers pose a serious risk of injury to consumers. Regardless, and due to other evidence of safety issues, recommend that a qualified electrician carefully evaluate all Federal Pacific panels and make repairs as necessary. Consider replacing Federal Pacific panels with modern panels that offer more flexibility for new, safer protective technologies like ground fault circuit interrupters (GFCIs) and arc fault circuit interrupters (AFCIs).

Recommendation
Contact a qualified electrical contractor.
Estimated Cost
\$1,550 - \$2,000

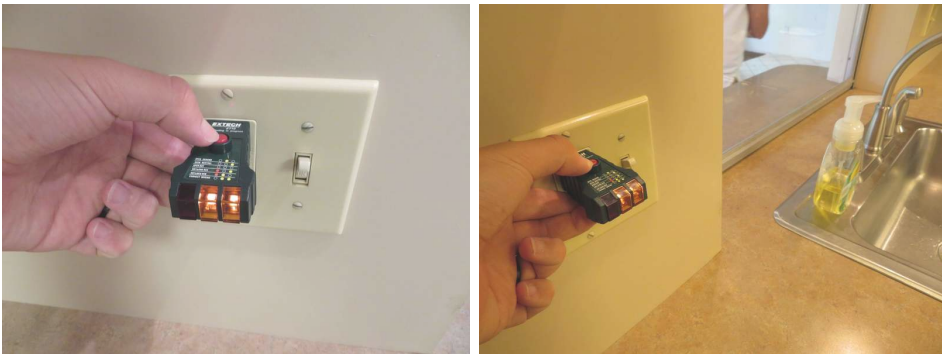
9.3.1 Electrical

GFCI-WONT TRIP

One or more ground fault circuit interrupter (GFCI) electric receptacles did not trip when tested. A qualified electrician should evaluate and repair as necessary.

Recommendation
Contact a qualified electrical contractor.
Estimated Cost
\$150 - \$200

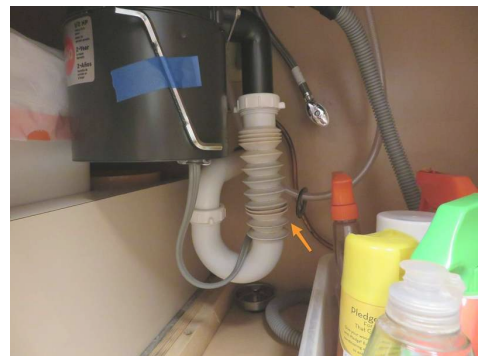
9.5.1 Sink

DRAIN FLEXIBLE PIPE

One or more sink drains use flexible drain pipe. This type of drain pipe is more likely to clog than smooth wall pipe. Recommend having a qualified plumber replace this pipe with standard plumbing components (smooth wall pipe) to prevent clogged drains.

Recommendation
Contact a qualified plumbing contractor.
Estimated Cost
\$150 - \$200

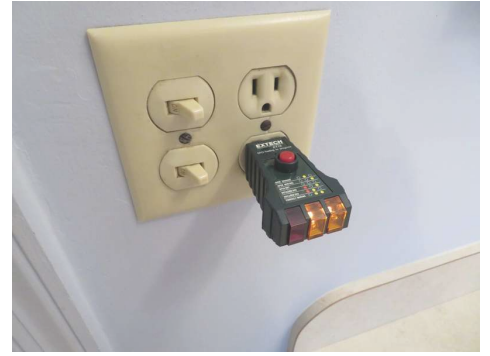
10.3.1 Electrical

GFCI MISSING

One or more electric receptacles at the bathroom(s) had no visible ground fault circuit interrupter (GFCI) protection, or the inspector was unable to determine if GFCI protection was present. If not GFCI-protected, receptacles in wet areas pose a shock hazard. Recommend that a qualified electrician evaluate and install GFCI protection if necessary and per standard building practices. General guidelines for GFCI-protected receptacles include the following locations:

Contact a qualified electrical contractor.

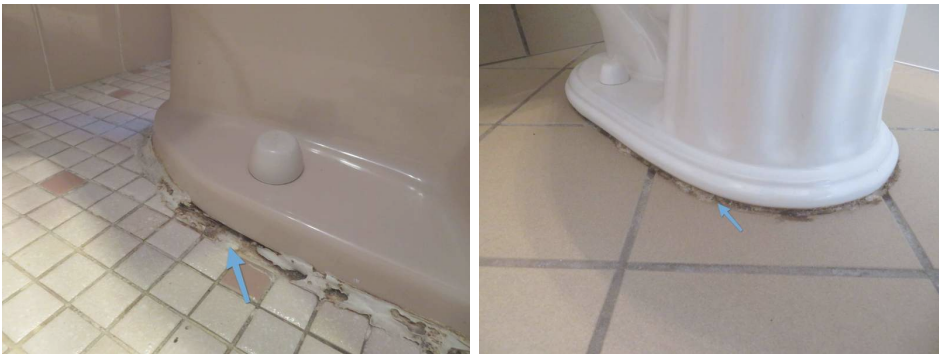
10.8.1 Toilets

NO OR BAD CAULK BASE

Caulk around the base of the toilet was missing, substandard and/or deteriorated. Modern standards require caulk to be installed around the entire toilet base where it meets the floor for sanitary reasons. Without it, soiled water can soak into flooring and sub-floor materials if the toilet overflows. Condensation from the toilet can also soak into the flooring. Recommend that a qualified person caulk around toilet bases per standard building practices.

Recommended DIY Project

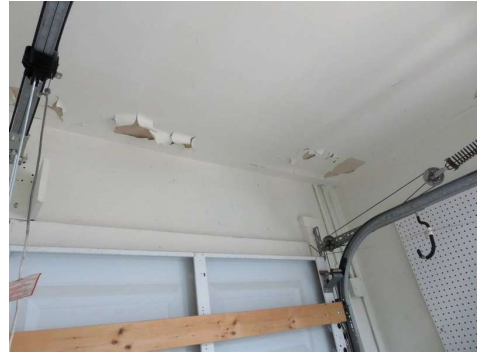
12.3.1 Floors, walls, Ceiling

PEELING PAINT CEILING

Paint is peeling at one or more locations in the ceiling. This is typically due to the heat in the garage and/or poor preparation. The areas should be properly repaired.

Contact a qualified professional.

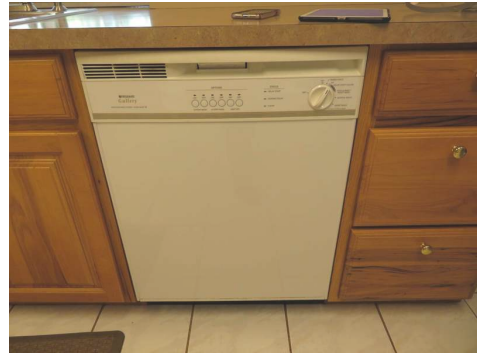
13.2.1 Dishwasher
DISHWASHER INOP

The dishwasher was not run during the inspection. The inspector was informed of a leak and asked not to run it. The client(s) should ask the property owner(s) about this, and if necessary, the dishwasher should be replaced, or a qualified appliance technician should evaluate and repair.

Recommendation
Contact a qualified appliance repair professional.
